CONTAMINATION TECHNICAL MEMORANDUM FOR MAINLINE AND DRAINAGE SITES

Florida Department of Transportation

Harborview Road PD&E Re-evaluation

Limits of Project: From Melbourne Street to I-75

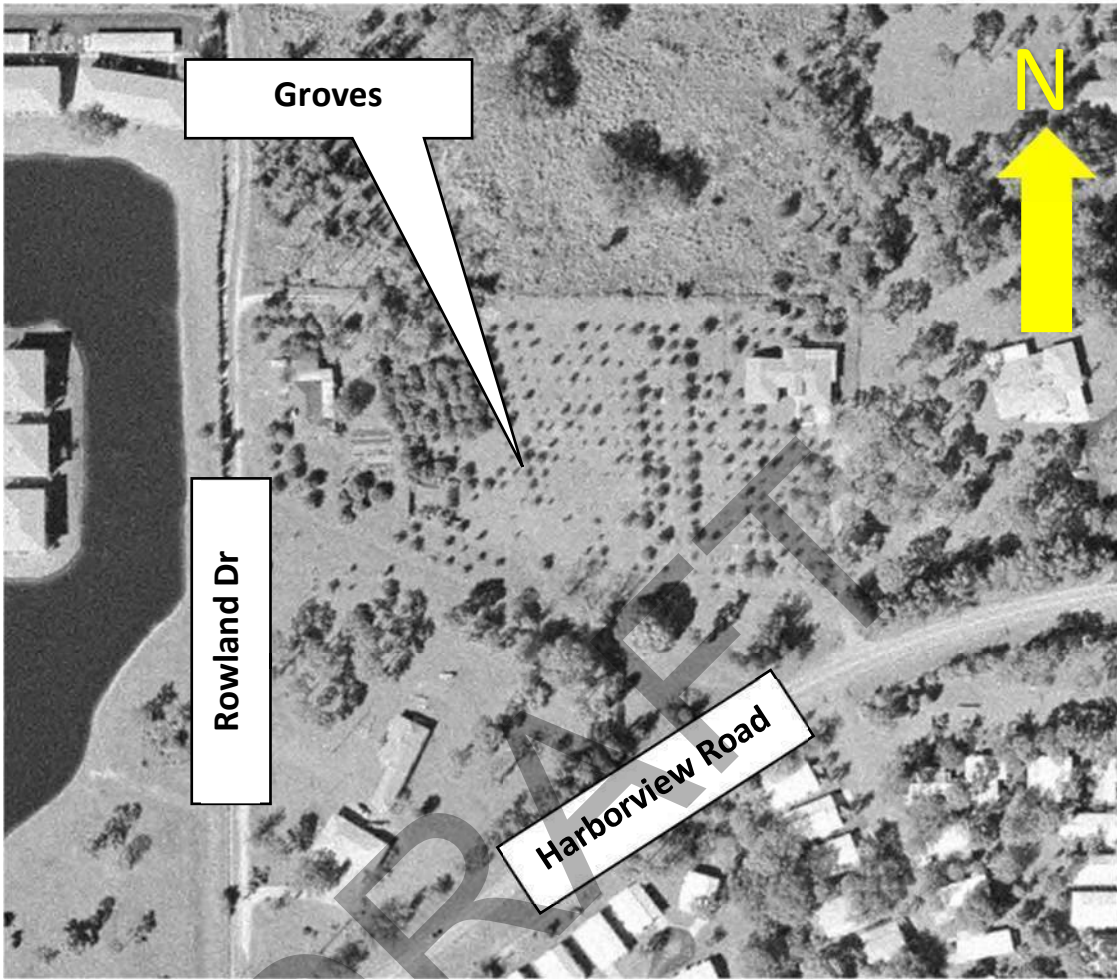
**SITE 7 – FORMER GROVES  
1995 AERIAL PHOTOGRAPH**

In accordance with the PD&E Manual, all sites rated Medium or High should be further evaluated through the completion of Level II testing. One site (Map ID 7– Former Groves) is assigned a risk rating of Medium. None were rated High. Level II testing is recommended given the proximity of the former groves to the Harborview Road ROW.

- One site (Map ID 7 – Former Groves) is assigned a risk rating of Medium. Level II testing is recommended given the potential for contamination impacts related to the use of pesticides and herbicides. The Former Groves appear to be adjoining north of the Harborview Road mainline and therefore Level II testing is warranted. Laboratory analysis of soil samples may include one or more of the following: arsenic by EPA Method 6010, Organochlorine Pesticides by EPA Method 8081, Organophosphorus Pesticides by EPA Method 8141, and Chlorinated Herbicides by EPA Method 8151. If impacts from this site are identified during Level II testing, Level III support activities such as source removal

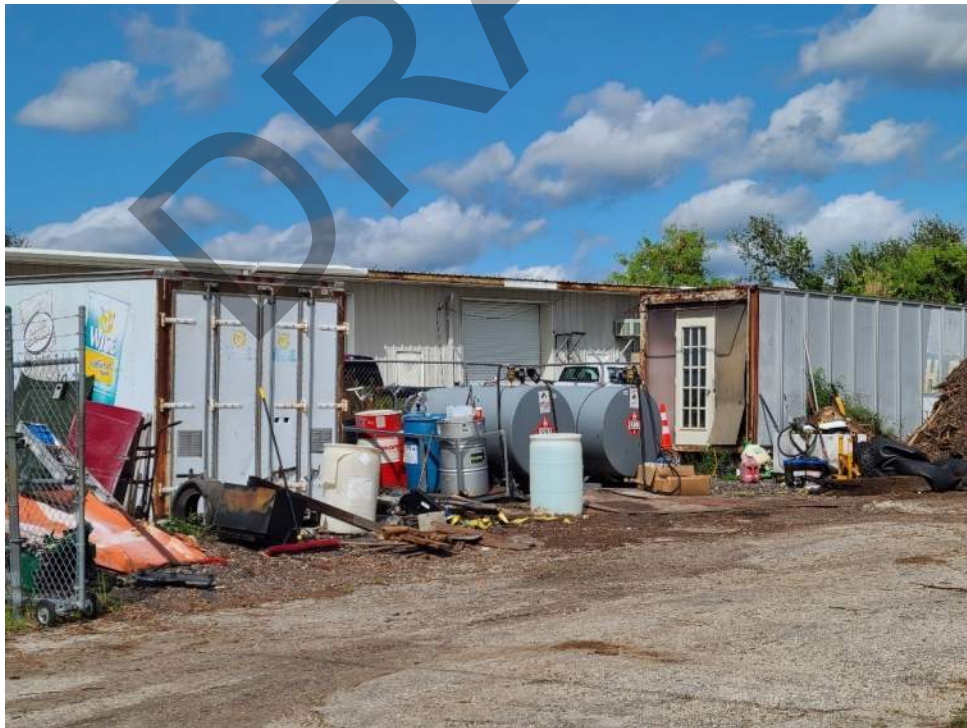
Site 2 – Former Bailey’s Towing  
Two petroleum ASTs and drums miscellaneous use

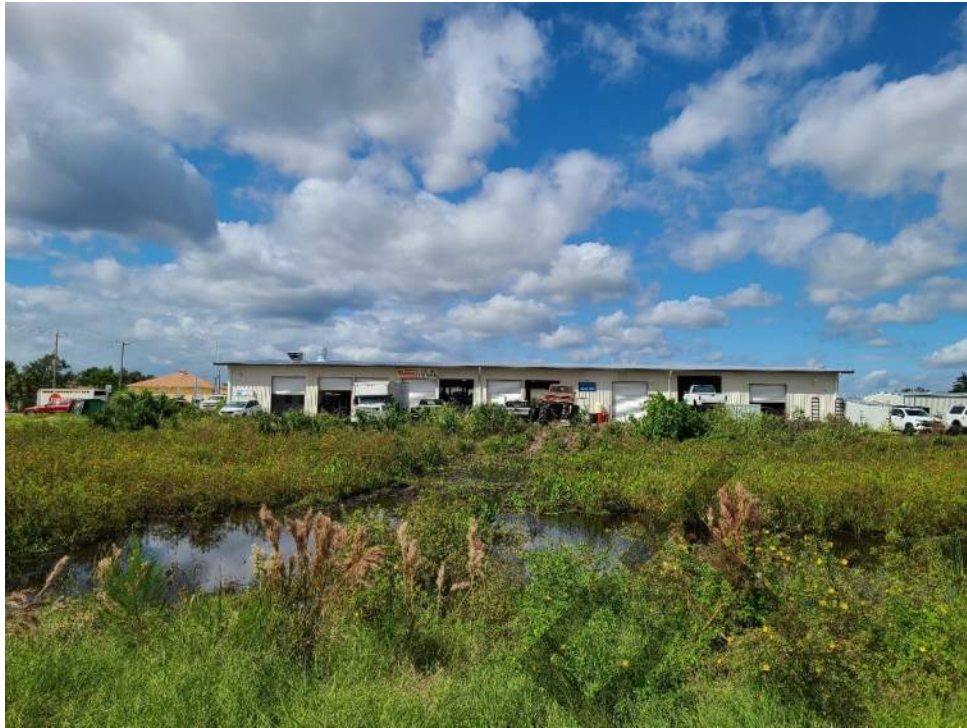
8	<b>Clune's Autobody Inc./Dr. D's Auto &amp; Marine Repair</b> 23415 Janice Avenue Punta Gorda, FL	2023 Re-Evaluation MapDirect Aerial photographs Site reconnaissance	Adjoining north of Harborview Road ROW  Hydraulic lifts adjacent 120 feet north	Petroleum	Low	This site was first identified in the April 2023 Re-evaluation and was assigned a risk rating of Low due to a lack of reported contamination concerns. During the April 2023 and October 2023 site reconnaissance, this site was observed as Clunes Autobody, Inc. Hydraulic lifts were observed inside the autobody shop approximately 120 feet north of Harborview Road ROW. No subsequent regulatory files were identified since the April 2023 Re-evaluation.  <b>Risk Rating:</b> Given the lack of reported contamination concerns, and a separation distance of 120 feet of the hydraulic lifts from the Harborview Road ROW, this site retains a risk rating of Low.

Site 8 – Clune’s Autobody Inc/Dr. D’s Auto & Marine Repair  
North end of Harborview Road and Melbourne Street intersection

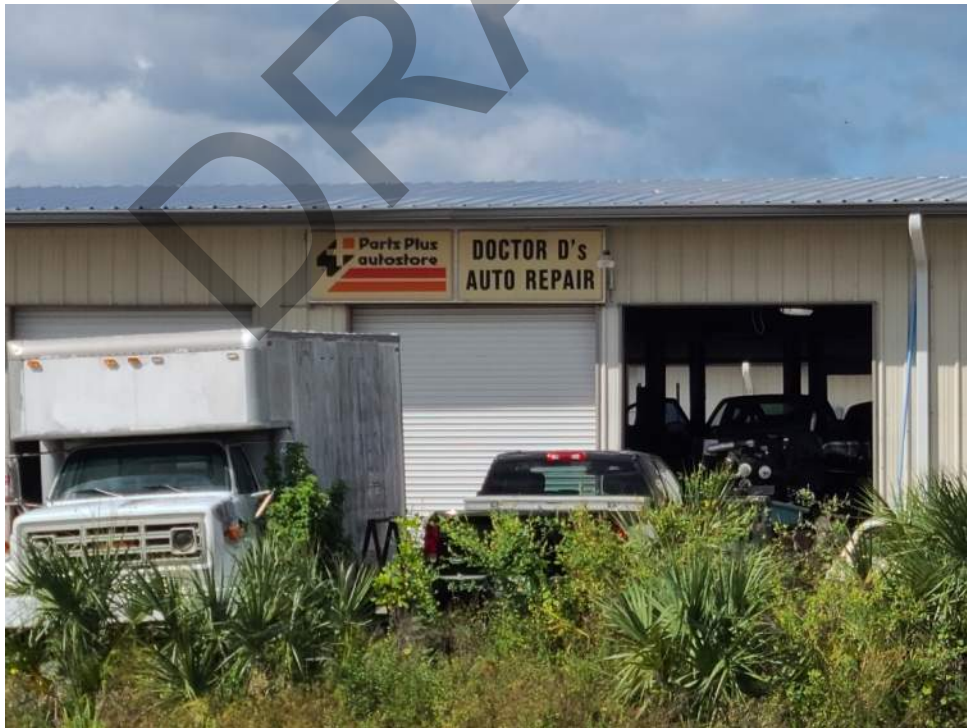
Site 8 – Clune’s Autobody Inc/Dr. D’s Auto & Marine Repair  
North end of Harborview Road and Melbourne Street intersection

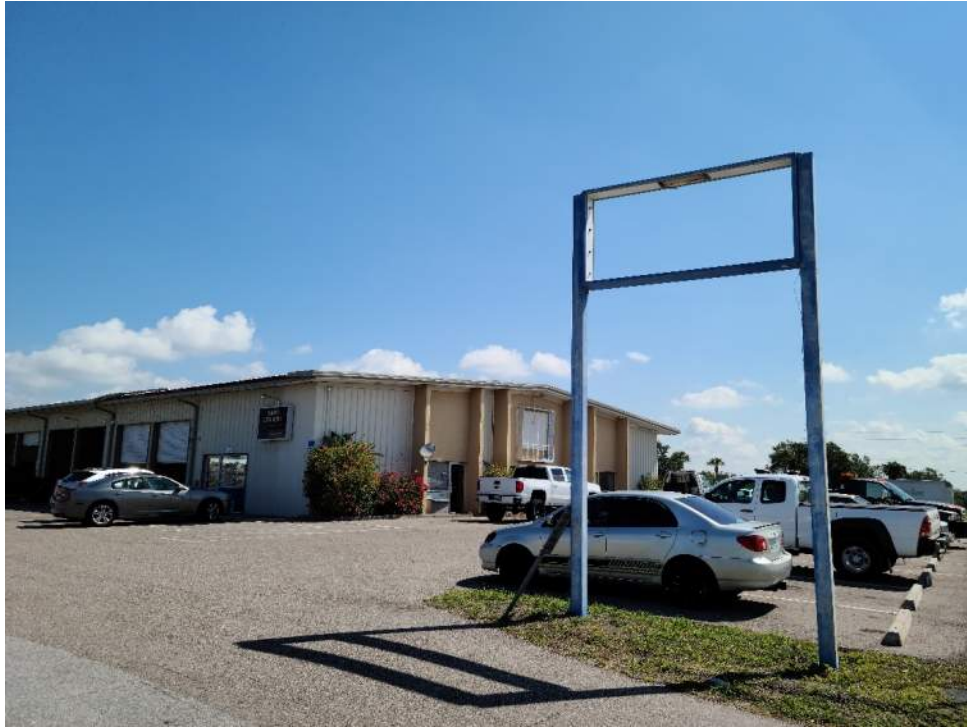
8*	<b>Clune's Auto Body Inc/Dr. D's Auto &amp; Marine Repair</b> 23415 Janice Avenue Punta Gorda	N/A	Low	This site was not previously identified in the PD&E CSER dated October 2018. This site is adjoining Harborview ROW along the western project boundary. According to information found on the FDEP MapDirect database, the site is registered as a Conditionally Exempt Small Quantity Generator of hazardous waste. No discharges have been reported. During the site reconnaissance, this site was observed as Clunes Autobody, Inc. Hydraulic lifts were observed inside the autobody shop approximately 120 feet north of Harborview ROW. No regulatory information was provided after 2010. This site was assigned a risk rating of Low.

Site 8 – Clune’s Auto Body Inc/Former Dr. D’s Auto & Marine Repair  
Harborview Road looking northeast

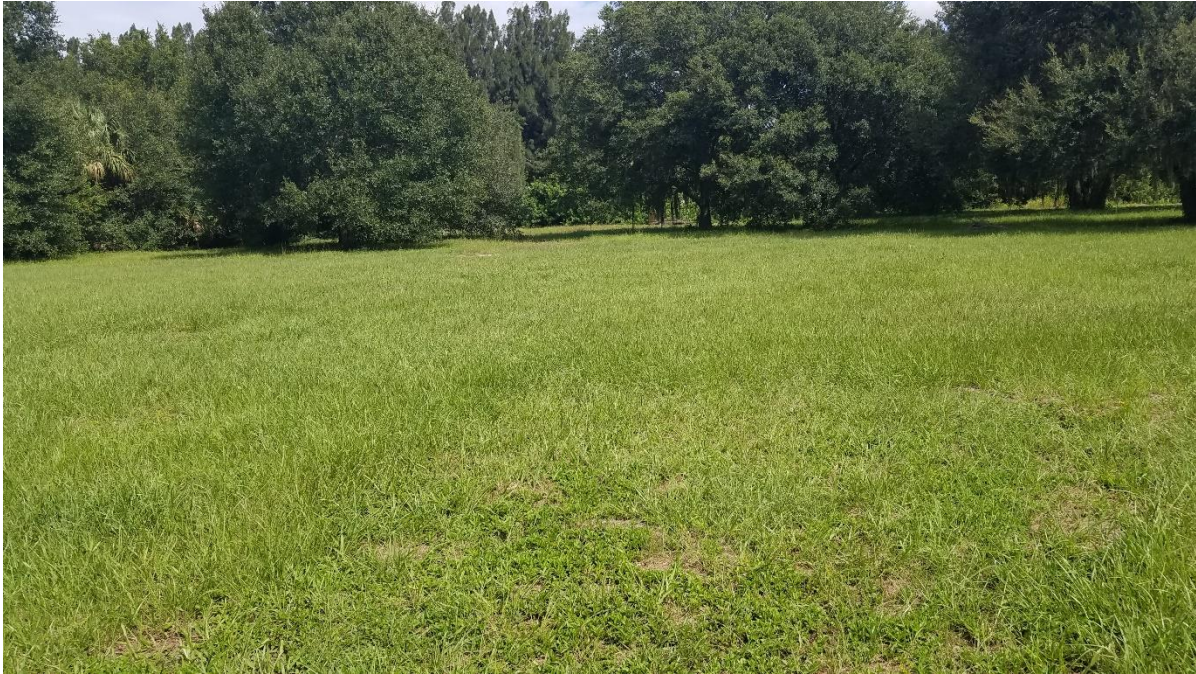
Pond 3C: west-central area looking north

One drainage site (SMF 3) is assigned a risk rating of Medium. None were rated High. Level II testing is recommended given the proximity of the former groves within and adjoining the footprint of SMF 3.

SMF 3	Herbicides Pesticides Petroleum Solid Waste	Medium	<p>This drainage site was first identified in the September 2021 CSER (Drainage) as Pond 3C and was assigned a risk rating of <b>Medium</b> due to the former groves located within this drainage site from 1975 to 2005. Aerial photographs (<b>Appendix B</b>) depict this site as an open field from 2022 to 2023. No likely sources of concentrated contamination concerns such as pole barns, irrigation pumps, or machinery were observed during aerial photograph review. During the September 2021 and October 2023 site reconnaissance, this drainage site was observed as an open field. No regulatory information was identified.</p> <p>One contamination site identified as <b>MAP ID 7 – Former Groves</b> is located within SMF 3. Contamination impacts regarding <b>Map ID 7</b> are anticipated.</p> <p>The nearest offsite contamination concern is <b>Map ID 6 - Former Raulerson Yard Trash Compost Site</b>, Rowland Drive Punta Gorda (Facility ID: 72563, 72909), located 450 feet north of SMF 3. This site was first identified in the September 2021 CSER (Drainage), and the April 2023 Re-evaluation. No subsequent regulatory files were found after the April 2023 Re-evaluation. Contamination impacts are not anticipated.</p> <p><b>Risk Rating:</b> Given the historic land use of groves within SMF 3, this site retains a risk rating of <b>Medium</b>.</p>

- One drainage site identified as SMF 3 is assigned a risk rating of Medium. Level II testing is recommended given the potential for contamination impacts related to the use of pesticides and herbicides. The Former Groves appear to be within and adjoining the SMF 3 drainage site footprint and therefore Level II testing is warranted. Laboratory analysis of soil samples may include one or more of the following: arsenic by EPA Method 6010, Organochlorine Pesticides by EPA Method 8081, Organophosphorus Pesticides by EPA Method 8141, and Chlorinated Herbicides by EPA Method 8151. If impacts from this site are identified during Level II testing, Level III support activities such as source removal and/or dewatering may be required during construction. Level II testing costs are estimated at \$2,000 to \$10,000 per site.
