RE: DRAFT NESHAP Asbestos Survey Report and Screening for Metals-Based Coatings

SR 60 Eastbound over Peace Creek (FDOT Structure No. 160133) SR 60 Westbound over Peace Creek (FDOT Structure No. 160045)

Polk County, Florida FPID: 436559-1-22-01

# DRAFT NESHAP ASBESTOS SURVEY AND SCREENING FOR METALS-BASED COATINGS

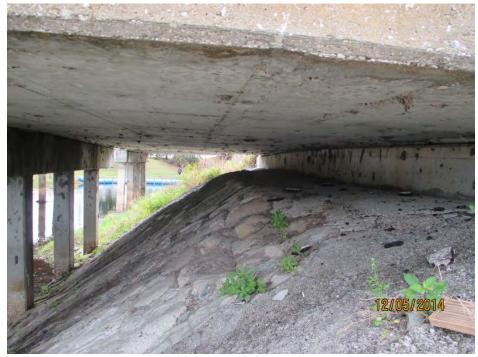
Photo 2: Homogeneous Area # 1 (Samples 001B-003B) Gray Concrete w/ Aggregate, End Bent (160045)

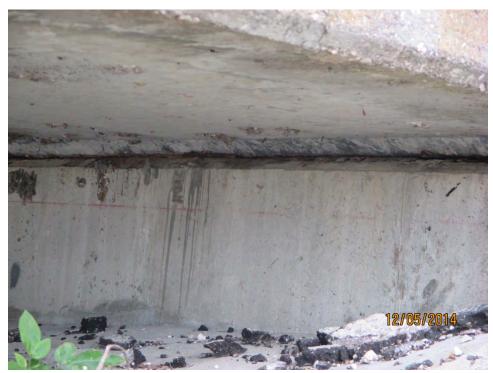
Photo 3: Homogeneous Area #2 (Samples 004B-006B) Black Tar Paper, Bent and Homogeneous Area #6 (Samples 016B-018B) Light gray concrete, Deck (160045)

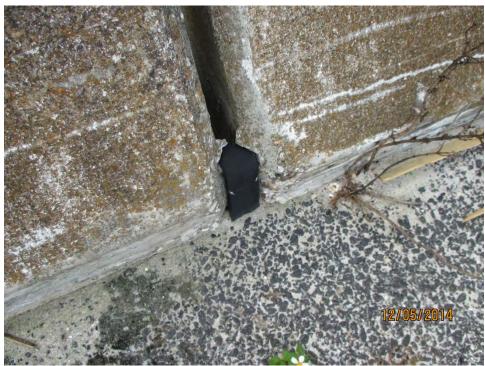
Photo 4: Homogeneous Area # 3 (Samples 007T-009T) Black expansion fill, Deck (160045)

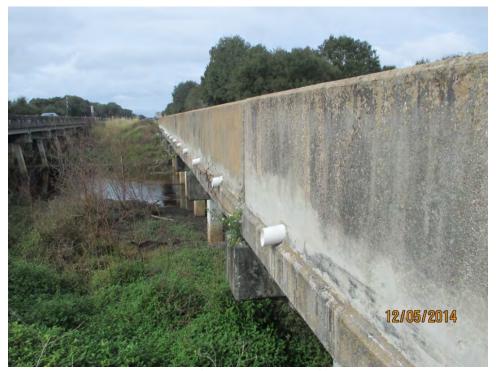
Photo 5: Homogeneous Area #4 (Samples 010S-012S) Gray Concrete, Barrier Wall (160045)

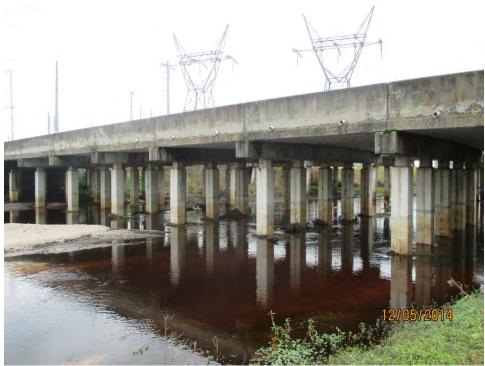
Photo 6: Homogeneous Area #5 (Samples 013B-015B) Smooth gray concrete w/ fiberglass coat, Pile (160045)

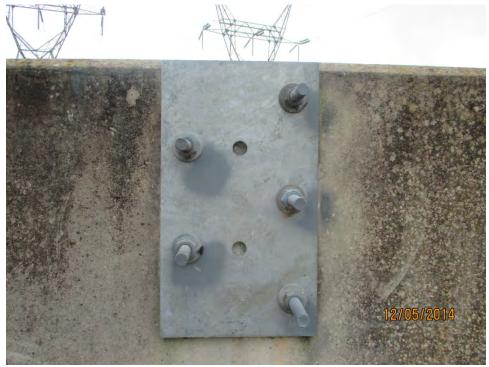
Steel surfaces with suspected metals-based paints and/or protective coatings were observed on one (1) of the bridge structures during the survey, SR 60 Westbound over Peace Creek bridge structure (FDOT No. 160045). The gray coating was observed on three (3) steel mounting plates used to attach the guardrails to the handrails. One (1) of the mounting plates was approximately 1' x 1' and the other two (2) mounting plates were approximately 2' x 1' in size.

Photo 7: 2' x 1' steel mounting plate on Bridge Structure 160045 (Sample PC-1)

Based on the presence of metals in the paints, any renovation activities which could result in exposure to workers, such as sand blasting, should be performed in accordance with OSHA regulations to protect workers. Based on the total concentrations of the above metals it does appear that the paint waste would be deemed a hazardous waste. However, the method used to remove the paint has an impact on the outcome of the waste determination (i.e. sandblasting verses solvent based paint removers). A sample of the actual waste generated during the renovation process should be tested prior to disposal.

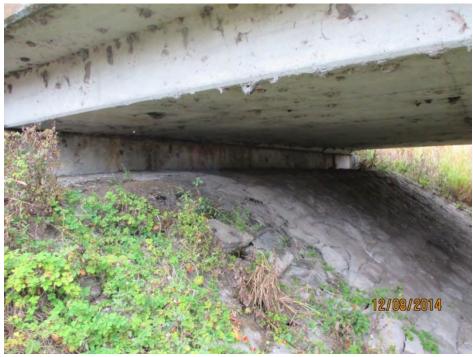
Photo 9: Homogeneous Area # 1 (Samples 016B-018B) Gray Concrete w/ Aggregate, End Bent (160133)

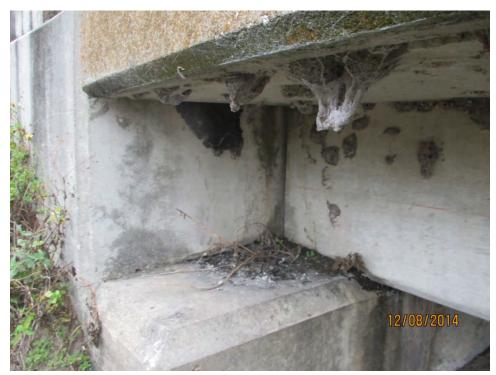
Photo 10: Homogeneous Area #2 (Samples 019B-021B) Black Tar Paper, Bent (160133)

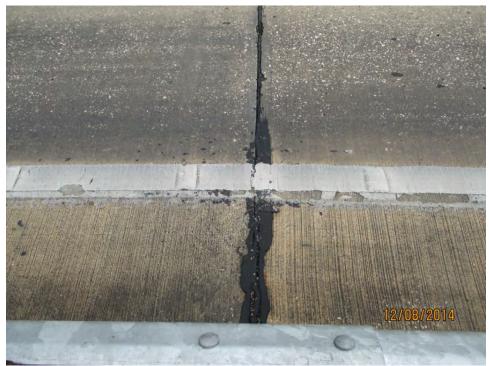
Photo 11: Homogeneous Area # 3 (Samples 022T-024T) Black Expansion Fill, Deck (160133)

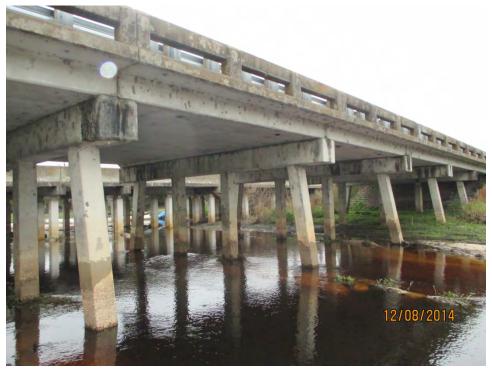
Photo 12: Homogeneous Area #4 (Samples 025T-027T) Gray Concrete, Hand Rail and Homogeneous Area # 7 (Samples 034B-036B) Smooth gray concrete, Pile (160133)

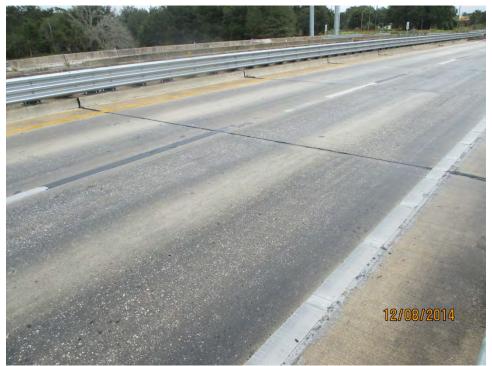
Photo 13: Homogeneous Area #5 (Samples 028T-030T) Gray Concrete w/ black coat, Deck (160133)

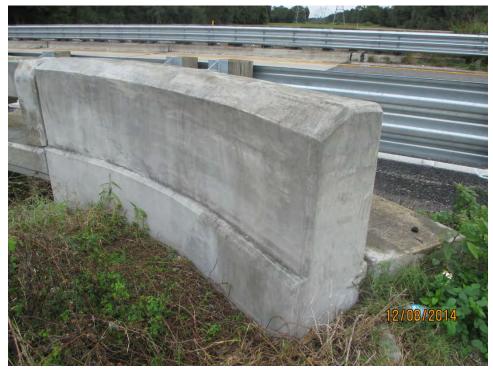
Photo 14: View of Homogeneous Area #6 (Samples 031S-033S) Light Gray Concrete, Wingwall (160133)

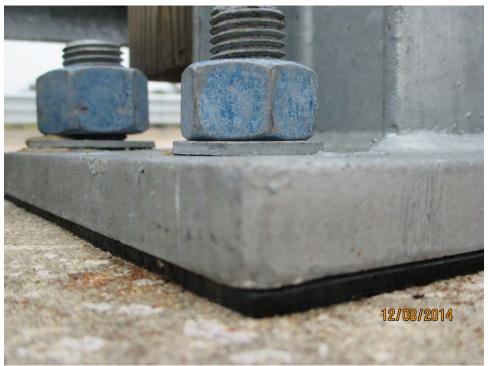
Photo 15: View of Homogeneous Area #8 (Samples 037T-039T) Black Pad, Guardrail (160133)

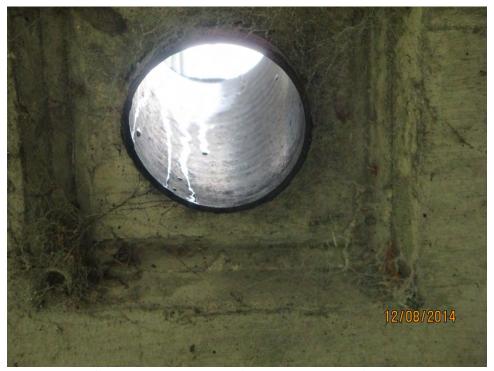
Photo 16: View of Homogeneous Area #9 (Samples 040B-042B) Black Drain Pipe, Deck (160133)
