PRELIMINARY ENGINEERING REPORT

Florida Department of Transportation

DeSoto Bridge Replacement SR 55 US 301/US 41

Financial Management Number: 442630-1

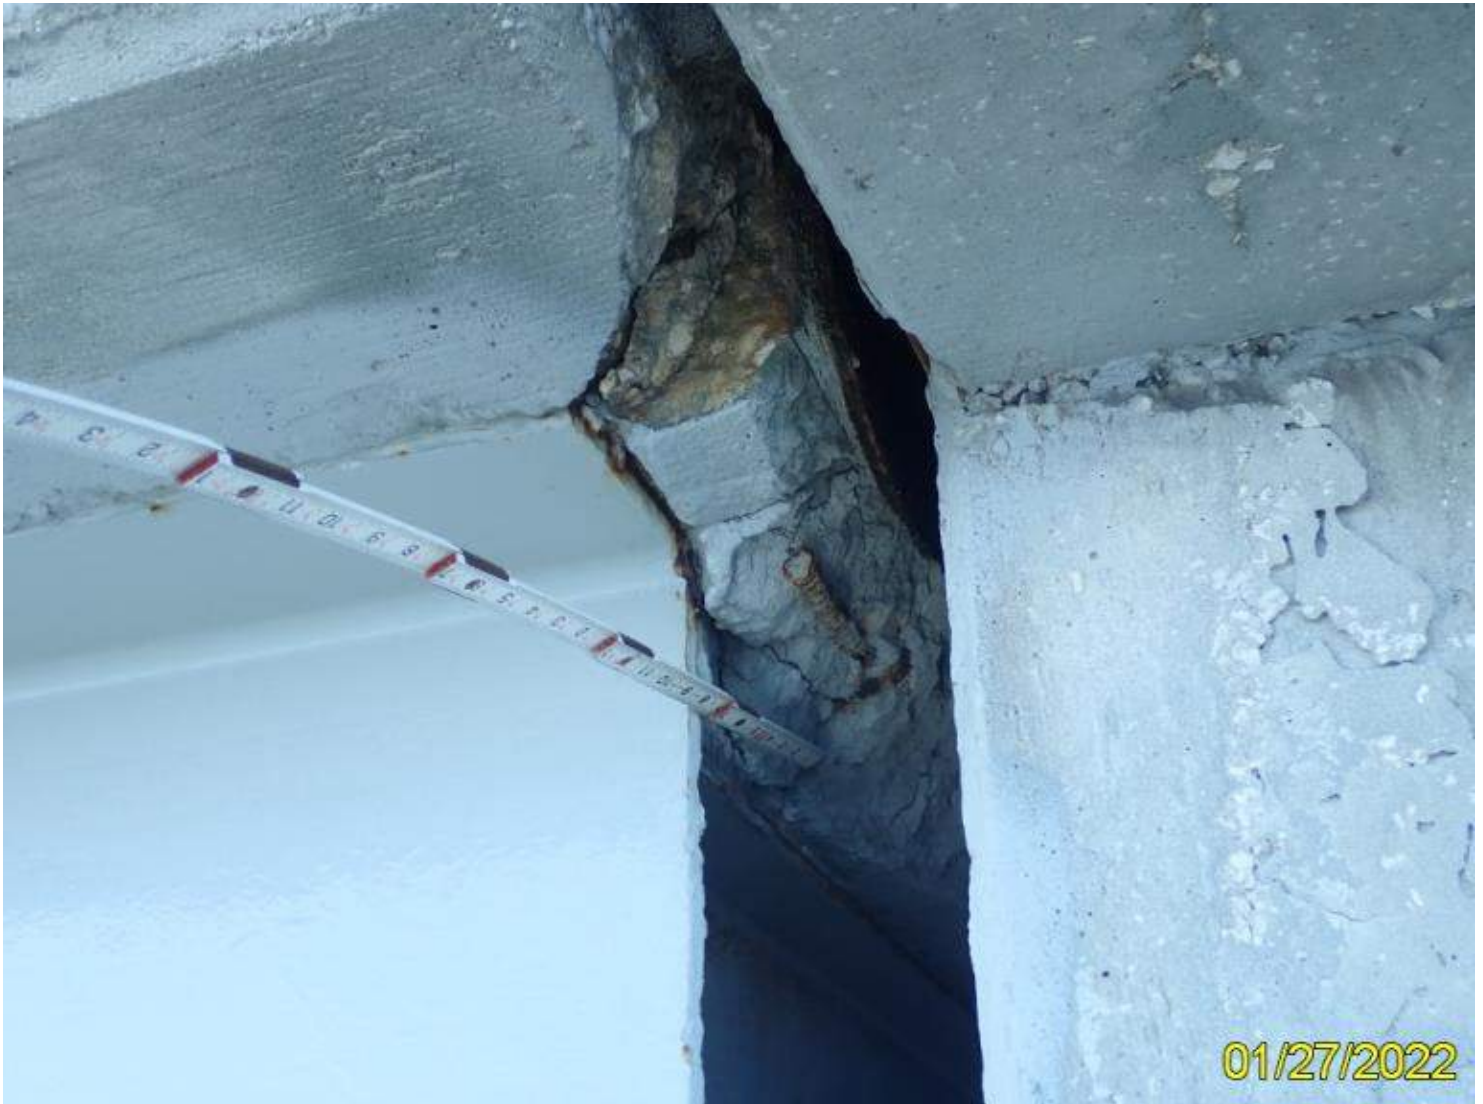
Photo 1 - Element 12 Re Concrete Deck

Span 18 deck underside right (NB) at Pier 19 spall with exposed rebar

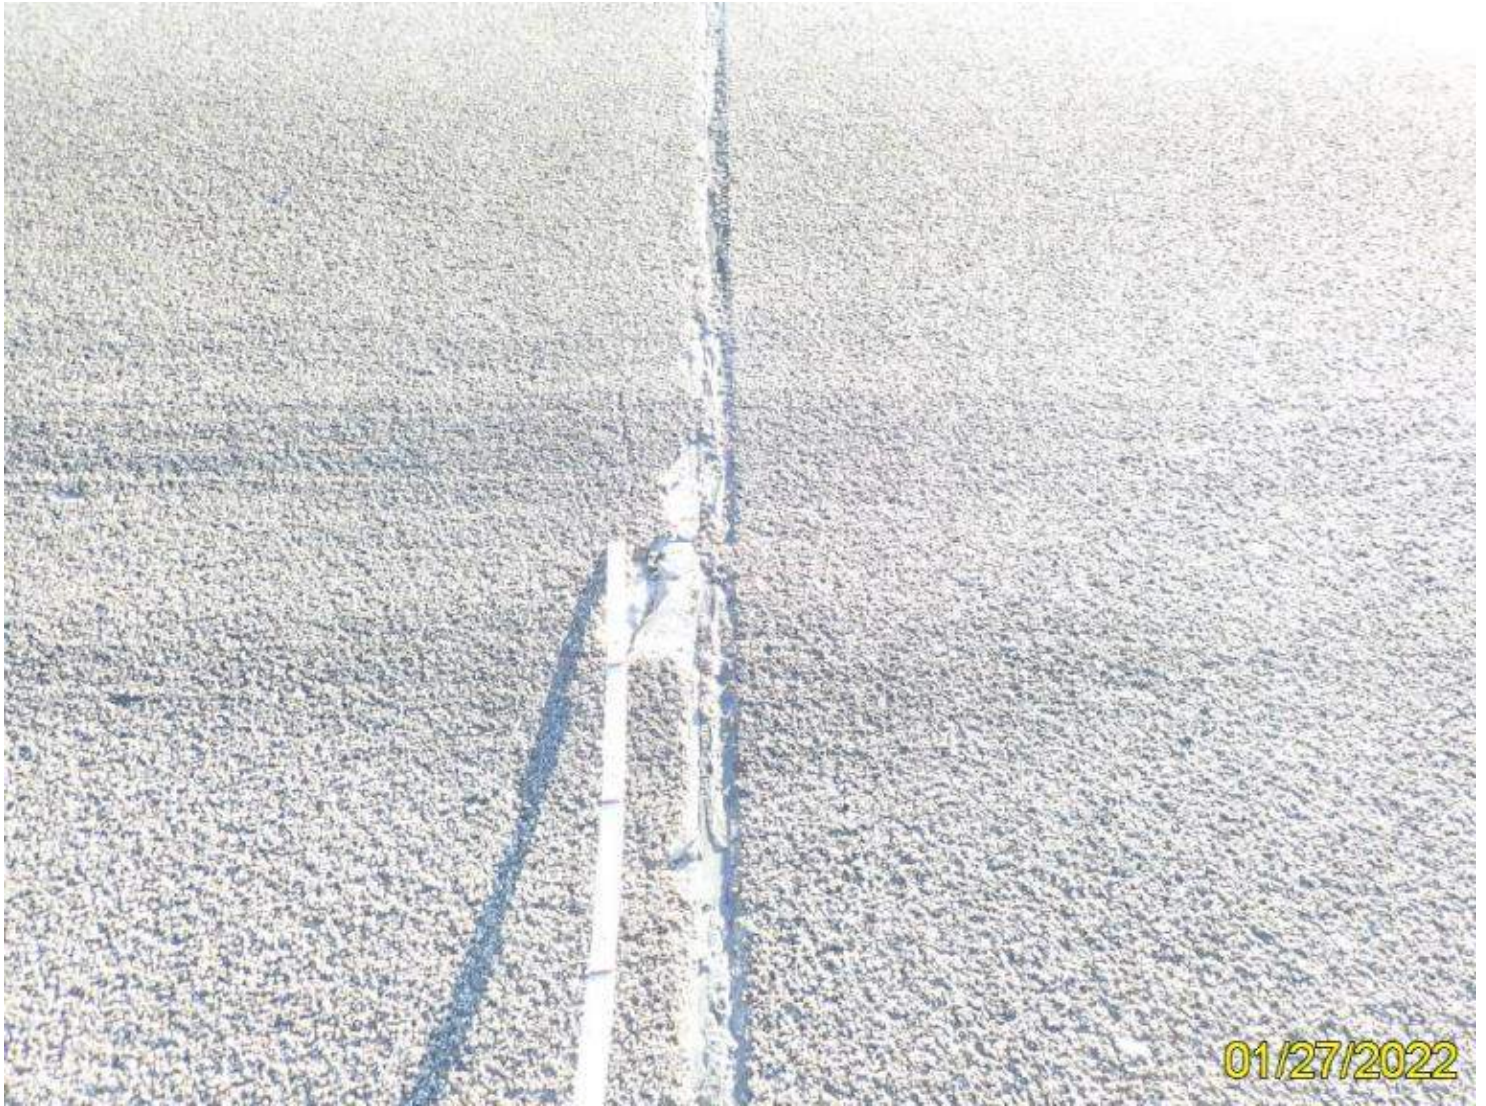
Photo 2 - Element 12 Re Concrete Deck (510 Wearing Surfaces)

Unsound area in the right wheel path of Lane 1 at Pier 18

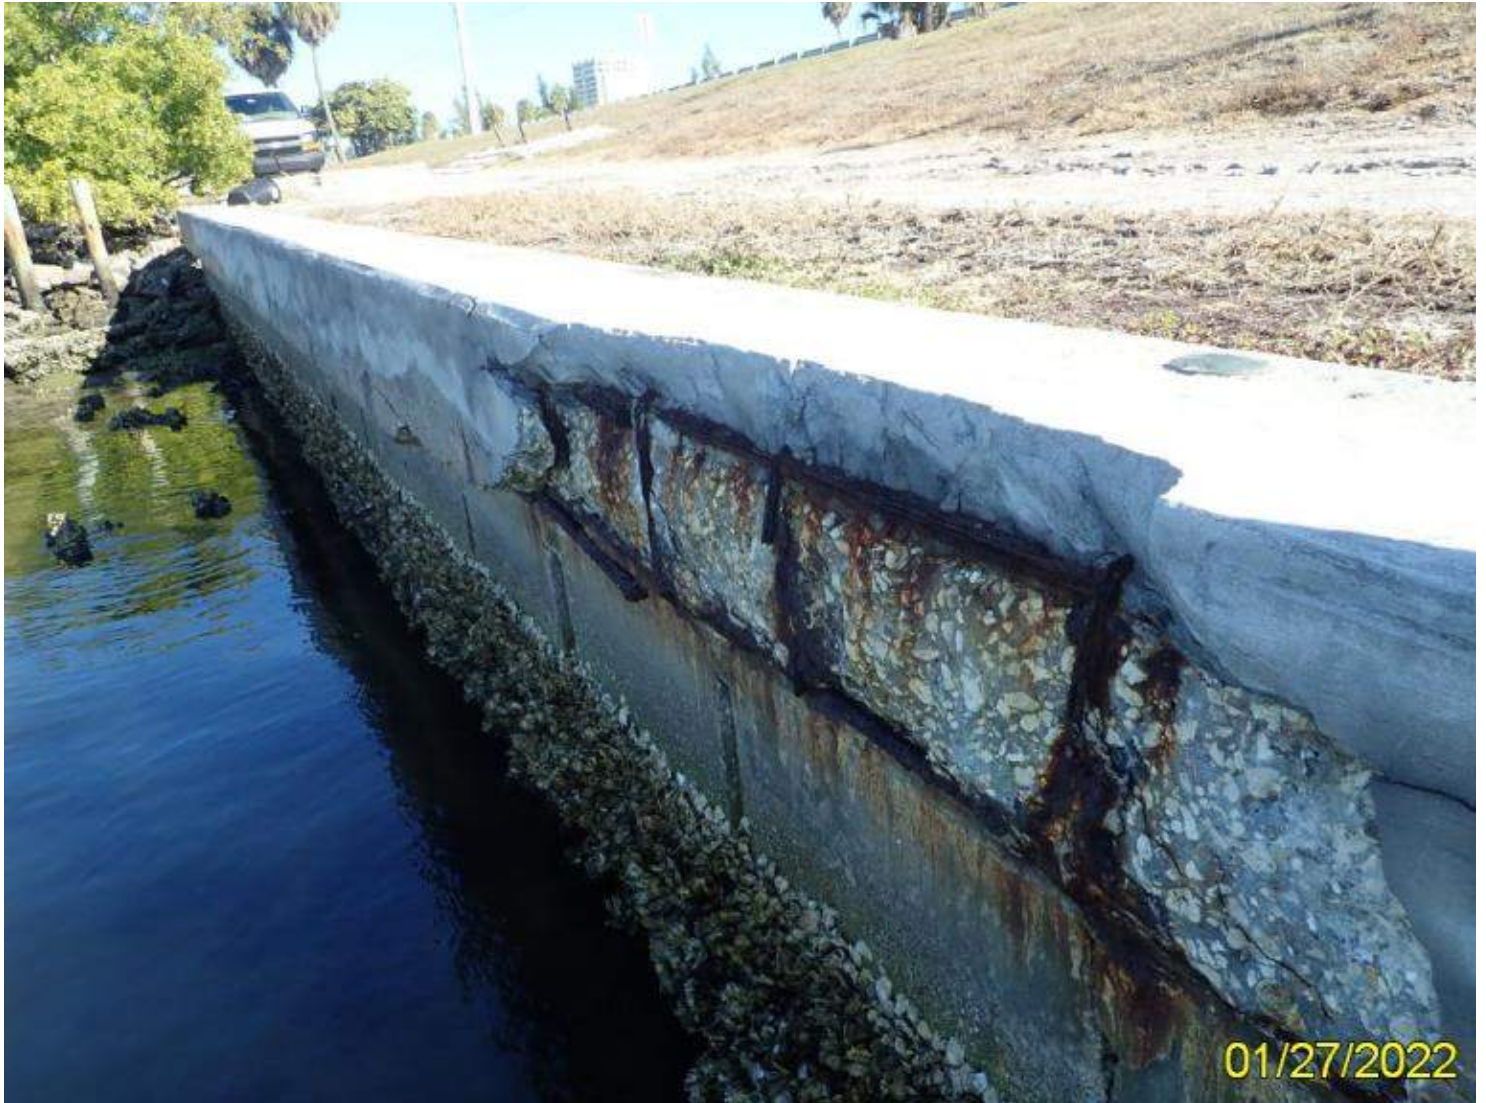
Photo 3 - Element 8290 Channel

Typical spall with exposed steel in the north seawall cap

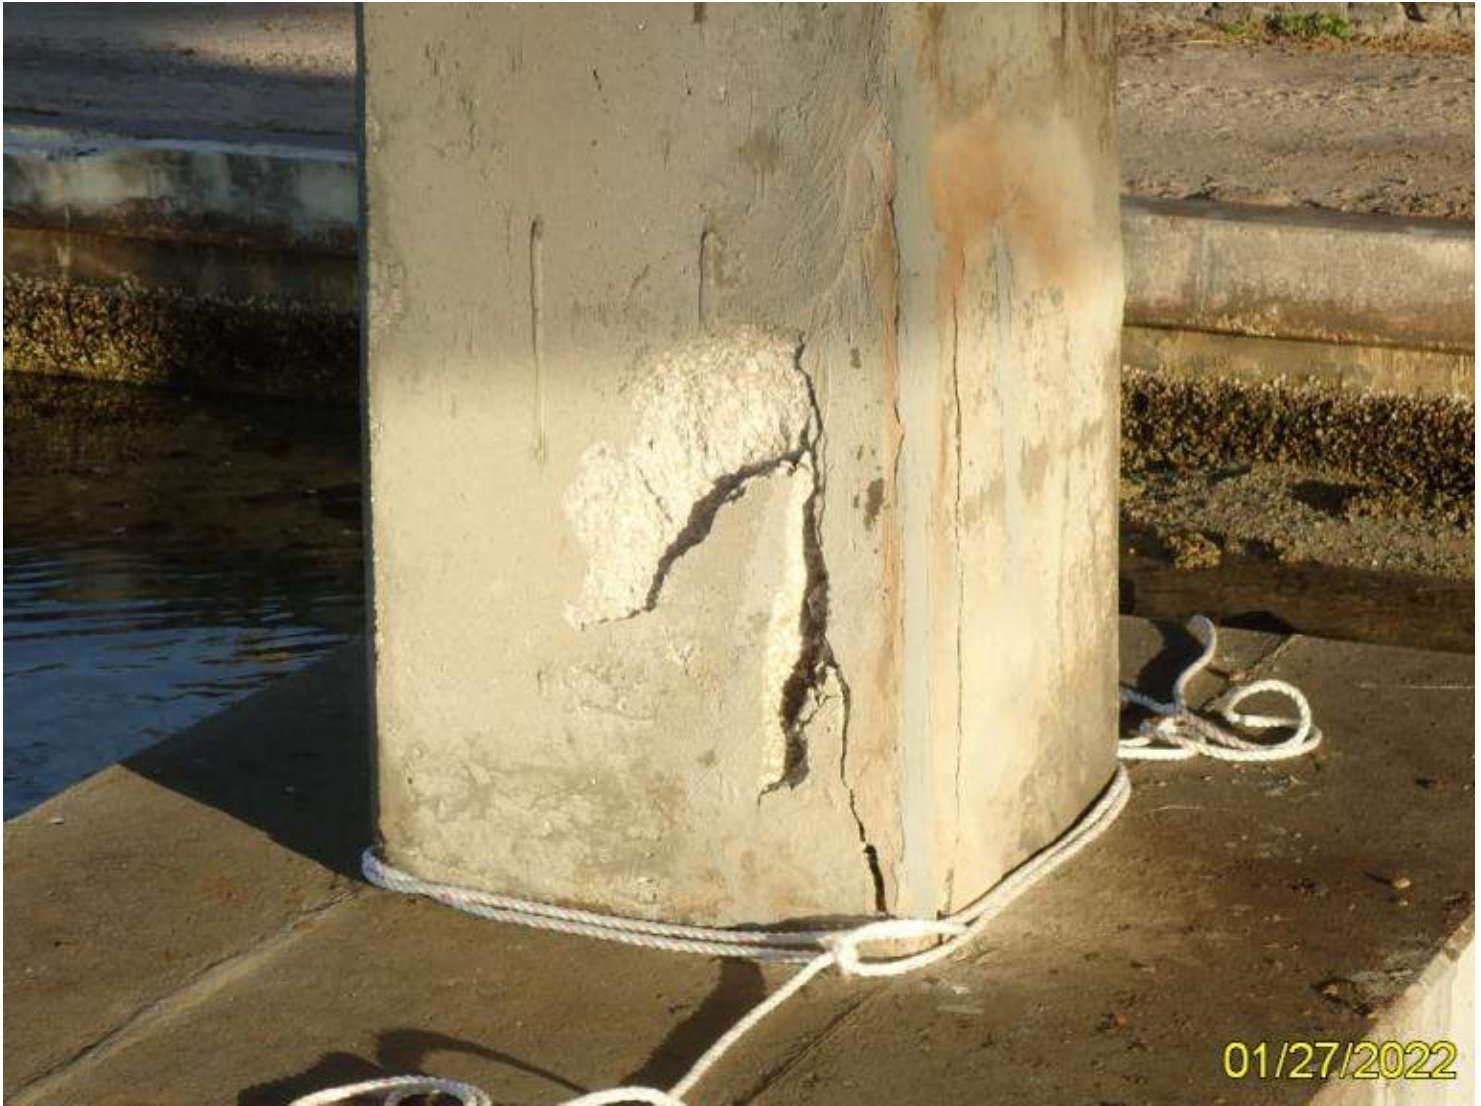
Photo 4 - Element 205 Re Conc Column

Column 33-1 delamination and associated spalls in the south face

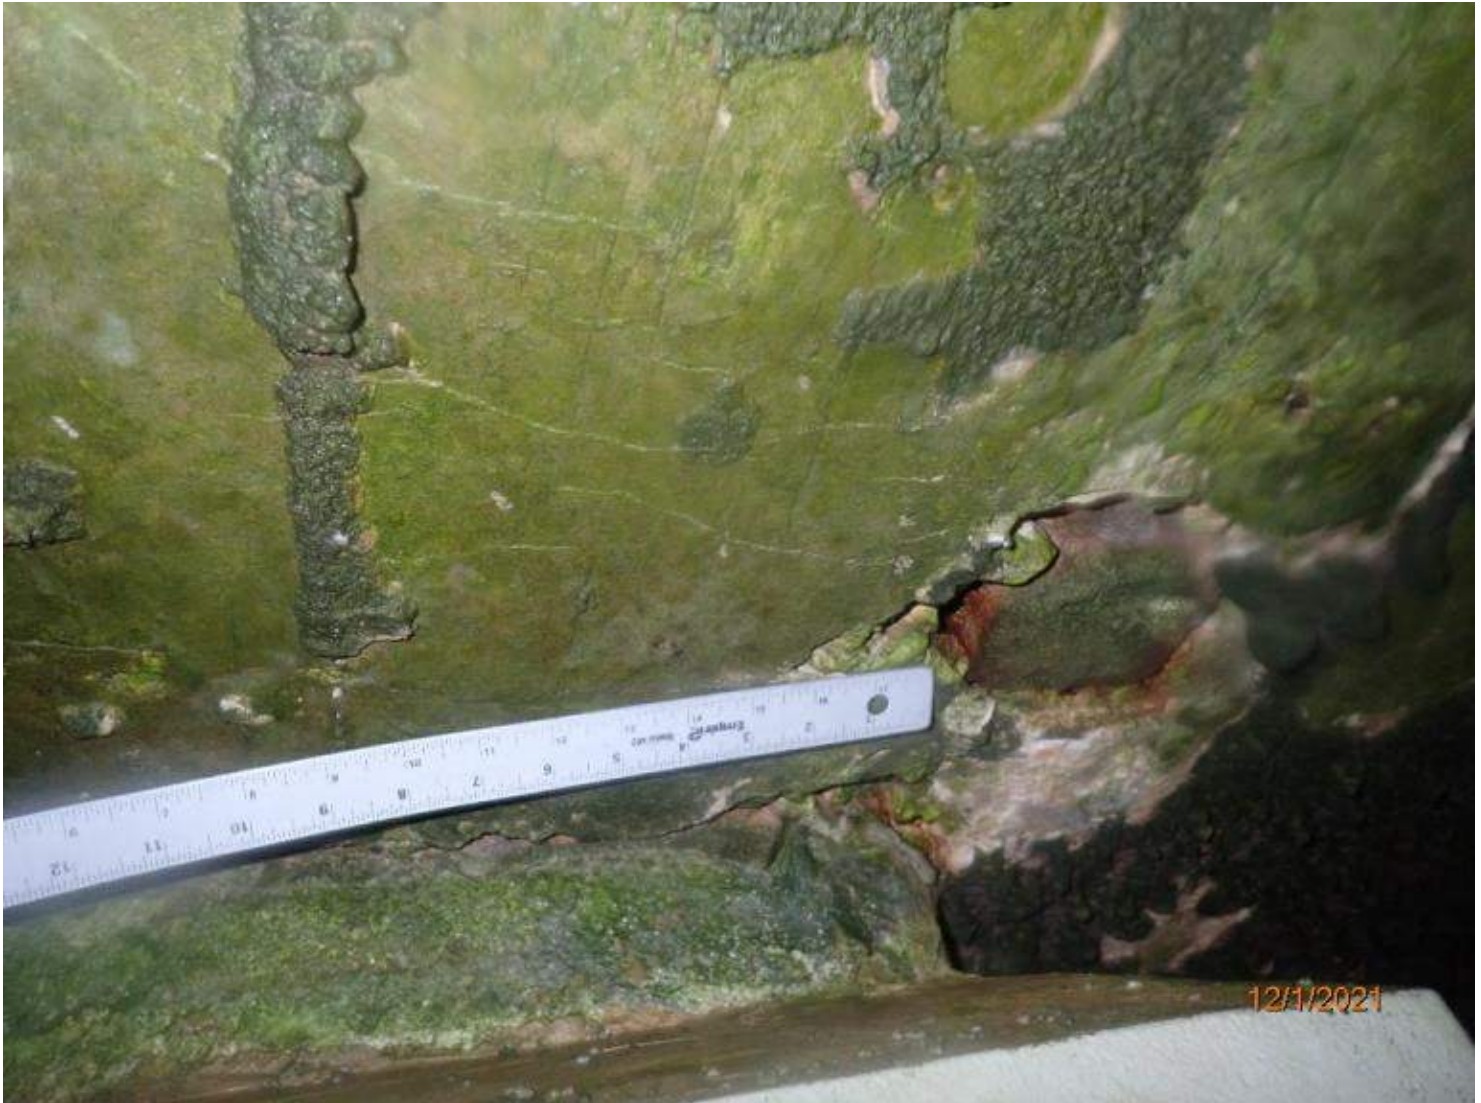
Photo 5 - Element 220 Re Conc Pile Cap/Ftg

Footing 5-1 Spall delamination

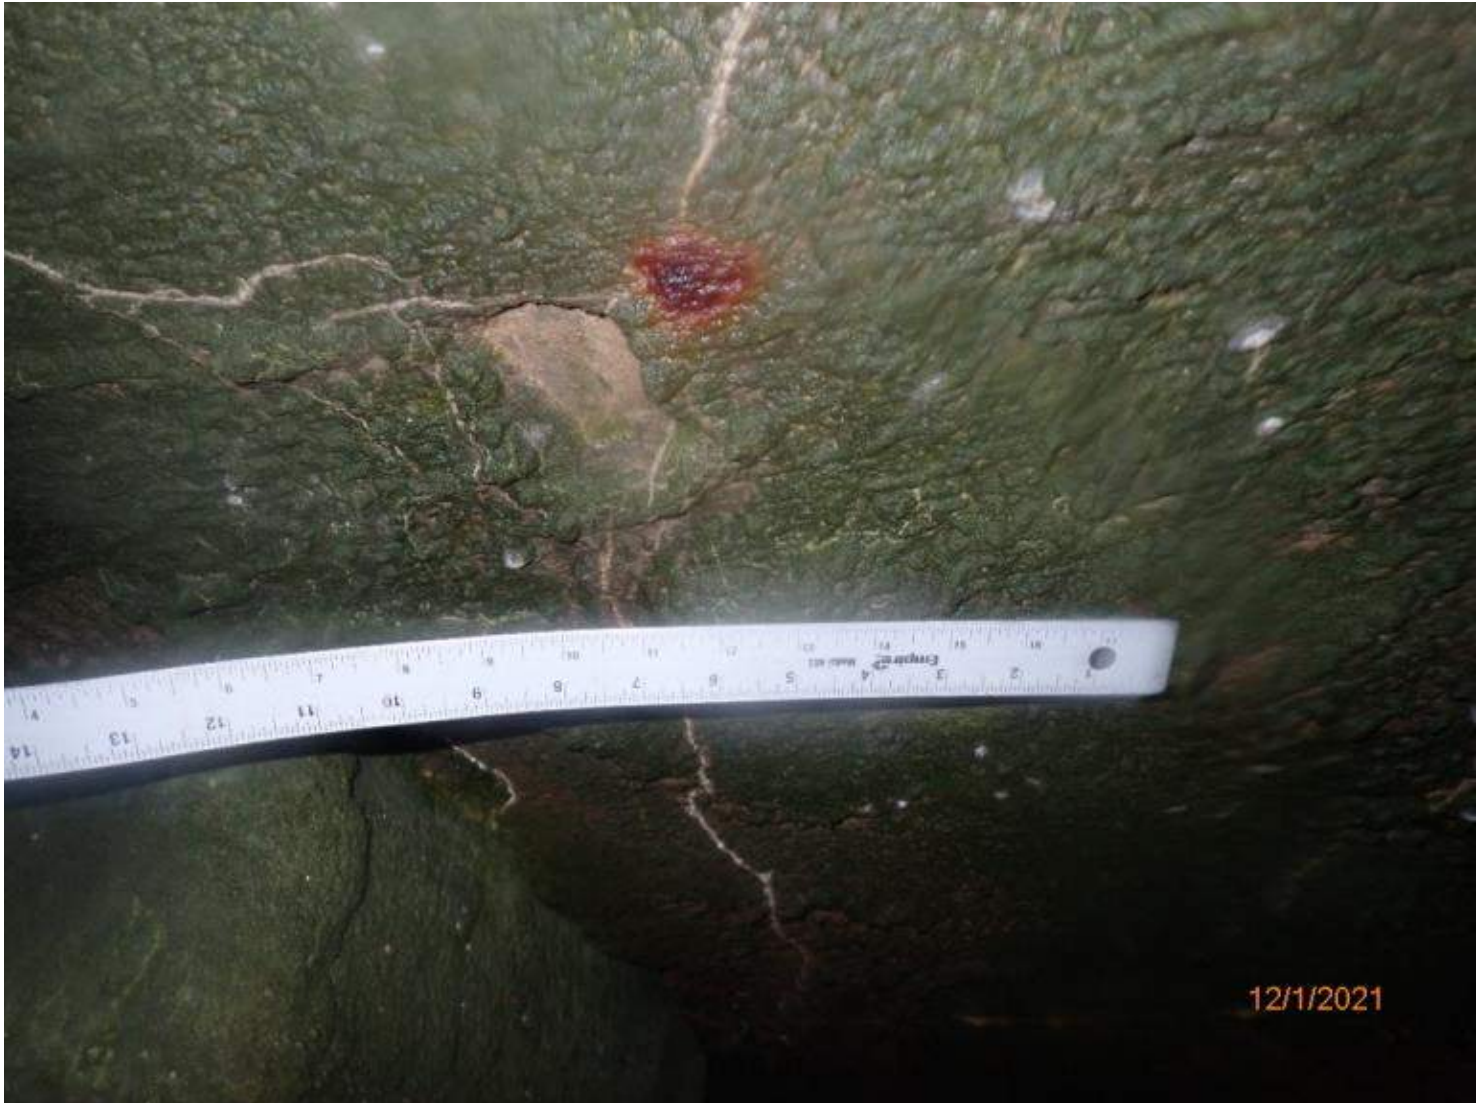
Photo 6 - Element 220 Re Conc Pile Cap/Ftg

Footing 5-2 corrosion Bleedout

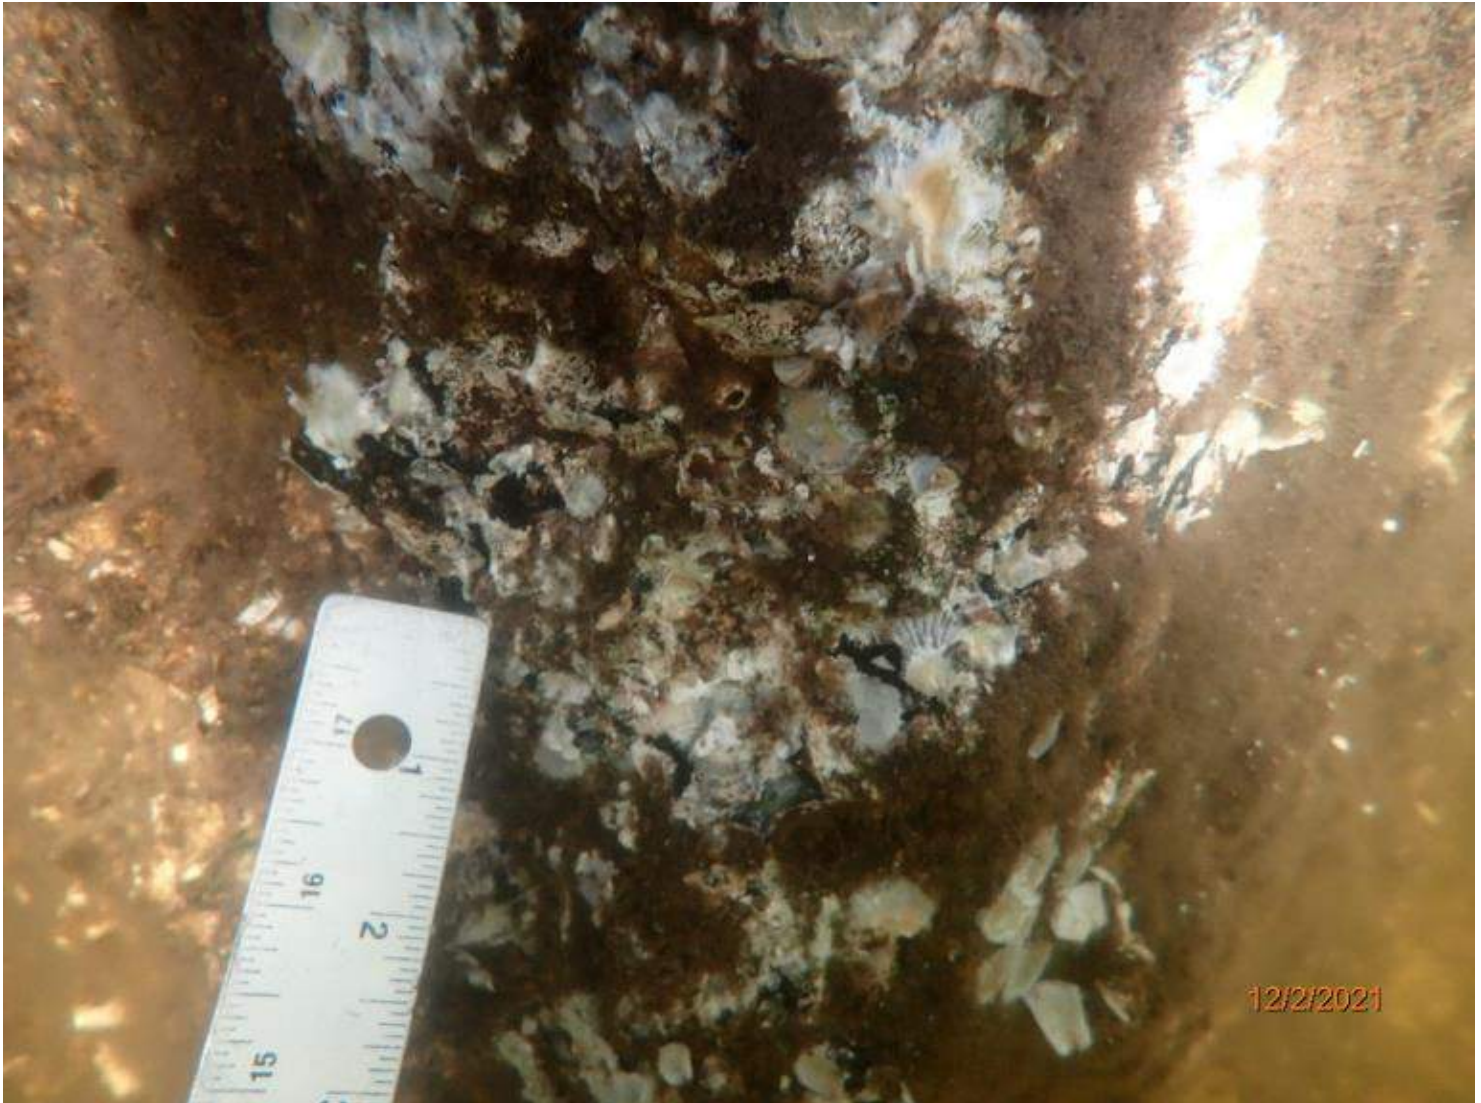
Photo 8 - Element 227 Re Conc Pile

Spall in southeast corner of Pile 13-4

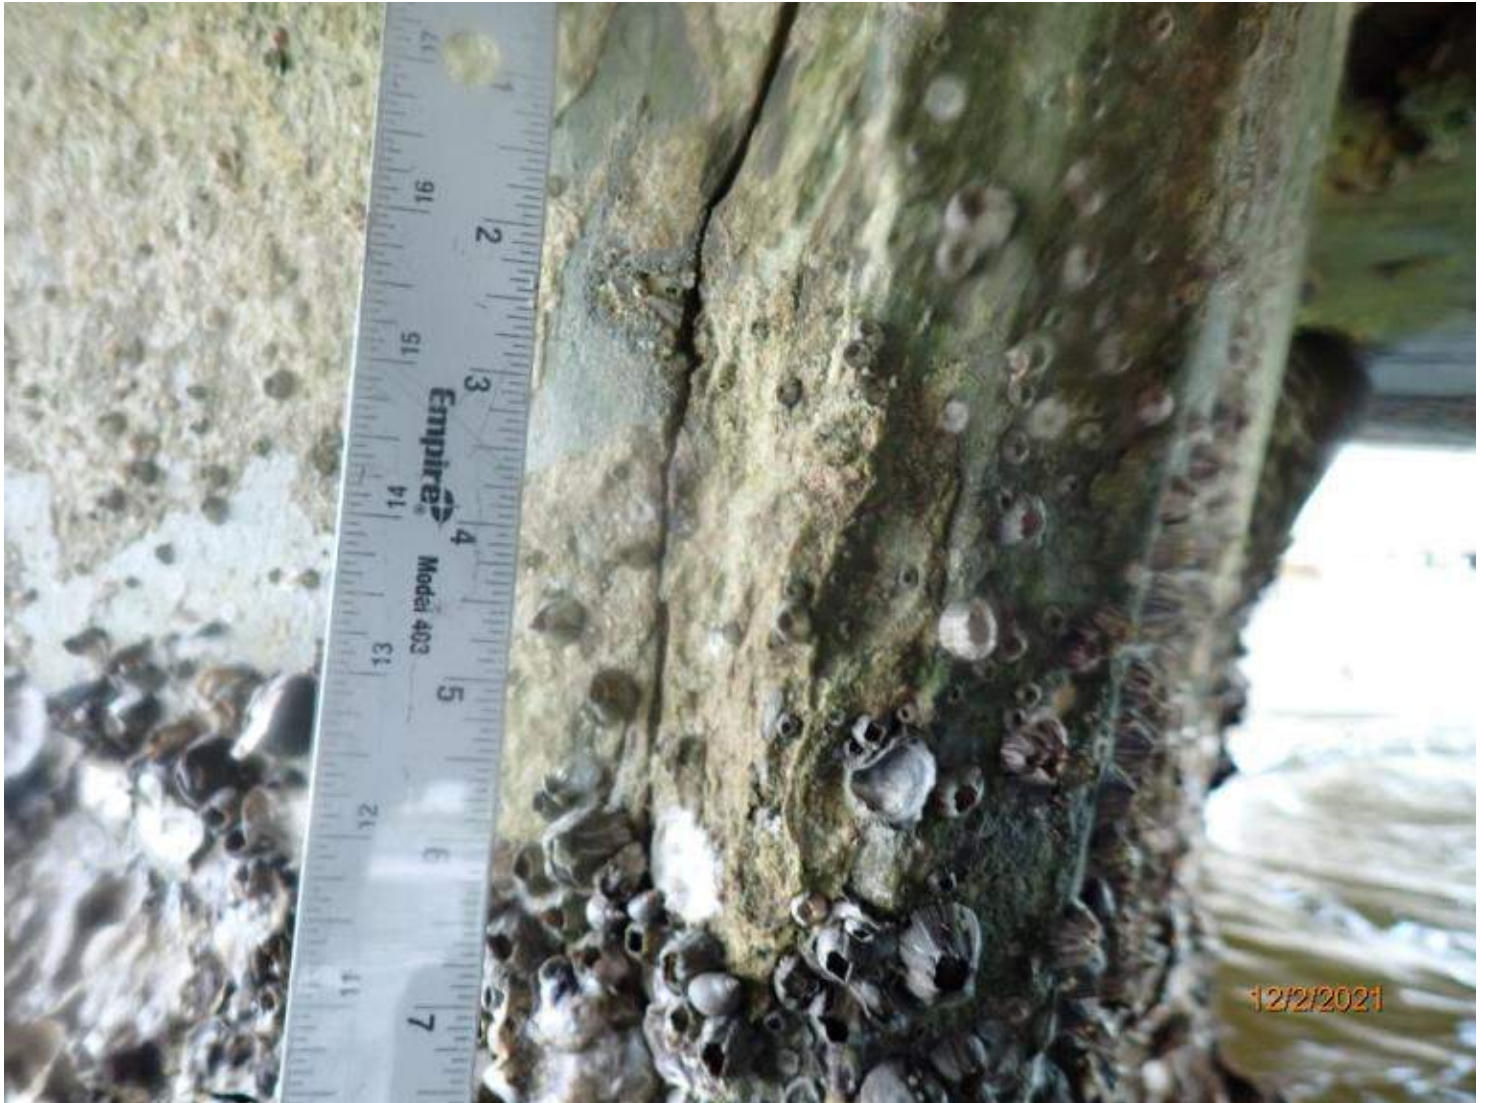
Photo 9 - Element 227 Re Conc Pile

Vertical crack with corrosion bleedout at the southeast corner of Pile 9-3

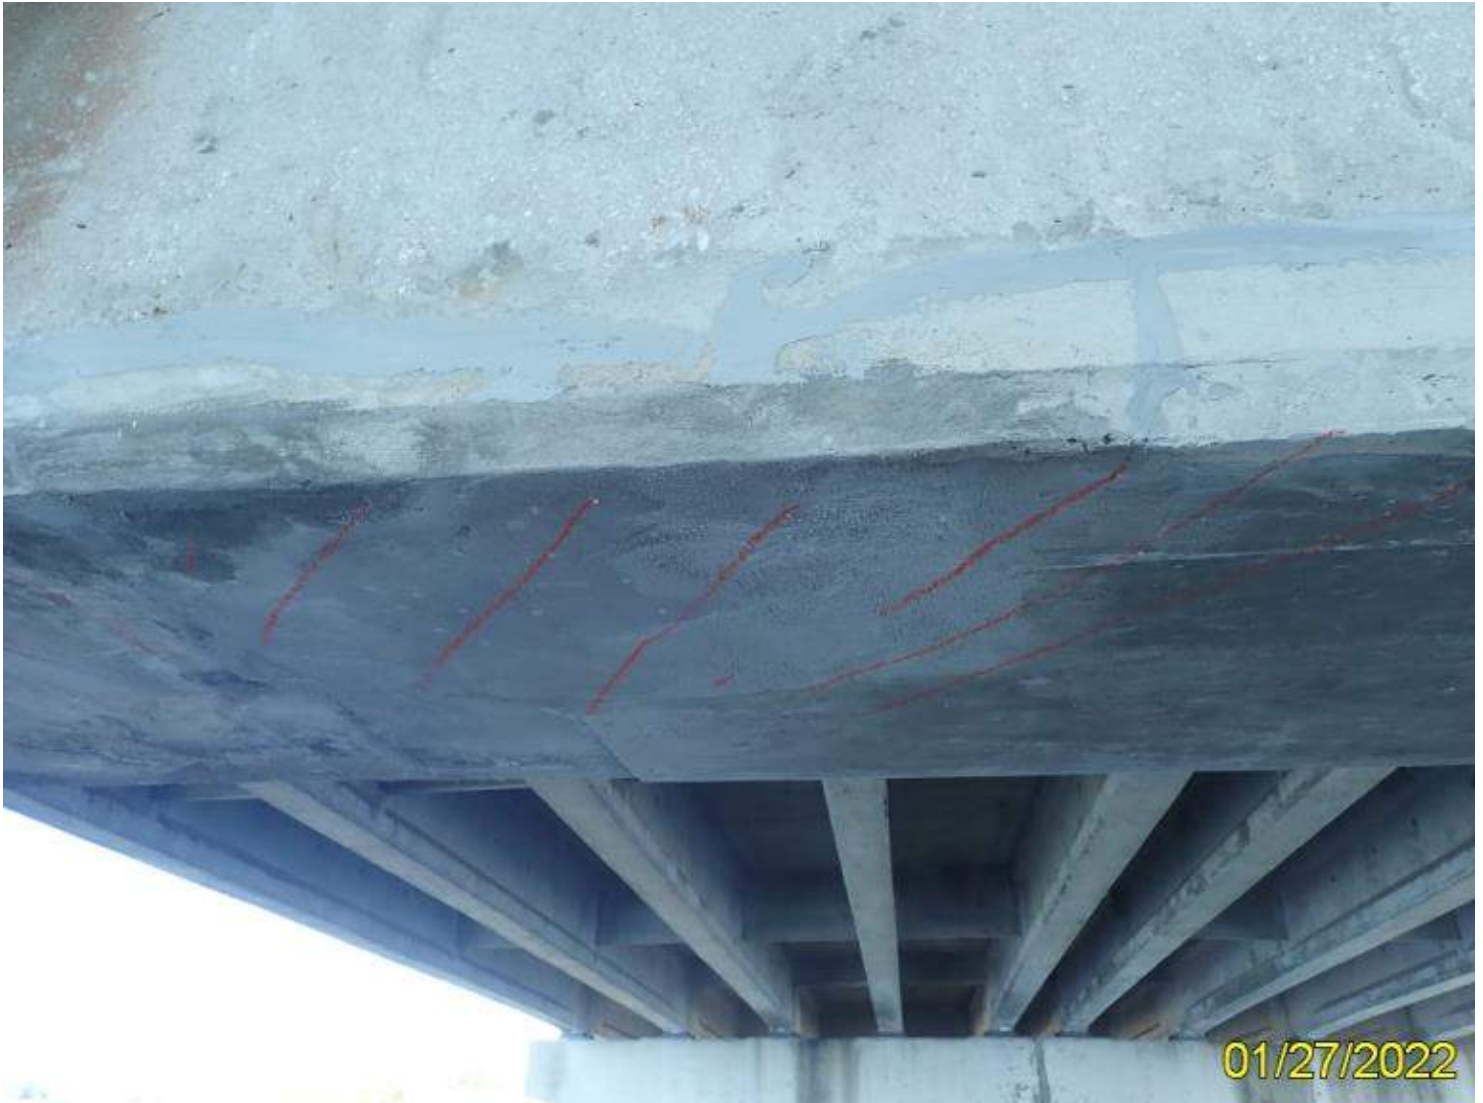
Photo 10 - Element 234 Re Conc Pier Cap

Unsound repair Pier 32 cap underside, between columns 32-1 and 32-2

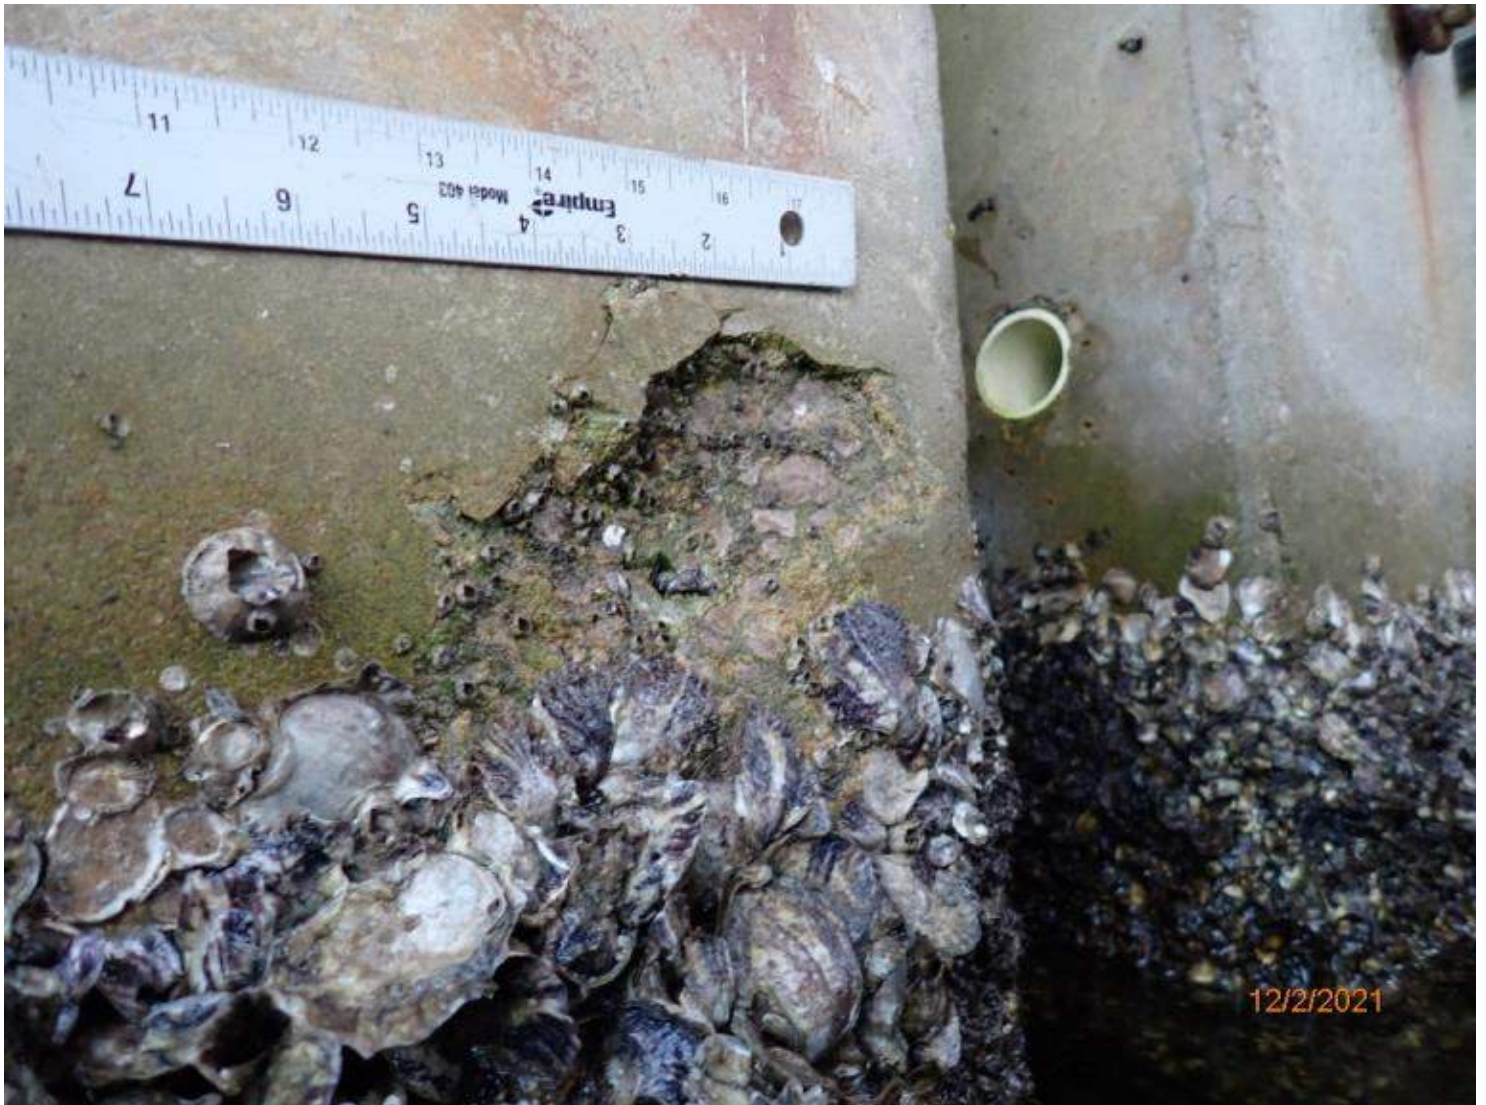
Photo 11 - Element 8387 PS Fender/Dolphin

Typical corner spall in south fender pile

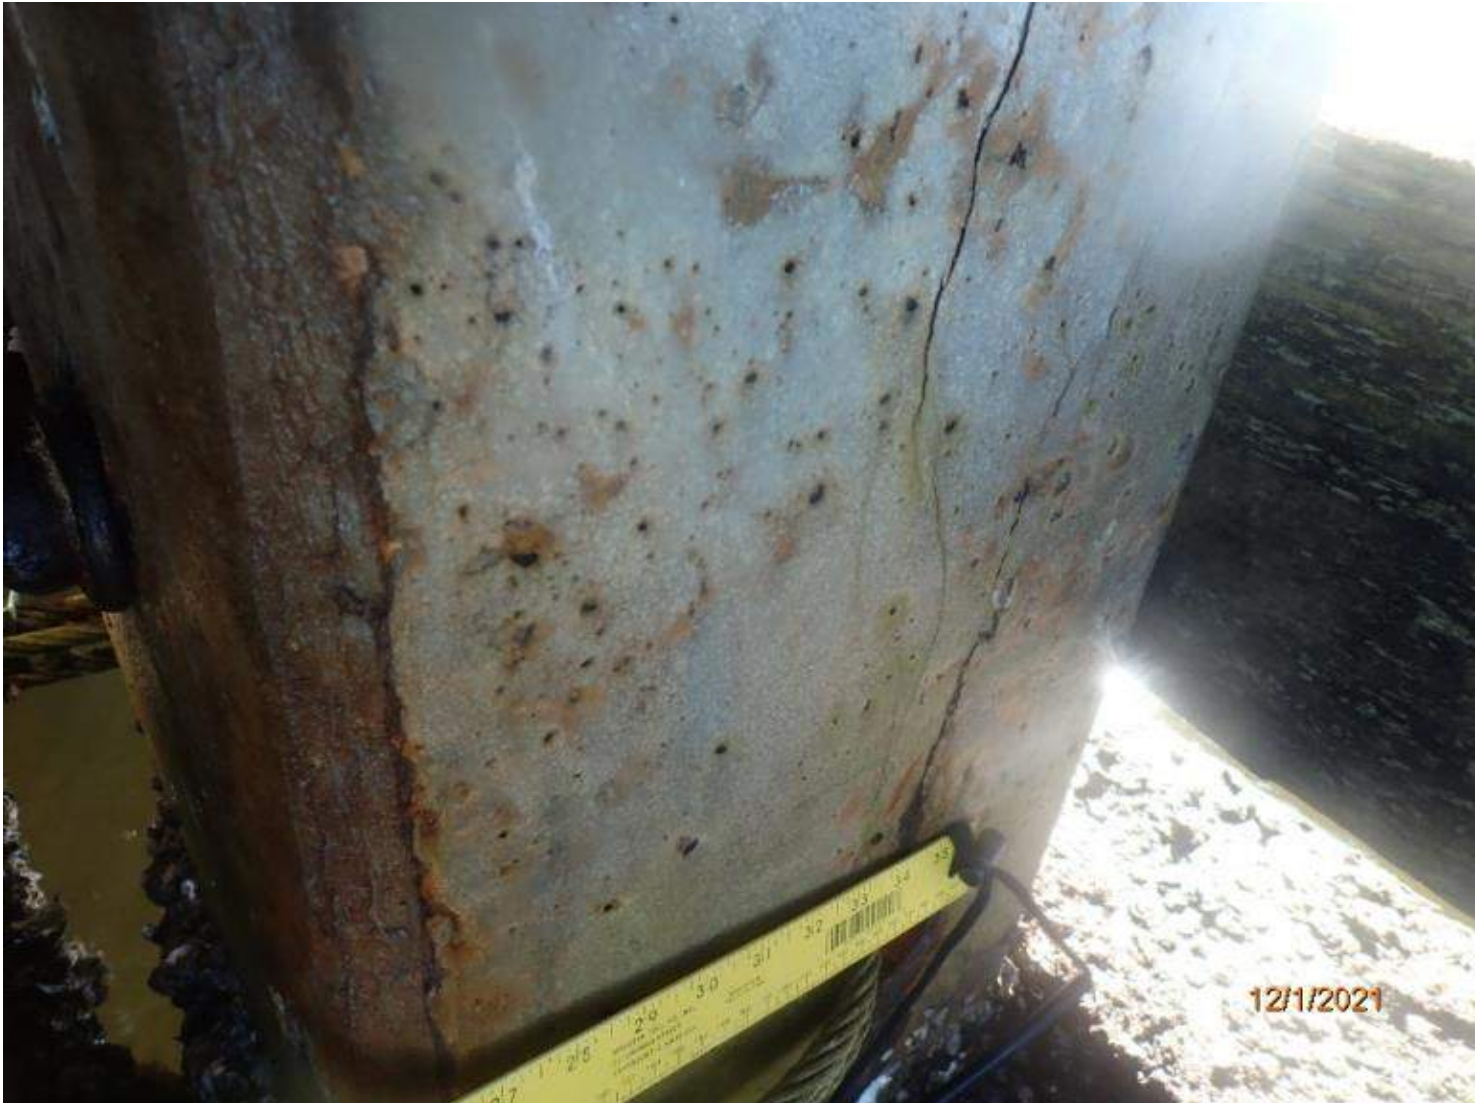
Photo 12 - Element 8387 PS Fender/Dolphin

Typical vertical crack with corrosion bleedout at north fender (14th cluster shown)

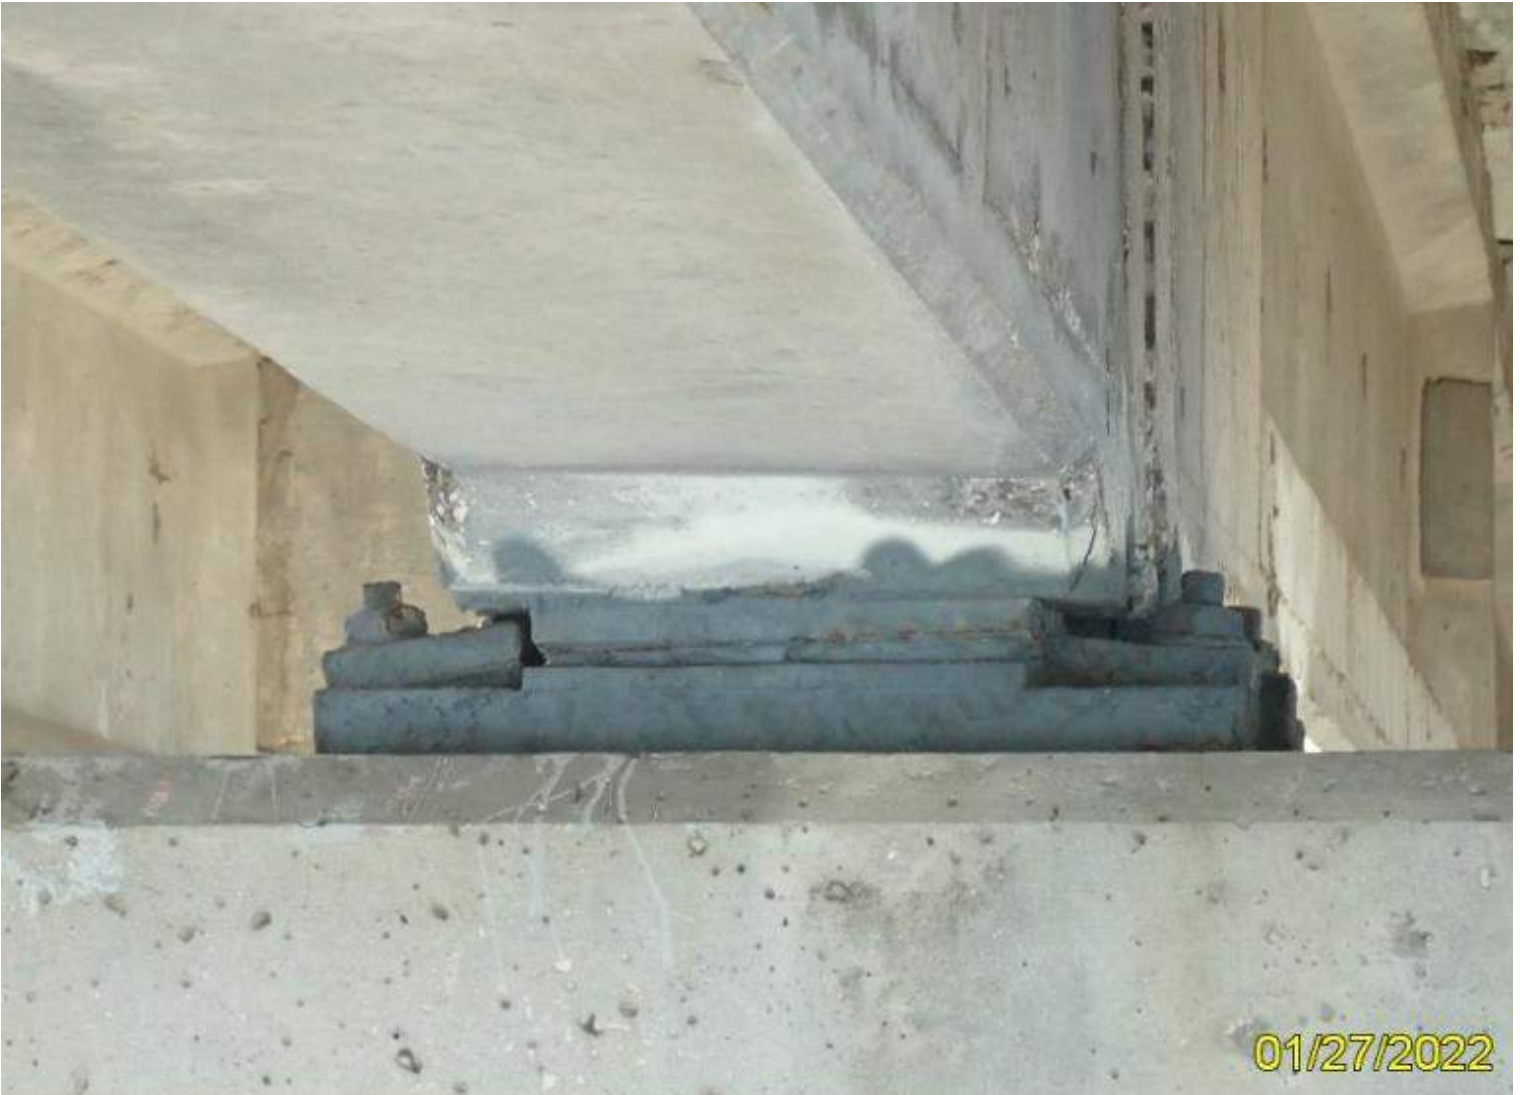
Photo 13 - Element 311 Moveable Bearing (8516 Painted Steel)

Typical bearing with painted over corrosion

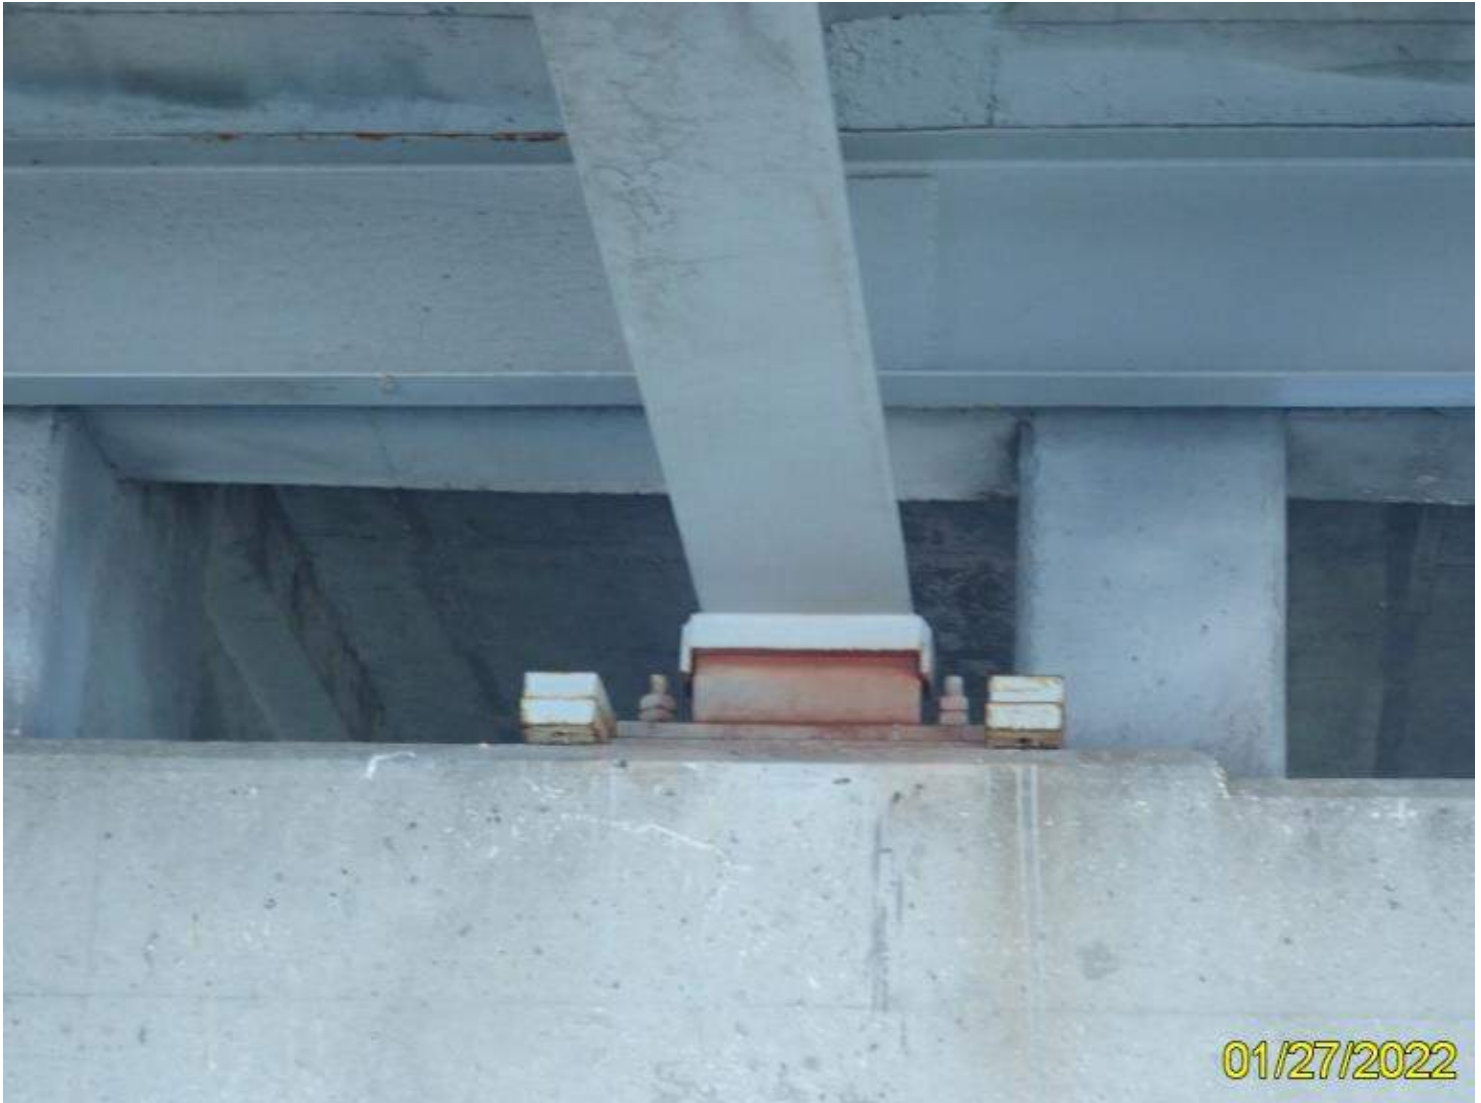
Photo 15 - Element 311 Moveable Bearing (8516 Painted Steel)

Bearing 18-7 over Pier 19 fretting corrosion

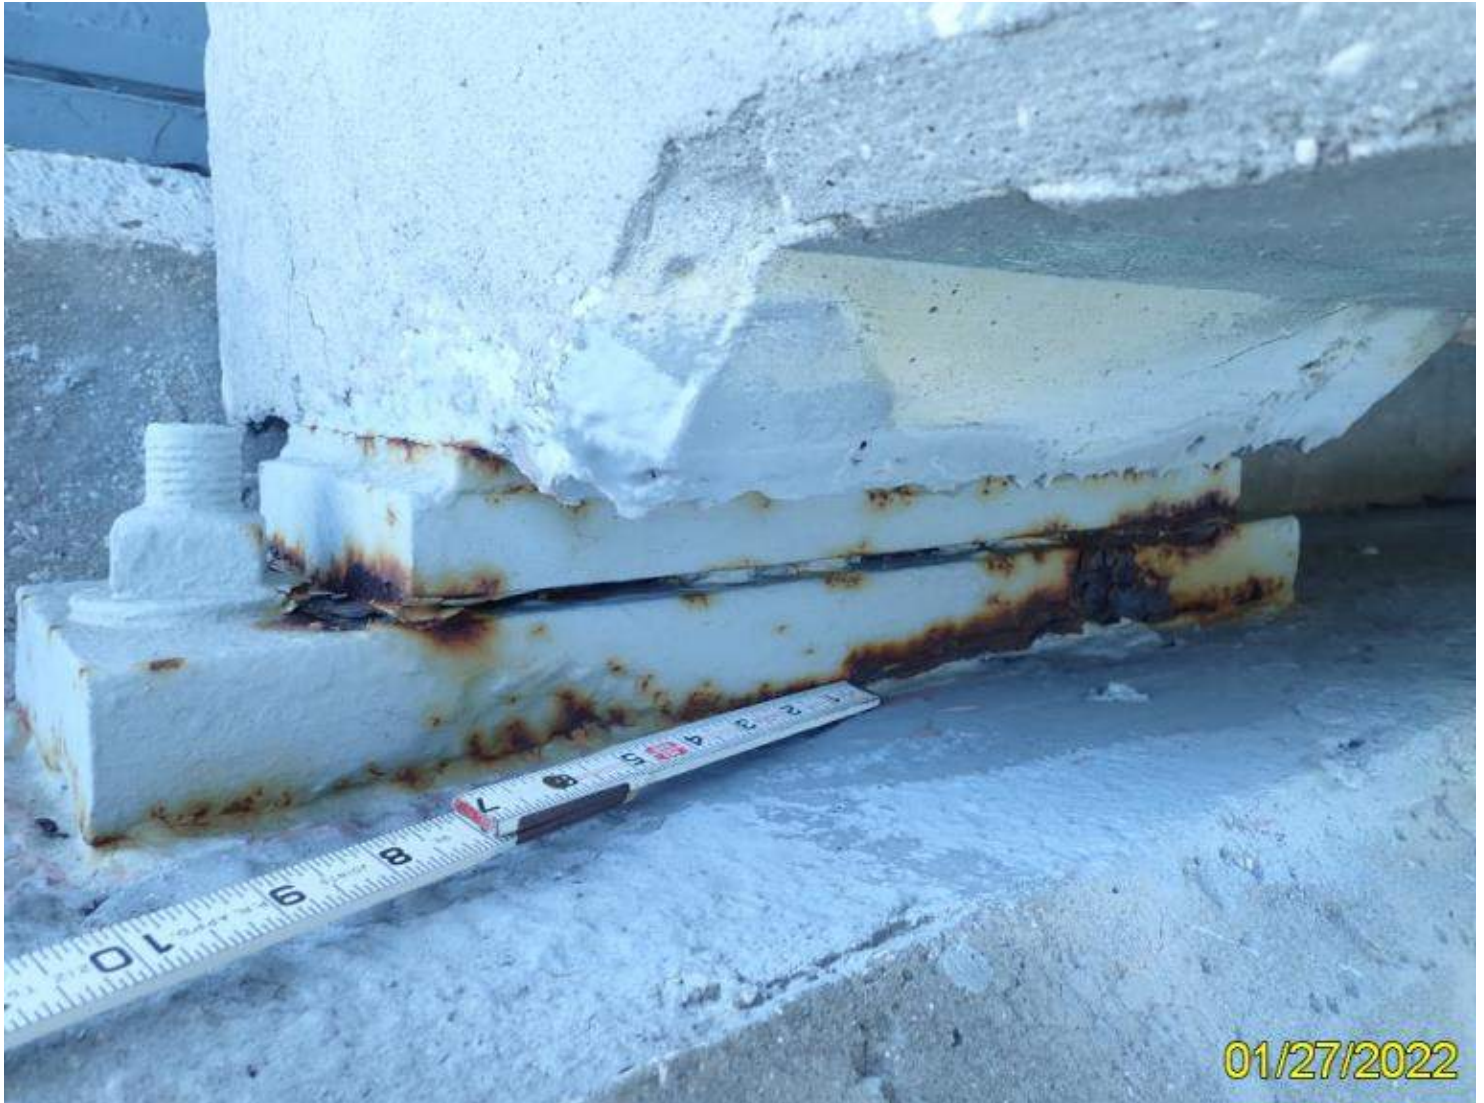
Photo 16 - Element 313 Fixed Bearing (8516 Painted Steel)

Typical bearing condition, restricted movement and associated corrosion
