PRELIMINARY ENGINEERING REPORT

Florida Department of Transportation

DeSoto Bridge Replacement SR 55 US 301/US 41

Financial Management Number: 442630-1

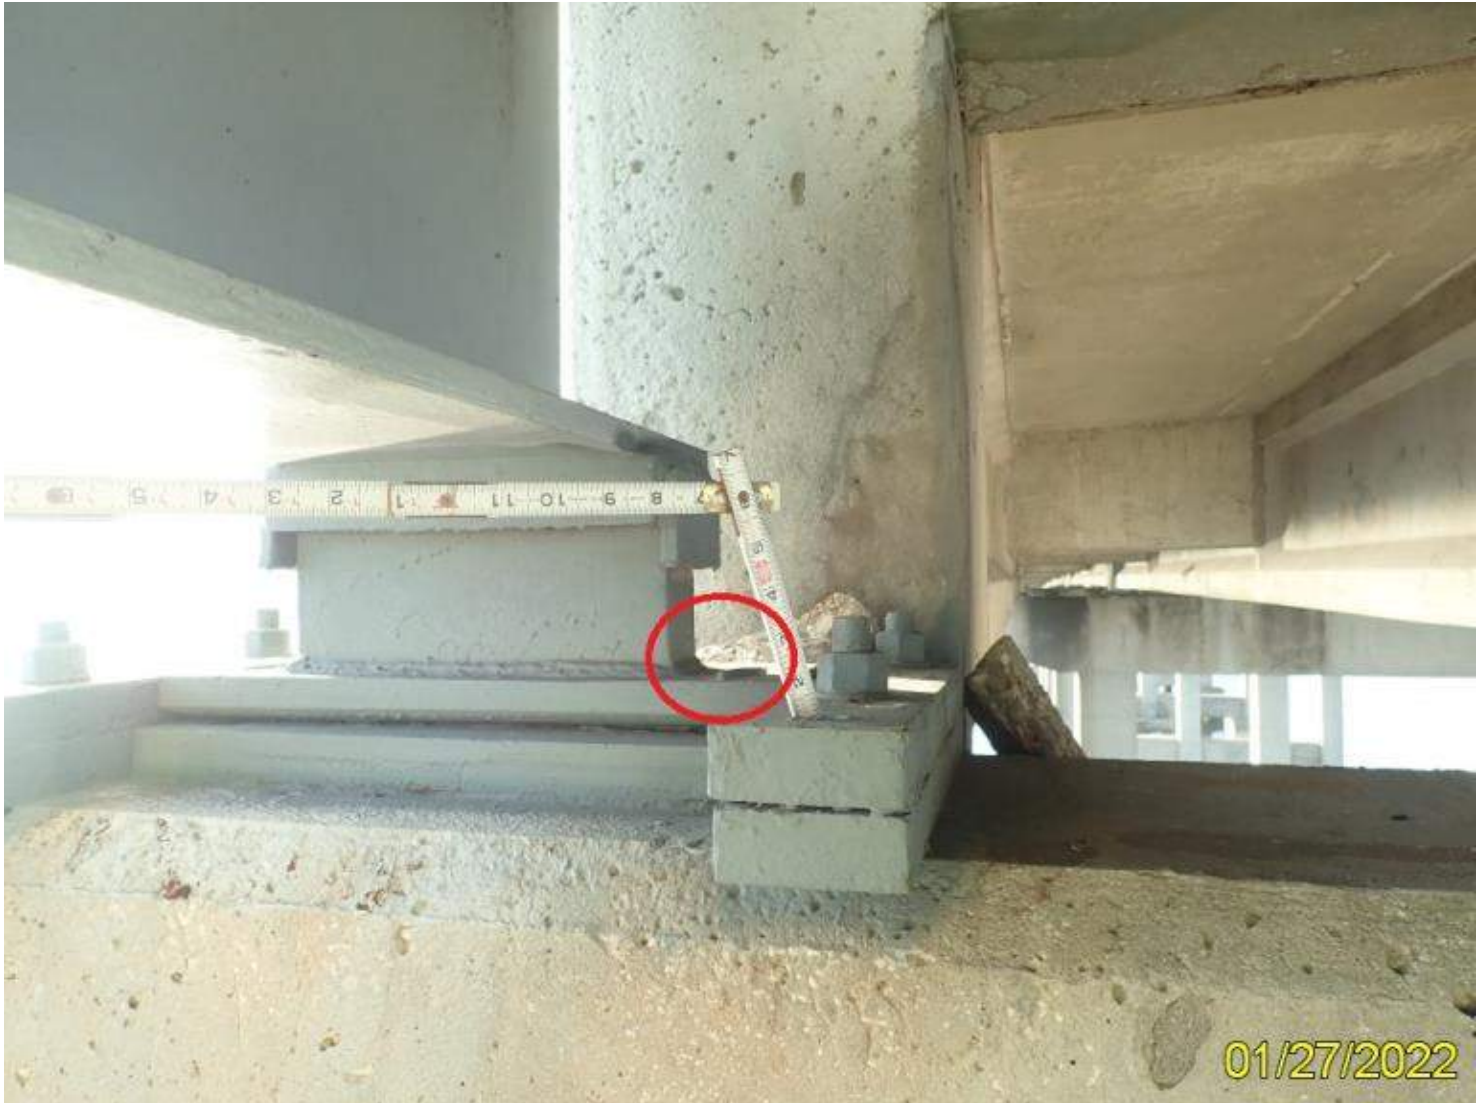
Photo 17 - Element 313 Fixed Bearing (8516 Painted Steel)

Bearing 16-8 over Pier 16 missing anchor bolt and typical areas of corrosion

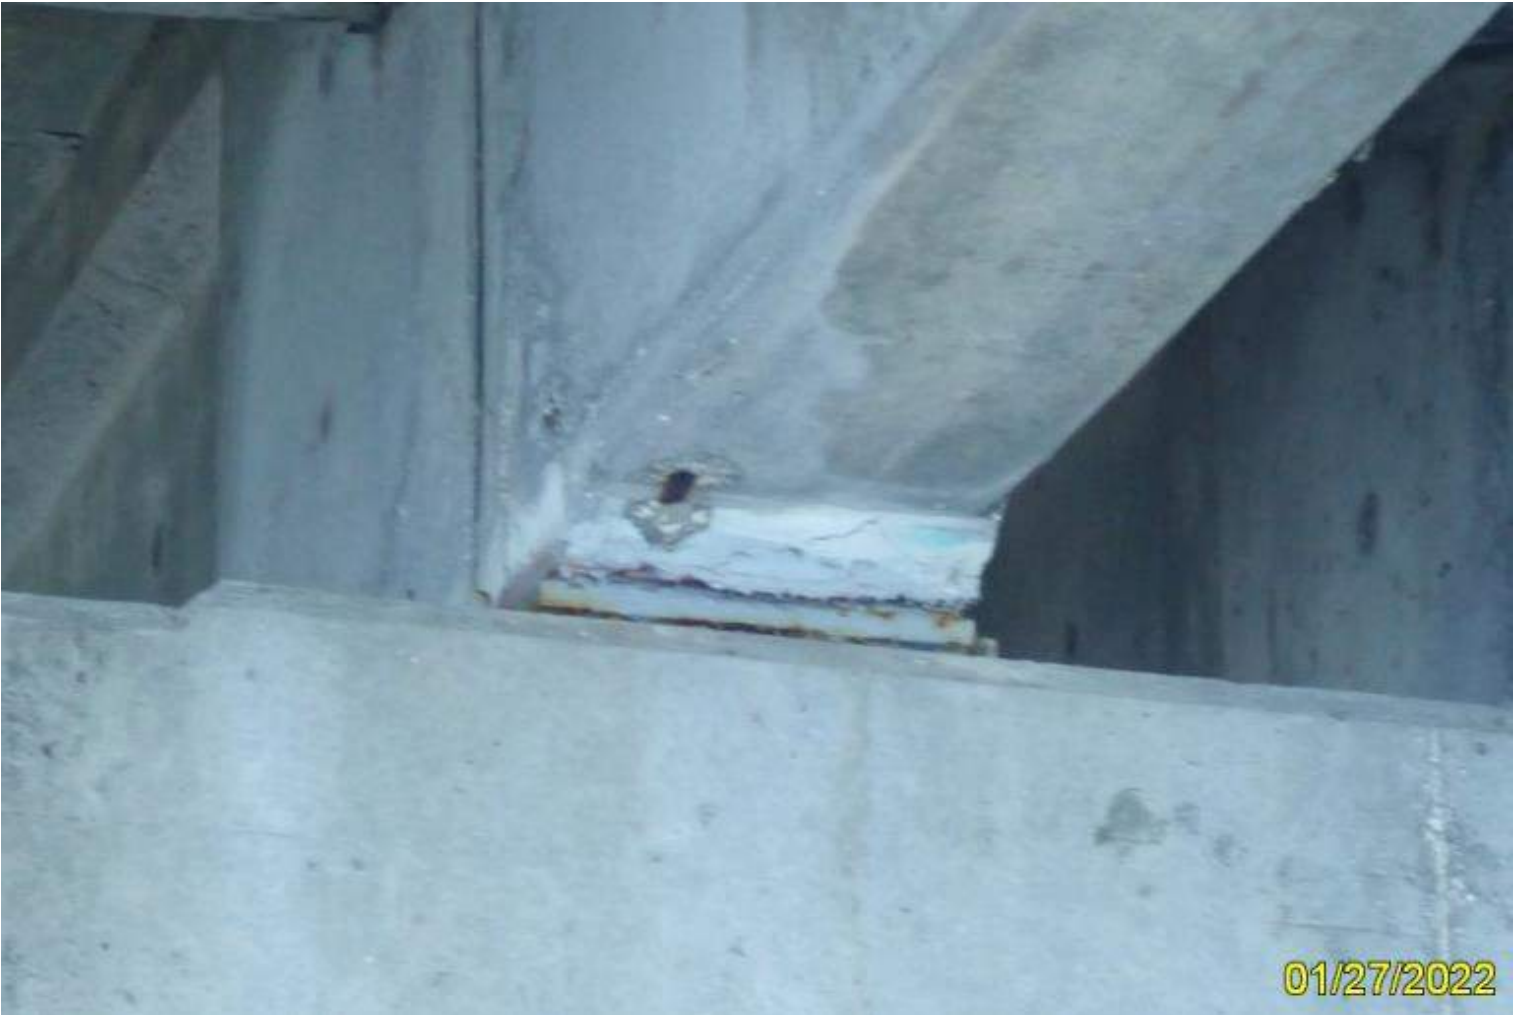
Photo 18 - Element 109 Pre Opn Conc Girder/Beam

Spall with exposed steel in Beam 20-5 over Pier 21

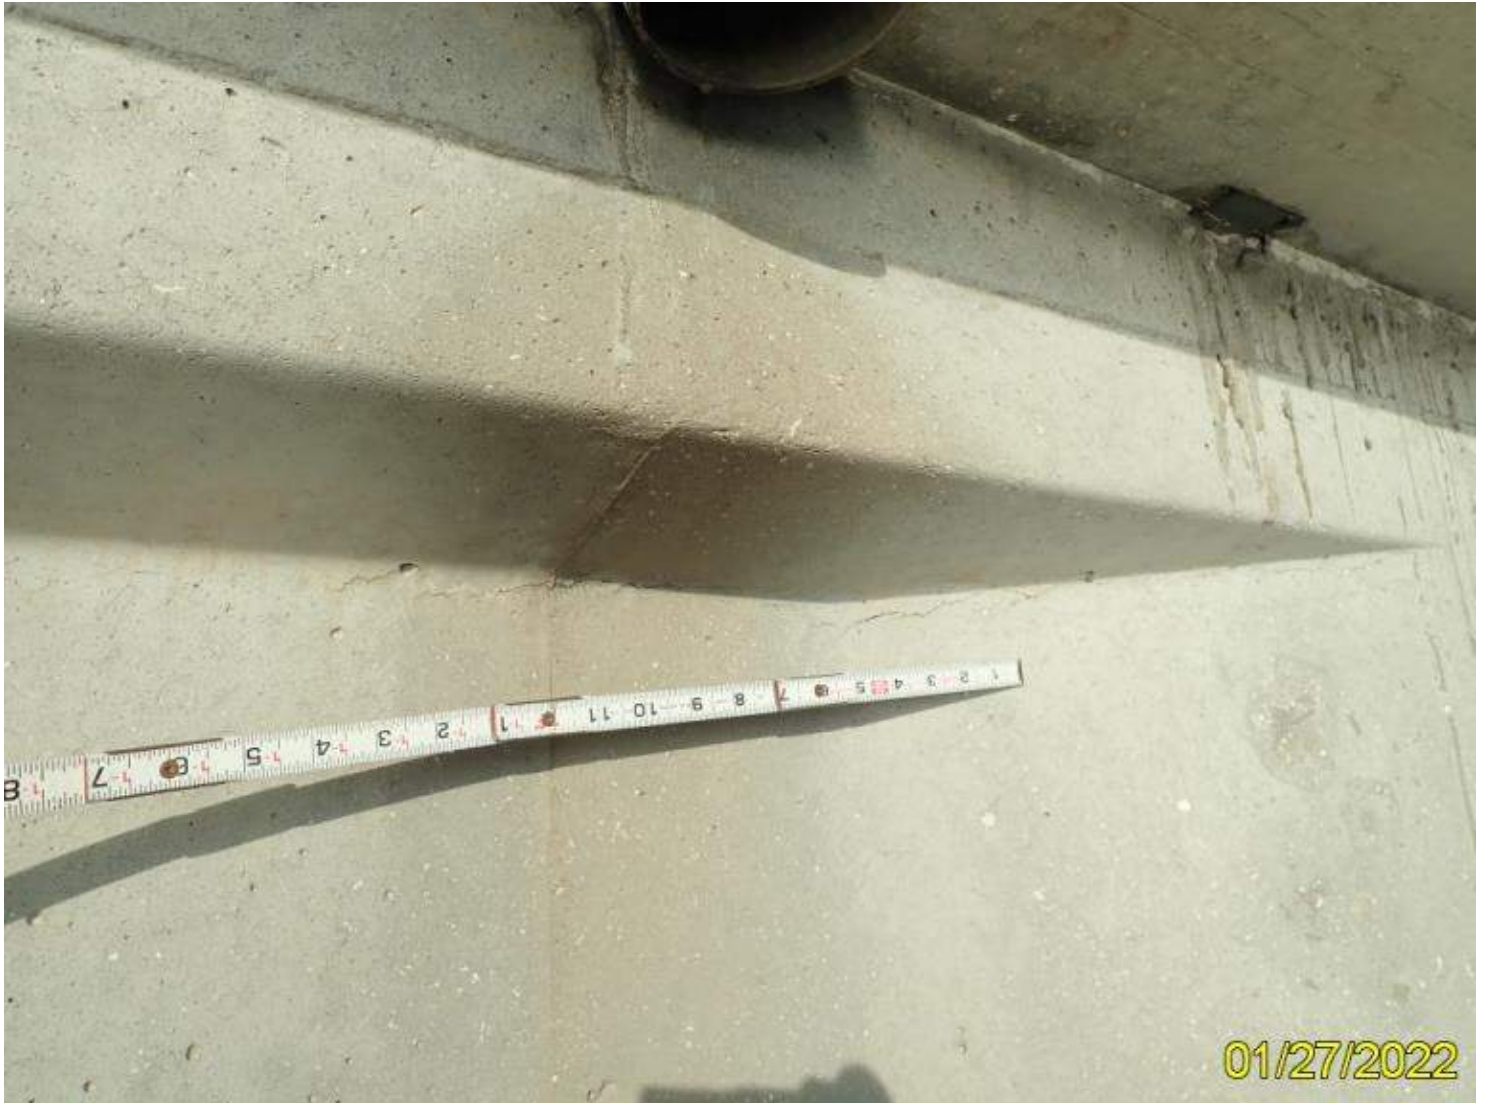
Photo 19 - Element 109 Pre Opn Conc Girder/Beam

Typical crack in Beam 14-10 right at Pier 15

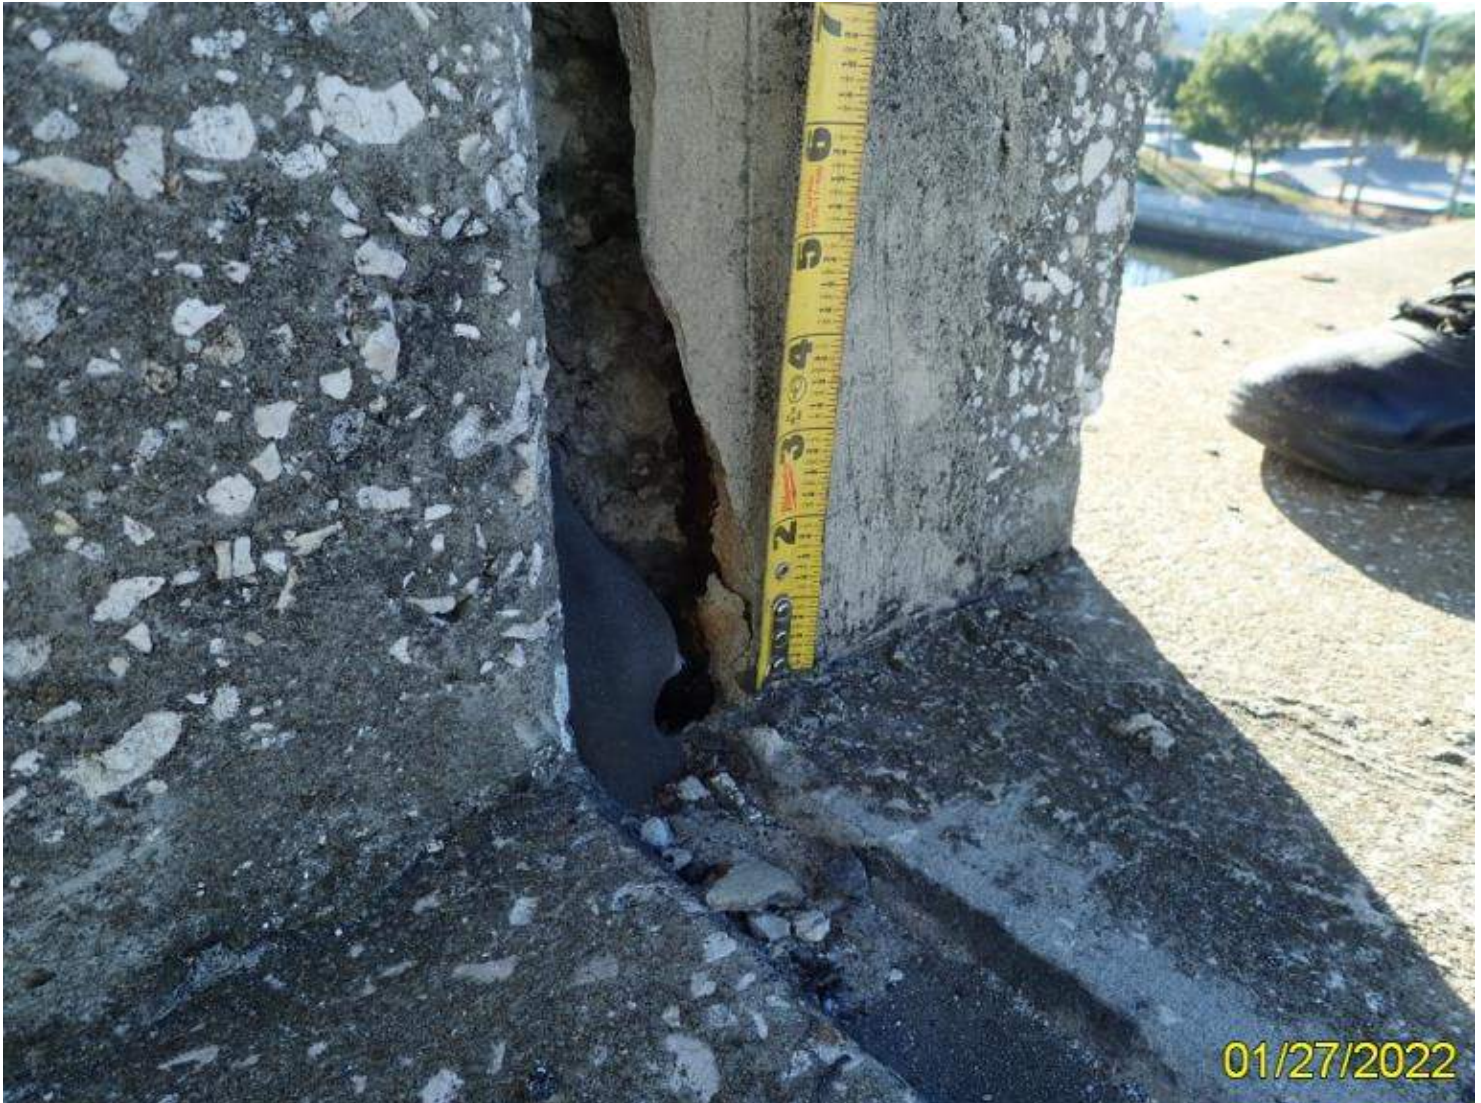
Photo 20 - Element 331 Re Conc Bridge Railing

Spall with exposed steel at Bridge Rail 5-6 right in the traffic face

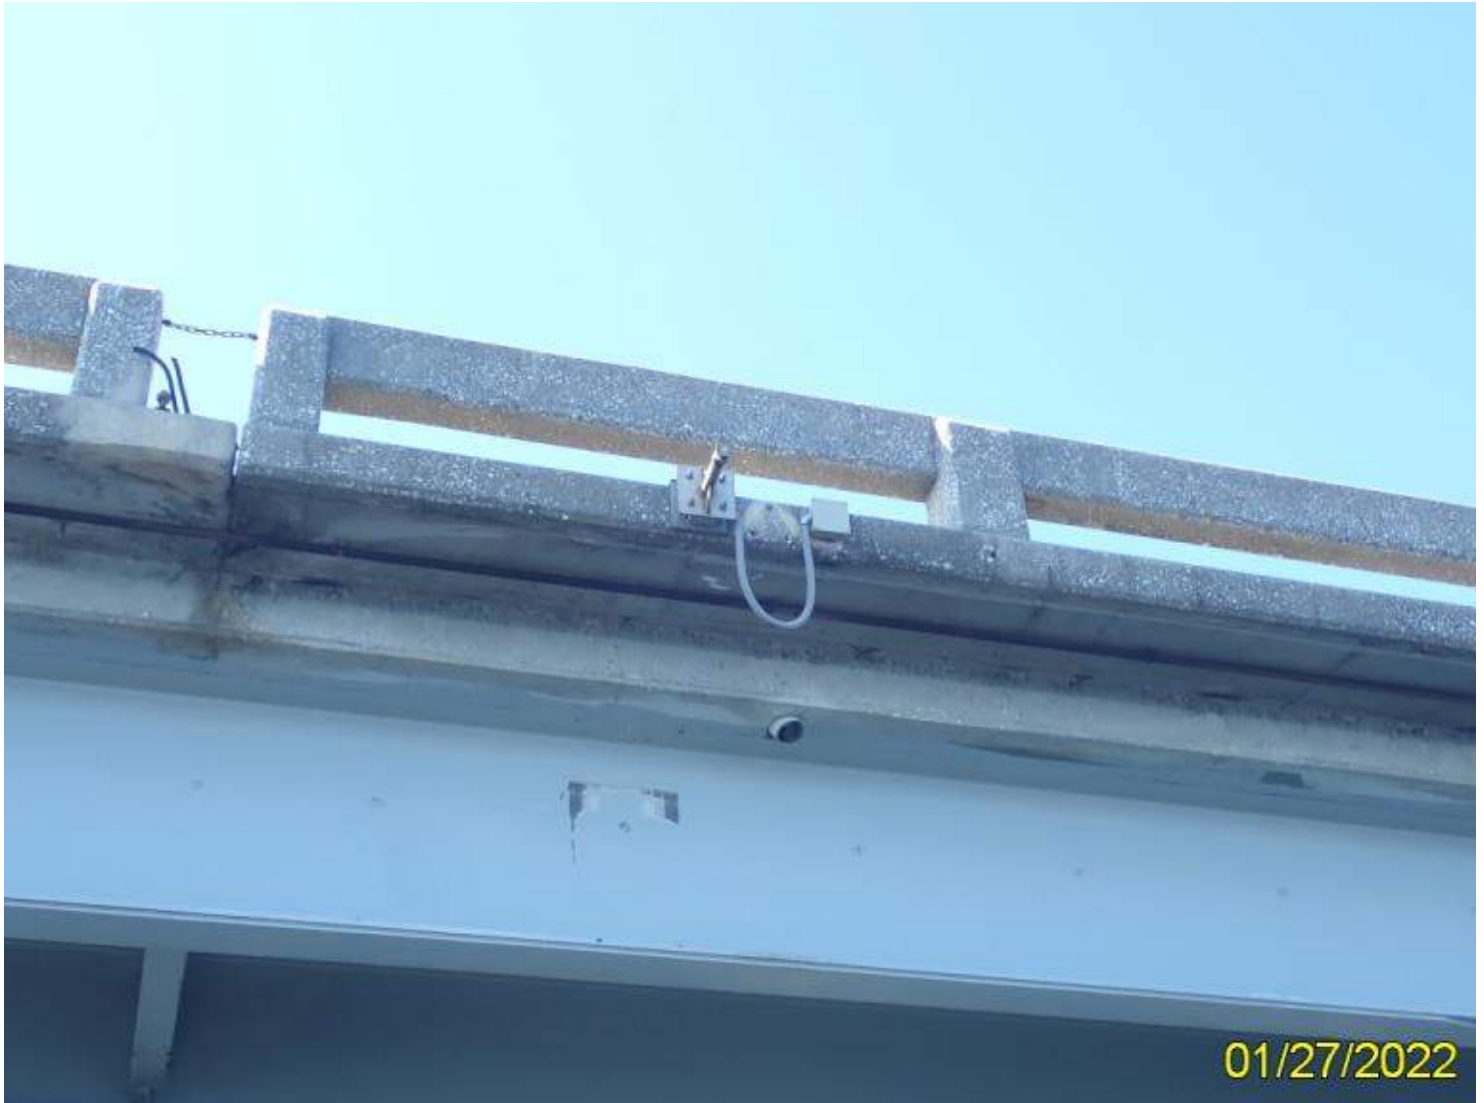
Photo 21 - Element 8580 Navigational Lights

Center of channel navigation light in Span 18 right broken off and not functioning

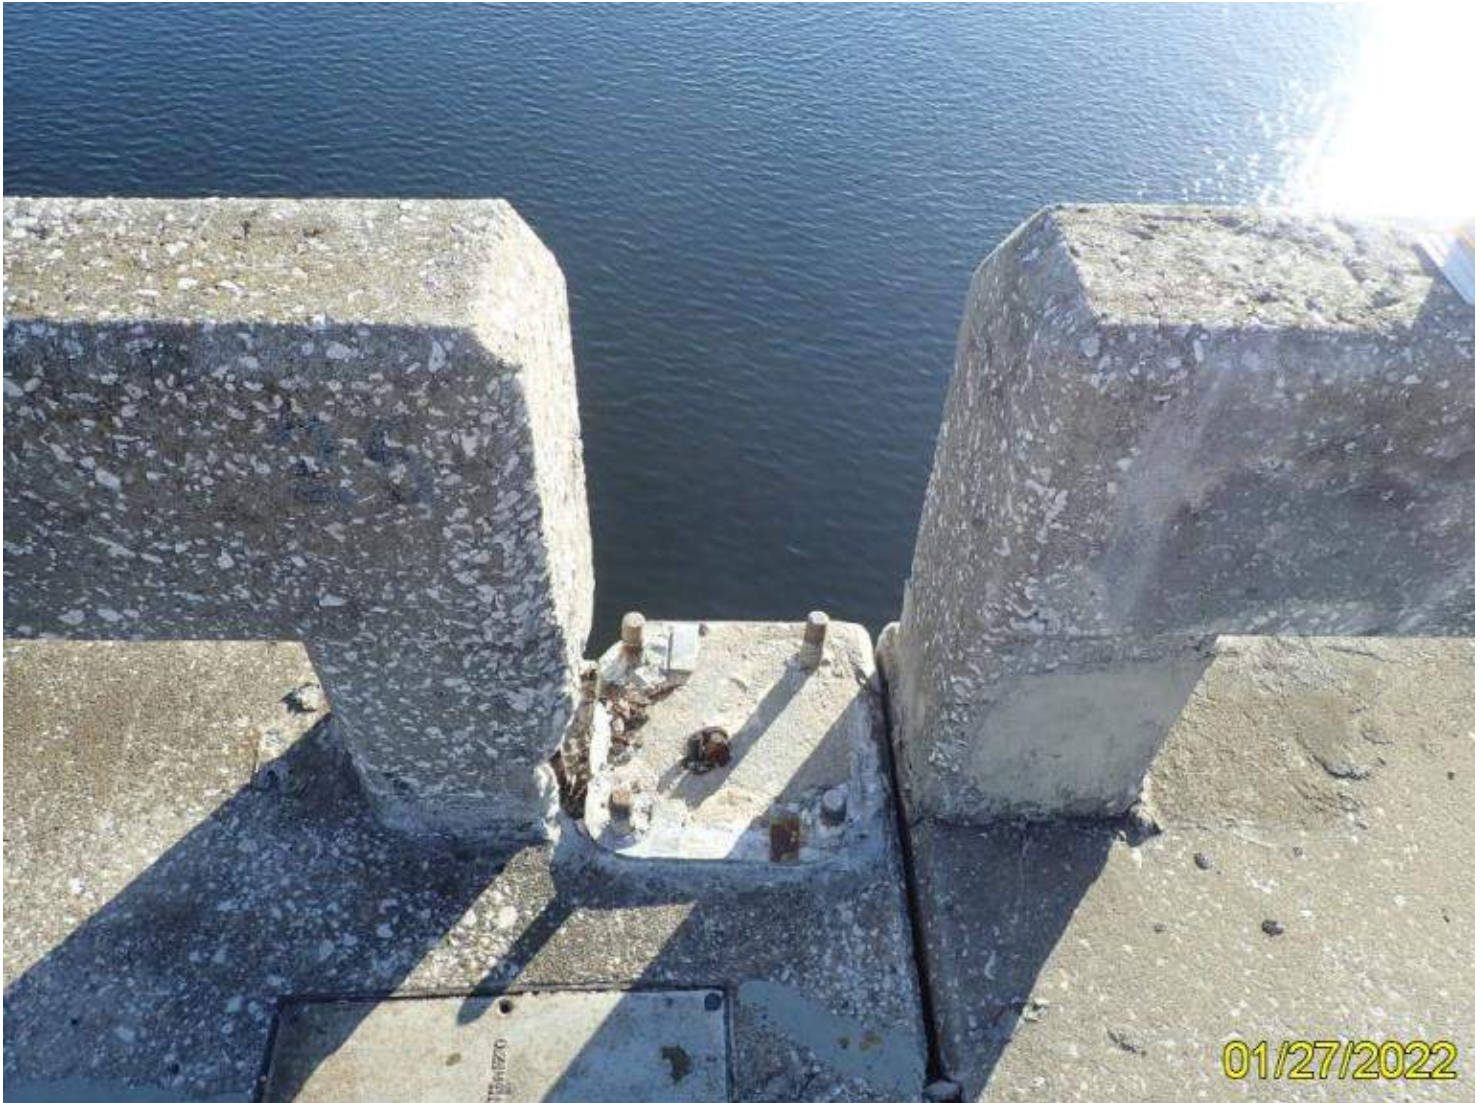
Photo 22 - Inspection Notes

Pier 25 right missing light pole

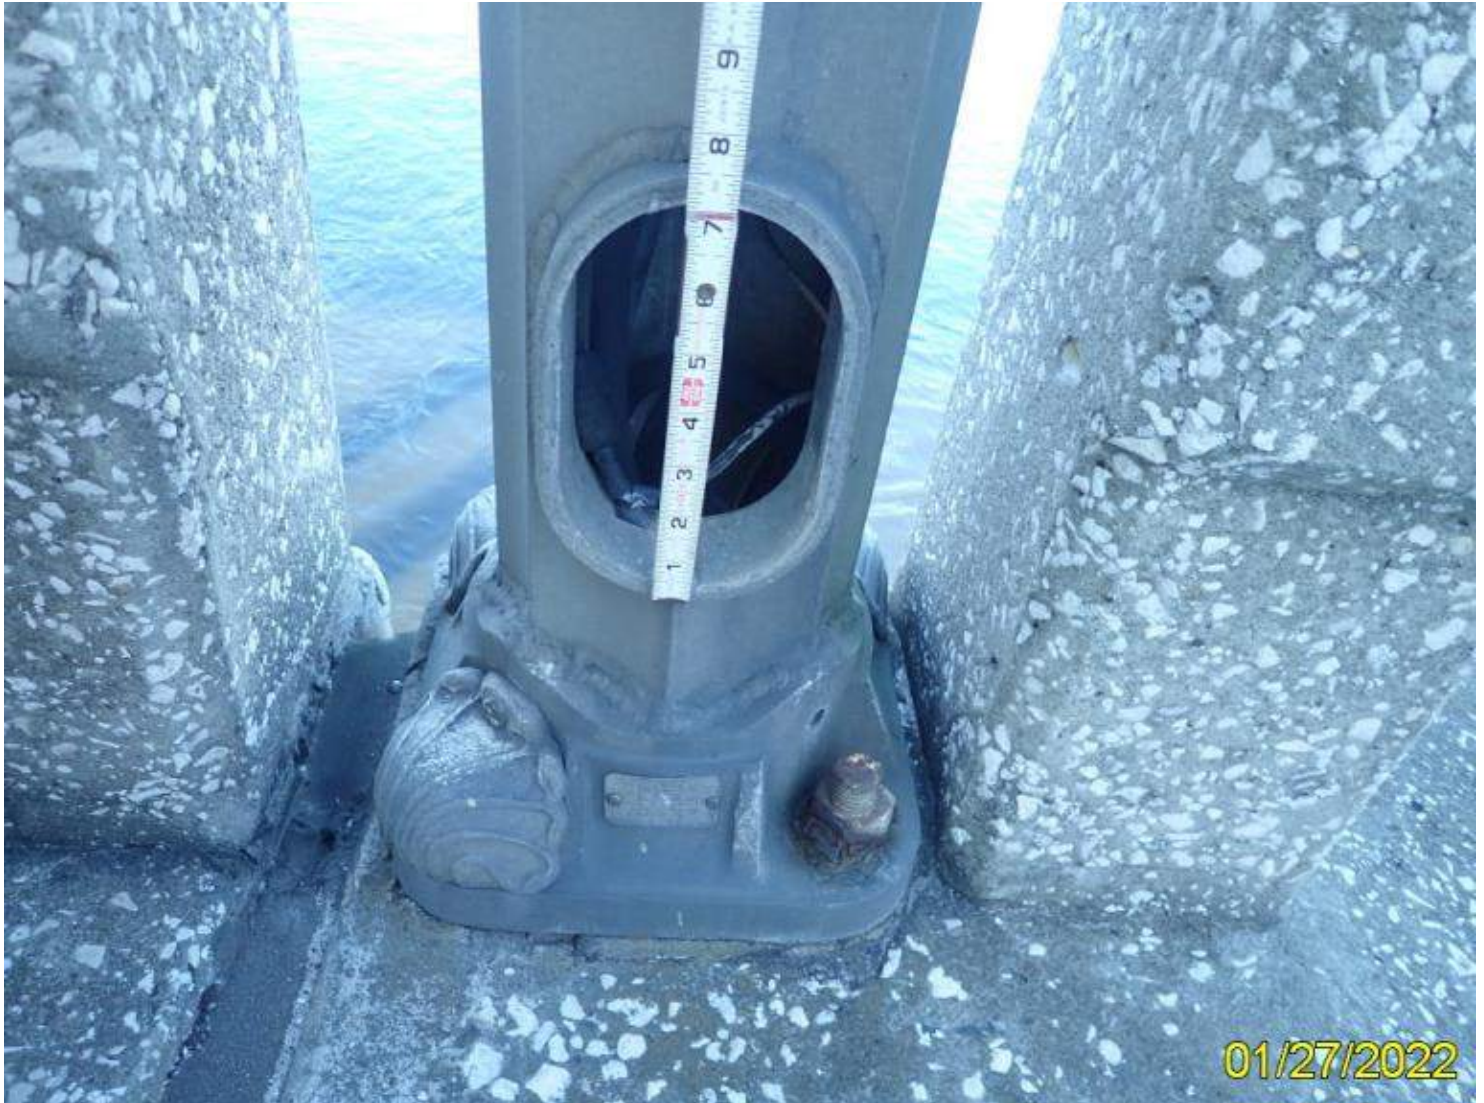
Photo 25 - Inspection Notes

Light pole missing handhole access cover at Pier 19 left

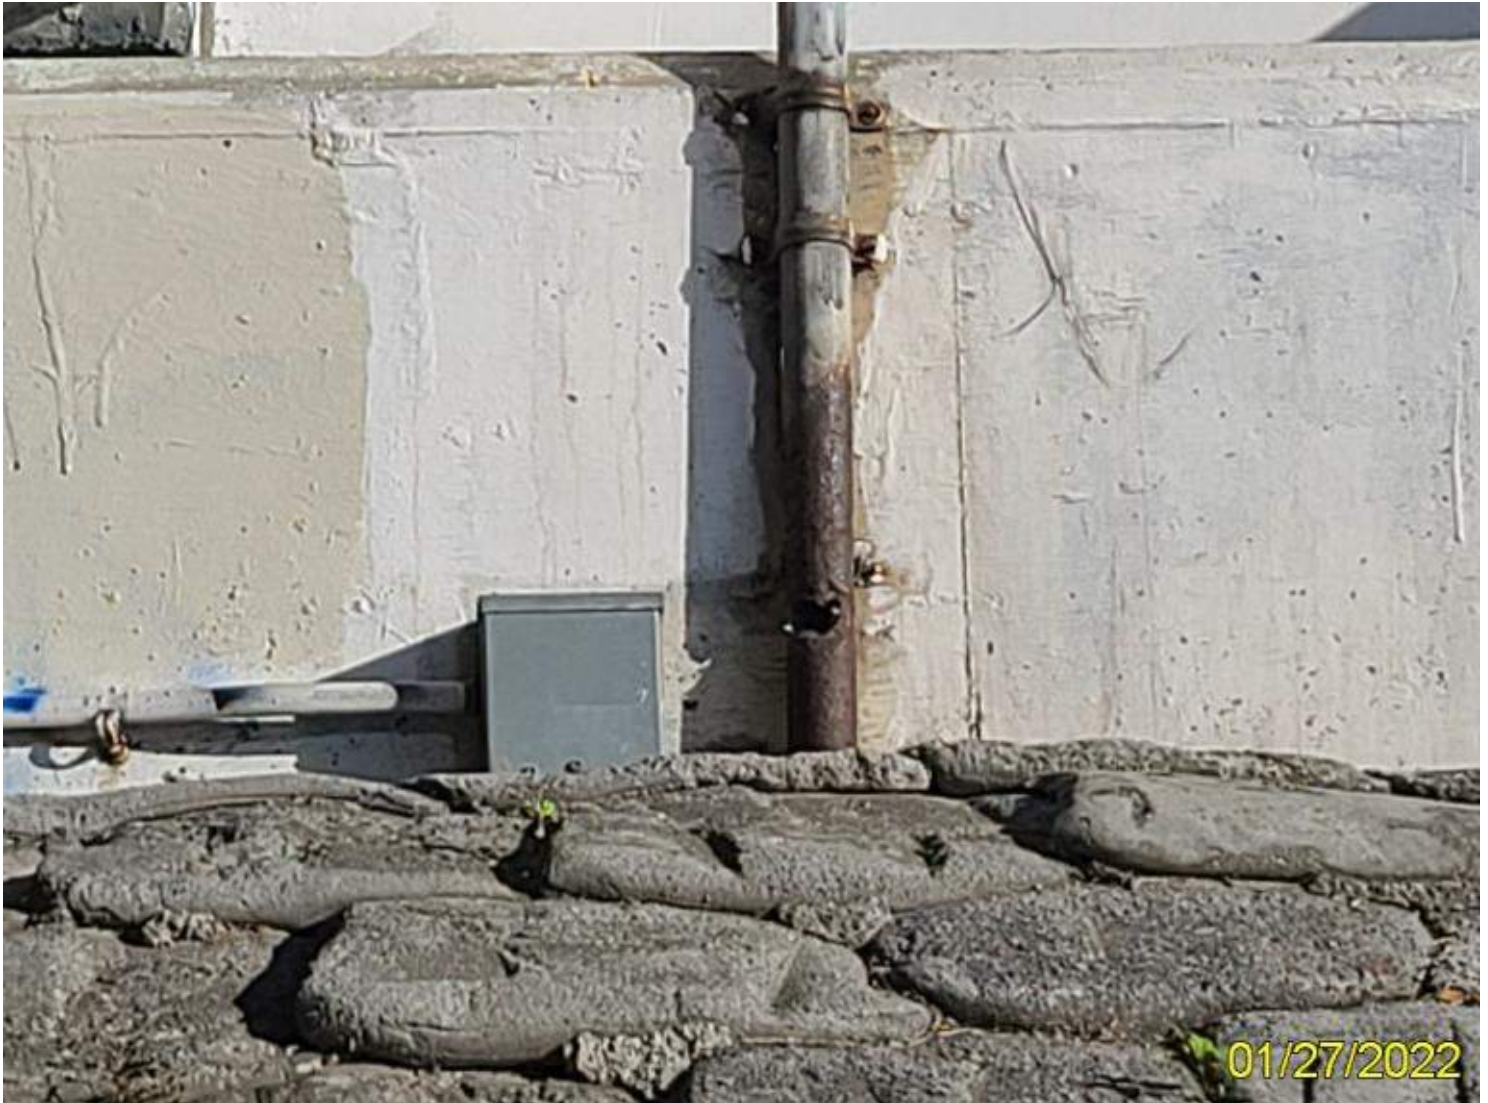
Photo 26 - Inspection Notes

Corrosion hole in Abutment 34 utility conduit

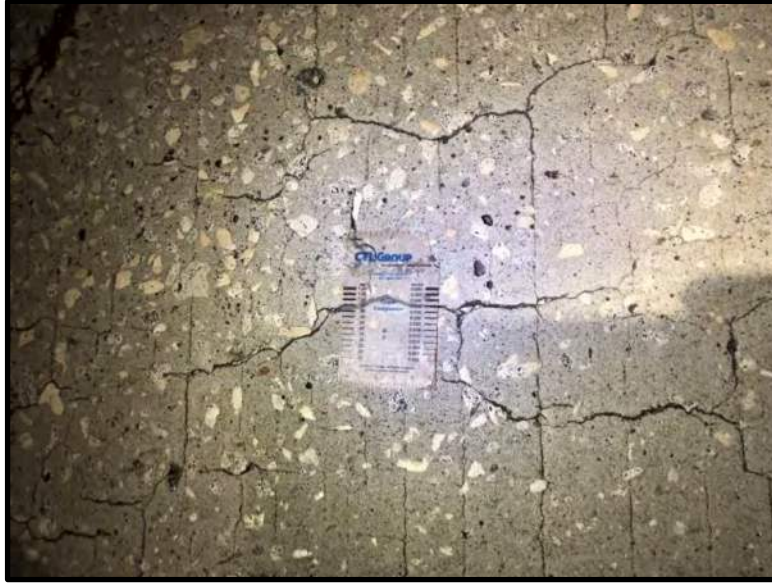
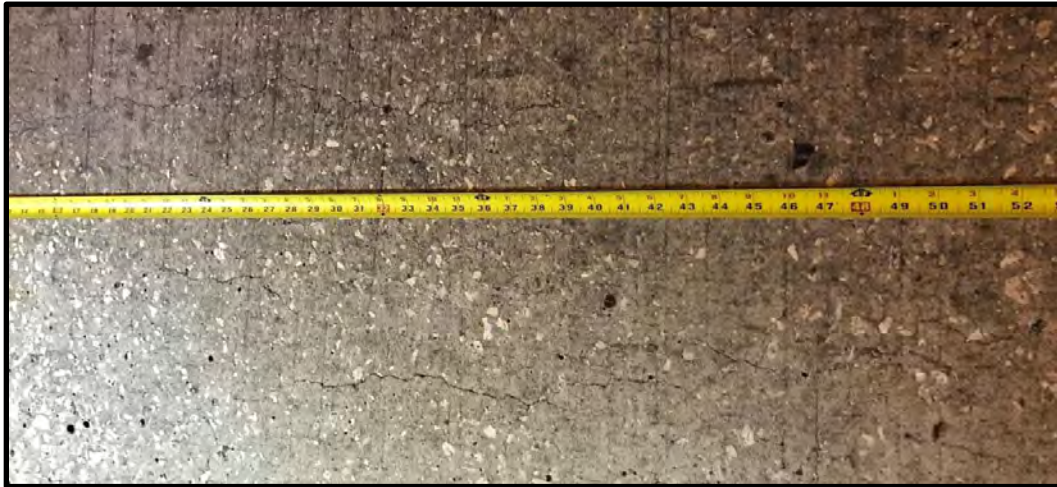
The top surface of the deck in Spans 14, 16, 17, and 18 is covered with an overlay. The original concrete on the top surface of all of the other spans was assigned a condition rating of 2. Typical cracking observed on the top surface of the deck is shown in Figure 2. Sealed cracks and/or patch repairs were present on the top surface in 14 of the 33 spans. The repaired areas were in good condition (see Figure 3) except in Span 9 where patch repairs were assigned a condition rating of 2. The condition rating for original concrete on the bottom surface of the deck was a 1 in 29 spans, a 2 in one span, and a 3 in three spans (there is an overlay on the top surface of these three spans). The condition rating of 3 was due to the extent of cracks and spalls adjacent to the top flanges of the beams. No repairs were observed on the bottom surface of the deck.

Figure 2. Typical cracking on the top surface of the deck.

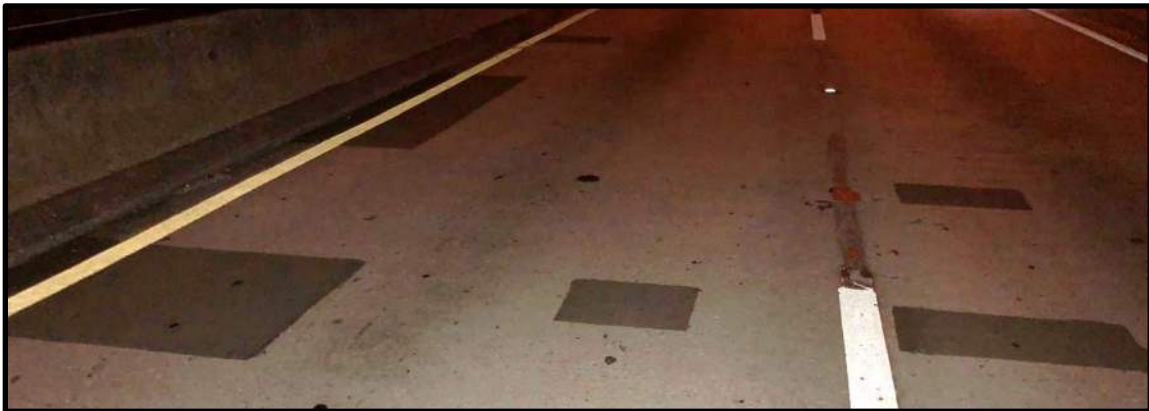
Figure 3. Typical patches on the top surface of the deck.

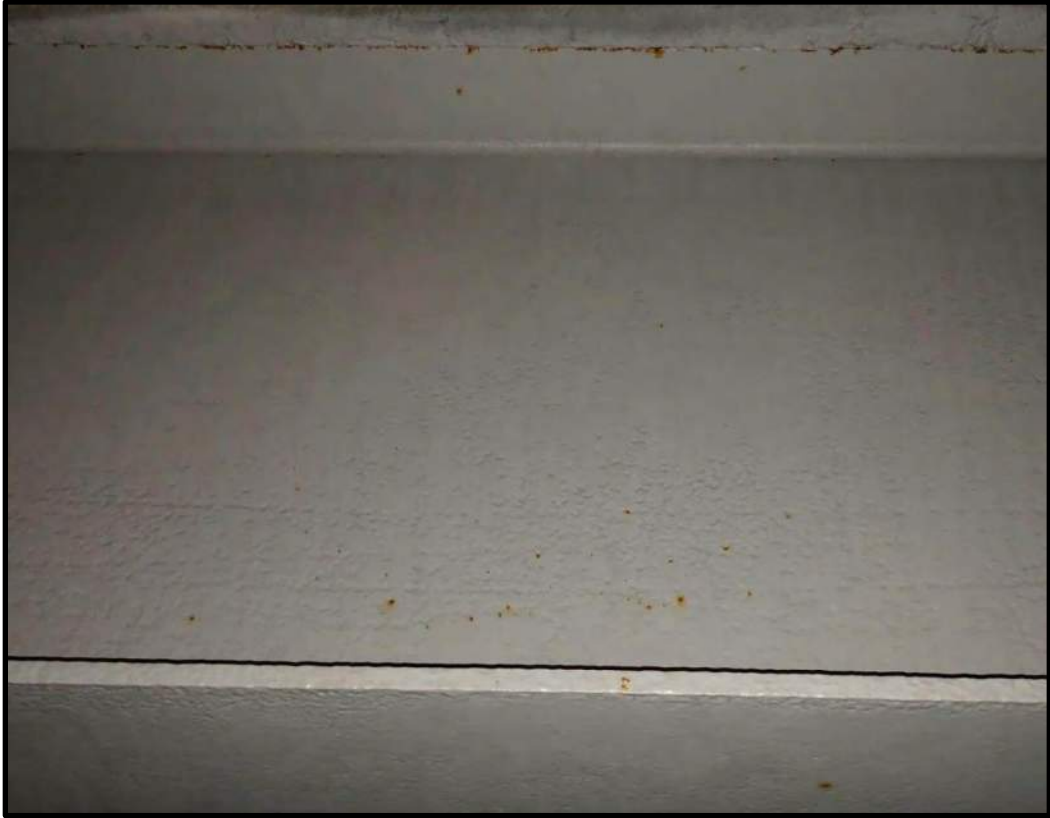
Figure 4. Typical pitting and corrosion staining on a steel beam in Span 18.

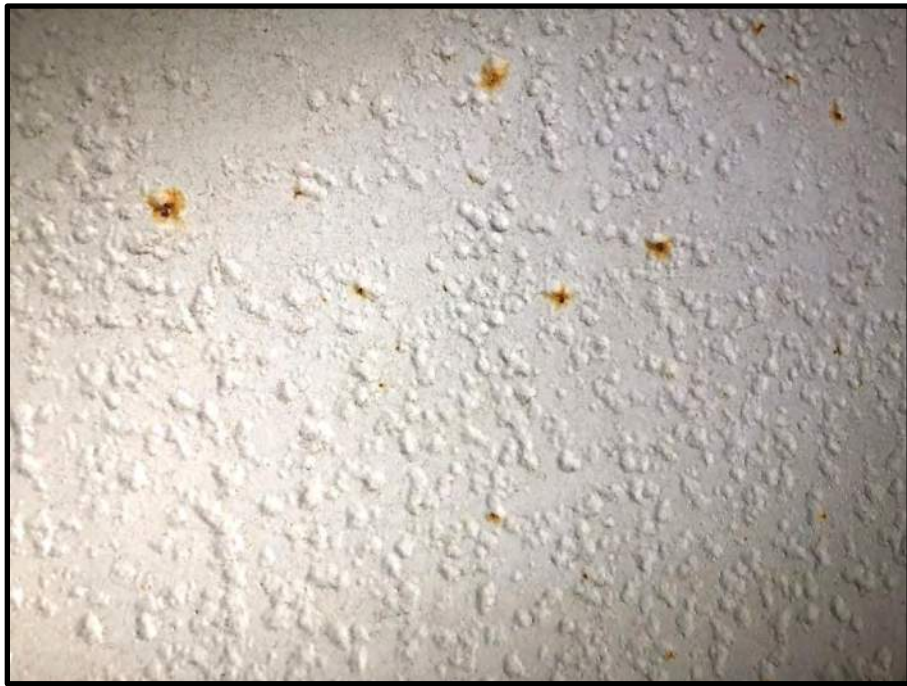
Figure 5. Apparent corrosion products under the coating on a steel beam in Span 18.

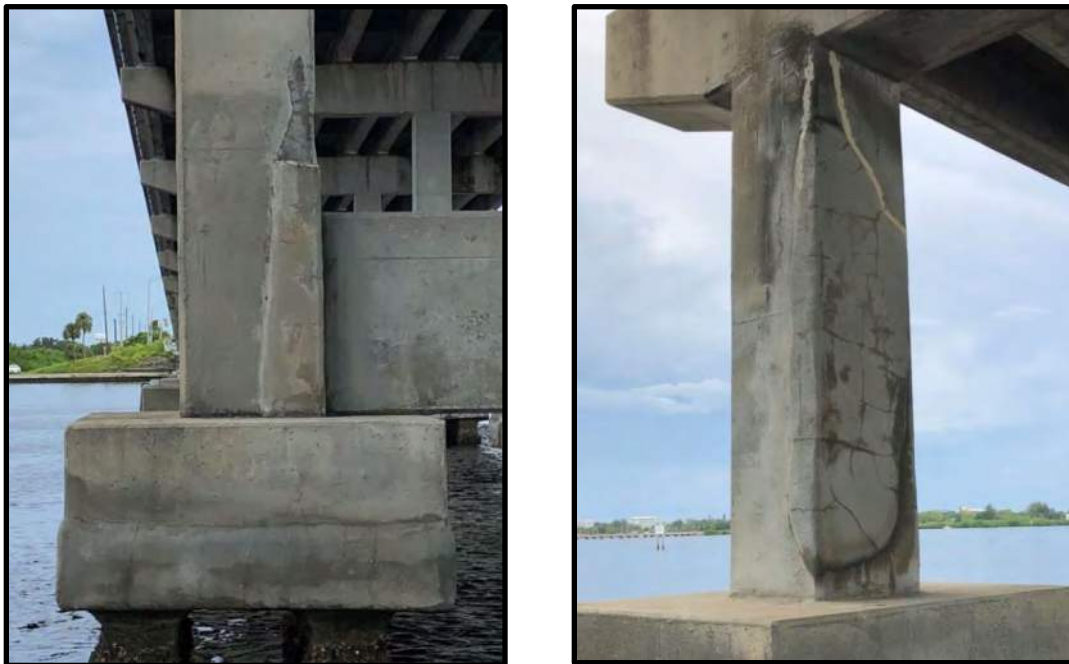
Figure 6. Examples of column repairs that were assigned a condition rating of 2.

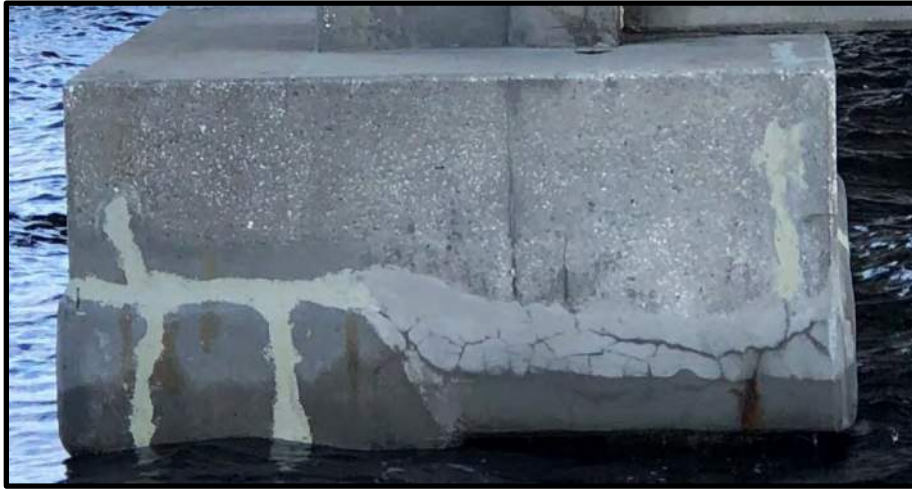
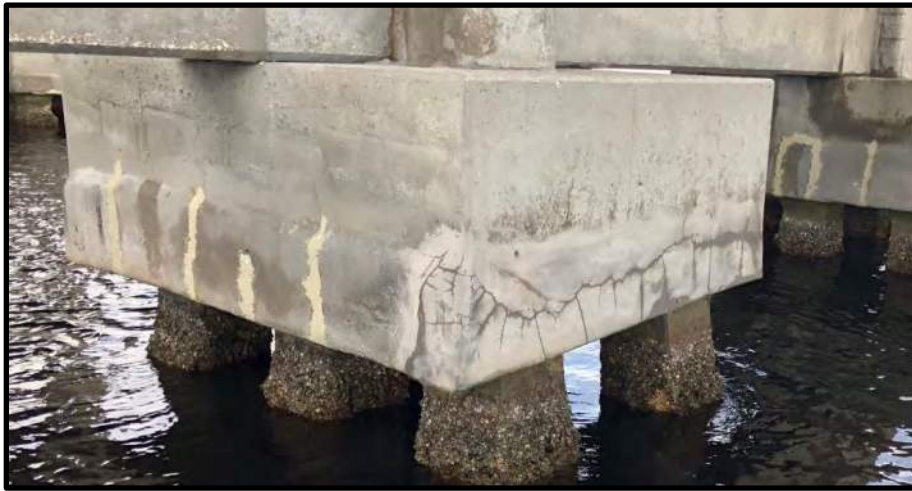
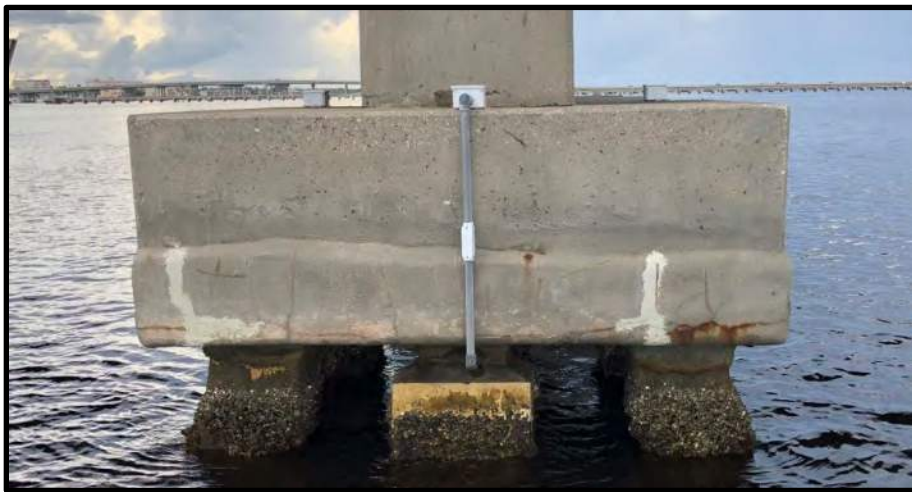
Figure 7. Examples of footing repairs that were assigned a condition rating of 2.

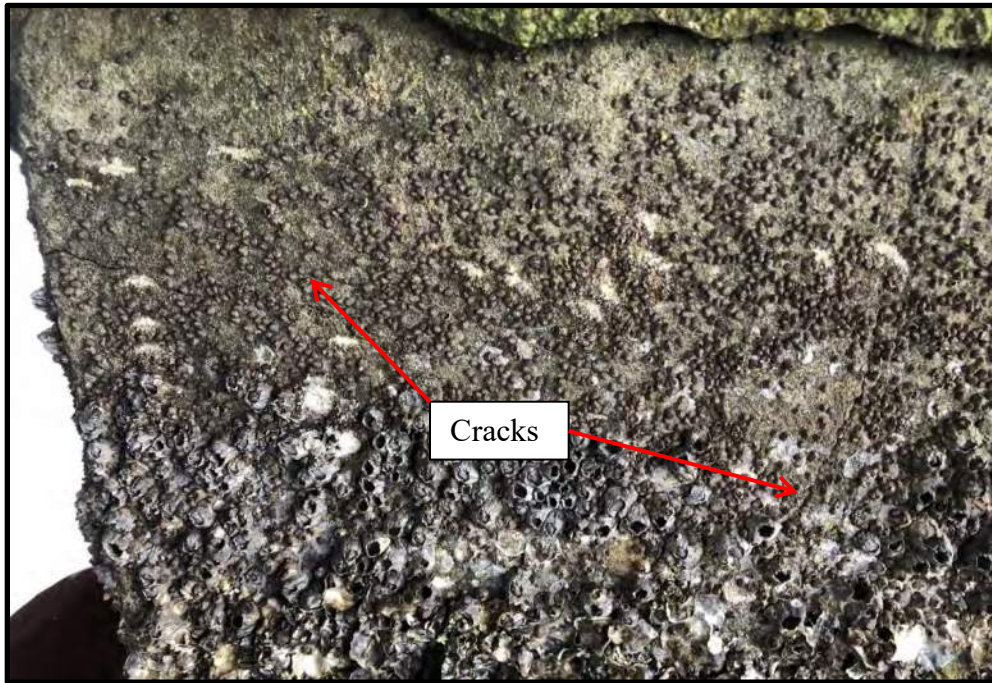
Figure 9. Cracks near the top of a pile.

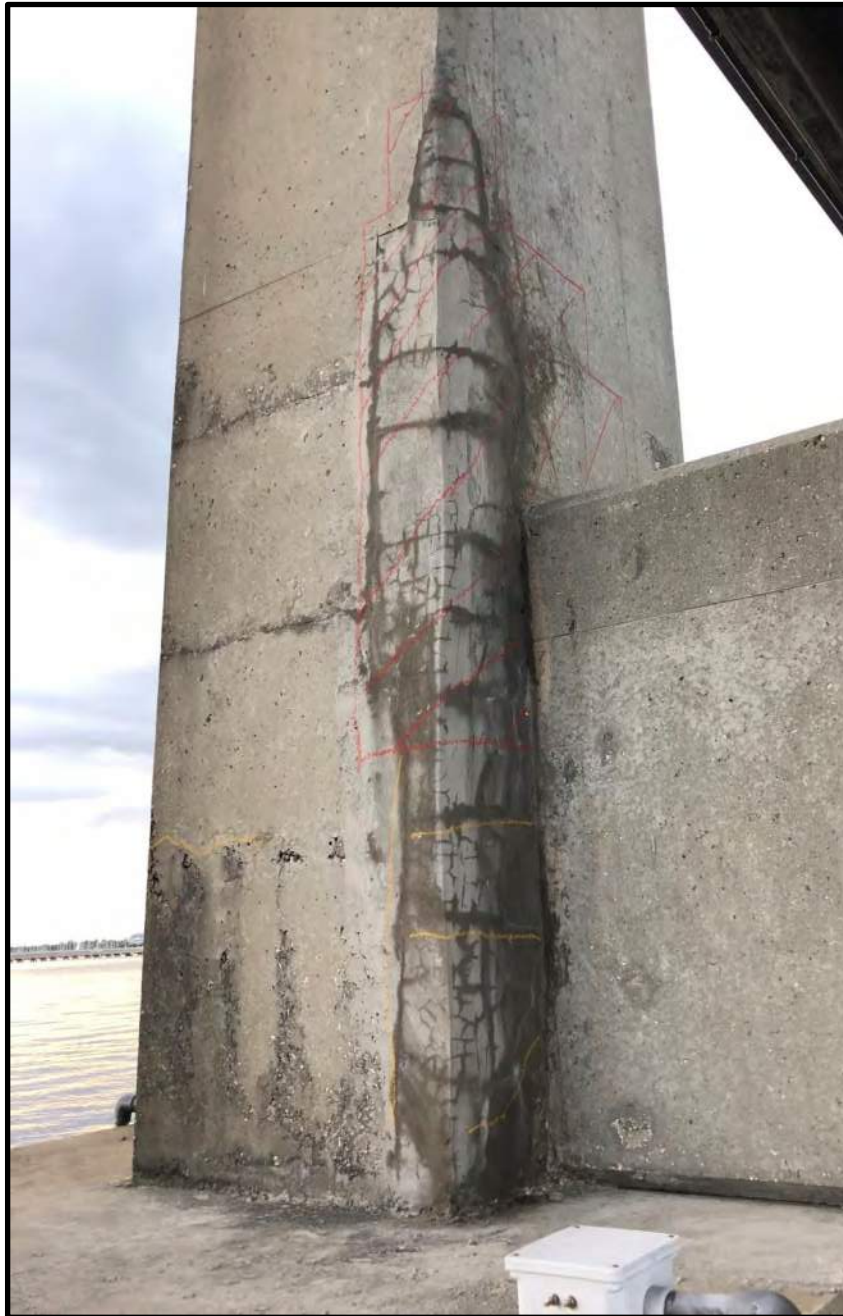
and sealed cracks. There are numerous unsealed cracks (maximum width of 16 mils) within the repaired areas on all four sides and 40% of the repaired area on the east face is delaminated (see Figure 11). There was also a small area with corrosion staining in the repaired area on the north face.

Figure 10. Patched area at the southeast corner of Column 15-1 (delaminated areas are crosshatched in red and larger cracks are highlighted in yellow).

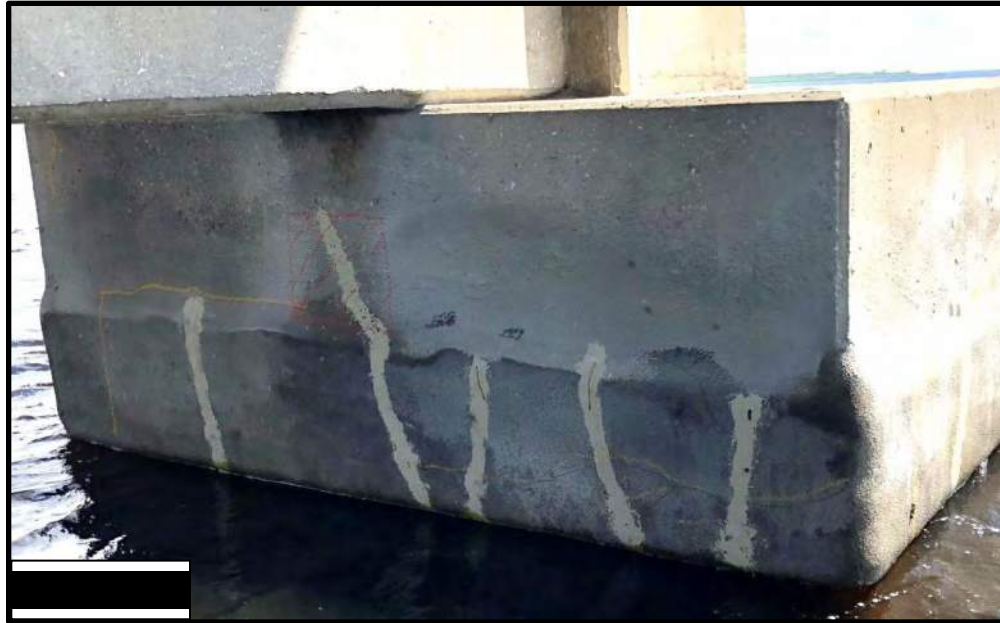
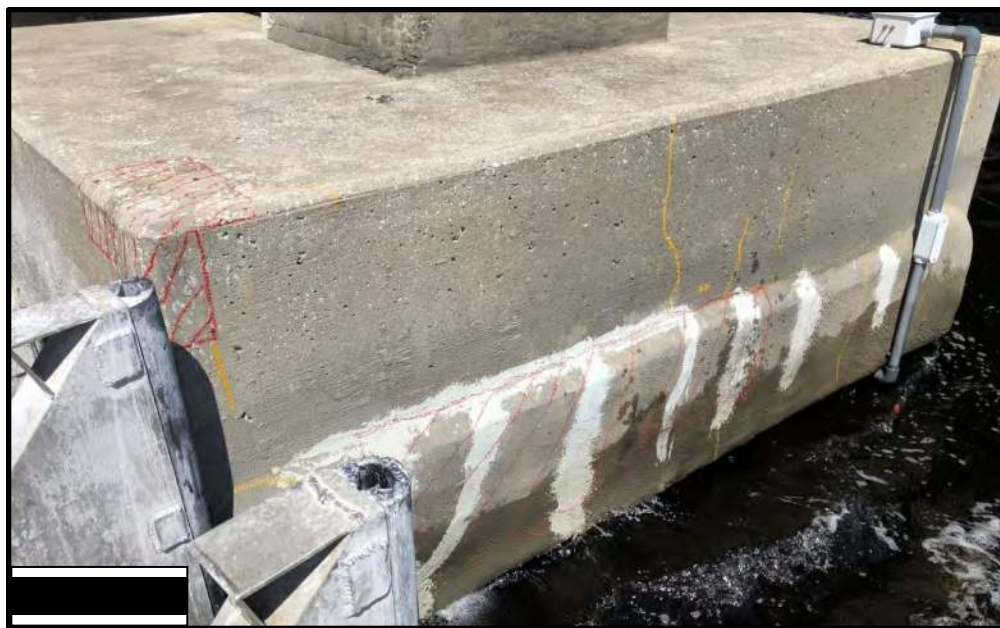
Figure 11. Conditions found on Footing 26-3 (delaminated areas are crosshatched in red and unsealed cracks are highlighted in yellow).

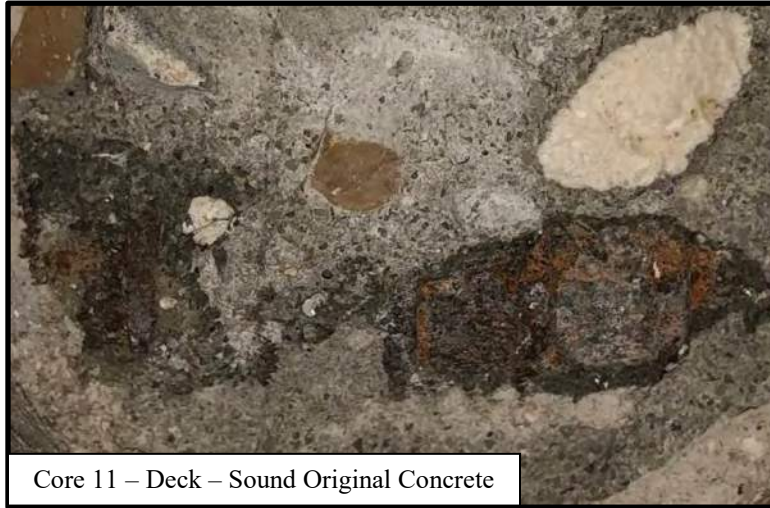
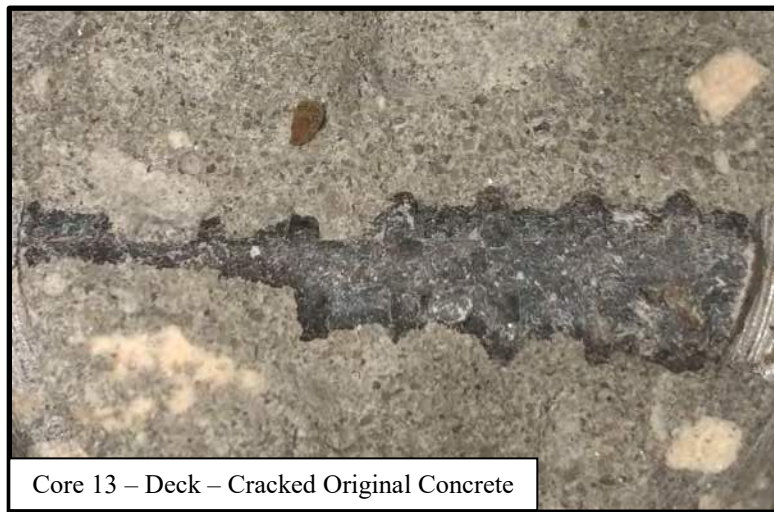
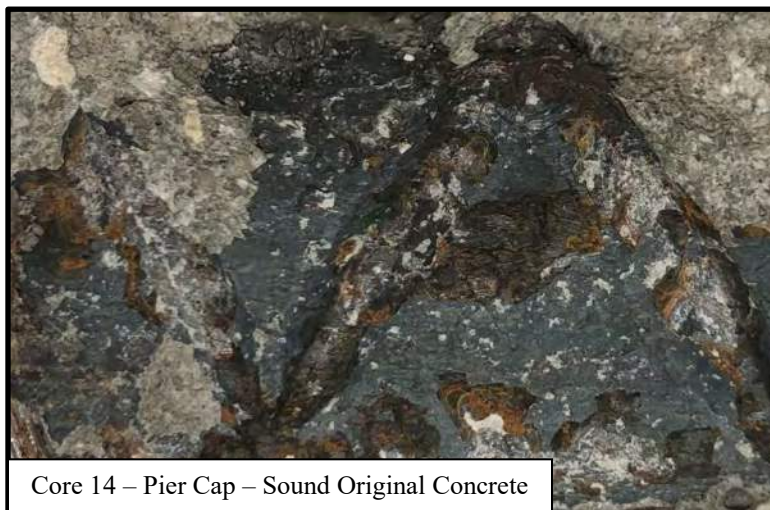
Figure 12. Condition of the reinforcing steel in deck and pier cap.

- A significant amount of chlorides have infiltrated into sound and cracked concrete on the deck, but the chloride content at the reinforcing steel depth is still well below the corrosion threshold.
