PRELIMINARY ENGINEERING REPORT

Florida Department of Transportation

DeSoto Bridge Replacement SR 55 US 301/US 41

Financial Management Number: 442630-1

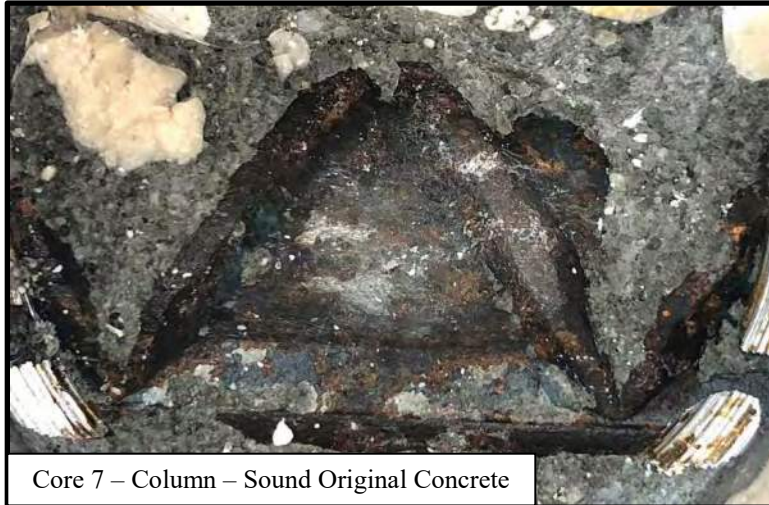
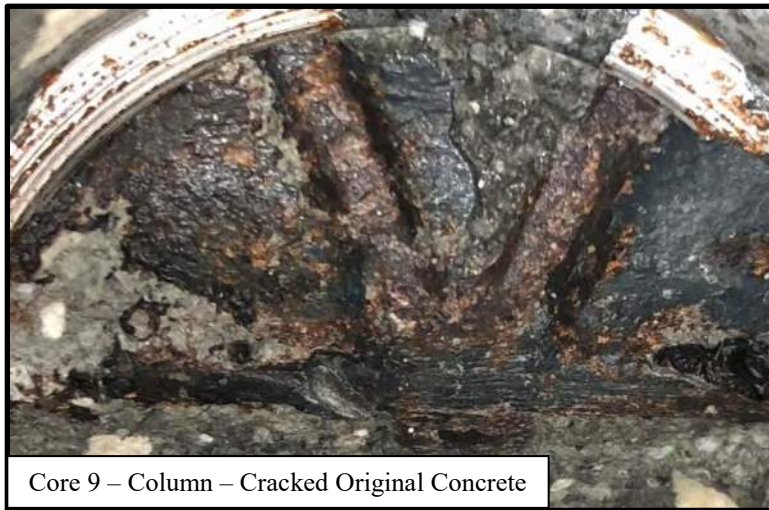
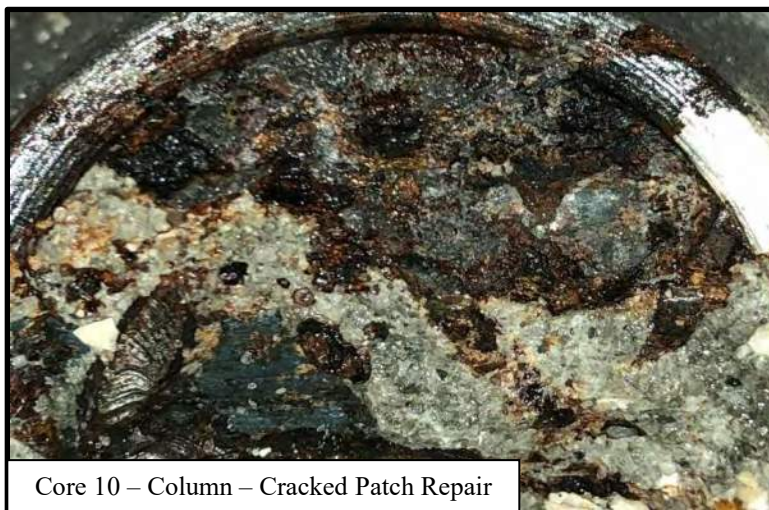
Figure 13. Condition of the reinforcing steel in Column 15-1.

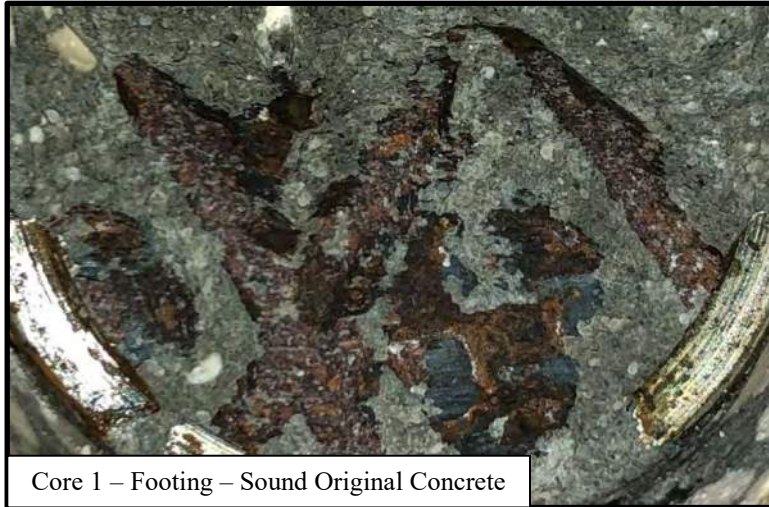
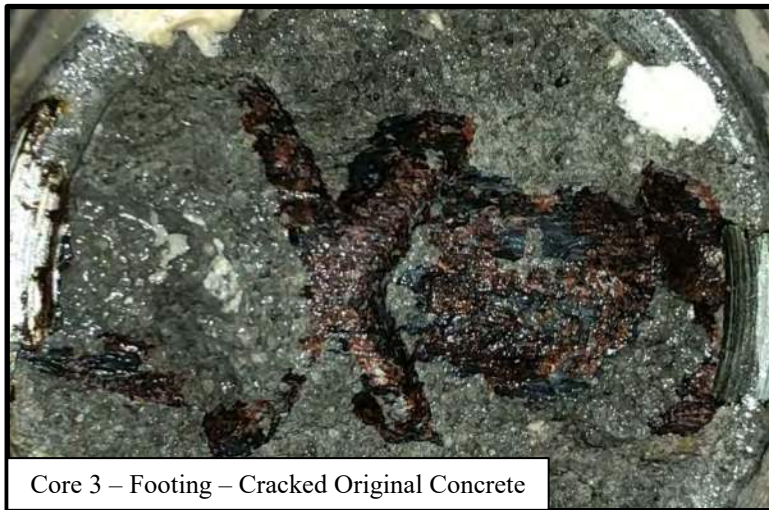
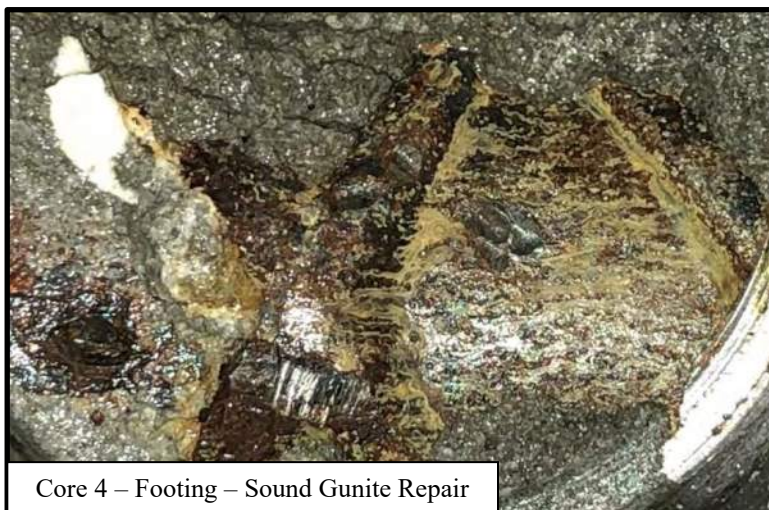
Figure 14. Condition of the reinforcing steel in Footing 26-3.

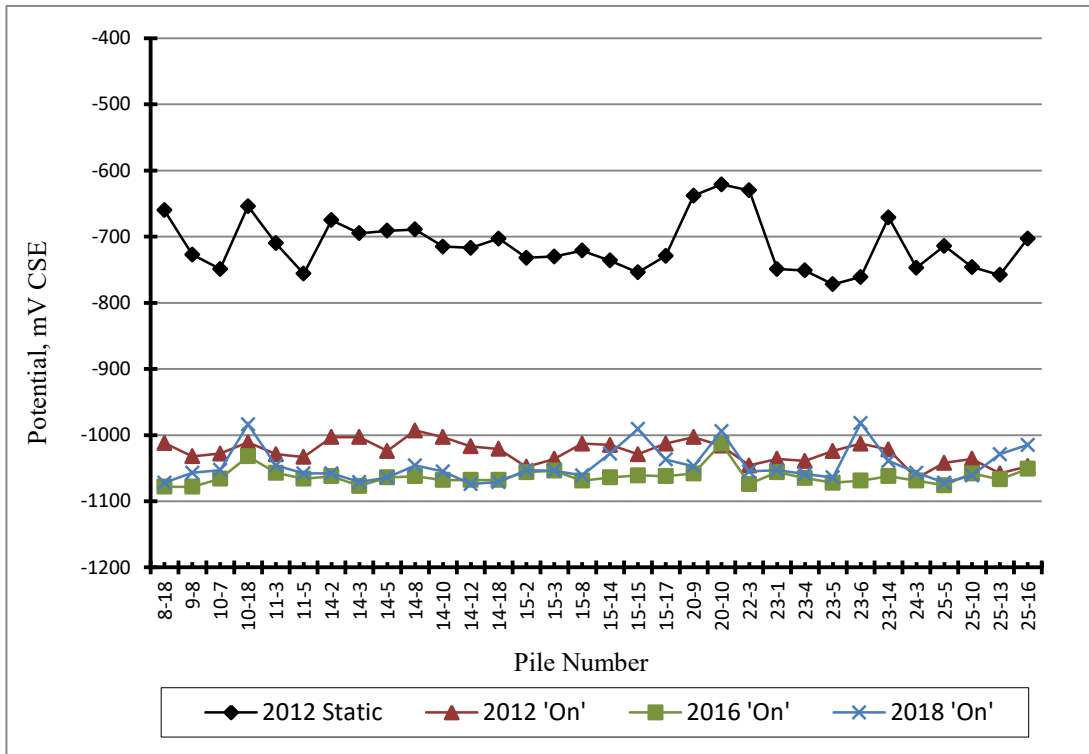
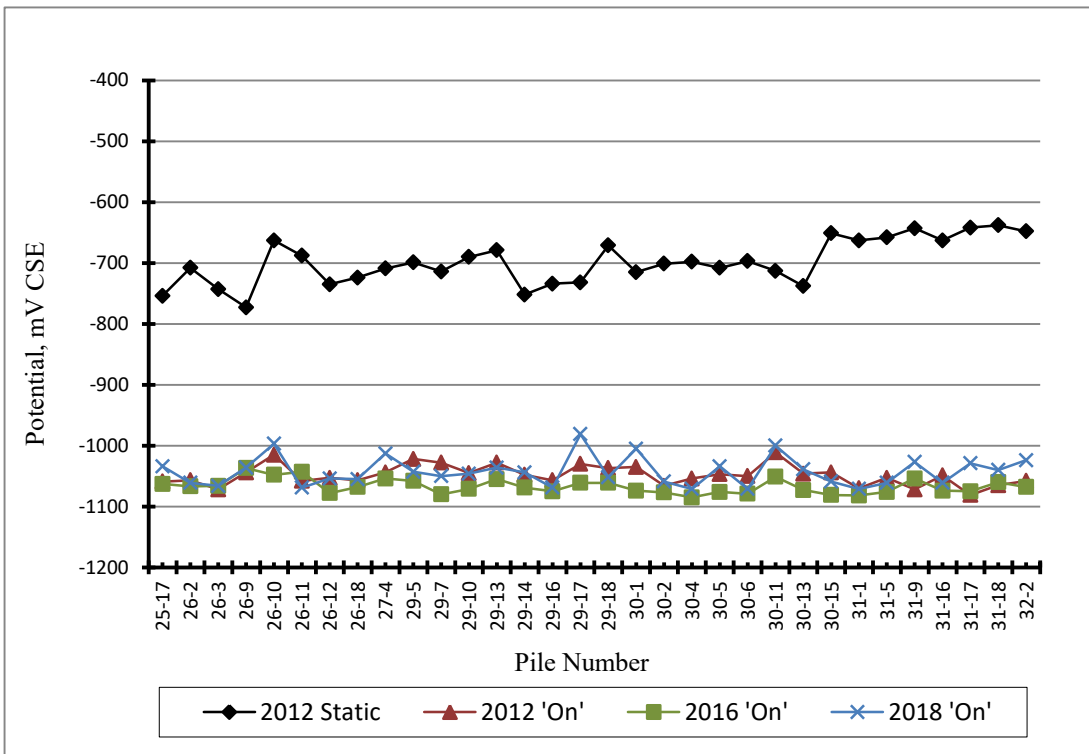
- There is a direct short or a near short between reinforcing steel and the zinc anode inside the jacket on eight of the 10 piles where the CP systems were installed in 2017 (Pile Nos. 5-4, 6-2, 6-6, 15-5, 23-17, 23-18, 28-2, and 31-2).

Figure 15. Static and 'on' potentials for the CP pile jackets that were installed in 2012.

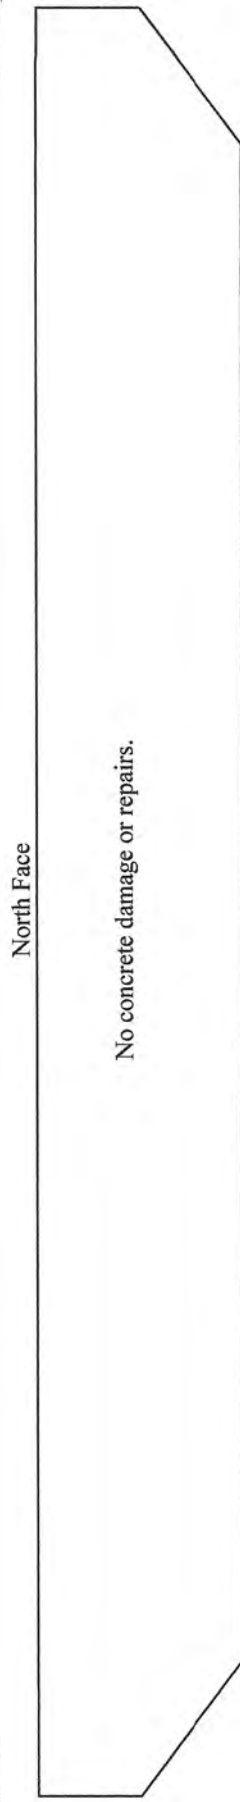
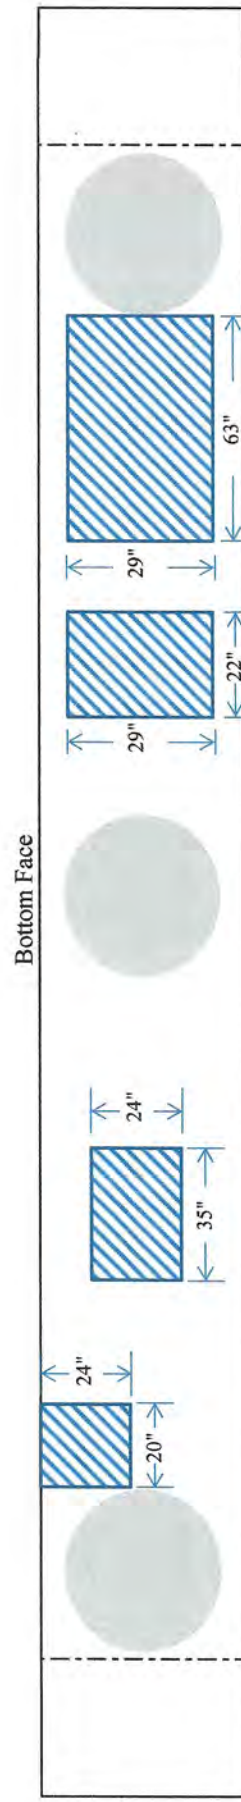
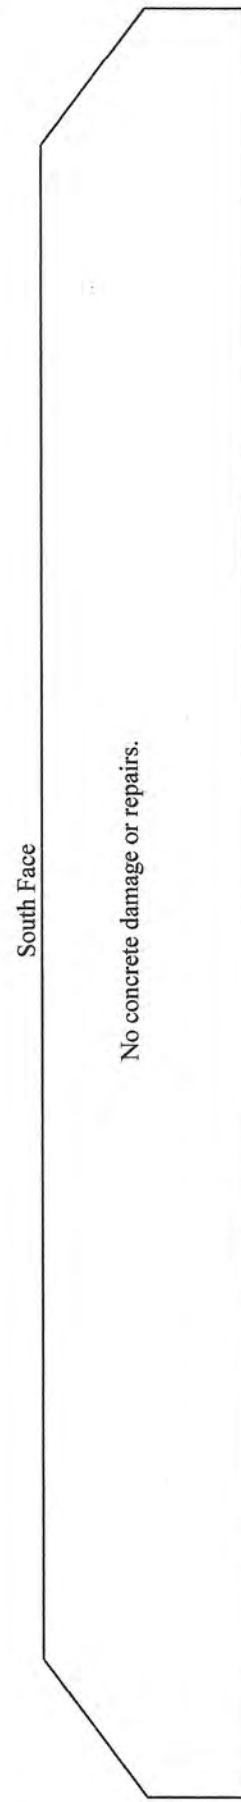
Pier Cap No. 24

Notes: Hatched areas represent delaminated concrete. There were also cracks in the largest delaminated area.

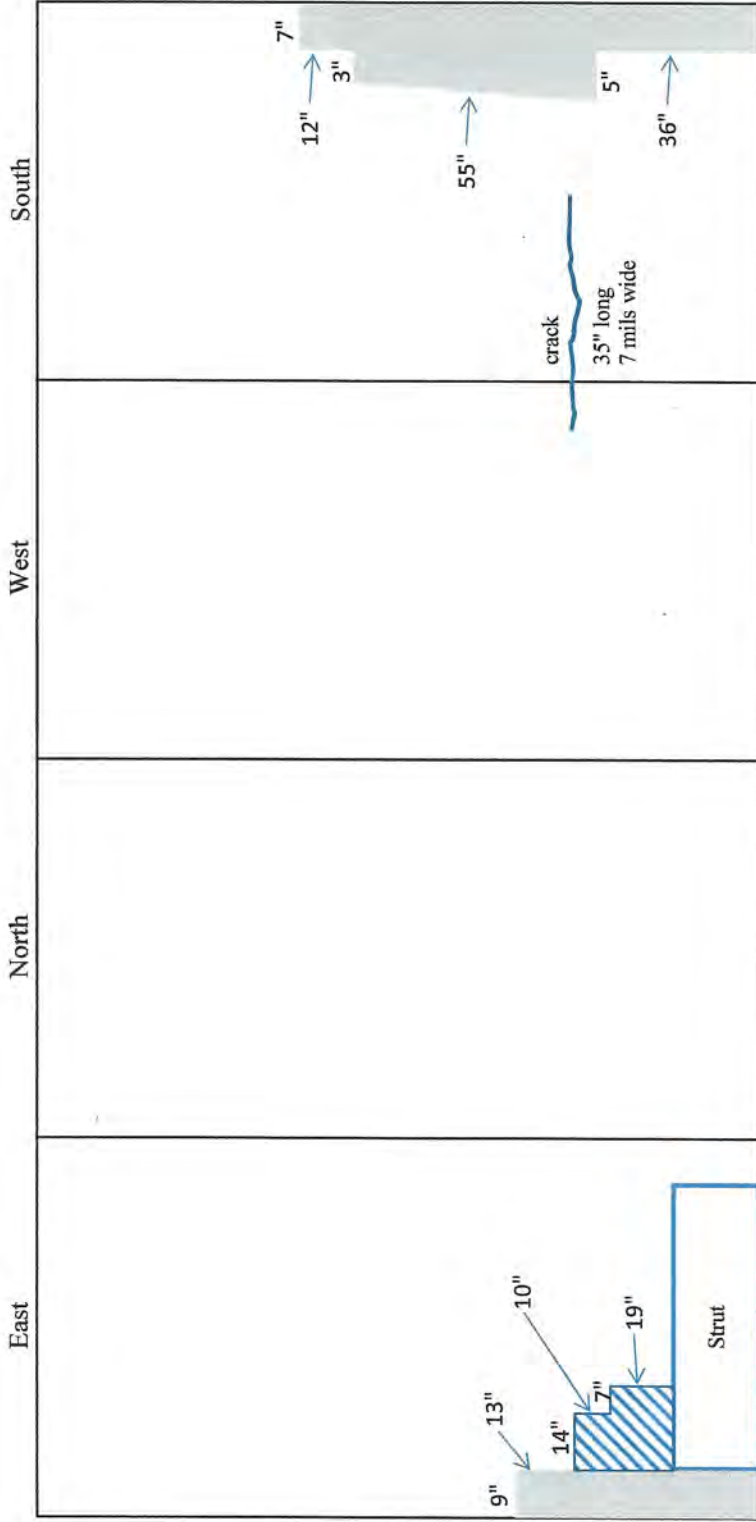
Column No. 1

Notes: Shaded areas are patches with cracking throughout. Approximately 2/3 of the patched area is delaminated. There is also delaminated original concrete adjacent to the patch on the east face in the hatched area. There is honeycombing on the lower portion of the north and south faces.

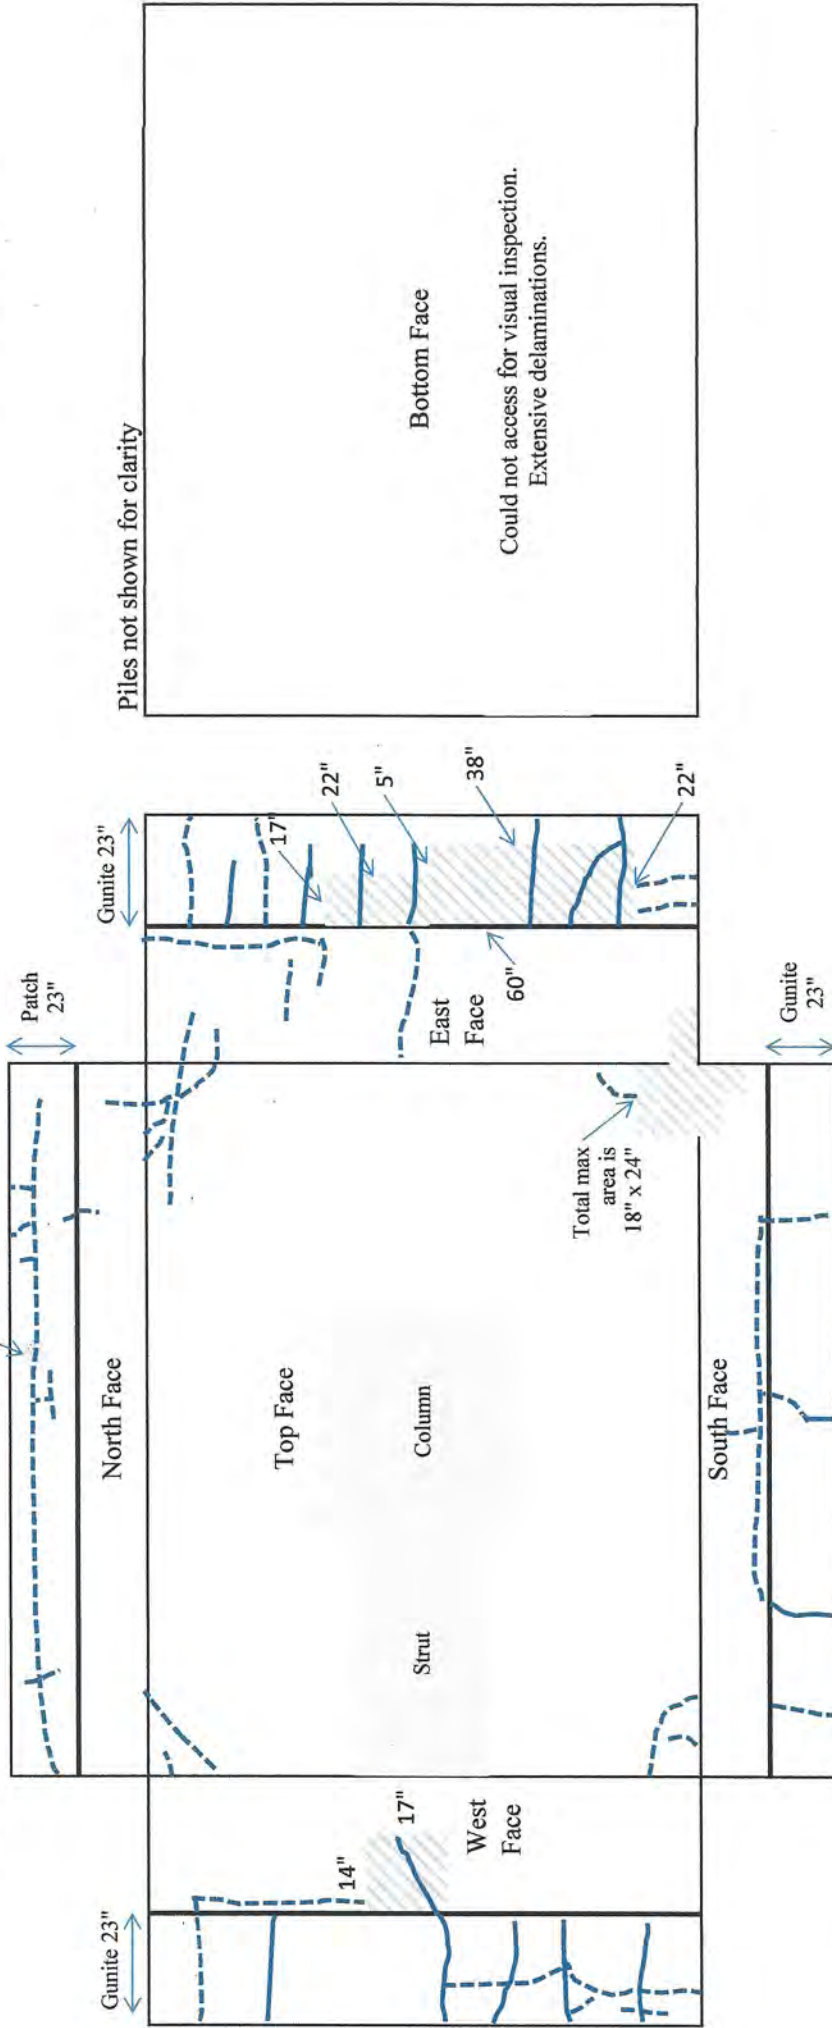
Footing No. 3

Notes: Maximum width of unsealed cracks in original concrete was 20 mils and in repaired areas was 16 mils.

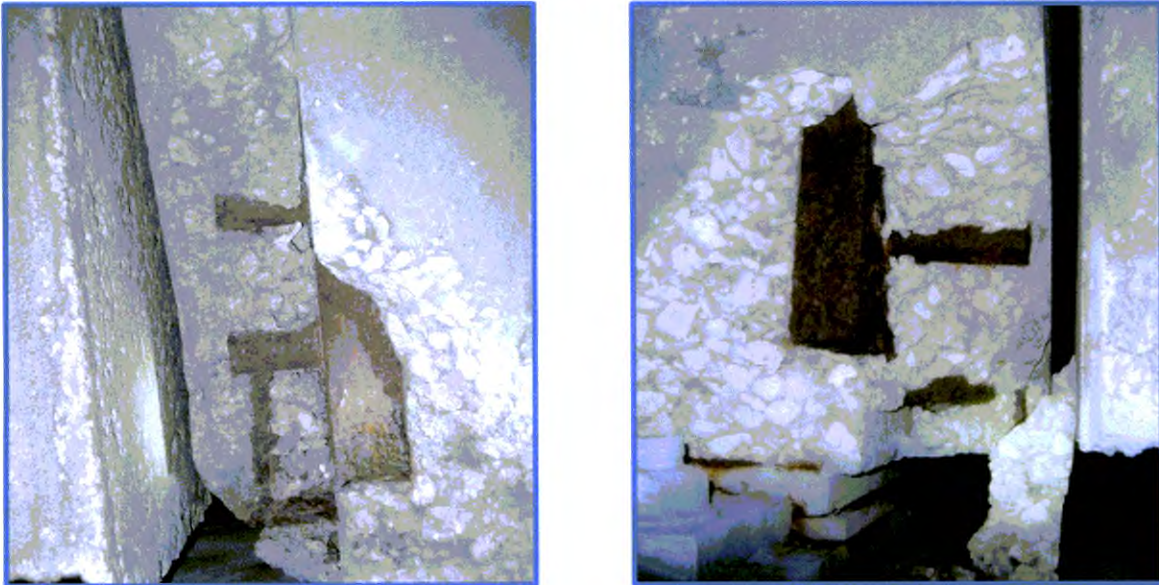
The Hernando Desoto Bridge (Bridge No. 130053) was constructed in 1957. Currently, there are numerous locations where concrete spalling has occurred at the ends of girders and corroded post-tensioned anchorages and tendons are exposed in the spalled areas. Figure 1 shows typical examples of the concrete damage and exposed post-tensioned components.

Figure 1. Typical examples of concrete damage and exposed post-tensioned components at the ends of girders.

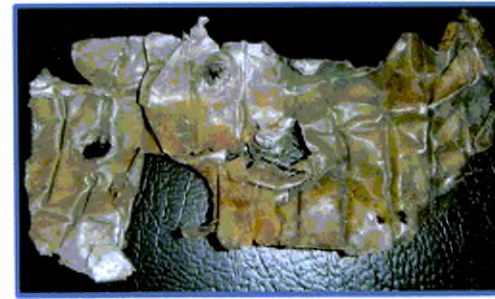
Girder 22-1 Top Tendon Duct

Figure 2. Condition on the inside surface of the ducts.
