PRELIMINARY ENGINEERING REPORT

DESOTO BRIDGE FROM STATE ROAD (SR) 64 (MANATEE AVENUE EAST) TO HABEN
BOULEVARD-BRIDGE #130053

Date 08/05/2025

APPENDIX D – DeSoto Bridge Inspection Report

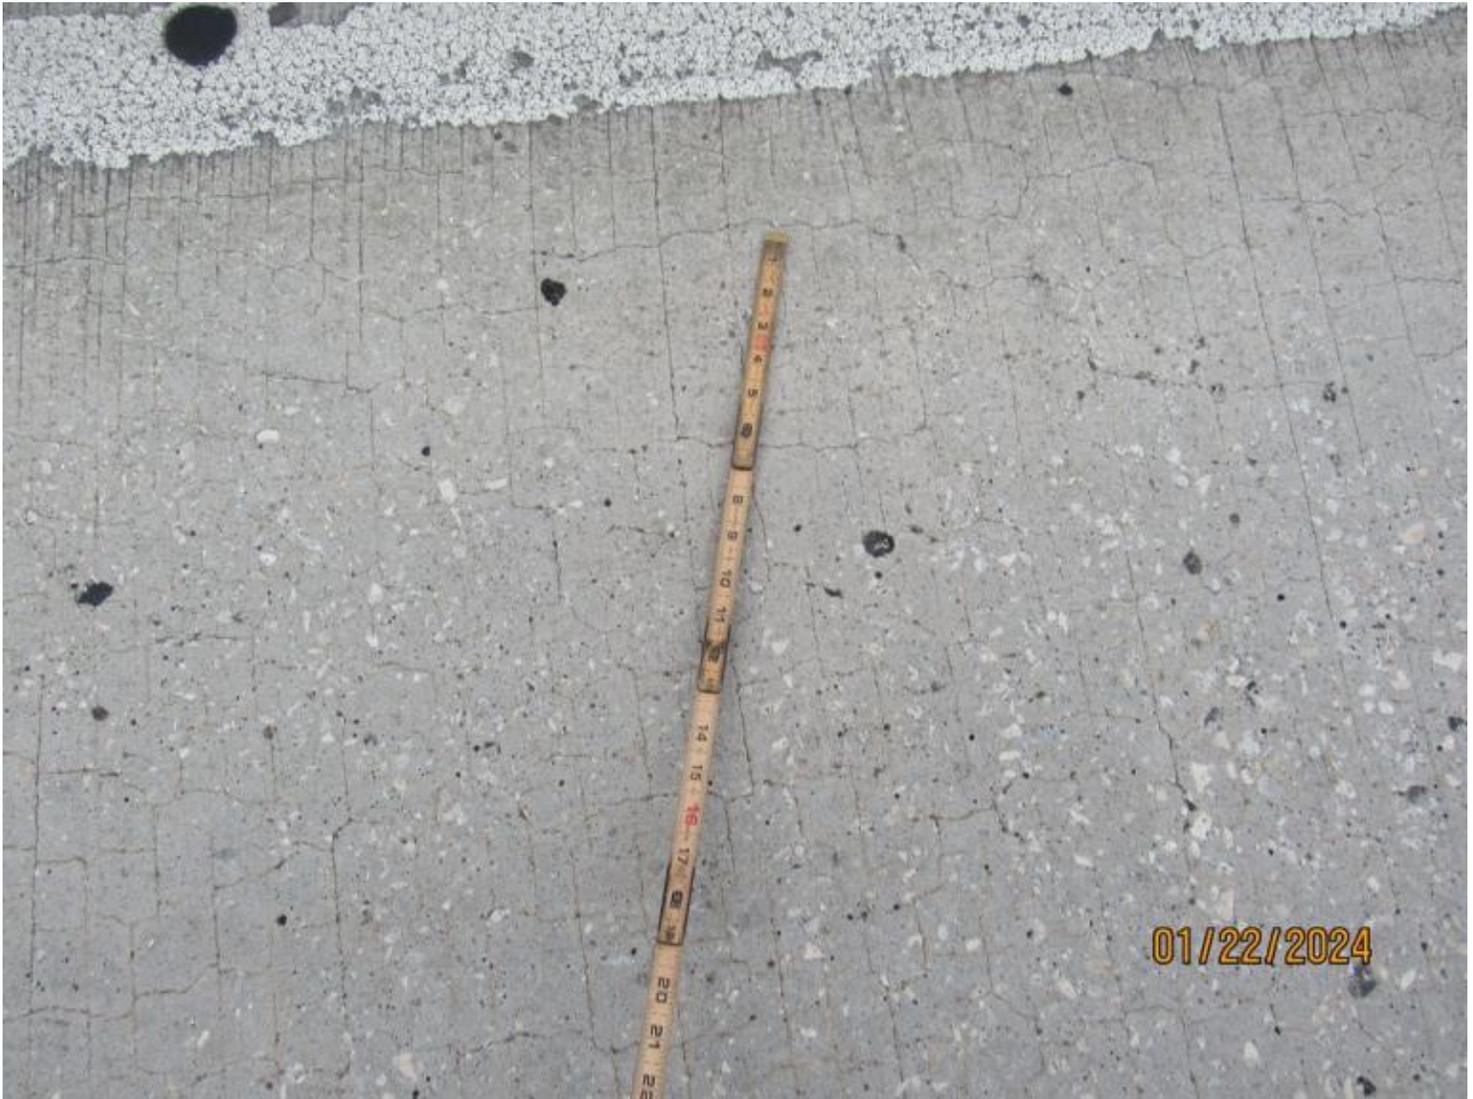
Photo 1: Element 12 Re Concrete Deck

Typical deck top map cracks.

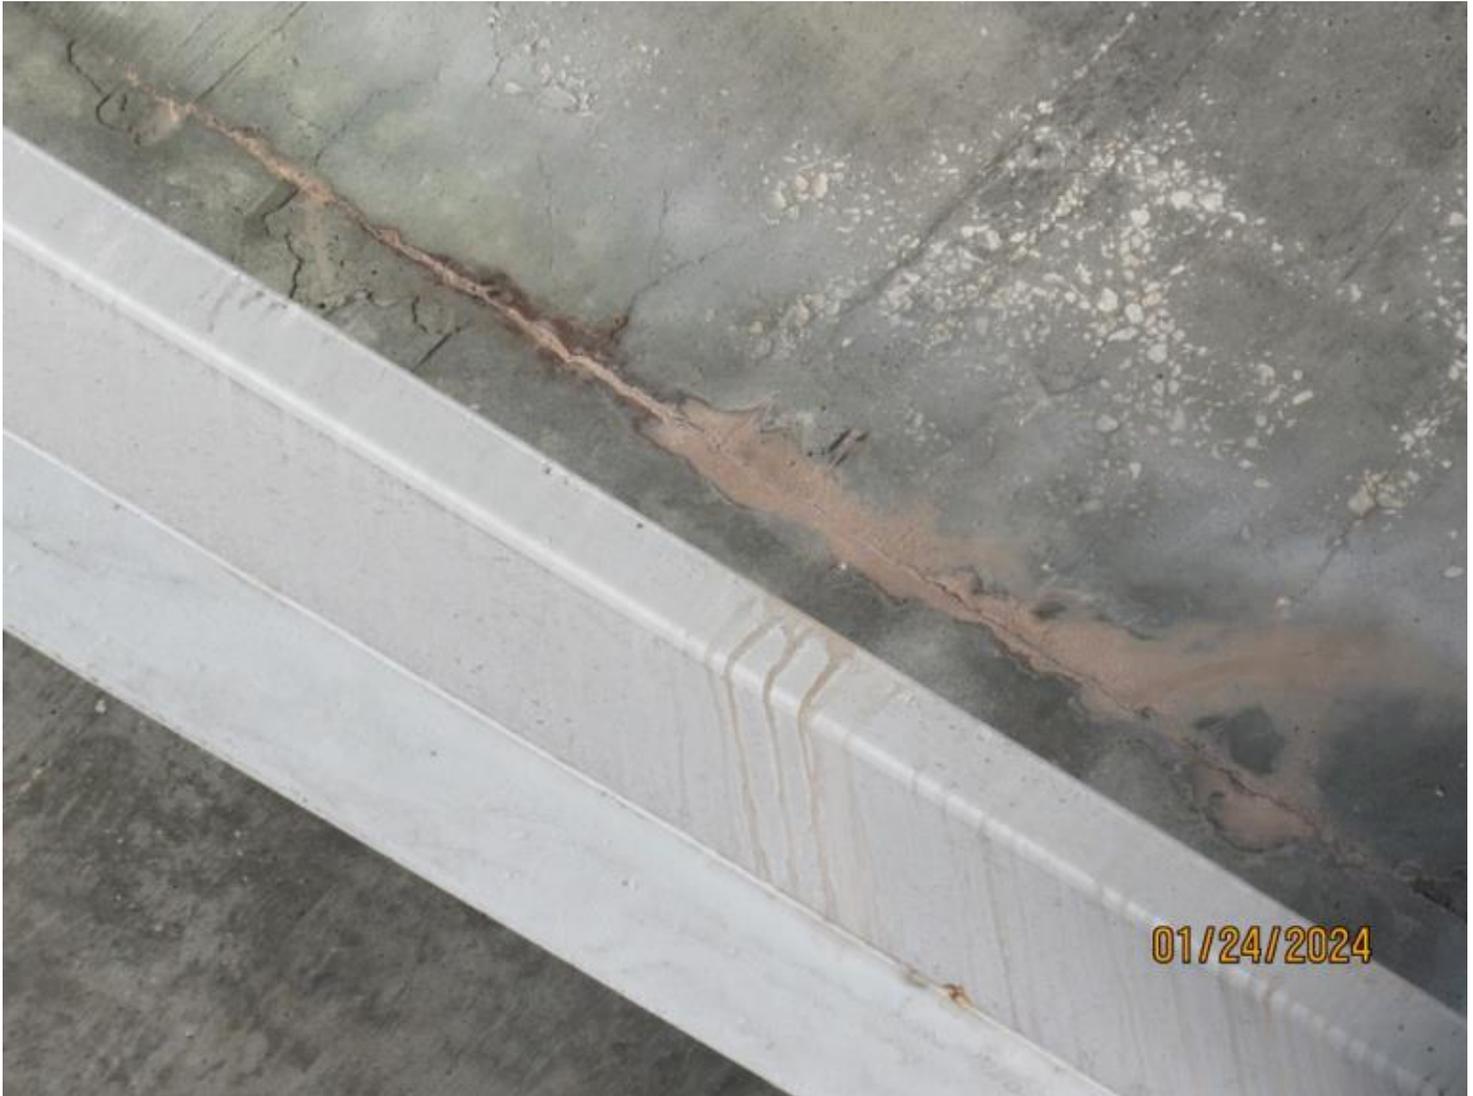
Photo 2: Element 12 Re Concrete Deck

Typical deck underside at the construction joint in Span 16 corrosion bleed out.

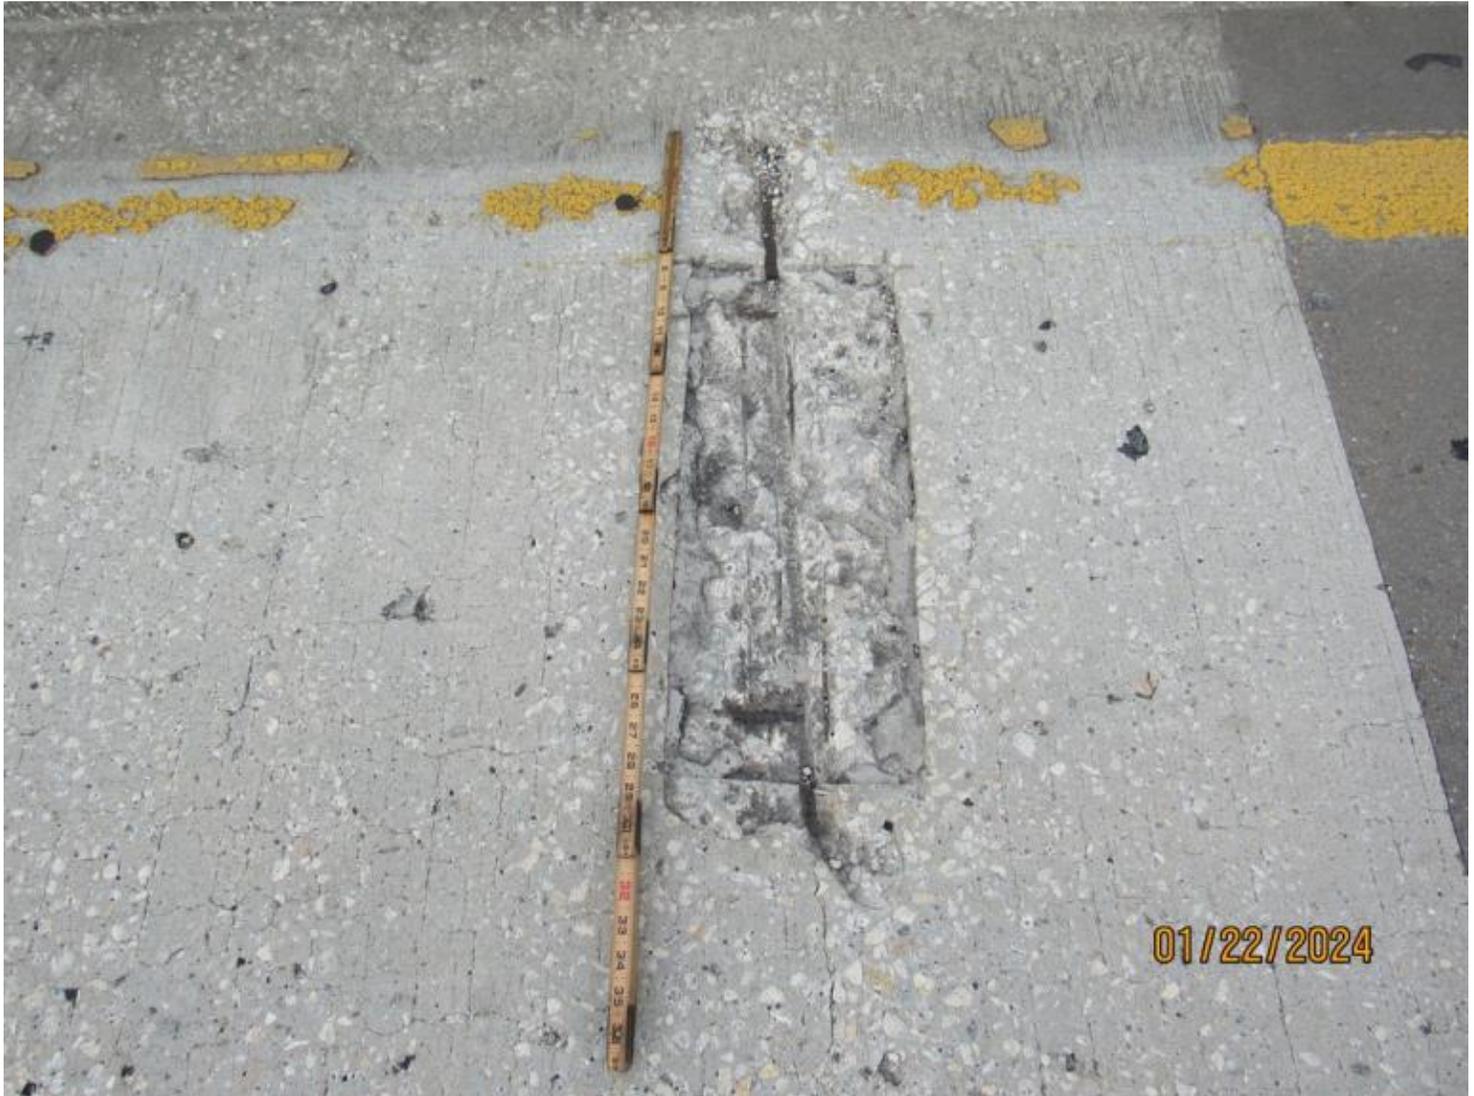
Photo 3: Element 12 Re Concrete Deck

Spall with exposed rebar in the deck top of Span 13 Lane 3.

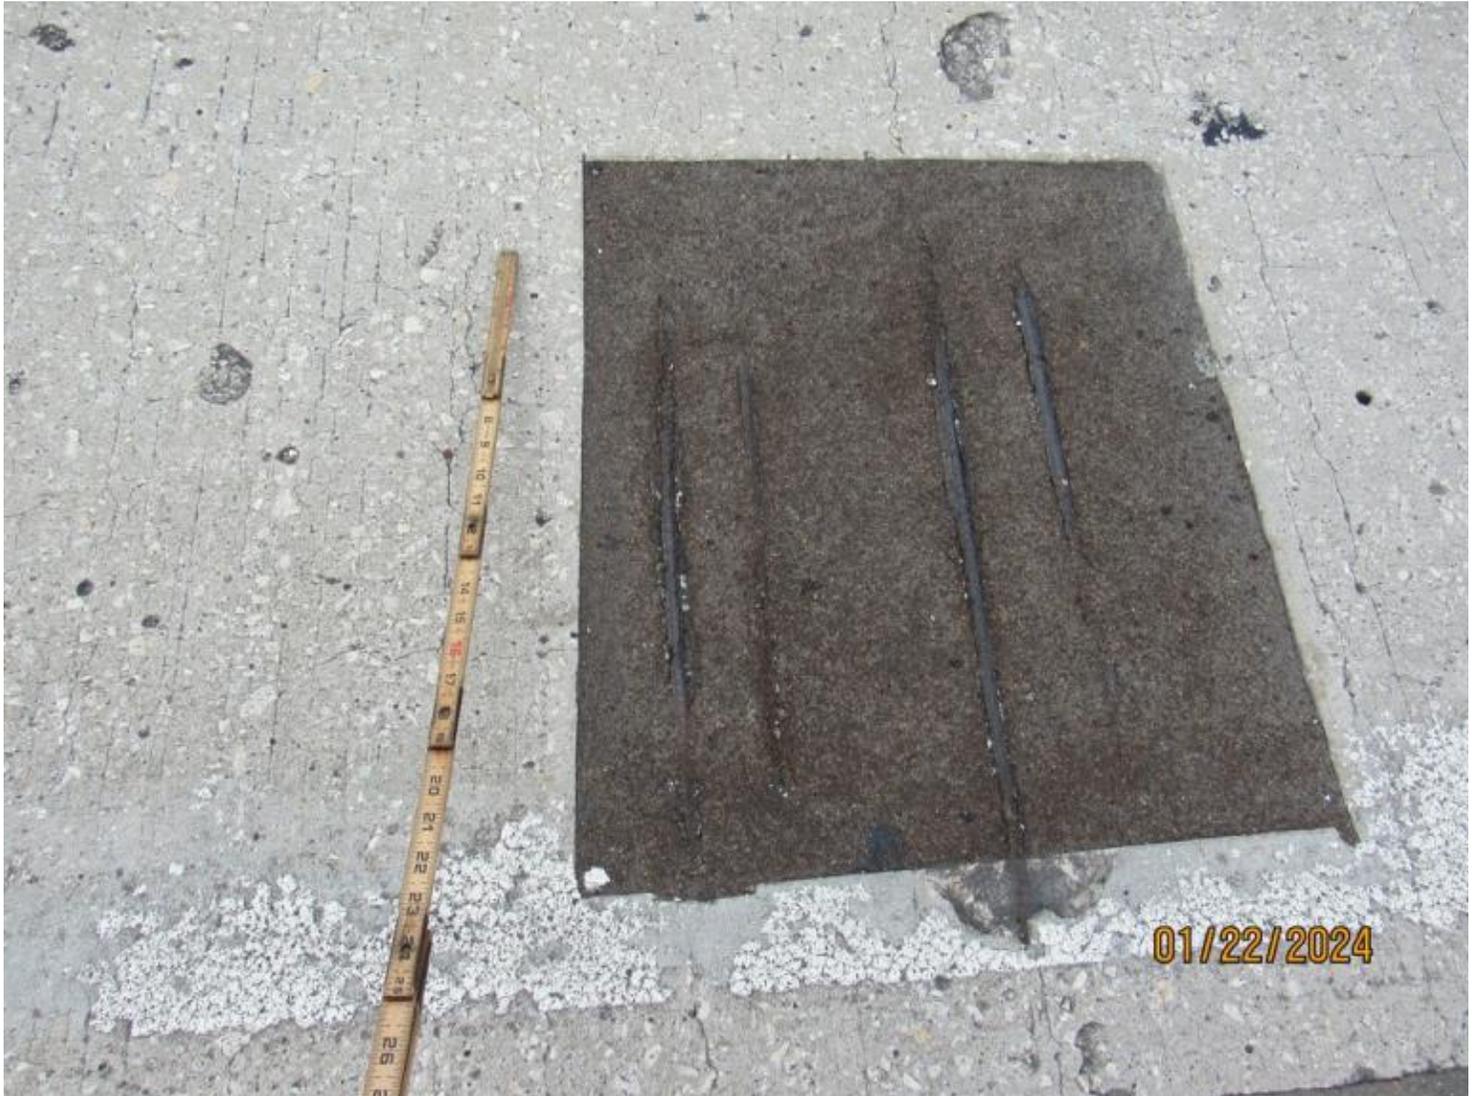
Photo 4: Element 12 Re Concrete Deck

Unsound repair with exposed rebar in the deck top of Span 15 Lane 3.

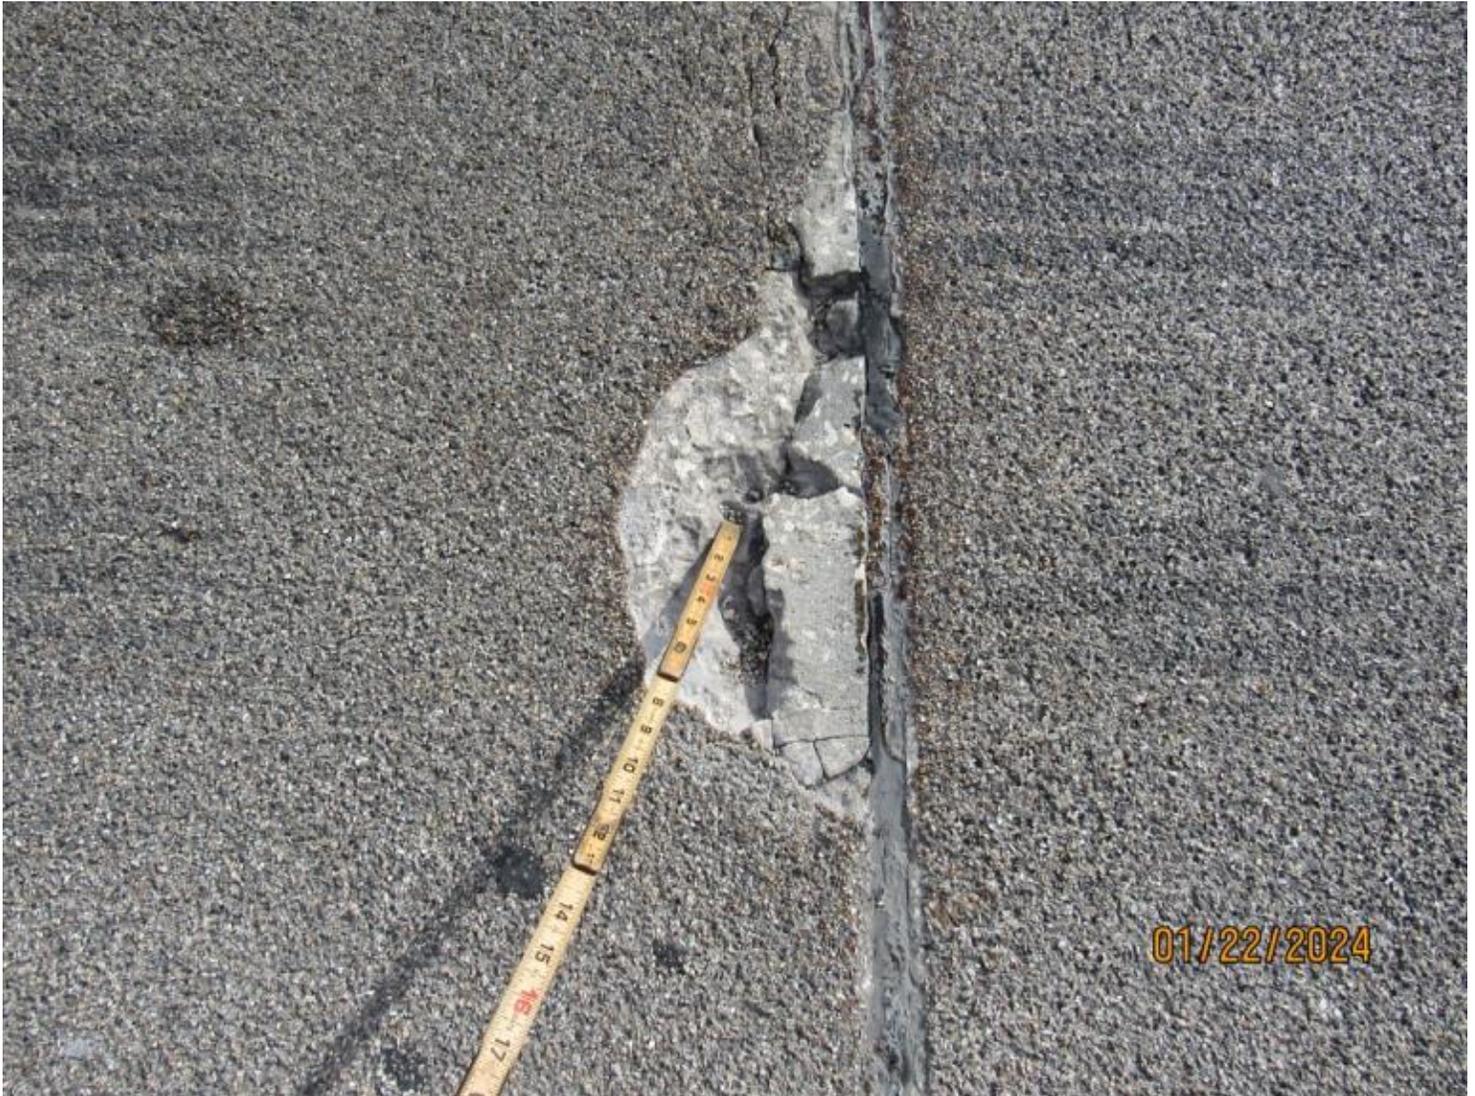
Photo 5: Element 12 Re Concrete Deck

Pothole in the asphalt and spall/delamination in the right wheel path of Lane 1 at Pier 18.

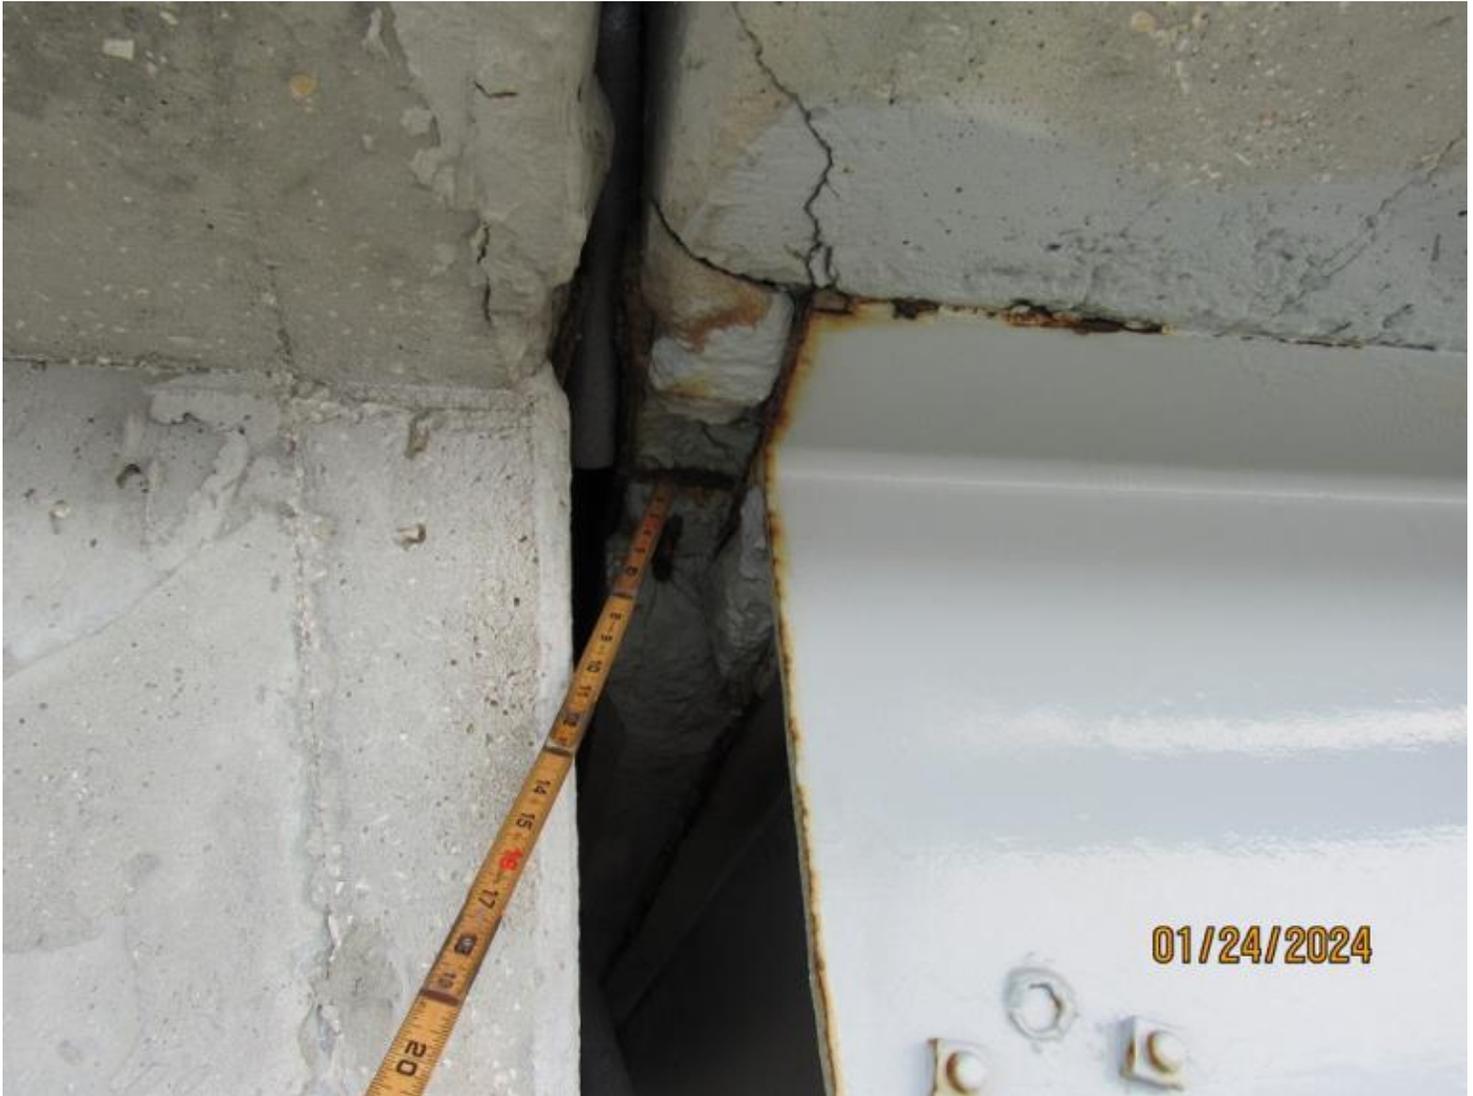
Photo 6: Element 12 Re Concrete Deck

Span 18 deck underside left at Pier 19 spall with exposed rebar.

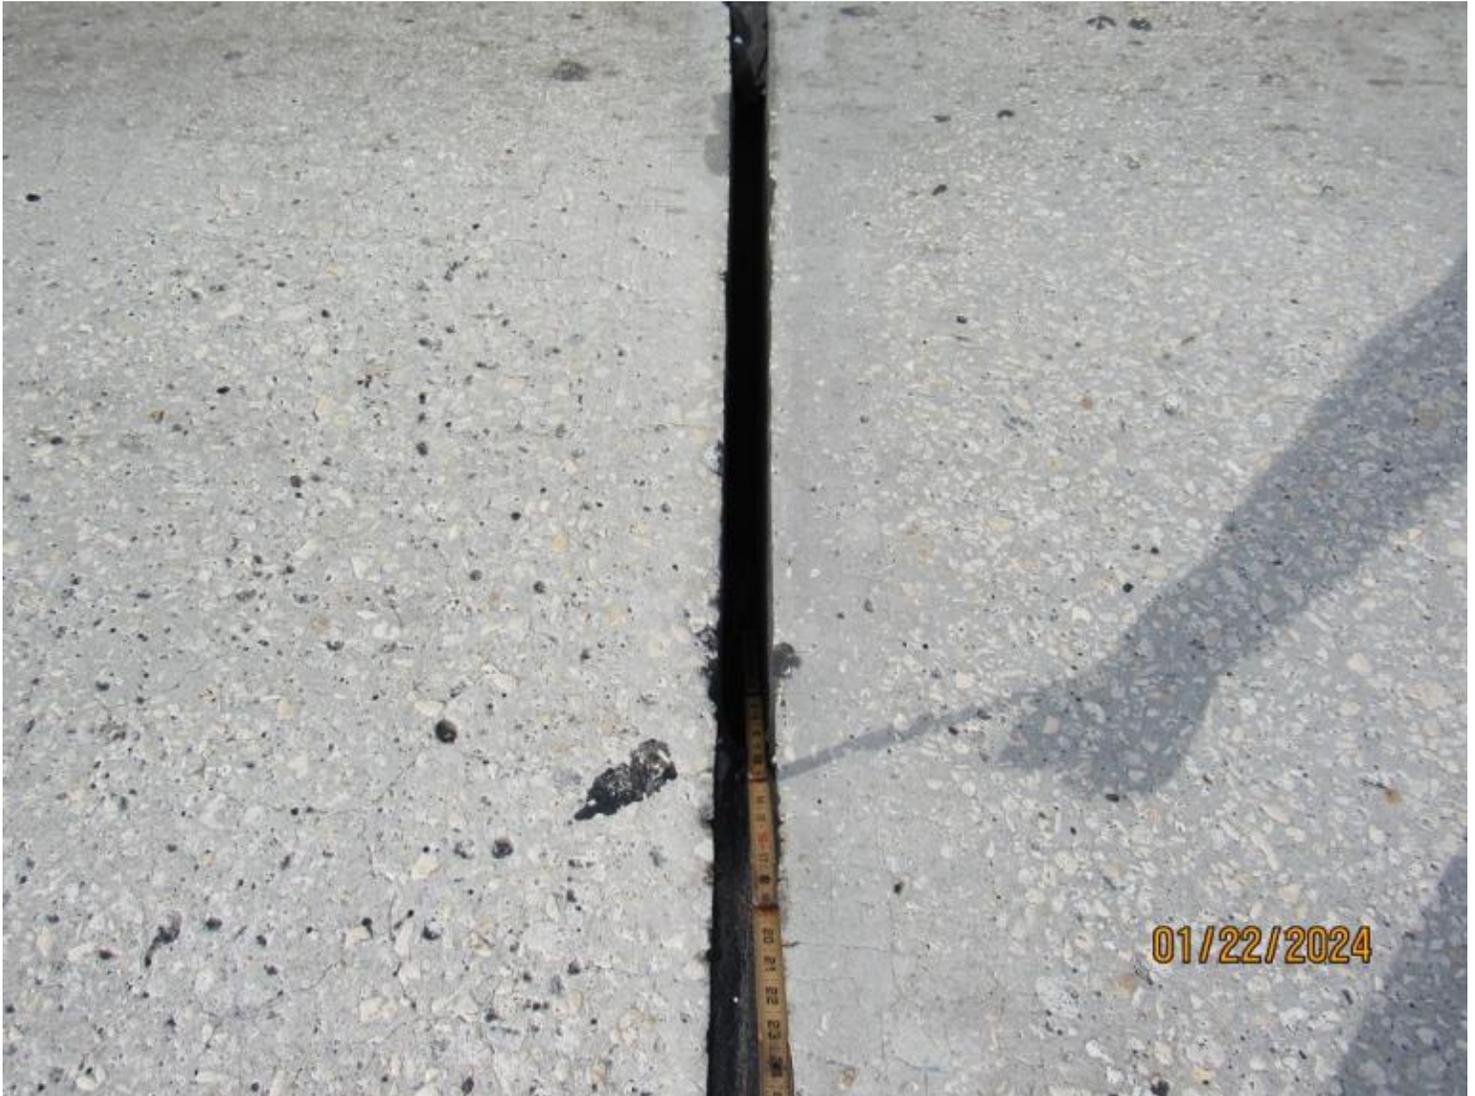
Photo 8: Element 301 Pourable Joint Seal

Pier 9 joint in Lane 3 area of missing sealant. Typical.

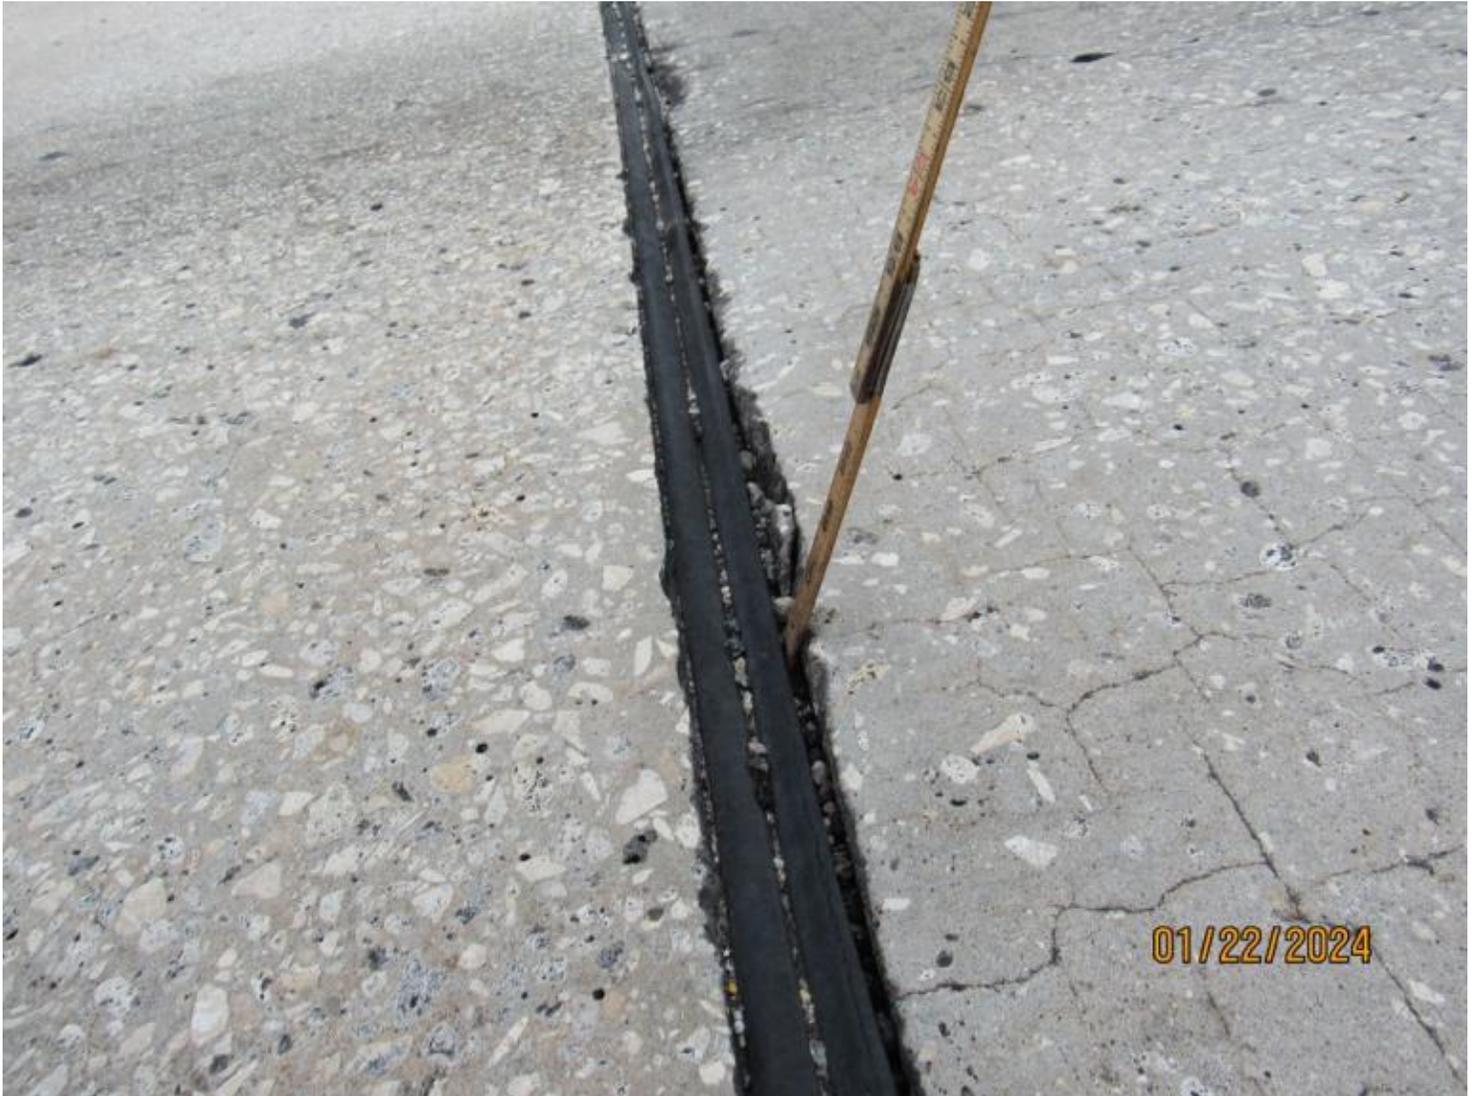
Photo 9: Element 302 Compressn Joint Seal

Typical area of adhesion failure in the compression joints.

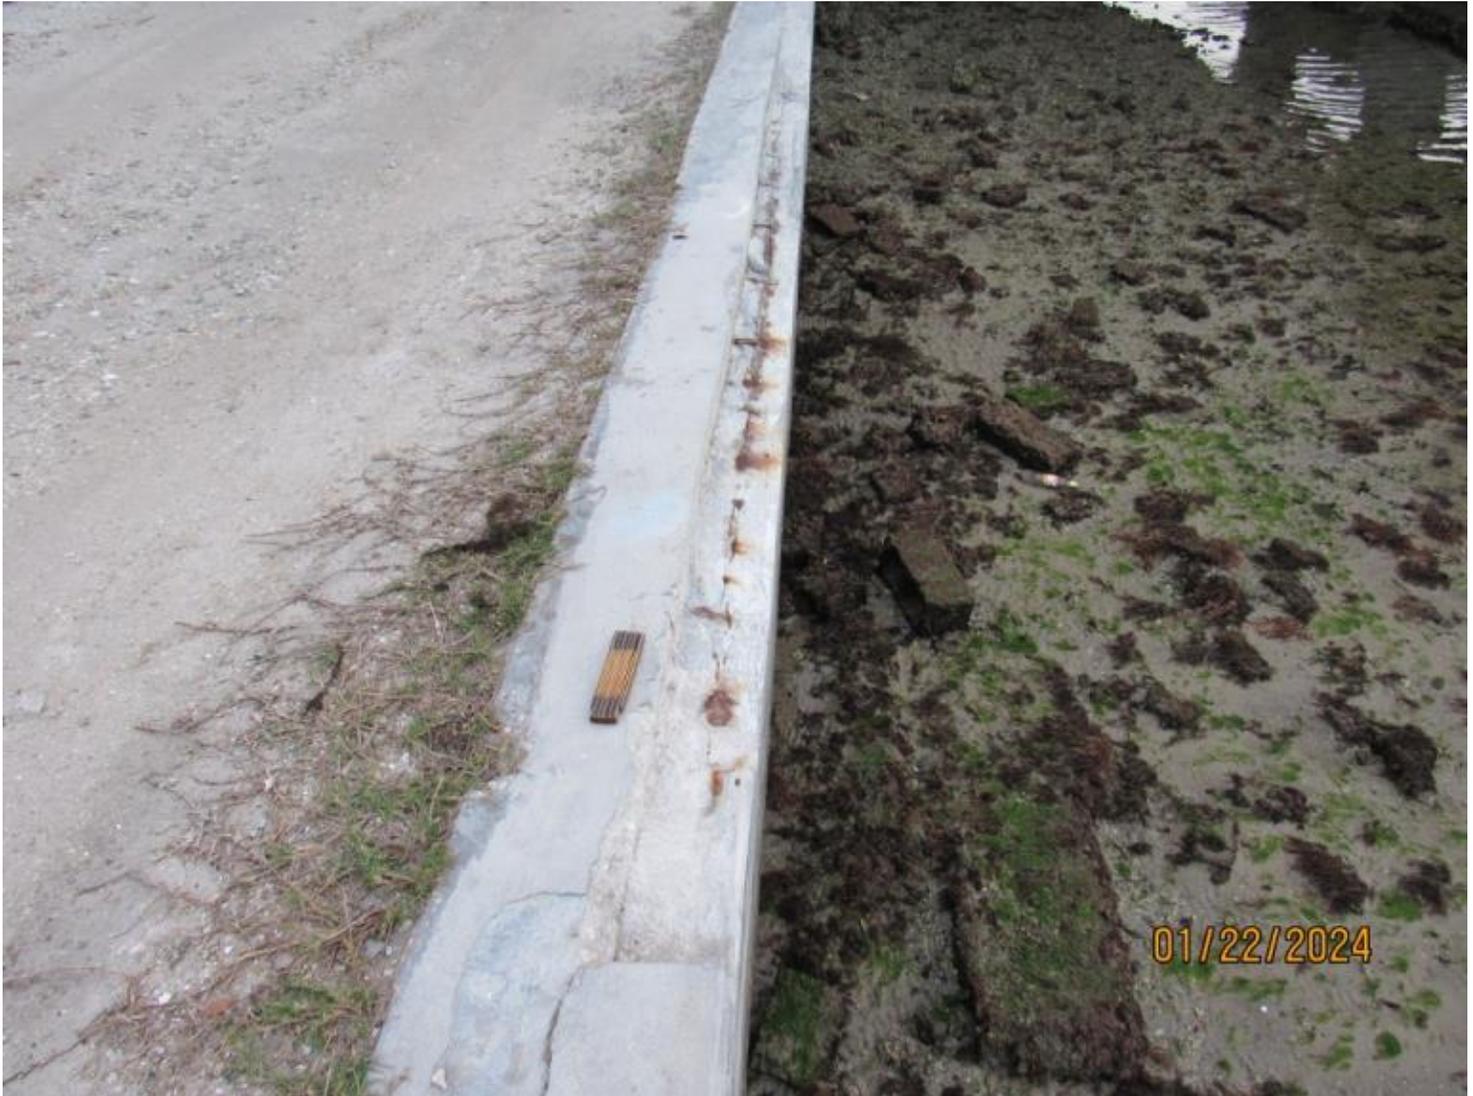
Photo 10: Element 8290 Channel

Typical spall with exposed steel in the north seawall cap.

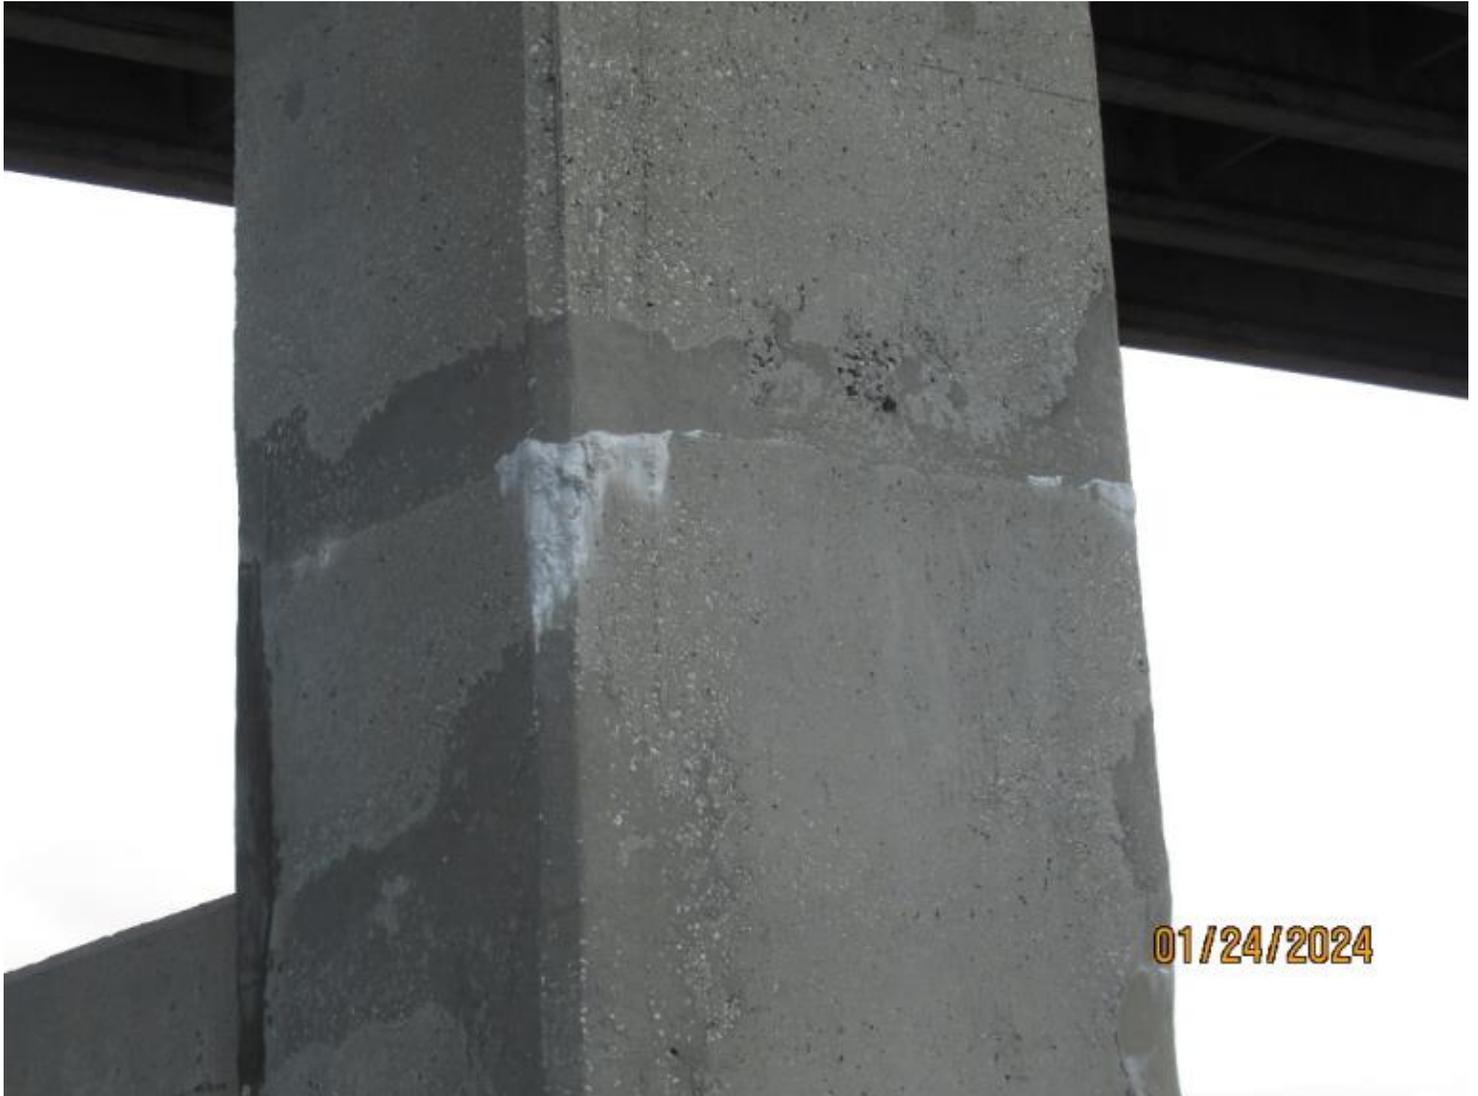
Photo 12: Element 205 Re Conc Column

Column 24-1 horizontal crack with efflorescence.

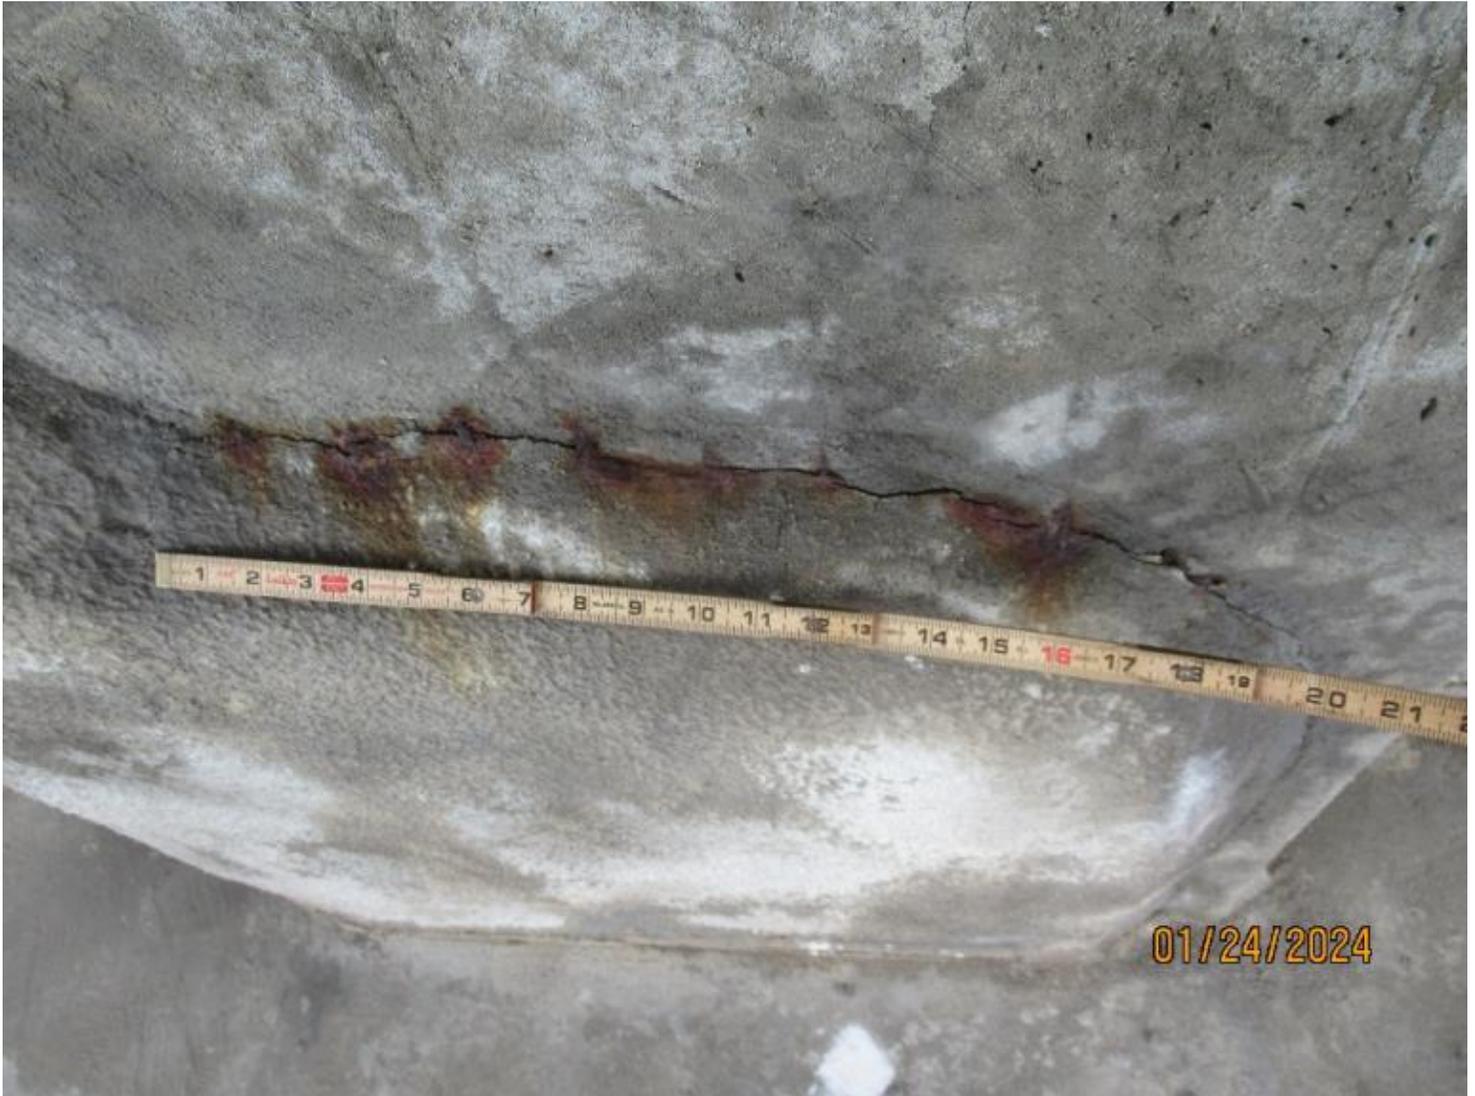
Photo 13: Element 205 Re Conc Column

Column 28-2 south face unsound repair with corrosion bleedout.

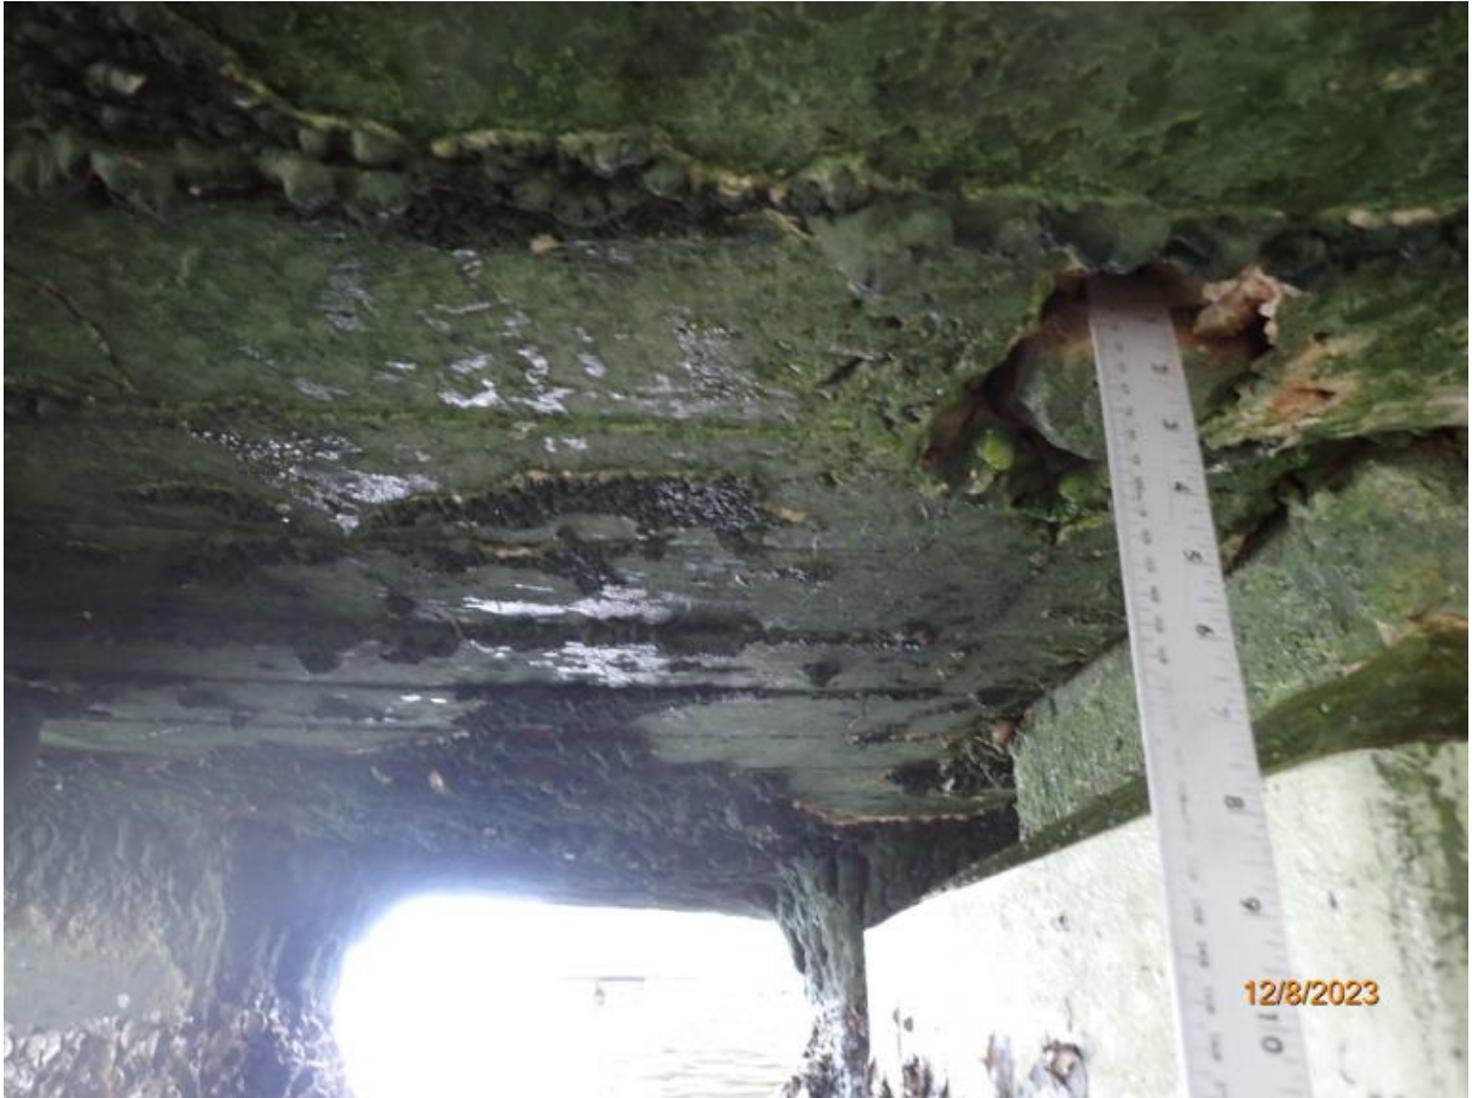
Photo 14: Element 220 Re Conc Pile Cap/Ftg

Footing 8-2 east face spall/delamination with corrosion bleedout.

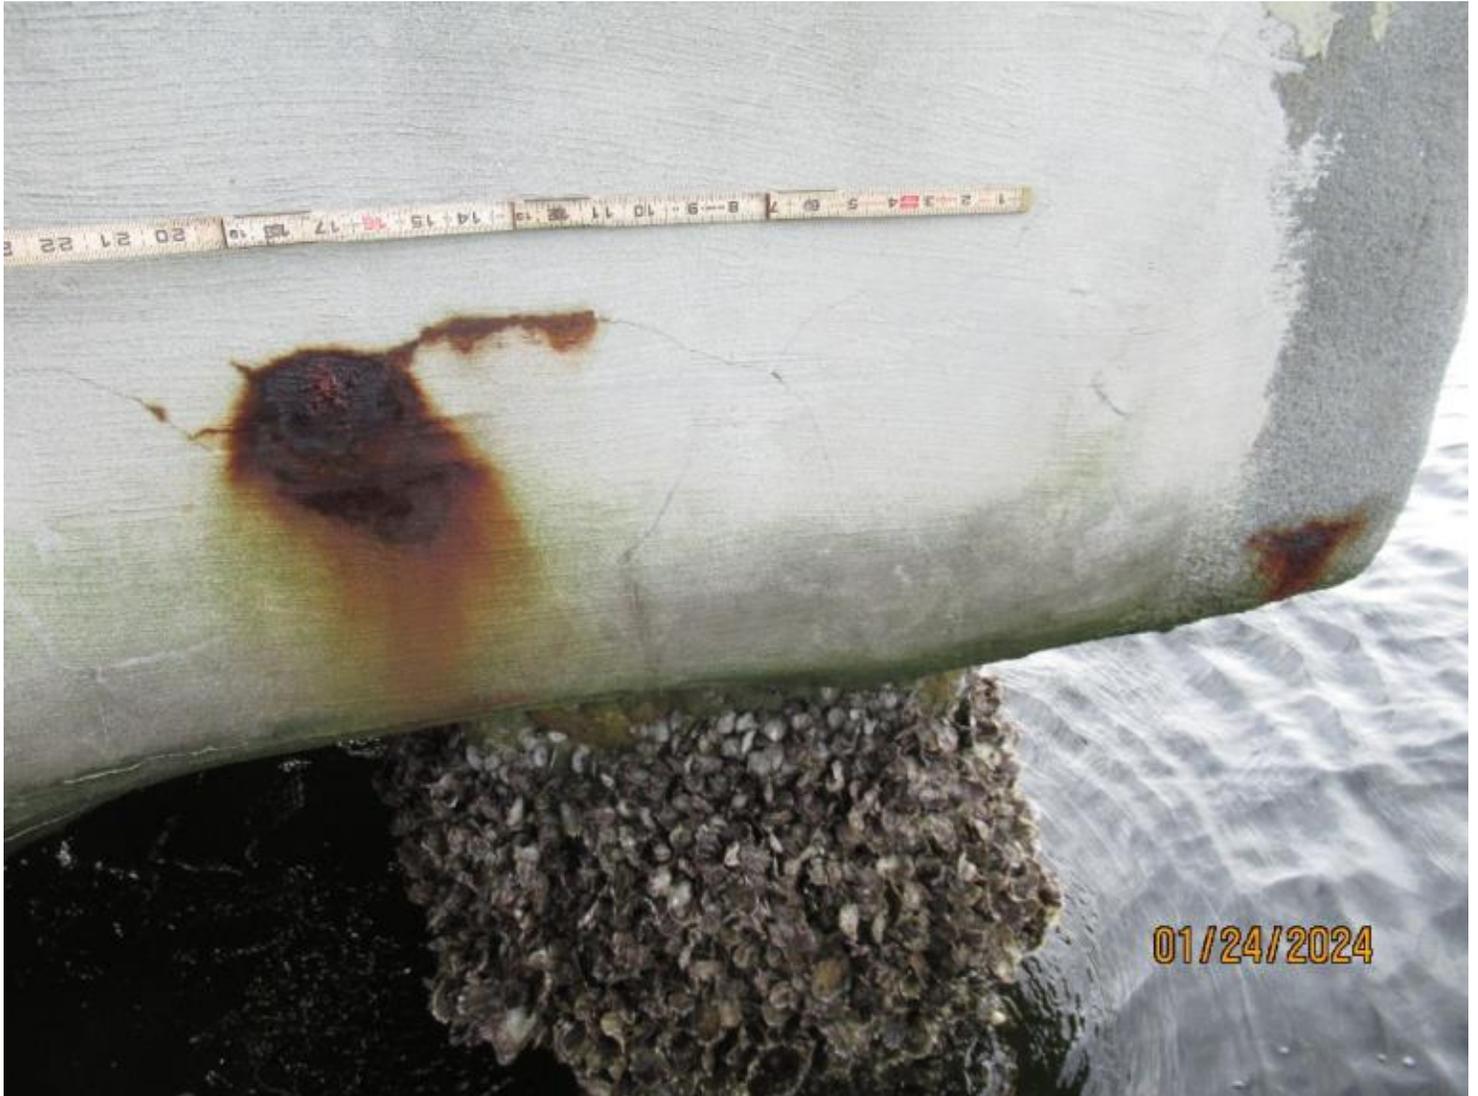
Photo 15: Element 220 Re Conc Pile Cap/Ftg

Typical area of corrosion bleedout from the gunite repairs.

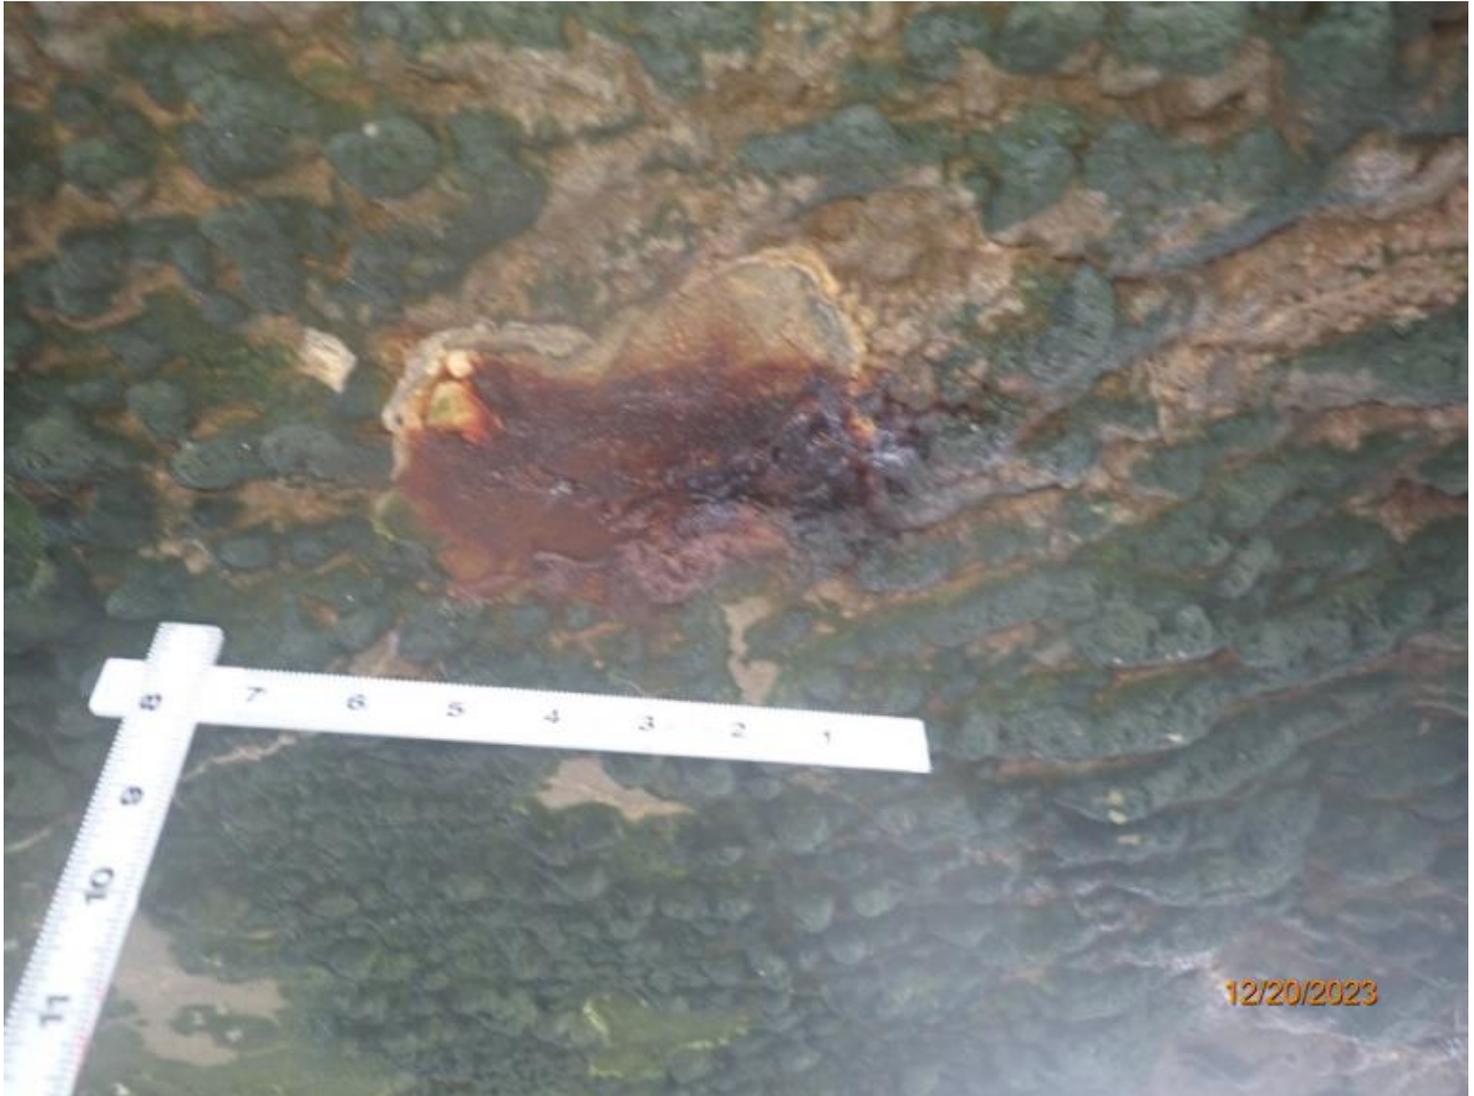
Photo 16: Element 220 Re Conc Pile Cap/Ftg

Footing 8-1 bottom face corrosion bleedout. Typical.
