PRELIMINARY ENGINEERING REPORT

DESOTO BRIDGE FROM STATE ROAD (SR) 64 (MANATEE AVENUE EAST) TO HABEN
BOULEVARD-BRIDGE #130053

Date 08/05/2025

APPENDIX D – DeSoto Bridge Inspection Report

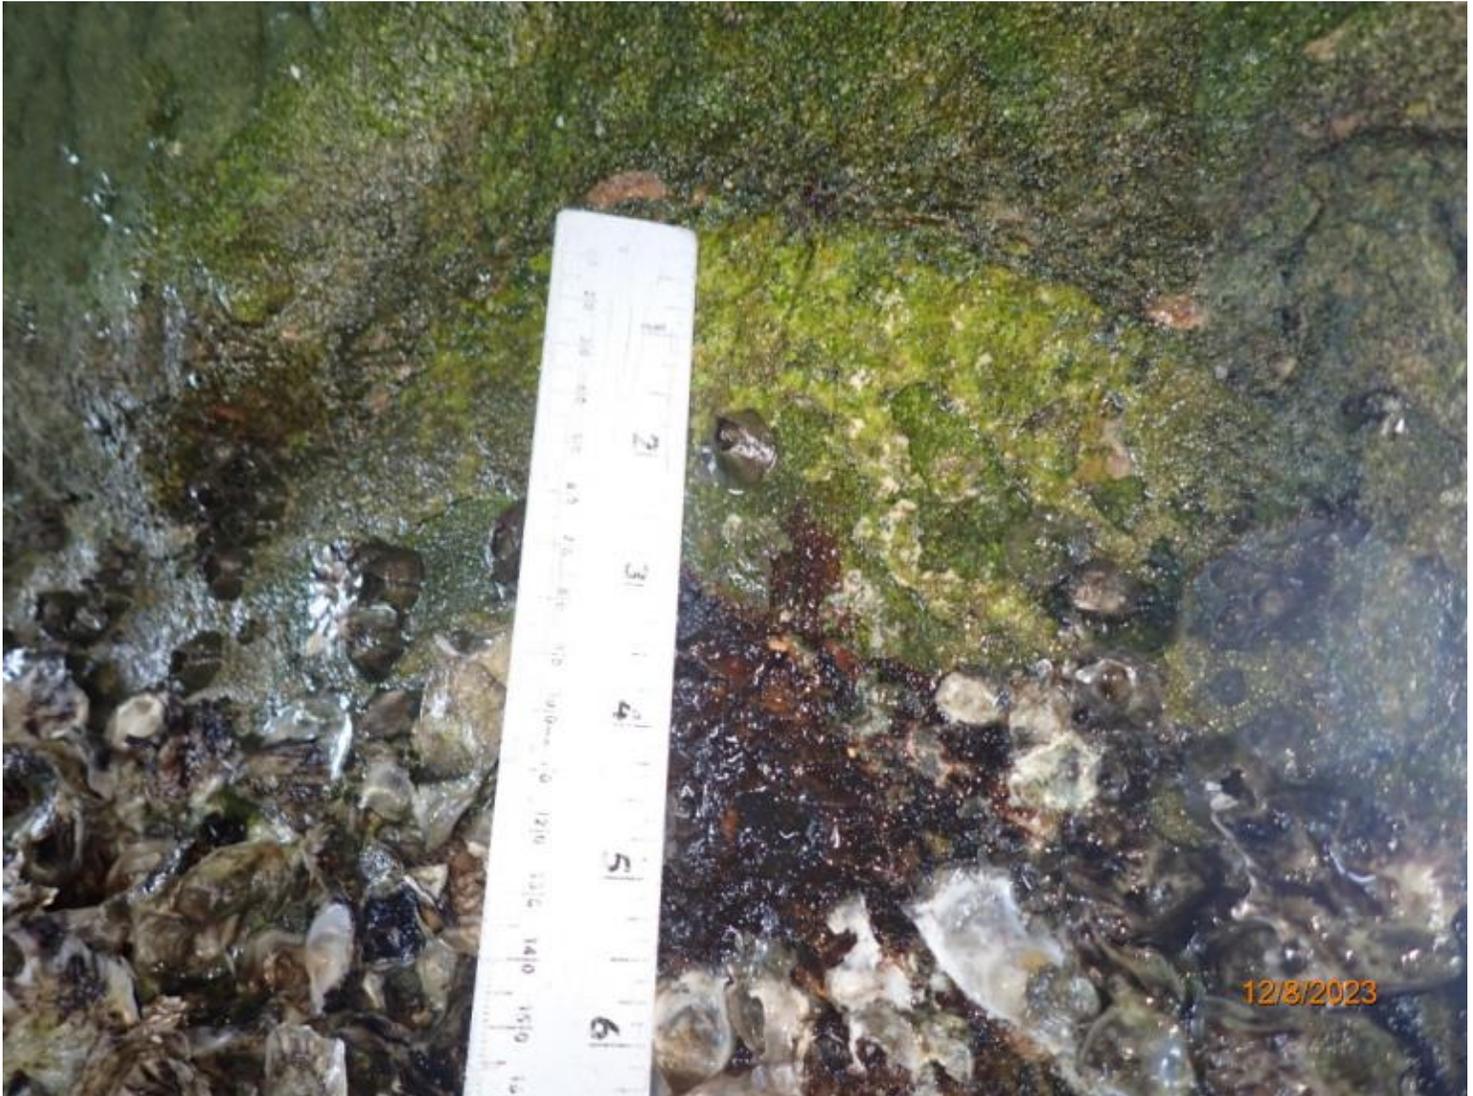
Photo 17: Element 227 Re Conc Pile

Vertical crack with corrosion bleedout at the southeast corner of Pile 11-4.

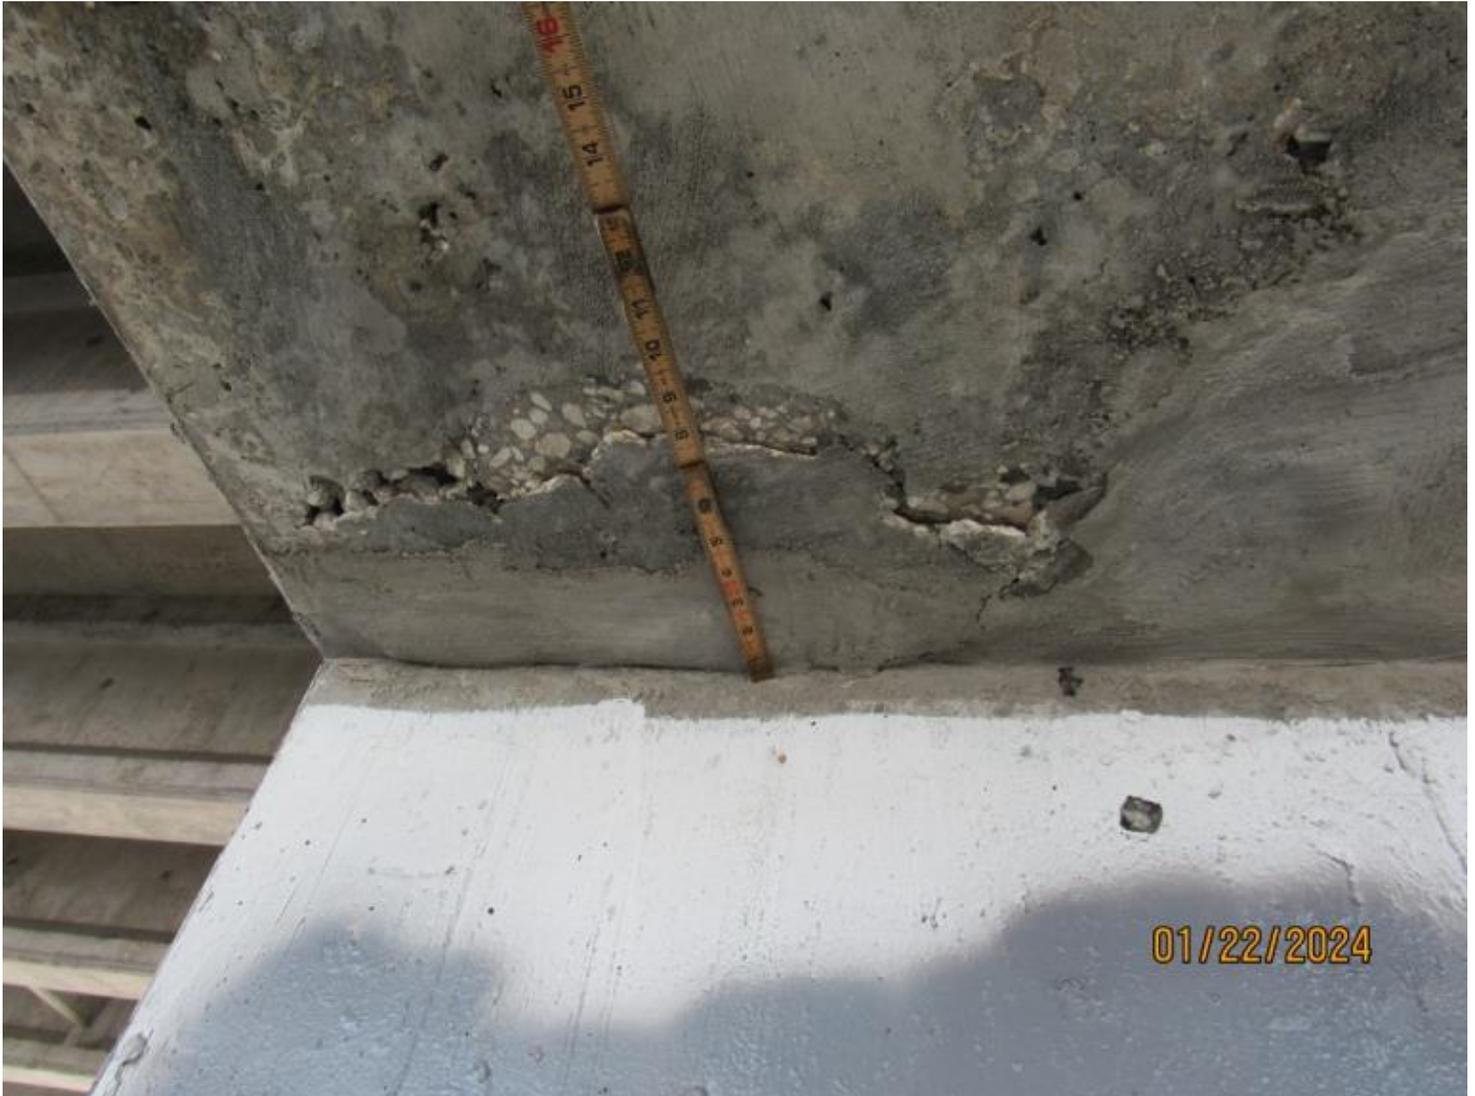
Photo 18: Element 234 Re Conc Pier Cap

Pier Cap 3 bottom face adjacent to Column 3-2 spall/delamination.

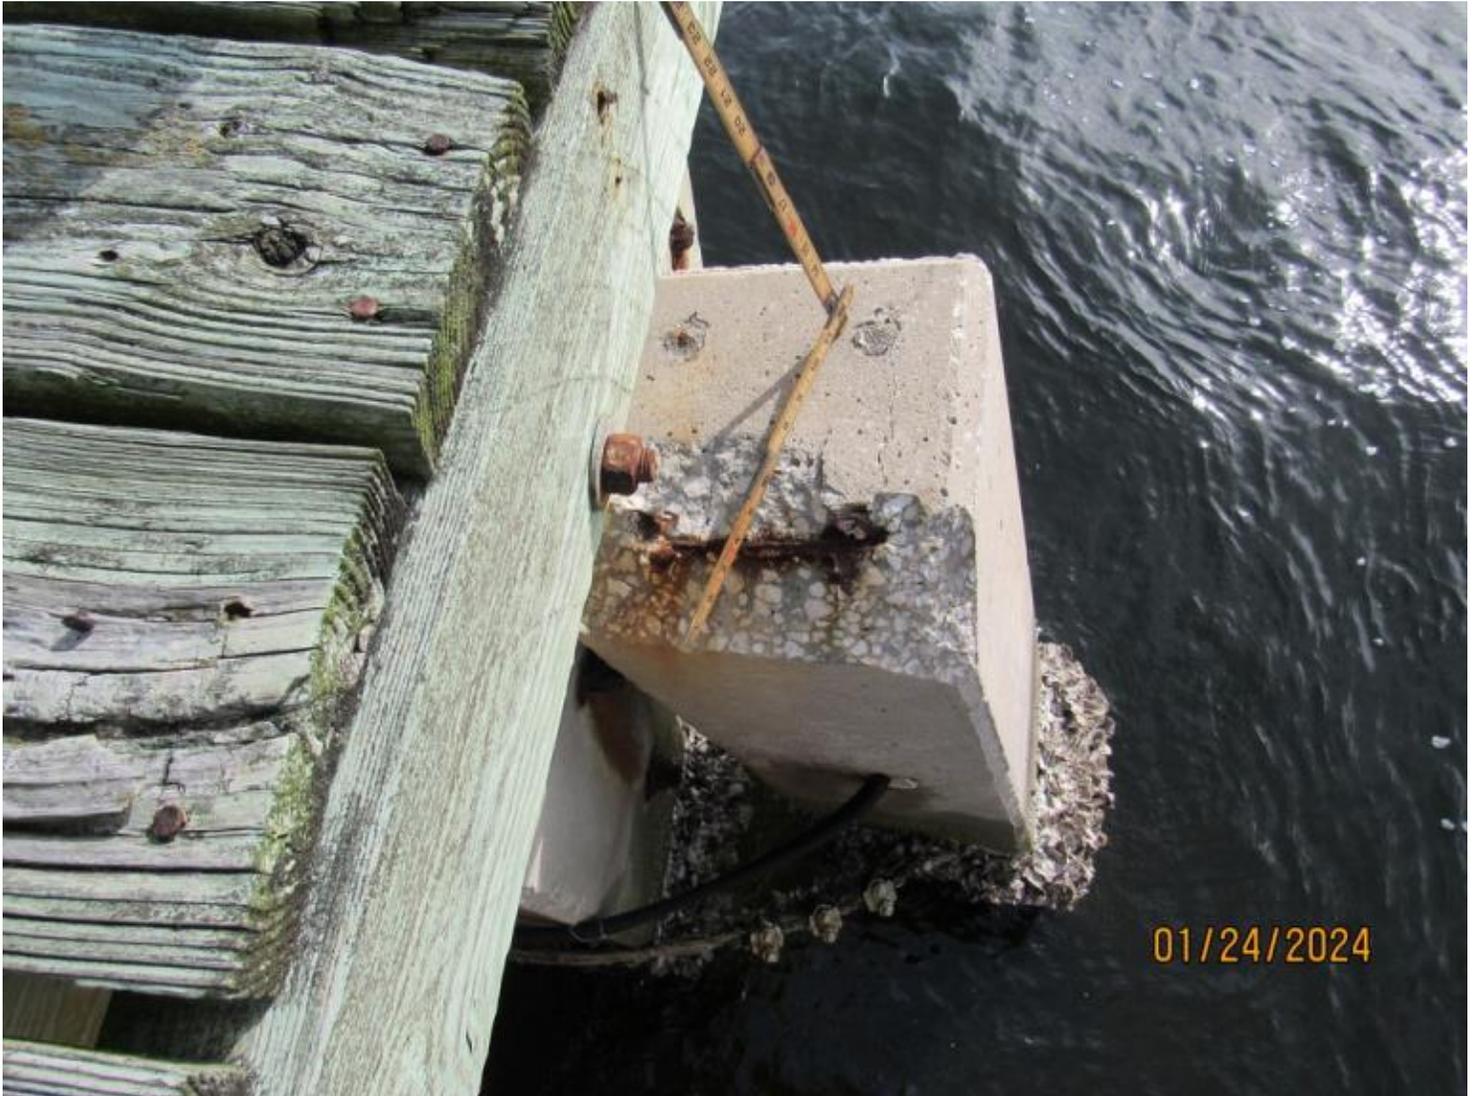
Photo 19: Element 8387 PS Fender/Dolphin

Typical spall in south fender pile top face with exposed rebar.

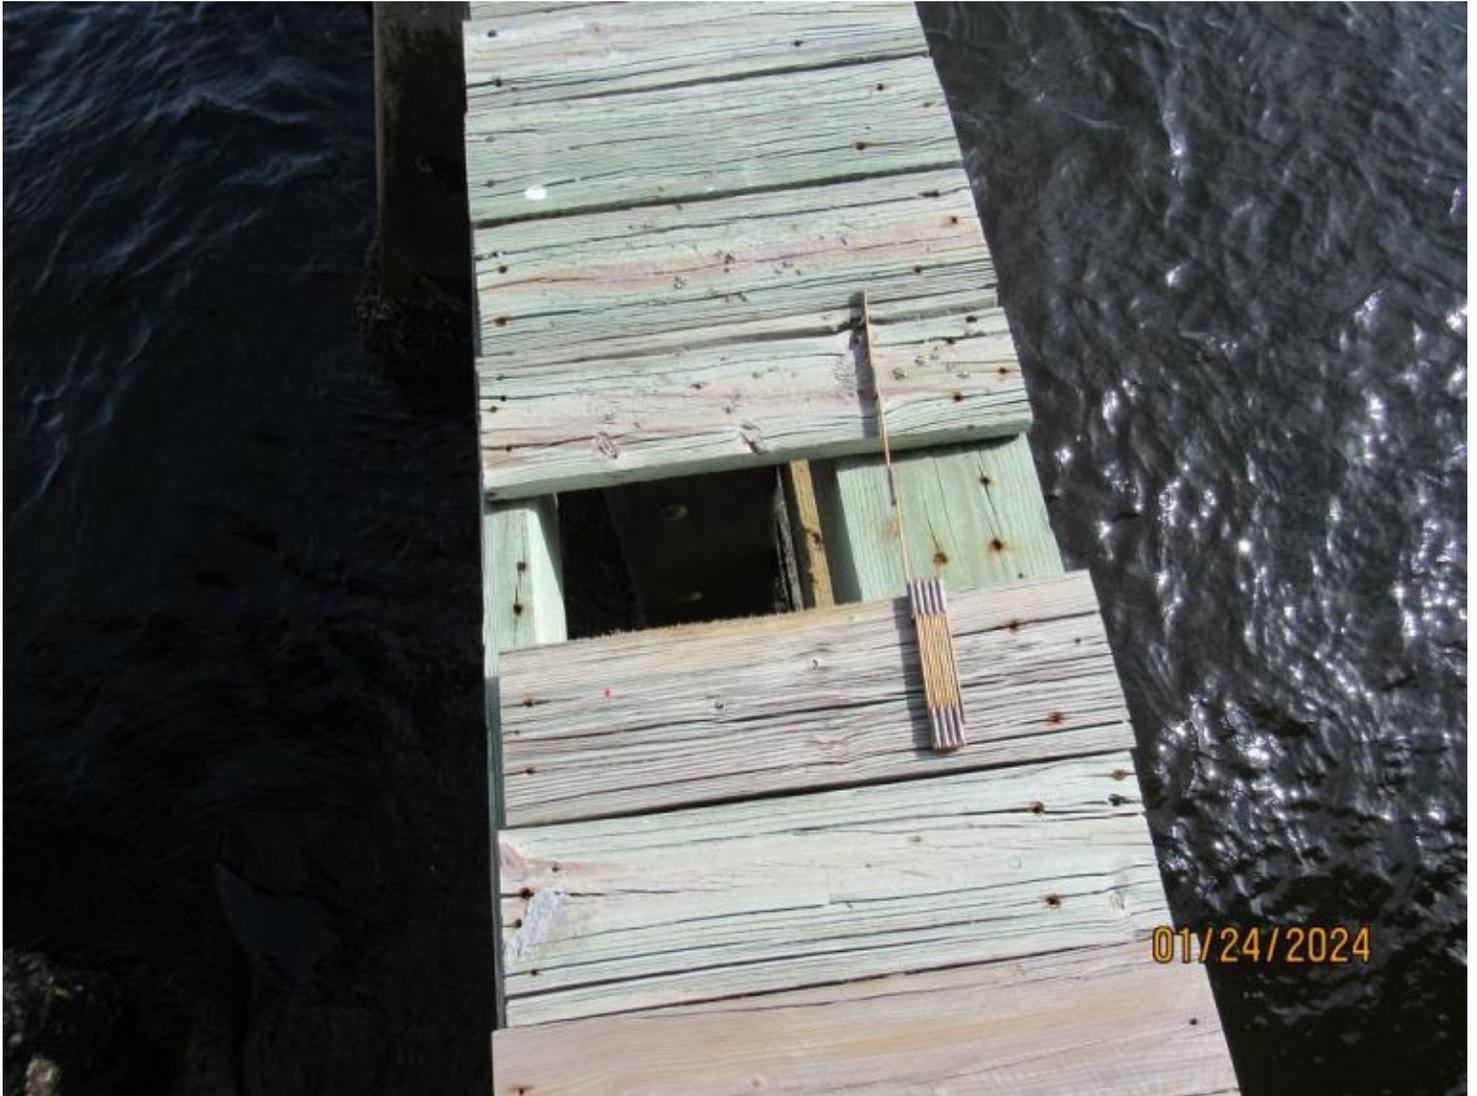
Photo 20: Element 8387 PS Fender/Dolphin

North fender missing timber walkway plank at the east end. Typical.

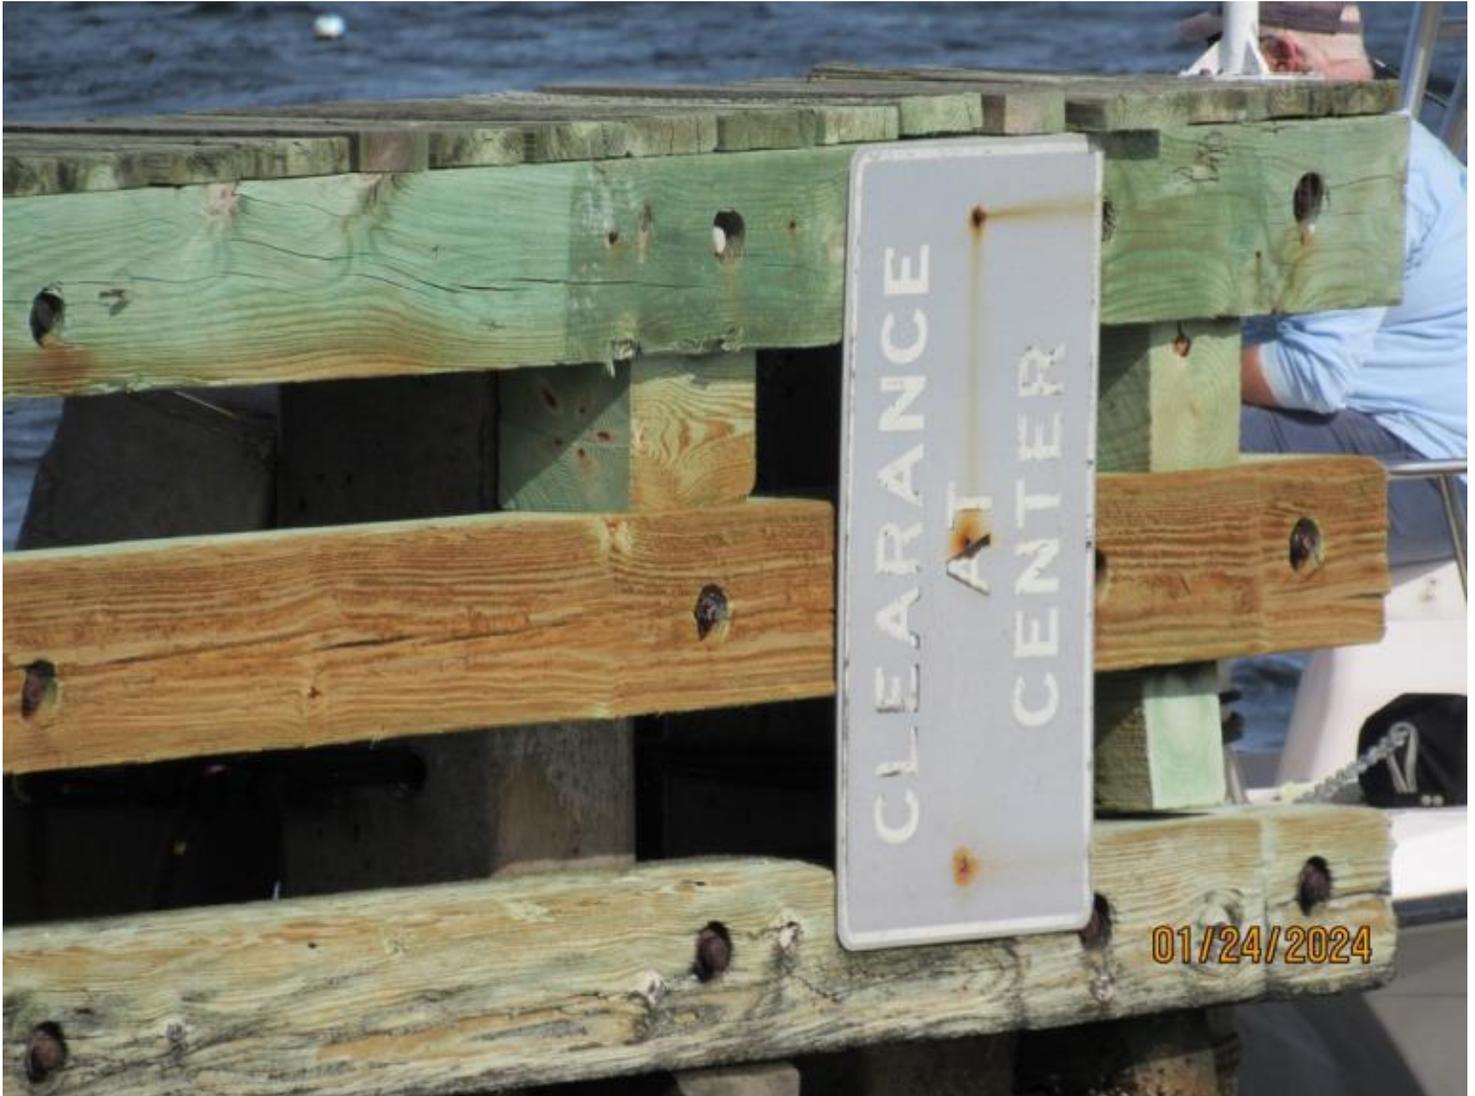
Photo 21: Element 8387 PS Fender/Dolphin

"Clearance At Center" sign attached to the northeast corner not secure and heavily faded and missing clearance gauge. Typical.

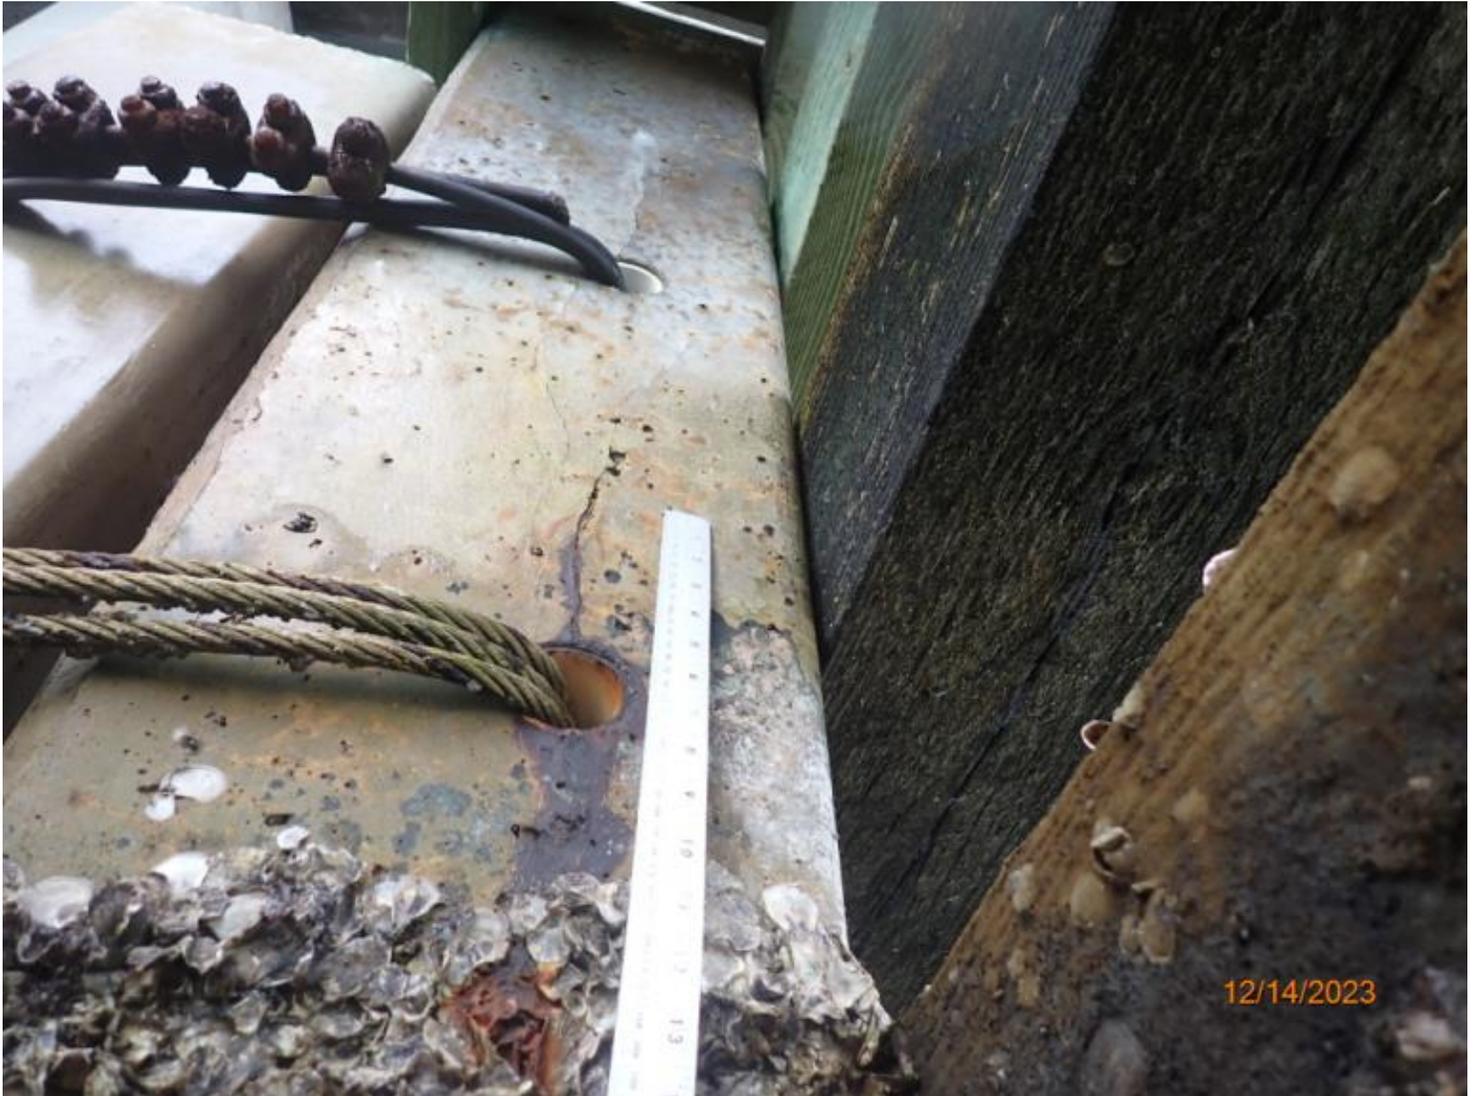
Photo 22: Element 8387 PS Fender/Dolphin

Typical vertical crack with corrosion bleedout at north fender. 14th cluster shown.

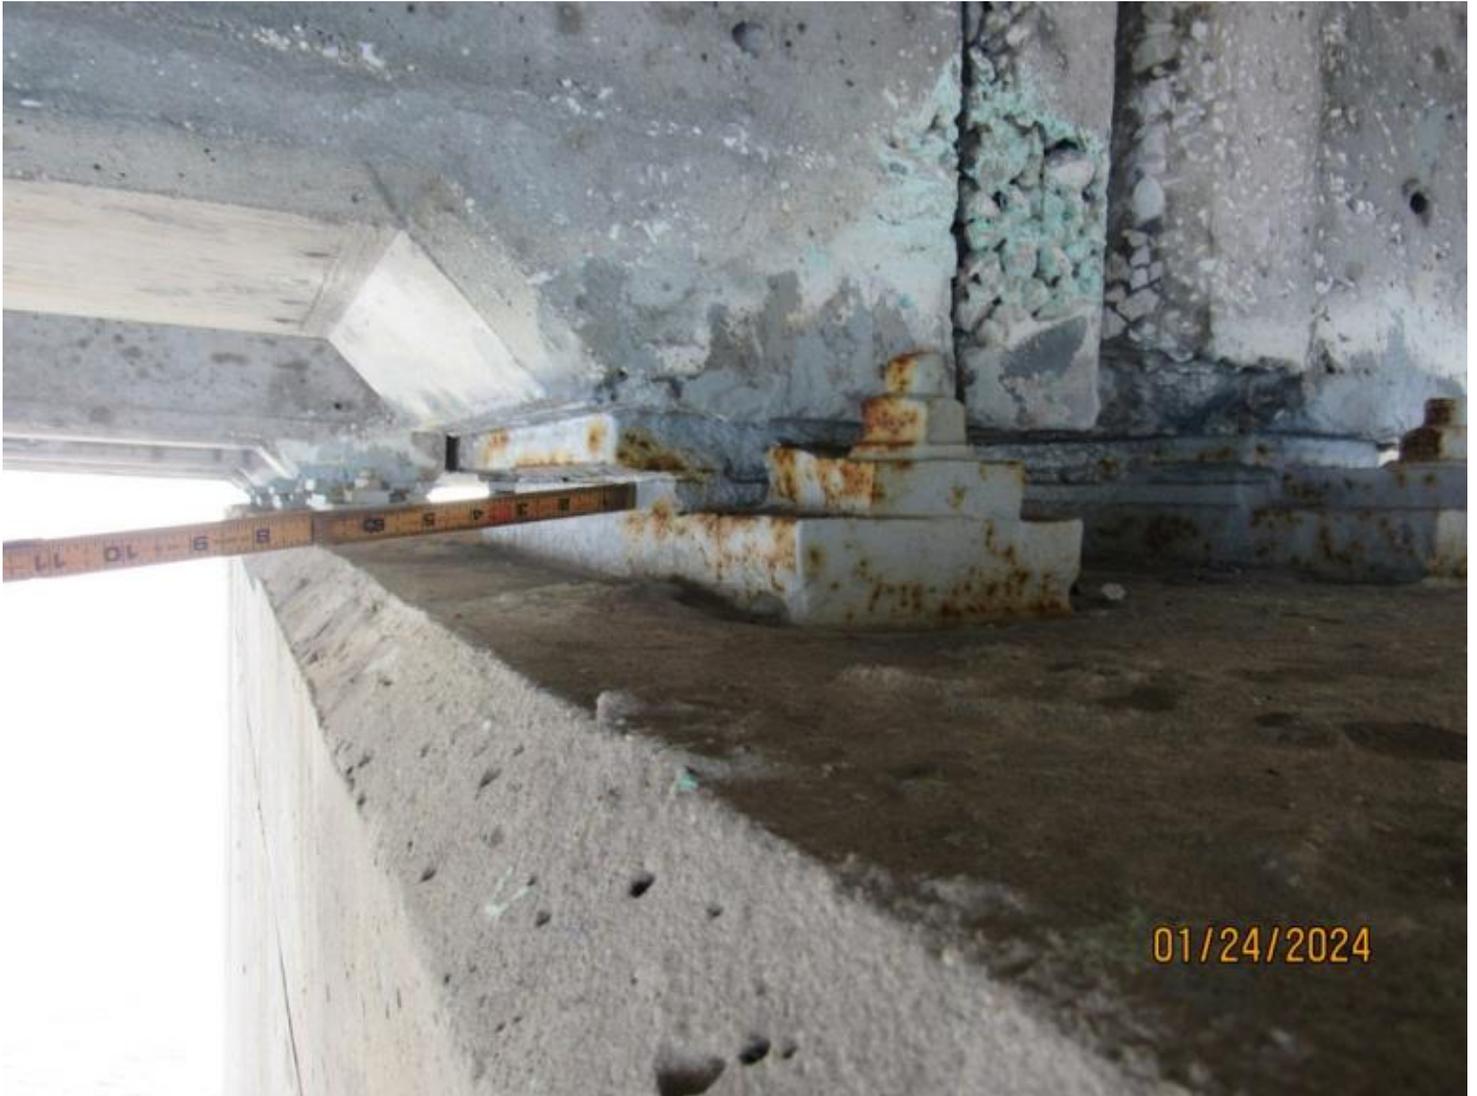
Photo 23: Element 311 Moveable Bearing

Typical bearing with painted over corrosion.

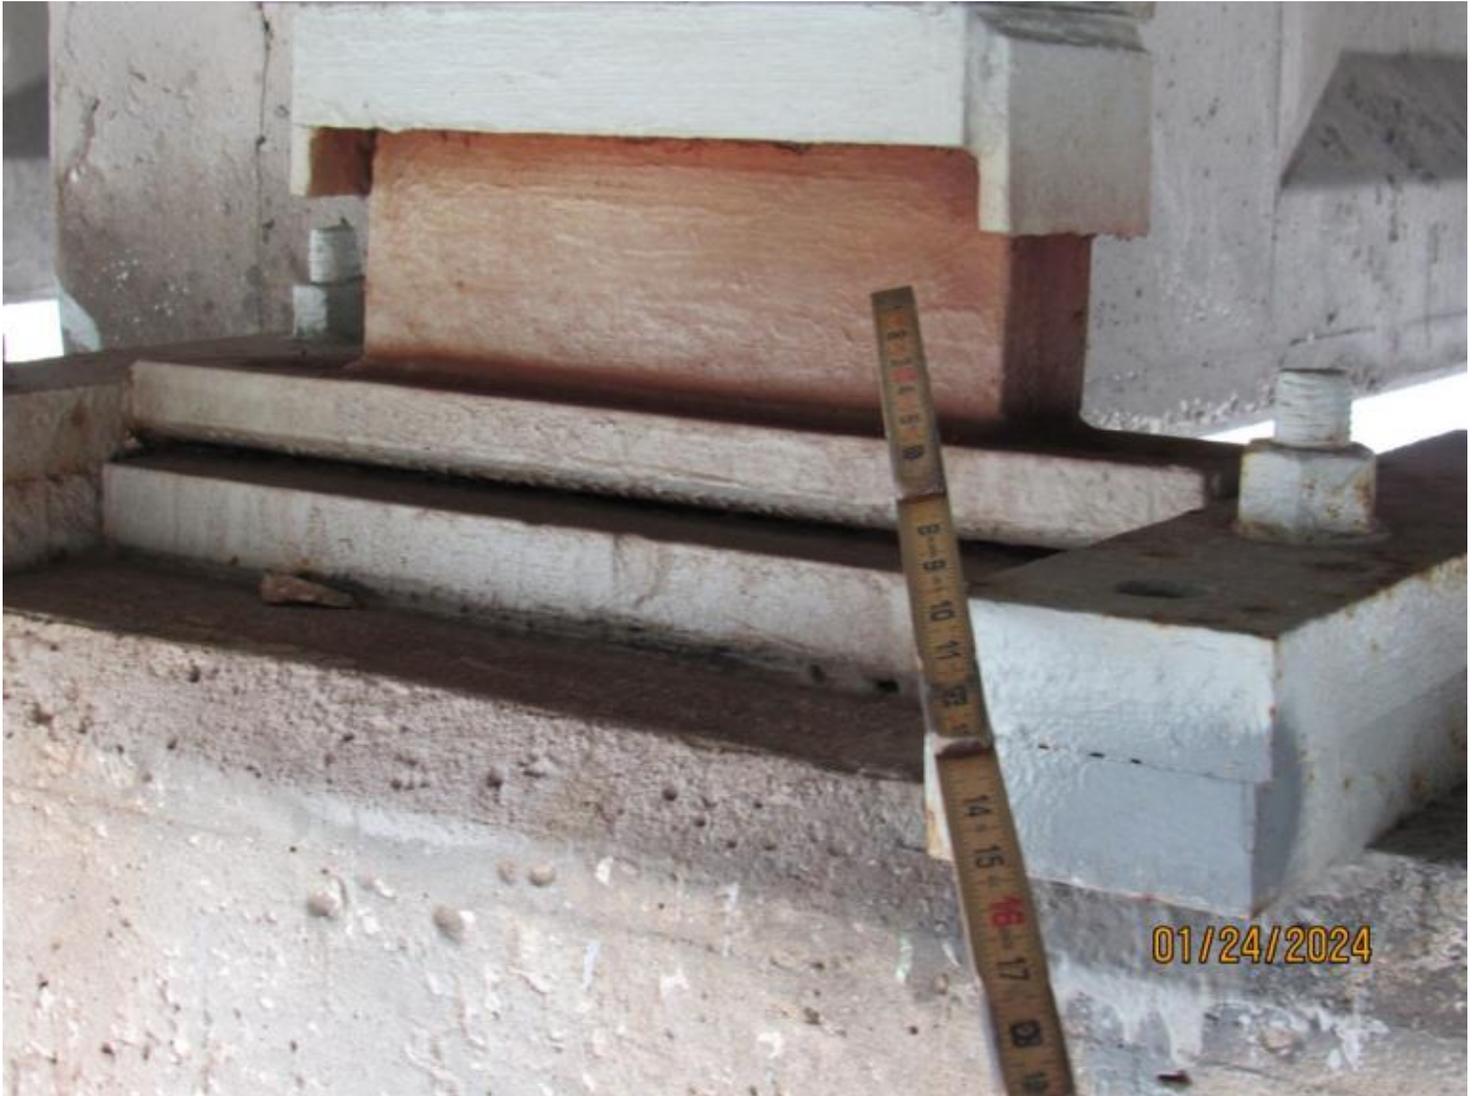
Photo 25: Element 311 Moveable Bearing

Bearing 18-7 over Pier 19 with fretting corrosion.

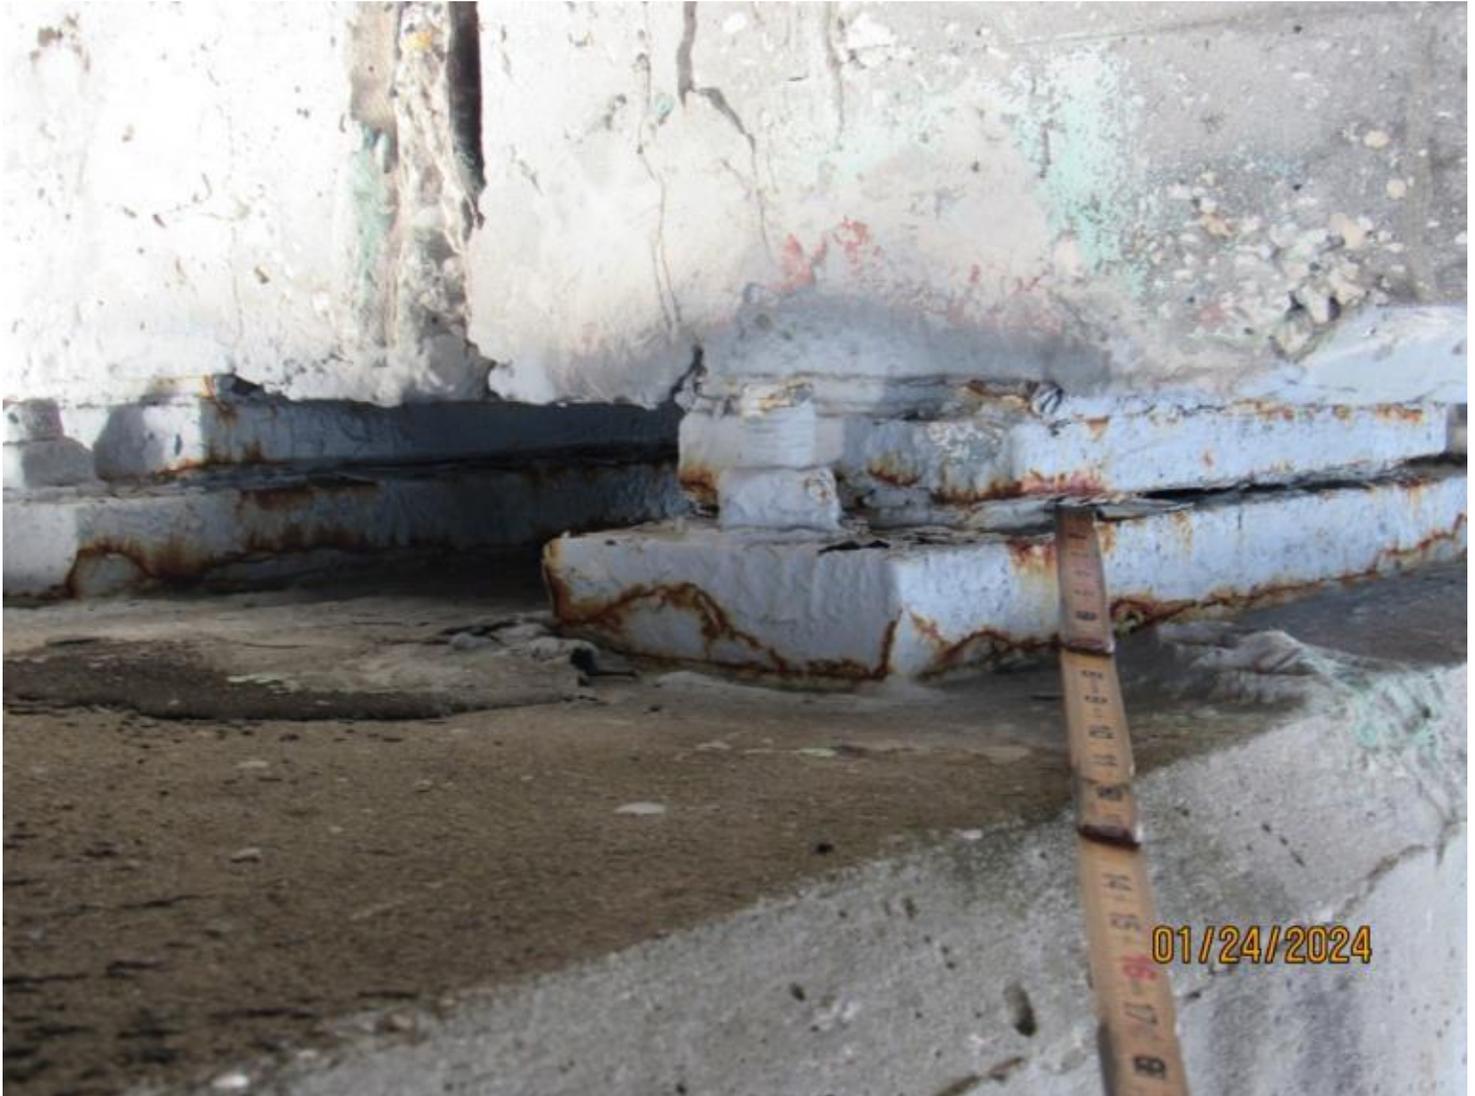
Photo 26: Element 313 Fixed Bearing

Typical bearing condition, restricted movement and associated corrosion.

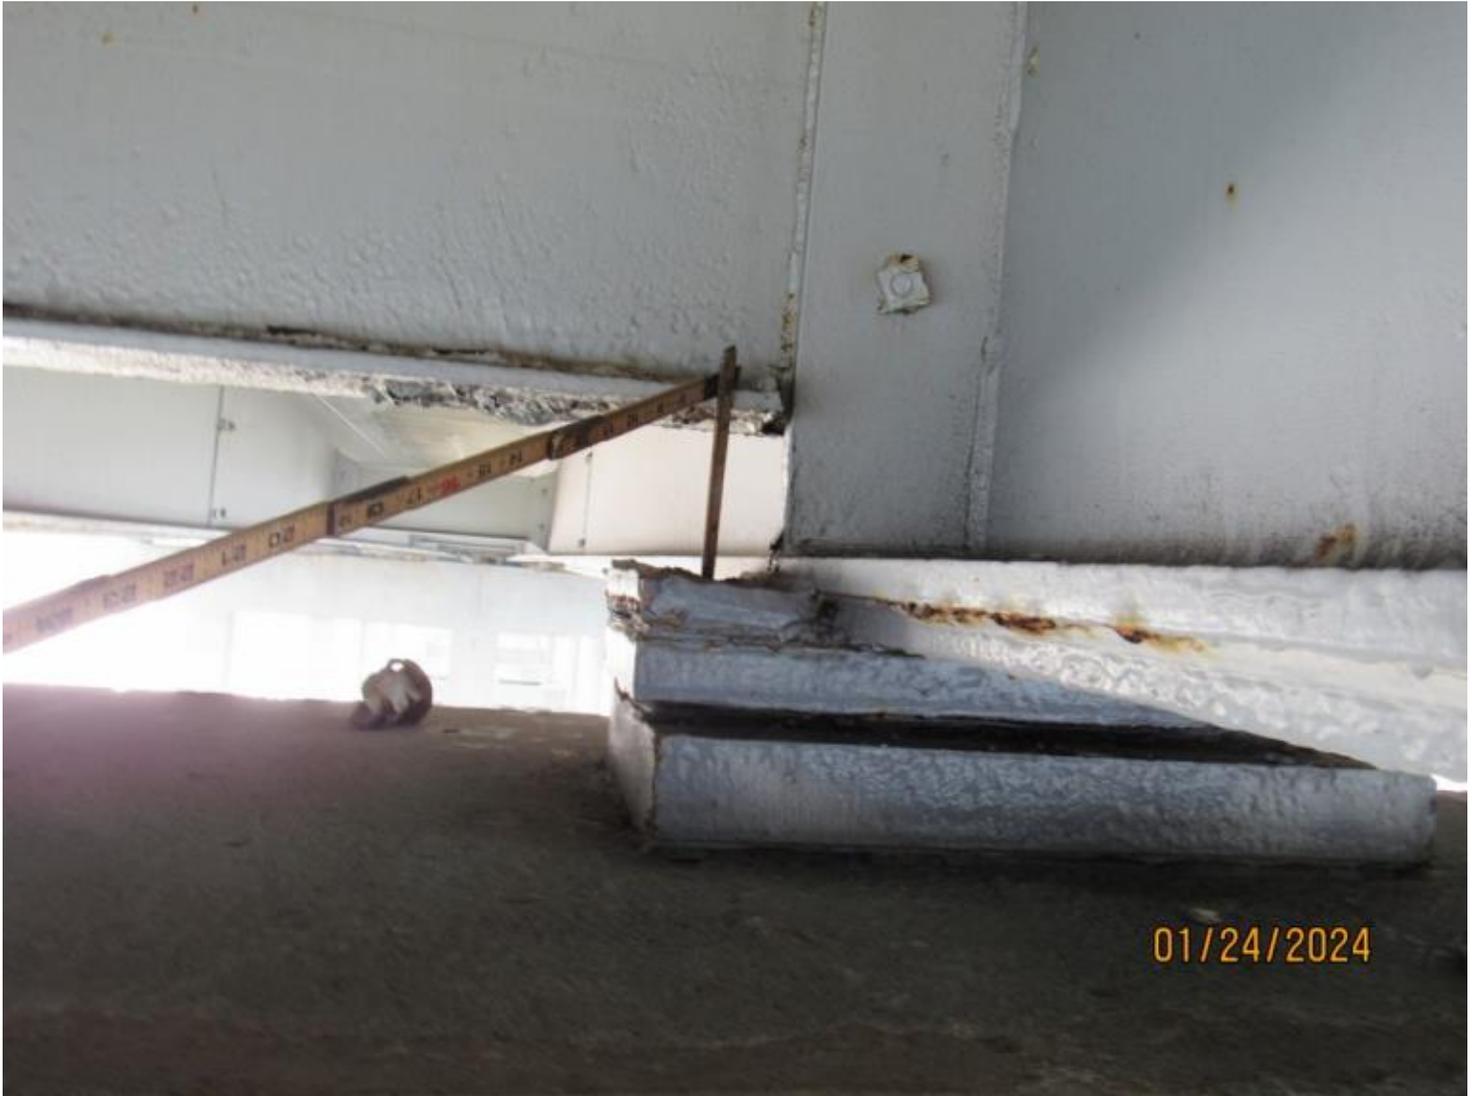
Photo 27: Element 313 Fixed Bearing

Typical bearing missing anchor bolt.

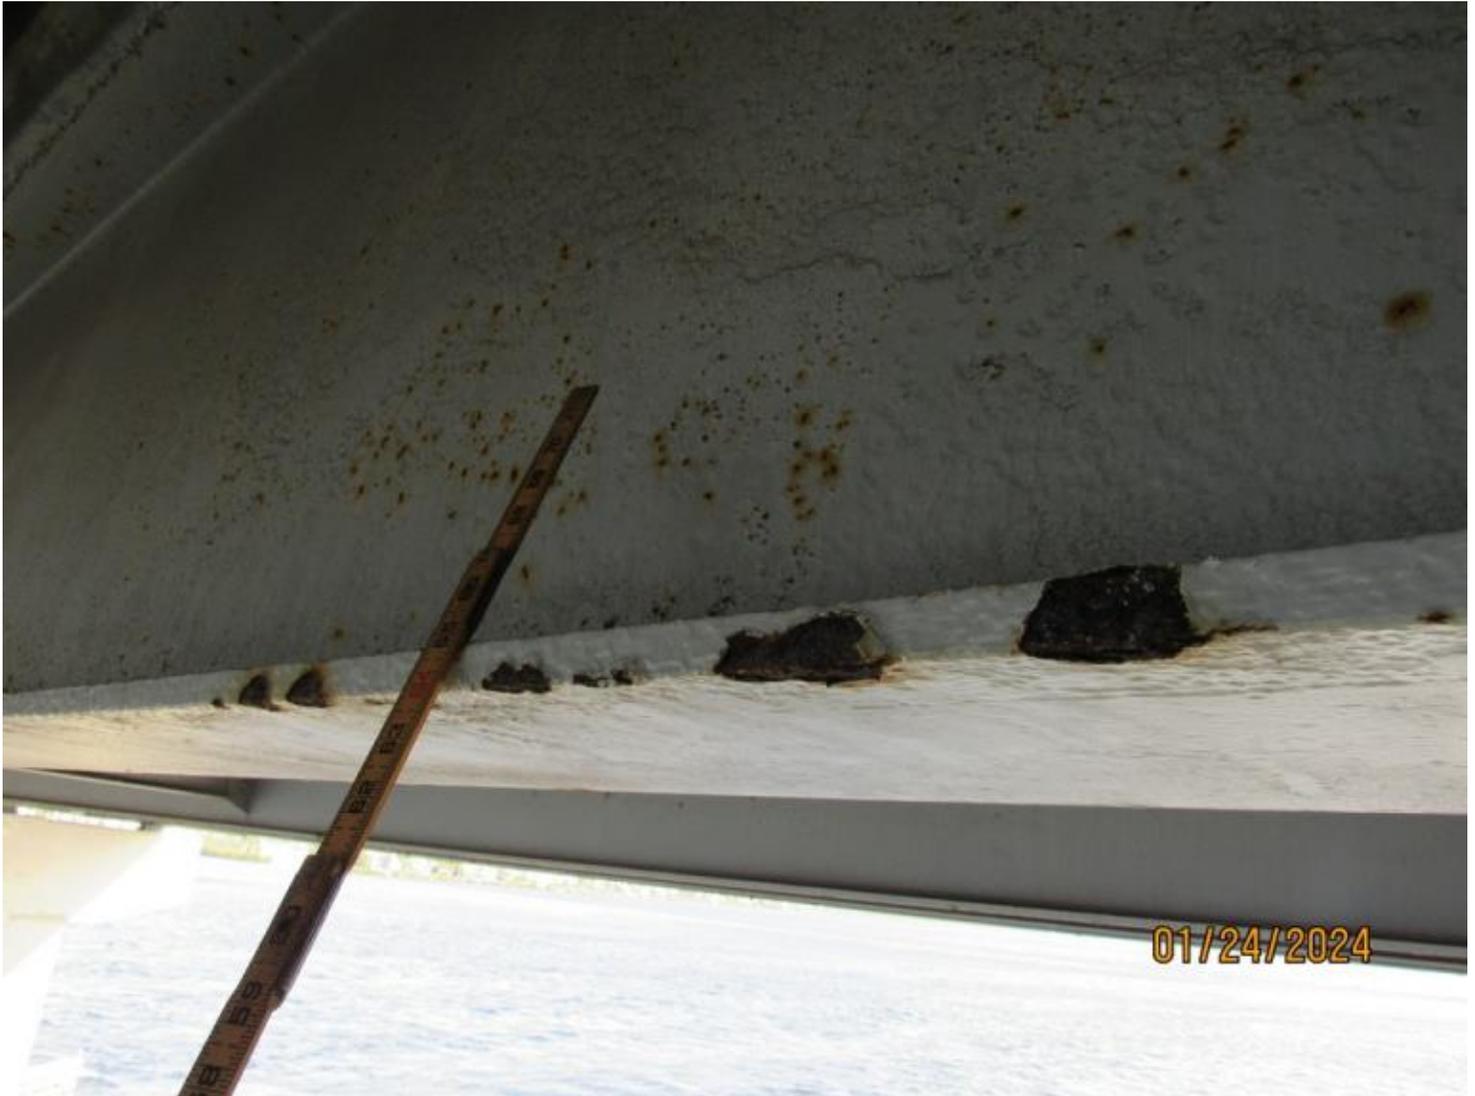
Photo 28: Element 107 Steel Opn Girder/Beam

Typical areas of corrosion in the beams.

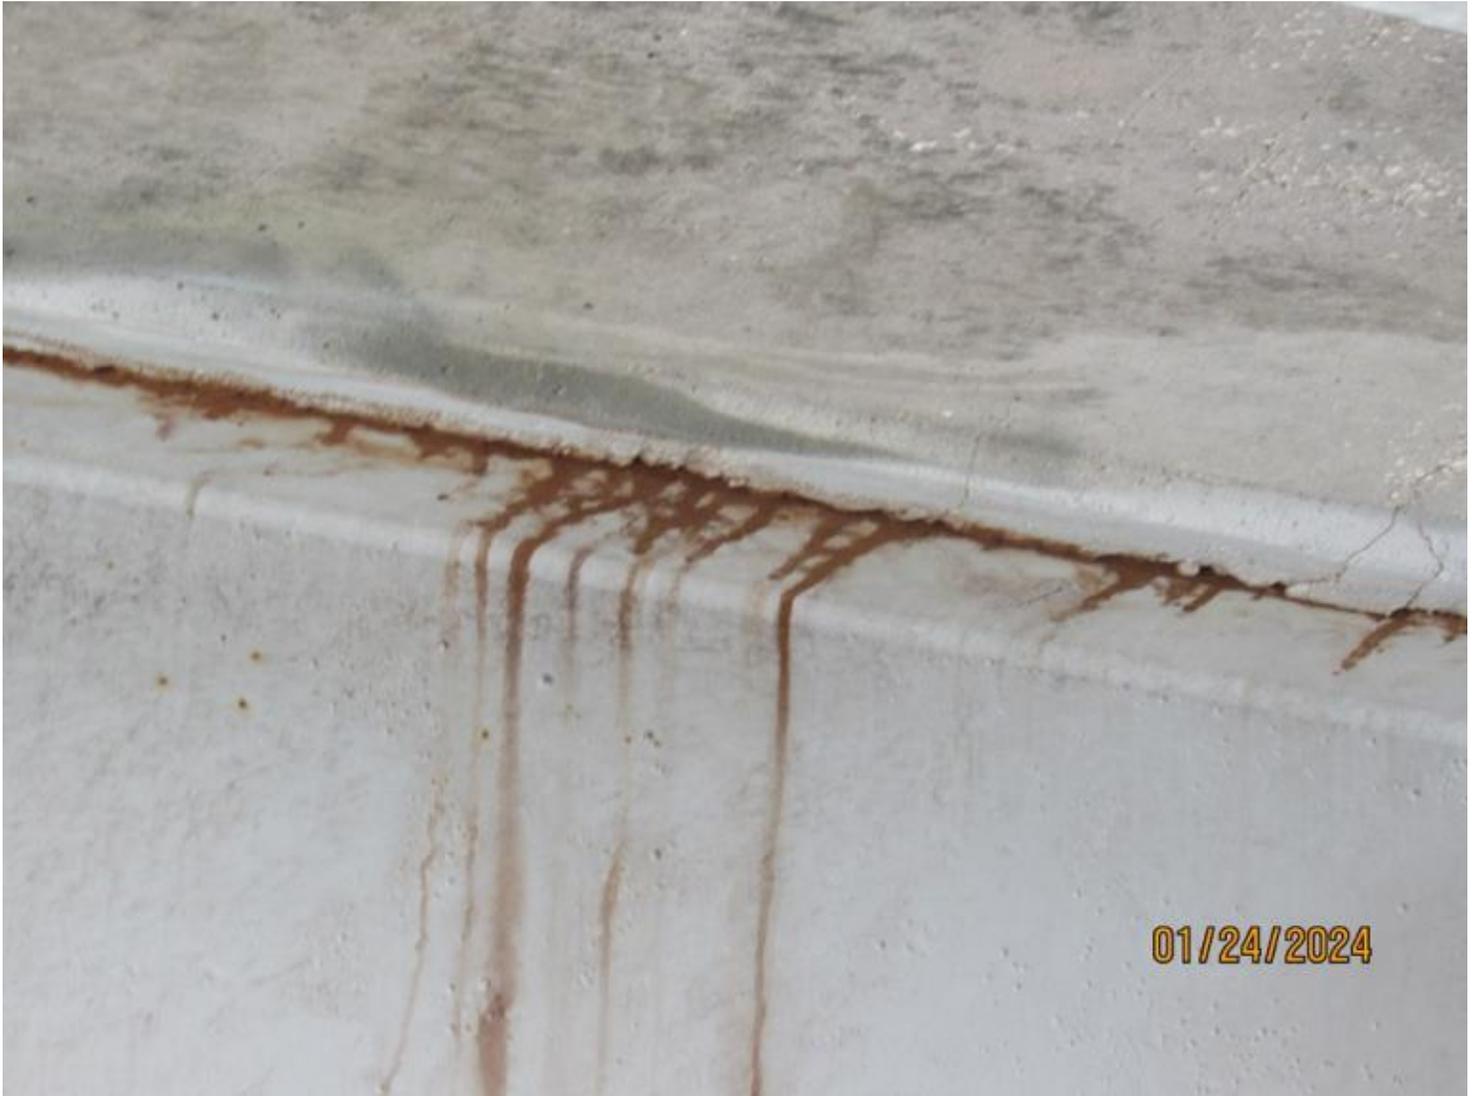
Photo 29: Element 107 Steel Opn Girder/Beam

Typical area of fretting corrosion at the beam top flange to deck interface.

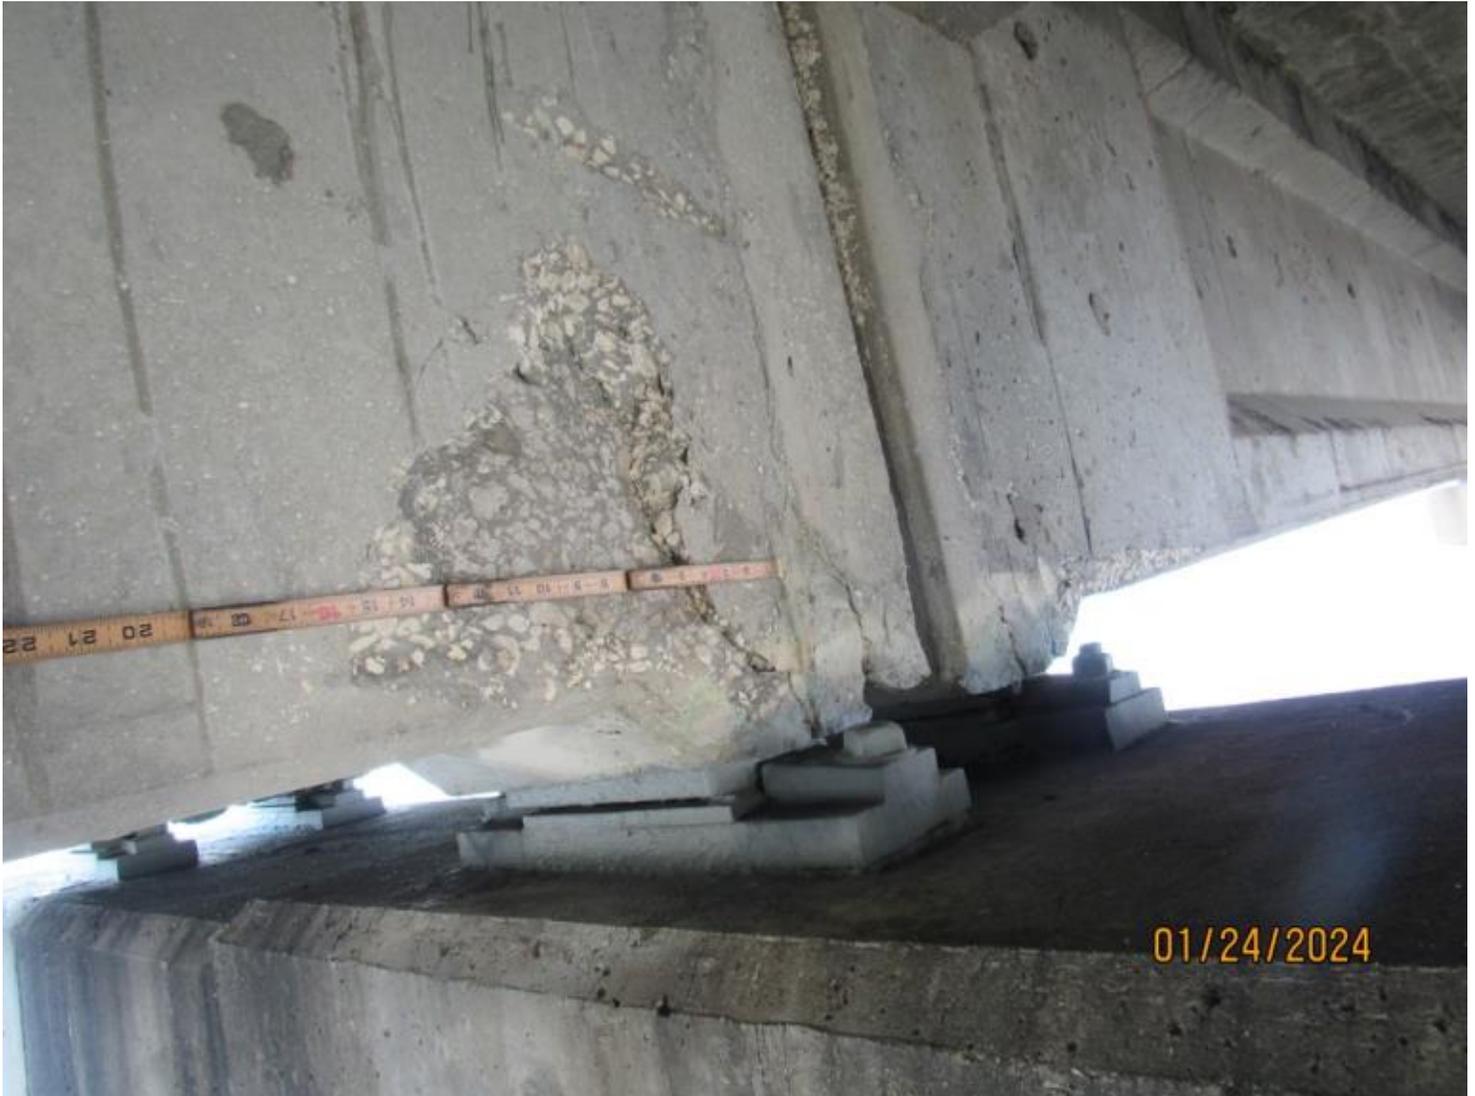
Photo 30: Element 109 Pre Opn Conc Girder/Beam

Typical spall/delamination in the beams. Beam 4-2 shown.

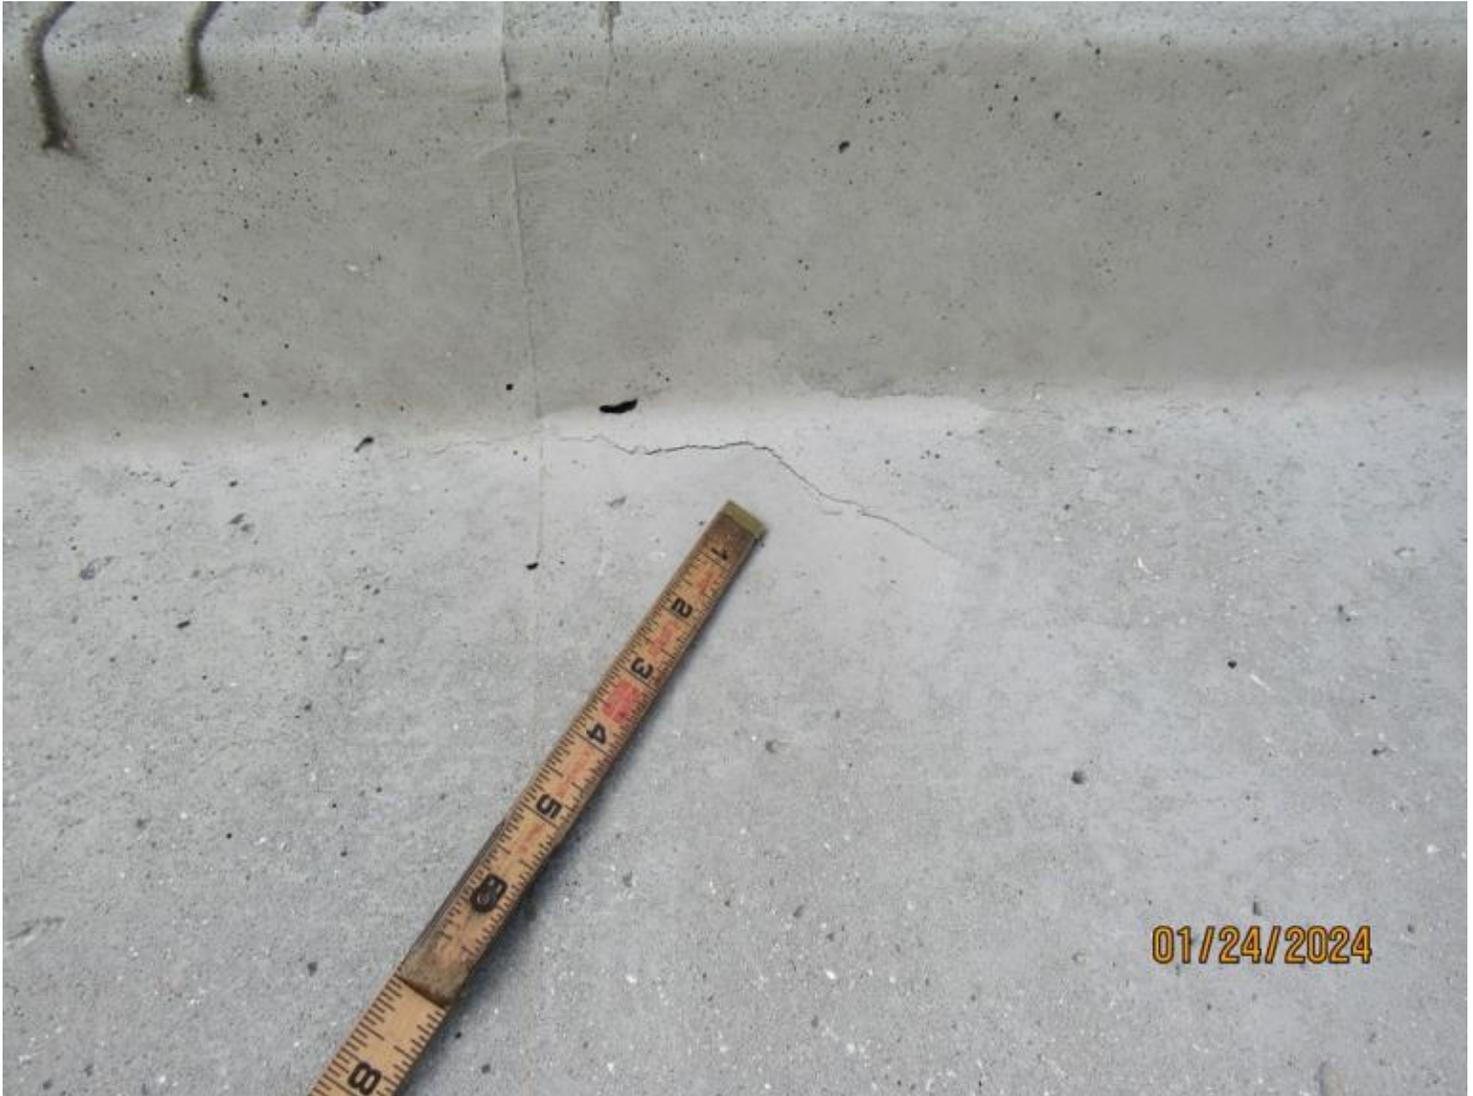
Photo 31: Element 109 Pre Opn Conc Girder/Beam

Typical crack in Beam 12-10 right face.
