PRELIMINARY ENGINEERING REPORT

DESOTO BRIDGE FROM STATE ROAD (SR) 64 (MANATEE AVENUE EAST) TO HABEN
BOULEVARD-BRIDGE #130053

Date 08/05/2025

APPENDIX D – DeSoto Bridge Inspection Report

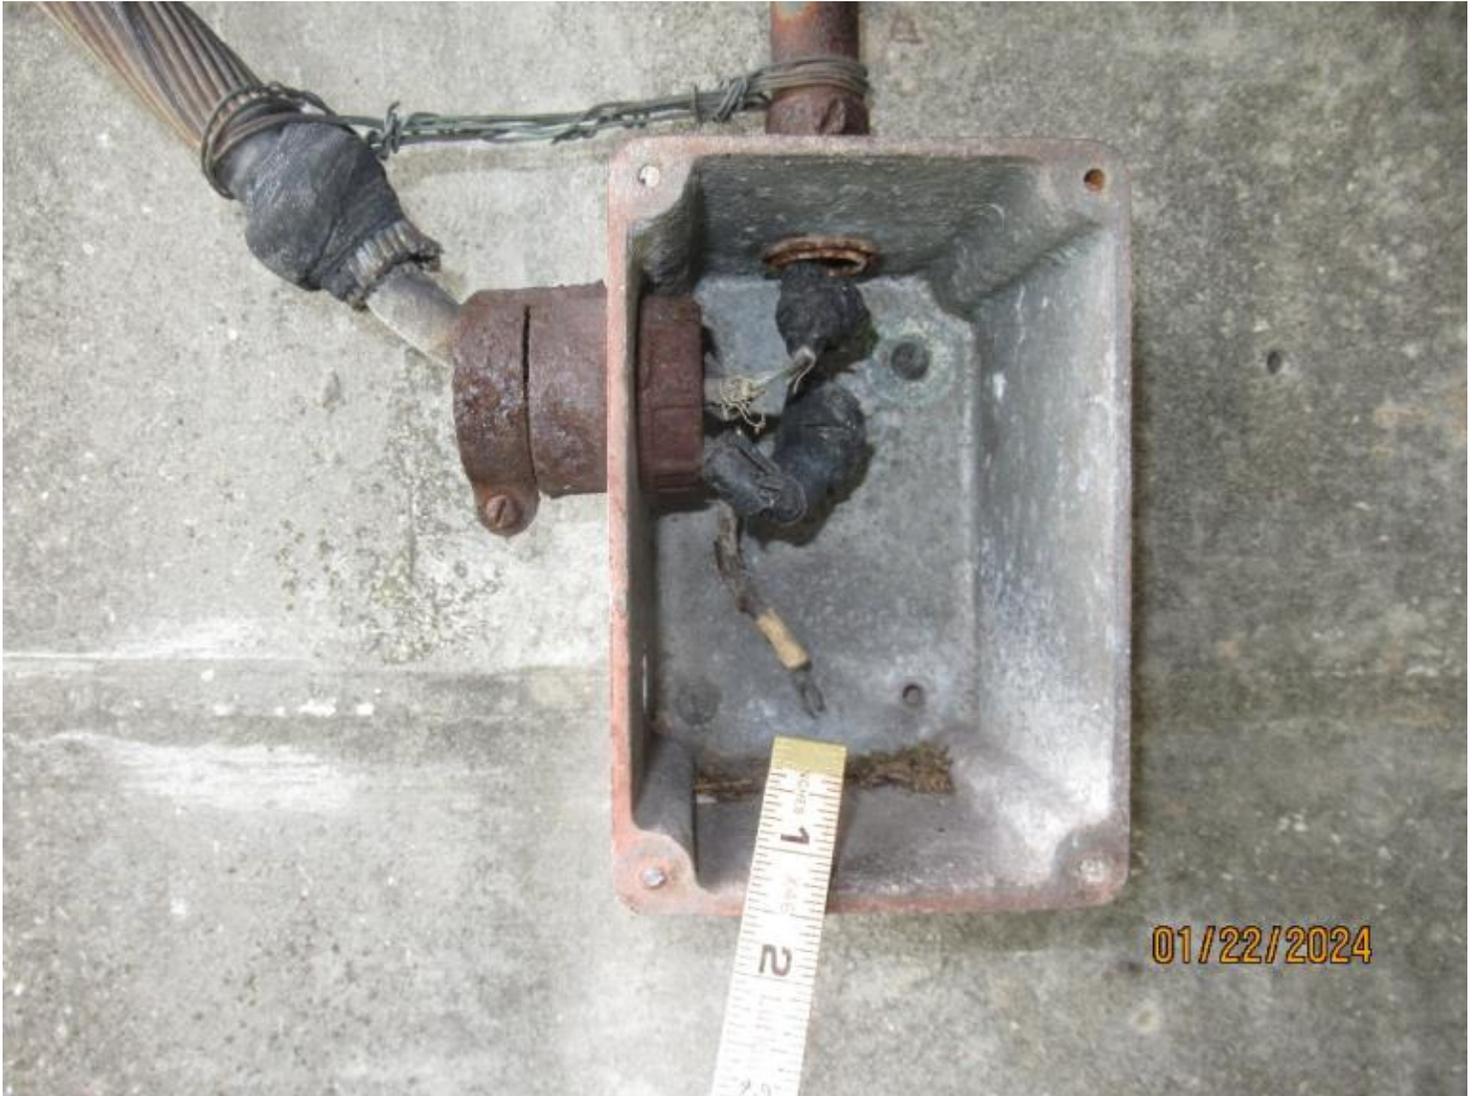
Photo 33: Inspection Notes

Utility junction box attached to Abutment 1 backwall on the right side of Beam 1-10 missing cover.

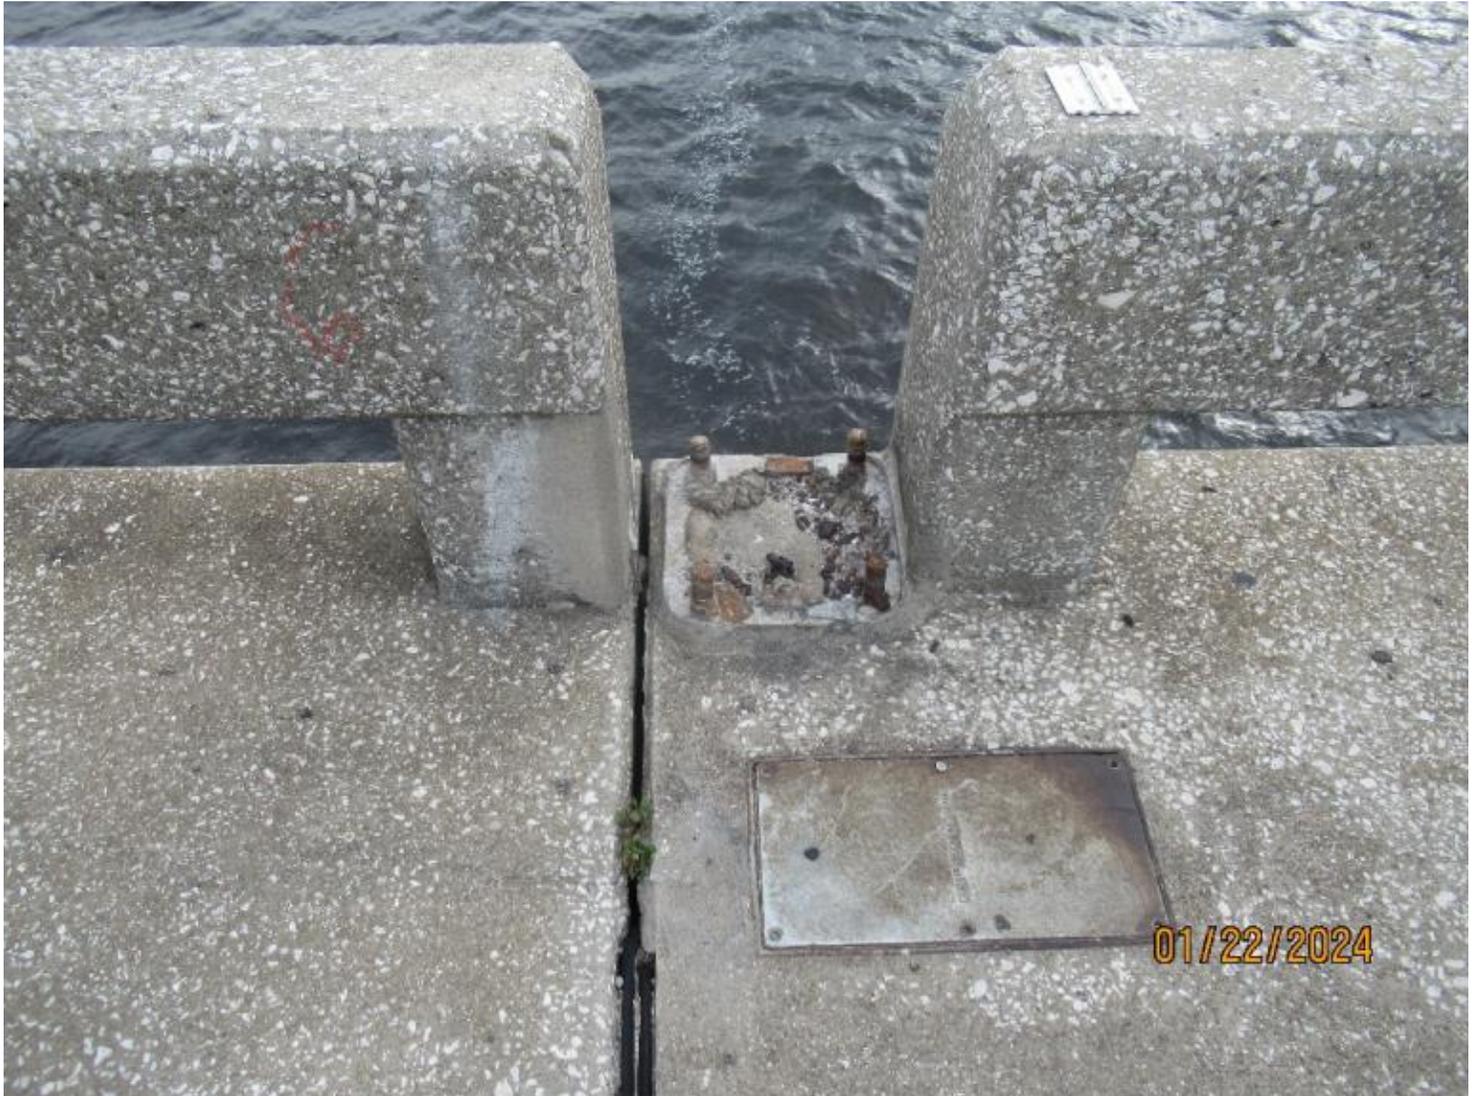
Photo 34: Inspection Notes

Pier 25 right missing light pole.

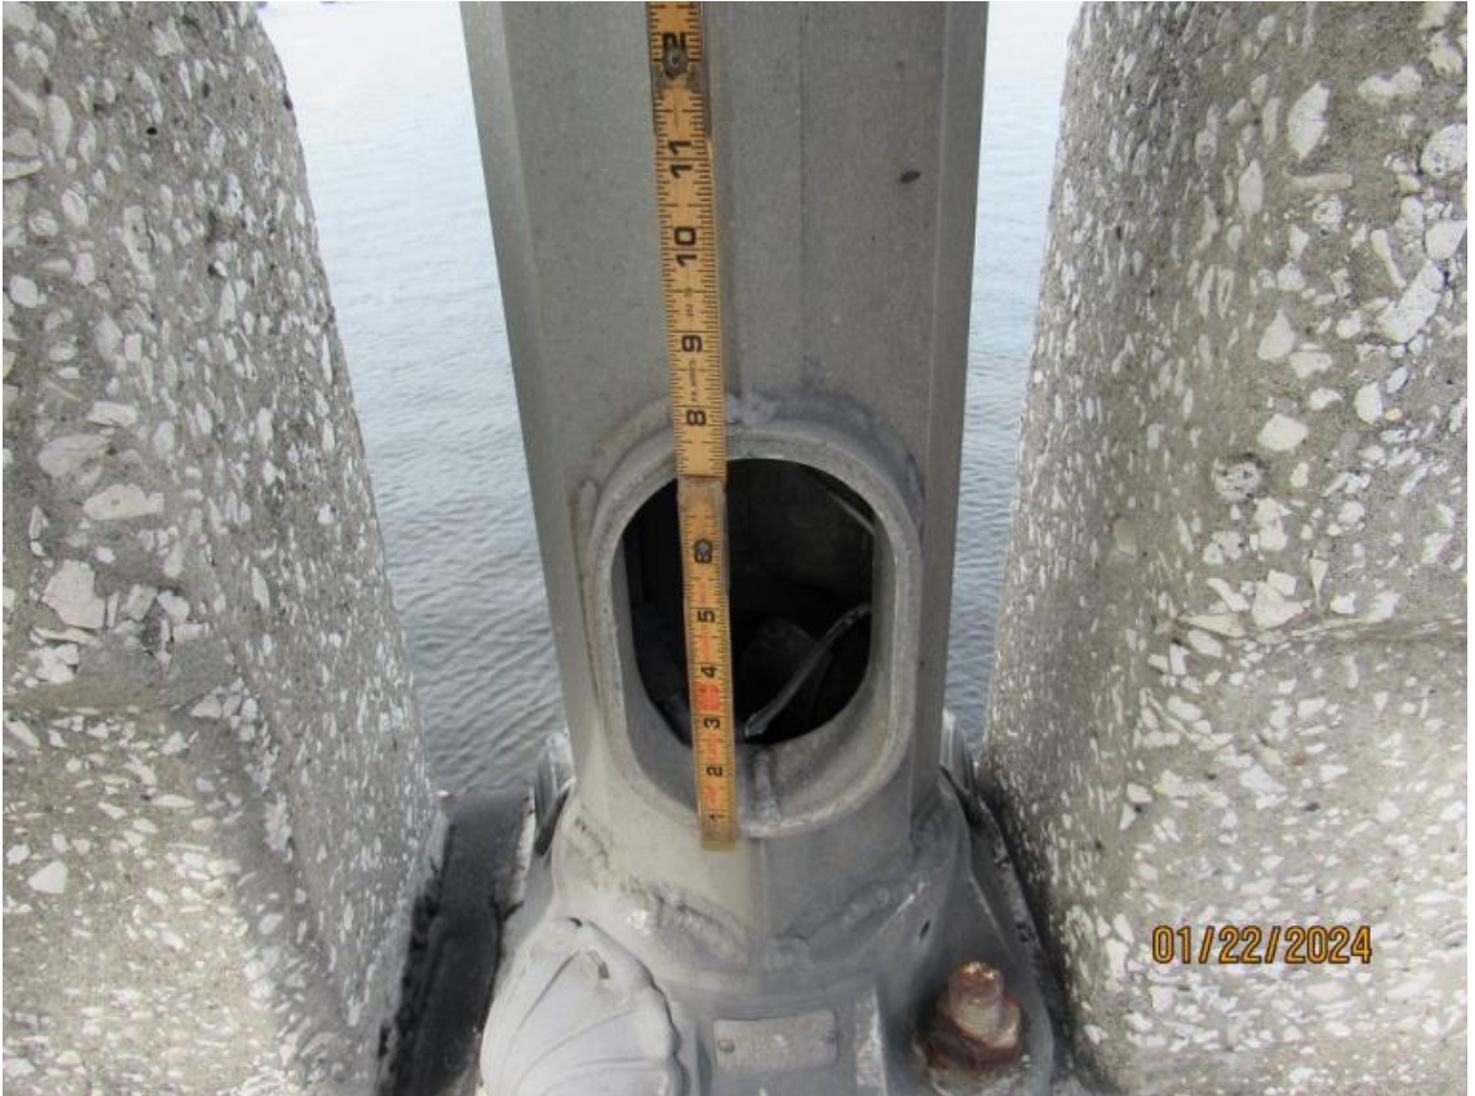
Photo 36: Inspection Notes

Light pole missing handhole access cover at Pier 19 left.

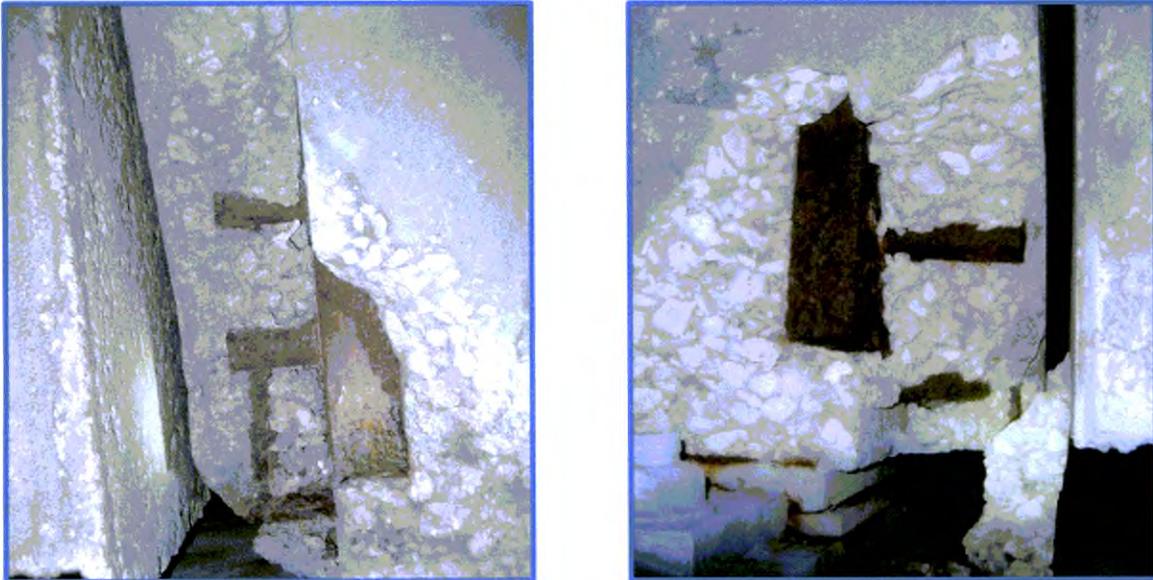
The Hernando Desoto Bridge (Bridge No. 130053) was constructed in 1957. Currently, there are numerous locations where concrete spalling has occurred at the ends of girders and corroded post-tensioned anchorages and tendons are exposed in the spalled areas. Figure 1 shows typical examples of the concrete damage and exposed post-tensioned components.

Figure 1. Typical examples of concrete damage and exposed post-tensioned components at the ends of girders.

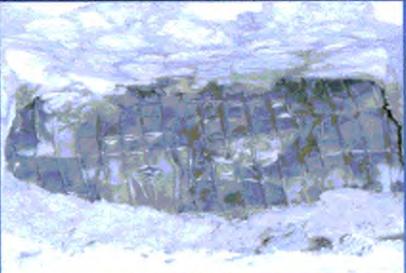
Girder	Location	Exterior Surface of Duct		Tendon	
		Condition	Photograph	Condition	Photograph
5-1	Bottom Tendon	No corrosion.

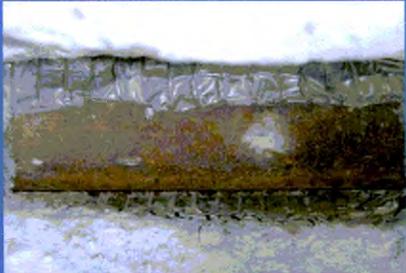
Uniform minor surface corrosion, no pitting.

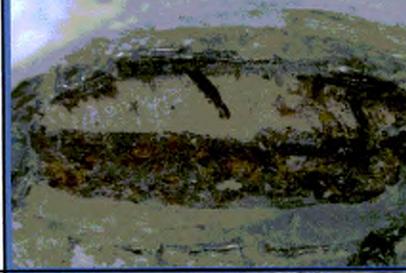
Spotty minor surface corrosion, no pitting.

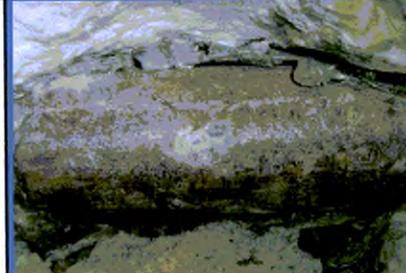
Spotty minor surface corrosion, no pitting.
