**NESHAP ASBESTOS SURVEY REPORT AND
SCREENING FOR METALS-BASED COATINGS**

State Road 710 from US 441 to the L-63 Canal

**RE: NESHAP Asbestos Survey Report and Screening for Metals-Based Coatings
SR 710 over Interceptor Canal L-63N (Bridge No. 910065)**

SR 710 from US 441 to the L-63 Canal
Okeechobee County, Florida
FPID: 419344-3-32-01
Tierra Project No.: 6511-12-054A

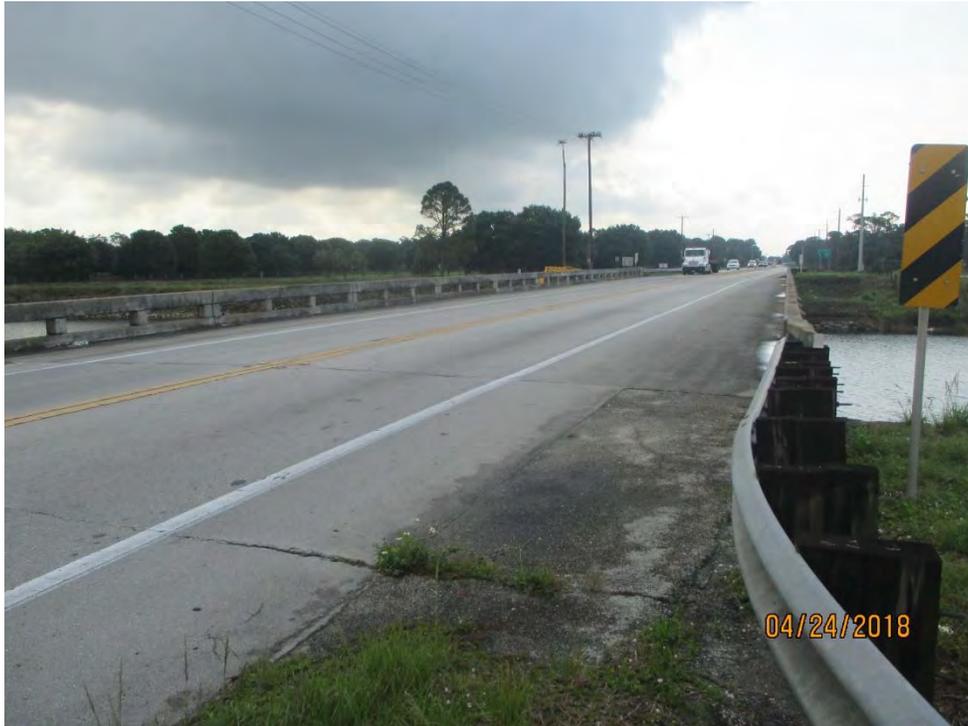
East of SR 710 over Interceptor Canal L-63N (Br. No. 910065) looking northwest

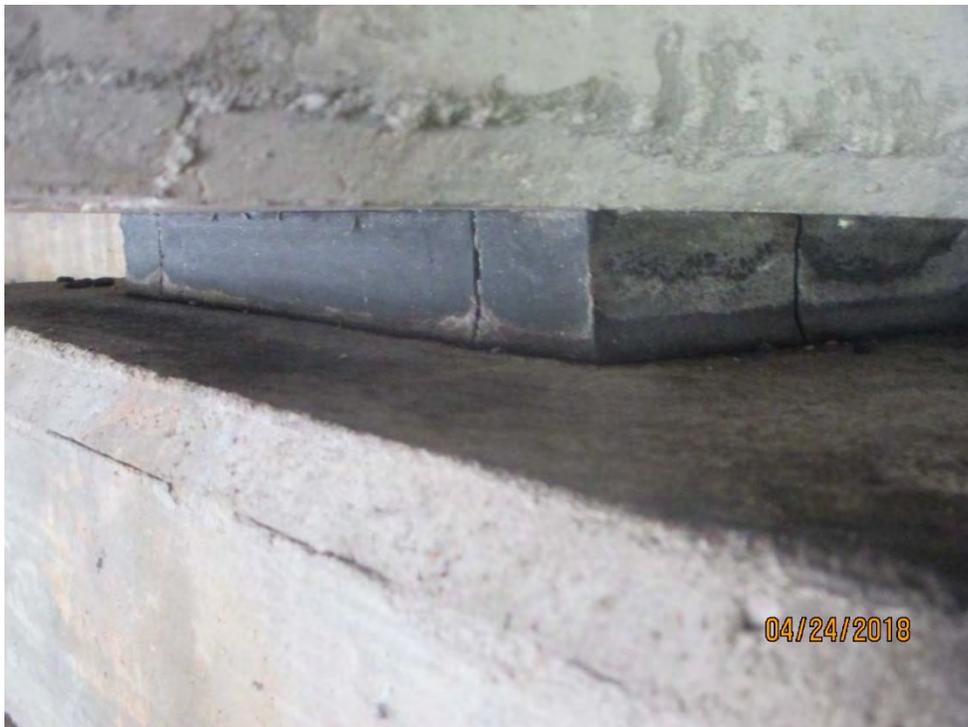
Homogeneous Area 1 (Samples 001-003) – Black bearing pad; between girder and end bent

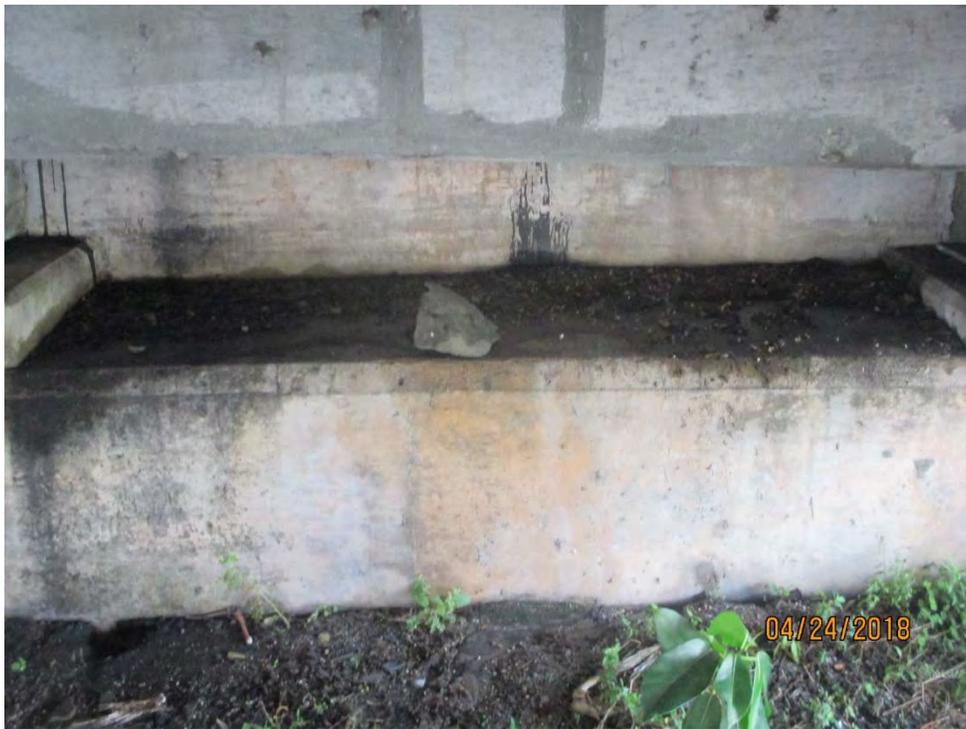
Homogeneous Area 2 (Samples 004-006) – Gray end bent concrete; end bents

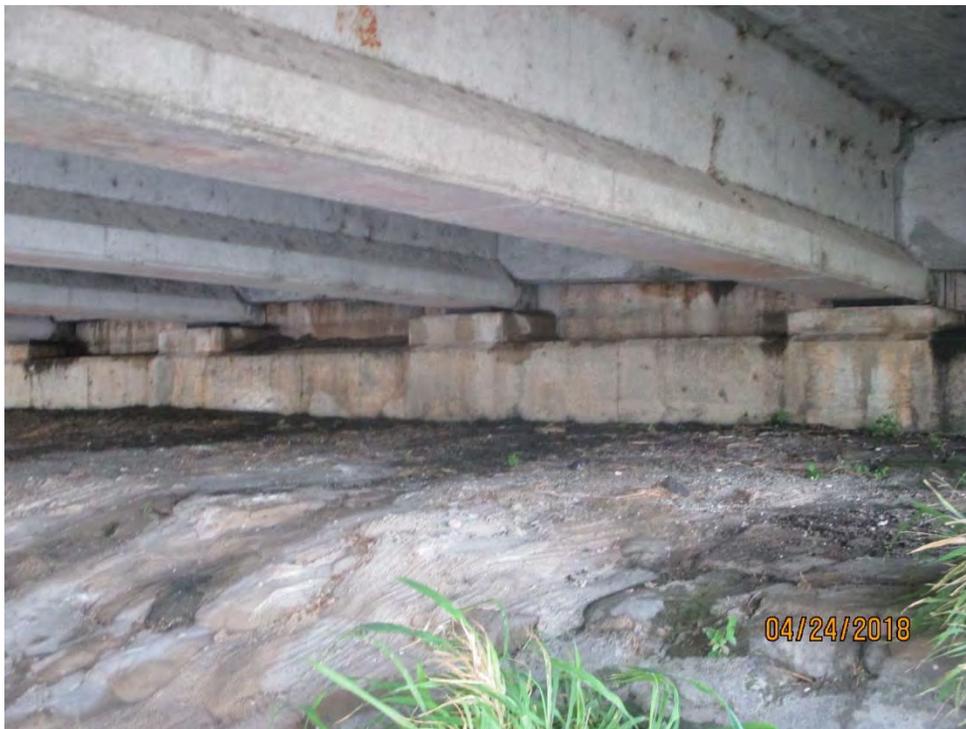
Homogeneous Area 3 (Samples 007-009) – Gray girder concrete; girders

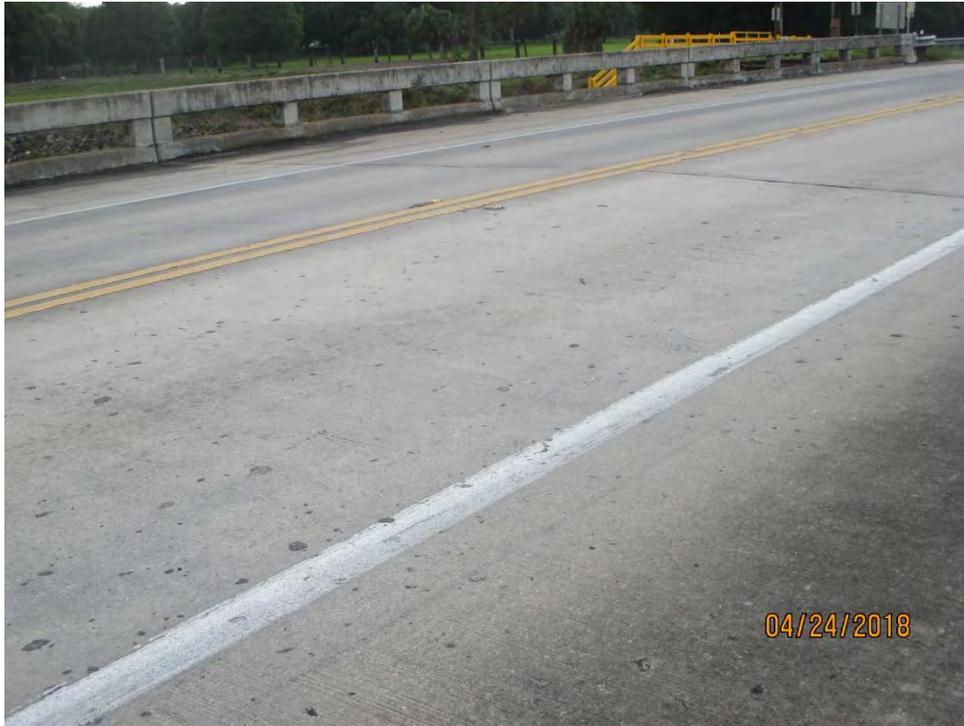
Homogeneous Area 4 (Samples 010-012) – Gray deck concrete; bridge deck

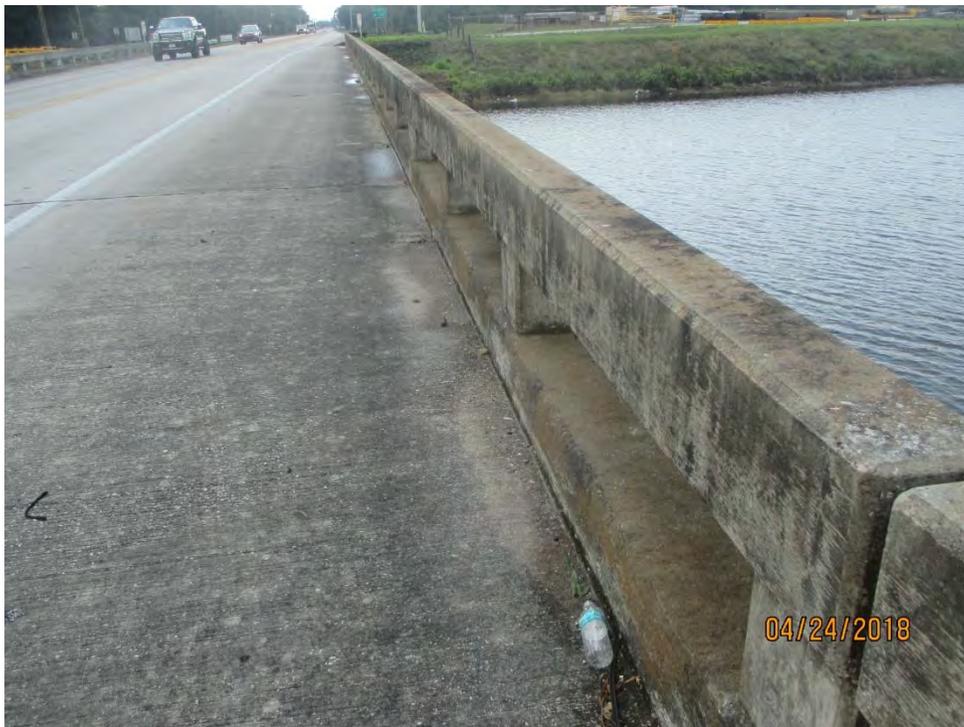
Homogeneous Area 5 (Samples 013-015) – Gray barrier wall concrete; barrier wall

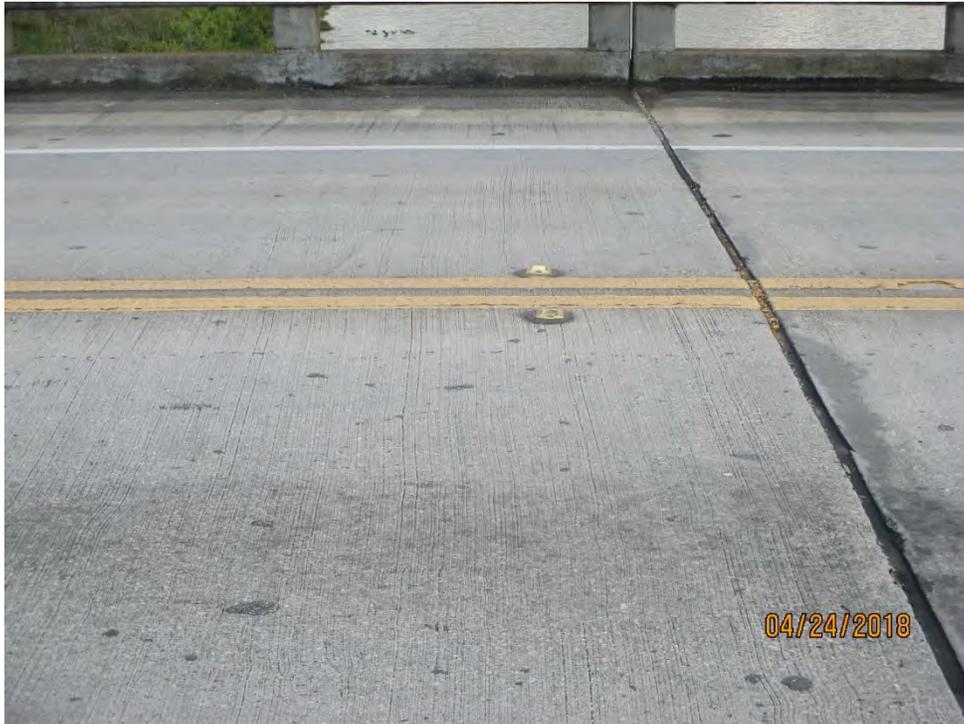
Homogeneous Area 6 (Samples 016-018) – Black reflector mastic; deck

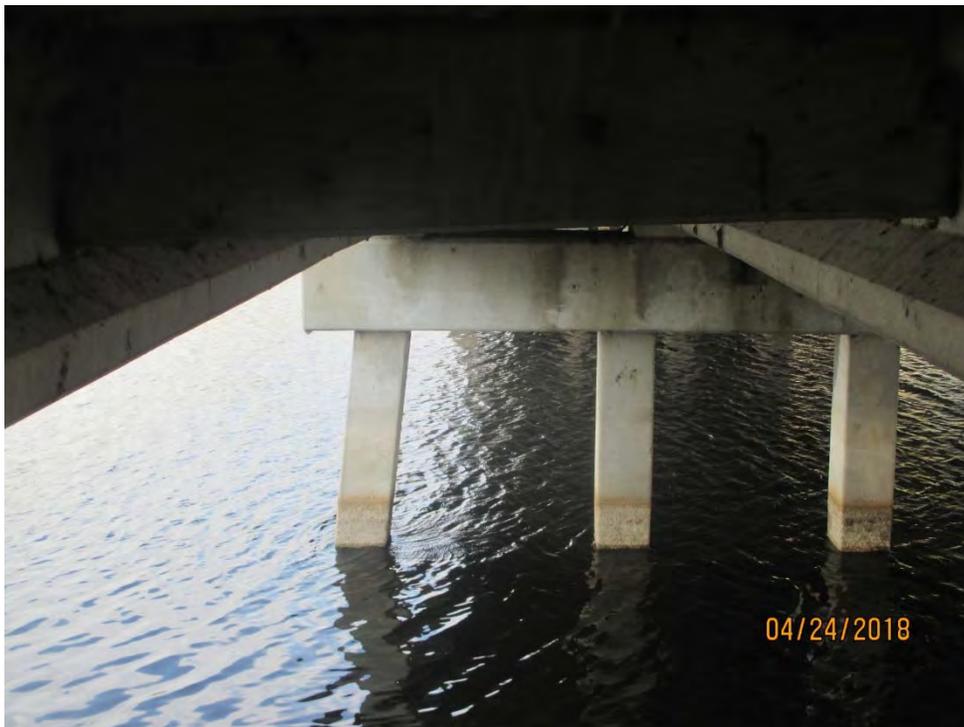
Homogeneous Area 7 (Samples 019-021) – Gray pile concrete; Bents

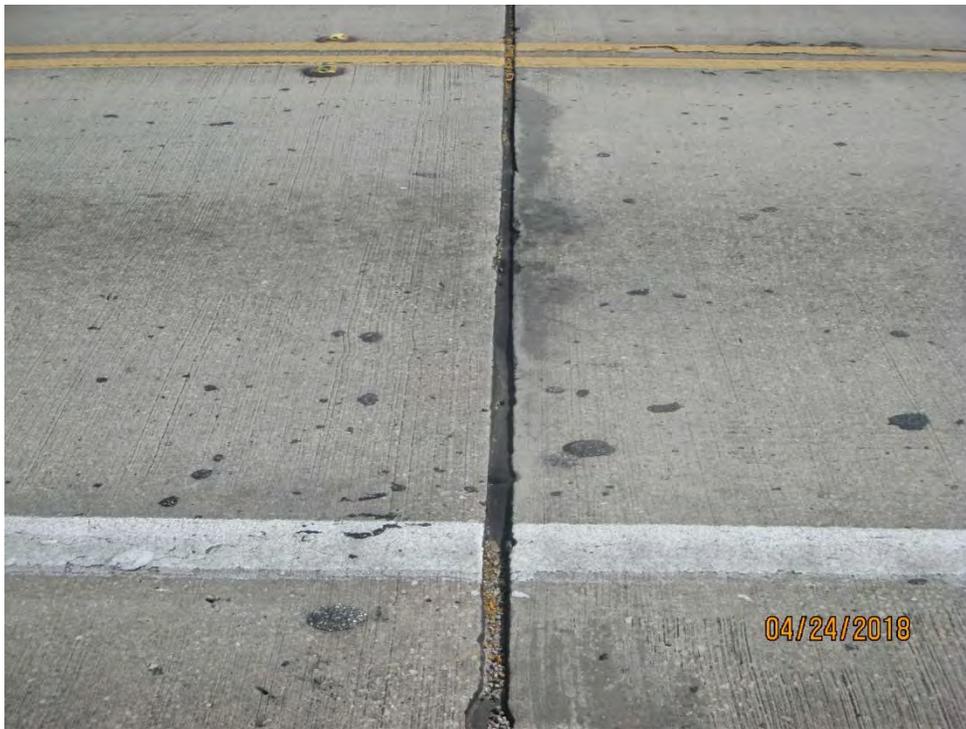
Homogeneous Area 8 (Samples 022-024) – Gray expansion fill; deck
