CULTURAL RESOURCE ASSESSMENT SURVEY

SR 789 (John Ringling Causeway) Bridge

Limits of Project: from Bird Key to Sarasota Harbour West

April 2023

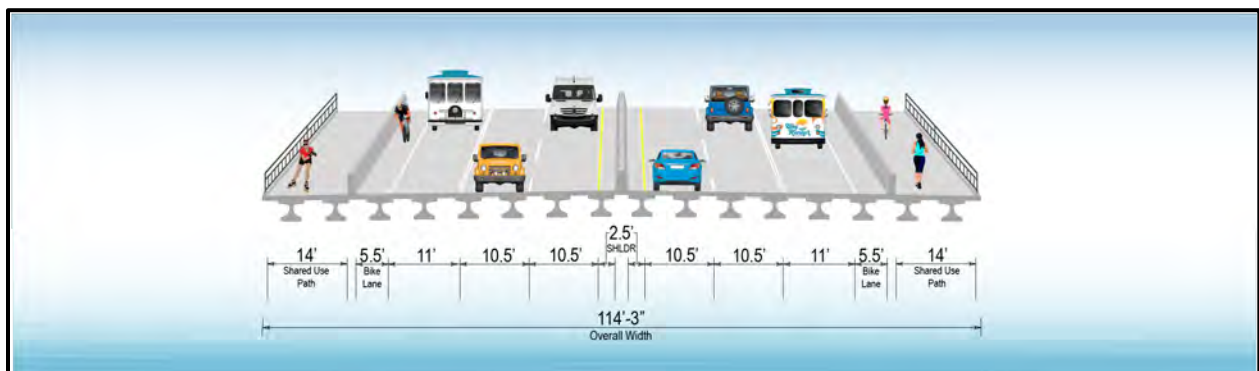
Figure 1-2
SR 789 Proposed Single Bridge Typical Section.

The preferred alternative replaces the existing twin bridges with a single bridge. The single bridge typical section includes two 10.5-ft wide travel lanes, a dedicated 11-ft transit lane, 2.5-ft inside shoulder, 5.5-ft bike lane, and 14-ft shared use path in each direction. The total width of the bridge is 114-ft 3-in, shown on **Figure 1-2**.

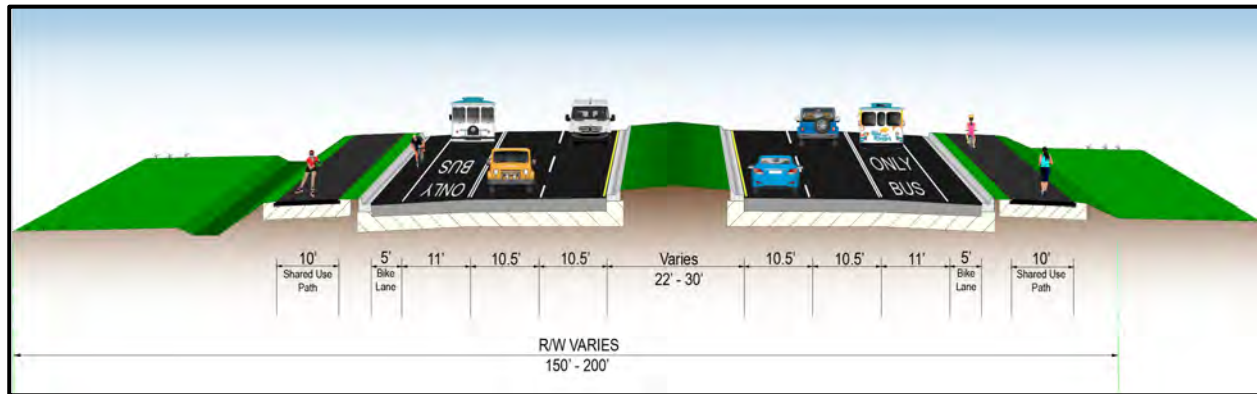
Figure 1-3
SR 789 Proposed Roadway Typical Section.

The new bridge will transition to a curb and gutter roadway typical section that includes two 10.5-ft wide travel lanes, a dedicated 11-ft transit lane, and 5-ft bike lane in each direction, separated

by a median with Type E curb and gutter. This section of roadway also includes a 10-ft shared-use path on both sides of the roadway that connects to the bridge, shown on **Figure 1-3**. The design speed is 40 mph with a posted and target speed of 35 mph.

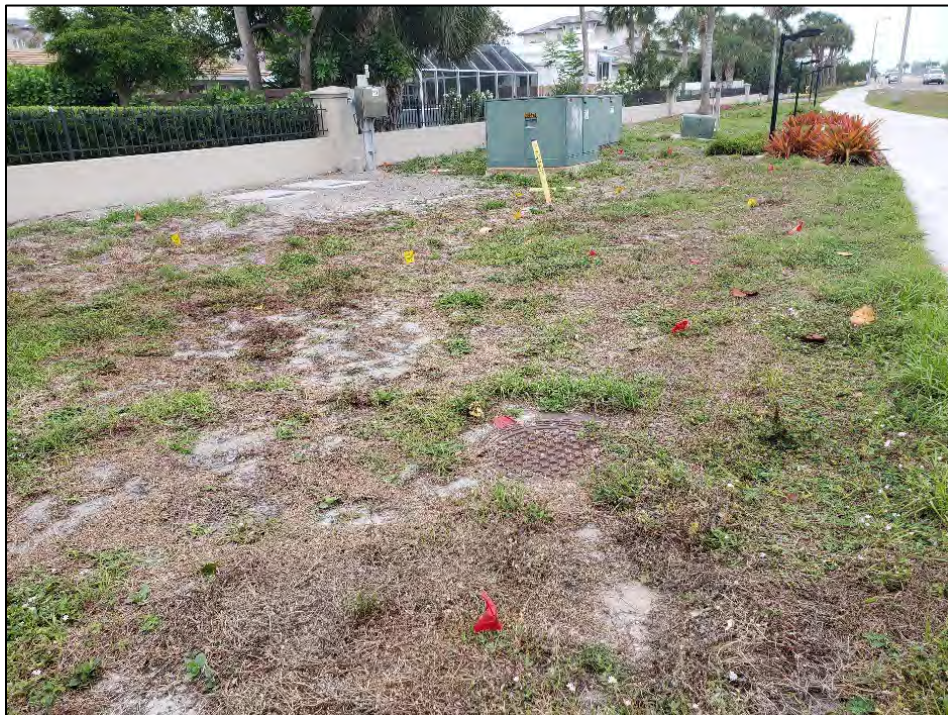
Photo 2-5. Sidewalk and subsurface utilities at the eastern end of Bird Key.

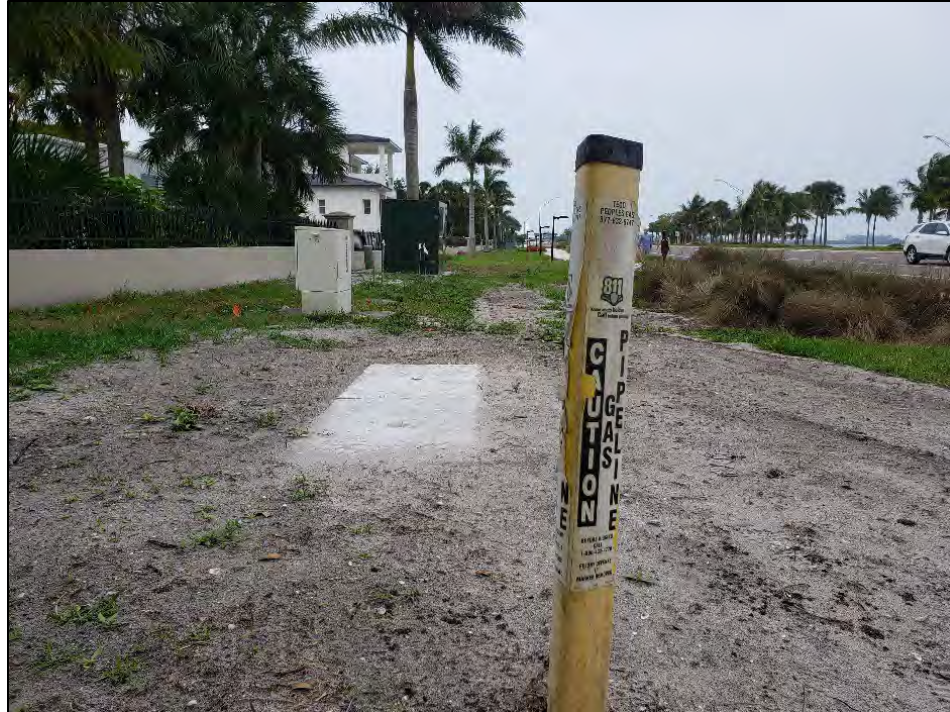
Photo 2-6. Subsurface disturbance and utilities on Bird Key.

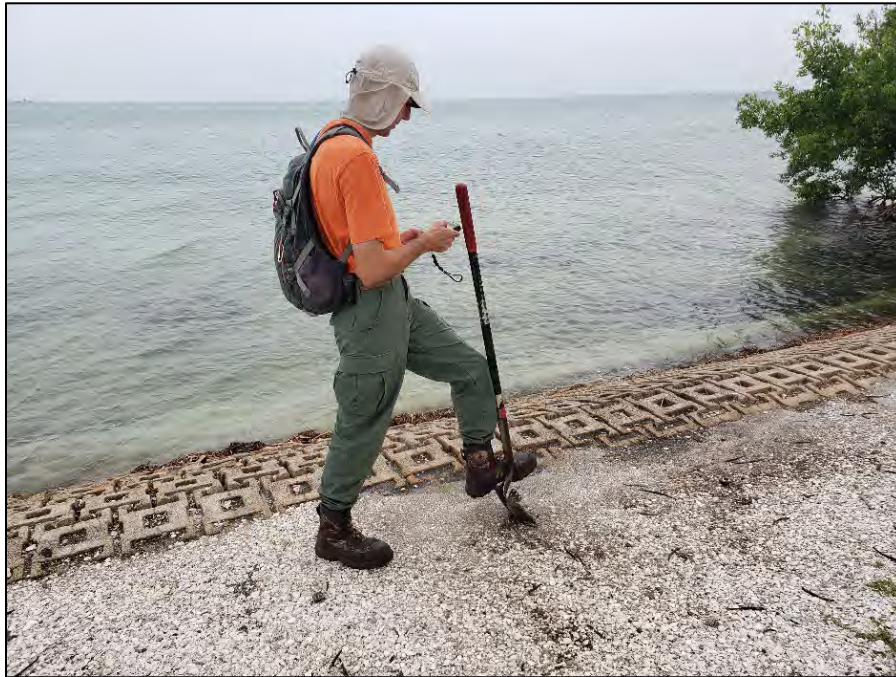
Photo 5-1. Testing along the John Ringling Causeway

The stratigraphy found in the shovel tests can be characterized as 0-20 cm of gray-brown sand and 20-100 cm of a light brown sand and shell mix. Several of the shovel tests in this area were terminated prior to 100 cm below surface due to buried concrete or asphalt. No artifacts were recovered from the tests and all tests indicated the area within the APE was filled and previously reworked. A reasonable and good faith effort was made per the regulations laid out in 36 CFR § 800.4(b)(1) (Advisory Council on Historic Preservation n.d.) to test all areas of the project APE; however, modern disturbances (buried utilities, ditches, etc.) did prevent testing in some areas.

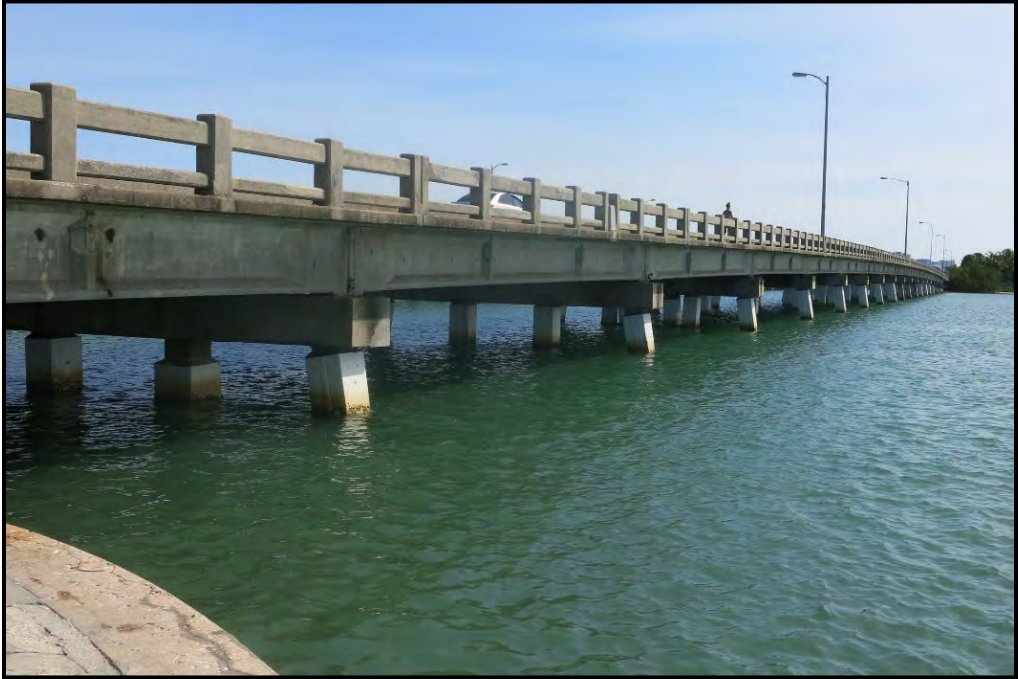
8SO06906 and 8SO06907: The SR 789 Northbound over Coon Key Waterway (Bridge No. 170022) (8SO06906) and SR 789 Southbound over Coon Key Waterway (Bridge No.170951) (8SO06907) are twenty-one span, prestressed concrete beam and girder bridges constructed in 1958 (**Photos 5-2 and 5-3**). The bridges were constructed to carry northbound and southbound SR 789/John Ringling Boulevard over the Coon Key Waterway between Bird Key and Coon Key. Each bridge is two lanes wide measuring approximately 37-ft wide with a 24-ft roadway width and flanked by short, concrete parapets which form a barrier between the roadway and sidewalks. The railings are comprised of solid, rectangular concrete posts with beveled edges and matching horizontal rails. A single span measures approximately 48-ft long with an overall length of 1,010-ft. The substructure of each bridge is comprised of concrete bents with four squared concrete piers each and a concrete header, as well as concrete abutments with riprap and seawalls. The bridge deck is constructed of concrete and covered with an asphalt surface. Metal streetlights are present along the bridges and each bridge is equipped with metal approach guardrails.

Photo 5-2. SR 789 Northbound over Coon Key Waterway (Bridge No. 170022/8SO06906), looking northeast.

The SR 789 Northbound over Coon Key Waterway (Bridge No. 170022) (8SO06906) and SR 789 Southbound over Coon Key Waterway (Bridge No. 170951) (8SO06907) bridges were determined ineligible for listing in the NRHP by the SHPO in 2011. The bridges have not been significantly altered since this determination and as a result were not updated for this CRAS. These are common post-World War II concrete beam and girder bridges found throughout Florida. These types of bridges were constructed as part of the massive expansion of the State's road system in the decades following the end of World War II (Parsons Brinckerhoff 2005). These bridges do not possess any notable engineering features or design elements that would differentiate them from dozens of similar examples built throughout Florida during the same time period. Furthermore, the Advisory Council on Historic Preservation (ACHP) issued a Program Comment in November 2012 that this type of bridge is excluded from Section 106 consideration by the Program Comment for Common Post-1945 Concrete and Steel Bridges (Federal Register 2012:68793).

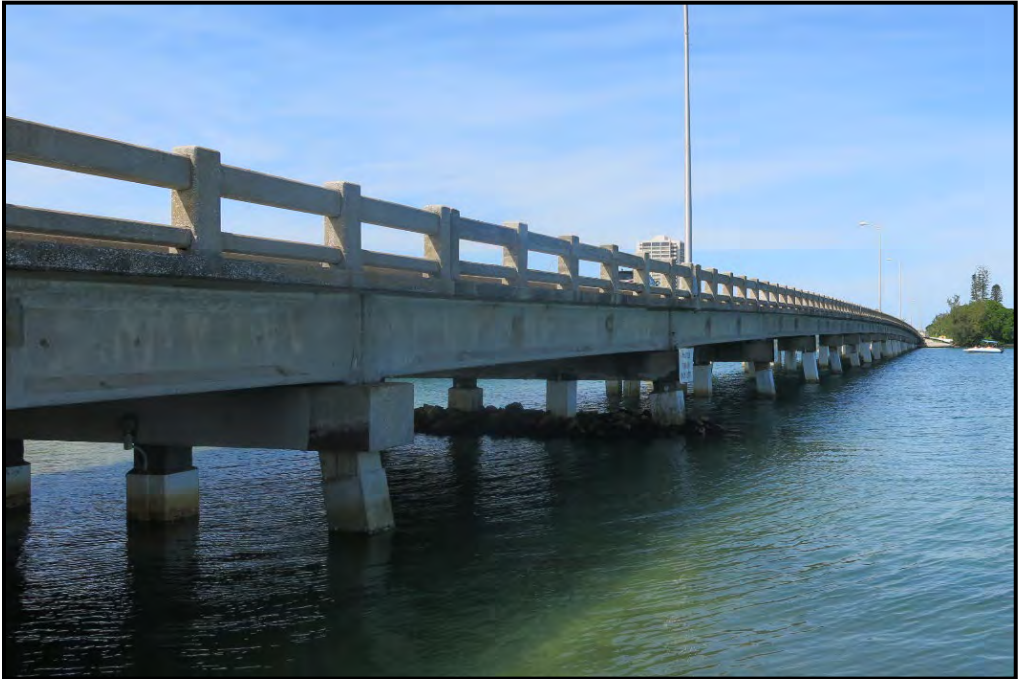
Photo 5-3 SR 789 Southbound over Coon Key Waterway (Bridge No. 170951/8SO06907), looking southwest.

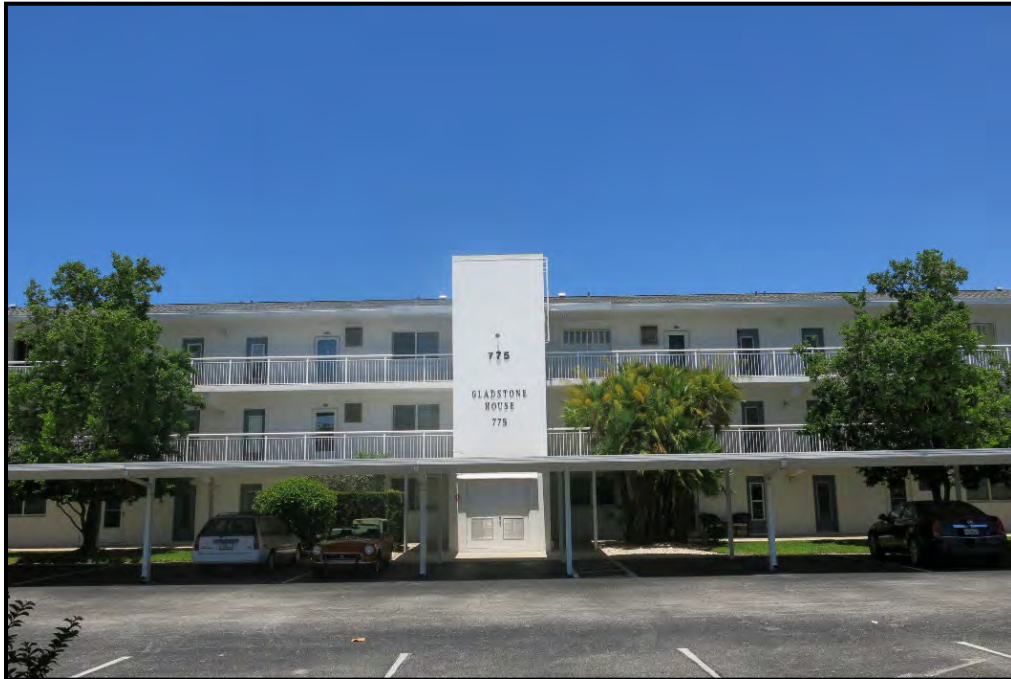
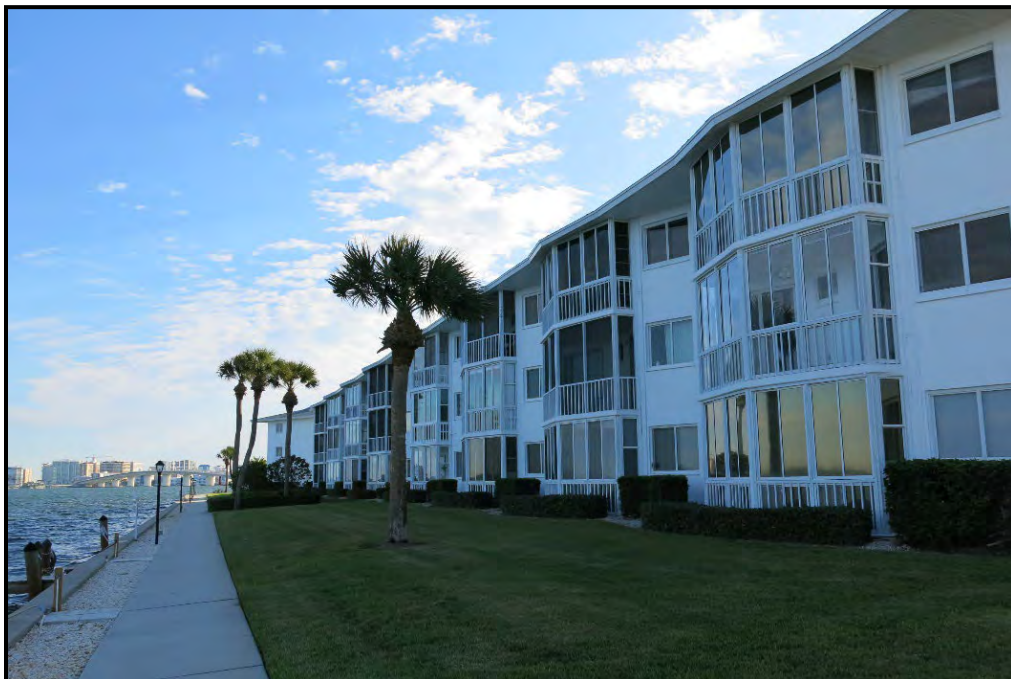
Harbour (now Sarasota Harbour West). As a result, 8SO12048 does not appear eligible for listing in the NRHP, either individually or as part of a historic district.

Photo 5-4. 775 John Ringling Boulevard/Gladstone House (8SO12048), looking northwest.

Photo 5-5. 775 John Ringling Boulevard/Gladstone House (8SO12048), looking east.

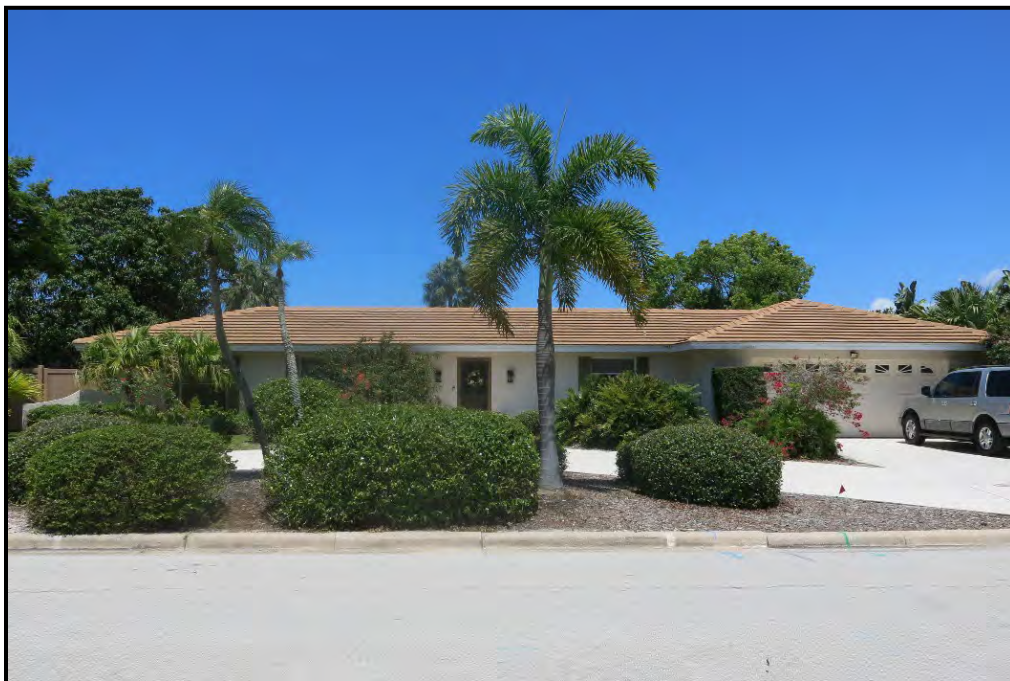
8SO12111: The Ranch style building at 109 Seagull Lane was constructed in ca. 1963 (**Photo 5-6**). The one-story, irregular plan building rests on a continuous concrete block foundation and has a concrete block structural system clad in stucco. The hip roof with hip extension is covered with flat tile, while the shed roof on the north elevation is covered with standing seam metal. The main entryway is on the south elevation through a single door with paneling, two inset leaded lights, and a screened storm door. Visible windows include a mixture of individual and paired, one-over-one vinyl single-hung sash units. Distinguishing architectural features include overhanging eaves with boxed rafter tails, shutters, stucco windowsills, and a stucco wingwall on the west elevation. Alterations include replacement windows and shutters. An integrated two-car garage with a sectional garage door and inset fanlights is located on the east end of the south elevation. A non-historic swimming pool with a screened enclosure is located to the north of the building. Overall, the building has been altered, lacks sufficient architectural features, and is not a significant embodiment of a type, period, or method of construction. In addition, background research did not reveal any historic associations with significant persons and/or events. While the resource was identified during the 2020 as a potential contributor to the potential Bird Key historic district, the subdivision was never formally recorded within the FMSF (Survey No. 26961). It is beyond the scope of the current survey to record and evaluate the potential Bird Key historic district. As such, 8SO12111 does not appear eligible for listing in the NRHP, either individually or as part of a historic district.

Photo 5-6 109 Seagull Lane (8SO12111), looking northwest.

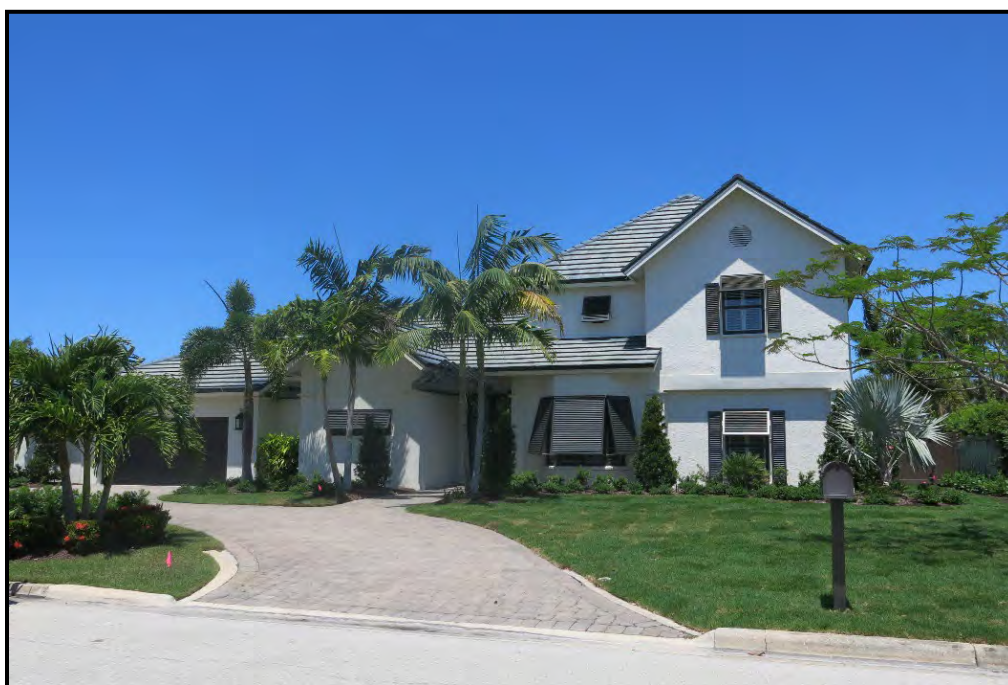
8SO12112: The Frame Vernacular style building at 113 Seagull Lane was constructed in ca. 1961 (**Photo 5-7**). The two-story, irregular plan building rests on a concrete slab foundation and has a wood frame structural system clad in stucco. The hip-on-hip roof with gable extensions is covered with flat tile. The main entryway is on the south elevation through double metal doors with inset 'X' patterned lights, recessed beneath the principal roof. Visible windows include individual one-over-one vinyl single-hung sash units. Distinguishing architectural features include overhanging eaves with boxed rafter tails, stucco windowsills, shutters (standard and Bahama-style), a triangular metal entry pergola, and stucco engaged columns. Alterations include replacement roofing, siding, and windows, as well as the installation of shutters. Additions include the two-car garage on the west elevation, gable roof extension on the south elevation, and the second story. A non-historic swimming pool and gazebo are located to the north of the building. Overall, the building has been significantly altered, lacks sufficient architectural features, and is not a significant embodiment of a type, period, or method of construction. In addition, background research did not reveal any historic associations with significant persons and/or events. During the 2020 survey, *City of Sarasota Historic Preservation Project*, the resource was identified as non-contributing to the potential Bird Key historic district; however, the subdivision was never formally recorded within the FMSF (Survey No. 26961). It is beyond the scope of the current survey to record and evaluate the potential Bird Key historic district. As such, 8SO12112 does not appear eligible for listing in the NRHP, either individually or as part of a historic district.

Photo 5-7. 113 Seagull Lane (8SO12112), looking northwest.

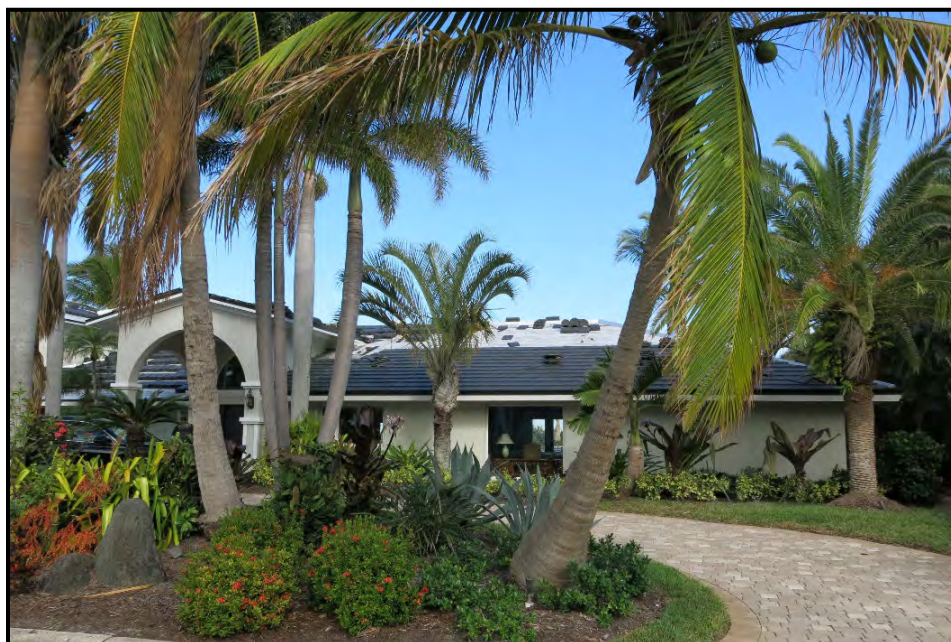
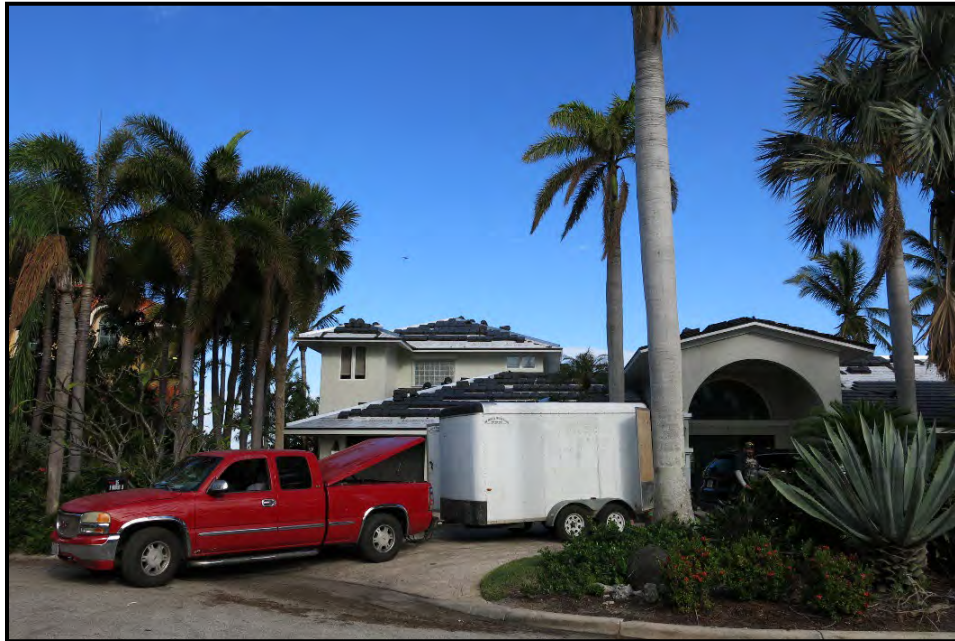
8SO12125: The Masonry Vernacular style building at 105 N Warbler Lane was constructed in ca. 1970 (**Photos 5-8 and 5-9**). The one-story, irregular plan building rests on a concrete slab foundation and has a concrete block system clad in stucco. The complex hip roof with hip roof extensions is covered with tile. The main entryway is on the south elevation through double wooden doors with sidelights and a half half-circle transom beneath a hip roof extension with an arched opening. Visible windows include a mixture of individual, single pane metal fixed units; paired single pane vinyl casement units; an individual glass block panel with glass blocks in an 8 x 5 pattern. Distinguishing architectural features include overhanging eaves with boxed rafter tails and an arched opening with decorative stucco trim at the entrance vestibule. Alterations include replacement roofing (in progress), siding, and windows. Additions include the second story located on the west elevation, as well as the hip roof extension entrance vestibule on the south elevation. Paired one-car garages are located on the west end of the south elevation. A non-historic swimming pool and boat dock are located to the north of the building. Overall, the building has been altered, lacks sufficient architectural features, and is not a significant embodiment of a type, period, or method of construction. In addition, background research did not reveal any historic associations with significant persons and/or events. During the 2020 survey, *City of Sarasota Historic Preservation Project*, the resource was identified as non-contributing to the potential Bird Key historic district; however, the subdivision was never formally recorded within the FMSF (Survey No. 26961). It is beyond the scope of the current survey to record and evaluate the potential Bird Key historic district. As such, 8SO12125 does not appear eligible for listing in the NRHP, either individually or as part of a historic district.

Photo 5-8. 105 N Warbler Lane (8SO12125), looking northwest.

Photo 5-9. 105 N Warbler Lane (8SO12125), looking north.

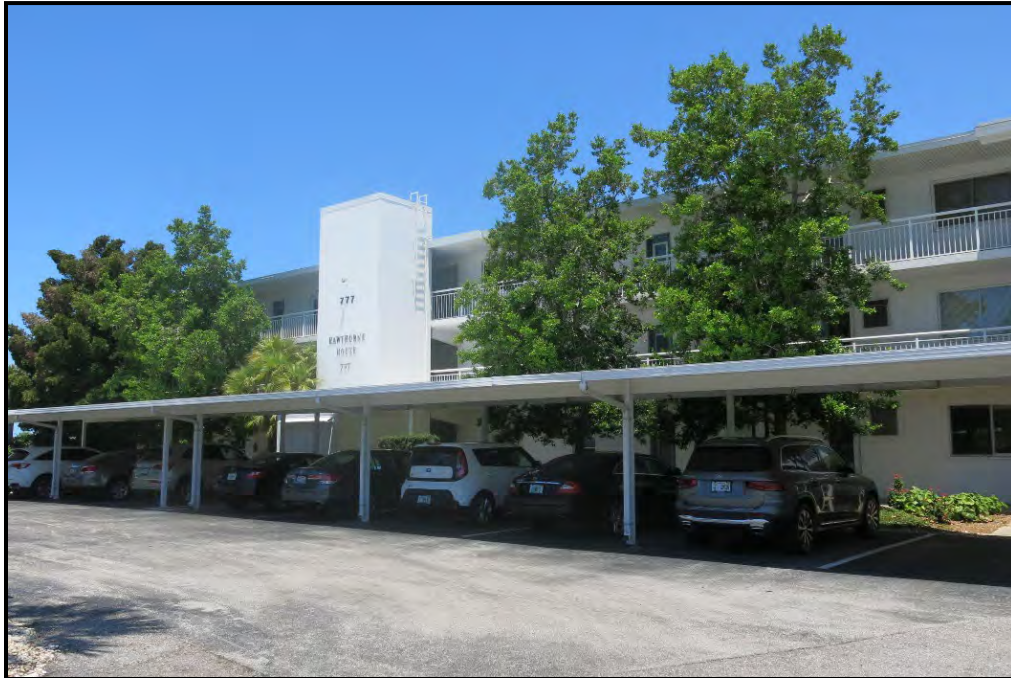
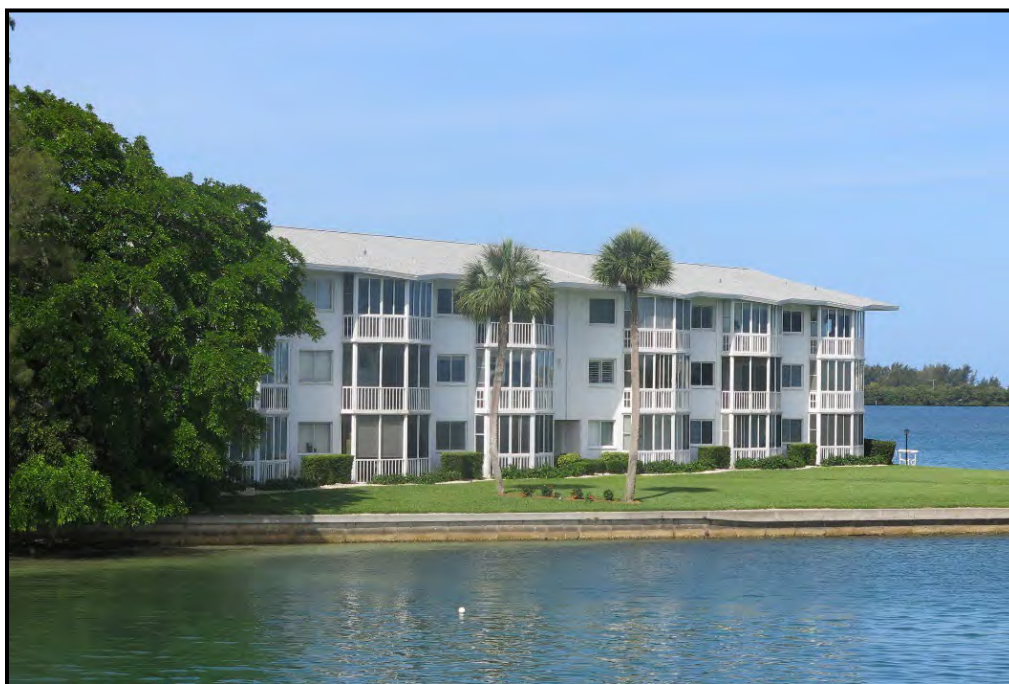
8SO14518: The Mid-Century Modern style building at 777 John Ringling Boulevard was constructed in ca. 1965 (**Photos 5-10 and 5-11**). The three-story, irregular plan building rests on a concrete slab foundation and has a concrete block structural system clad in stucco. The gable on hip roof with shed extensions is covered with composition shingles. The main entryways are on the west elevation through a single door per unit flanked by a wall-mounted air-conditioning unit along a walkway lined with a metal railing. Each unit includes a partial width incised porch on the east elevation with screening or sliding windows beneath the principal roof with triangular kickouts. Visible windows include individual one-over-one metal sliding units. Distinguishing architectural features include overhanging eaves with boxed rafter tails, exposed beams, and triangular roof kickouts along the east elevation. Alterations include replacement roofing. An elevator shaft with “Hawthorne House” signage is centrally located on the west elevation and open-air stairwells are located on the north and south ends of the west elevation. A central breezeway is located on the first story and provides access to the east elevation. The building is located within the Sarasota Harbour East condominium development with the Gladstone House (8SO12048) located west of the building.

constructed in ca. 1965 to the east on Coon Key and sold within a slightly higher price bracket (Tampa Bay Times 1964b). Overall, the building lacks sufficient architectural features, and is not a significant embodiment of a type, period, or method of construction. In addition, background research did not reveal any historic associations with significant persons and/or events as the building is associated with a later project, separate from the county's first condominium apartment, Sarasota Harbour (now Sarasota Harbour West). As a result, 8SO14518 does not appear eligible for listing in the NRHP, either individually or as part of a historic district.

Photo 5-10. 777 John Ringling Boulevard/Hawthorne House (8SO14518), looking north.

Photo 5-11. 777 John Ringling Boulevard/Hawthorne House (8SO14518), looking northwest.

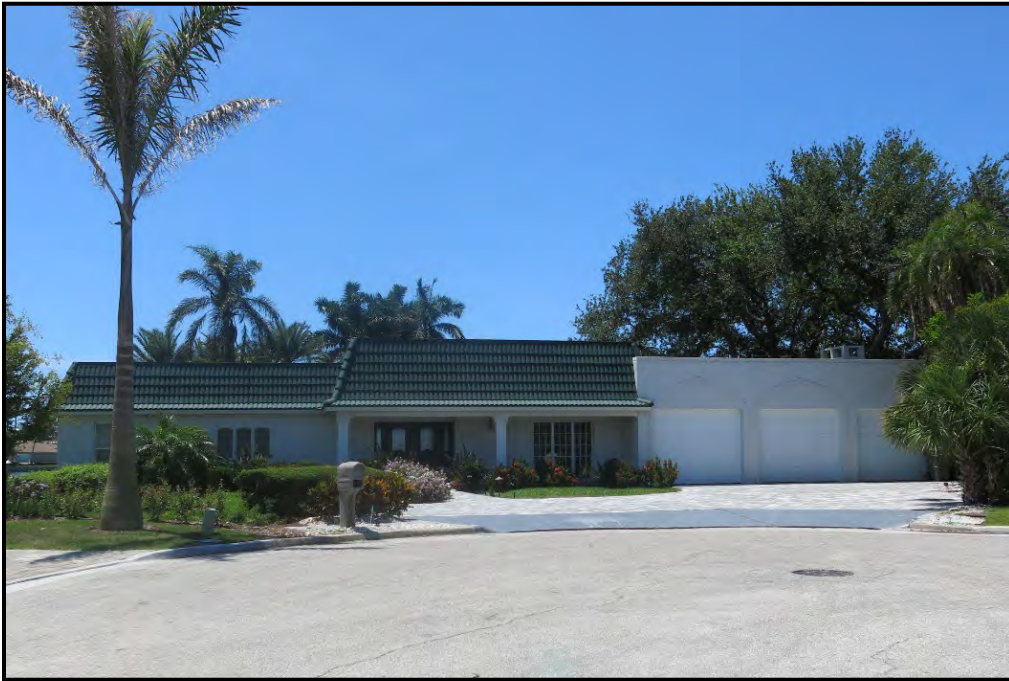
8SO14519: The Masonry Vernacular style building at 102 Seagull Lane was constructed in ca. 1973 (**Photo 5-12**). The one-story, irregular plan building rests on a concrete slab foundation and has a concrete block structural system clad in stucco. The flat roof is covered with built-up roofing membrane. A masonry chimney is located within the roof of the west elevation. The main entryway is on the north elevation through double doors with decorative inset lights and sidelights within a partial width incised porch beneath the principal roof with squared column porch supports. Visible windows include a mixture of individual and grouped (3), one-over-one and nine-over-six vinyl single-hung sash units and grouped (3), arched single pane vinyl fixed units. Distinguishing architectural features include a non-structural faux-mansard style barrel tile parapet and arched stucco trim around the windows and garage doors. Alterations include replacement roofing, siding, and windows. Additions include a three-car garage with sectional garage doors. A ca. 1973 swimming pool with a screened enclosure and a non-historic boat dock are located to the south of the building. Overall, the building has been altered, lacks sufficient architectural features, and is not a significant embodiment of a type, period, or method of construction. In addition, background research did not reveal any historic associations with significant persons and/or events. As a result, 8SO14519 does not appear eligible for listing in the NRHP, either individually or as part of a historic district.

Photo 5-12. 102 Seagull Lane (8SO14519), looking southwest.
