Contamination Screening Evaluation Report

Florida Department of Transportation
District One

Project Development and Environment Study
SR 31 (Babcock Ranch Road)
from SR 80 (Palm Beach Boulevard) to SR 78 (Bayshore Road)

September 22, 2023, Rev. 2

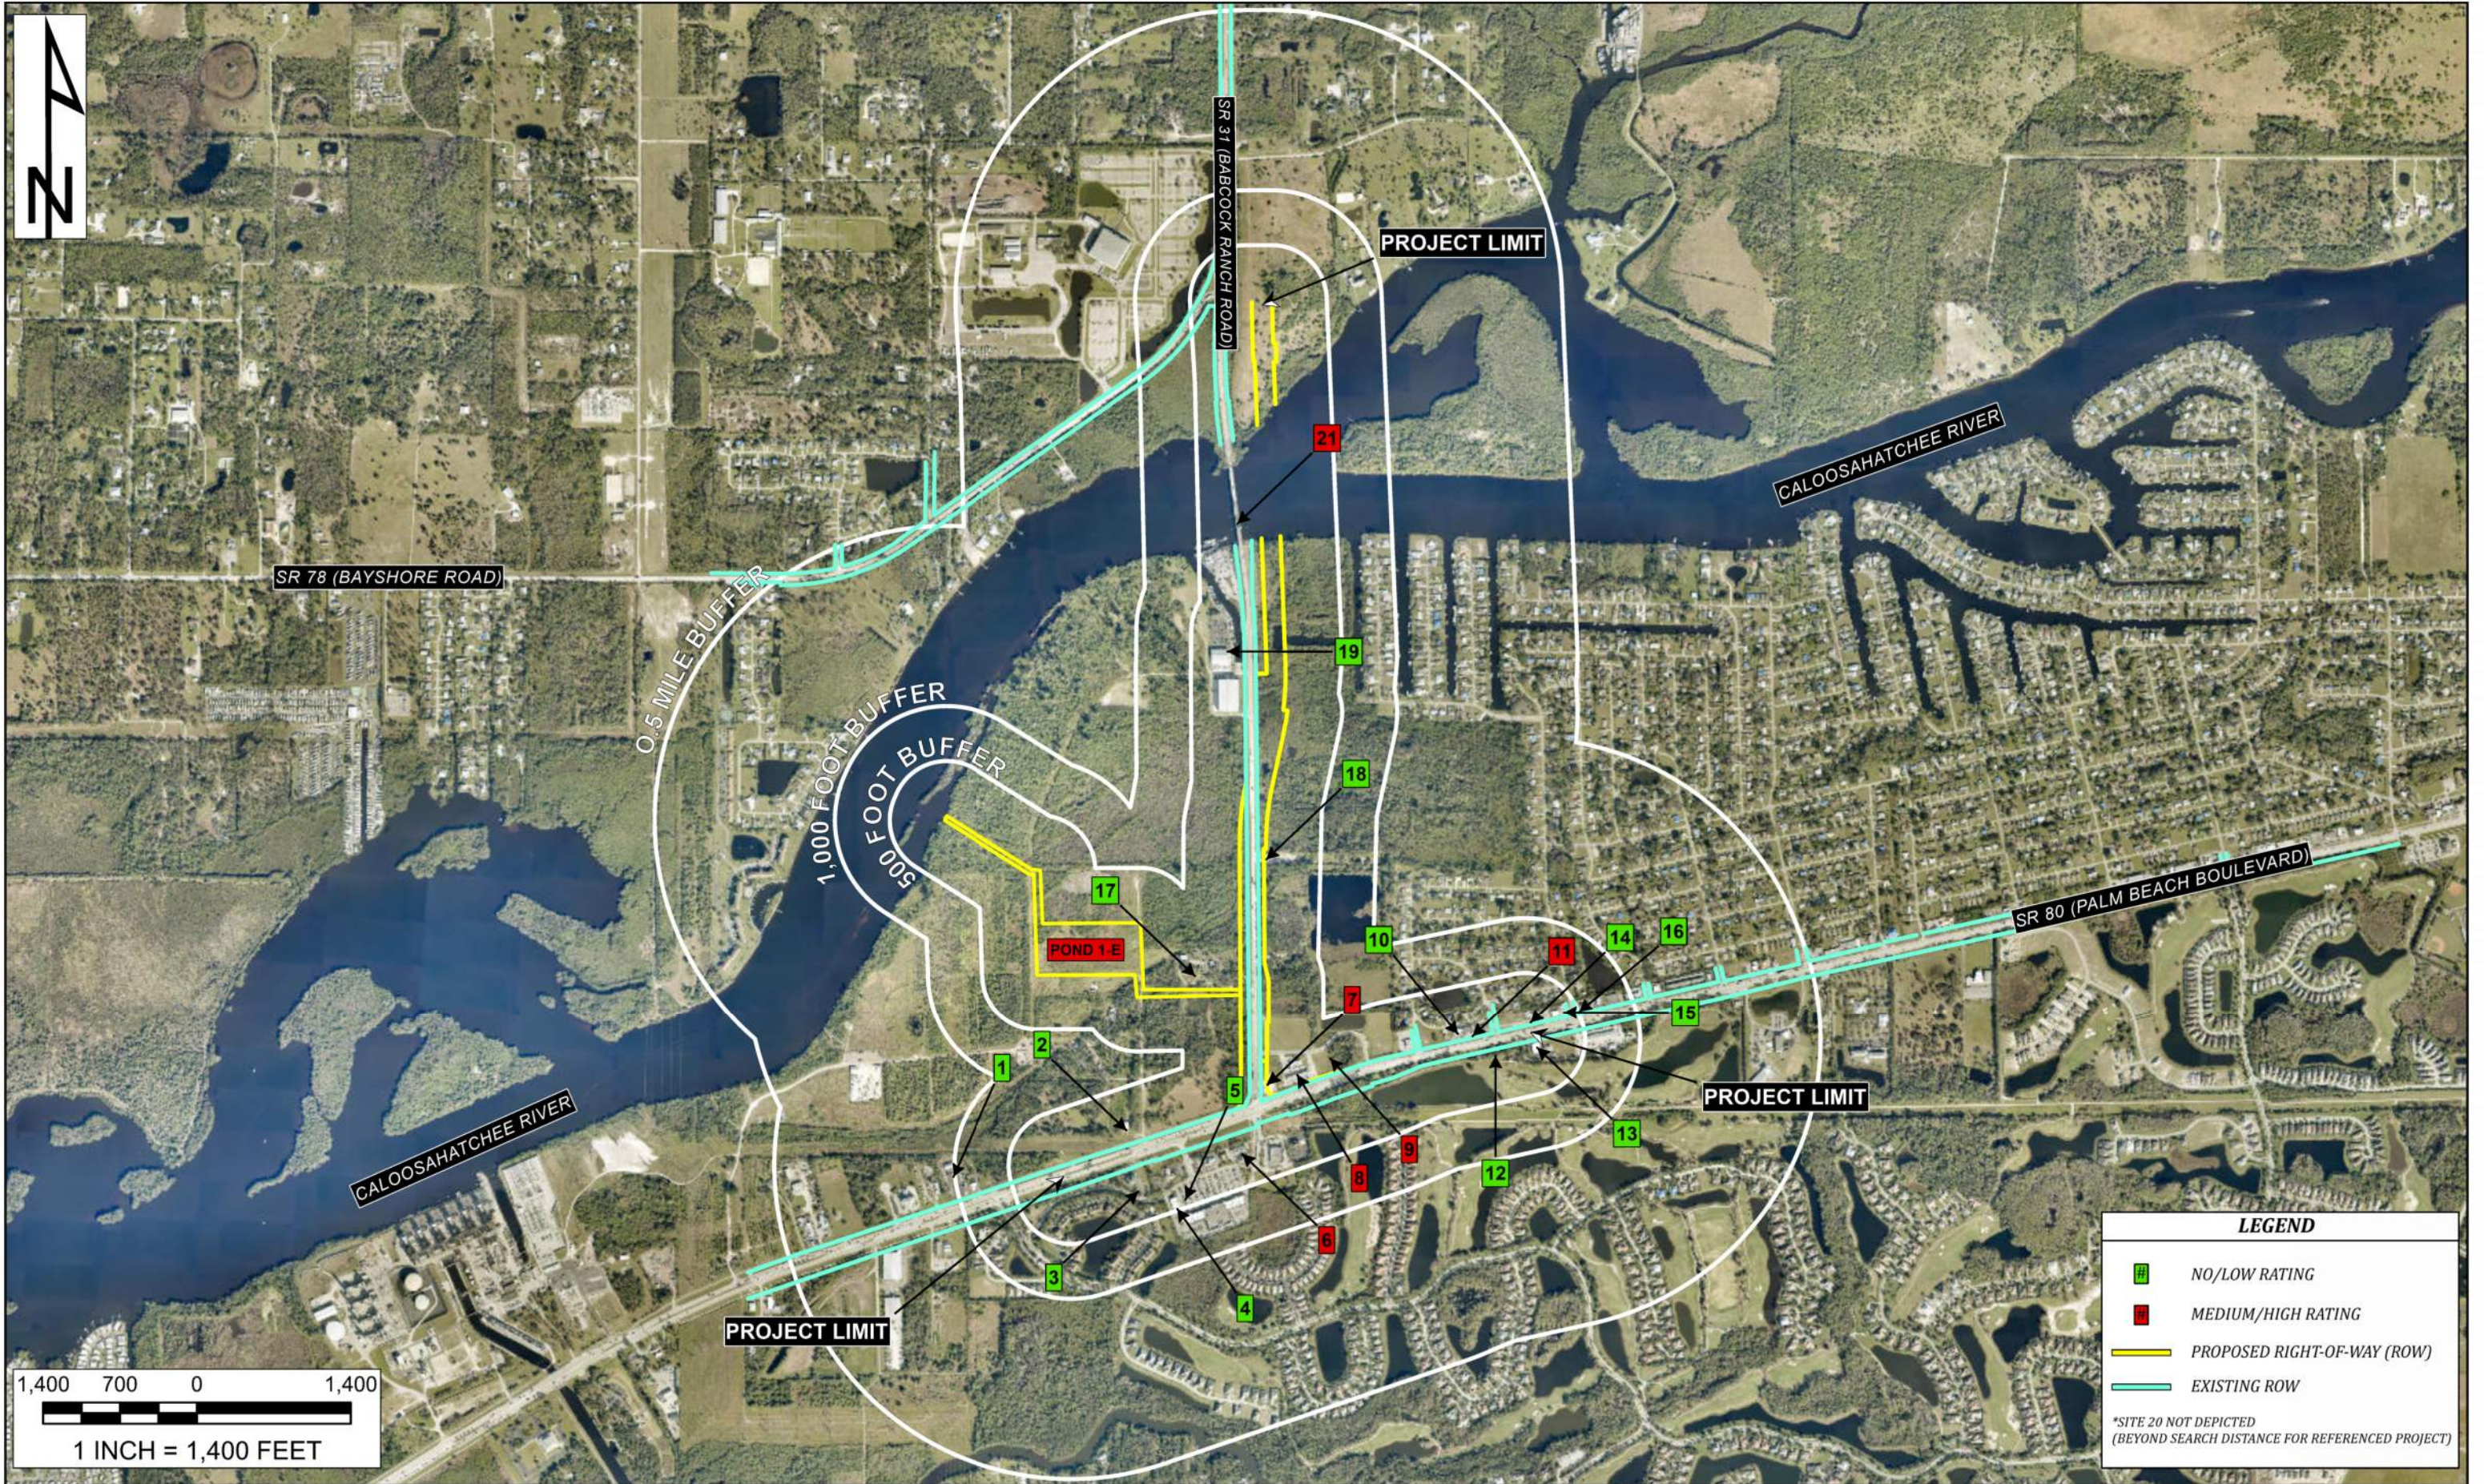
APPENDIX A
POTENTIAL CONTAMINATION SITES
AND
DRAINAGE ALTERNATIVES MAP

OWNER: FDOT-DISTRICT 1			PROJECT DEVELOPMENT AND ENVIRONMENT STUDY SR 31 (BABCOCK RANCH ROAD) FROM SR 80 (PALM BEACH BOULEVARD) TO SR 78 (BAYSHORE ROAD)	POTENTIAL CONTAMINATION SITES AND DRAINAGE ALTERNATIVES MAP	SHEET NO.
	COUNTY	TIERRA PROJECT NO.	FINANCIAL PROJECT ID			1
	LEE	6511-18-173E	441942-1-22-01

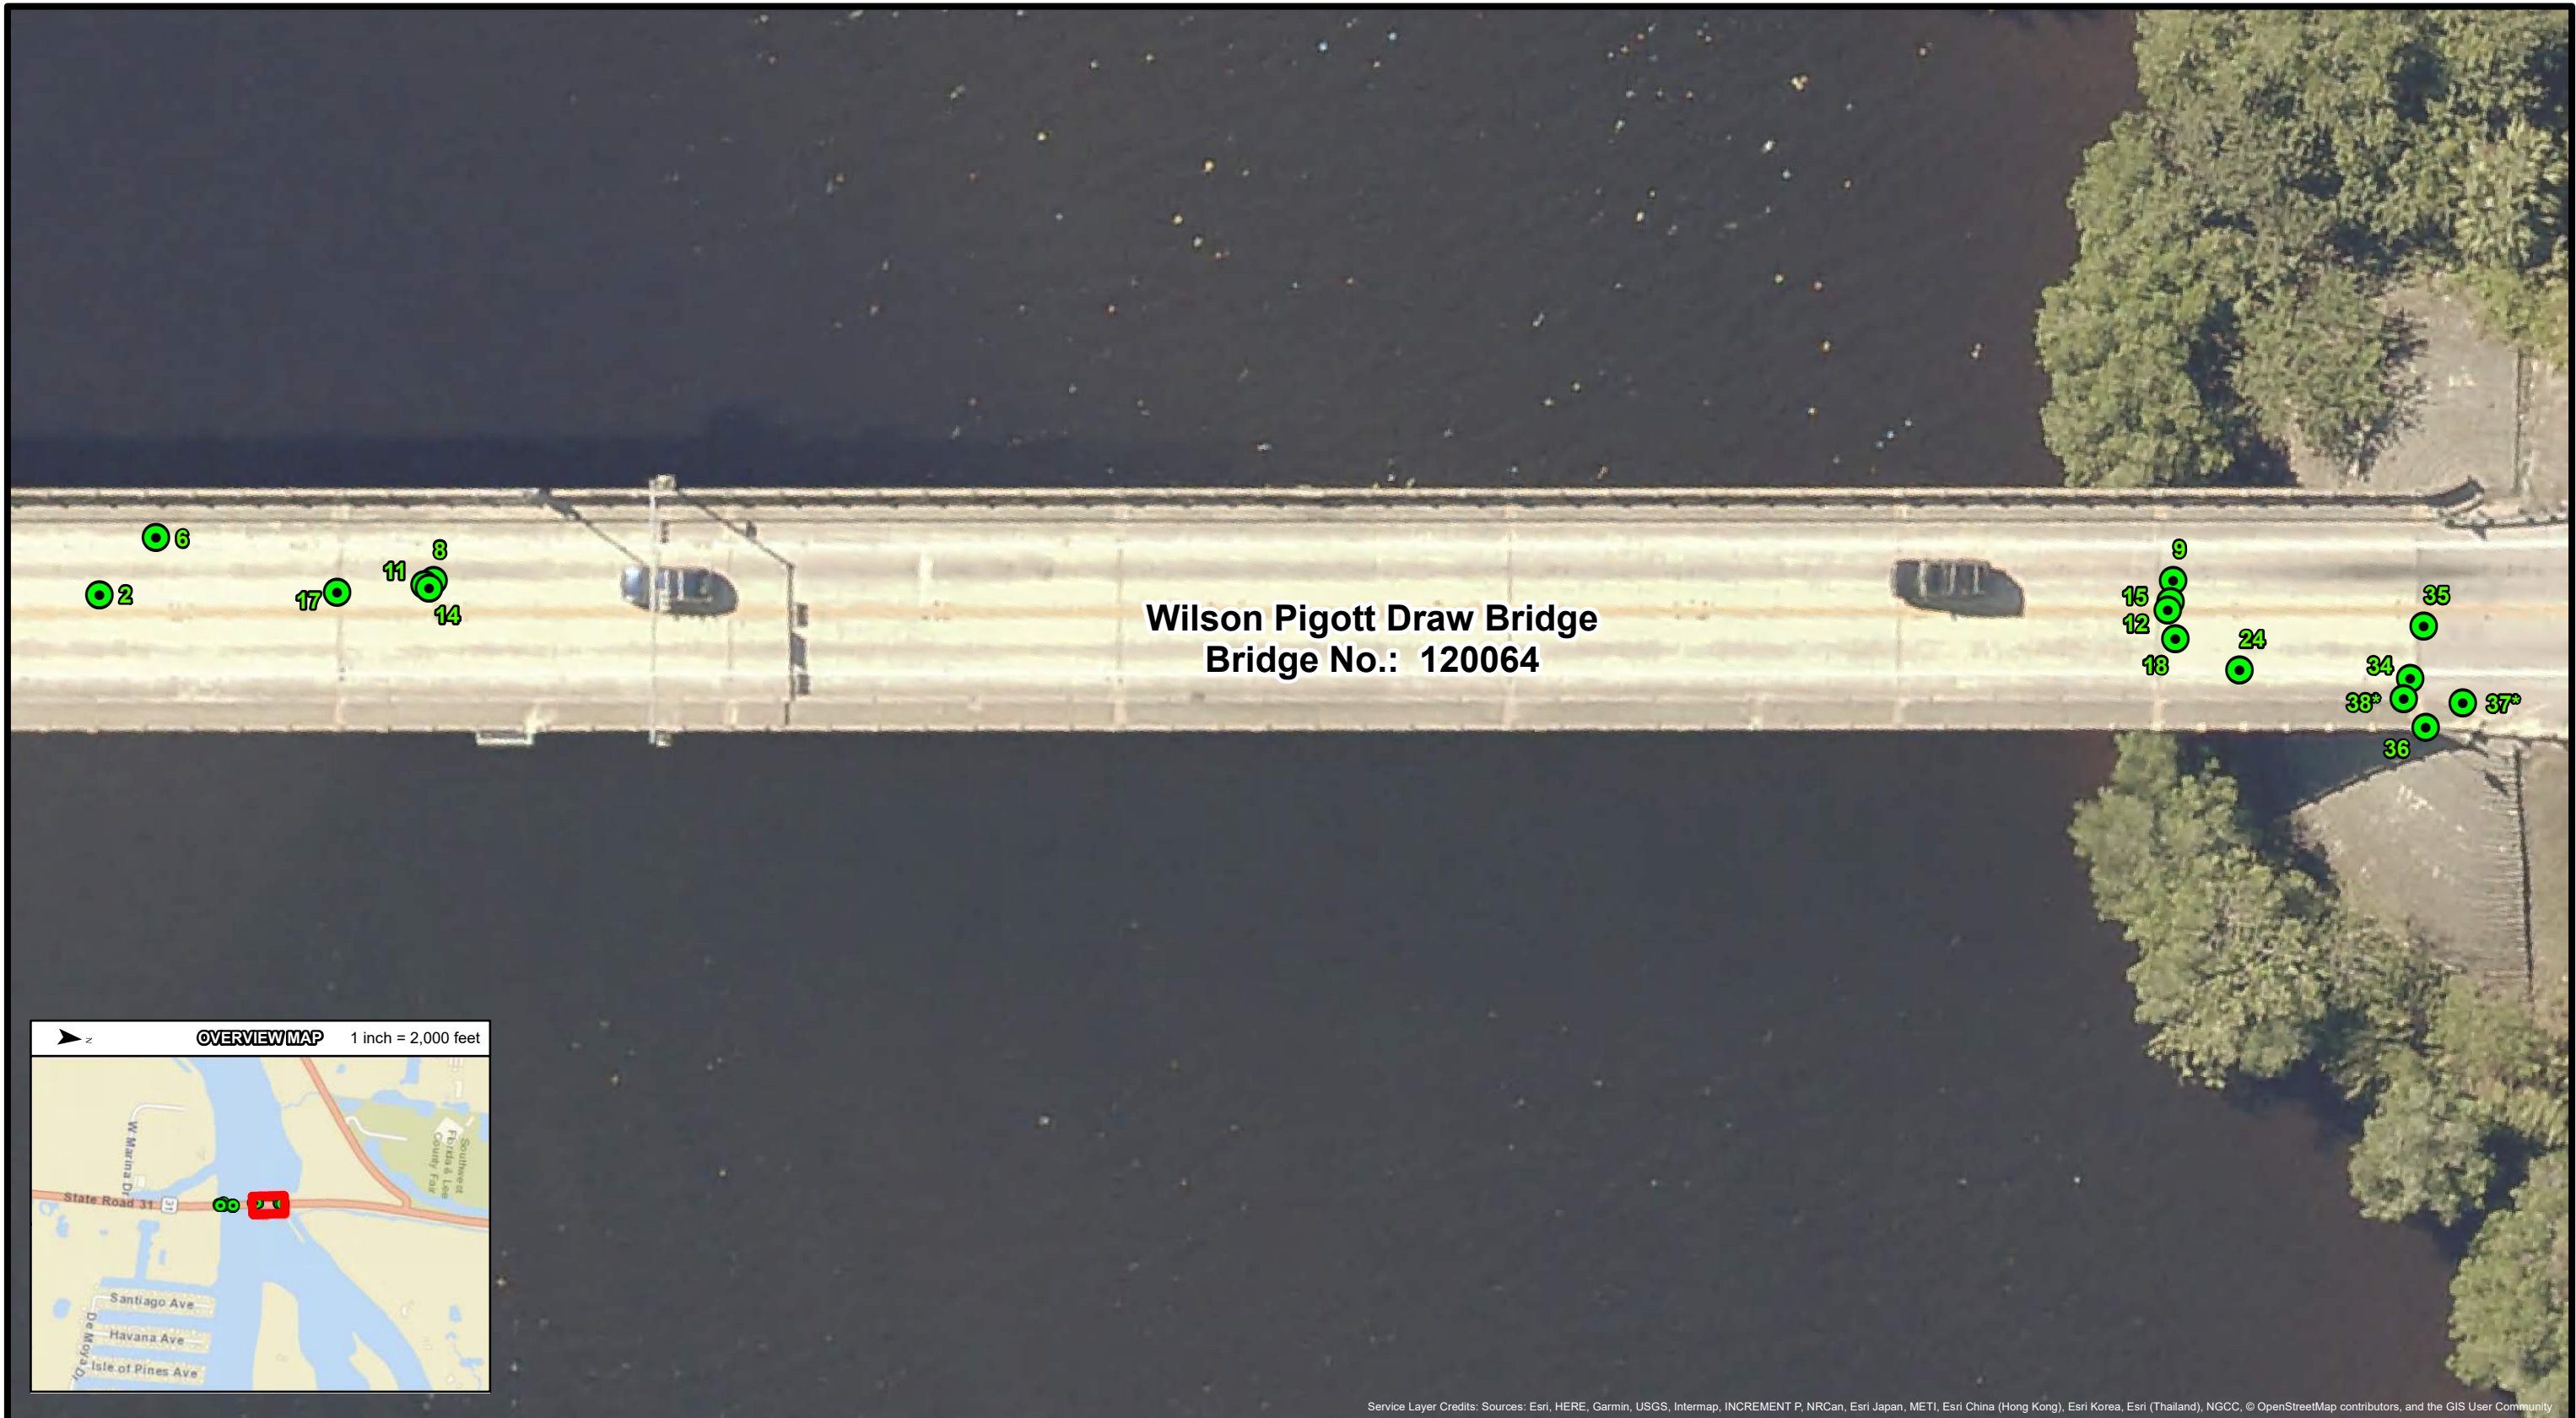
FIGURE 2A
 ASBESTOS SAMPLE LOCATIONS MAP
 WILSON PIGOTT DRAW
 BRIDGE NO.: 120064 REHABILITATION
 LEE COUNTY, FLORIDA
 FDOT FINANCIAL PROJECT NO.: 440055-1-C2-32

Wilson Pigott Draw Bridge
 Bridge No.: 120064

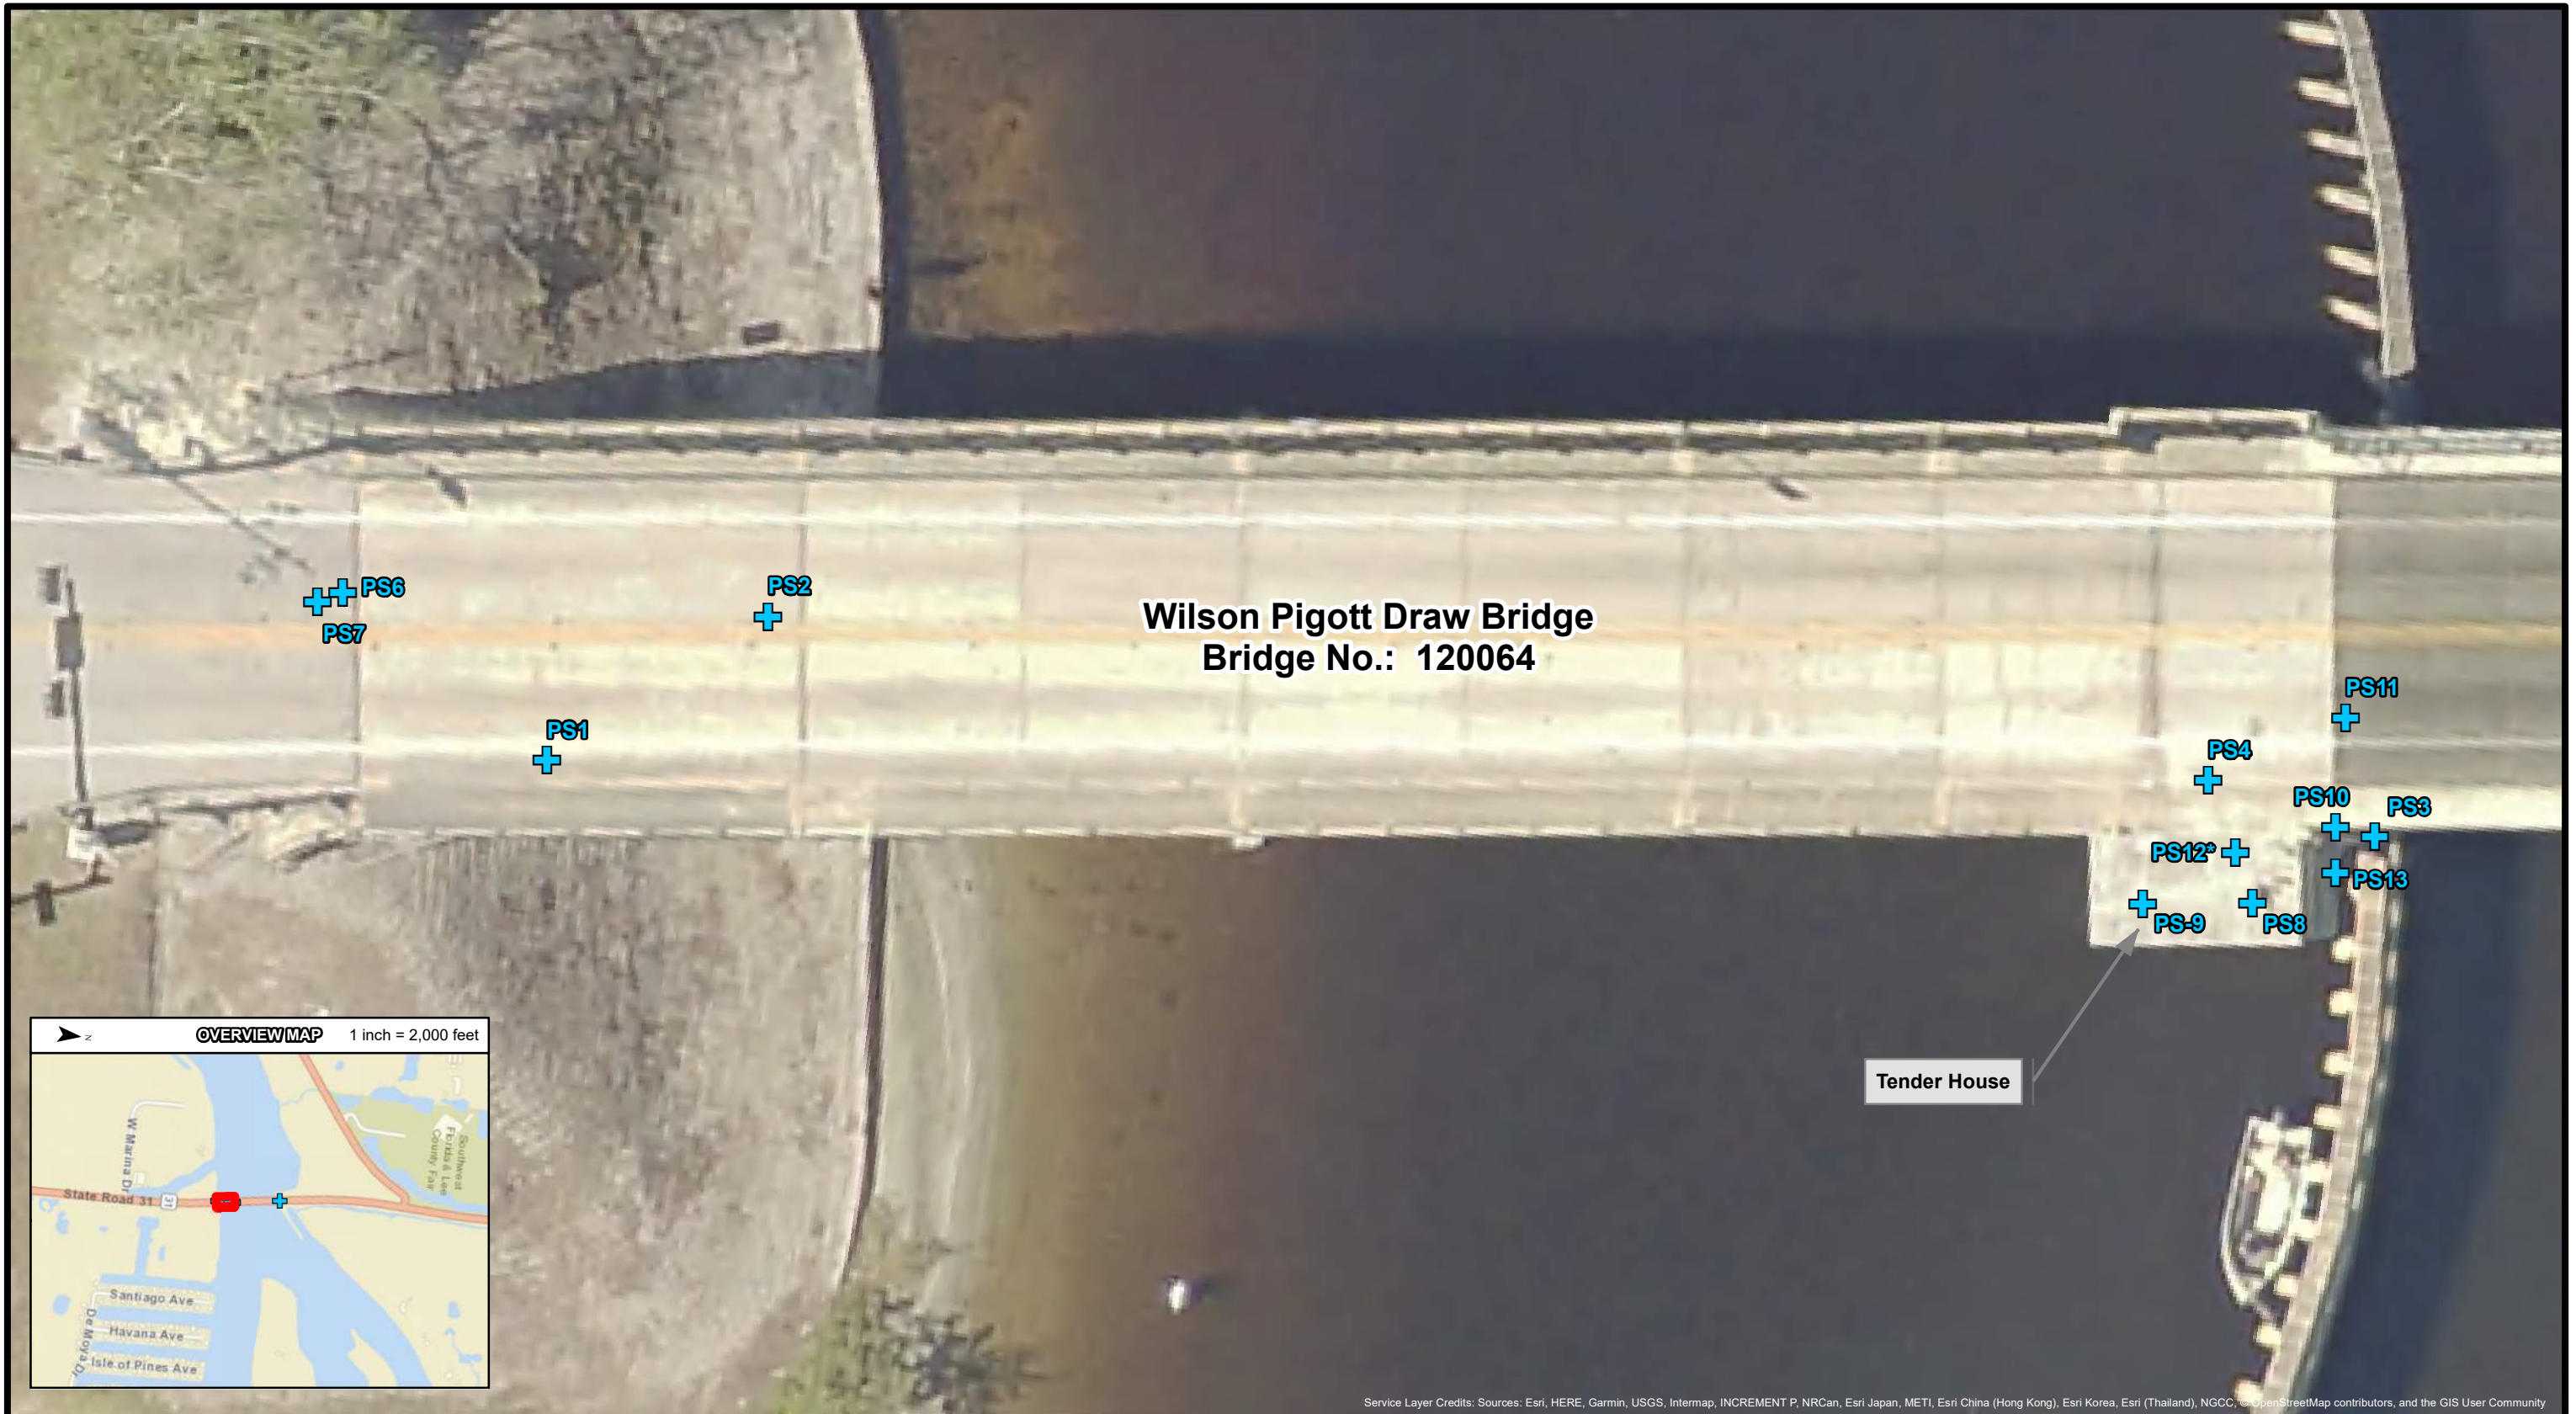
FIGURE 2B
 ASBESTOS SAMPLE LOCATIONS MAP
 WILSON PIGOTT DRAW
 BRIDGE NO.: 120064 REHABILITATION
 LEE COUNTY, FLORIDA
 FDOT FINANCIAL PROJECT NO.: 440055-1-C2-32

Wilson Pigott Draw Bridge
Bridge No.: 120064

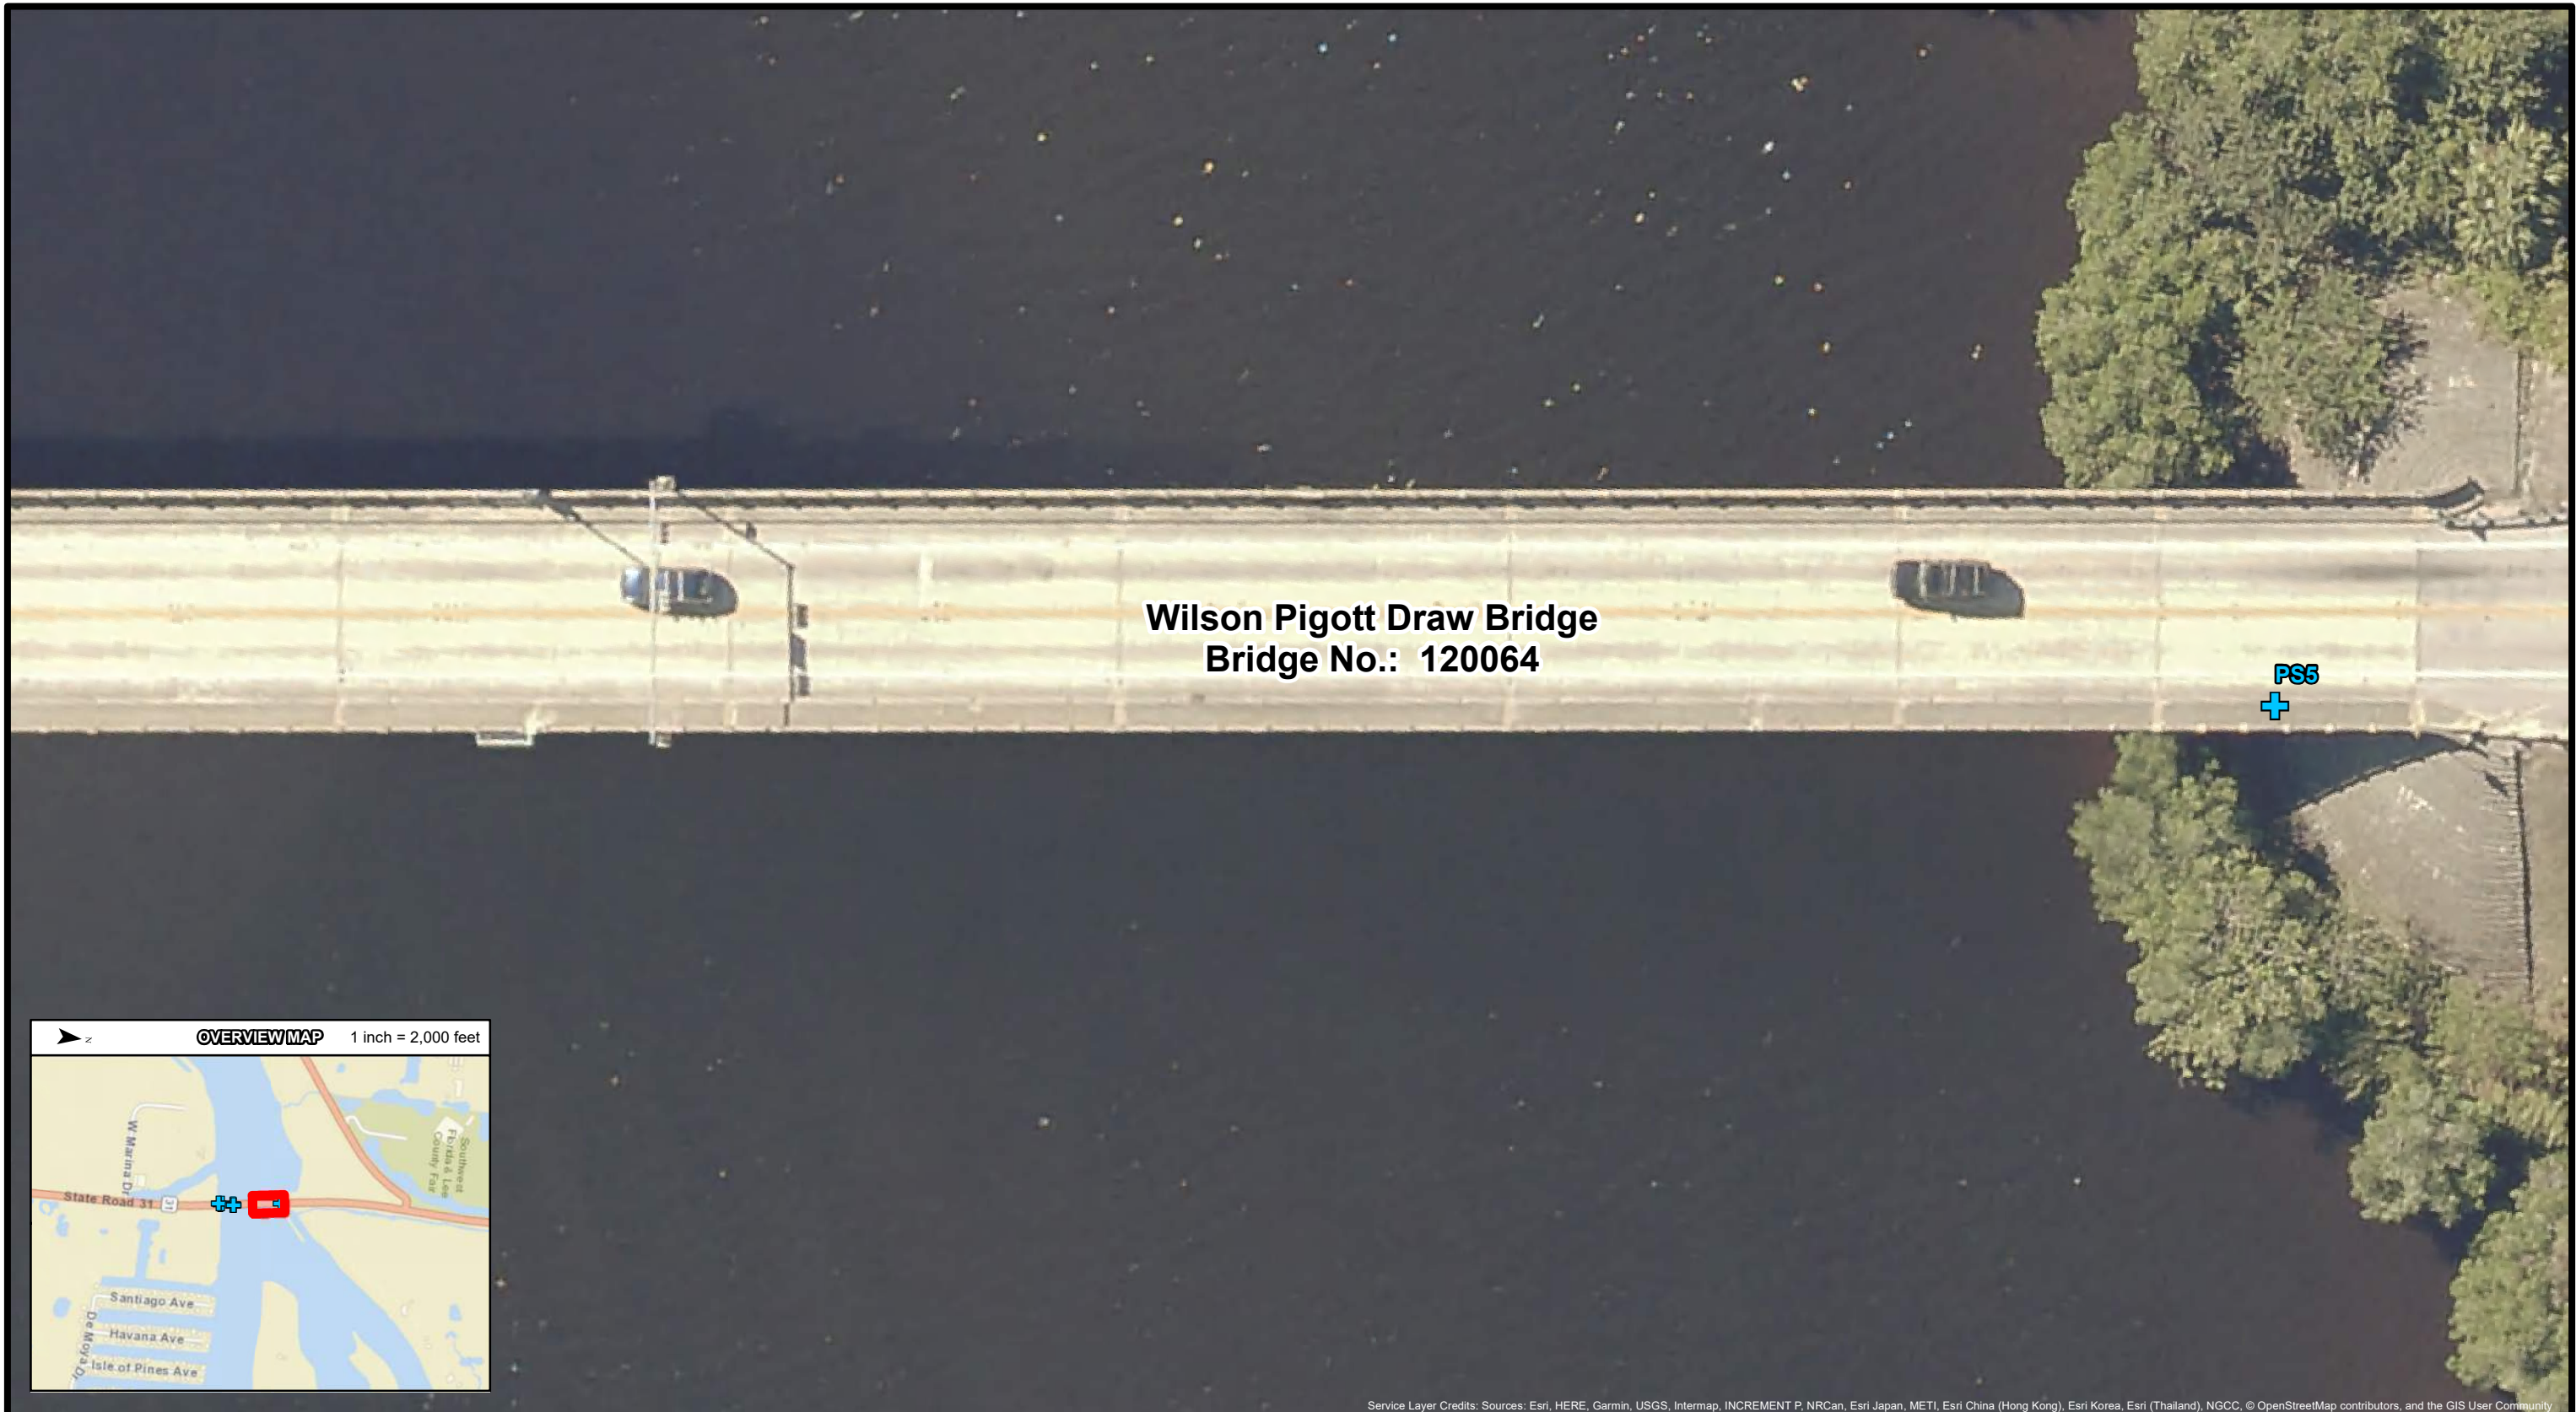
FIGURE 3A
 METALS BASED COATINGS SAMPLE LOCATIONS MAP
 WILSON PIGOTT DRAW
 BRIDGE NO.: 120064 REHABILITATION
 LEE COUNTY, FLORIDA
 FDOT FINANCIAL PROJECT NO.: 440055-1-C2-32

Wilson Pigott Draw Bridge
Bridge No.: 120064
