**ADDENDUM TO THE
CULTURAL RESOURCE ASSESSMENT SURVEY
PROJECT DEVELOPMENT AND ENVIRONMENT (PD&E) STUDY**

**SR 865 (SAN CARLOS BOULEVARD) FROM NORTH OF
CRESCENT STREET TO NORTH OF HURRICANE BAY BRIDGE
LEE COUNTY, FLORIDA**

FPID No. 433726-1-22-01

October 2020

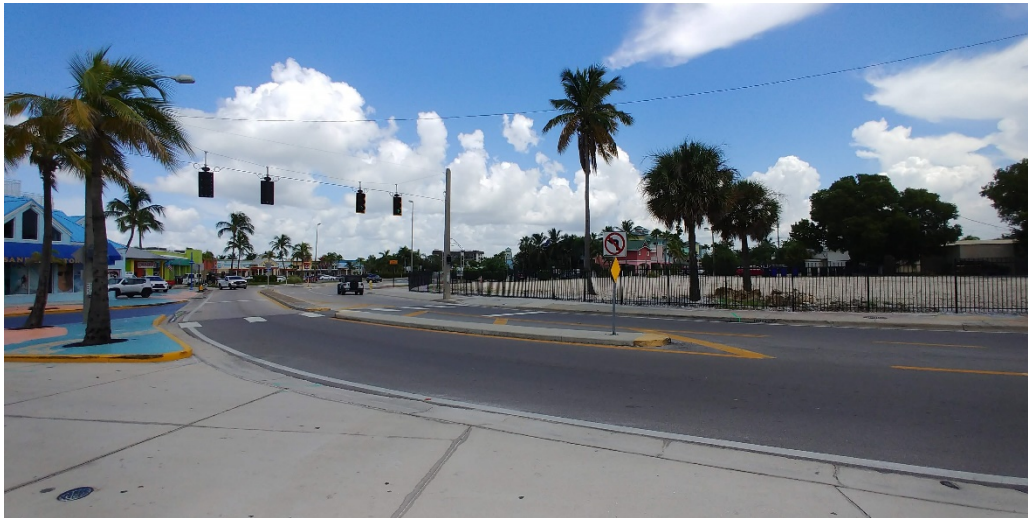
Photo 1. Sample of the urban environment within the APE demonstrating the limited number of shovel tests.

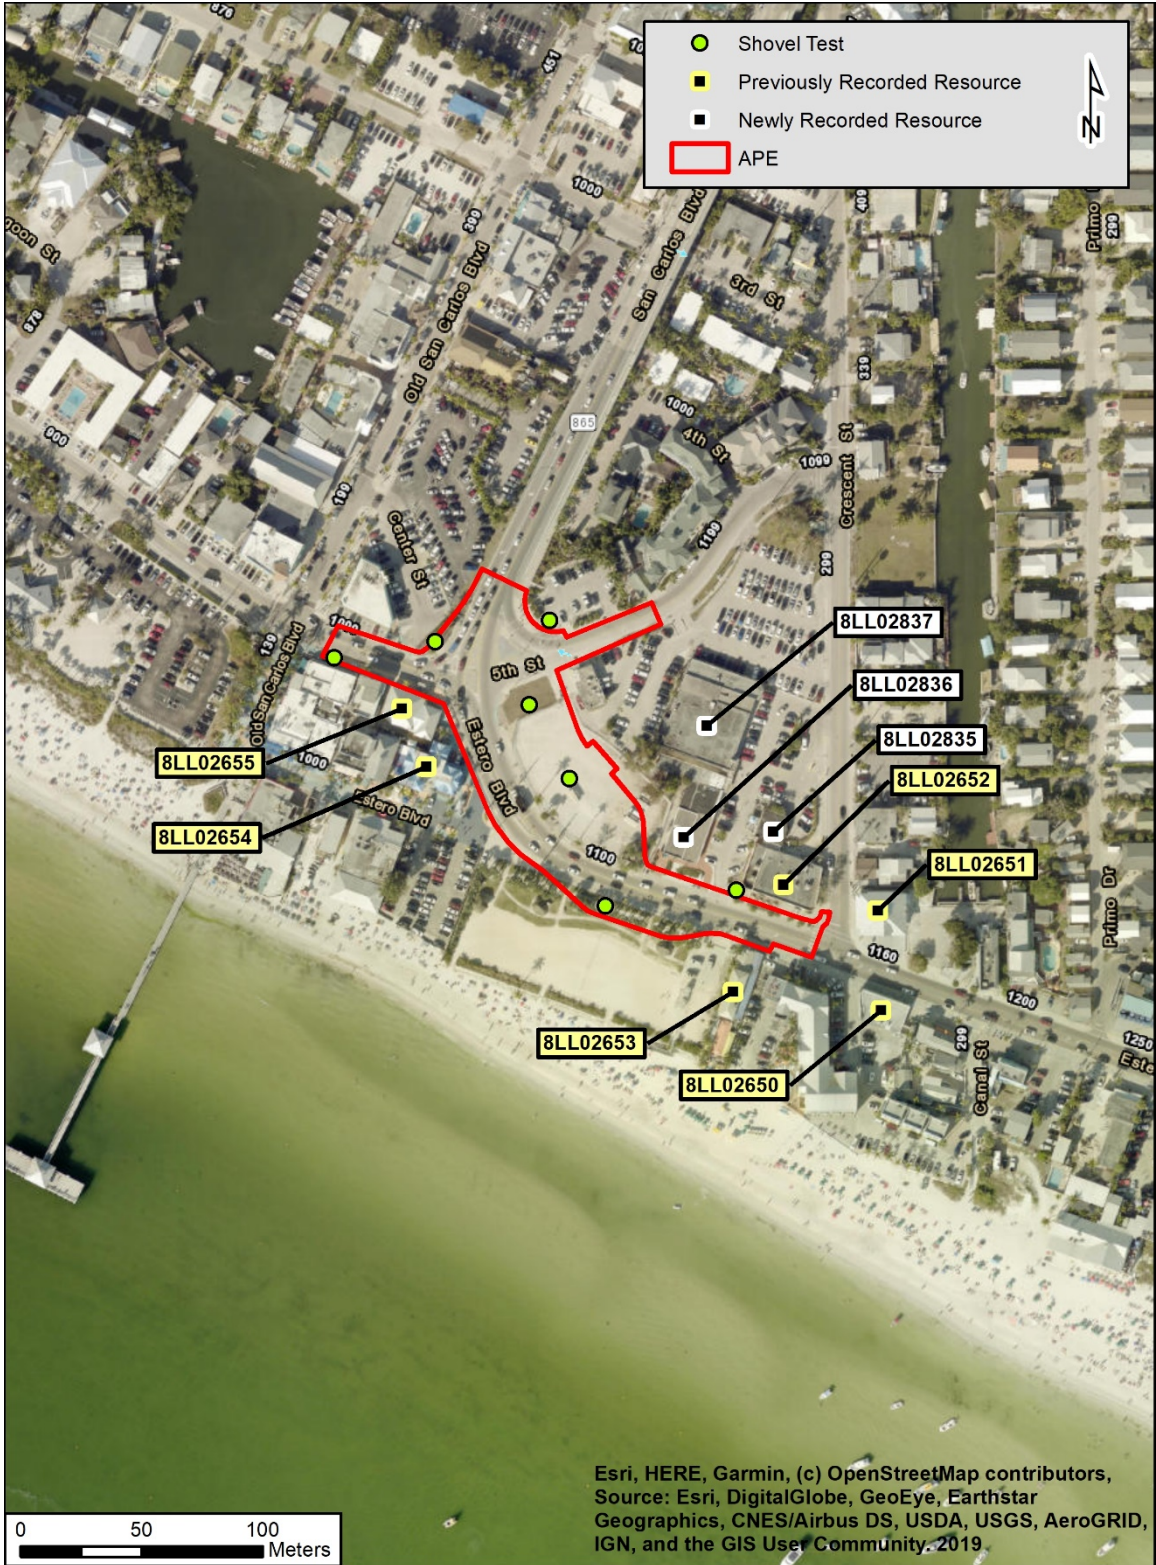
Figure 2. Location of shovel tests and historic resources within the APE.

Archaeological field survey included surface reconnaissance and the excavation of seven shovel tests (**Figure 2**). These were placed judgmentally throughout the APE and although planned to be excavated to 100 cm, most were terminated at shallow depths due to dense fill and utilities. In addition, shovel tests were limited due to impervious surfaces (**Photo 1**). The general stratigraphy of the shovel tests consisted of 0-40 cm of grey/brown gravelly sand; 40-60 cm of mottled tan, gravelly sand with shell; and 60-100 cm of light, grey/brown shell, shell hash and gravel. A reasonable and good faith effort was made per the regulations laid out in 36 CFR § 800.4(b) (1) (Advisory Council on Historic Preservation n.d.) to test all areas of the project APE.

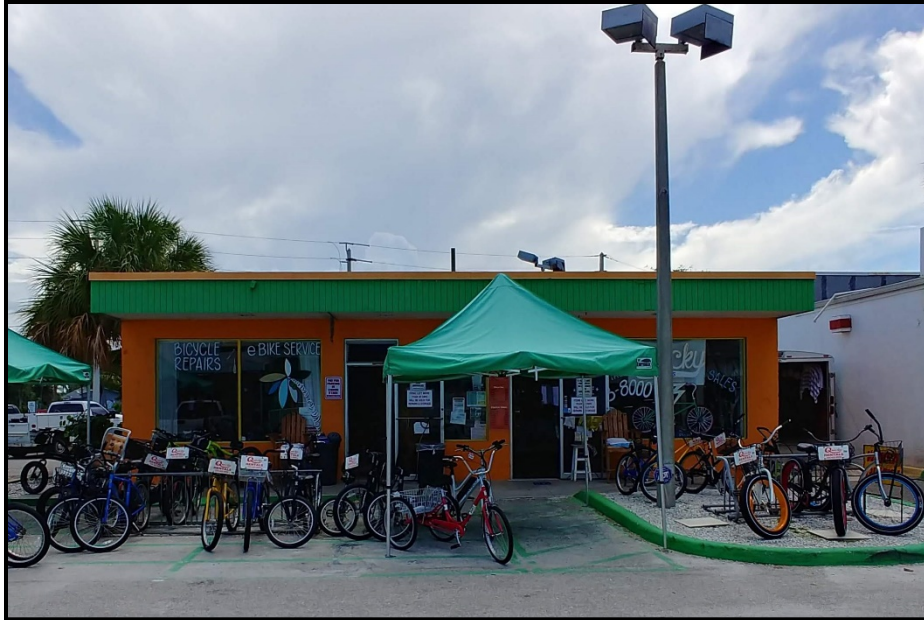
Photo 2. 1149 Estero Boulevard (8LL02835), looking southeast.

8LL02835: The Commercial style building at 1149 Estero Boulevard was constructed in c. 1972 (**Photo 2**). The one-story, irregular plan building rests on a concrete slab foundation and has a concrete block structural system clad in stucco. The flat roof is covered with built-up roofing membrane. The main entryway is on the west elevation through two separate, single, metal frame full view doors with transom lights beneath a flat metal awning. Visible windows include a mixture of individual, single pane and two-light metal fixed units and individual two-stacked metal awning units. Distinguishing architectural features include a metal awning with metal coping and vents. Alterations include replacement roofing and siding, as well as the enclosure of a window on the north elevation and the removal of canvas awnings. Three other Commercial style buildings constructed between c. 1947 and c. 1949 are located on the parcel (8LL02652, 8LL02836, and 8LL02837). Overall, the building has been altered, lacks sufficient architectural features, and is not a significant embodiment of a type, period, or method of construction. In addition, background research did not reveal any historic associations with significant persons and/or events. As a result, 8LL02835 does not appear eligible for listing in the NRHP, either individually or as part of a historic district.

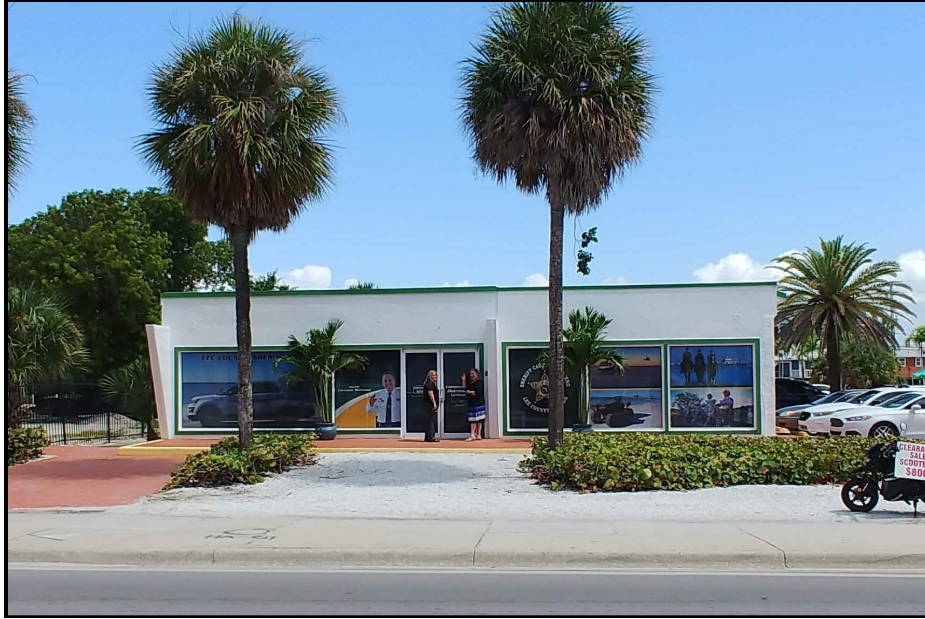
Photo 3. 1133 Estero Boulevard (Bldg 1) (8LL02836), looking northeast.

8LL02836: The Commercial style building at 1133 Estero Boulevard was constructed in c. 1947 (**Photos 3 and 4**). The one-story, irregular plan building rests on a continuous concrete block foundation and has a concrete block structural system clad in stucco. The flat roof is covered with built-up roofing membrane. The main entryways are on the south and east elevation through single or double metal frame full view doors per unit. Three retail units are present, including one on the south elevation and two on the east elevation. Visible windows include a mixture of individual, paired, and grouped (3), single pane metal fixed units. Distinguishing architectural features include a parapet with metal coping, tapered triangular wing walls, stucco trim around the windows and doors, a scalloped parapet with affixed signage, and advertising window film. Alterations include replacement roofing, windows, and siding. A flat roof addition was constructed

on the north elevation. Three other Commercial style buildings constructed between c. 1947 and c. 1972 are located on the parcel (8LL02652, 8LL02835, and 8LL02837). Overall, the building has been altered, lacks sufficient architectural features, and is not a significant embodiment of a type, period, or method of construction. In addition, background research did not reveal any historic associations with significant persons and/or events. As a result, 8LL02836 does not appear eligible for listing in the NRHP, either individually or as part of a historic district.

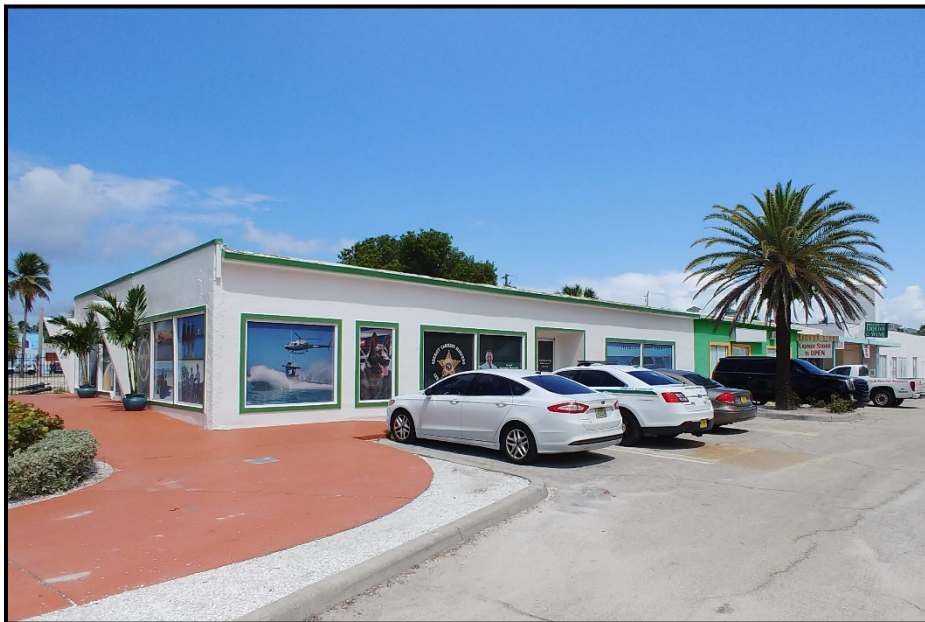
Photo 4. 1133 Estero Boulevard (Bldg 1) (8LL02836), looking north.

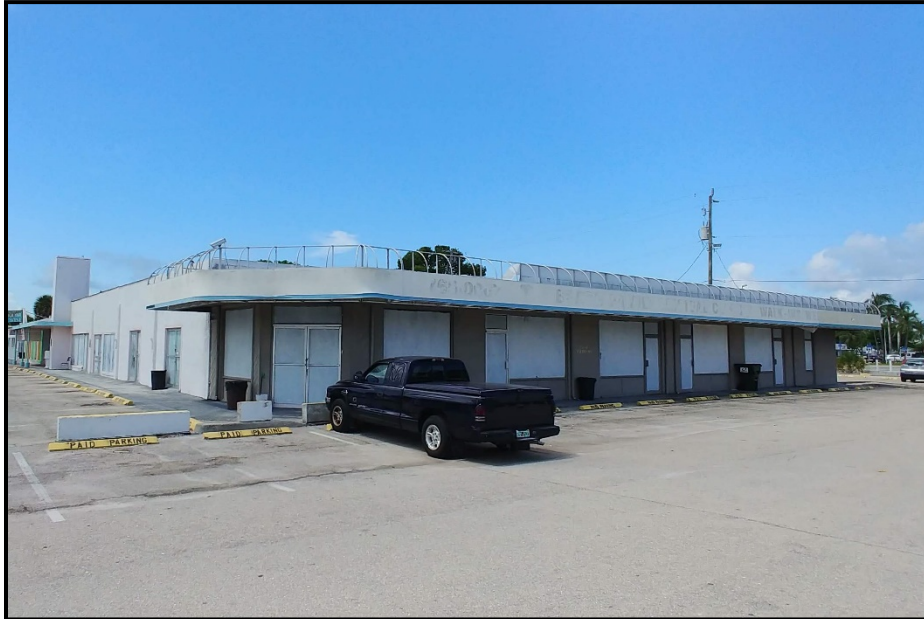
Photo 5. 1133 Estero Boulevard (Bldg 2) (8LL02837), looking southwest.

8LL02837: The Commercial style building at 1133 Estero Boulevard was constructed in c. 1948 (**Photo 5**). The one-story, irregular plan building rests on a concrete slab foundation and has a concrete block structural system clad in stucco. The flat roof is covered with built-up roofing membrane. The main entryways are on the north elevation through single or double metal frame full view doors with transom lights per unit beneath a metal awning frame. Visible windows include a mixture of individual and paired, single pane metal fixed units and individual one-over-one metal single-hung sash units. Distinguishing architectural features include a parapet with metal coping, curved awning metal frame parapet, rectangular wall projection, stucco pilasters, and stucco trim around the windows and doors. Alterations include replacement roofing, siding, and windows, as well as the installation of awnings and painting of the windows and doors. Furthermore, the building is in fair condition where all the windows and doors have been boarded up and the canvas from the curved awning parapet has been removed. Multiple flat roof additions have been constructed on the north elevation. Three other Commercial style buildings constructed between c. 1947 and c. 1972 are located on the parcel (8LL02652, 8LL02835, and 8LL02836). Overall, the building has been altered, lacks sufficient architectural features, and is not a significant embodiment of a type, period, or method of construction. In addition, background research did not reveal any historic associations with significant persons and/or events. As a result, 8LL02837 does not appear eligible for listing in the NRHP, either individually or as part of a historic district.

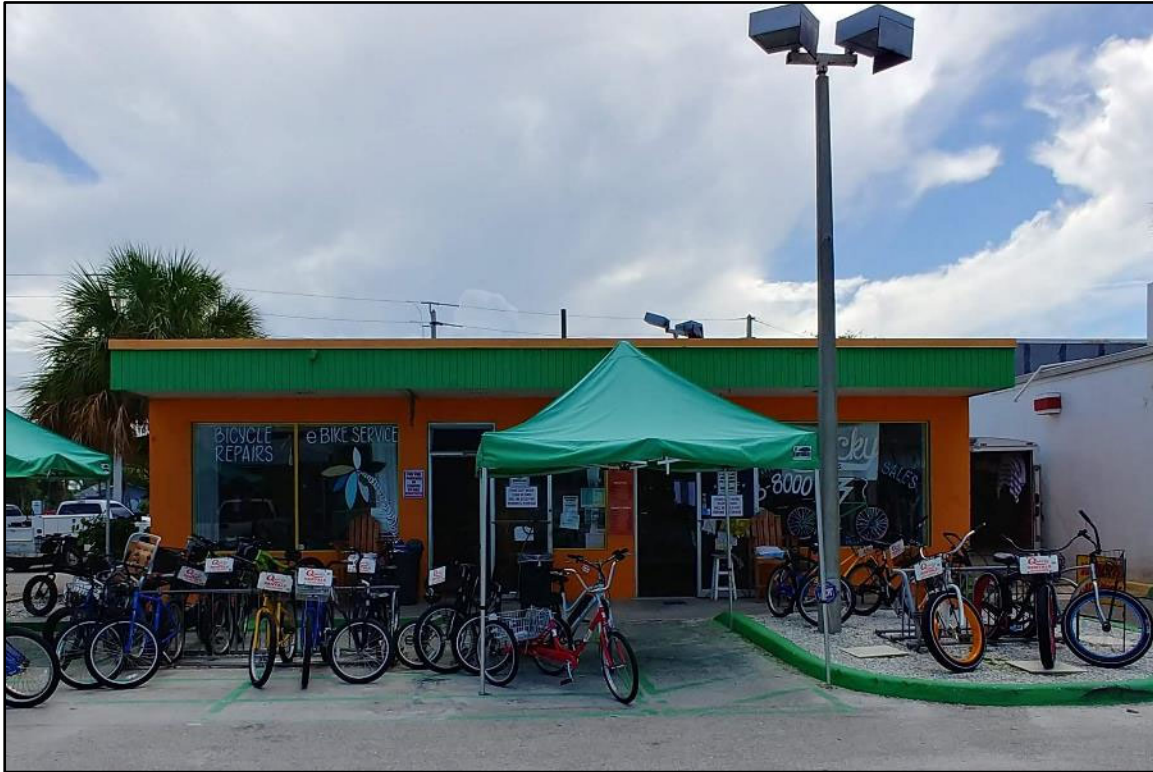
PHOTOGRAPHS

A one-story Commercial style building w/ an enclosed window on the N ELEV.
