CULTURAL RESOURCE ASSESSMENT SURVEY TECHNICAL MEMORANDUM
STORMWATER MANGEMENT FACILITY (SMF) SITES AND
FLOODPLAIN COPENSAATION (FPC) SITES

SR 35 (US 98) PD&E Study

Limits of Project: From North of West Socrum Loop Road to South of CR 54

Date: November 2021

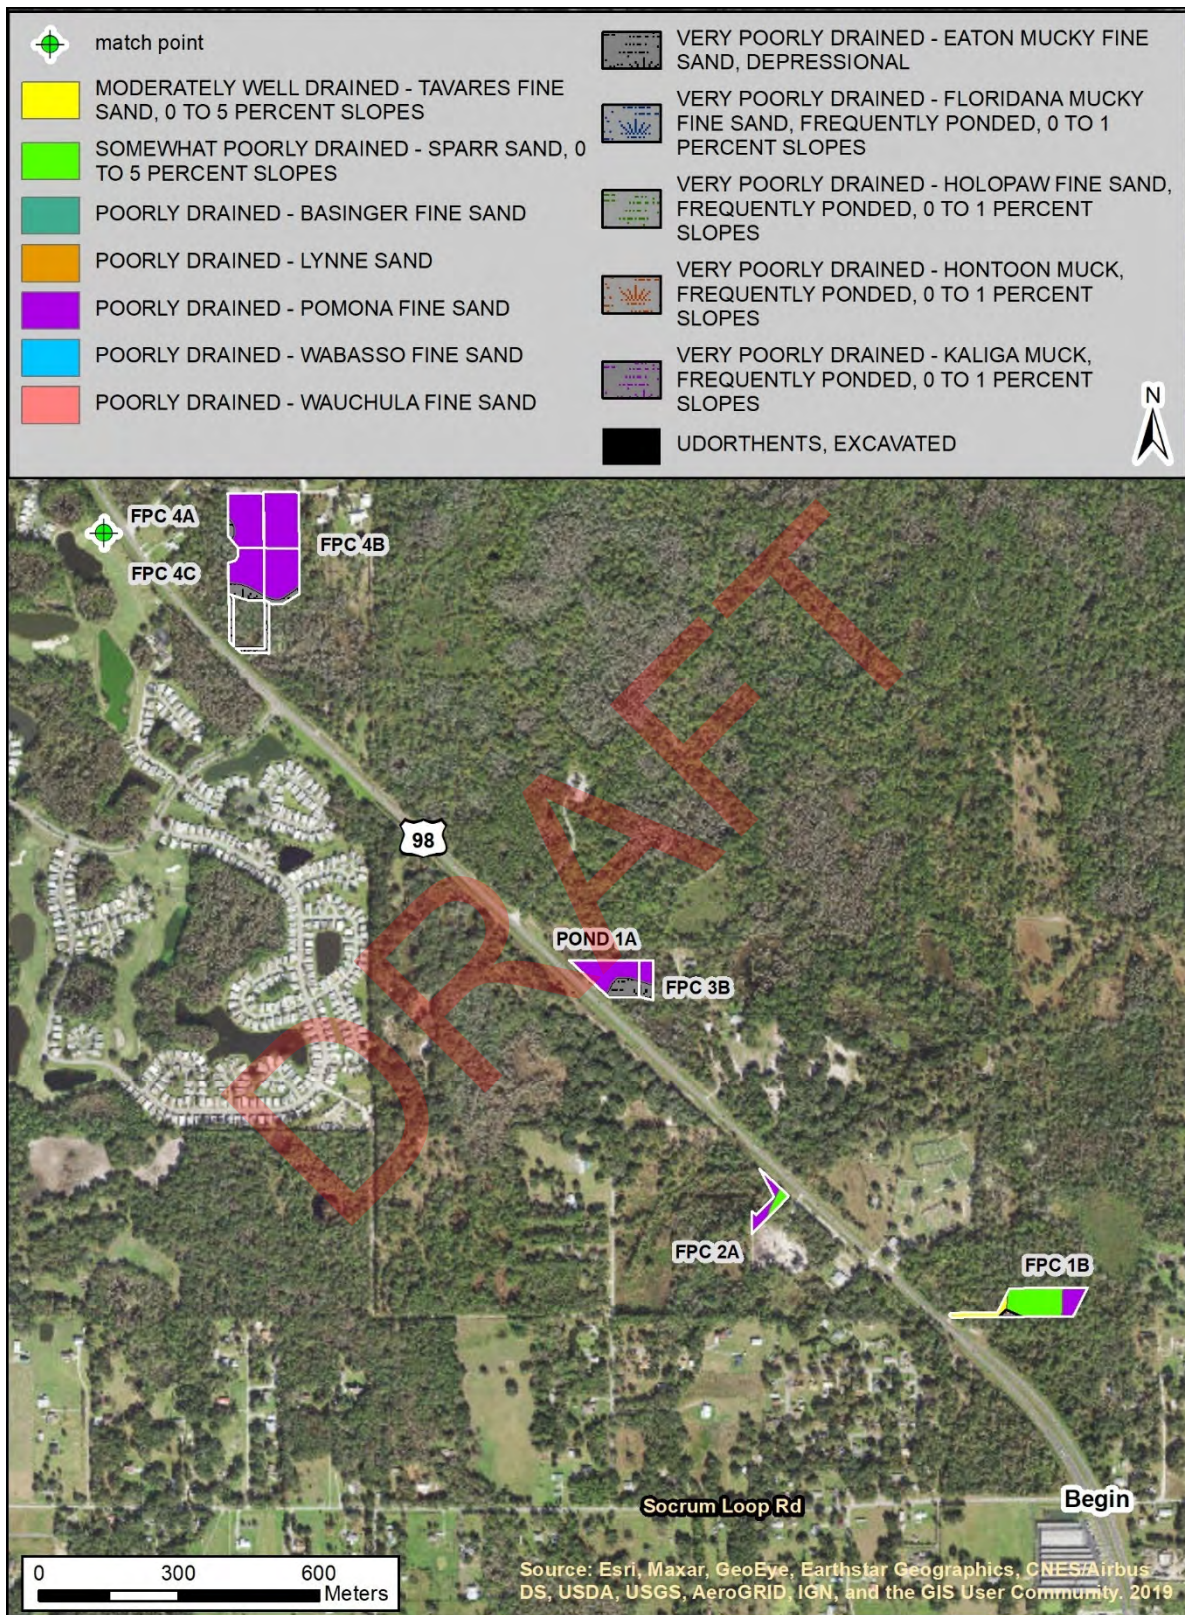
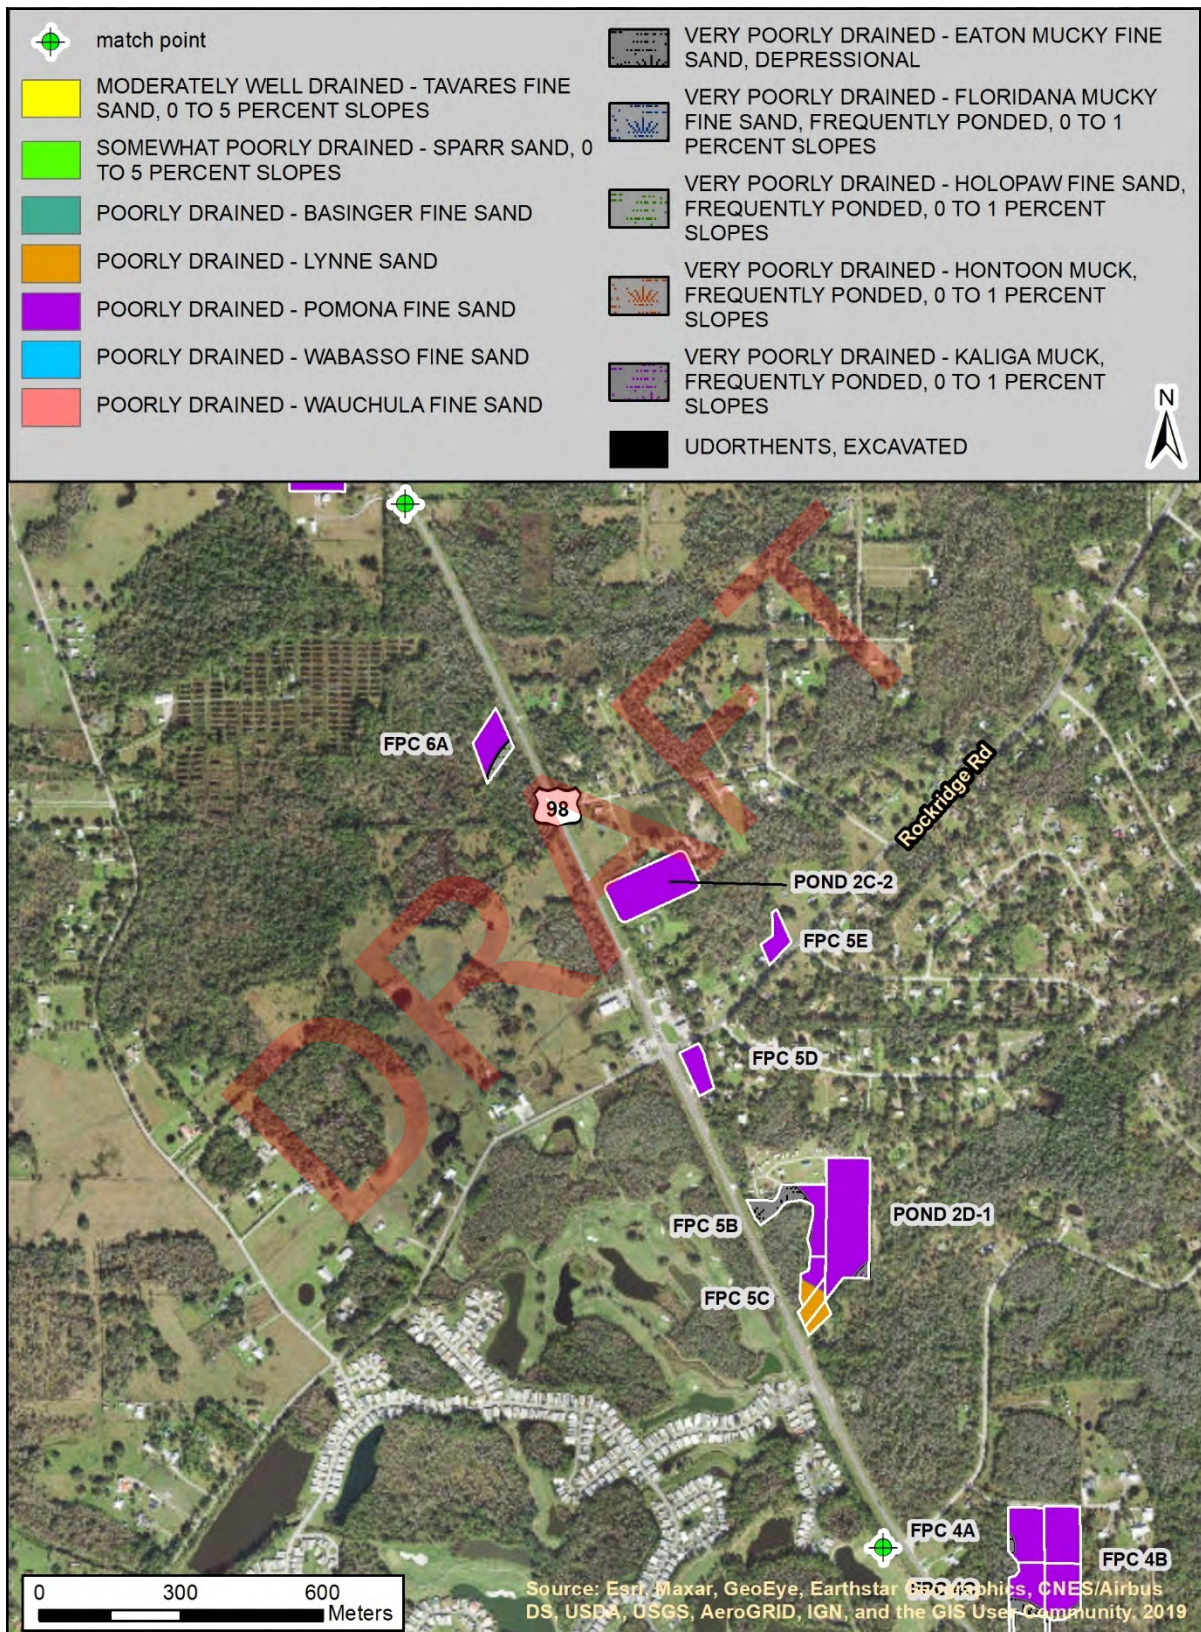
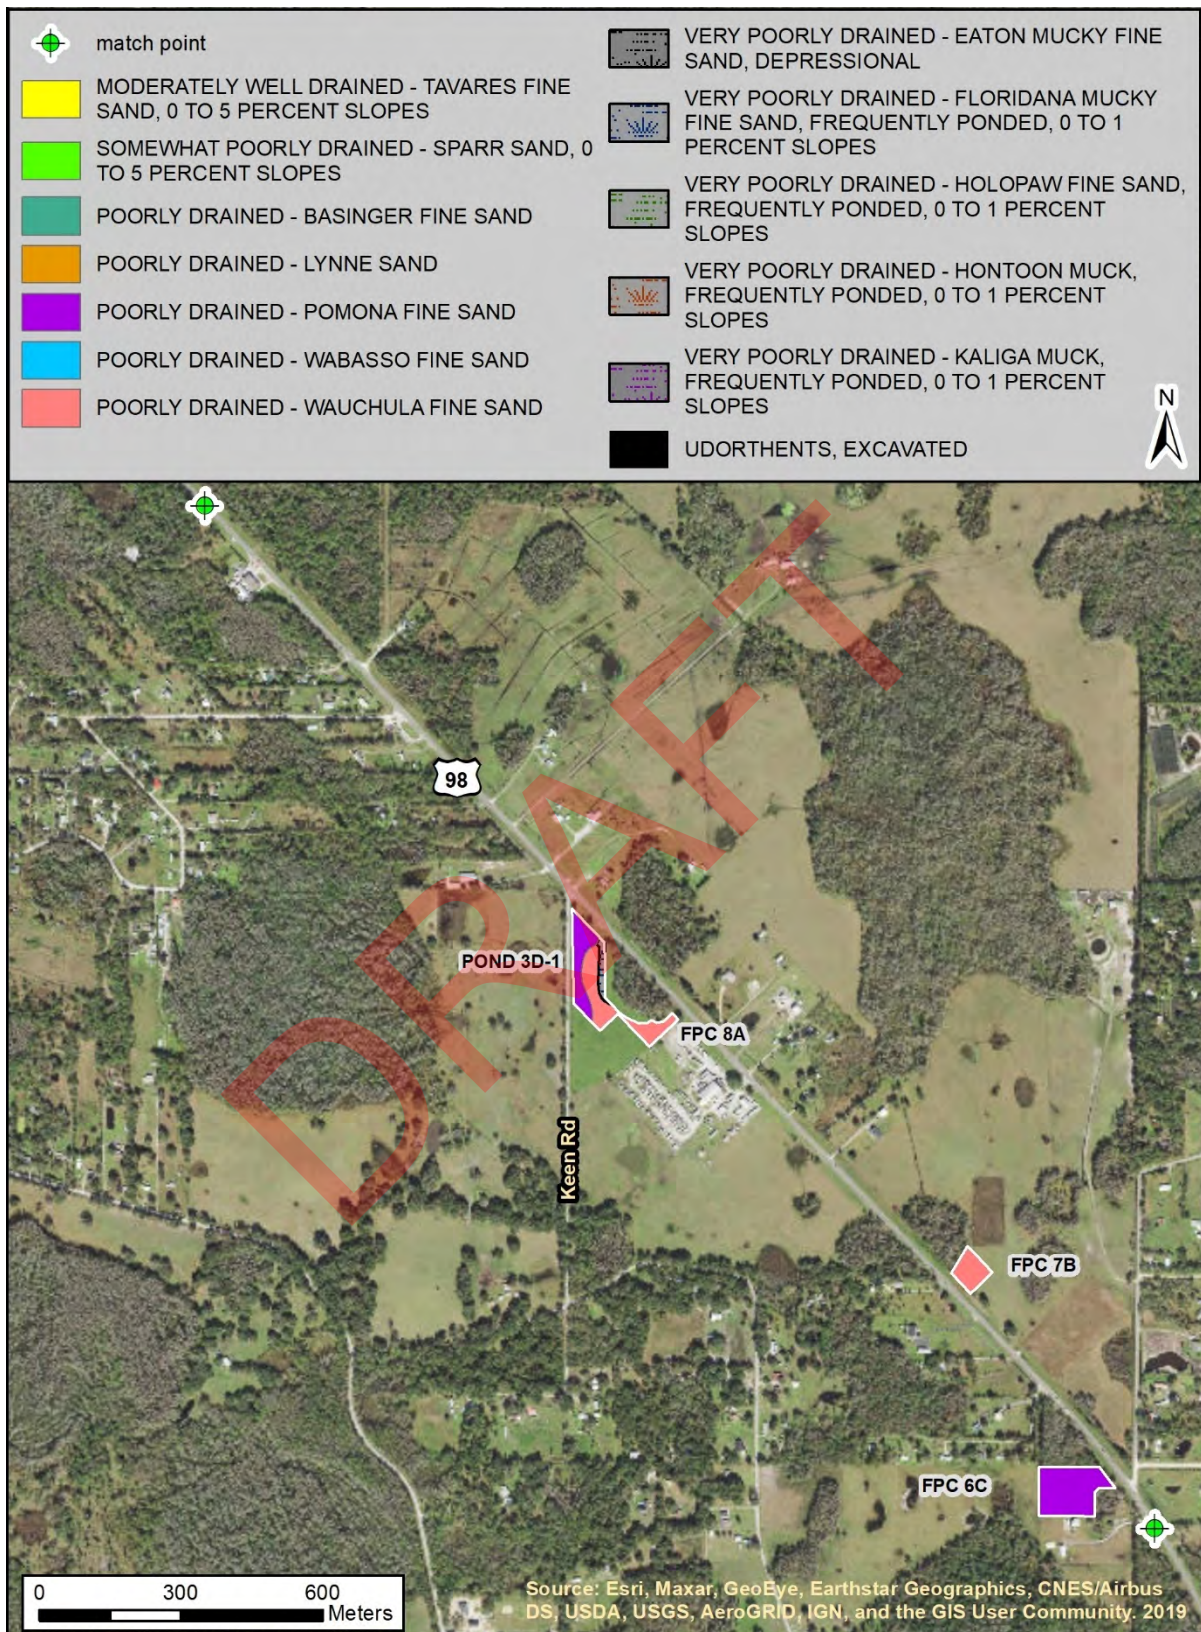
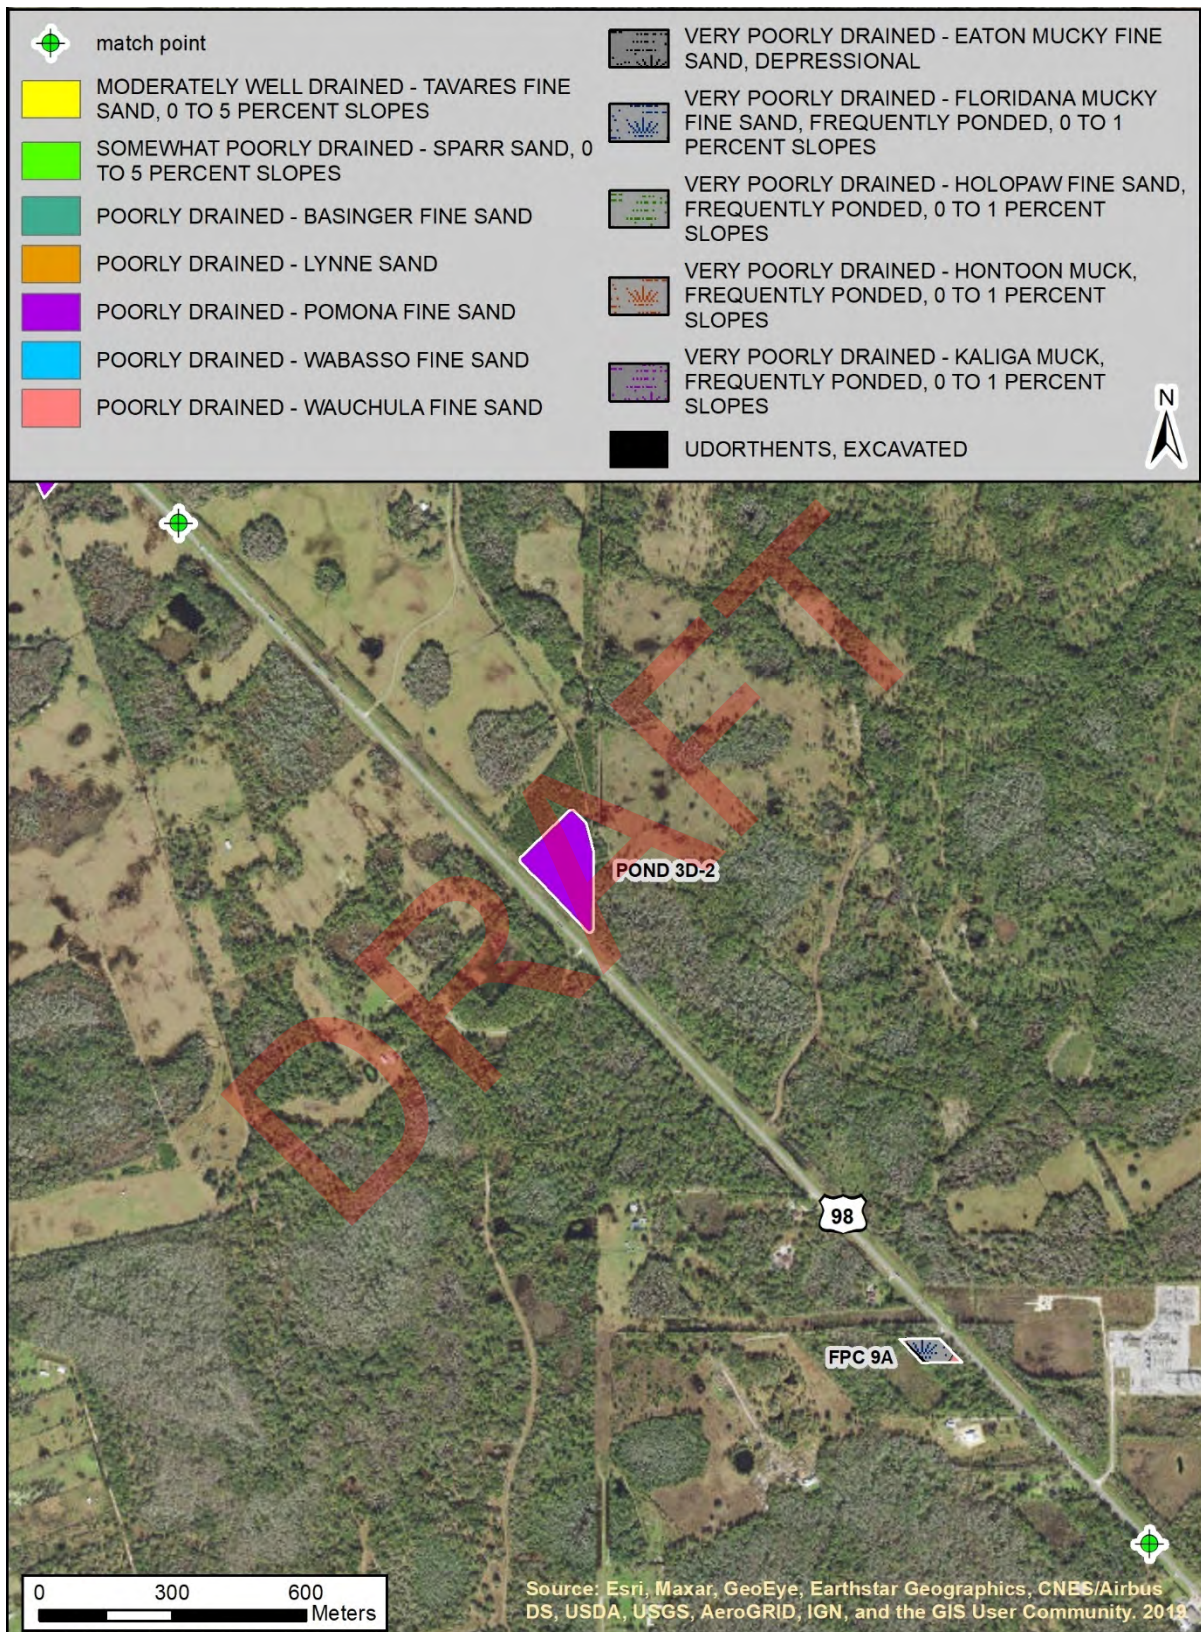
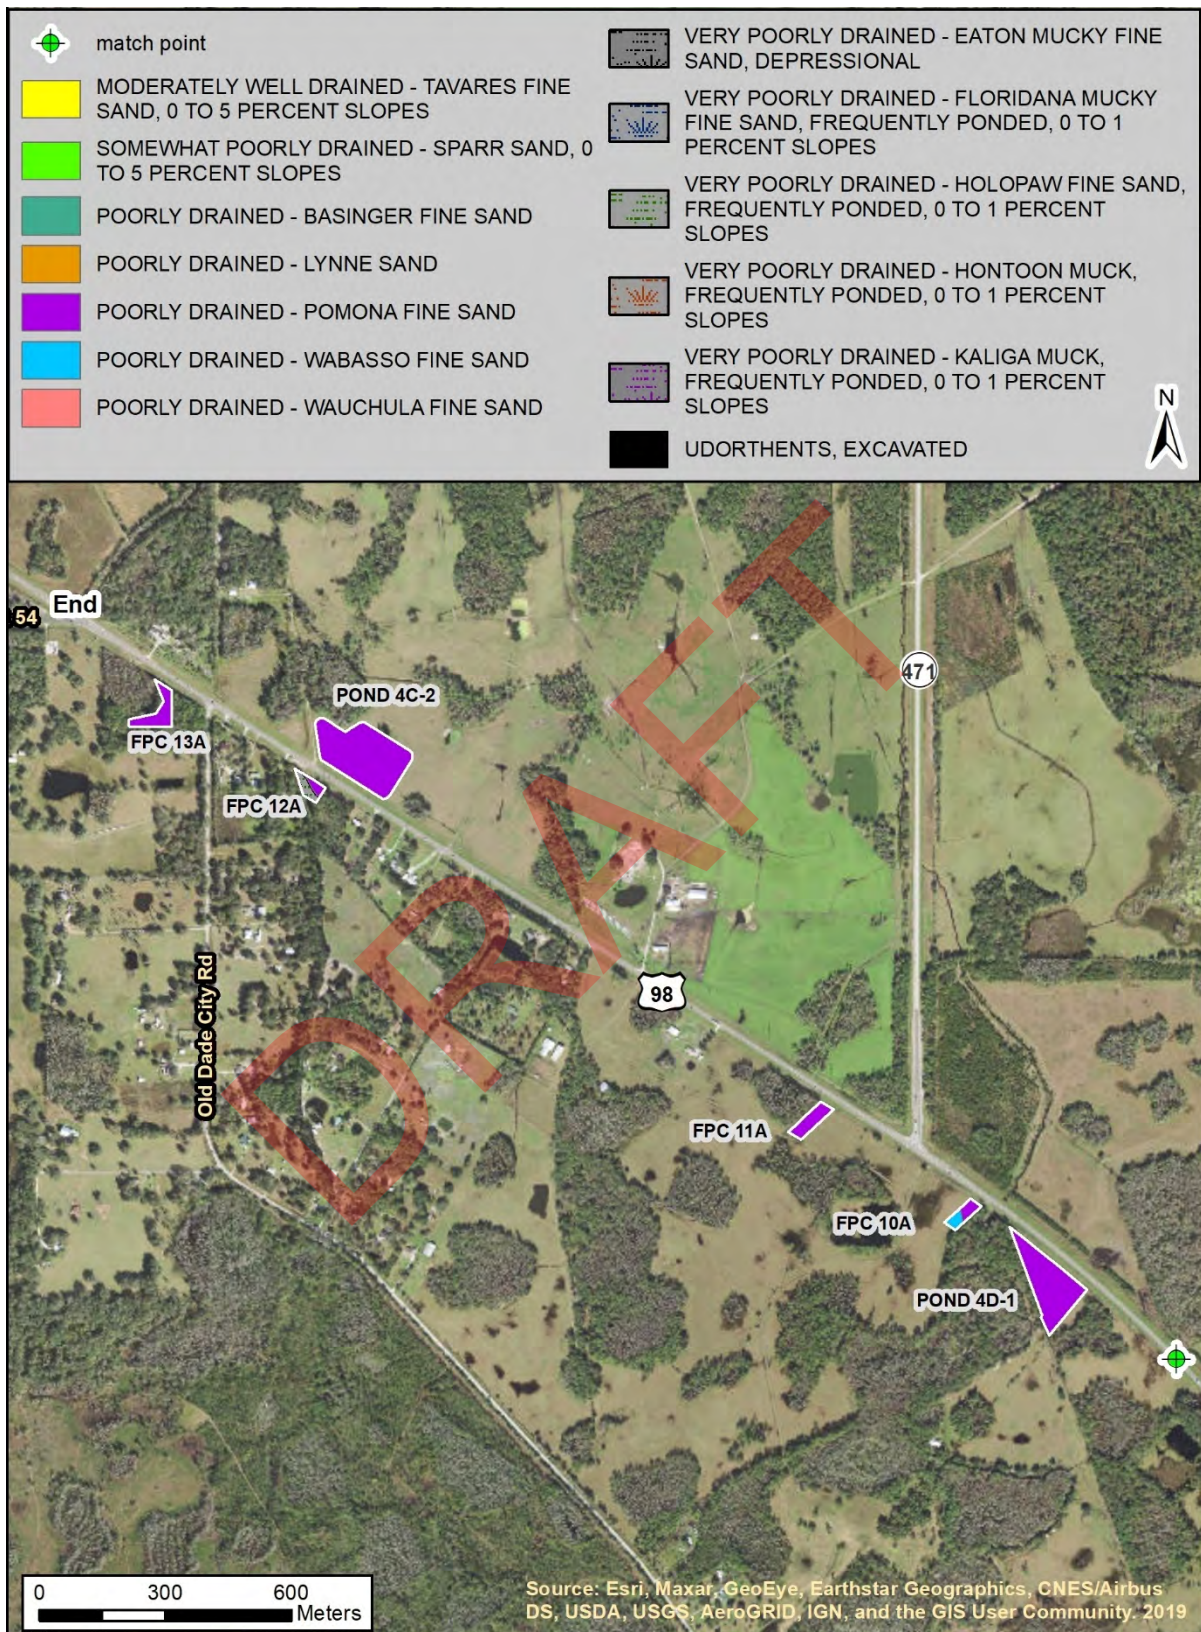
Figure 2. Soil types within the APE.

Figure 3. Soil types within the APE.

Figure 4. Soil types within the APE.

Figure 5. Soil types within the APE.

Figure 6. Soil types within the APE.

The APE is located within one soil association: the Pomona-Myakka-Smyrna soil association. **Figures 2 - 6** show the specific soils within the archaeological APE. Vegetation associated with the soils within the APE includes South Florida slash pine, longleaf pine, saw palmetto, running oak, water oak, gallberry, waxmyrtle, pineland threeawn, and scattered fetterbush. Bay, cypress, maple, gum, sawgrass and other aquatic plants make up the wetter areas (United States Department of Agriculture [USDA] 1990).

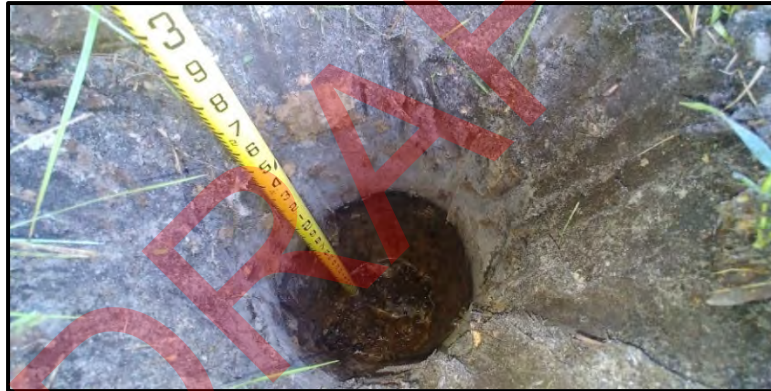
Photo 7. Average soil profile found throughout pasture areas.

Shovel tests stratigraphy was variable throughout the APE. Below is a representation of the types of soil stratigraphy encountered with sample photographs (**Photos 7 - 9**).

- 0 to 40 cm below surface of dark gray/brown sand; 40-60 of light gray sand; 60 to 100 cm of dark orange/brown, mottled sand
- 0-70 cm of light to medium brown sand followed by 70-100 cm of brown sand
- 0-40 cm of gray/brown sand; 40-80 cm of light gray sand; and 80-100 cm of wet, brown sand

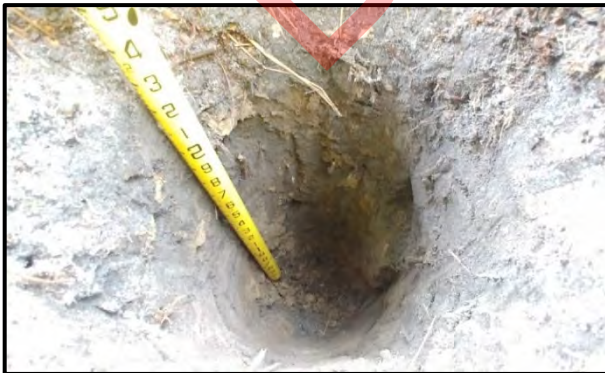
Photo 8. Typical soil stratigraphy found in the oak hammock environment.

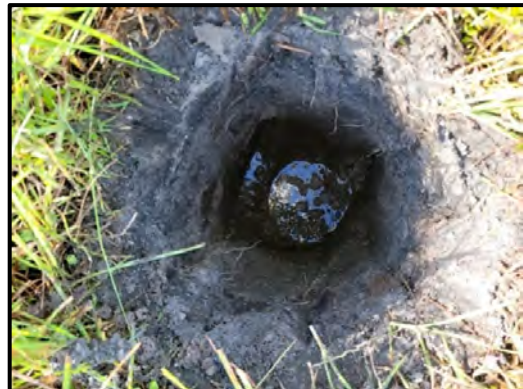
Photo 9. One of many shovel tests where water was encountered.

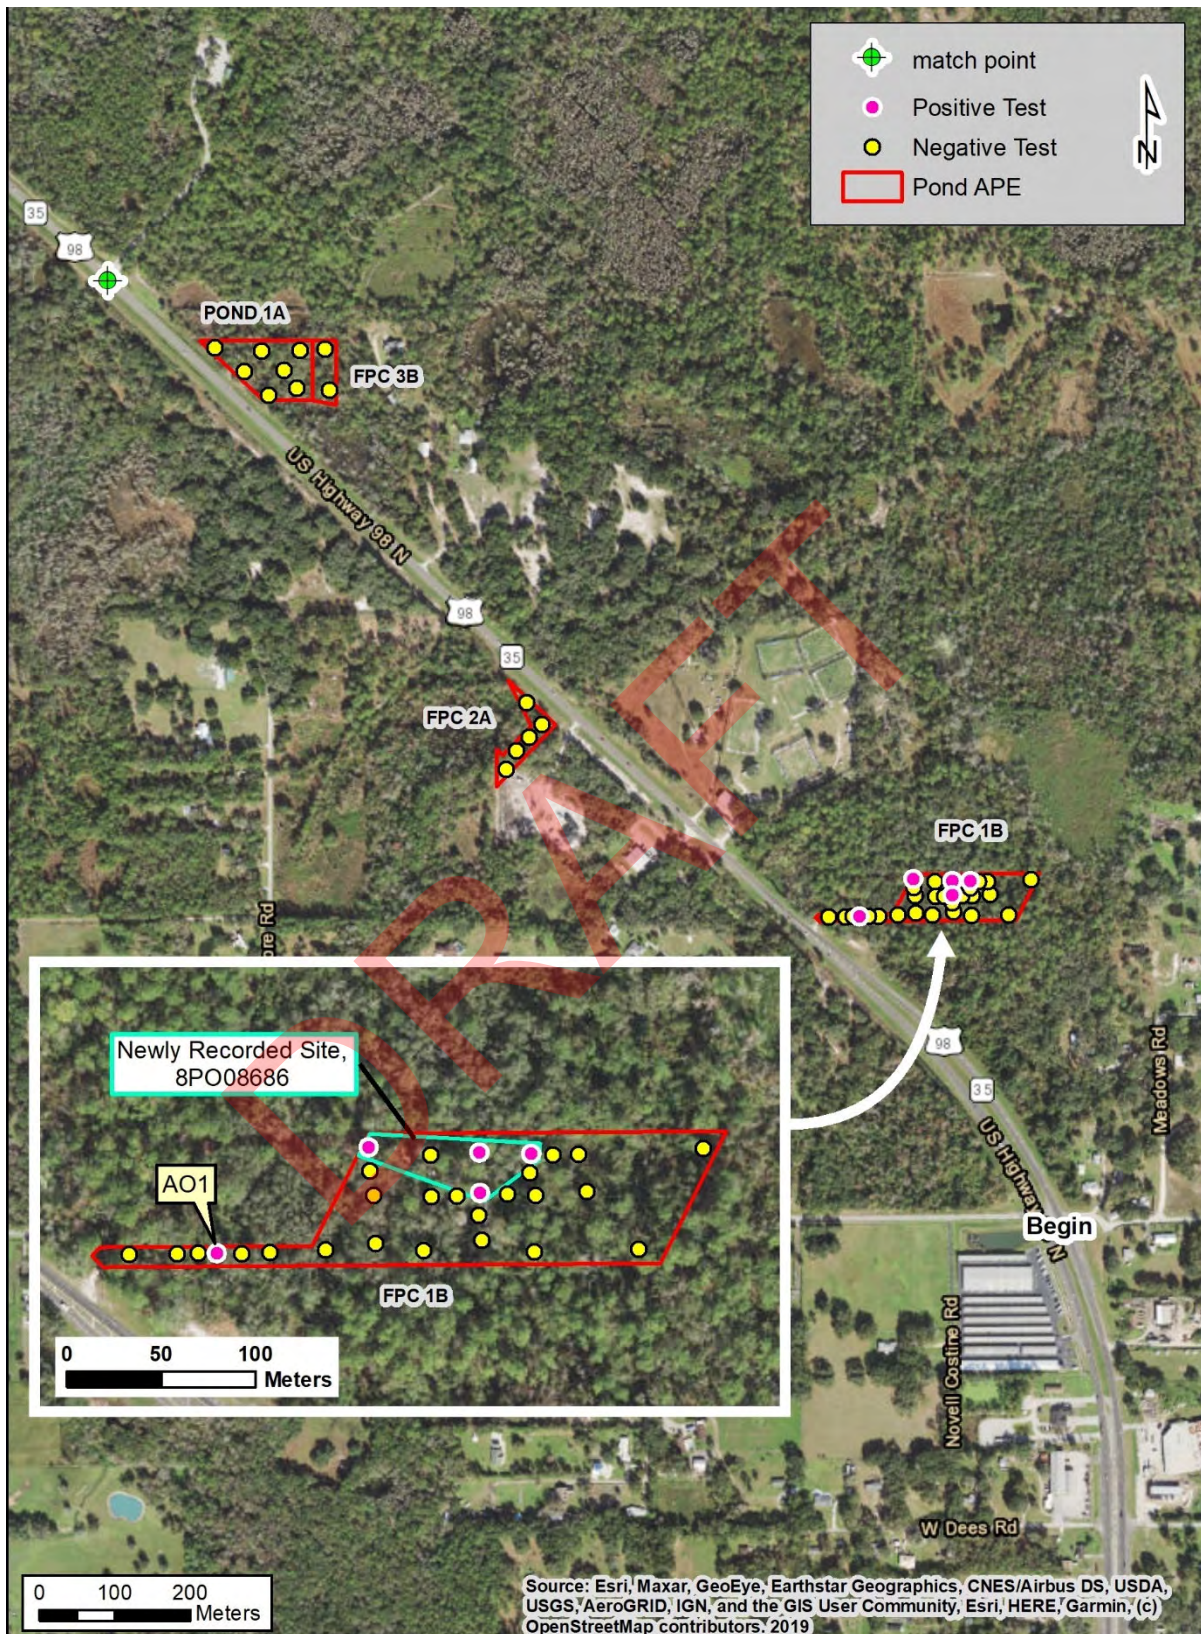
Figure 11. Approximate location of shovel tests within the APE, AO and newly recorded resource.

AO#1 is in the northeast quarter of Section 2 in Township 27 South, Range 23 East within FPC 1B (**Figure 11**). It occurs on the moderately well-drained Tavares fine sand at an elevation of 35 ft amsl. The lithic artifacts consist of two, large sized (2-3 cm), non-decortication chert flakes recovered at a depth of 70 cm. One had been thermally altered. The stratigraphy of the single positive test consists of 0-10 cm of dark gray sand followed by 10-80 cm of light gray sand and 80-100 cm of dark, brown sand. The area has been disturbed by the placement of mobile homes in the vicinity and reworking of the land. The AO was found during 50 m interval tests and no artifacts were found in the additional four tests at 12.5 m intervals around the positive test. Due to its low research potential, it is not considered eligible for listing in the NRHP.

8PO08686: FPC 1B Site: is located in the northeast quarter of Section 2 in Township 27 South, Range 23 East, in FPC 1B (**Figure 11, Photo 10**). It is located on the somewhat poorly drained Sparr fine sand at an approximate elevation of 35 ft amsl. Swamps are adjacent to the north and south and the site is vegetated with live oak, pine, and saw palmetto. However, the site has been disturbed by the placement of several residential mobile homes. The general stratigraphy of the site consists of 0-30 cm of gray sand and 30-100 cm of light brown sand.

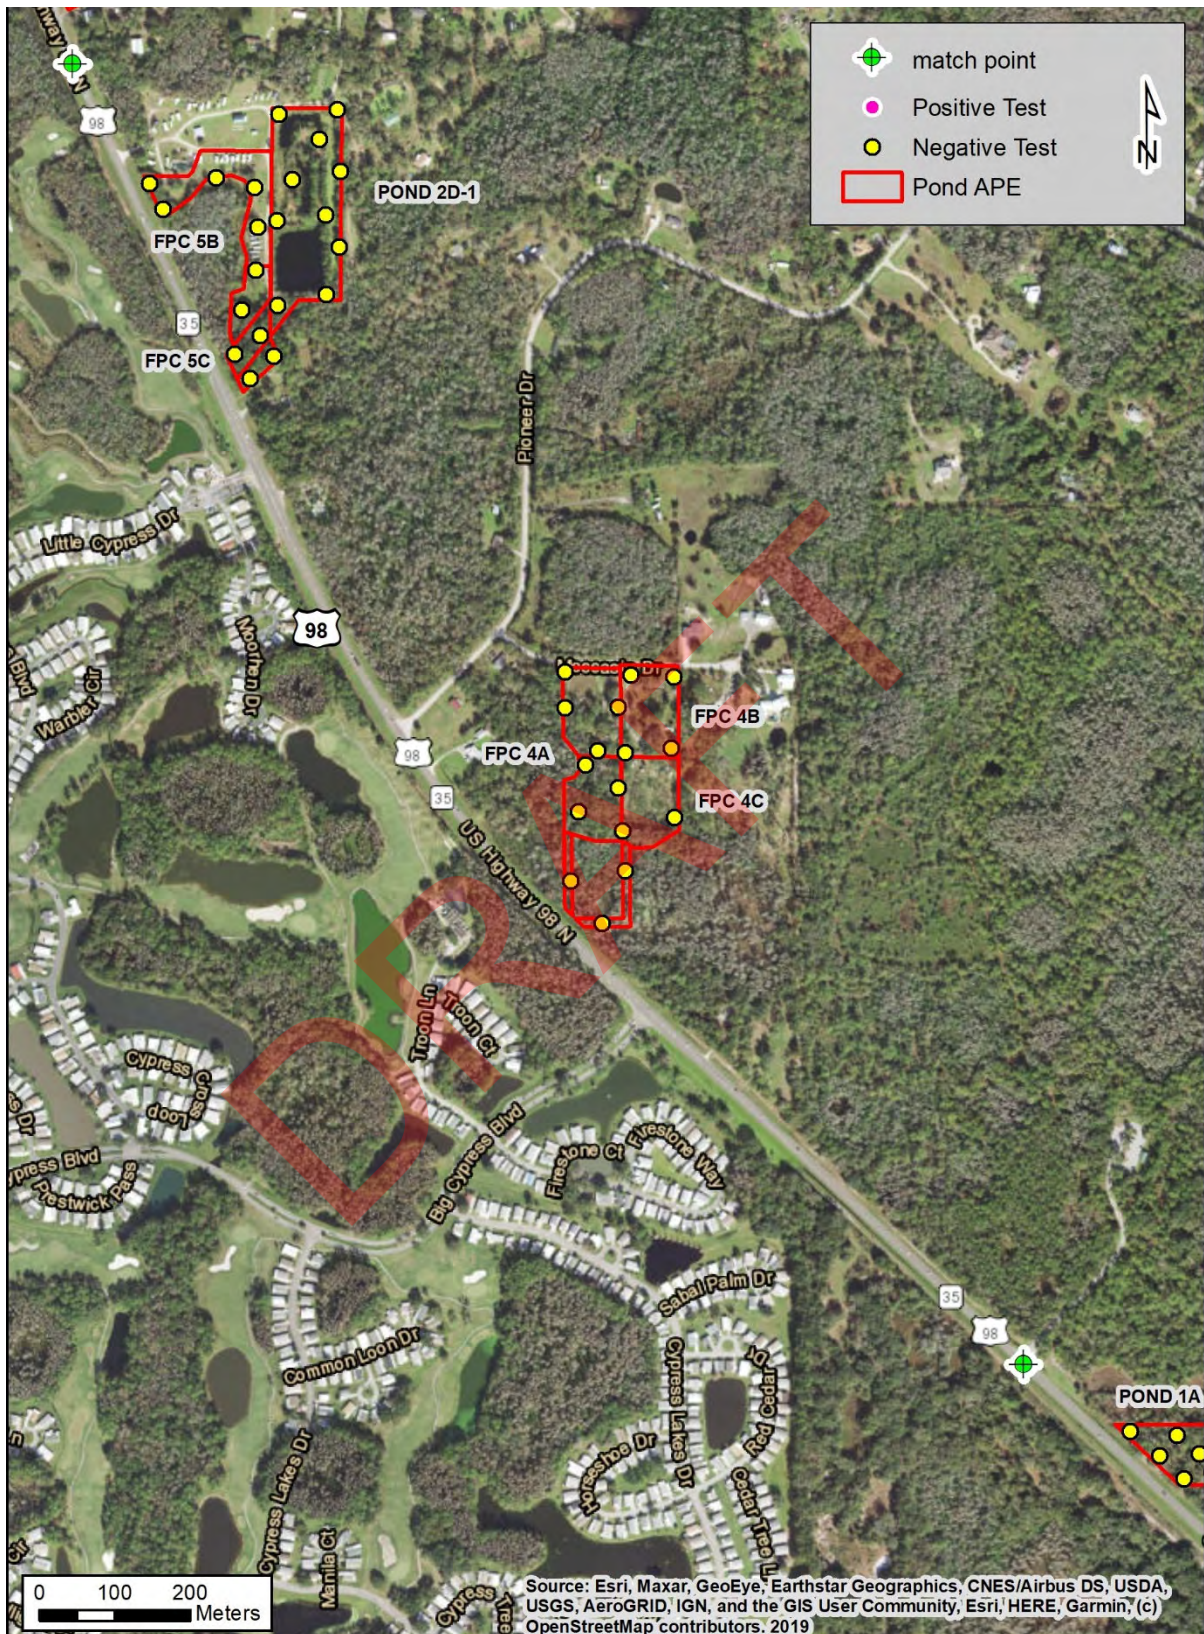
Figure 12. Approximate location of shovel tests within the APE.

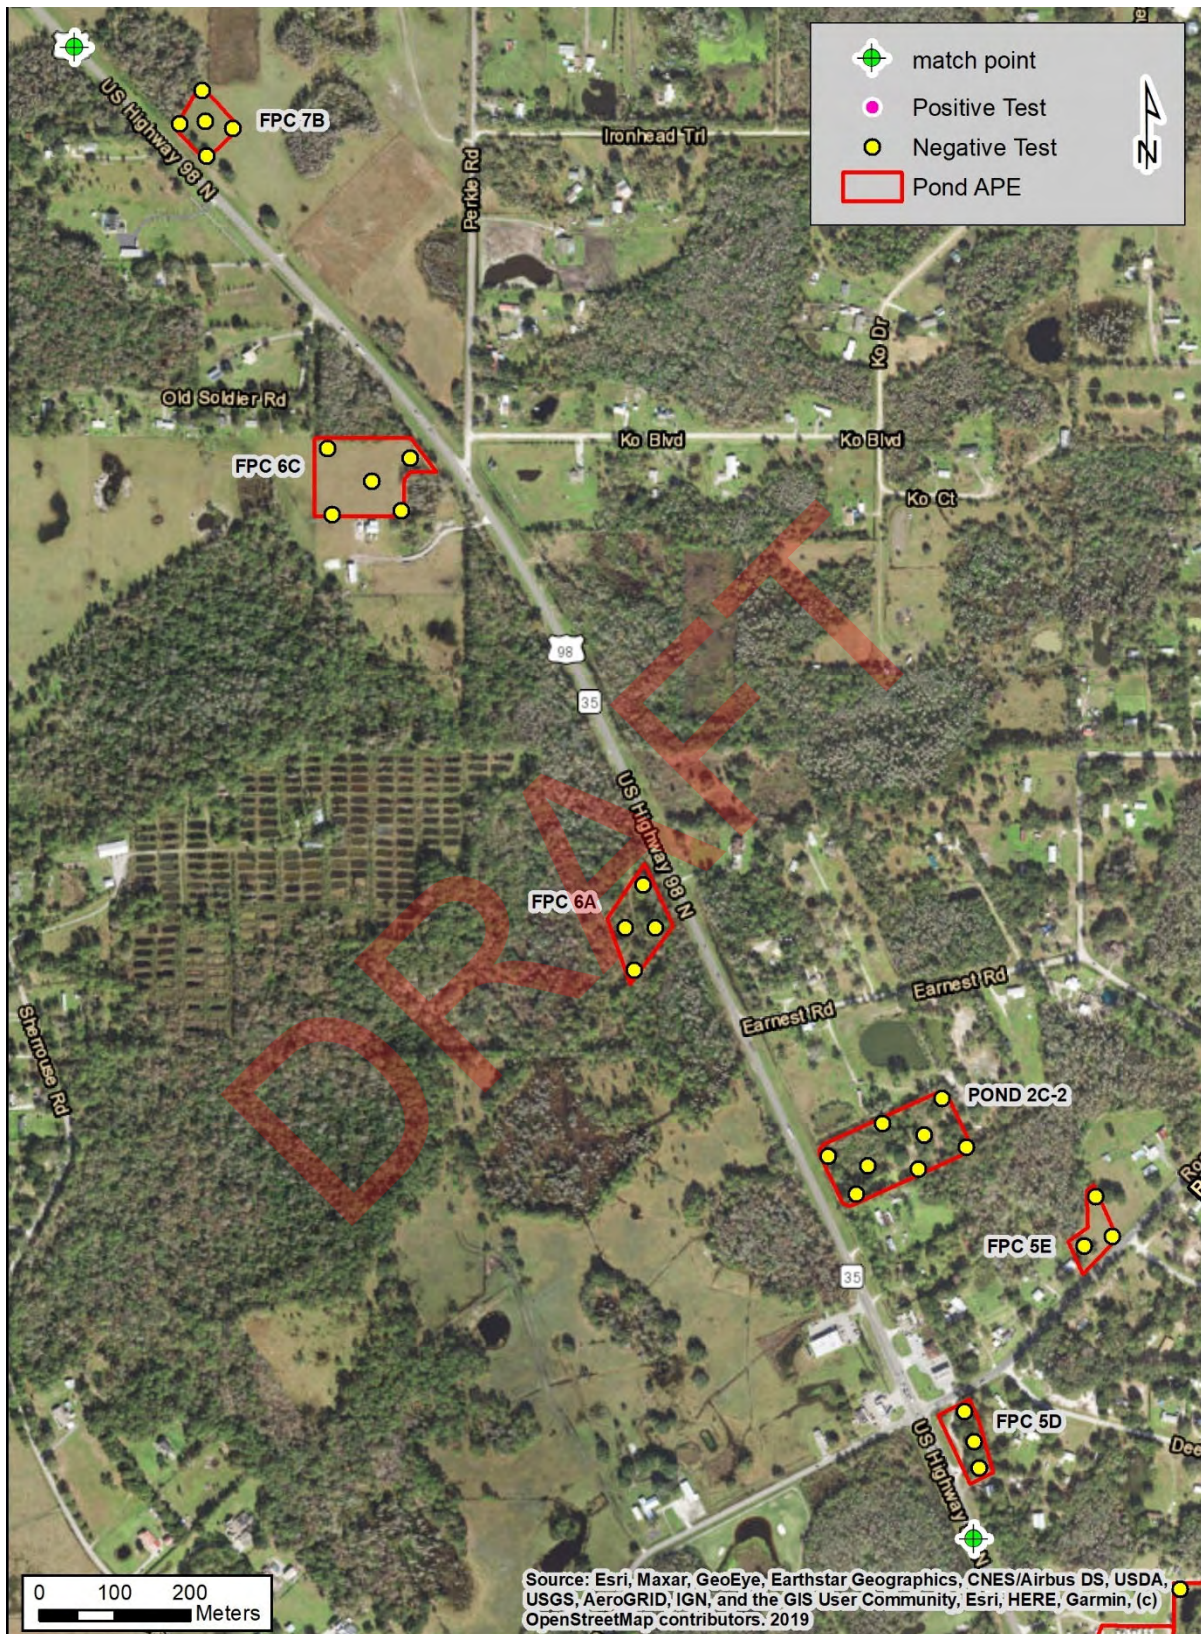
Figure 13. Approximate location of shovel tests within the APE.

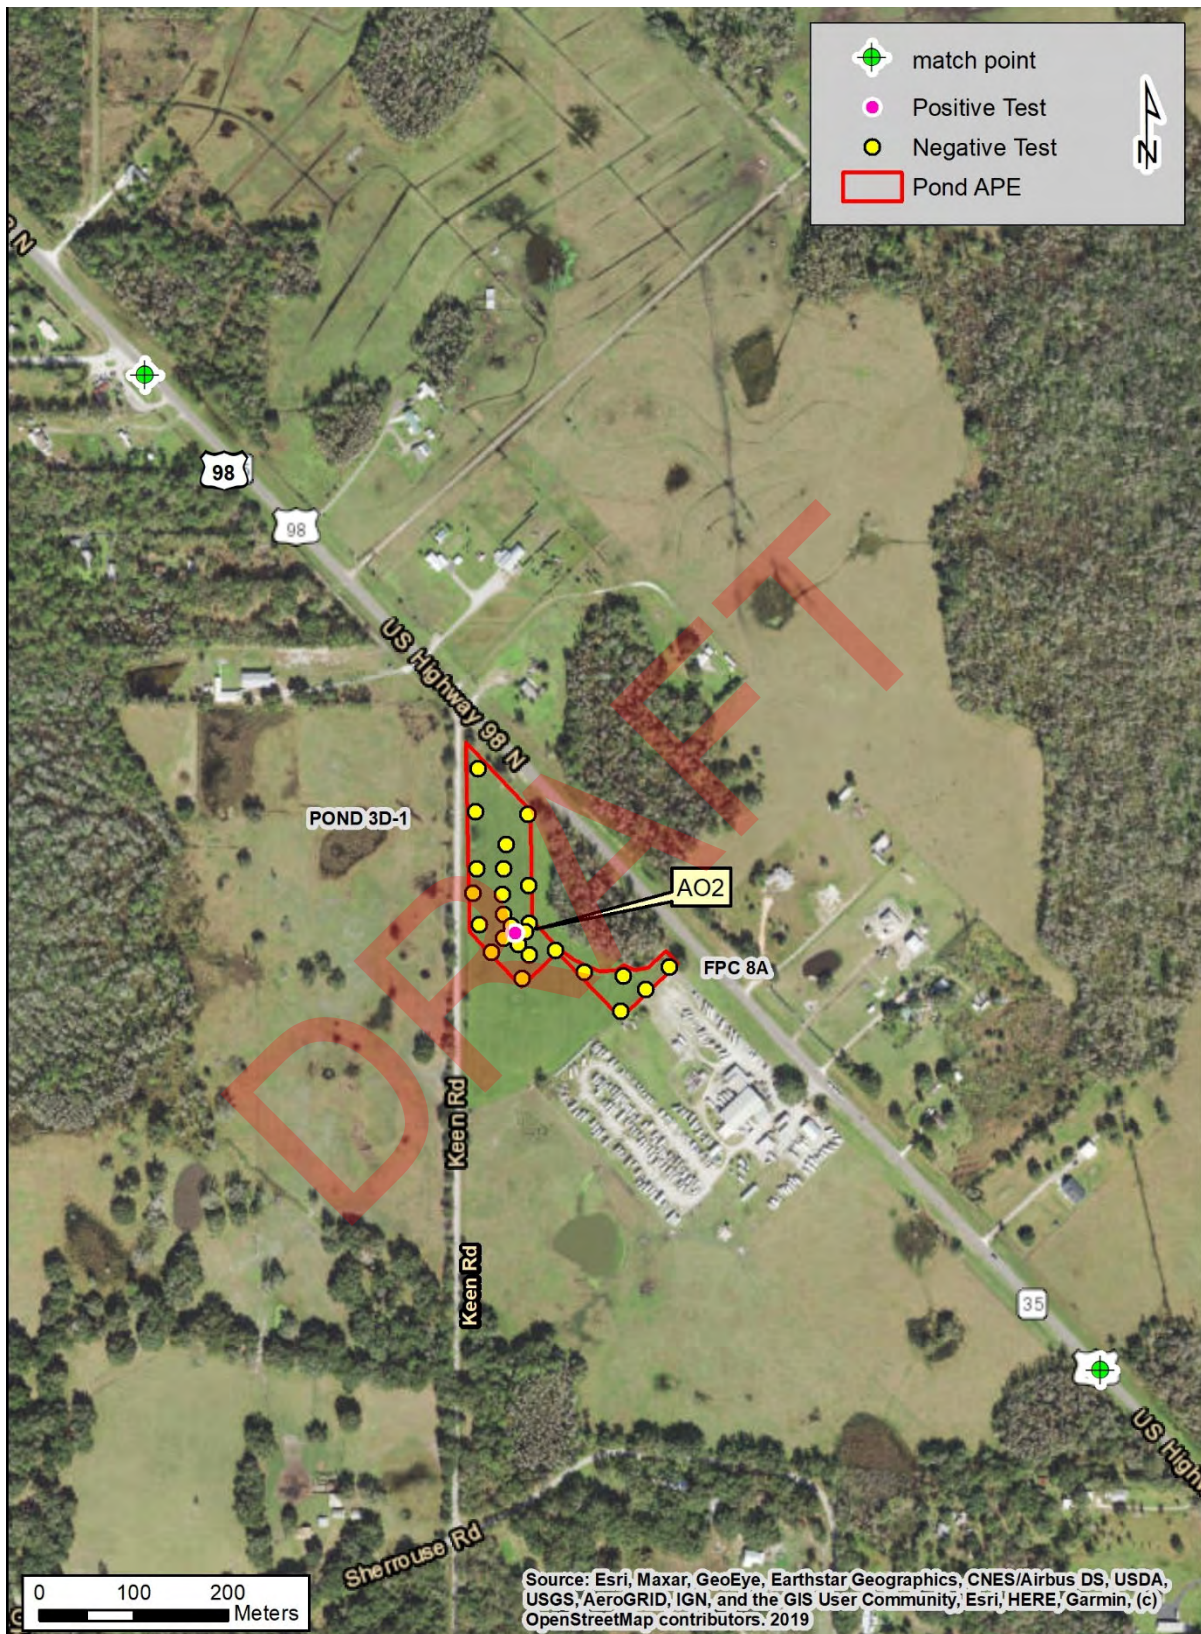
Figure 14. Approximate location of shovel tests within the APE and AO.

AO#2 is in the northwest quarter of Section 21 in Township 26 South, Range 23 East within Pond 3D-1 (**Figure 14**). It occurs on the poorly drained Wachula fine sand at an elevation of 35 ft amsl. The single artifact, a medium sized (1-2 cm), non-thermally altered, non-decortication chert flake recovered at a depth of 20 cm. The stratigraphy of the single positive test consists of 0-20 cm of dark gray sand followed by 20-60 cm brown sand with water at 60 cm. The area has been disturbed by clearing associated with a cattle pasture. The AO was found during 50 m interval tests and no artifacts were found in the additional eight tests at 12.5 m intervals around the positive test. Due to its low research potential, it is not considered eligible for listing in the NRHP.

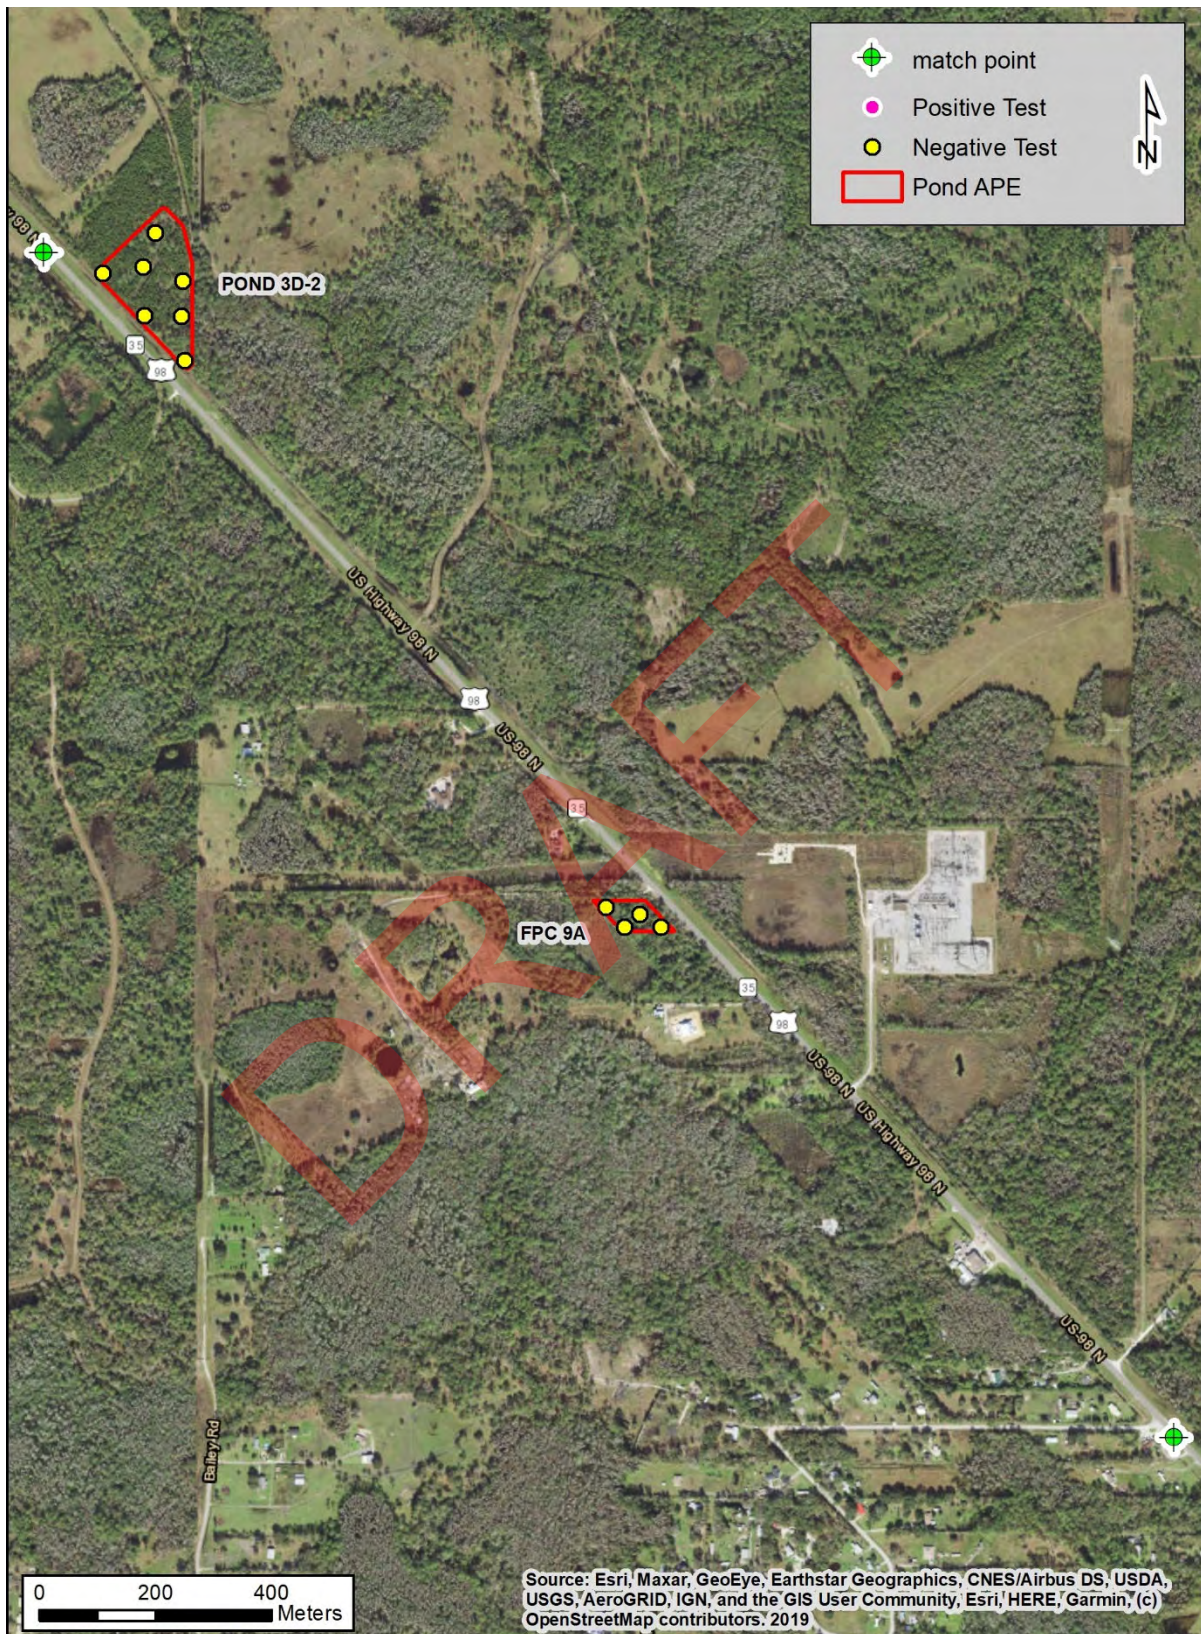
Figure 15. Approximate location of shovel tests within the APE.
