CULTURAL RESOURCE ASSESSMENT SURVEY TECHNICAL MEMORANDUM
STORMWATER MANGEMENT FACILITY (SMF) SITES AND
FLOODPLAIN COPENSAATION (FPC) SITES

SR 35 (US 98) PD&E Study

Limits of Project: From North of West Socrum Loop Road to South of CR 54

Date: November 2021

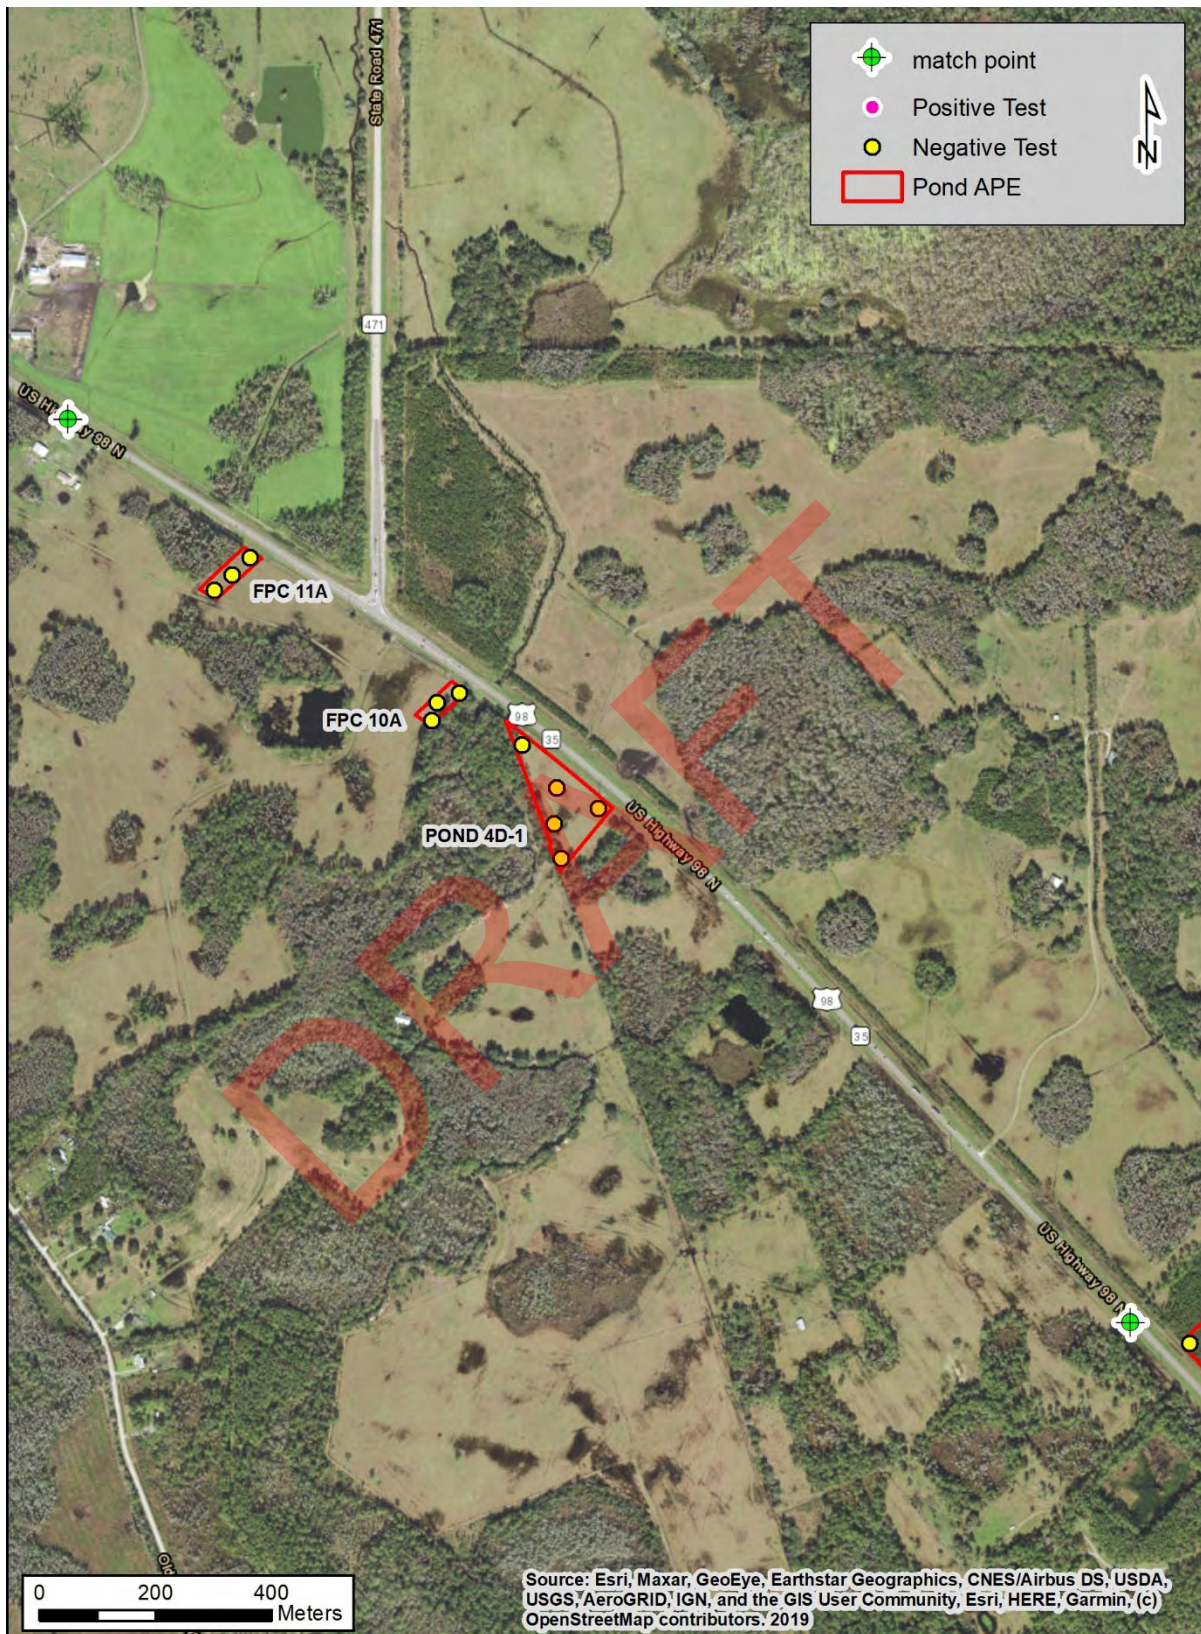
Figure 16. Approximate location of shovel tests within the APE.

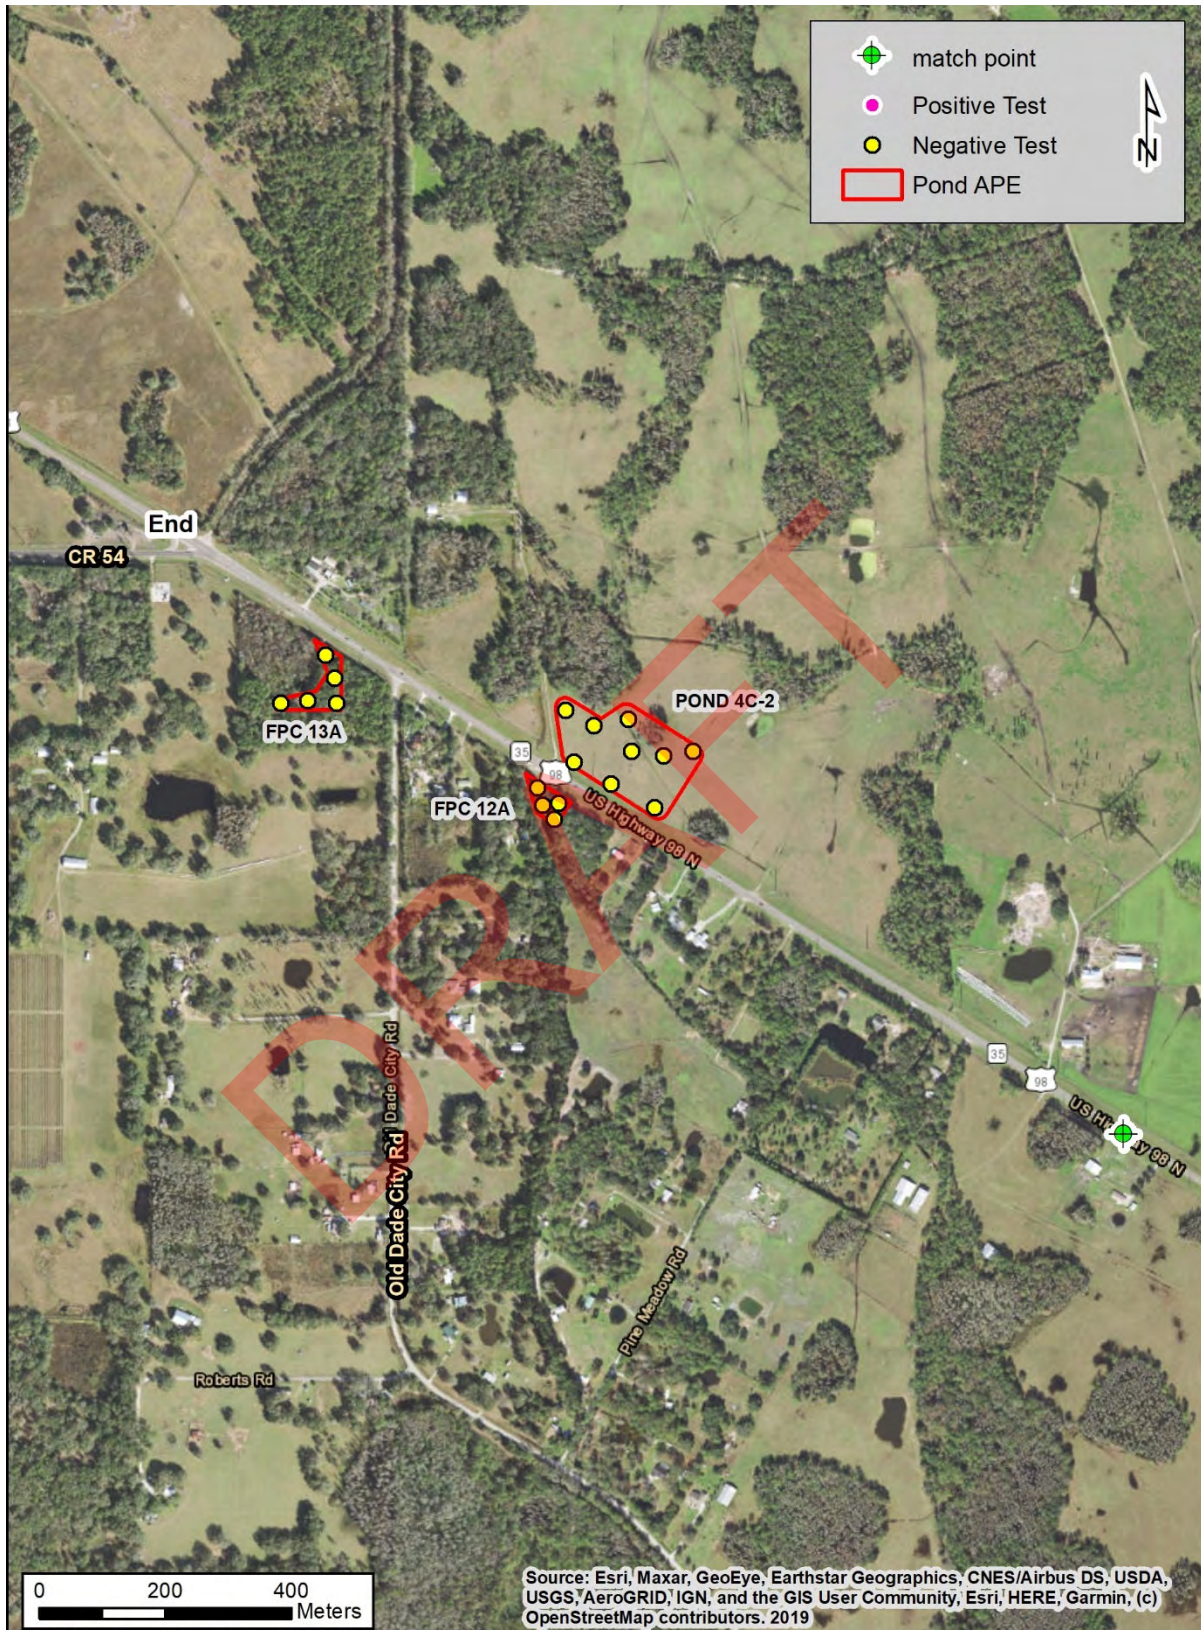
Figure 17. Approximate location of shovel tests within the APE.

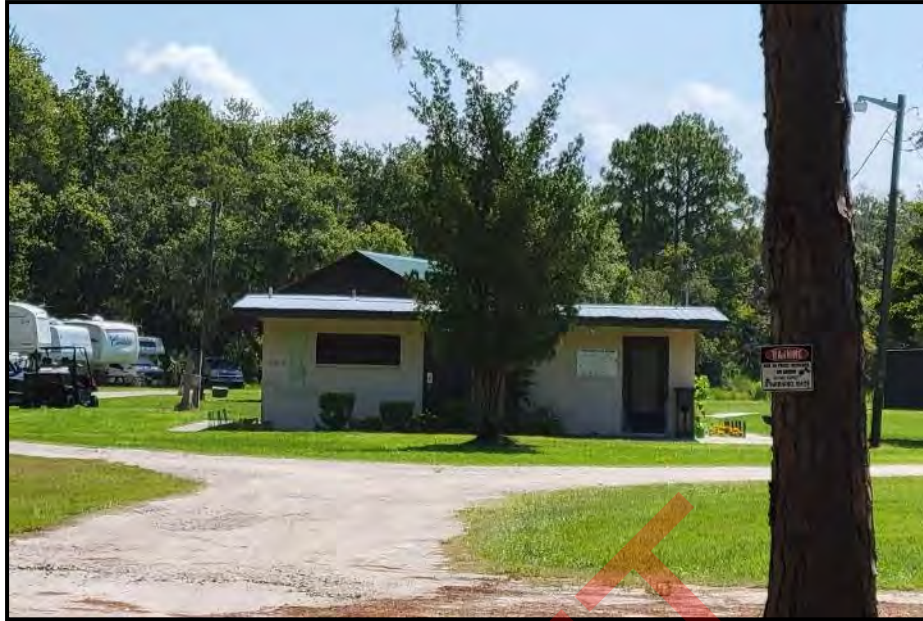
Photo 11. 10545 US 98 N (8PO08681), looking northeast.

8PO08681: The Masonry Vernacular style building at 10545 US 98 N was constructed in ca. 1971 and is immediately adjacent to FPC 5B (**Photo 11**). The one-story, rectangular plan building rests on a concrete slab foundation and has an exposed concrete block structural system covered in paint. The side gable roof is covered with 3V crimp sheet metal. The main entryway is on the west elevation through a single door with an inset rectangular light. No windows are visible; however, a large rectangular window-sized vent is located on the west elevation. Distinguishing architectural features include overhanging eaves with boxed rafter tails and the large rectangular vent. Alterations include replacement roofing. The building is utilized as the clubhouse and restrooms for the surrounding Gator Creek Campground. Overall, the building has been altered, lacks sufficient architectural features, and is not a significant embodiment of a type, period, or method of construction. In addition, background research did not reveal any historic associations with significant persons and/or events. As a result, 8PO08681 does not appear eligible for listing in the NRHP, either individually or as part of a historic district.
