**LEVEL I
CONTAMINATION SCREENING
EVALUATION REPORT (PONDS)**

**FLORIDA DEPARTMENT OF TRANSPORTATION
DISTRICT ONE**

**SR 70 from Lorraine Road to CR 675 (Waterbury Road)
Manatee County, Florida**

Financial Project ID: 414506-2-32-01

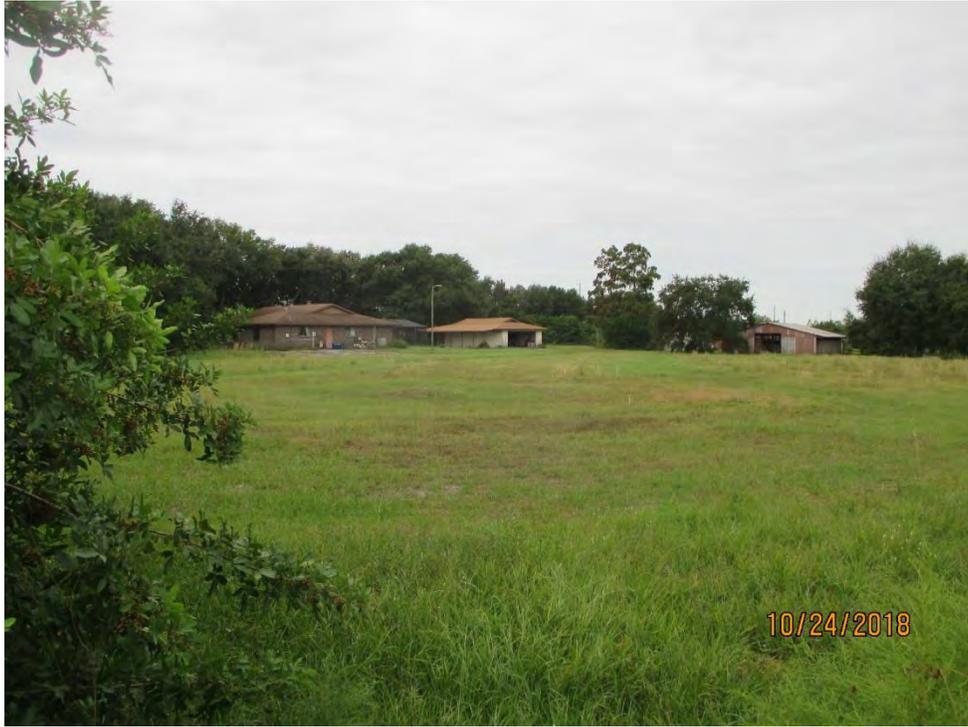
During the site reconnaissance, SMF 2A was observed as a vacant residence. Two structures and two pole barns are onsite. No evidence of fuel storage tanks, monitoring wells, buried debris, or other contamination concerns were noted. Surrounding properties include a fuel station and commercial businesses to the south, and a plant nursery to the west. The land to the north was being cleared of all vegetation with heavy machinery, and the land to the east was observed as grassland. A summary of historical land use is provided in **Section 2.1**.

Northeast area of **SMF 2A** looking southwest

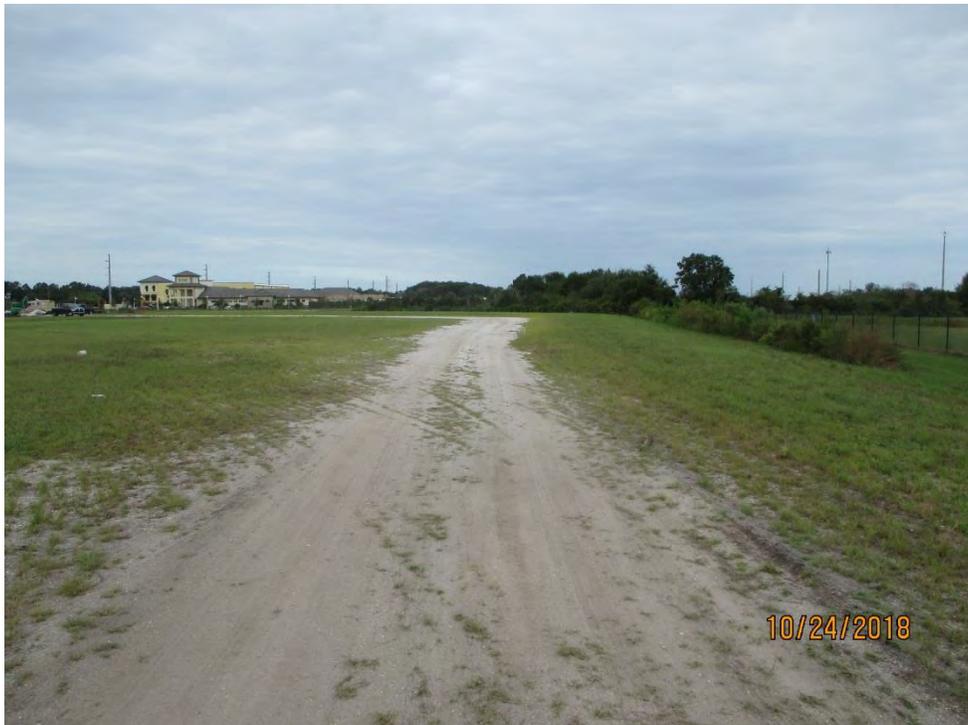
During the site reconnaissance, SMF 1A was observed as vacant land. No evidence of fuel storage tanks, monitoring wells, buried debris, or other contamination concerns were noted. Surrounding properties include a US Post Office to the north, a stormwater pond to the east, woods to the west, and a paved road followed by vacant land to the south. A summary of historical land use is provided in **Section 2.1**.

Northeast area of **SMF 1A** looking west

This site was not listed in the EDM report because it is not regulated. Review of historical aerials indicated this pond site was formerly used as row crops. Row crops and citrus groves can be associated with contamination from residual pesticides, herbicides, and heavy metals contaminants in the soil and/or groundwater. Agricultural uses of organic and inorganic pesticides are exempt from most RCRA provisions, provided that the farmers apply the chemicals on their own farms and in accordance with labeled instructions. Spills, improper application, too much application and application of disallowed pesticides are not exempted from these requirements. Based on this information, areas used as row crops and citrus groves are risk rated "Medium" for potential contamination.

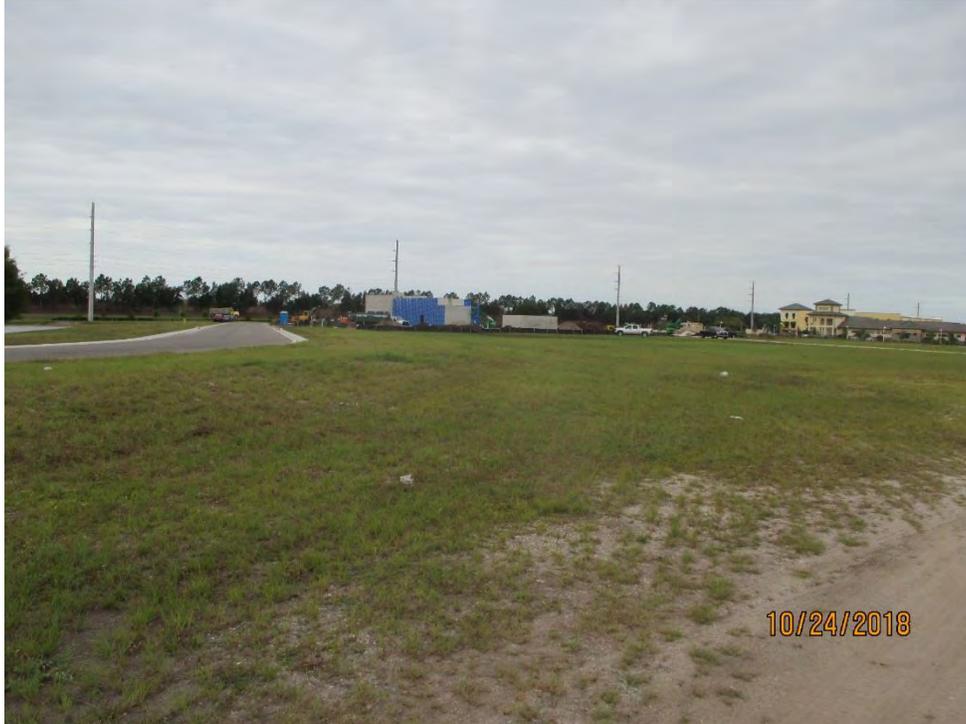
Northeast area of **SMF 1A** looking southwest

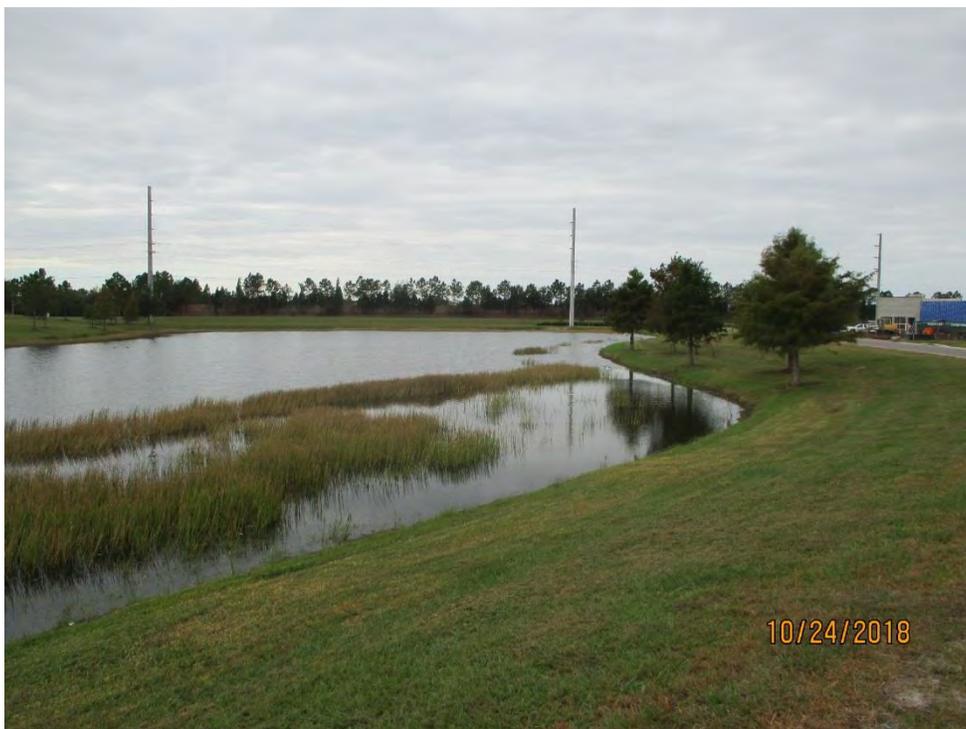
During the site reconnaissance, the Joint Use Pond was observed as two existing ponds. No evidence of fuel storage tanks, monitoring wells, buried debris, or other contamination concerns were noted. Surrounding properties include a US Post Office to the north, a recreational complex to the east, vacant land to the west, and residences to the south. A summary of historical land use is provided in **Section 2.1**.

View to the south from northern border of **Joint Use** pond

This site was not listed in the EDM report because it is not regulated. Review of historical aerials indicated this pond site was formerly used as row crops. Row crops and citrus groves can be associated with contamination from residual pesticides, herbicides, and heavy metals contaminants in the soil and/or groundwater. Agricultural uses of organic and inorganic pesticides are exempt from most RCRA provisions, provided that the farmers apply the chemicals on their own farms and in accordance with labeled instructions. Spills, improper application, too much application and application of disallowed pesticides are not exempted from these requirements. Based on this information, areas used as row crops and citrus groves are risk rated "Medium" for potential contamination.

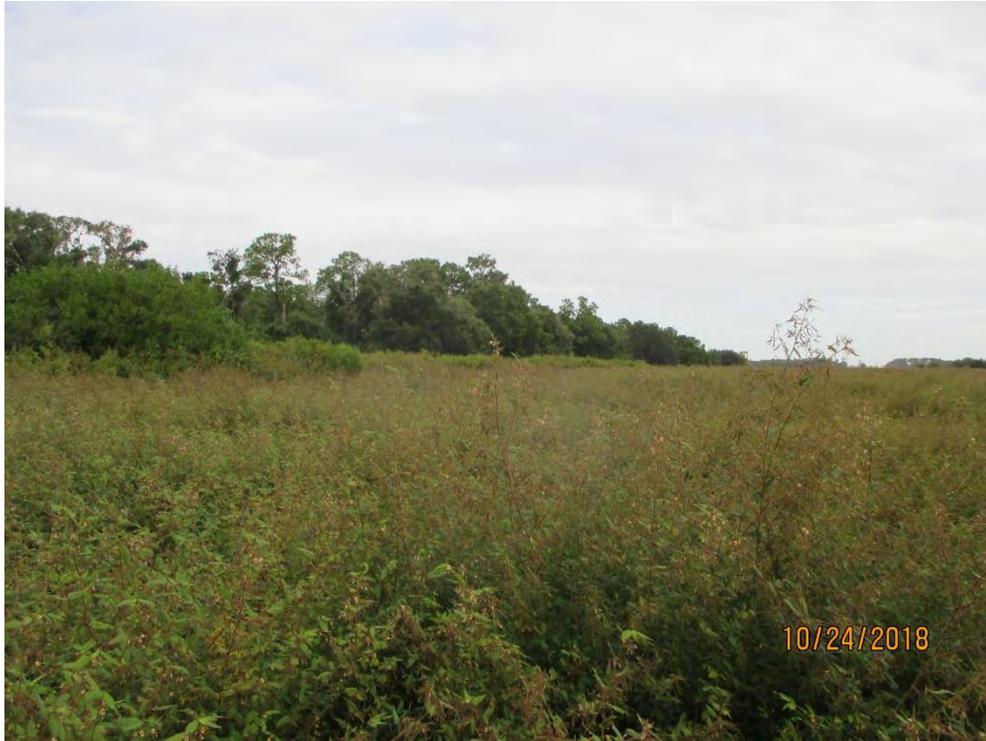
During the site reconnaissance, FPC 1A was observed as woods and grassland. No evidence of fuel storage tanks, monitoring wells, buried debris, or other contamination concerns were noted. Surrounding properties include grassland to the north and east, woods and a recreational complex to the west, and woods followed by SR 70 to the south. A summary of historical land use is provided in **Section 2.1**.

View to the north from southern area of **FPC 1A**

This site was not listed in the EDM report because it is not regulated. Review of historical aerials indicated this pond site was formerly used as row crops. Row crops and citrus groves can be associated with contamination from residual pesticides, herbicides, and heavy metals contaminants in the soil and/or groundwater. Agricultural uses of organic and inorganic pesticides are exempt from most RCRA provisions, provided that the farmers apply the chemicals on their own farms and in accordance with labeled instructions. Spills, improper application, too much application and application of disallowed pesticides are not exempted from these requirements. Based on this information, areas used as row crops and citrus groves are risk rated "Medium" for potential contamination.

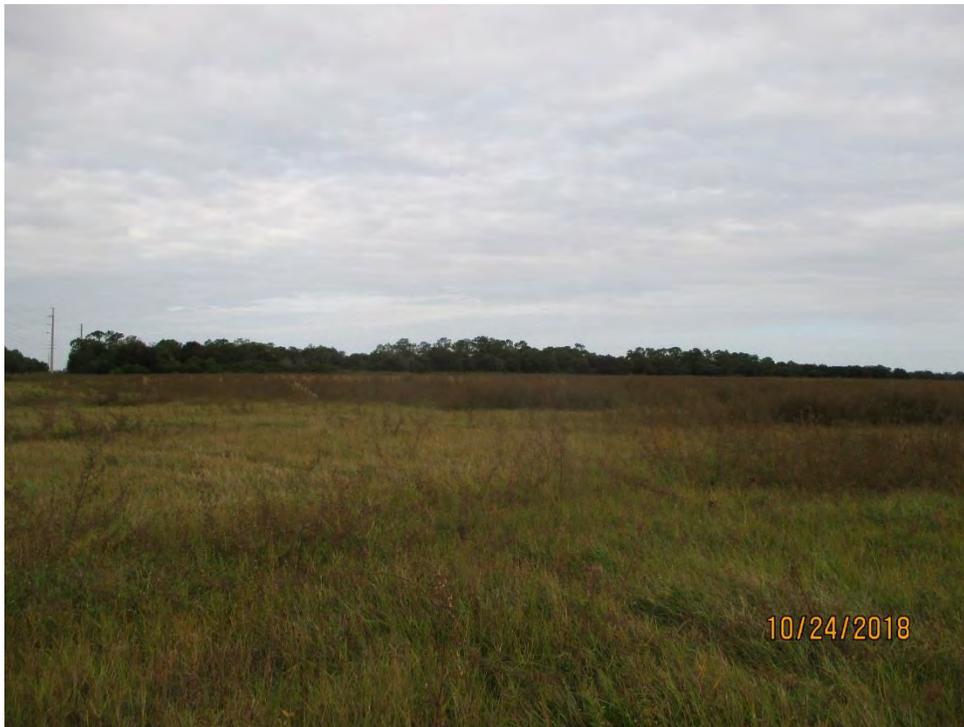
During the site reconnaissance, FPC 2A was observed as woods, grassland, and a section of Uihlein Rd. No evidence of fuel storage tanks, monitoring wells, buried debris, or other contamination concerns were noted. Surrounding properties include grassland to the north, a golf course to the east, woods and a recreational complex to the west, and woods/SR 70 to the south. A summary of historical land use is provided in **Section 2.1**.

View to the west from central area of **FPC 2A**

This site was not listed in the EDM report because it is not regulated. Review of historical aerials indicated this pond site was formerly used as row crops. Row crops and citrus groves can be associated with contamination from residual pesticides, herbicides, and heavy metals contaminants in the soil and/or groundwater. Agricultural uses of organic and inorganic pesticides are exempt from most RCRA provisions, provided that the farmers apply the chemicals on their own farms and in accordance with labeled instructions. Spills, improper application, too much application and application of disallowed pesticides are not exempted from

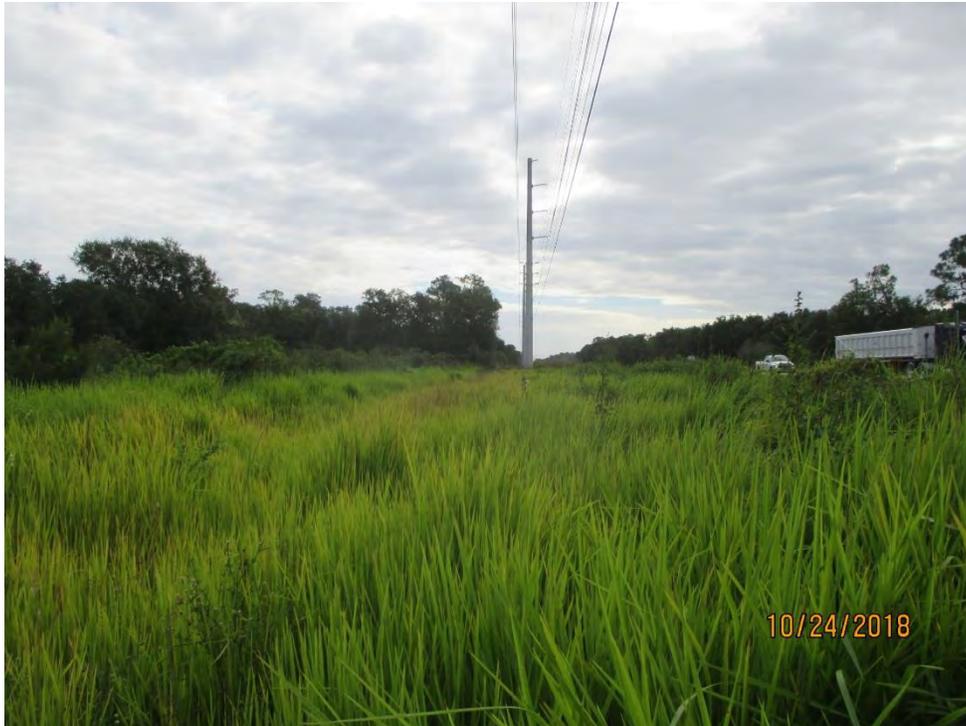
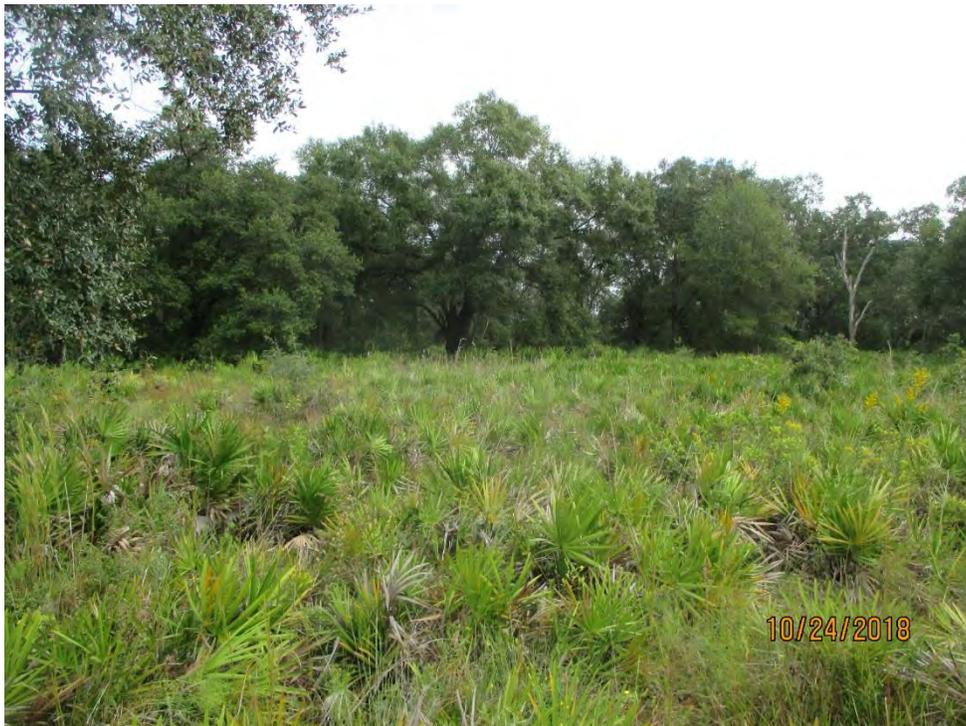
During the site reconnaissance, Alternative 1 D-G was observed as woods. No evidence of fuel storage tanks, monitoring wells, buried debris, or other contamination concerns were noted. Surrounding properties include woods and grassland to the north, woods to the east, SR 70 and woods to the south, and an existing pond and residential subdivision to the west. A summary of historical land use is provided in **Section 2.1**.

View to the east along southern border of **Alternative 1 D-G**

View to the north from central area of **Alternative 1 D-G**

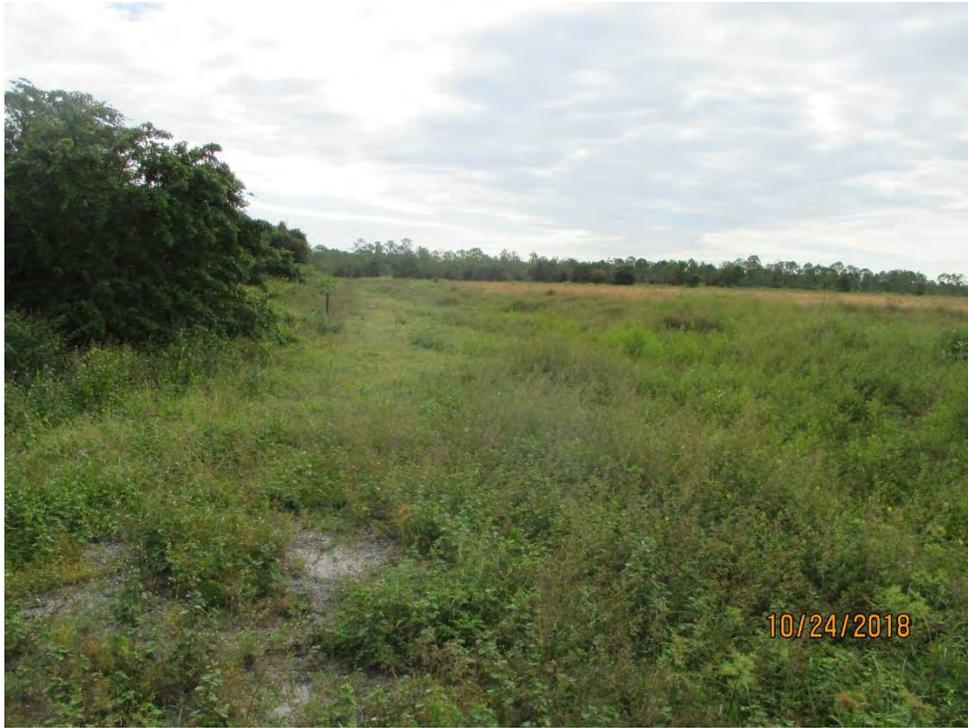
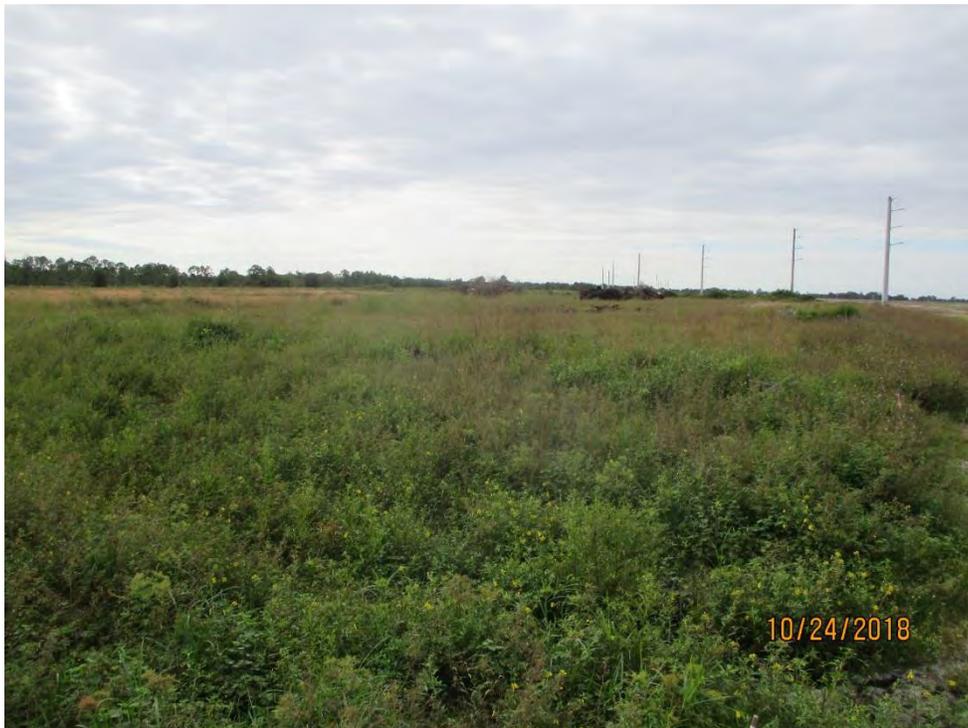
During the site reconnaissance, Alternative FPC-1B was observed as grassland and woods. No evidence of fuel storage tanks, monitoring wells, buried debris, or other contamination concerns were noted. Surrounding properties include woods to the north and east, and grassland to the south. The land to the west was being cleared of all vegetation with heavy machinery. A summary of historical land use is provided in **Section 2.1**.

View to the east from northern area of **Alternative FPC-1B**

View to the south from northern area of **Alternative FPC-1B**

This site was not listed in the EDM report because it is not regulated. Review of historical aerials indicated this pond site was formerly used as row crops. Row crops and citrus groves can be associated with contamination from residual pesticides, herbicides, and heavy metals contaminants in the soil and/or groundwater. Agricultural uses of organic and inorganic pesticides are exempt from most RCRA provisions, provided that the farmers apply the chemicals on their own farms and in accordance with labeled instructions. Spills, improper application, too much application and application of disallowed pesticides are not exempted from these requirements. Based on this information, areas used as row crops and citrus groves are risk rated "Medium" for potential contamination.

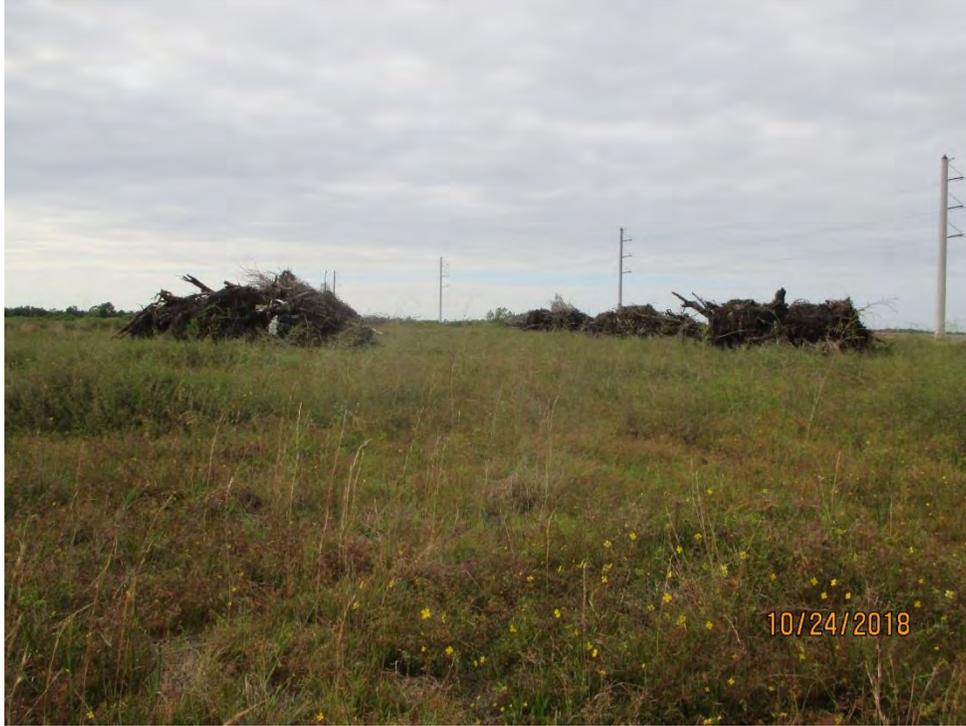
View to the south including wooden debris piles located on northwest area of **Alternative 2 D-J**

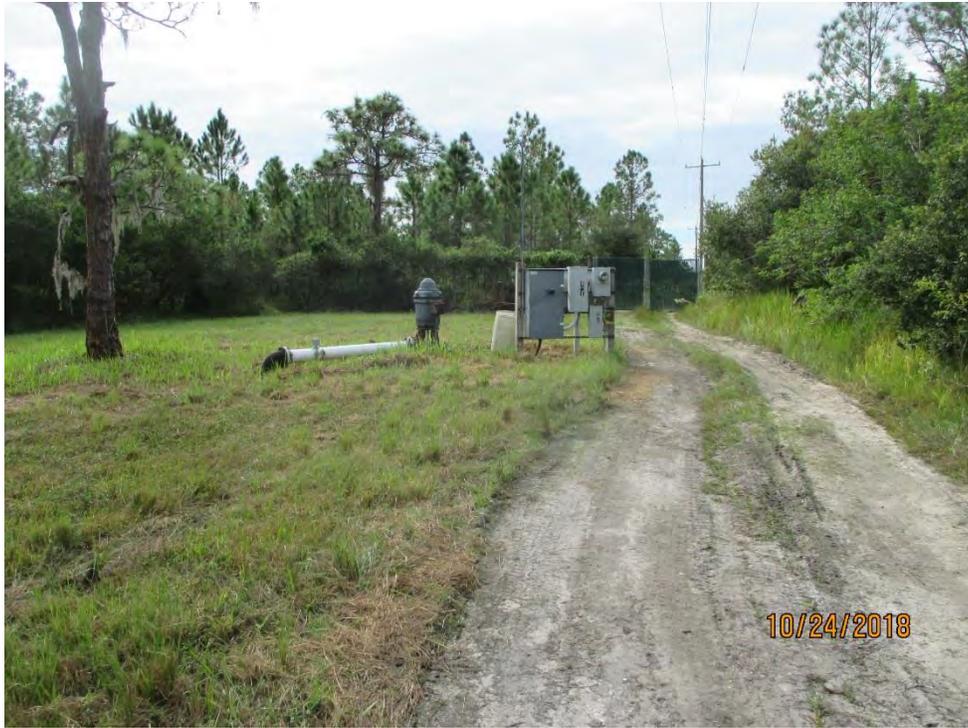
View of lift station located in northwest area of **Alternative FPC-2B**

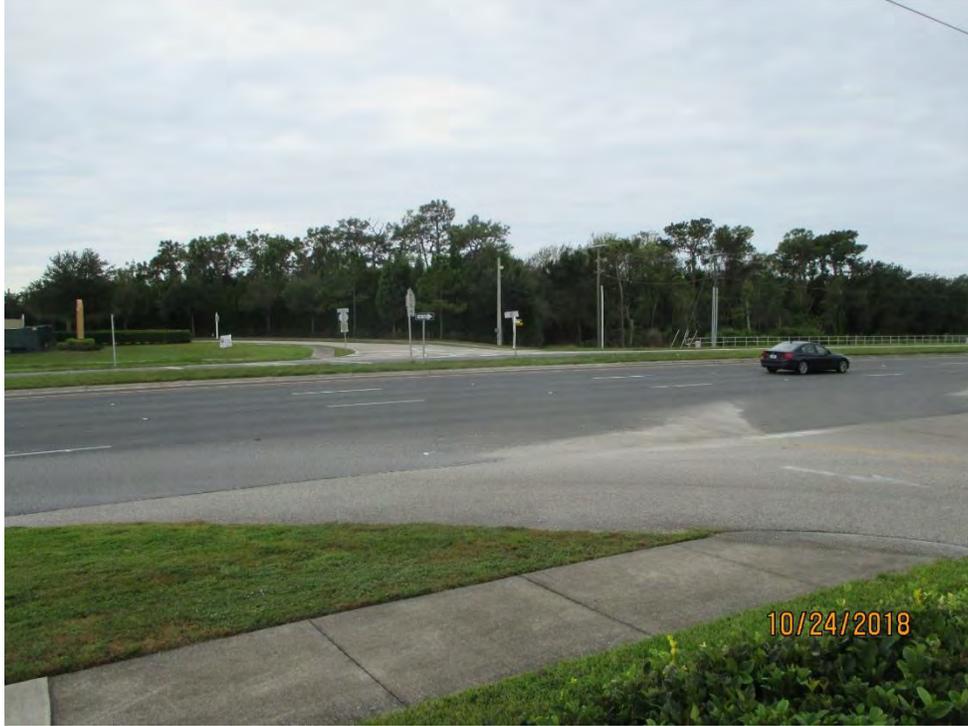
During the site reconnaissance, this facility was observed as SR 70. According to the EDM report, it is registered under the ECHO database as well as the NPDES as a Minor: General Permit Covered Facility whose permit expired on 11/2/2017. According to the FDEP website, the U.S. EPA developed the federal NPDES stormwater permitting program in two phases. Phase I, promulgated in 1990, addresses the following sources: "Large" and "Medium" municipal separate storm sewer systems (MS4s) located in incorporated places and counties with populations of 100,000 or more, and eleven categories of industrial activity, one of which is large construction activity that disturbs 5 or more acres of land. Phase II, promulgated in 1999, addresses additional sources, including MS4s not regulated under Phase I, and small construction activity disturbing between 1 and 5 acres. In October 2000, EPA authorized the FDEP to implement the NPDES stormwater permitting program in the State of Florida. The NPDES stormwater program regulates point source discharges of stormwater into surface waters of the State of Florida from certain municipal, industrial and construction activities. The sources of stormwater discharges regulated under the NPDES program fall into three categories:

According to the Three Year Compliance Status by Quarter report, this facility has not had any recent violations. Given the separation distance and lack of reported contamination concerns, this facility is not considered a contamination concern to SMF 2A.

View of Site No.1-State Road 70E

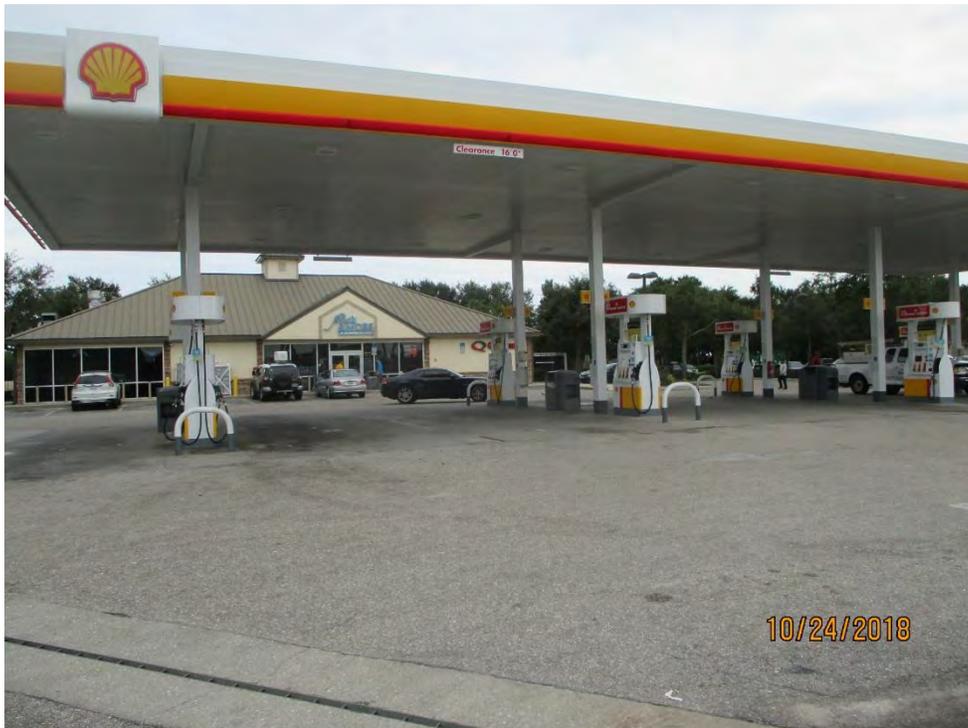
During the site reconnaissance, this facility was observed as Shell fuel station. According to the EDM report, this facility currently maintains two 20,000-gallon unleaded gasoline Underground Storage Tanks (USTs). In January 2006, petroleum contamination was detected in pea gravel during a replacement of a spill bucket associated with the regular unleaded gasoline UST. A Site Assessment was performed by installing monitor wells around the facility. Recent monitor events occurring in October 2017 indicated all contaminants of concern were below the FDEPs cleanup target levels (CTLs) with the exception of benzo(b)fluoranthene in MW-3, which was found to exceed the CTL but is below the Natural Attenuation Default Concentration (NADC). The contamination plume is contained onsite and does not encroach any surrounding properties. Groundwater in the vicinity was recorded from 5 to 7 feet below grade with a west/southwest flow, away from the pond alternative. Given the close proximity and current contamination status of this facility, it is considered a contamination concern to SMF 2A. Supplemental information can be found in **CSER-Appendix F**.

View of Site No.2-Lakewood Ranch Shell

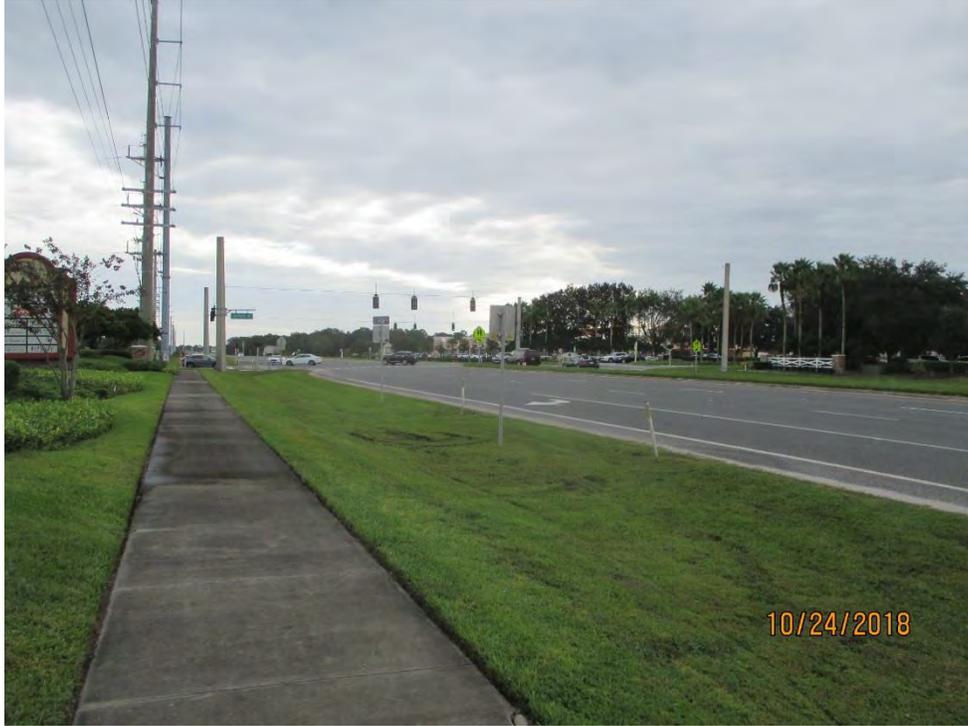
View of Site No.3-Energy Transfer Company/ETG/Lorraine Farms/Mill Creek Farms/Peerless
Manatee
