Wetland Evaluation and ERP Narrative

SR 60 Grade Separation Over CSX Railroad

FPID 436559-1-52-01

Polk County

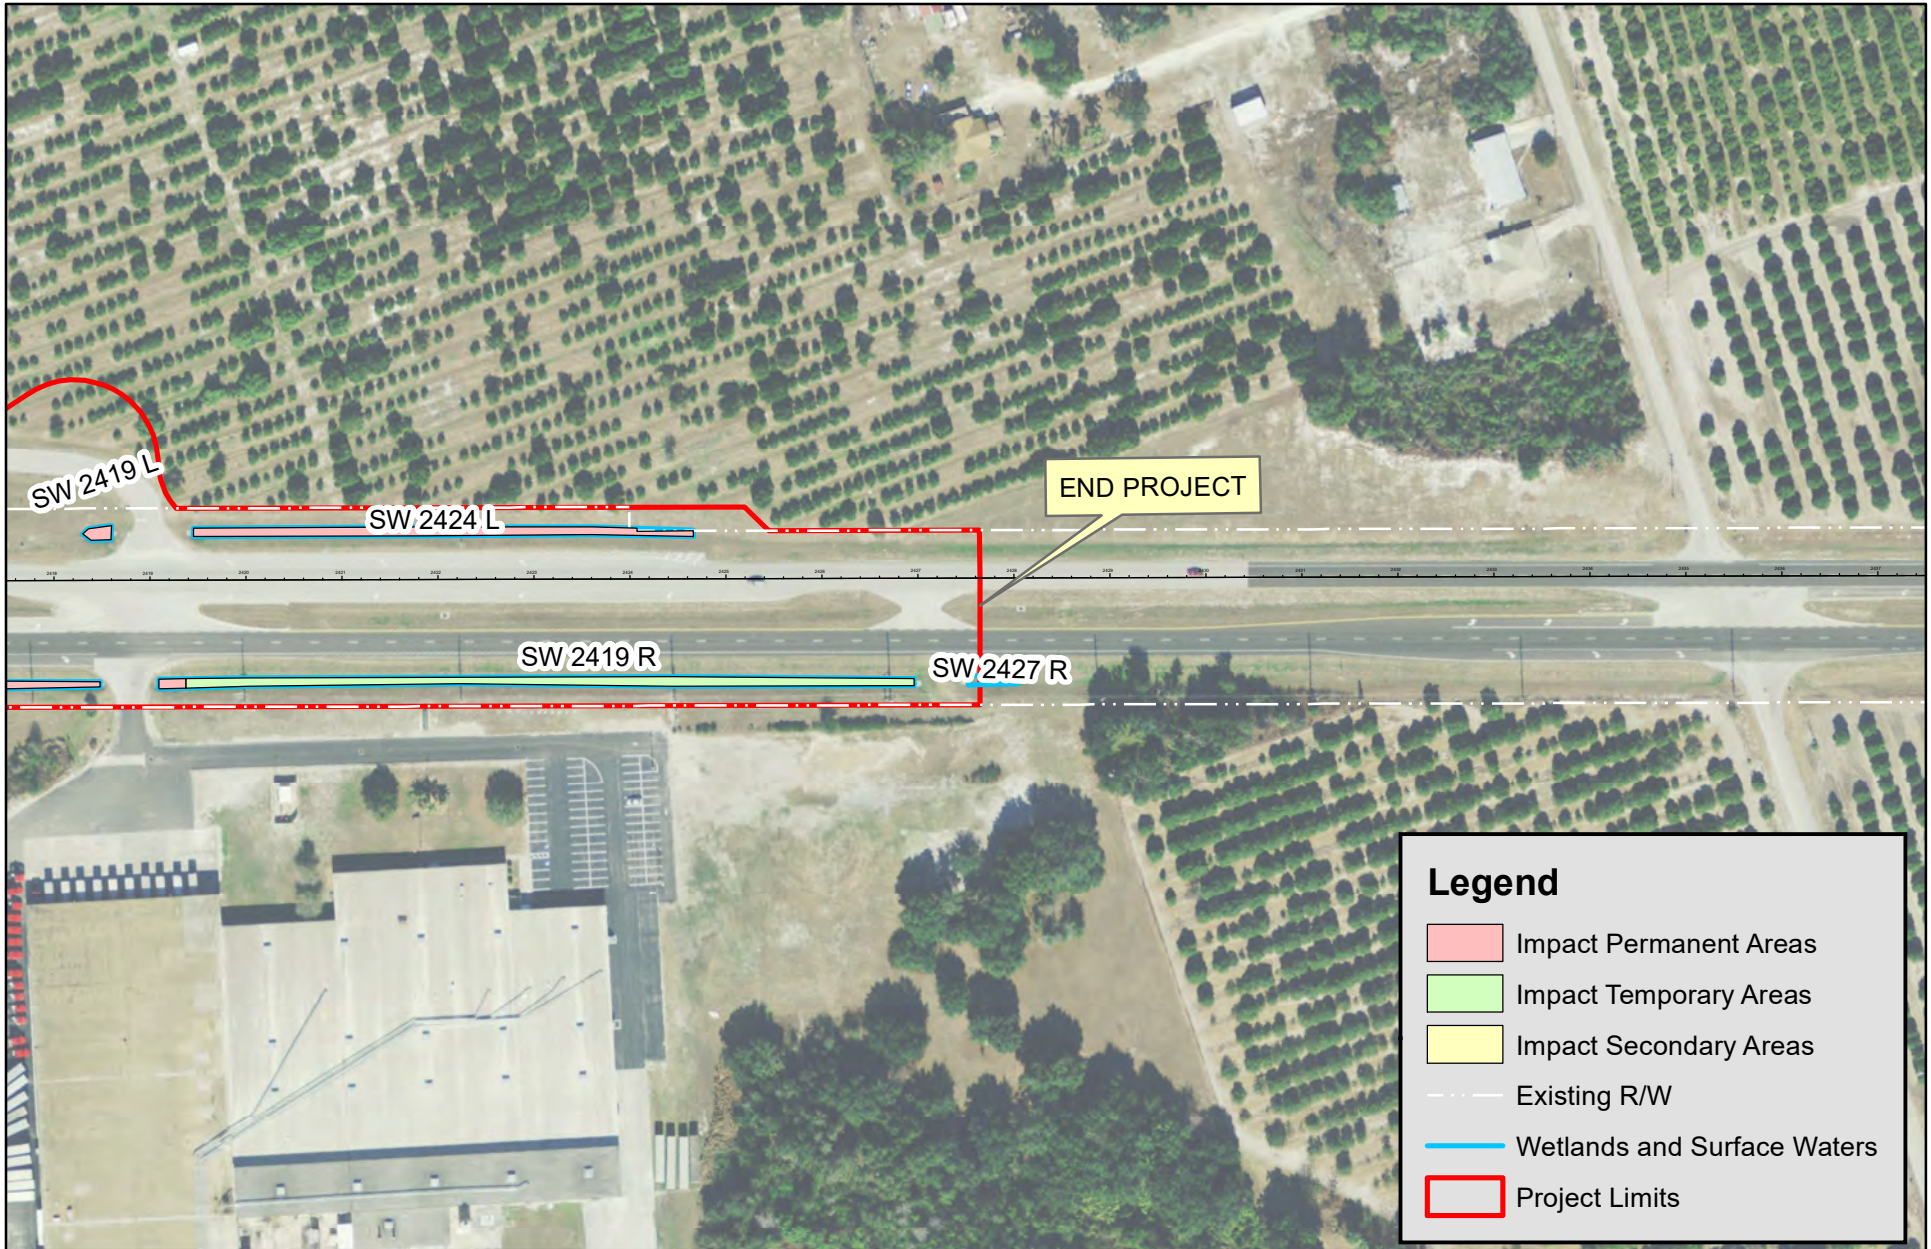
Figure 7-d

SR 60 Grade Separation over CSX Railroad
 FPID 436559-1-52-01
 Wetland and Surface Water Impacts

The impacts to wetlands and surface waters were assessed separately for federal and state permitting. The state permitting agency is SWFWMD and the federal permitting agency is USACE. Because each agency assesses jurisdiction and mitigation requirements somewhat differently over wetlands and surface waters, the impacts for the project are presented below in respect to the two separate agencies. Figures 7a-f provide an aerial view of the impacts.

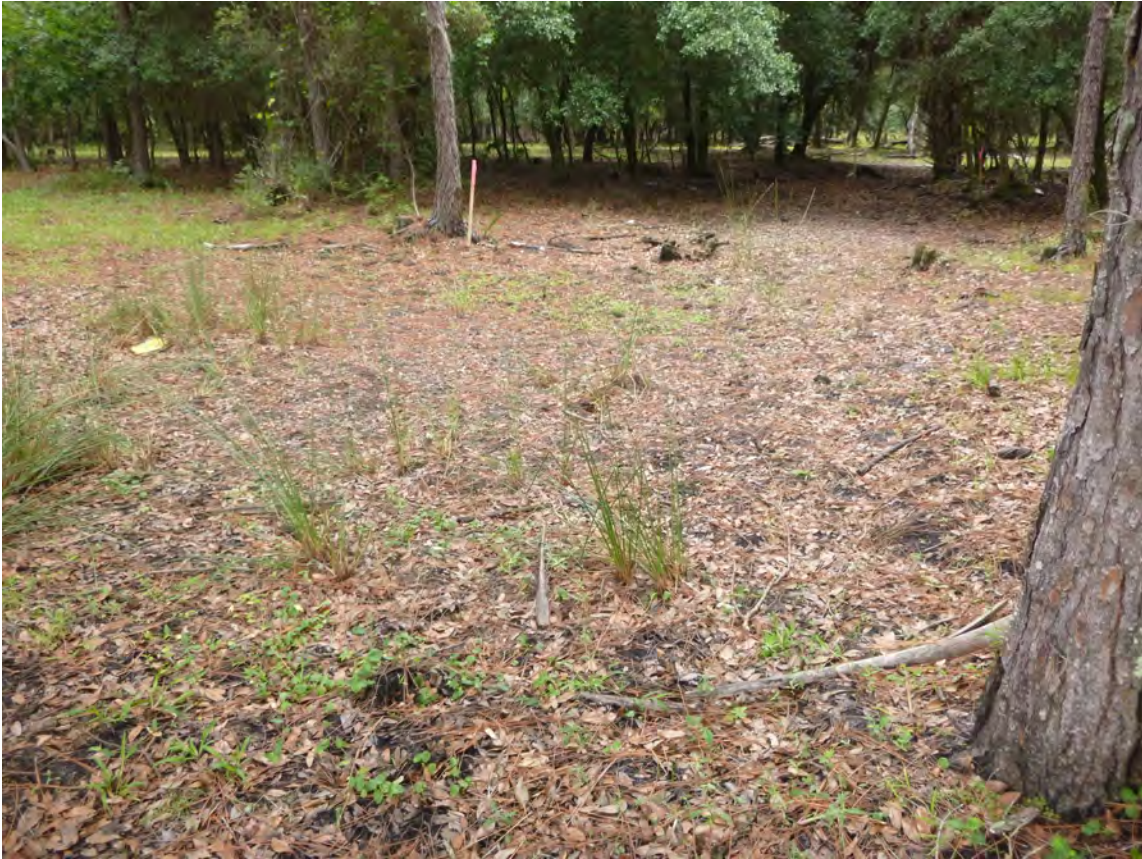
WL 2377 L

FLUCFCS: 641
USFWS: PEM1C

This wetland is a small depressional, herbaceous wetland north of SR 60 at Station 2377 Left (L) and west of the PCDC. Dominant vegetation is soft rush (*Juncus effusus*). Minimal invasive species are present. The wetland is seasonally flooded. No evidence of wildlife utilization was noted during field reviews; however, this wetland meets the criteria for Wood Stork suitable foraging habitat (SFH).

Soils in this area are mapped as Pamona fine sand (non-hydric); however, on-site soil conditions indicate hydric soils. Seasonal high water and normal pool elevations were set in this area.

Impacts will occur as a result fill for the new sidewalk on the north and the reconfigured roadway design to allow for the frontage road to the south. Federal mitigation will be provided for impacts to wetland value and function. State mitigation is not required as the wetland is exempt per 10.2.2.1 of the Environmental Resource Permit Applicant's Handbook Volume I (FDEP, 2013).

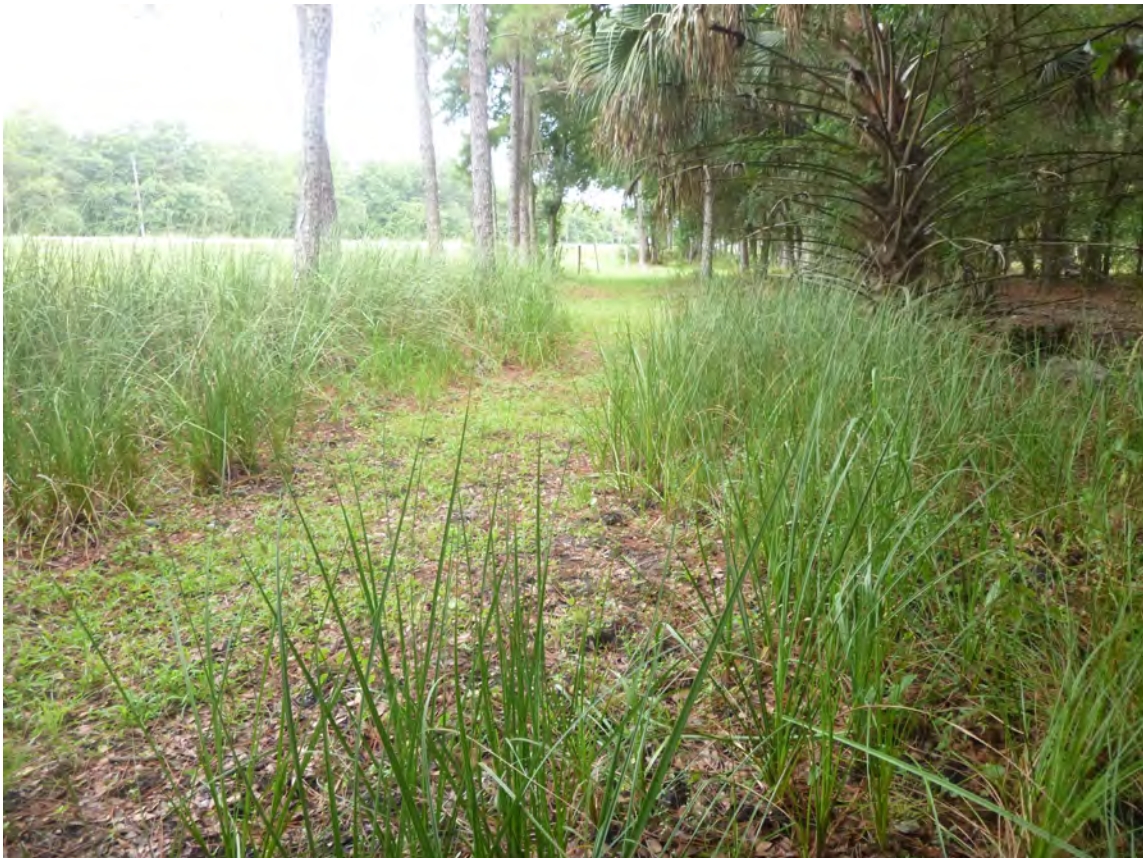
WL 2380 L

FLUCFCS: 641
USFWS: PEM1C

Wetland 2380 L is a small depressional, herbaceous wetland north of SR 60 at Station 2380 L and west of the PCDC. Dominant groundcover vegetation is saw grass (*Cladium jamaicense*) and dollarweed (*Hydrocotyle umbellata*). Laurel oak (*Quercus laurifolia*) provides scattered overstory. Minimal invasive species are present. The wetland is seasonally flooded. Evidence of hog rooting was noted which left open areas of disturbed soil throughout the wetland. This wetland provides SFH for the Wood Stork.

Soils in this area are mapped as Felda fine sand and Pamona fine sand (non-hydric); however, on-site soil conditions indicate hydric soils. Seasonal high water and normal pool elevations were set in this area.

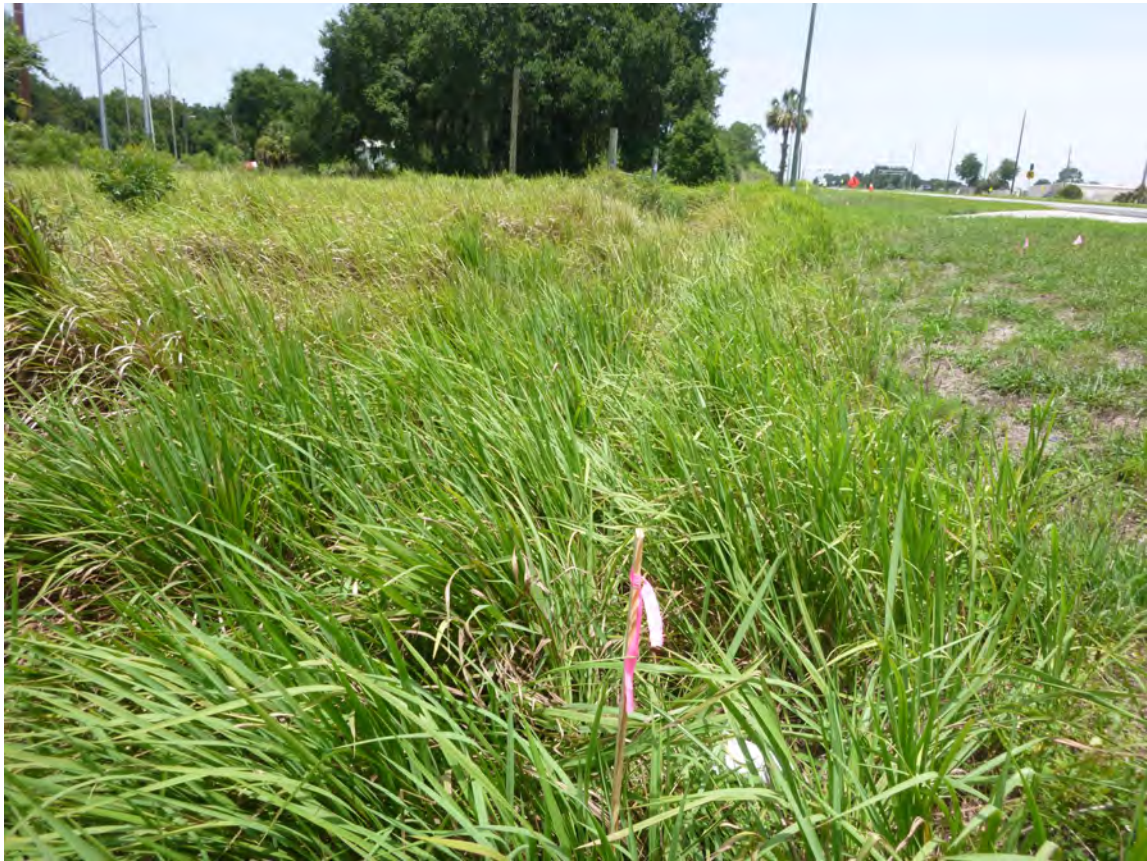
SW 2392 L
Cut in hydric soil/ 100% nuisance, no SFH

FLUCFCS:510
USFWS: PEM1Cx

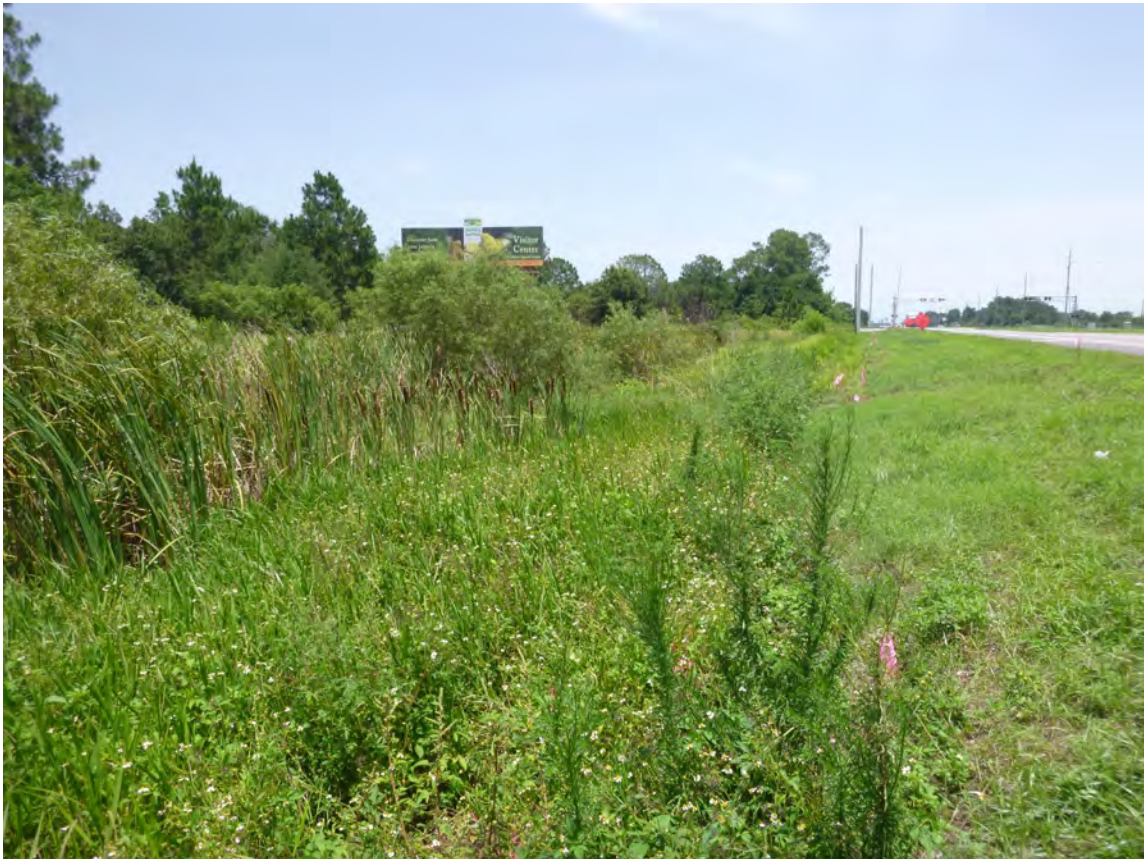
SW 2399 L
Cut in hydric soil, no SFH

FLUCFCS: 510
USFWS: PEM1Cx

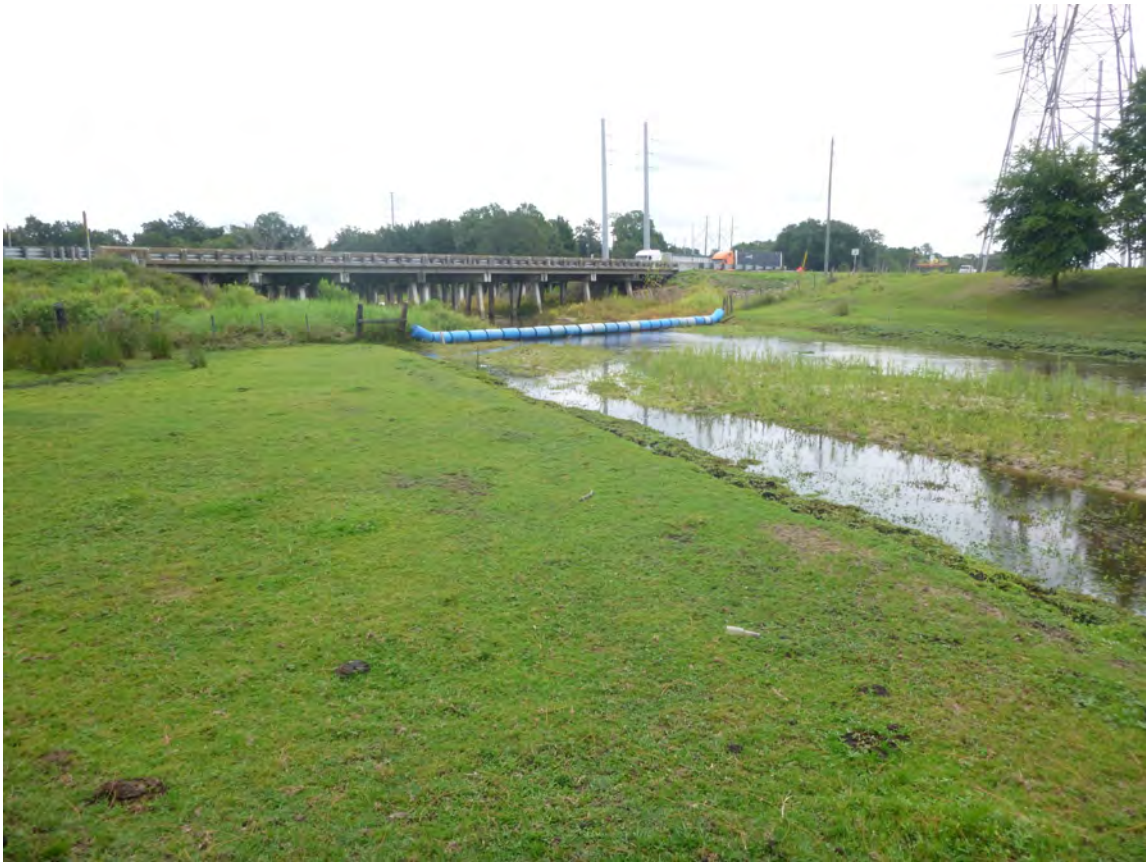
SW 1 (Peace Creek Drainage Canal)
Relatively Permanent Water, provides SFH

FLUCFCS: 510
USFWS: R2UB3Hx

Impacts at this location will include permanent fill resulting from the new bridge structures including piles and rubble rip rap. Temporary impacts will also occur as a result of construction vehicles needed to construct the bridge. Cranes will be used during construction and potential crane paths will cause temporary impacts along the banks of the canal. Following construction, the banks will be returned to existing grade.

The bridge area of the canal provides SFH for the Wood Stork. Wood Storks, Great Blue Herons, and other wading birds have been observed foraging in the shallow areas of PCDC near the bridge location.
