West Lake Hunter Trail Feasibility Study

Existing Conditions Report

November 2020

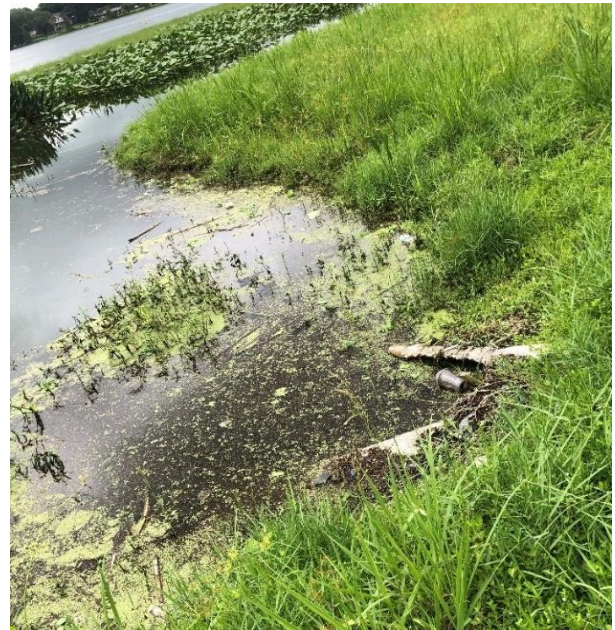
Figure 13: Eroded MES with Outfall to Lake Hunter (August 2020)

There are approximately 16 MES structures of various sizes within the study limits as well as an existing double box culvert at the intersection of Ariana Blvd and Sikes Boulevard. A field review performed by drainage engineer Kelly Thomas on August 31st, 2020 showed that the existing MES structures that outfall into Lake Hunter are in poor condition. Inverts of these outfalls were as close as 10' from the edge of the sidewalk in various locations. Figure 13 represents the average physical standing of these structures.

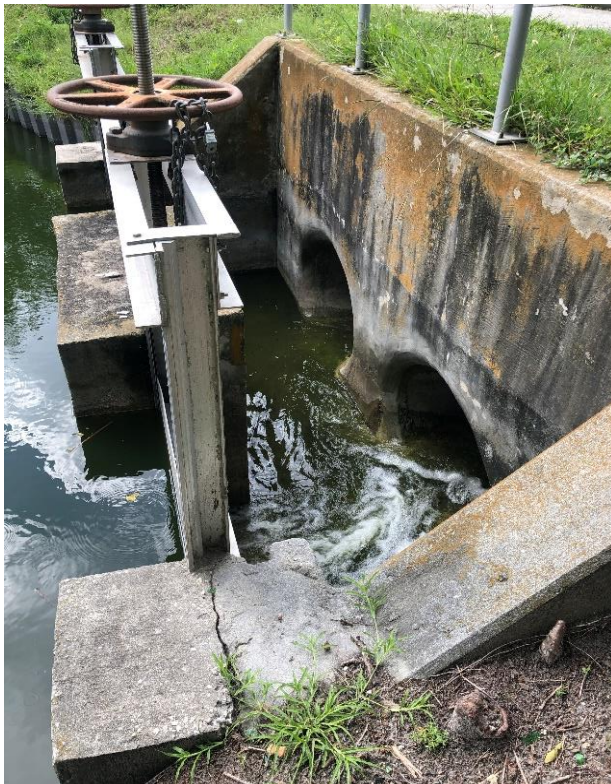
Figure 14. Weir Control Structure for Overflow into Regulatory Floodway

A previously-permitted control structure (Permit No. 40515.000) at the south end of Lake Hunter connects two 30" X 44" RCP's to the existing floodway south of Lake Hunter Drive.

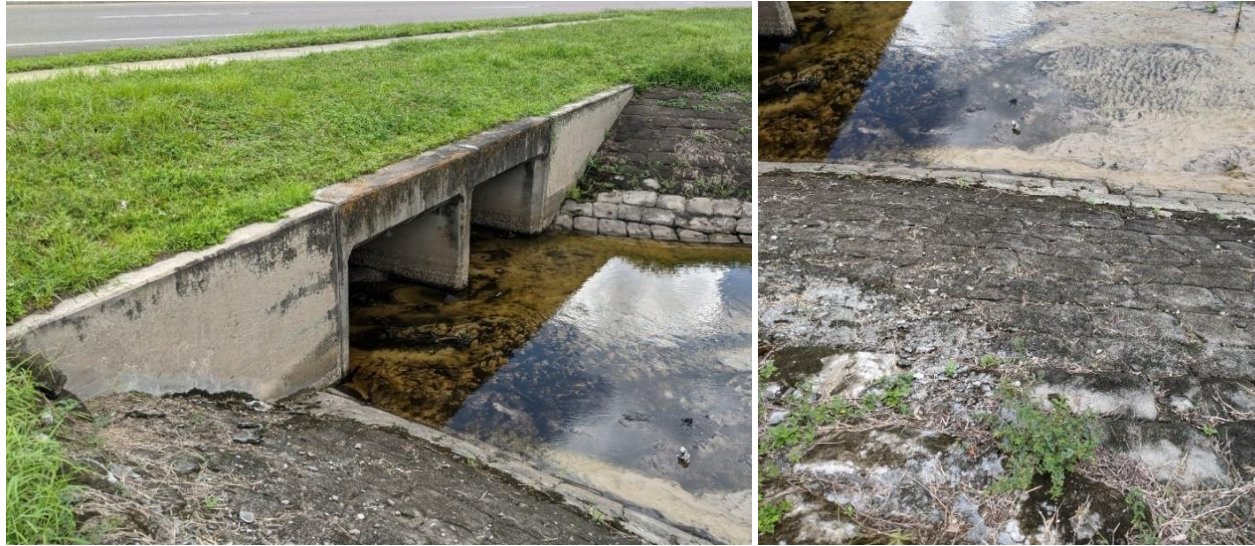
Figure 16: Concrete Box Culvert
North Of The Sikes Blvd. And Ariana St. Intersection (August 2020)

Left image: east end and wingwalls of the concrete box culvert north of the Sikes Blvd. and Ariana St. intersection. Right image: sand-cement rip rap protecting slopes adjacent to the east end of the concrete box culvert.

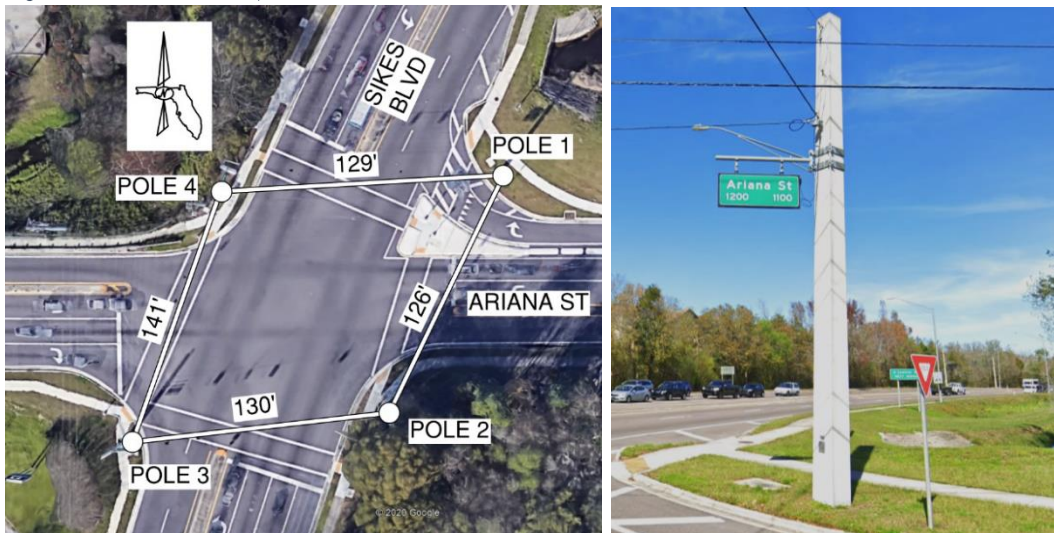
Figure 17: Strain Pole Representation at Sikes Blvd & Ariana St

There is a signalized intersection at Sikes Boulevard and Ariana Street with concrete strain poles at all four corners creating a box span (Figure 17). Based on a limited visual inspection, each of the poles appear to be in good condition. See the aerial image below for the strain pole locations and span lengths at the intersection. Based on desktop analysis, there is approximately 4' - 6" of clear space between Pole 1 and the back of the curb. Only Pole 1 will be evaluated for potential impacts from the proposed Trail alternatives.

Left image: aerial showing strain pole locations and span lengths at the intersection of Sikes Blvd. and Ariana St. Right image: Pole 1.

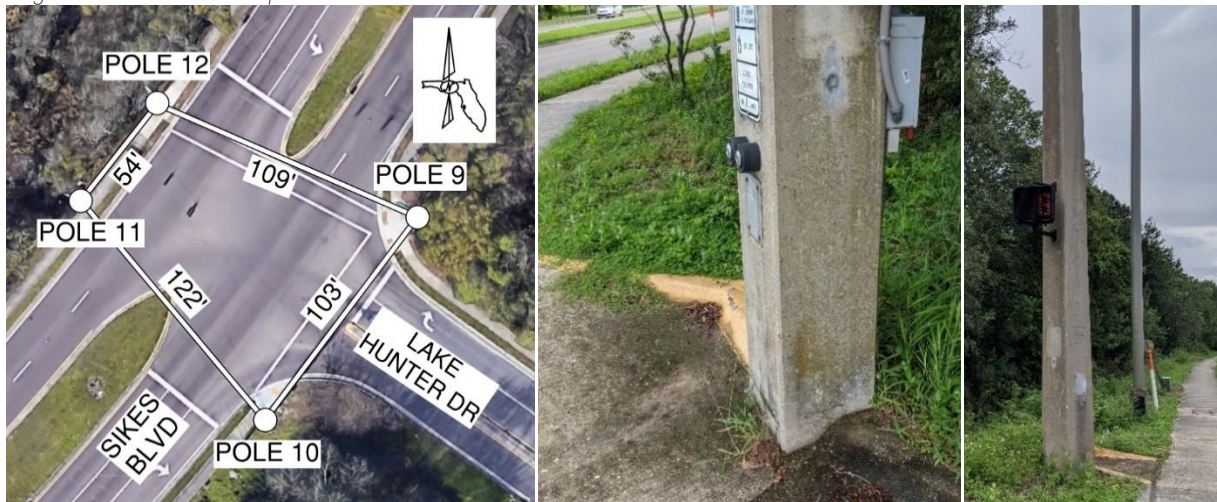
Figure 19: Strain Pole Representation at Sikes Blvd & Lake Hunter Drive

There is a signalized intersection at Sikes Boulevard and Lake Hunter Drive with concrete strain poles at all four corners creating a box span. Based on a limited visual inspection, each of the poles appear to be in good condition. Figure 20 shows the strain pole locations and span lengths. Based on desktop analysis, there is approximately 9' - 6" of clear space between Pole 10 and the back of curb, and 11' of clear space between Pole 9 and the back of curb. Only Pole 9 and Pole 10 will be evaluated for potential impacts from the proposed Trail alternatives.

Left image: aerial showing strain pole locations and span lengths at the intersection of Sikes Blvd. and Lake Hunter Dr. Middle image: the base of Pole 9. Right image: the base of Pole 10.

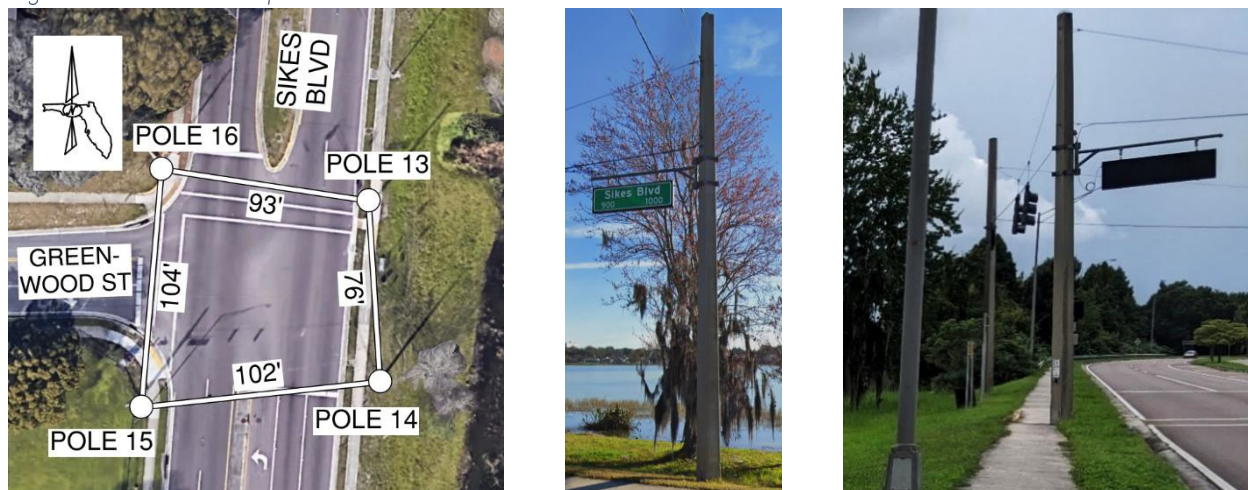
Figure 20: Strain Pole Representation at Sikes Blvd & West Greenwood St

There is a signalized intersection at Sikes Boulevard and West Greenwood Street with four concrete strain poles creating a box span. Based on a limited visual inspection, each of the poles appear to be in good condition. Figure 21 illustrates the strain pole locations and span lengths for this intersection. Based on desktop analysis, there is approximately 14' of clear space between Pole 14 and the back of curb, and 3' - 6" of clear space between Pole 13 and the back of curb. Only Pole 13 and Pole 14 will be evaluated for potential impacts from the proposed Trail alternatives.

Left image: aerial showing strain pole locations and span lengths at the intersection of Sikes Blvd. and Greenwood St. Middle image: Pole 14. Right image: a view of Pole 13 (foreground) and Pole 14

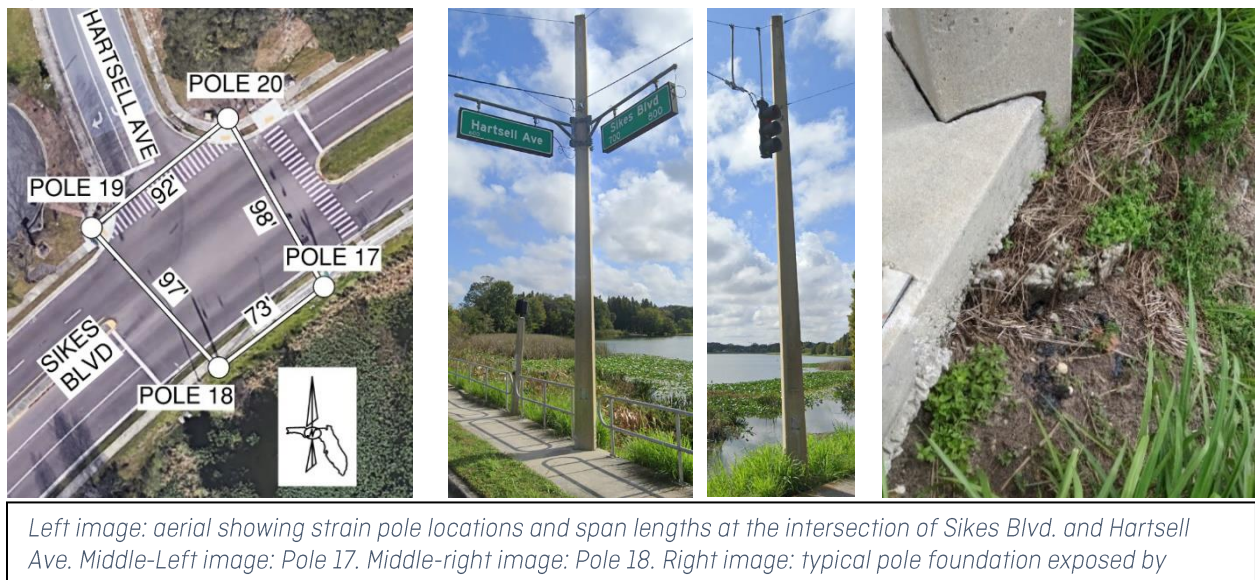
Figure 21: Strain Pole Representation at Sikes Blvd & Hartsell Ave

There is a signalized intersection at Sikes Boulevard and Hartsell Avenue with concrete strain poles at four corners creating a box span (see Figure 21). Based on a limited visual inspection, the surface of the concrete strain poles on the east side of Sikes Boulevard adjacent to Lake Hunter are free of cracking and damage. However, the foundations of these concrete strain poles have been exposed by erosion. The aerial image below illustrates the strain pole locations and span lengths at the intersection. Based on desktop analysis, there is approximately 8'-10" of clear space between Pole 18 and the back of curb, and 9'-4" of clear space between Pole 17 and the back of curb. Only Pole 17 and Pole 18 will be evaluated for potential impacts from the proposed Trail alternatives.

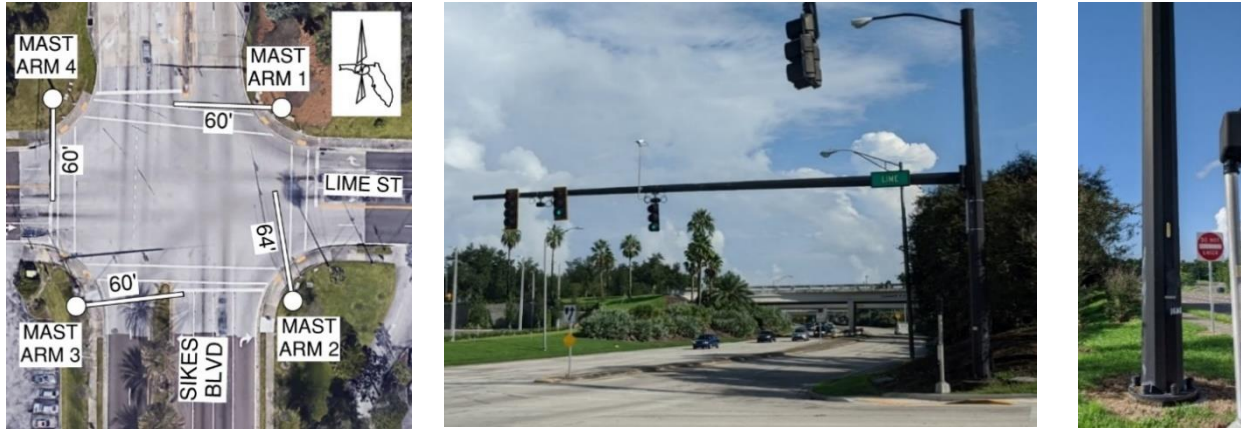
Figure 22: Mast Arm Representation at Sikes Blvd & West Lime St

There are four mast arm structures at the intersection of Sikes Boulevard and West Lime Street at the northern terminus of the project corridor (see Figure 22). Each traffic signal structure supports a single mast arm and luminaire. Based on a limited visual inspection, each mast arm appears to be in good condition, showing no signs of corrosion at the base of the upright. The mast arm locations and cantilever lengths can be seen in the aerial below. Based on desktop analysis, there is approximately 10' - 6" of clear space between Mast Arm 1 and the back of curb, and 13' of clear space between Mast Arm 2 and the back of curb. Only Mast Arm 1 and Mast Arm 2 will be evaluated for potential impacts from the proposed Trail alternatives.

Left image: aerial showing mast arm locations and lengths at the intersection of Sikes Blvd. and Lime St. Middle image: Mast Arm 1. Right image: the upright of Mast Arm 2.

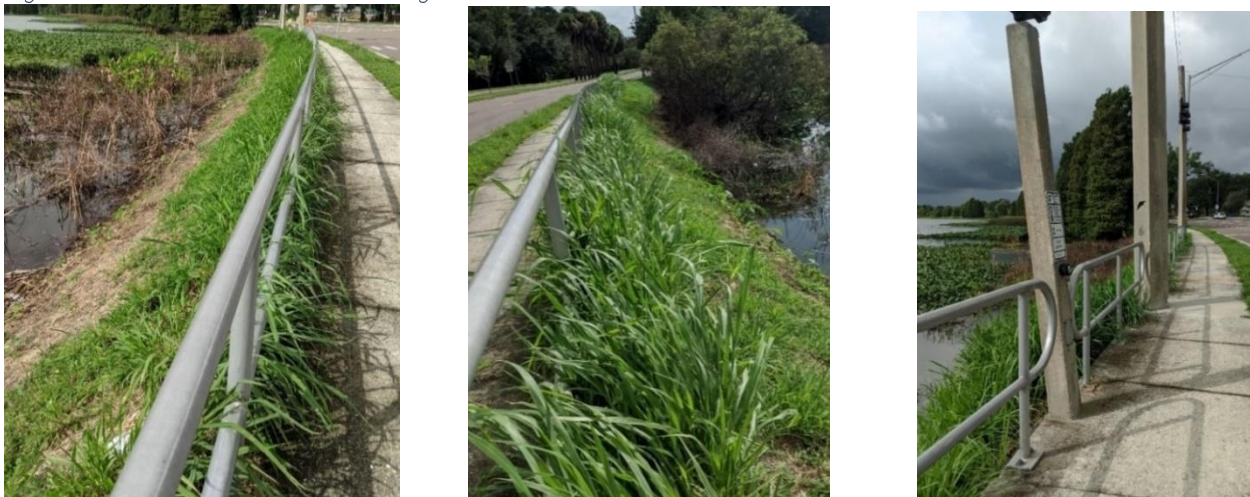
Figure 23: Bank on Lake Hunter Showing Erosion

There is evidence of erosion adjacent to the sidewalk bordering Lake Hunter starting approximately 80' west of the intersection at Hartsell Avenue and extending approximately 630' northeast along Sikes Boulevard (see Figure 23). At certain points along the bank, the underside of the sidewalk and concrete pole foundations have been exposed from erosion. The pedestrian signal pole at the southeast side of the Hartsell Avenue intersection is no longer supported on all sides by soil and is listing toward the lake. In the current condition, the stability of the sidewalk and concrete strain poles may be compromised by erosion.

Left image: view from 100' north of the Hartsell intersection, looking south along the Lake Hunter bank. Middle image: view from 100' north of the Hartsell intersection, looking north along the Lake Hunter bank. Right image: pedestrian signal pole listing toward Lake Hunter.

Given the proximity of the lake to the edge of the existing sidewalk and conditions observed in the field, erosion mitigation measures will need to be evaluated as part of the proposed Trail alternatives.

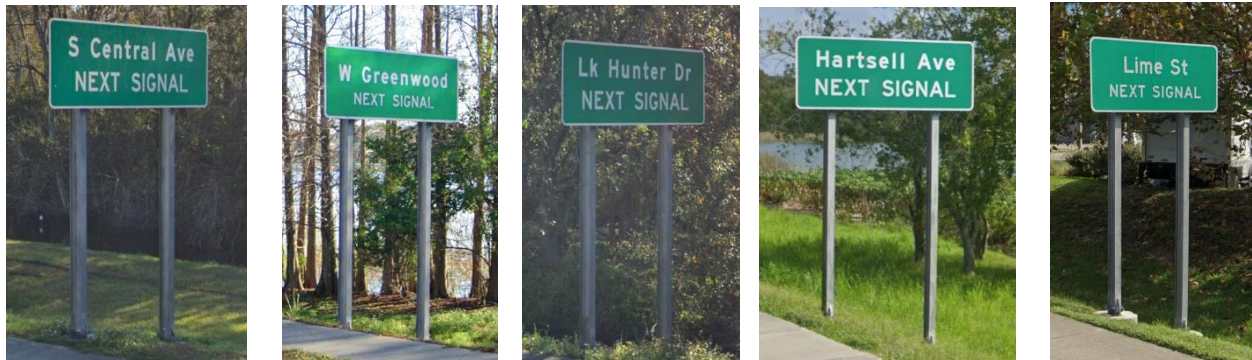
Figure 24: Multi-column Ground Signs

Based on a limited visual inspection, the advance street signs for South Central Avenue, Lake Hunter Drive, West Greenwood Street, Hartsell Avenue, and Lime Street are in good condition. They are multi-column ground signs, each consisting of two vertical posts with two horizontal panel supports. Each of these signs is placed adjacent to the back of the sidewalk with the position of the nearest vertical post about 2' - 4' from the edge of the sidewalk. Based on proximity to the existing sidewalk, each sign will be evaluated to determine if relocation is necessary to accommodate the proposed shared-use path.

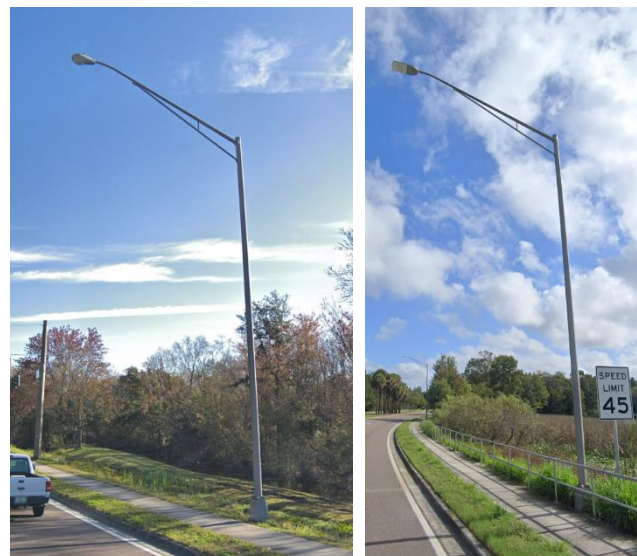
Figure 25: Typical Aluminum Street Lighting Along East Side of Corridor

There are many light poles spaced along the east side of Sikes Boulevard within the project limits. Based on a limited visual inspection, all the light poles within the project corridor appear to be in good condition. On the east side of the roadway, there is typically 6" of space between the back of the sidewalk and the edge of the light pole foundations. Based on proximity to the existing sidewalk, all the light poles will be evaluated to determine if relocation is necessary to accommodate the proposed Trail.
