**APPENDIX C**  
**REFERENCE MATERIALS**

Excerpts from Canals in South Florida: A Technical Support Document

The Florida Department of Transportation (FDOT) District One is conducting a Project Development and Environment (PD&E) Study along State Road (SR) 70 from County Road (CR) 29 to Lonesome Island Road in Highlands County, Florida. The purpose of this project is to improve roadway deficiencies of the SR 70 corridor from CR 29 to Lonesome Island Road. In addition, the project intends to enhance operational capacity of the corridor, thereby improving emergency evacuation/response times as well as access for standard roadway maintenance (FDOT 2022). The study is approximately 4.3-miles long and proposed improvements include realigning the two-lane undivided segment of SR 70 by reconstructing the two existing travel lanes on new alignment; the widening of this segment up to four lanes is also being considered. The realignment will occur on the south side of SR 70 where new right-of-way (ROW) is proposed and the existing canal that runs parallel to SR 70 will be rerouted; no additional ROW is required on the north side of the roadway. In addition, linear ponds will be constructed

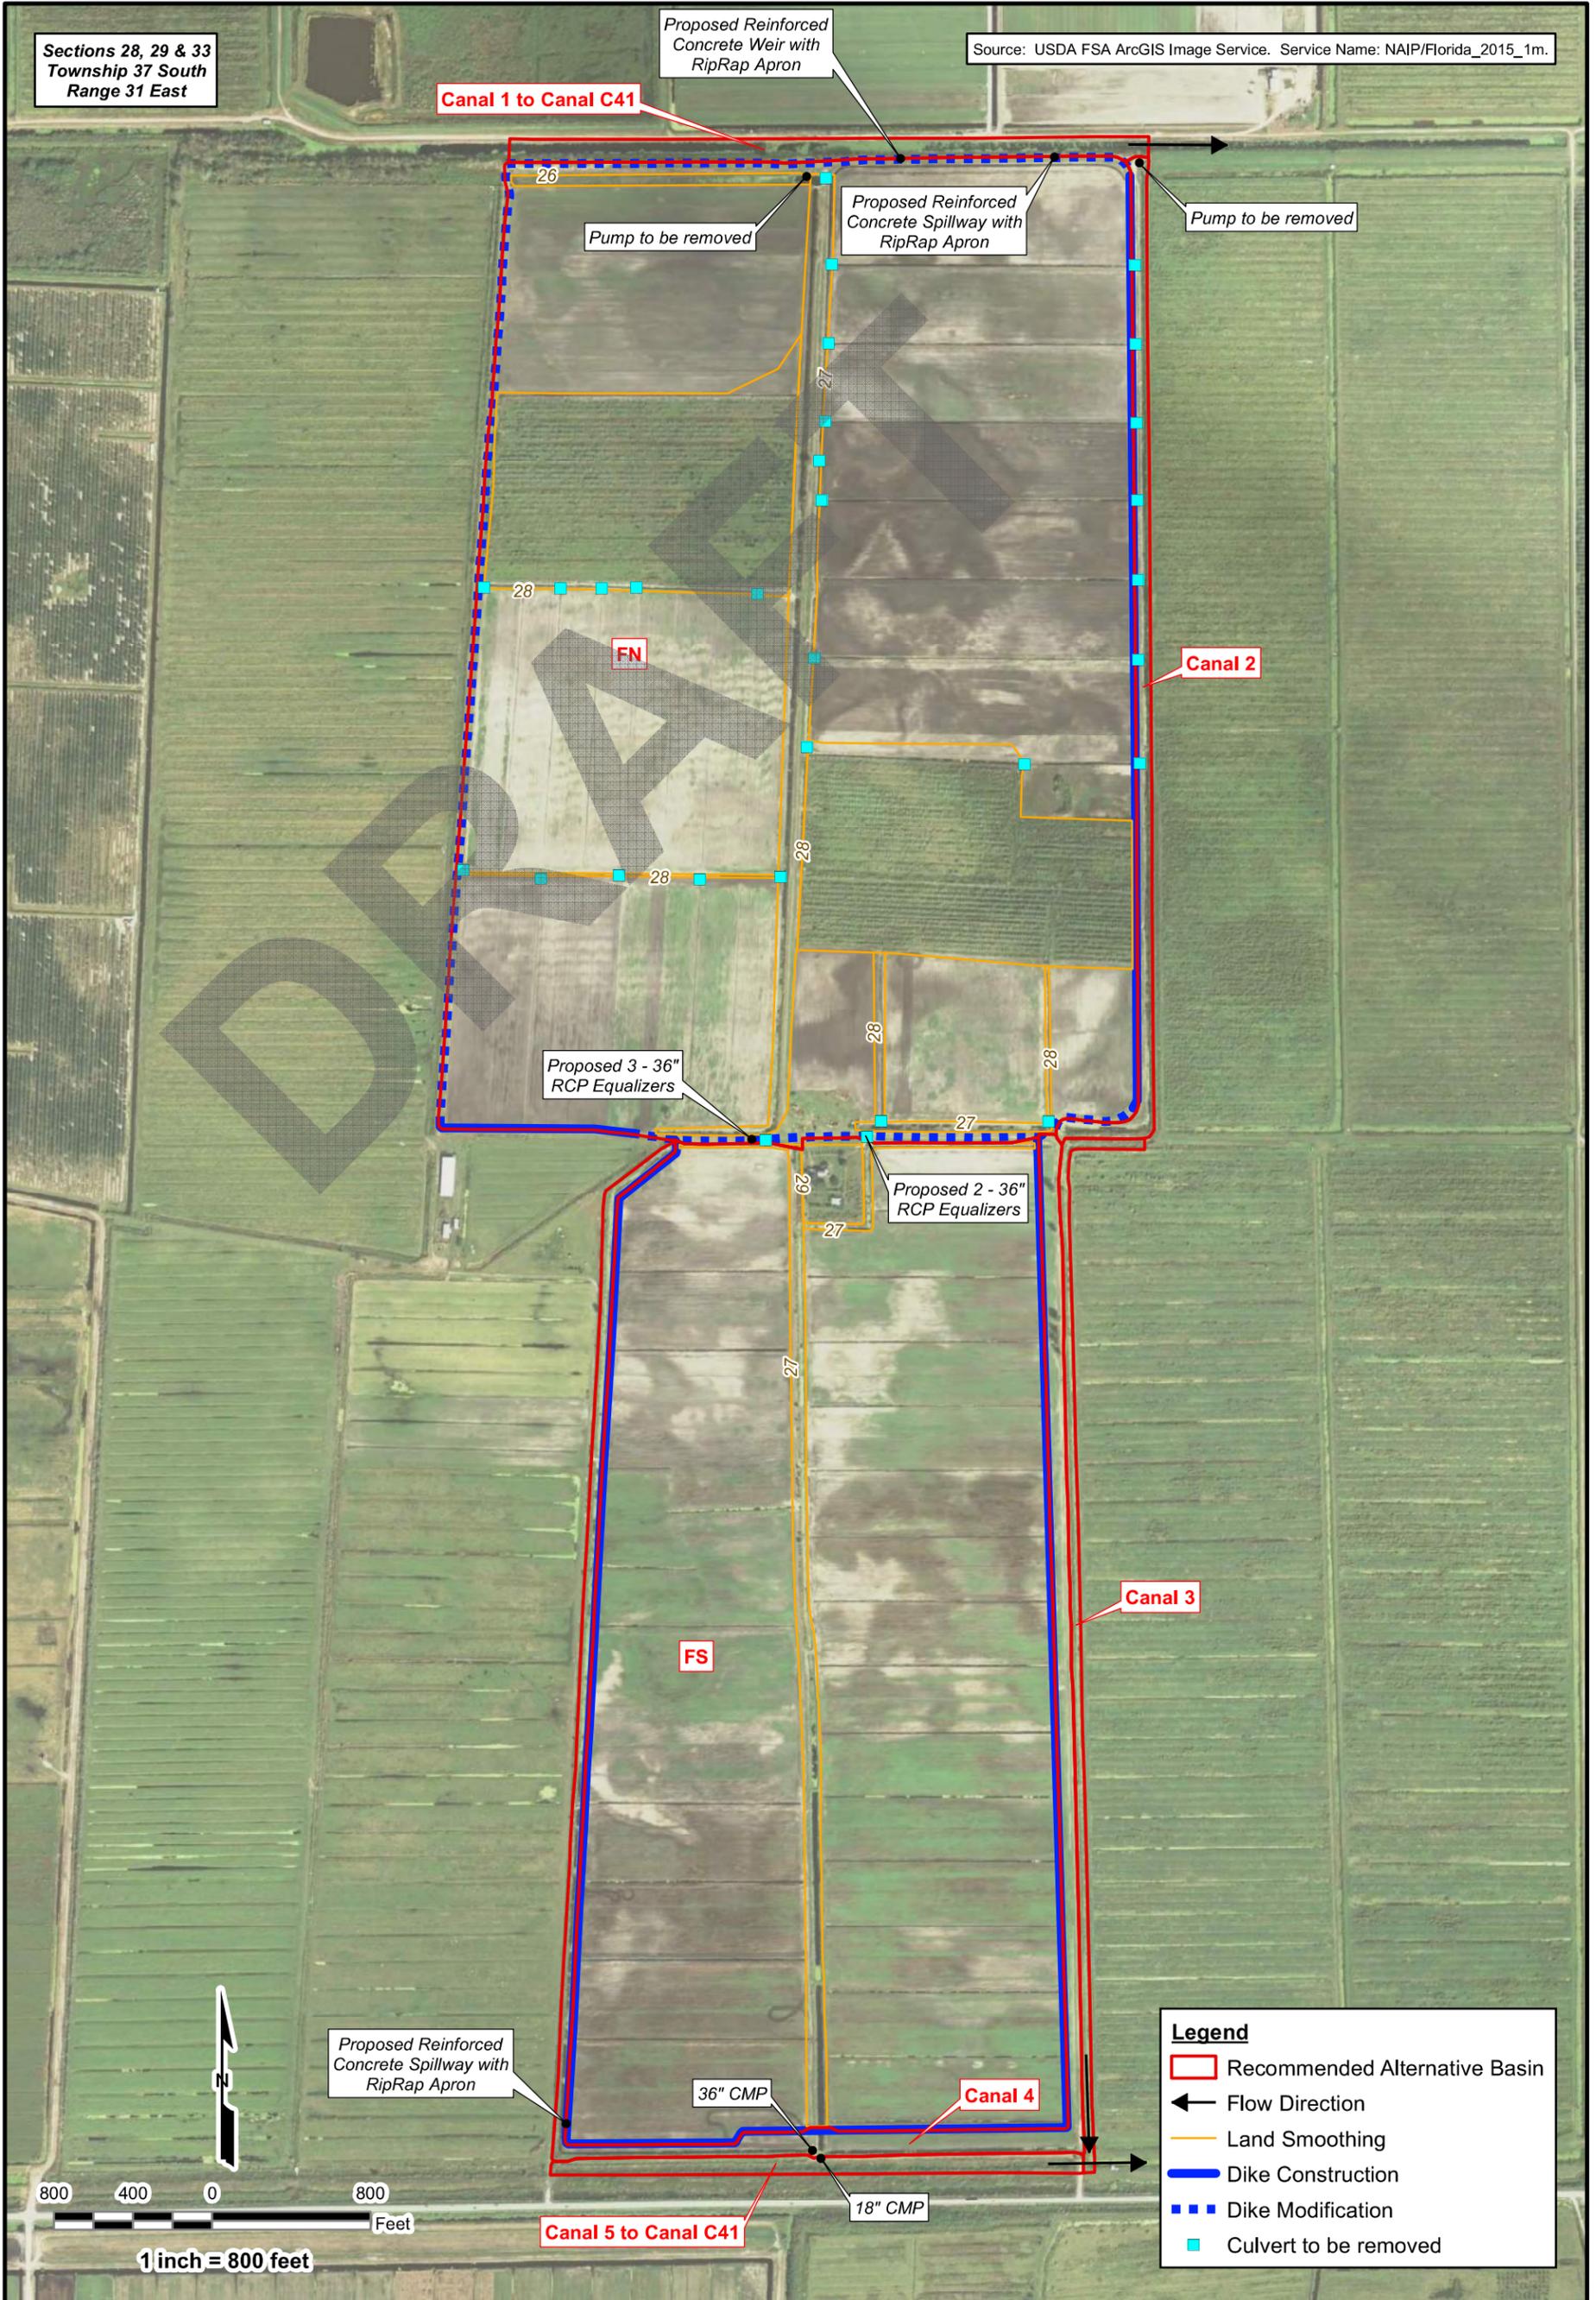
**Post-Restoration  
Recommended Alternative  
Basin Map**

The Recommended Alternative consists of dike construction and modifications along the property's boundary, construction of one reinforced concrete weir, two reinforced concrete emergency spillways, ditch filling, land smoothing areas, installation of equalizer culverts, pump removal, and existing culverts removal. The dike will be constructed or modified to an elevation of 31.0 feet-NAVD with 3:1 side slope and a top width of 12.0 feet to provide access for vehicles. These modifications will create two basins: FN to the north and FS to the south. The weir will be constructed in the FN basin. This weir will discharge into Canal 8. The proposed weir is trapezoidal with 15.0 feet wide broad crest at 28.0 feet (NAVD) with 10:1 side slope and top elevation at 31 feet-NAVD. The proposed spillways are trapezoidal with 15.0 feet wide broad crest at 29.0 feet-NAVD with 10:1 side slopes and top elevation at 31.0 feet-NAVD. Five 36 inch diameter reinforced concrete pipes are proposed to connect the north and south fields. The culvert invert elevation is proposed at 24.0 feet-NAVD. In addition, on-site borrow areas will be used as fill material to construct the dike. The borrow areas were not included in the hydrologic-hydraulic model. The initial conditions for the long term simulations and storm simulations were the same as Pre - Restoration conditions. The duration of the long term simulation was 20 years (January 1996 to December 2015). See **Section 2.1**, Recommended Alternative Basin Map for the location of the proposed structural improvements and drainage areas.

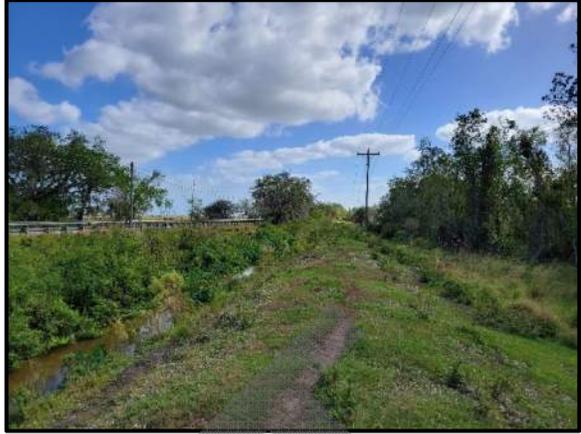
**Photo 2.4.** Southern ROW expansion and canal reroute intersecting wetland between FPC 1A and linear pond 1.

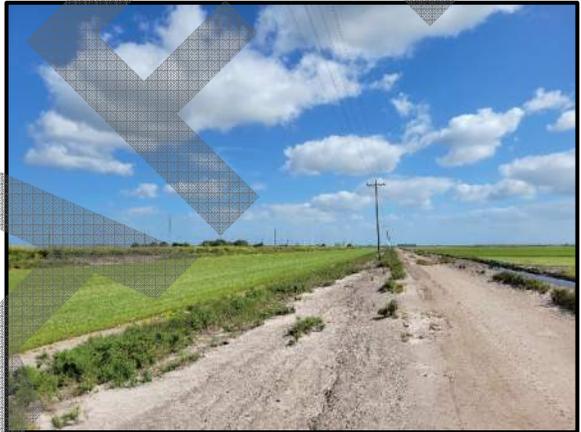
**Photo 2.6.** Southern ROW expansion and canal reroute conditions within RB sod farm.

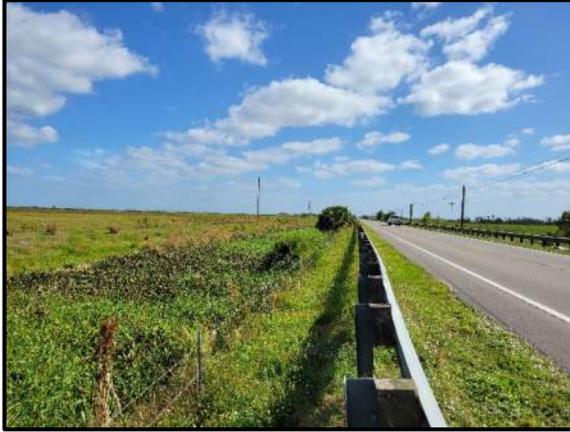
**Photo 2.9.** North canal conditions parallel within west half of SR 70 corridor.

The SR 70 APE consists of the ROW extending from CR 29 to Lonesome Island Road and is in Section 36, Township 37 South, Range 30 East; Sections 31-34, Township 37 South, Range 31 East; Section 1, Township 38 South, Range 30 East; Section 3-6, Township 38 South, Range 31 East (United States Geological Survey [USGS] Brighton NW and Childs 2013a, b) (**Figure 2.1**). The project area contains two defined FPCs: FPC 1A occupies the western terminus of the project corridor adjacent to south SR 70 and includes a 19-acre plot of lowland hay fields (**Photo 2.1**). FPC 2A currently overlaps a 31.5-acre portion of the Premier Citrus grove operation, including a proposed easement following Joe Durrance Road terminating at SR 70 (**Photo 2.2**). The proposed ROW expansion and canal reroute south of SR 70 initially proceeds through woodland pasture intersected by a minor bay swamp (**Photos 2.3, 2.4**). Conditions at L-7 Ranch Road transform into lowland pasture until reaching RB Farms which has intensive sod farming that shifts to abandoned citrus grove until Dosia Smith Road (**Photos 2.5-2.7**). At this point, ROW improvements adjust to the existing SR 70 boundaries terminating at Lonesome Island Road (**Photo 2.8**). Extensive disturbance within the project area largely consists of rural agricultural improvement particularly from citrus cultivation and sod farming. There are also parallel east and westbound canals that signal long-term destruction of the survey corridor (**Photos 2.9, 2.10**).

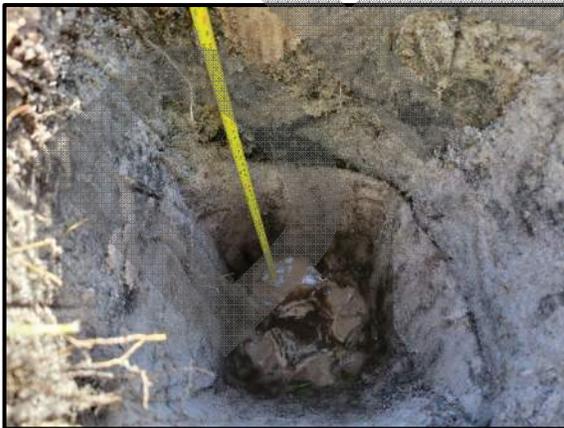
**Photo 5.1.** Standard soil profile within retention pond location of FPC 1A.

- FPC 1A (**Photo 5.1**): 0-20 centimeters below surface (cmbs) dark gray sand; 20-40 cmbs light gray sand; 40-100 cmbs grayish-brown sand; water at 70 cmbs

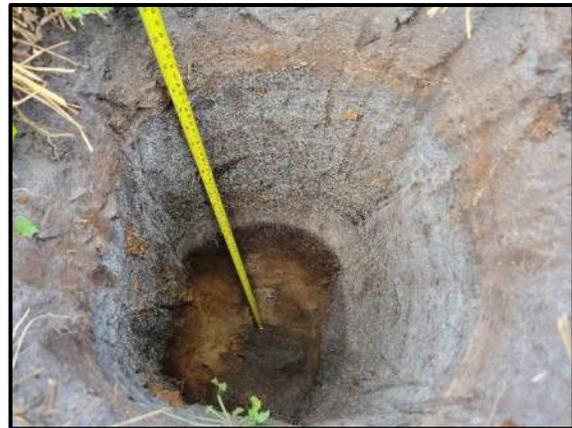
**Photo 5.2.** Standard soil profile within retention pond location of FPC 2A.

- FPC 2A (**Photo 5.2**): 0-50 cmbs gray sand; 50-60 cmbs dark brown sand; 60-100 cmbs light brown sand
- FPC 2A Easement (**Photo 5.3**): 0-30 cmbs light gray sand; 30-50 cmbs gray sand; 50-100 cmbs light gray sand

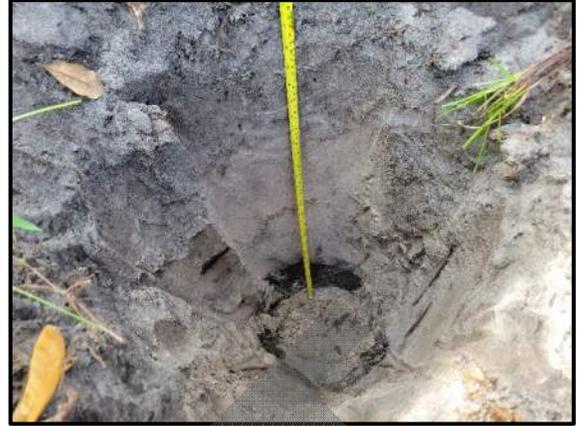
**Photo 5.4.** Standard soil profile between CR 29 and L-7 Ranch Road.

- CR 29 to L-7 Ranch Road (**Photo 5.4**): 0-30 cmbs gray sand; 30-80 cmbs light gray sand; 80-100 cmbs dark brown sand
- L-7 Ranch Road to RB Sod Farm (**Photo 5.5**): 0-20 cmbs dark gray sand; 20-40 cmbs light gray sand; 40-60 cmbs dark brown sand; 60-100 cmbs gray clay

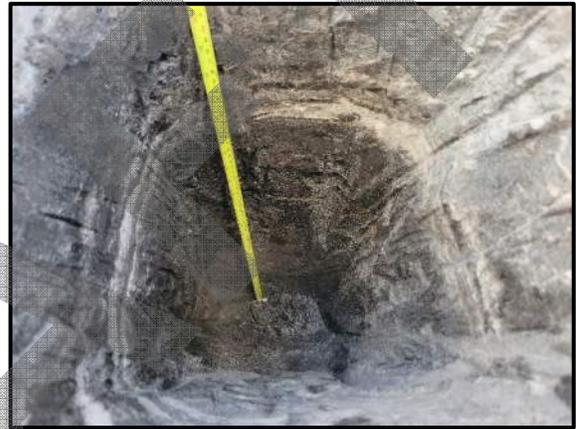
**Photo 5.6.** Standard soil profile within RB Sod Farm.

- RB Sod Farm to Southwind Road (**Photo 5.6**): 0-60 cmbs dark grayish-brown sandy clay; 60-100 cmbs gray clay
- Southwind Road to Lonesome Island Road (**Photo 5.7**): 0-100 cmbs mixed alternating layers of dark gray, gray, light gray and brown sand to sandy clay

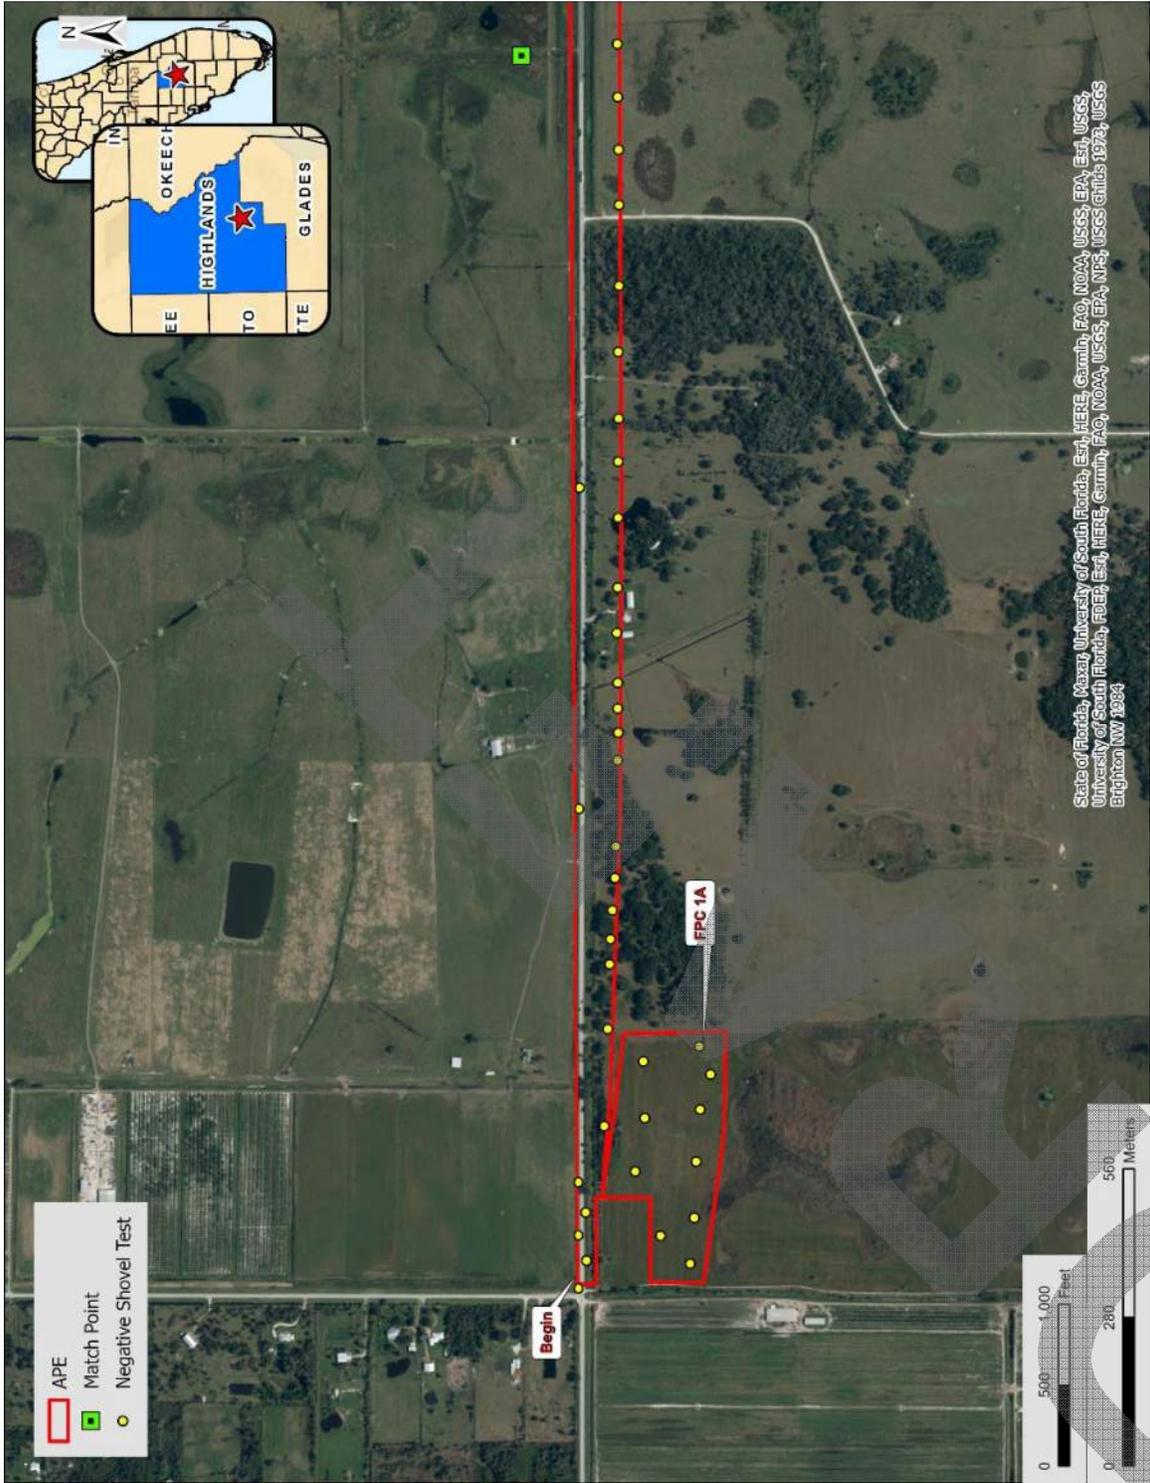
Figure 5.1. Approximate location of the shovel tests within the APE.

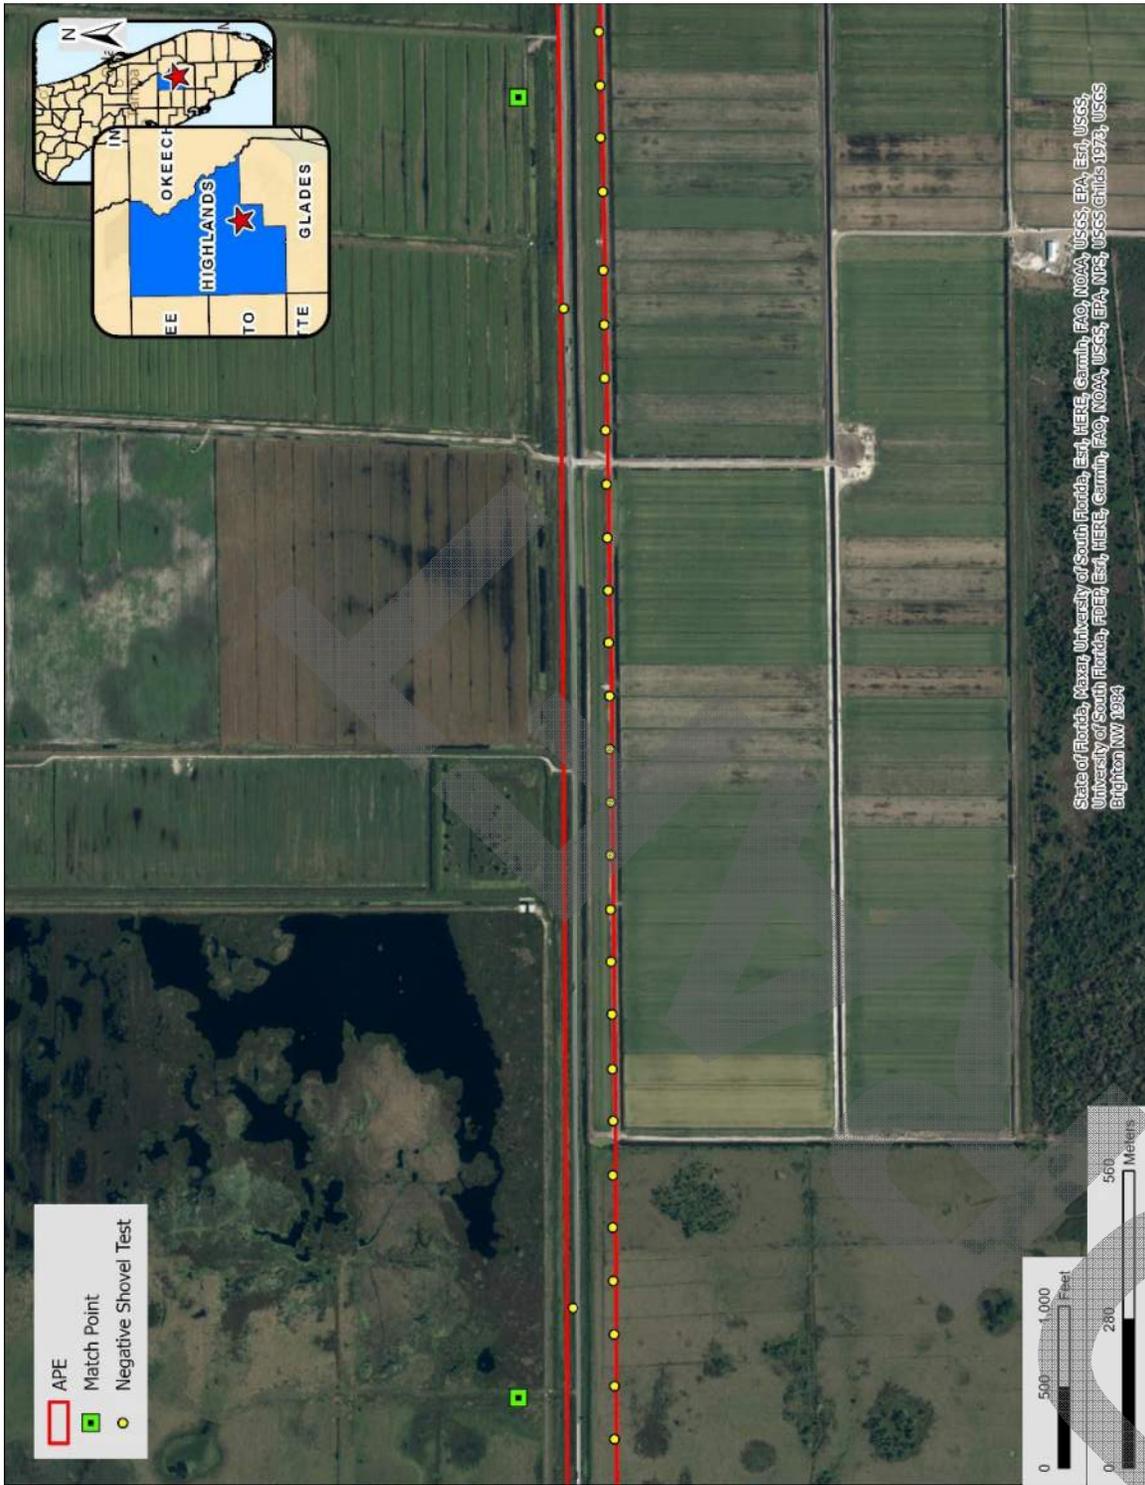
Figure 5.2. Approximate location of the shovel tests within the APE.

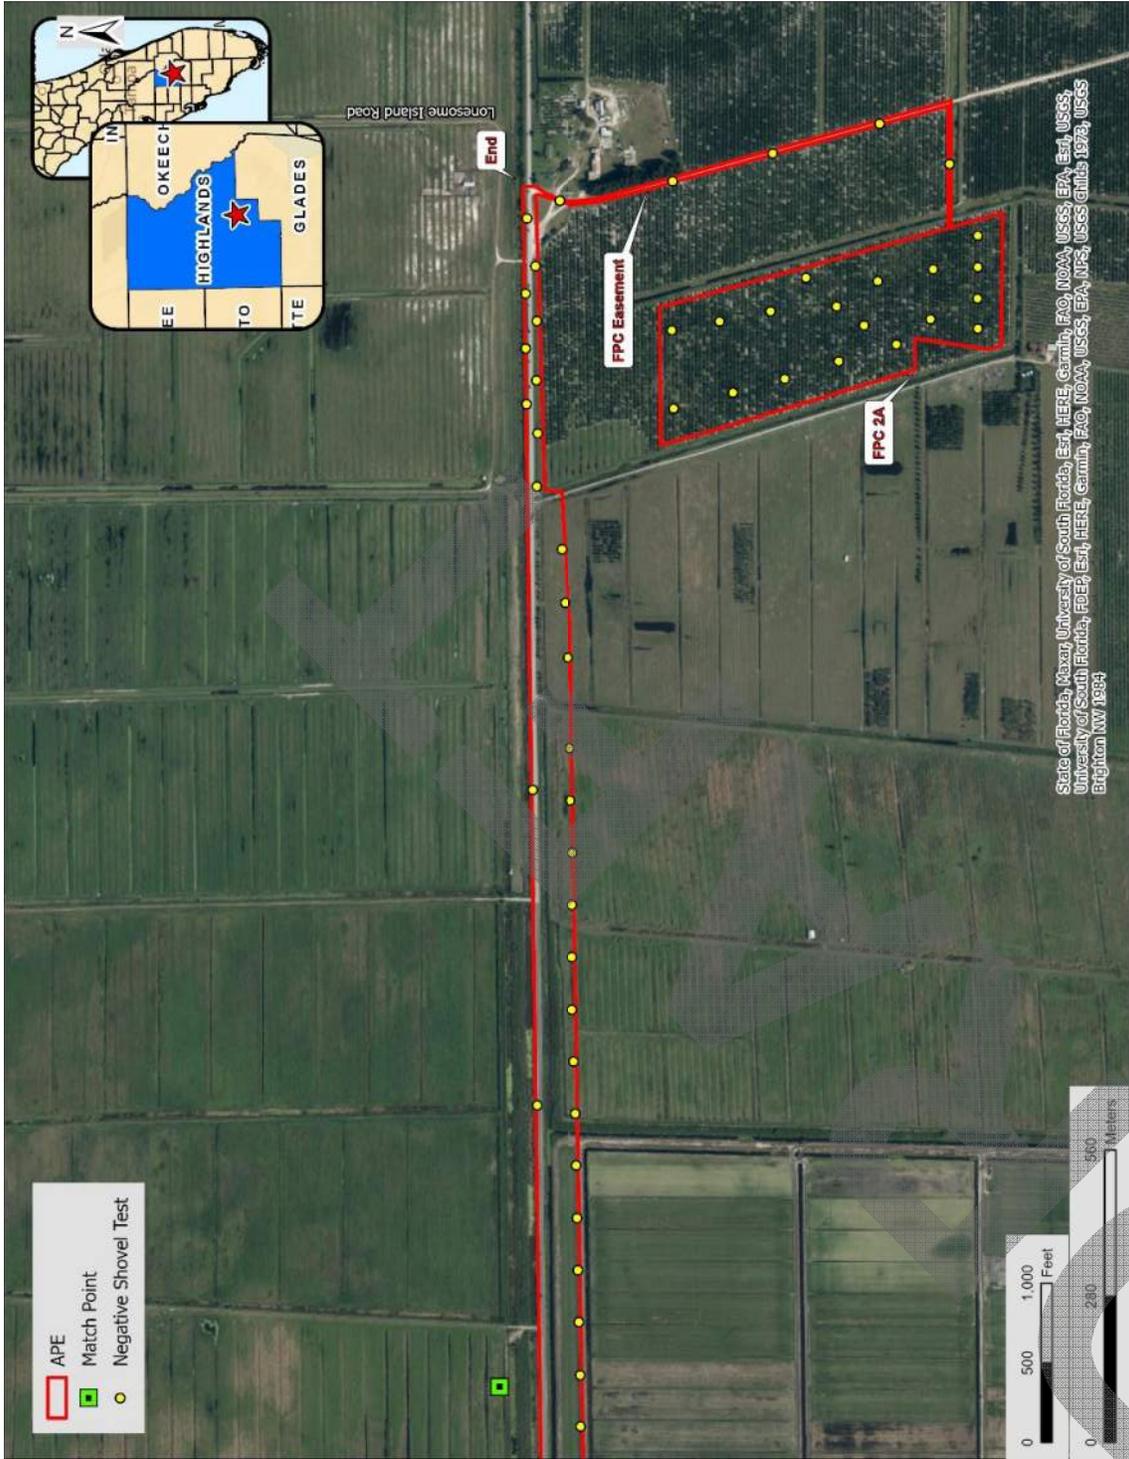
**Figure 5.3.** Approximate location of the shovel tests within the APE.

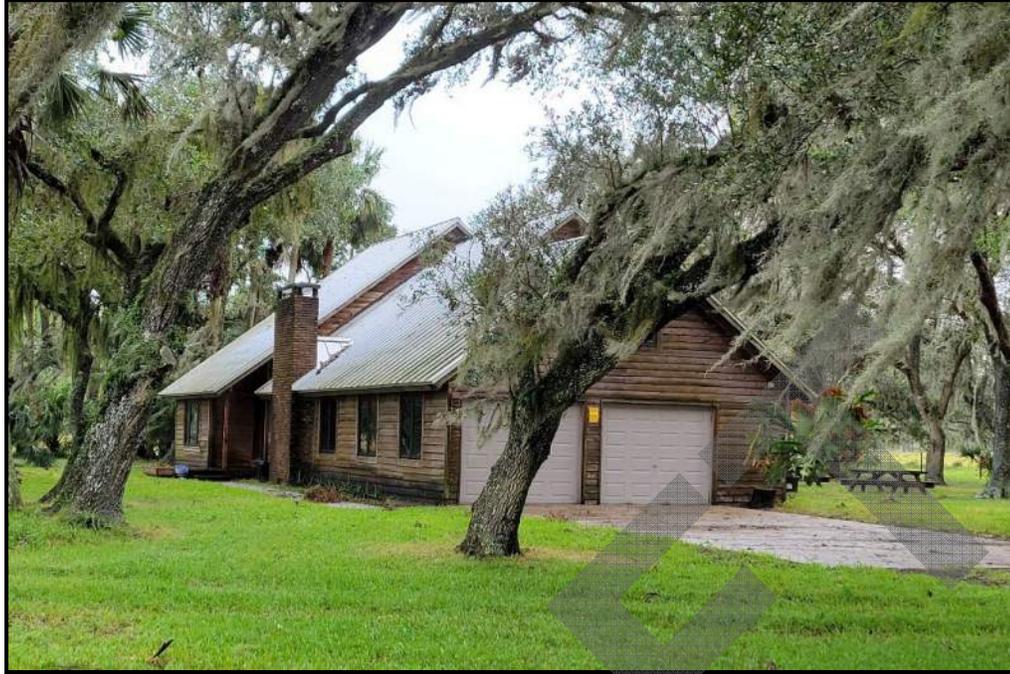
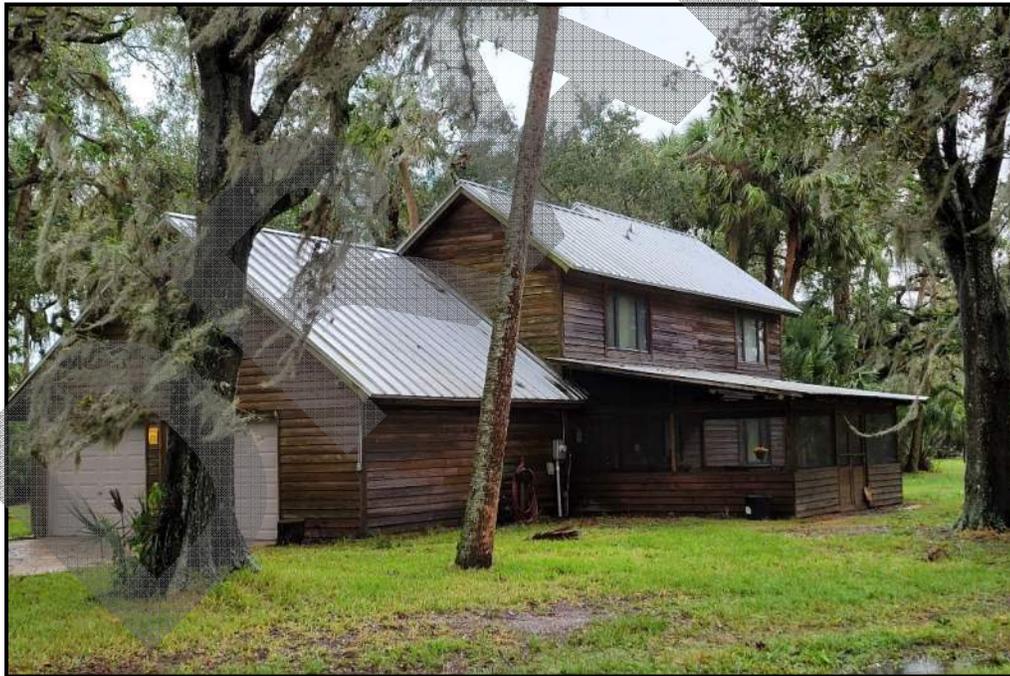
**Photo 5.8.** 2121 SR 70 E (8HG01577), looking south.

**Photo 5.9.** 2121 SR 70 E (8HG01577), looking east.

**8HG01577:** The Frame Vernacular style building at 2121 SR 70 E was constructed in ca. 1977 (**Photos 5.8 and 5.9**). The two-story, irregular plan building rests on a concrete slab and continuous concrete foundation and has a wood frame structural system clad in natural, unfinished wood siding. The side gable roofs and shed roof are covered with standing seam sheet metal. A brick chimney is located on the eave end of the northeast elevation. The main entryway is on the northeast elevation through a single door recessed beneath the principal roof with a wooden porch support and wooden platform. Visible windows include a mixture of individual three-light metal picture units and individual two-light metal sliding units. Distinguishing architectural features include overhanging eaves with boxed rafter tails, natural wood exterior, wood window and door trim, and corner boards. Alterations include replacement roofing. It is unclear whether additions have been made to the building as the historic aerial photographs are obscured by heavy tree coverage. A gable roof segment comprised of two one-car garages is located on the north elevation. Overall, the building lacks sufficient architectural features and is not a significant embodiment of a type, period, or method of construction. In addition, background research did not reveal any historic associations with significant persons and/or events. As a result, 8HG01577 does not appear eligible for listing in the NRHP, either individually or as part of a historic district.

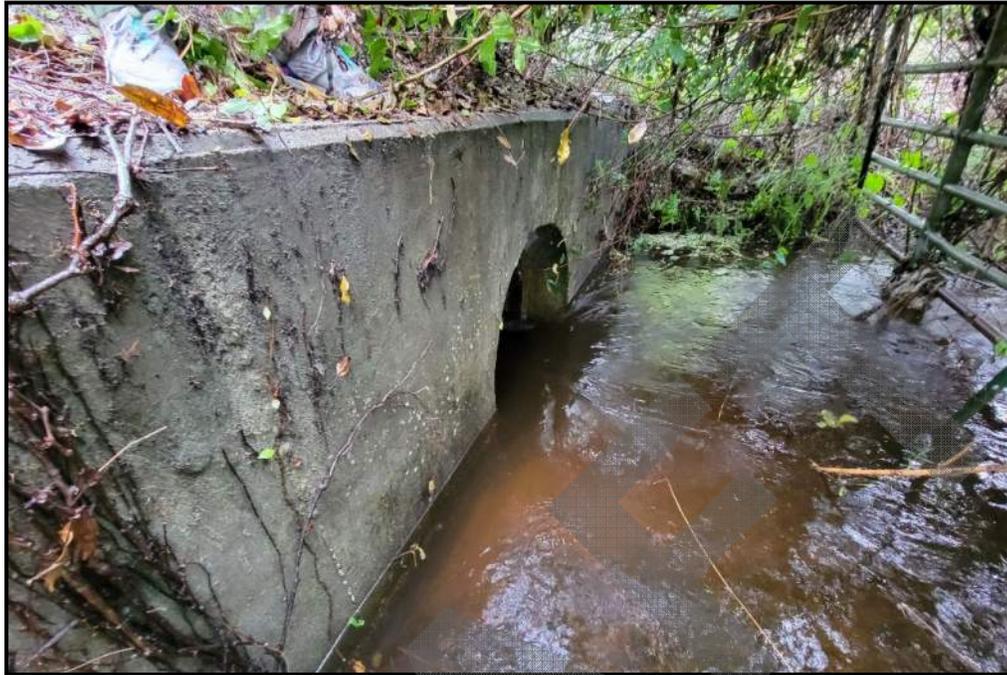
**Photo 5.10.** SR 70 Cross Drain Culvert (8HG01578), looking northeast.

guardrails are located along the north and south sides of the roadway. The culvert is approximately 50-ft wide with a paved roadway that is approximately 20-ft wide.

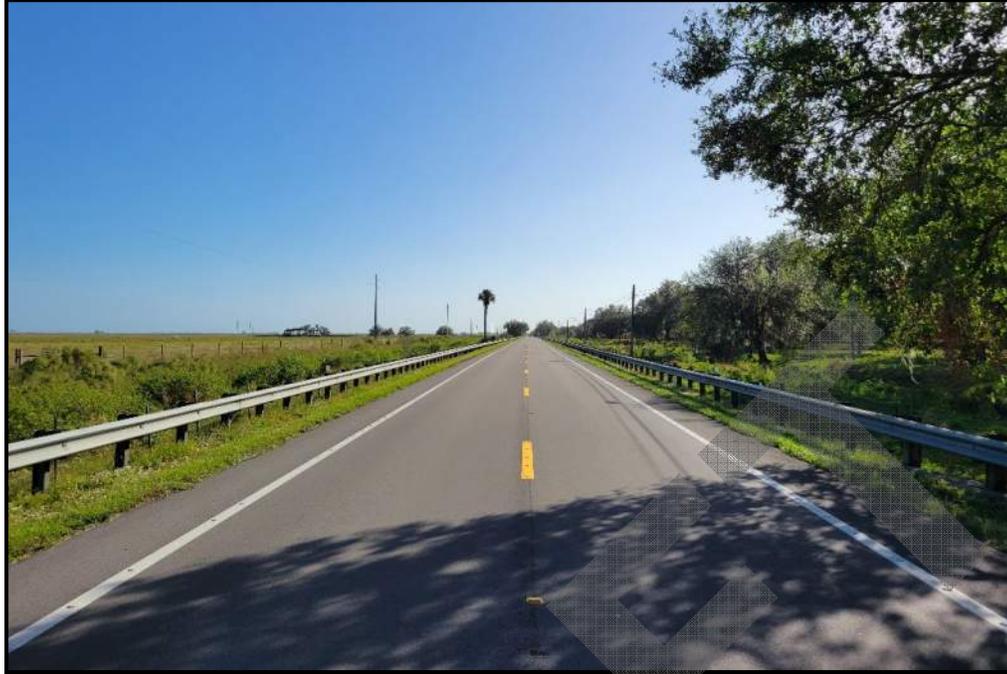
**Photo 5.11.** SR 70 (8HG01579), looking east.

**8HG01579:** The segment of SR 70 (also known as Fritz Street within the APE) is situated along the 37 South/38 South Township line and passes through Section 36 of Township 37 South, Range 30 East; Section 1 of Township 38 South, Range 30 East; Sections 31 – 34 of Township 37 South, Range 31 East; Sections 3, 4, 6, and 7 of Township 38 South, Range 31 East (USGS 1953a, 1953b). The segment within the APE is a two-lane undivided roadway that is 27-ft wide and spans approximately 4.3 miles from CR 29 to Lonesome Island Road (**Photo 5.11**). The road is lined with metal guardrails and drainage canals run parallel to the north and south of the roadway. The surrounding viewshed consists predominantly of irrigated agricultural land and wetlands. The segment of SR 70 within the APE was historically known as Florida State Road 8 and was constructed by ca. 1926 (FDOT 1926). The route spanned from Haines City through Sebring to Ft. Pierce. The alignment within the APE does not appear to have been significantly altered since ca. 1926; however, the road has been improved to modern standards.

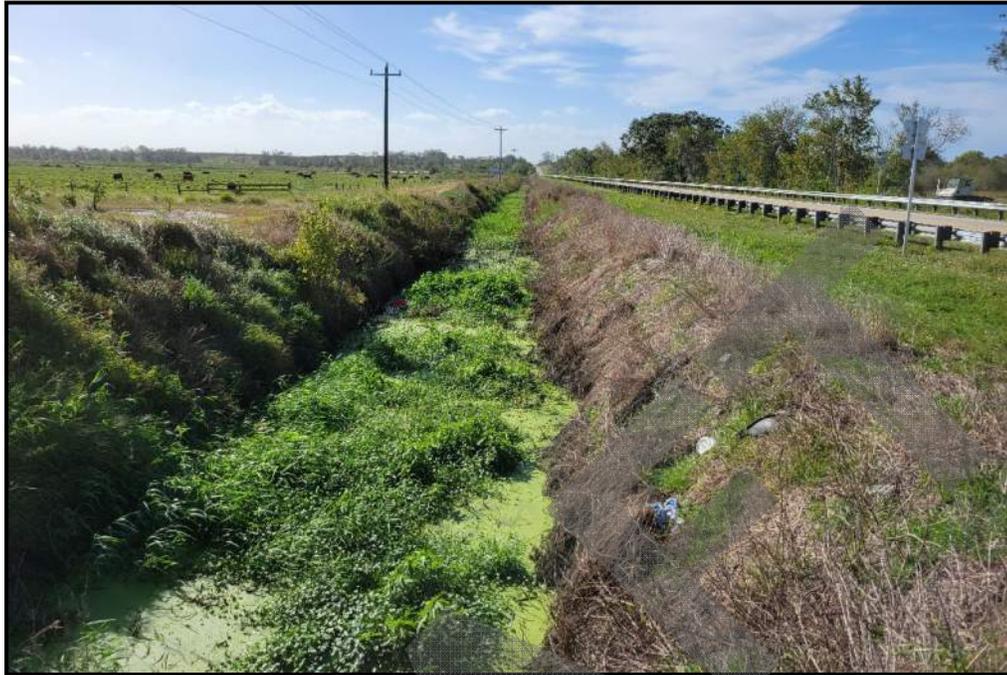
**Photo 5.12.** SR 70 Drainage Canals (8HG01580), looking west. The photo is of the southern canal and is representative of the segments throughout the APE.

**8HG01580:** The SR 70 Drainage Canals flow through Section 1 of Township 38 South, Range 30 East and Sections 3, 4, 6, and 7 of Township 38 South, Range 31 E (USGS 1953a, 1953b). The segments located within the APE are approximately 3.8 miles long (south of SR 70) and 4.3 miles long (north of SR 70) and range from 20 – 40-ft wide, with steep earthen banking that is moderately overgrown with vegetation (**Photo 5.12**). Within the APE, the non-navigable canals flow parallel along the south side of SR 70 from south of CR 29 in the west to just east of Southwind Road and parallel to the north side of SR 70 from CR 29 in the west to Lonesome Island Road in the east. The canals were constructed in ca. 1943 or earlier and several minor unnamed irrigation ditches flowing perpendicularly into the canals have been constructed over the years (USDA 1943). In addition, several driveways/minor roads have been constructed over the segments. A South Florida Water Management District (SFWMD) map of the area was reviewed, as well as a ca. 1973 map of the Central and Southern Florida Flood Control District (CSFFCD), and the canal was not represented on these maps further indicating the common nature of the canals (SFWMD n.d.(b); U.S. Army Corps of Engineers 1973). They are not associated with surrounding major drainage projects. Surveying and recording the entire linear resource are beyond the scope of this project, as such only the segments within the APE were surveyed and recorded. The canals continue briefly outside of the APE, including a segment approximately 0.34 miles long to the west of CR 29 and 0.74 miles to the east of Lonesome Island Road. Overall, the SR 70 Drainage Canals are a common example of early twentieth century drainage canals found throughout Highlands County and lack unique design or engineering features. Background research did not reveal any historic associations with significant persons and/or events. As a result,

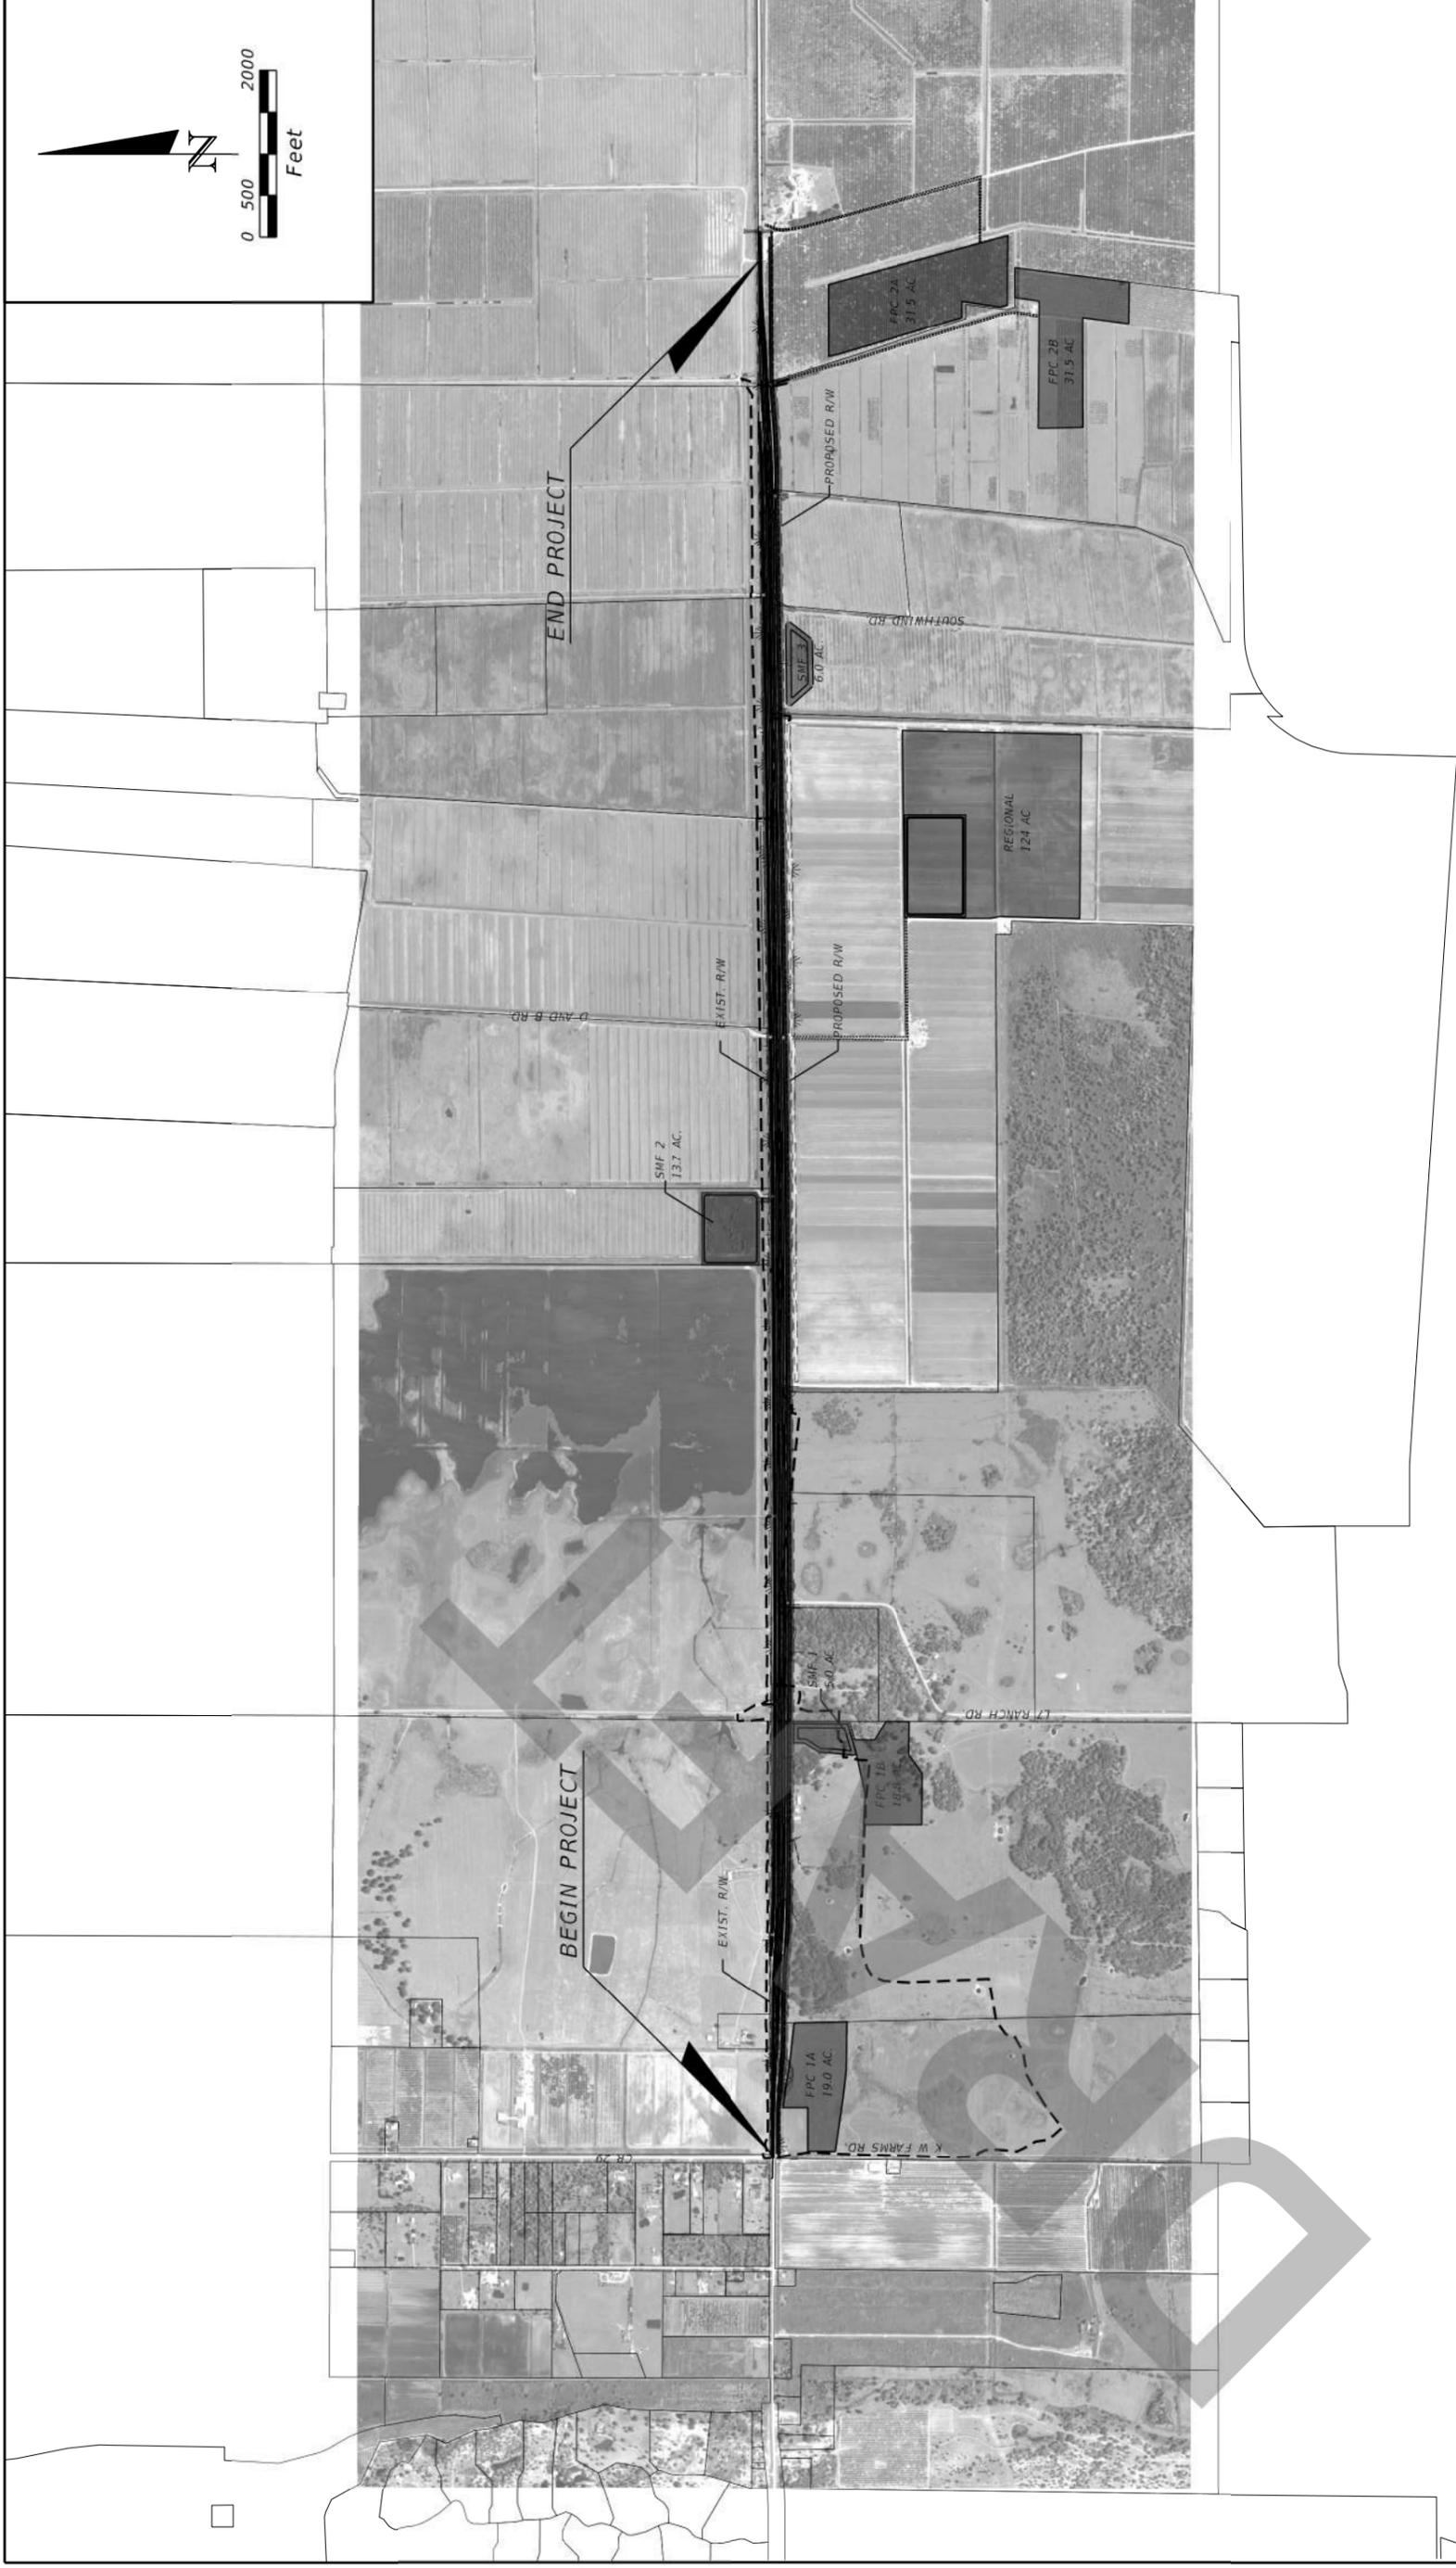
REVISIONS		STATE OF FLORIDA		POST-DEVELOPMENT		SHEET NO.	
DATE	DESCRIPTION	ROAD NO.	DEPARTMENT OF TRANSPORTATION	FINANCIAL PROJECT ID	EXHIBIT 5		
		SR 70	HIGHLANDS COUNTY	414506-1-22-01

DO NOT USE THE INFORMATION ON THIS SHEET FOR CONSTRUCTION PURPOSES. THIS SHEET IS IN THE PLANS FOR DOCUMENTATION AND TO ASSIST CONSTRUCTION PERSONNEL WITH DRAINAGE CONCERNS.
