Natural Resource Evaluation Addendum

Florida Department of Transportation

SR 72 at SR 70 Project Development and Environment Study

Limits of Project: SR 72 from CR 661 to SR 70, and SR 70 from CR 661 to the Peace River Bridge

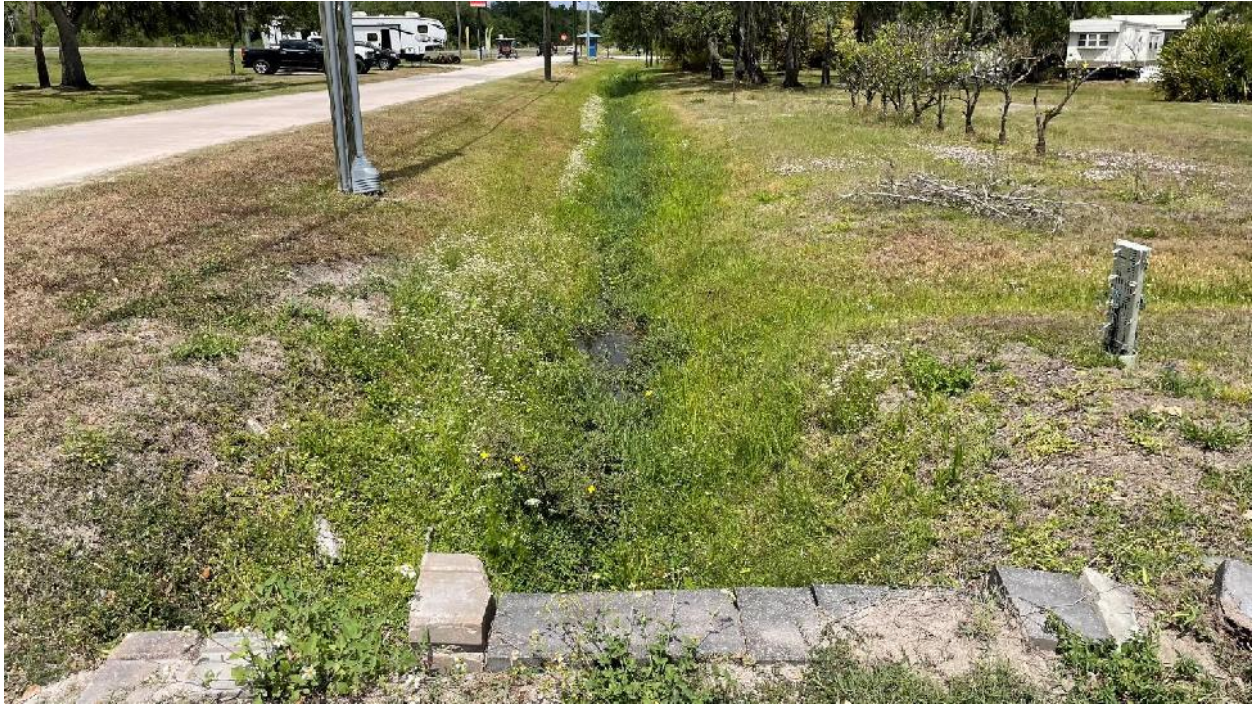
**Photo 1** – view west along Surface Water 6 (FLUCCS 5100), an excavated ditch in the northwest portion of the project area. The west portion of the ditch runs through maintained uplands and crosses under roadways via culverts and connects to wetlands west of the project area.

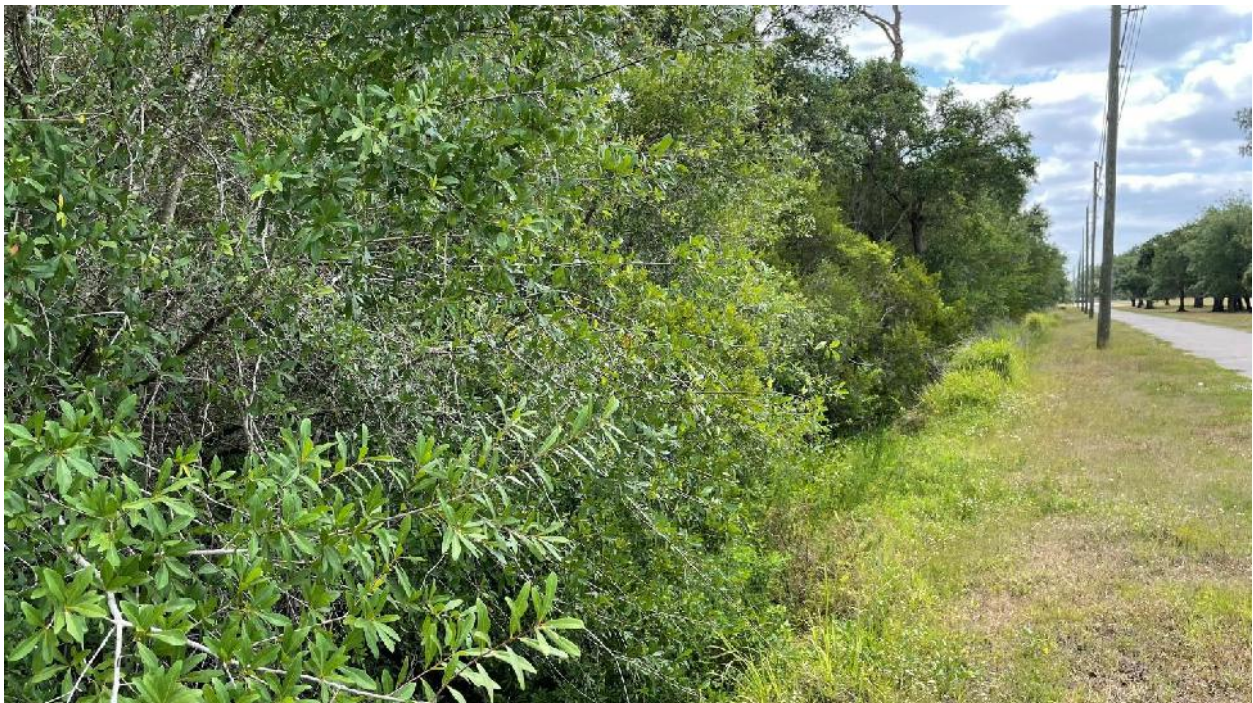
**Photo 2** – view east along Surface Water 6 (FLUCCS 5100), located between shrubby-forested uplands to the north and a mowed area adjacent to a paved walking path to the south. Surface Water 6 runs along the north boundary parallel to the paved pathway and ends at the Peace River.

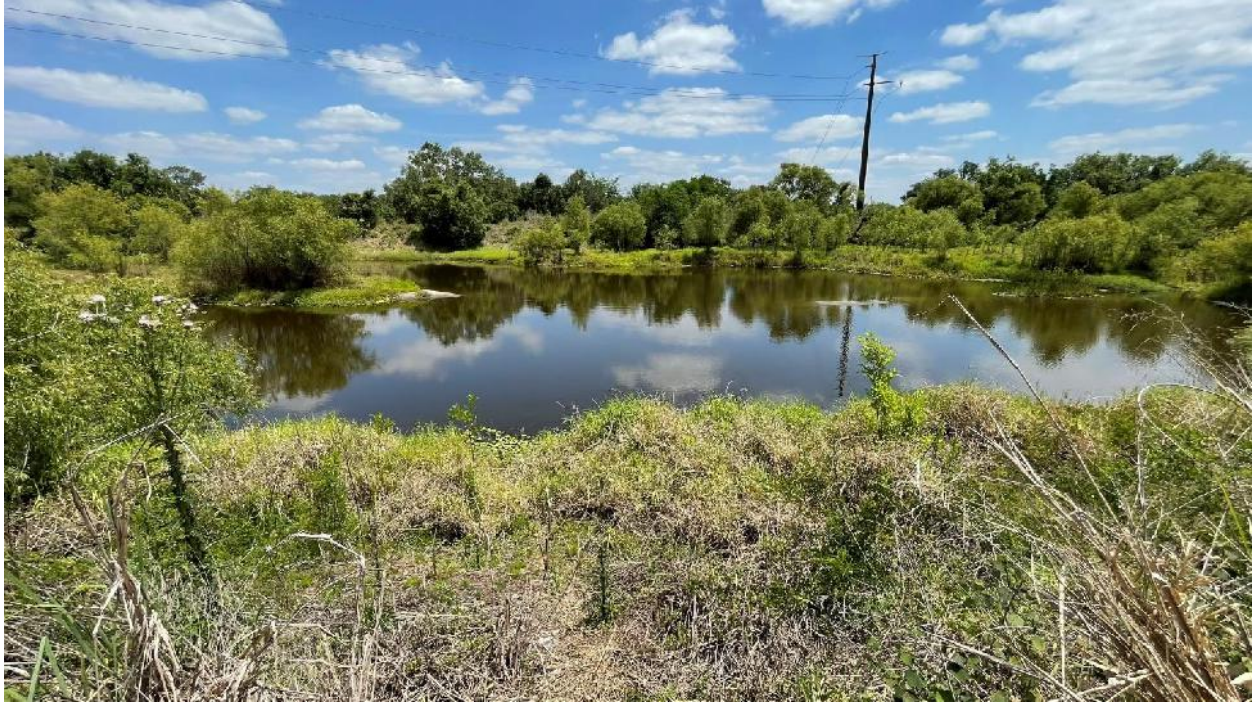
**Photo 3** – view east toward the east lobe of Wetland 6 (FLUCCS 5100) south of SR 70, consisting of open water interspersed with vegetated islands.

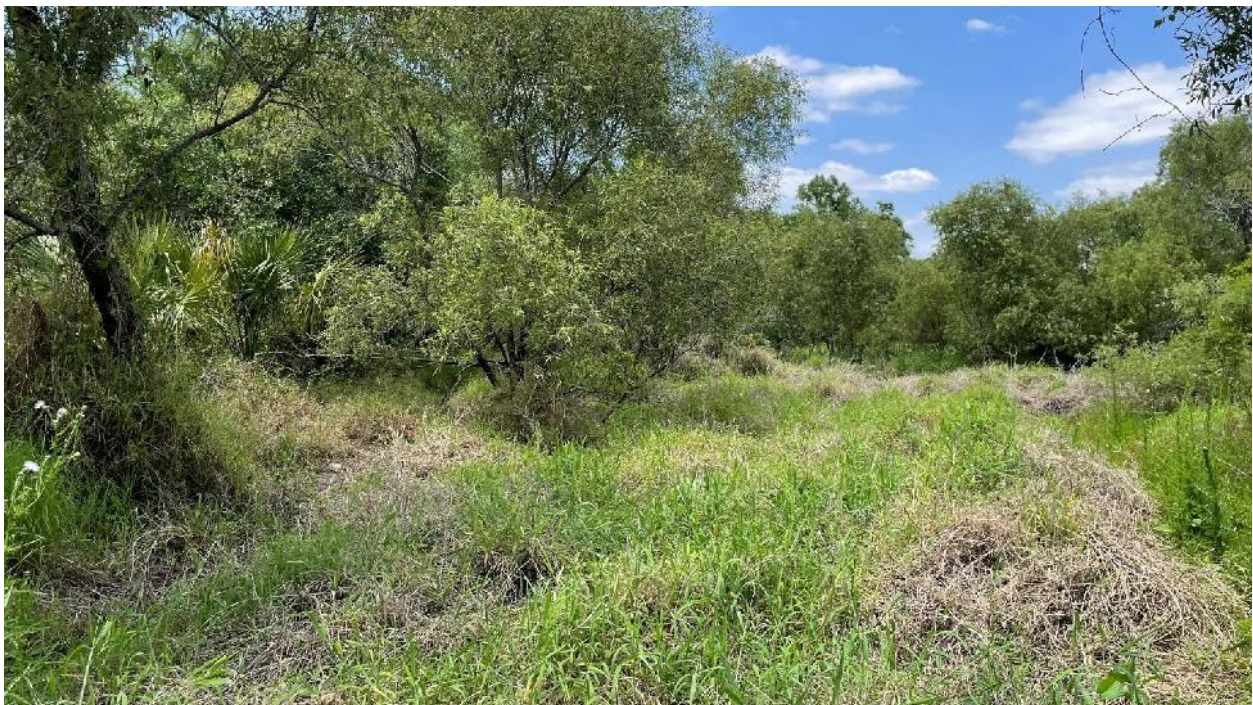
**Photo 4** – view north within the west lobe of Wetland 6 (FLUCCS 6180) south of SR 70. Carolina willow (*Salix caroliniana*) dominates the subcanopy and canopy while paragrass (*Urochloa mutica*) dominates groundcover.

This land use type is represented by the west lobe of Wetland 6, which is part of the Peace River floodplain. The west lobe is a shrub-scrub wetland habitat separated from the east lobe by an upland berm. Groundcover is dominated by the Category I invasive species paragrass (*Urochloa mutica*) and the subcanopy is dominated by Carolina willow. At the time of field review, soils were dry at the wetland edges and moist in the interior with patches of saturated soil. Protected species were not observed, but wildlife likely utilize Wetland 6 to cross beneath SR 70.

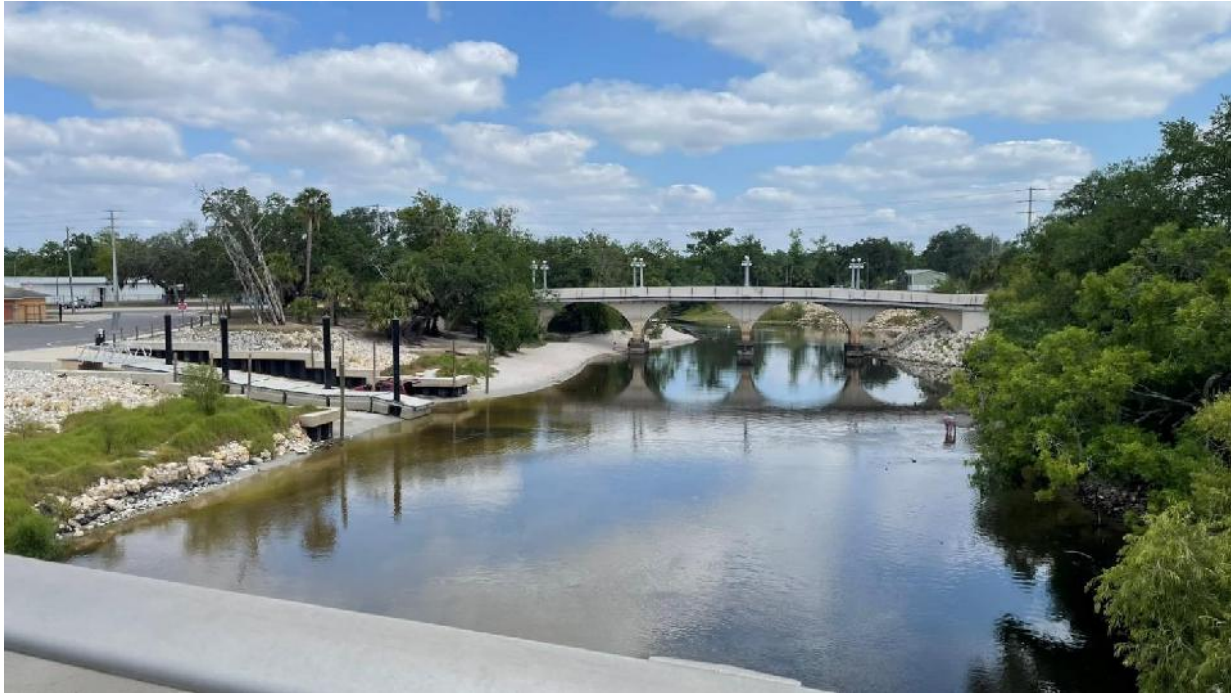
**Photo 5** – view north from the SR 70 bridge crossing the Peace River, Wetland 7 (FLUCCS 5100), bounded by a recreational area with a boat ramp to the west. At the time of field review, waters adjacent to the project area were being utilized for wading, kayaking, and fishing.

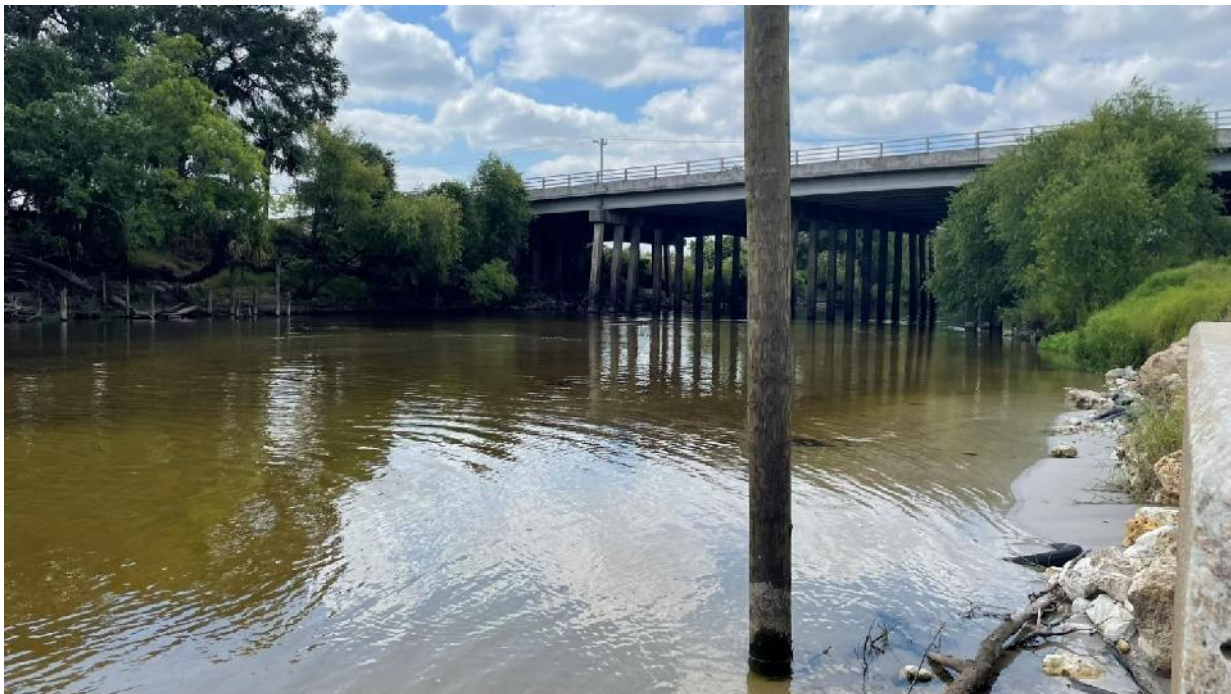
**Photo 6** – view south toward the SR 70 bridge crossing the Peace River, Wetland 7 (FLUCCS 5100). The river is shallow and sandy at this location, with banks that are largely altered by previous construction. Portions of the river banks contain trees and shrubs including Brazilian pepper (*Schinus terebinthifolia*), Carolina willow, and buttonbush (*Cephalanthus occidentalis*).

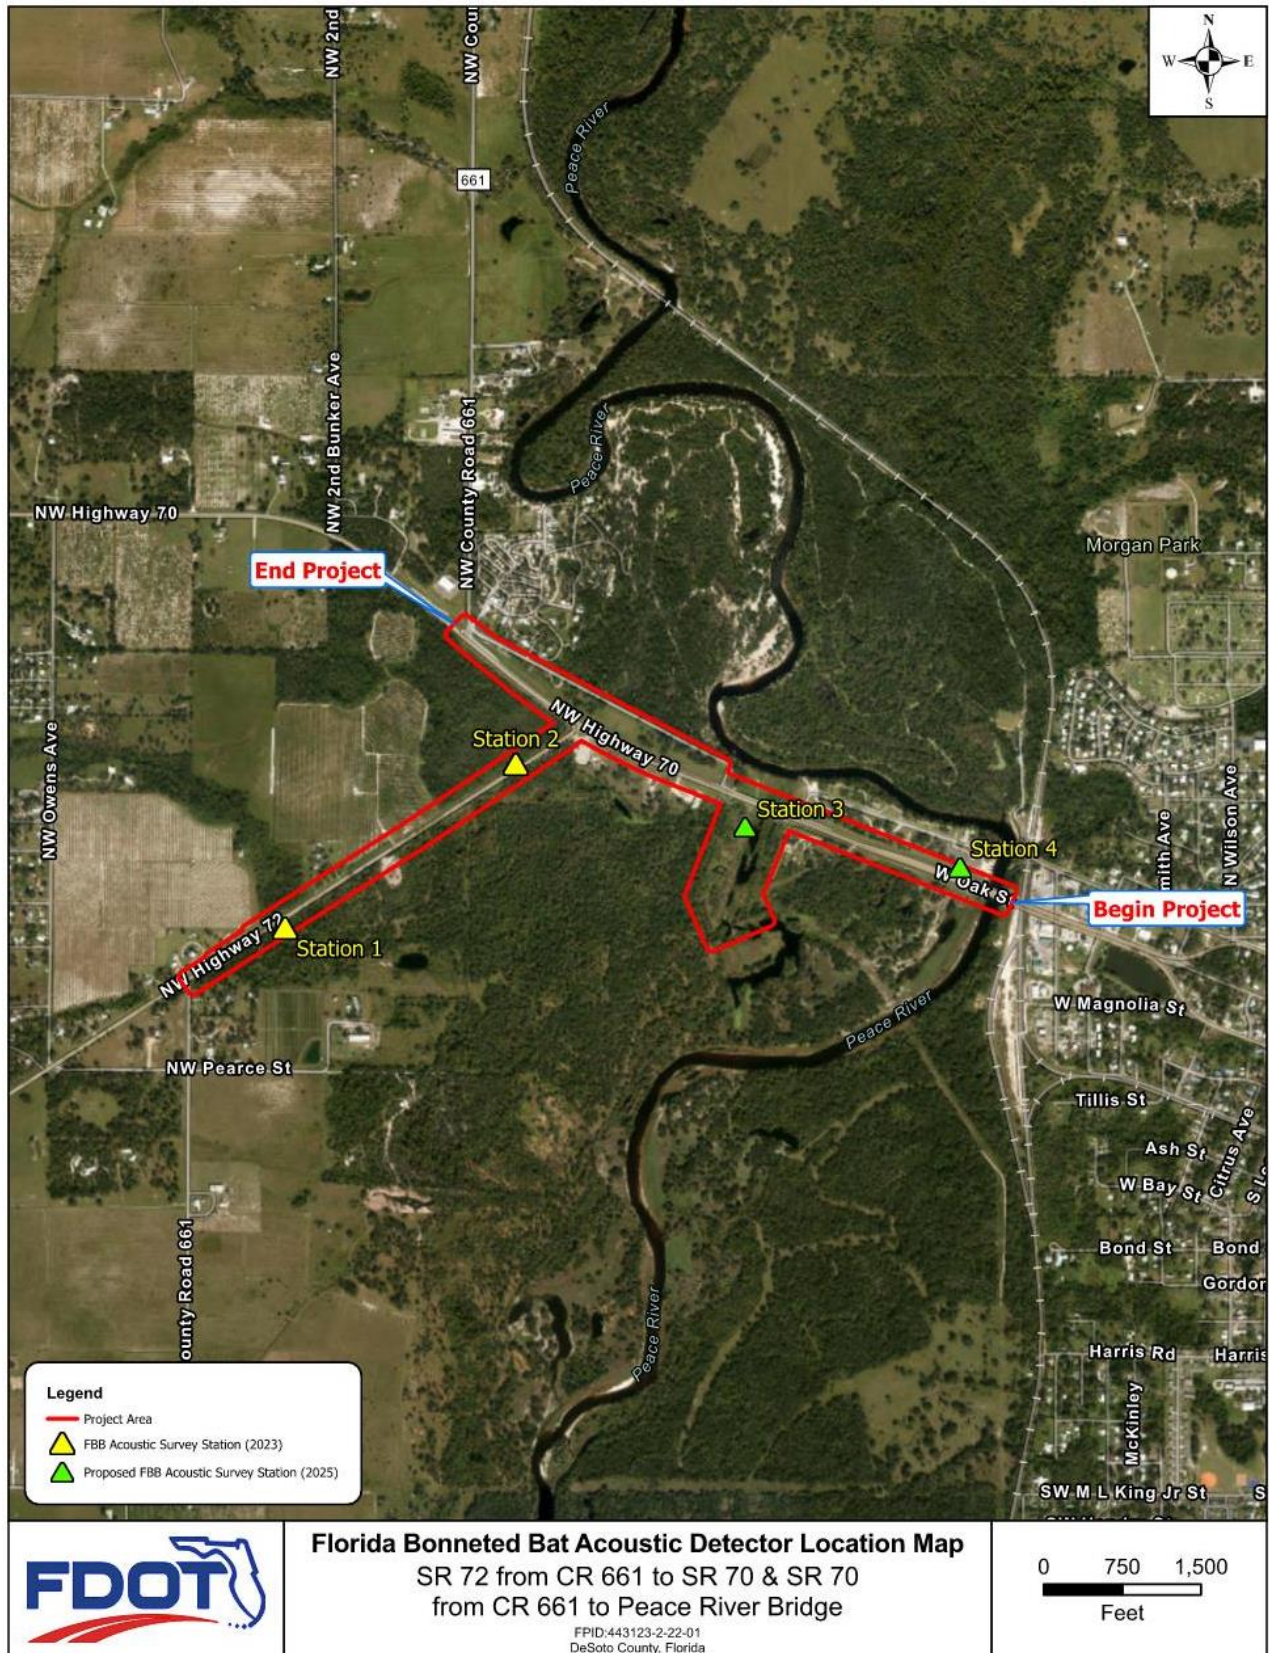
Figure 1 – Florida Bonneted Bat Acoustic Detector Location Map

acceptable weather conditions for each Station 1 and 2 will also be recorded and analyzed. The approximate locations for proposed detector placement along the project corridor are depicted in **Figure 1**.

These locations are proposed and may be adjusted during deployment to accommodate environmental conditions. Detectors are proposed to be placed with a maximum distance of 0.6 miles with no less than 300 meters in between. Acoustic deployment data sheets to be utilized are included in **Attachment 2**.

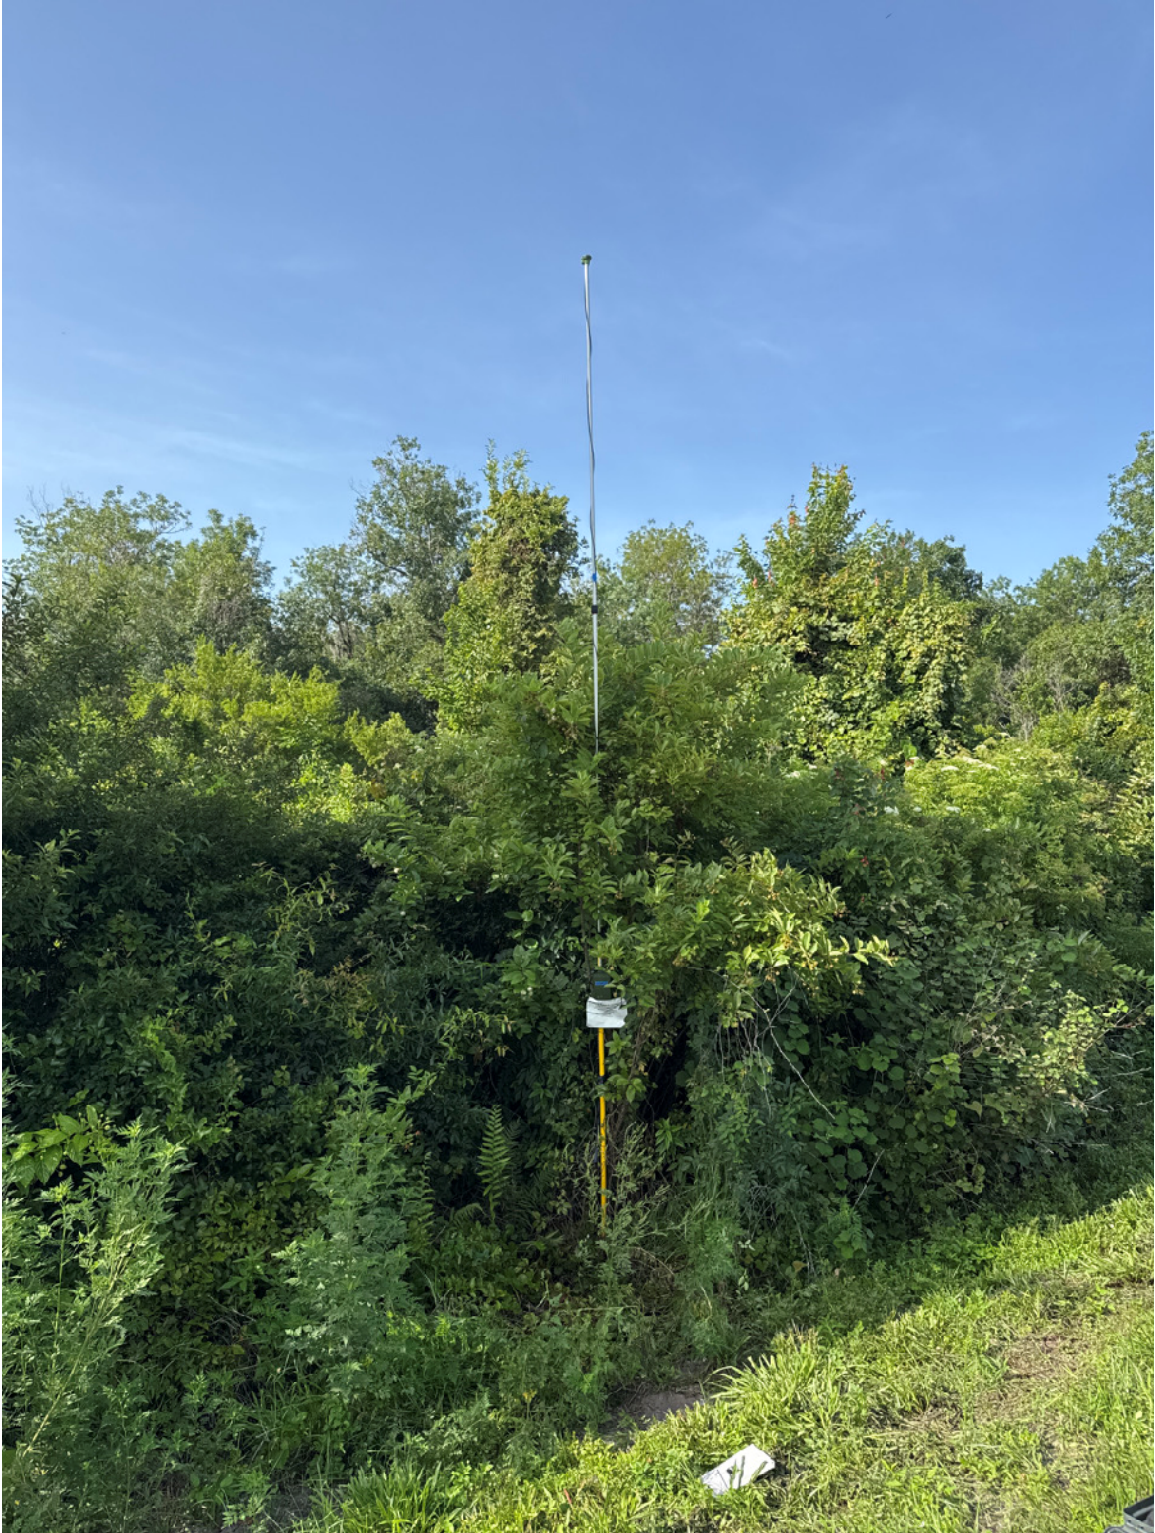
**Photograph 1.** Photograph looking south at Detector 1 with microphone deployment height of 7 meters – Wildlife Acoustics Song Meter SM4BAT FS Ultrasonic Recorder with SMM U2 Ultrasonic Mic.

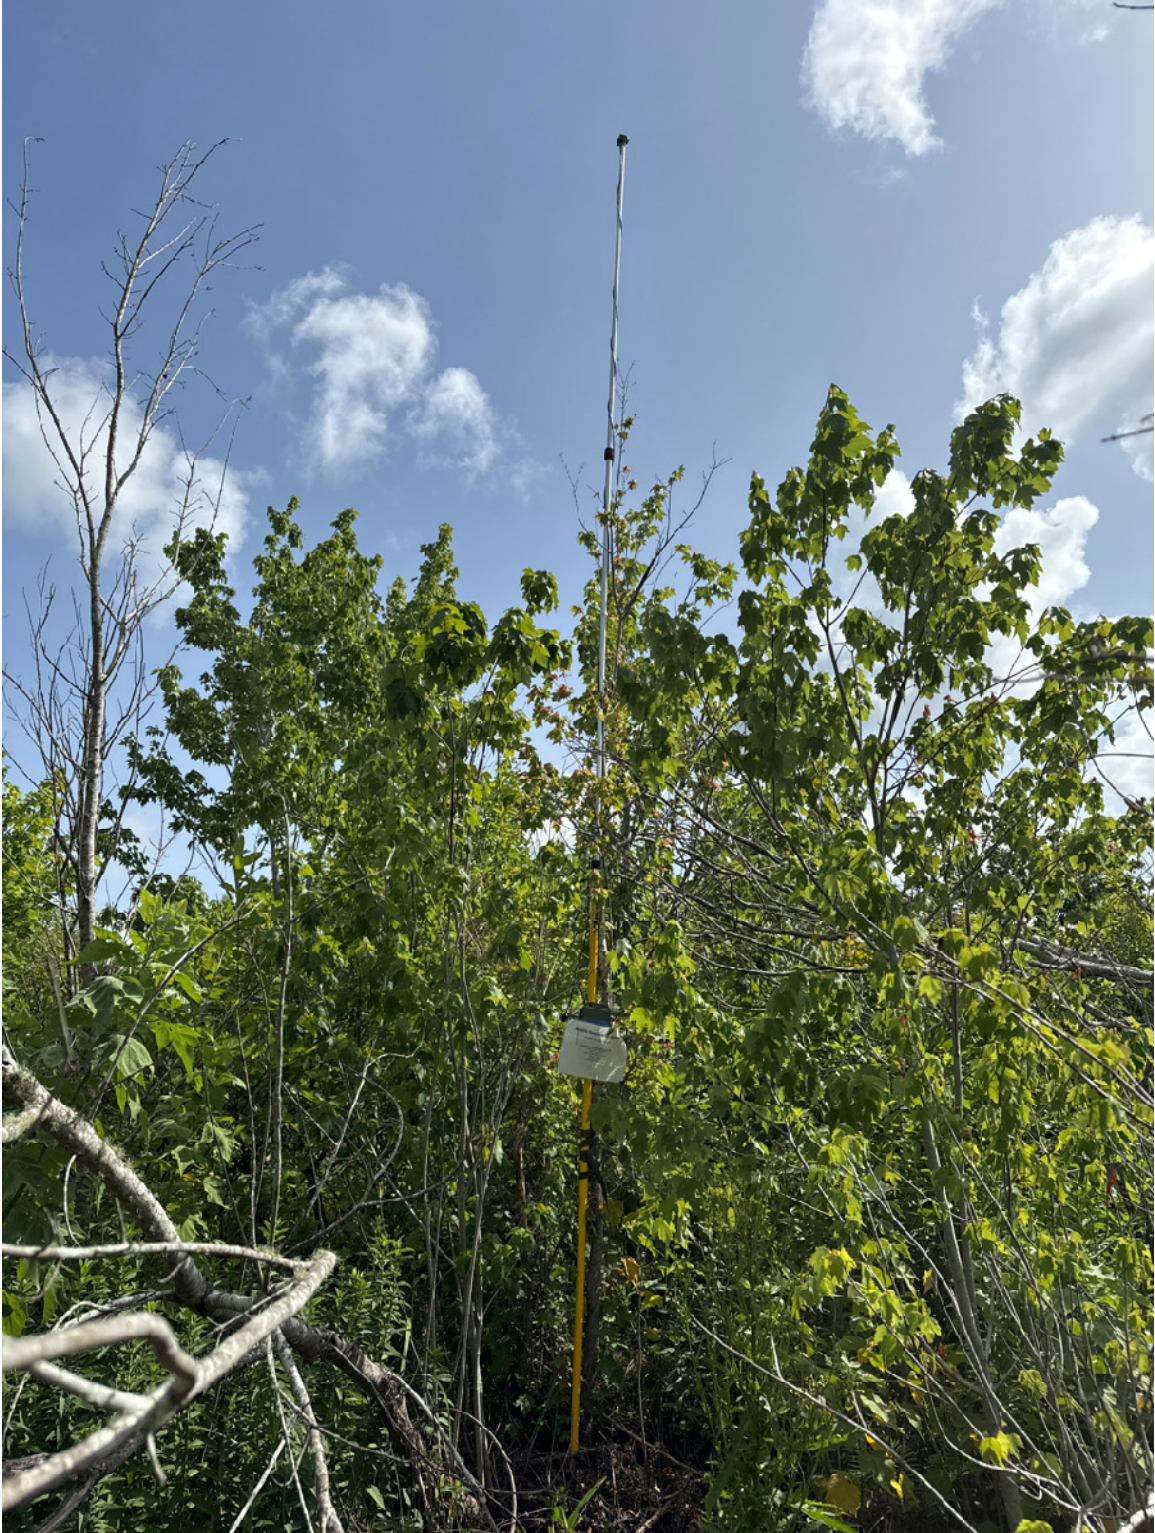
**Photograph 2.** Photograph looking north at Detector 2 with microphone deployment height of 7 meters – Wildlife Acoustics Song Meter SM4BAT FS Ultrasonic Recorder with SMM U2 Ultrasonic Mic.

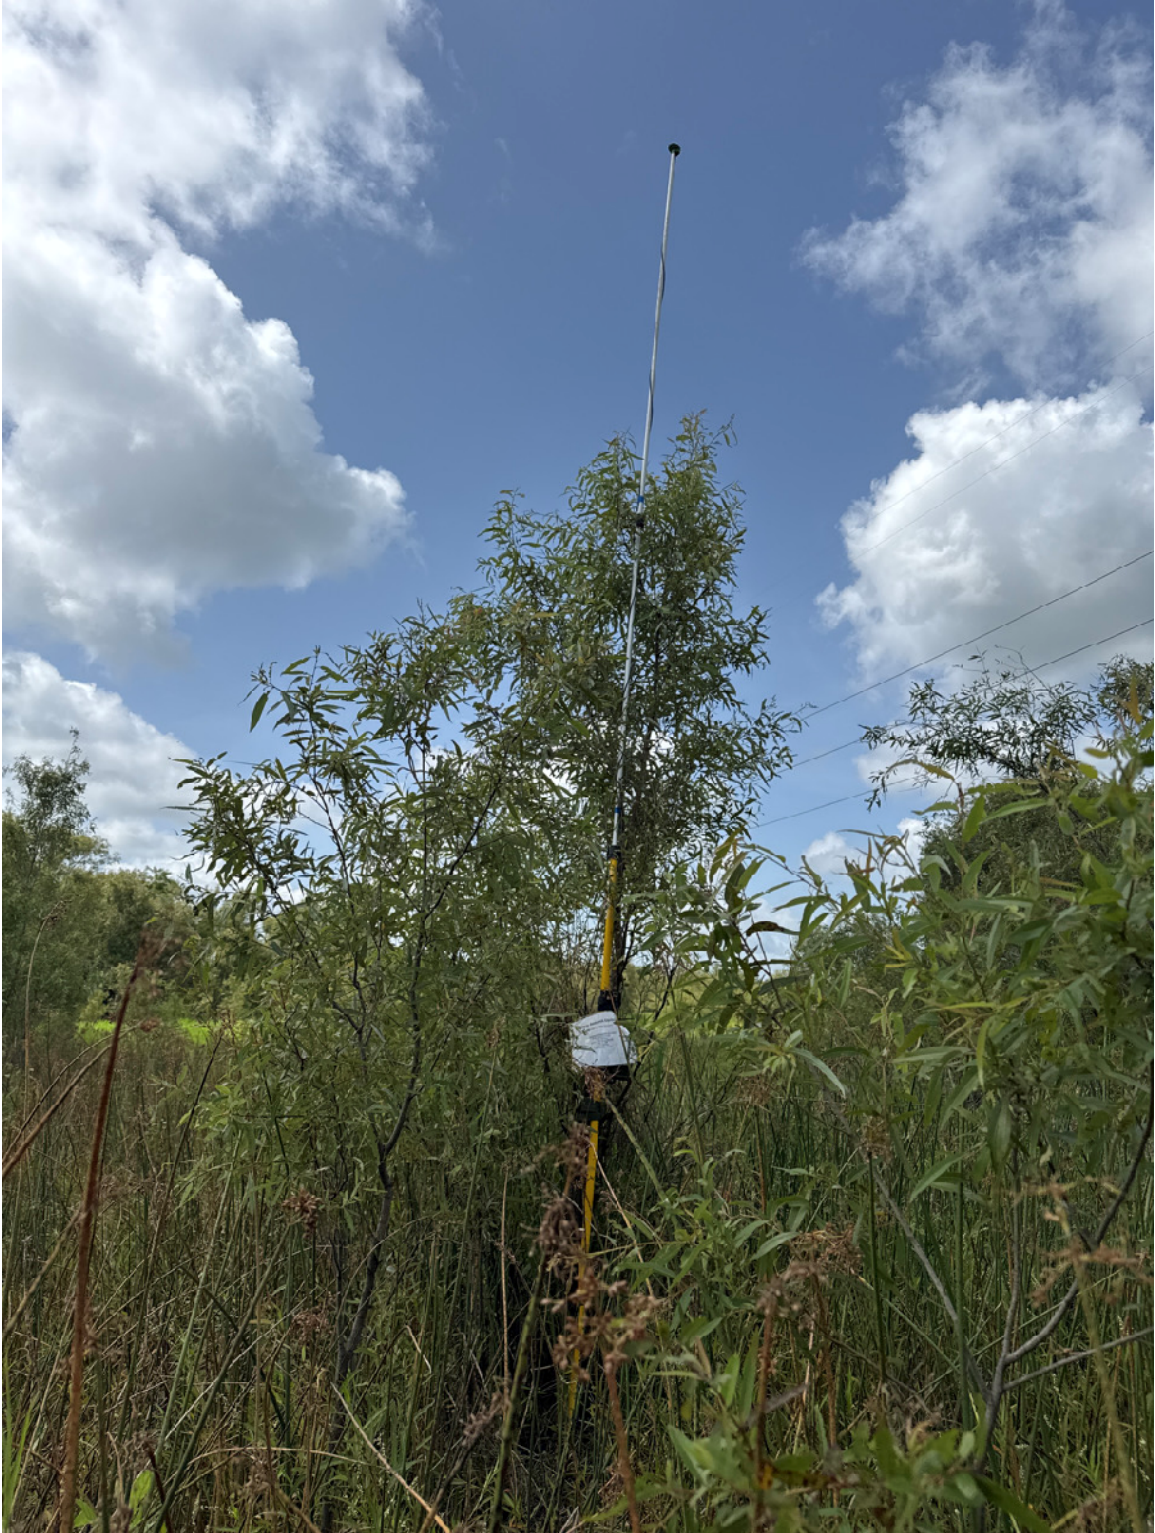
**Photograph 3.** Photograph looking southwest at Detector 3 with microphone deployment height of 10 meters – Wildlife Acoustics Song Meter SM4BAT FS Ultrasonic Recorder with SMM U2 Ultrasonic Mic.

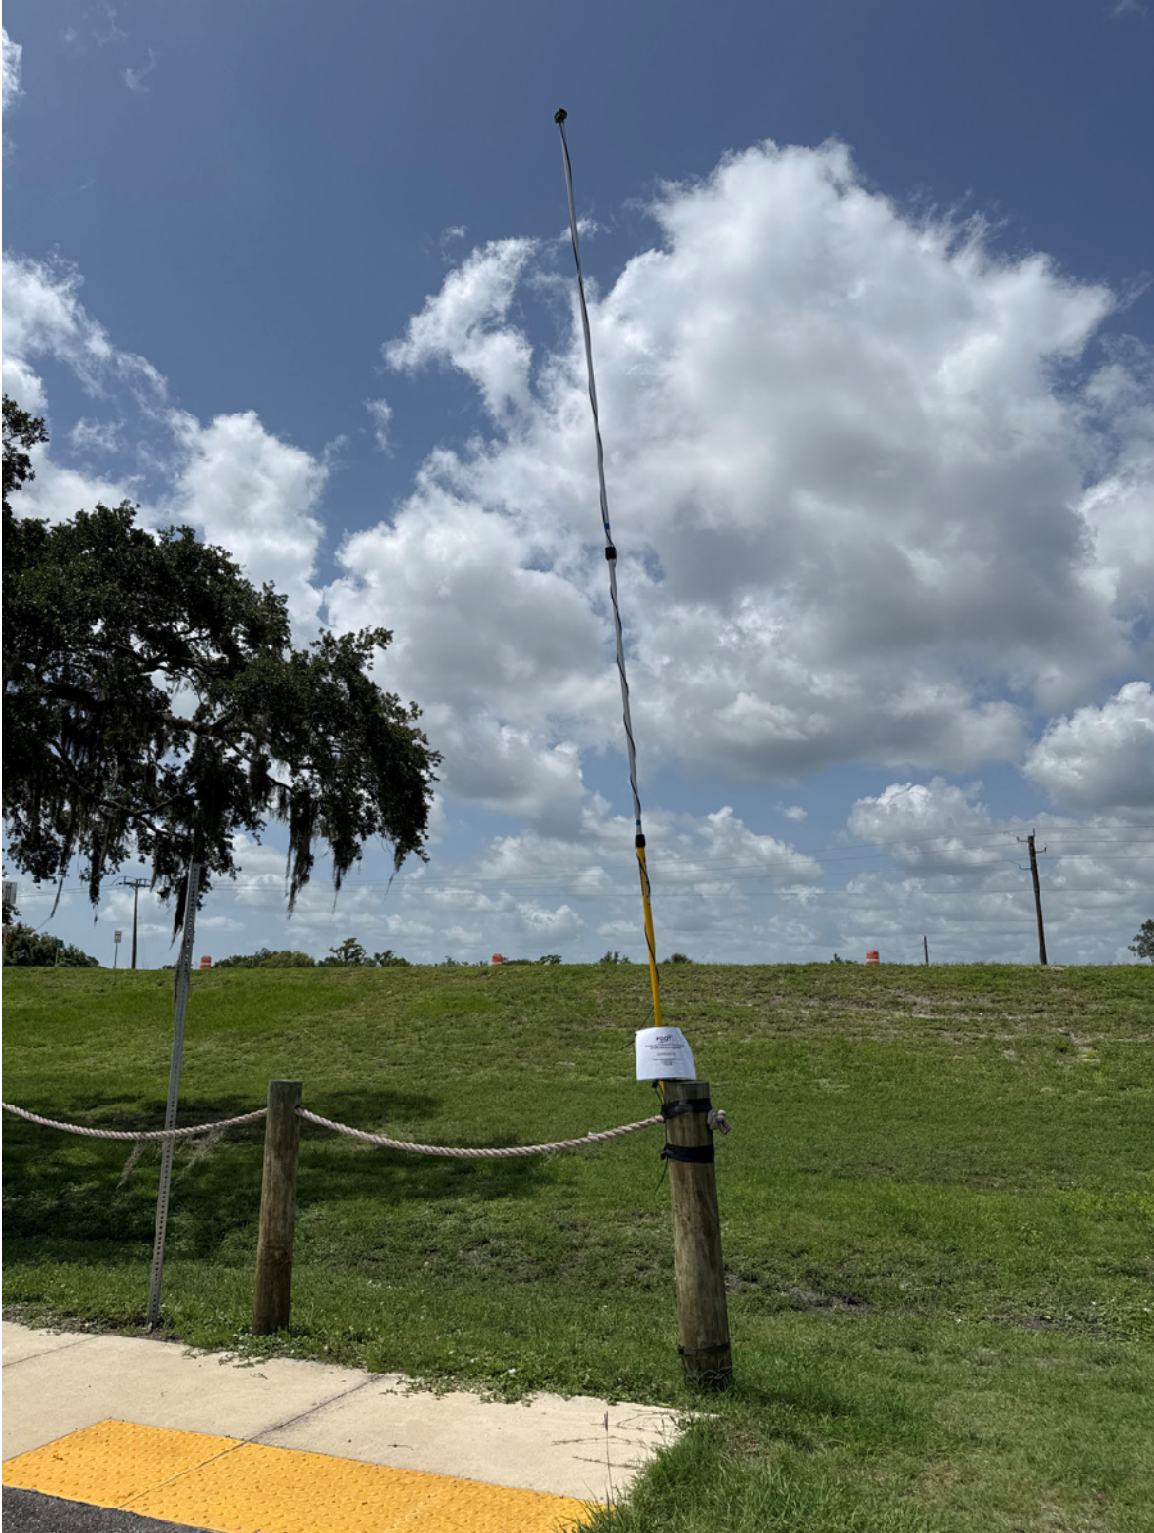
**Photograph 4.** Photograph looking south at Detector 4 with microphone deployment height of 6 meters – Wildlife Acoustics Song Meter SM4BAT FS Ultrasonic Recorder with SMM U2 Ultrasonic Mic.
