SANIBEL CAUSEWAY RESTORATION

Kiwanis Update | November 2023

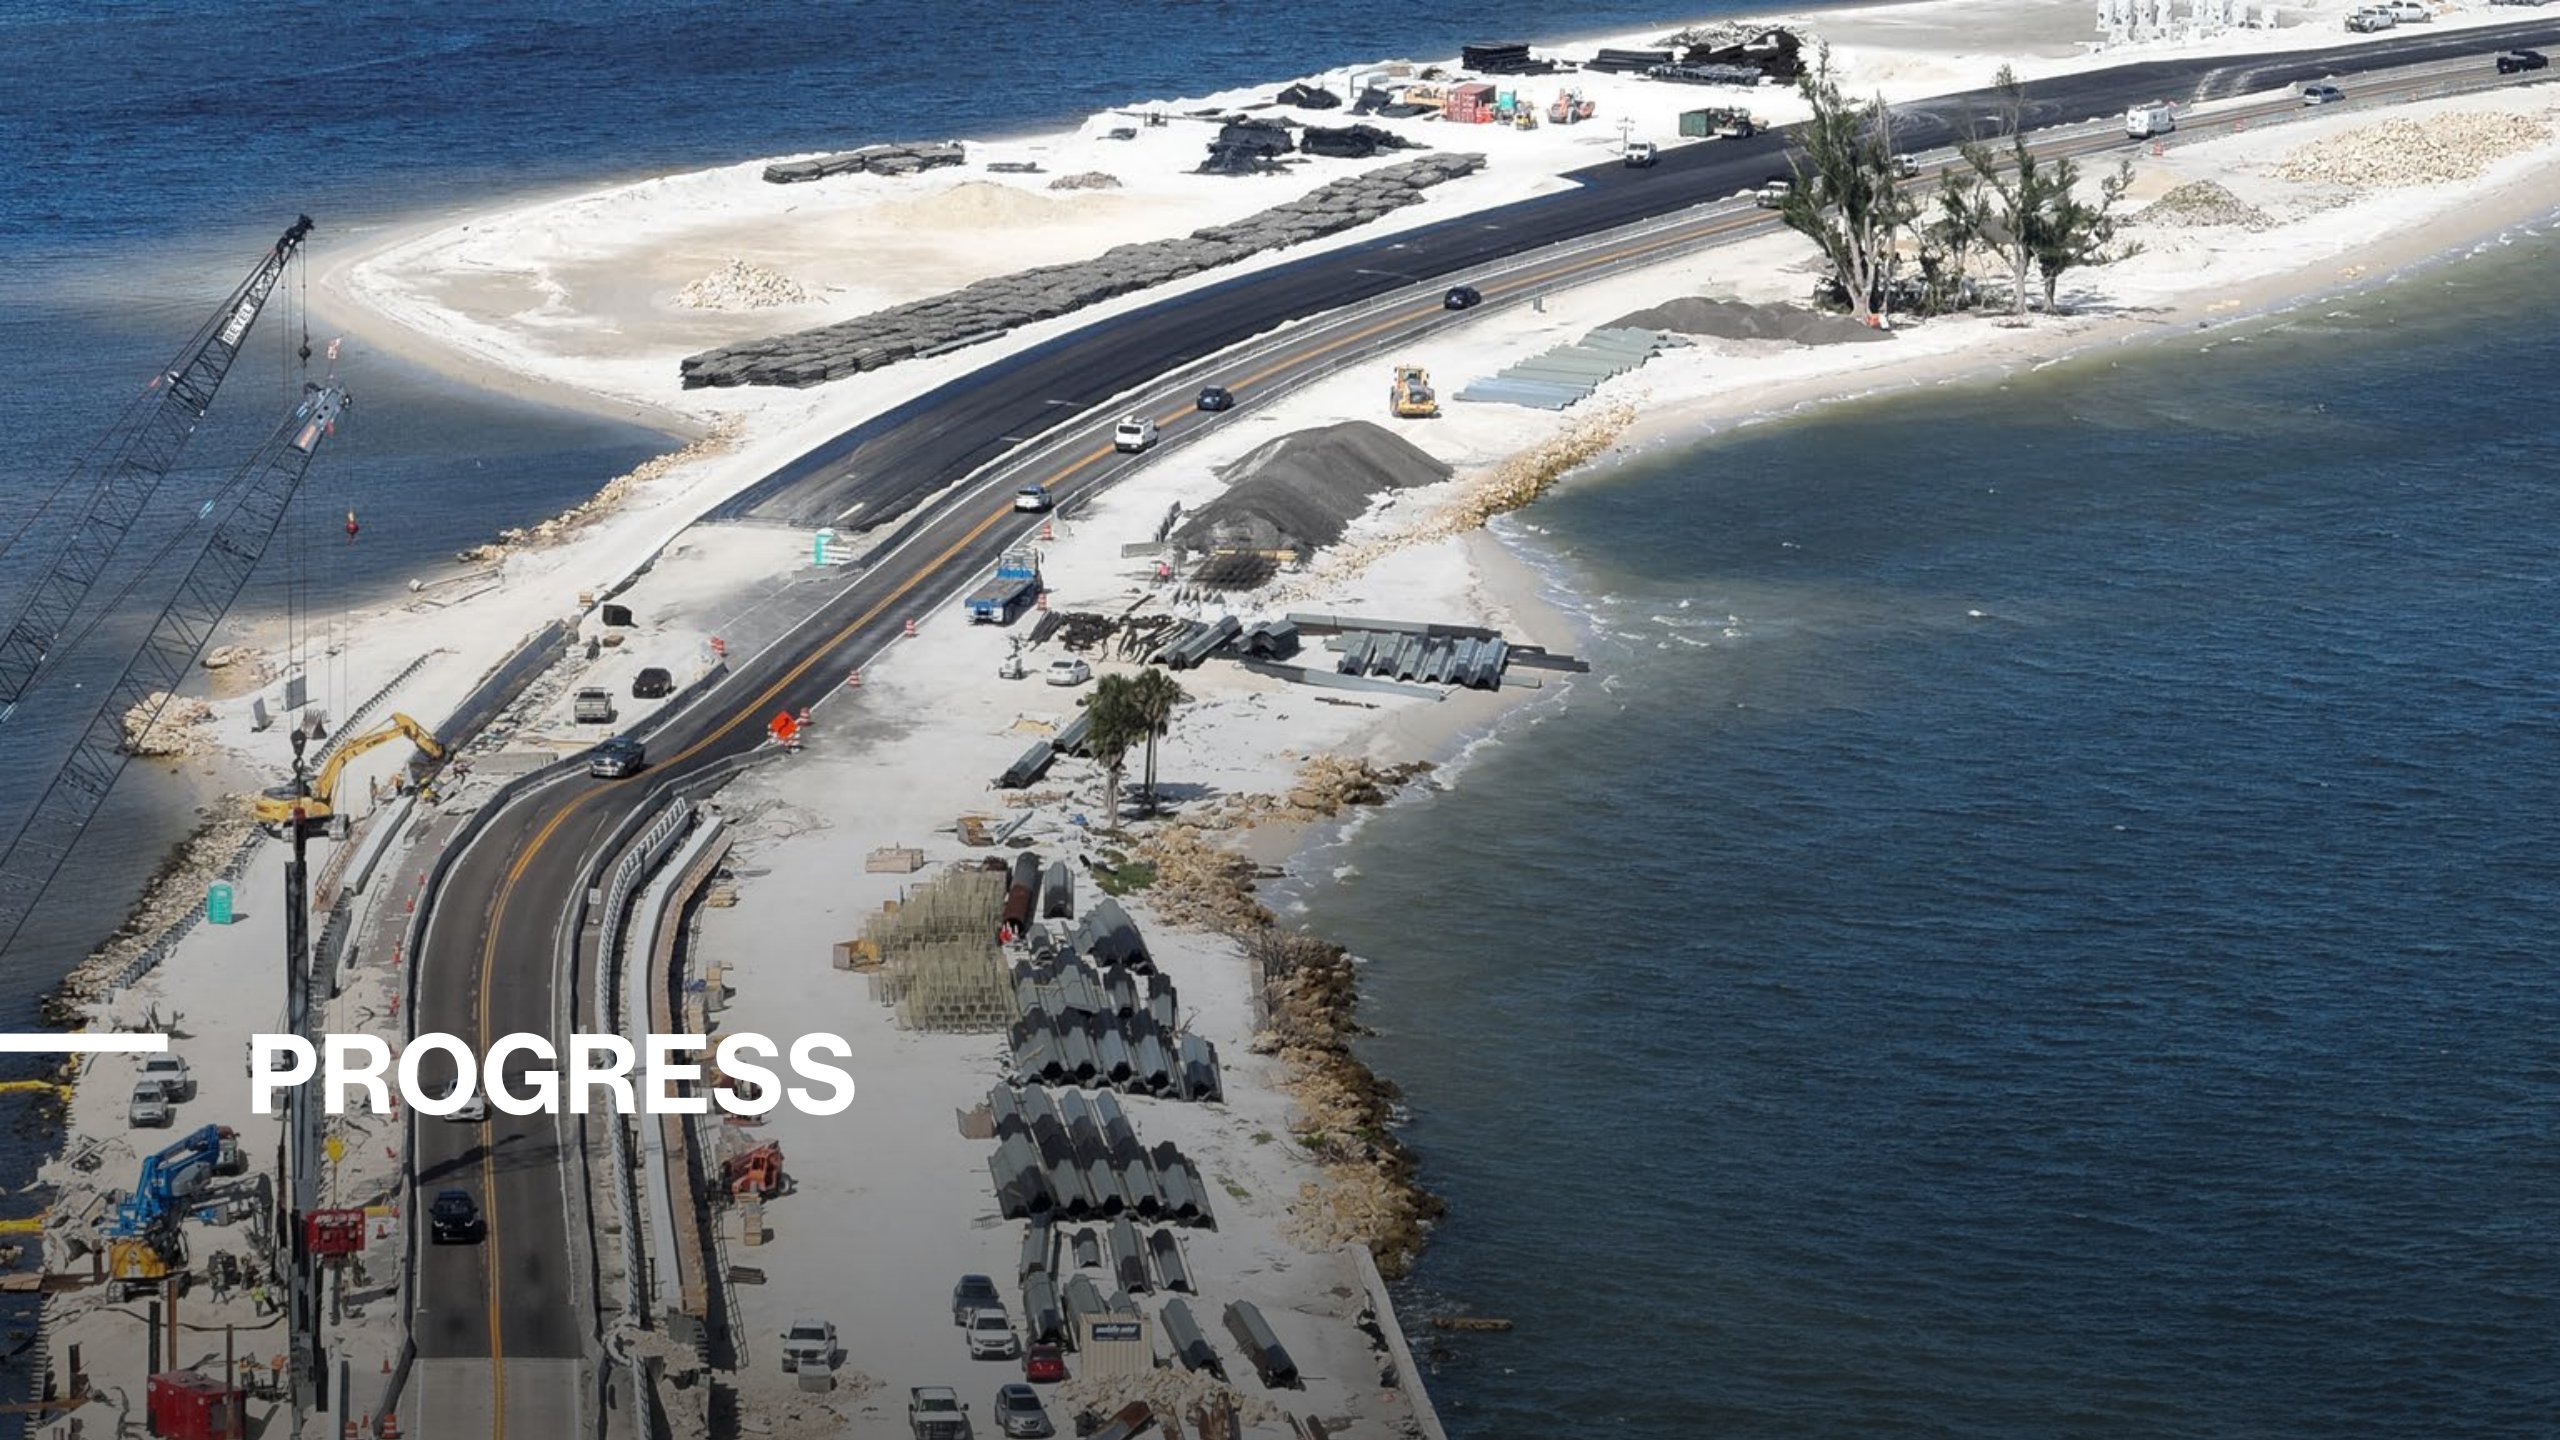
Temporary Roadway

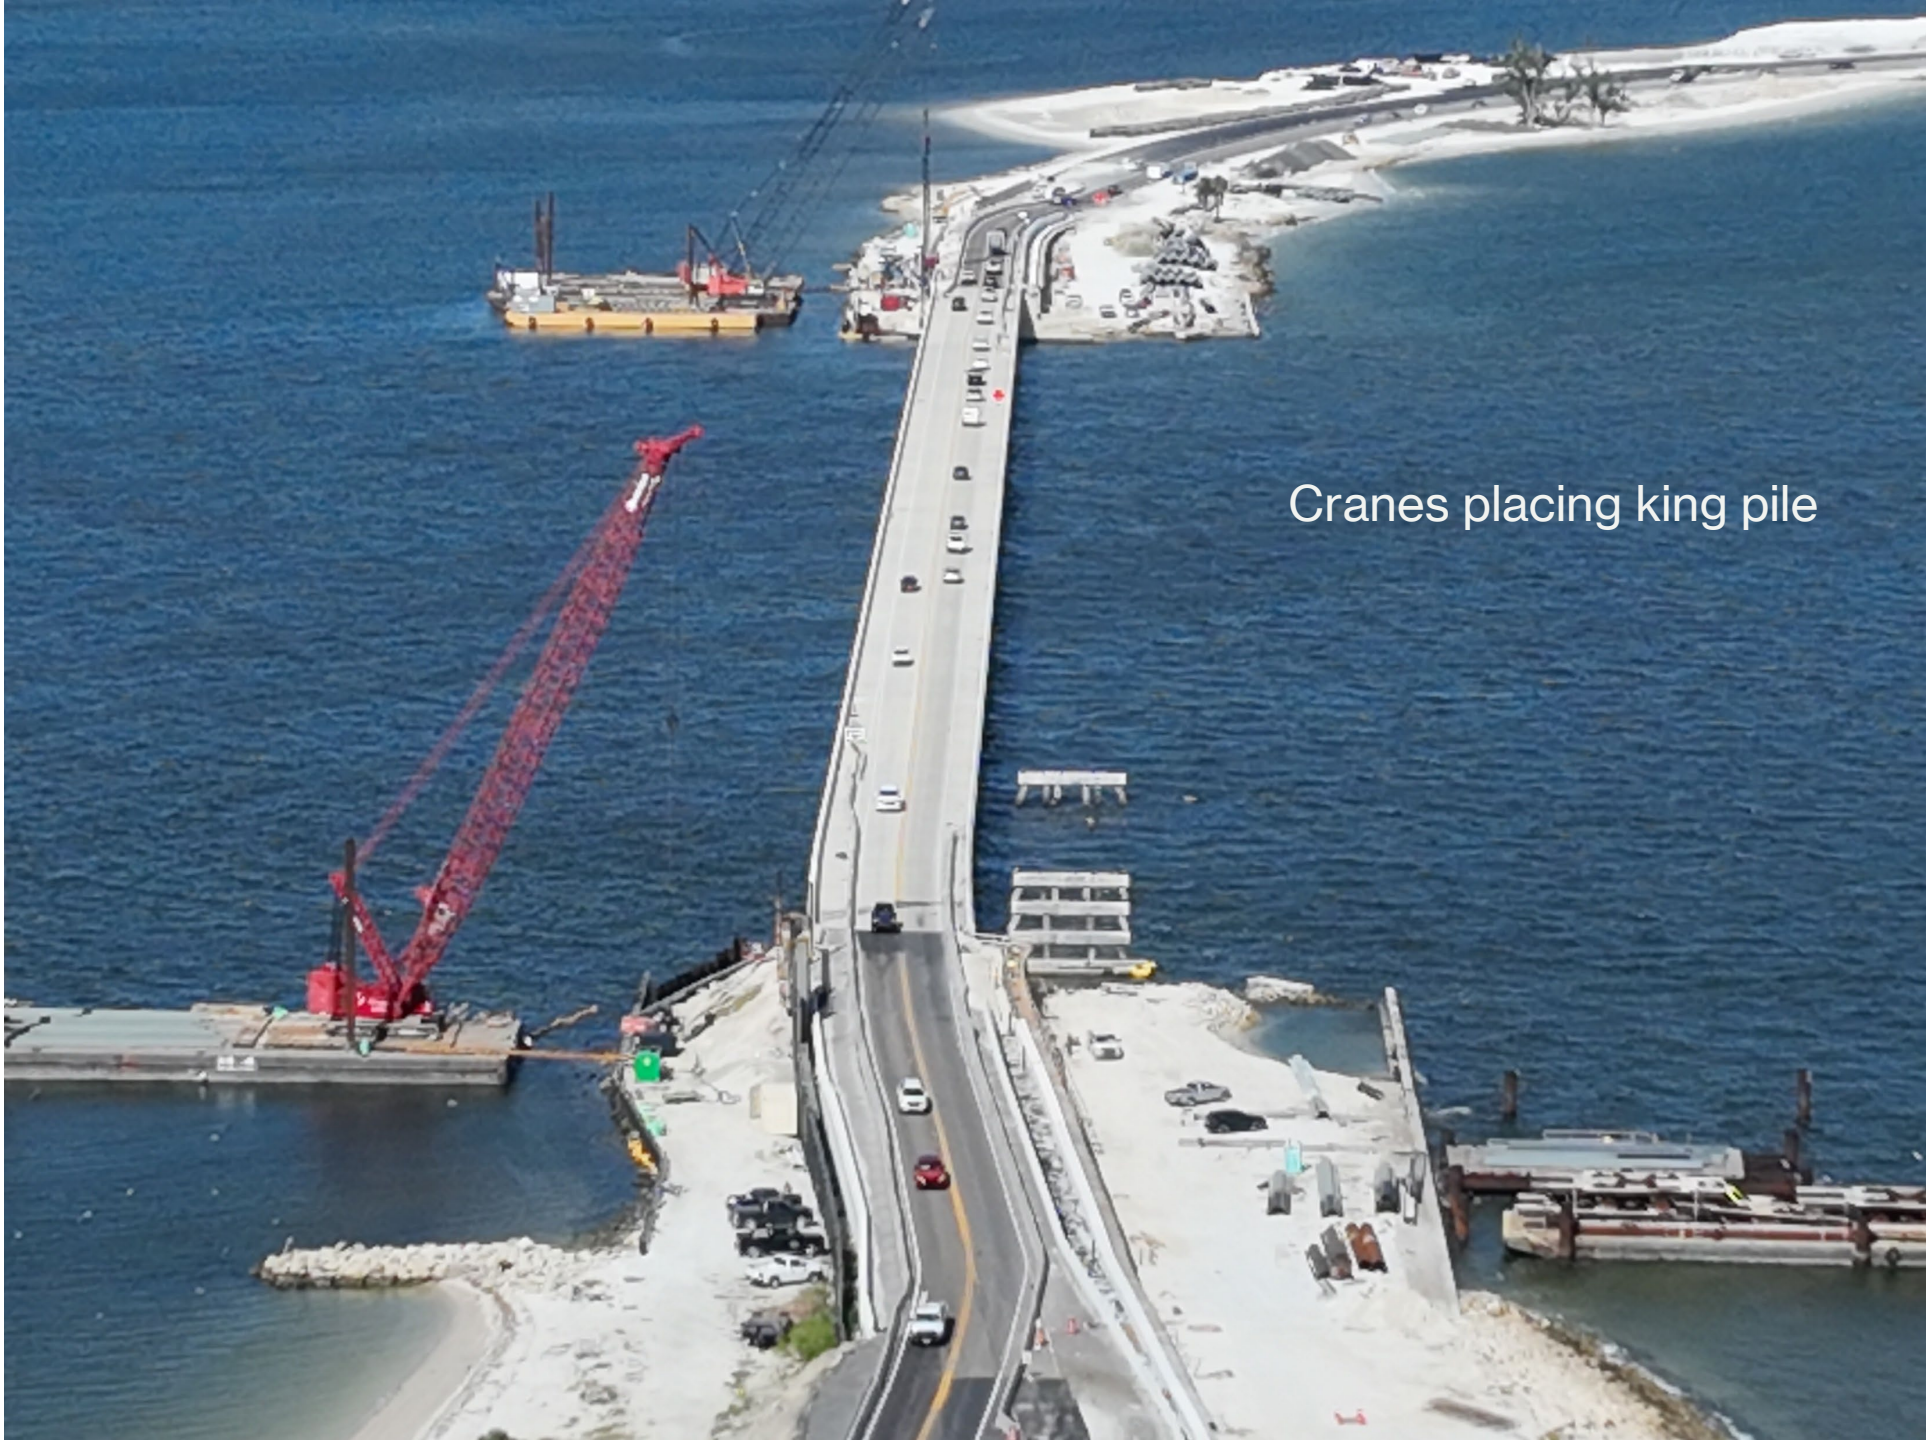
Cranes placing king pile

- Large “King” pile sheets are driven 50’ under the water’s surface to protect the bridge abutments
- Held in place by a template while driven into the ground
- King pile installation is complete

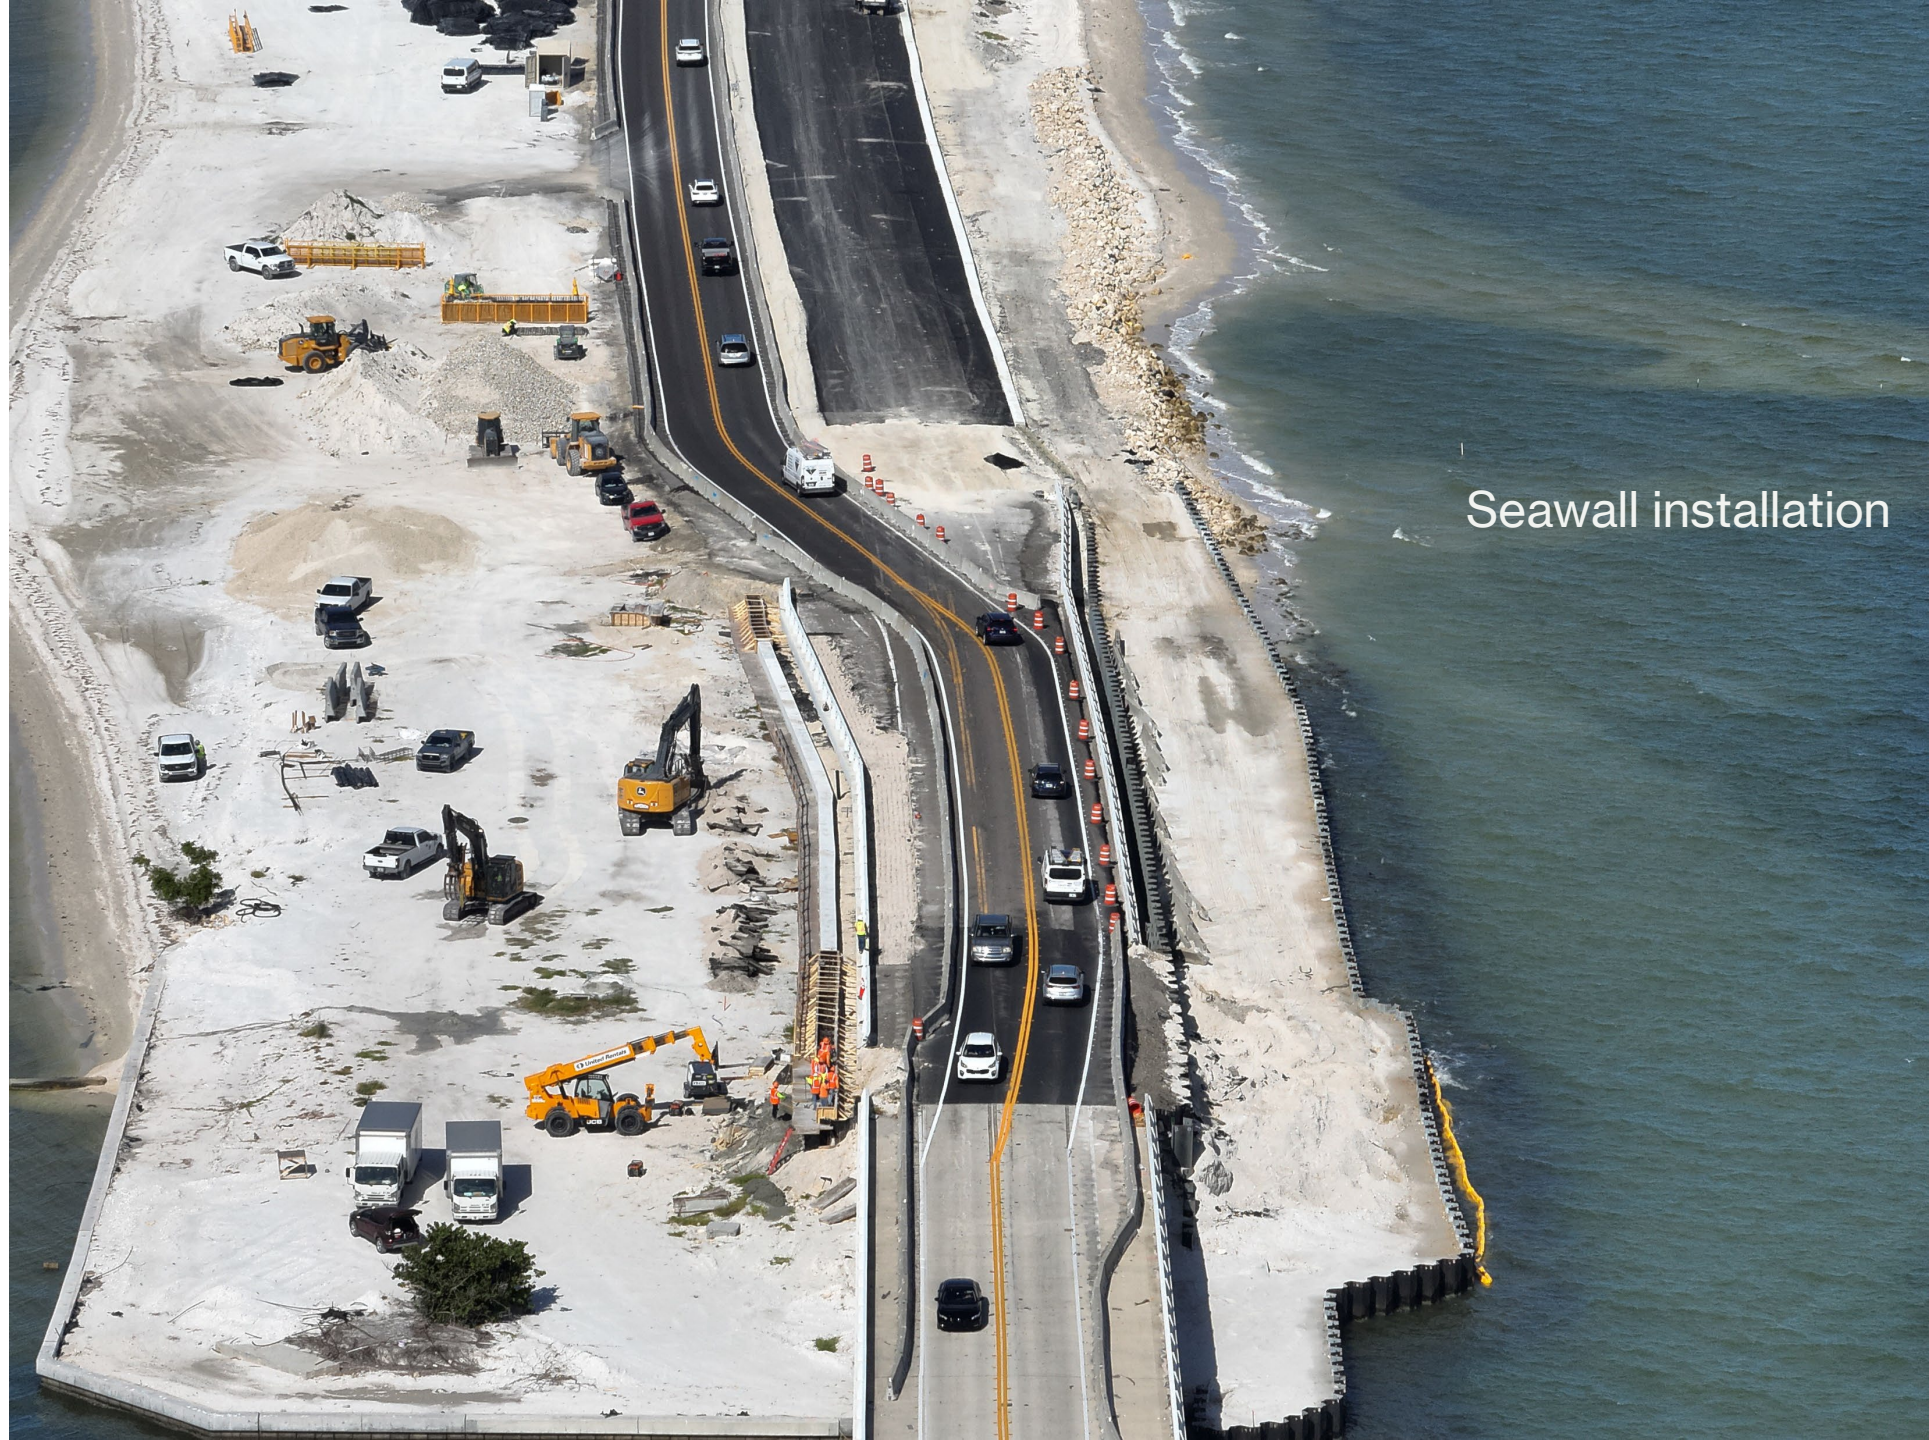
Seawall installation

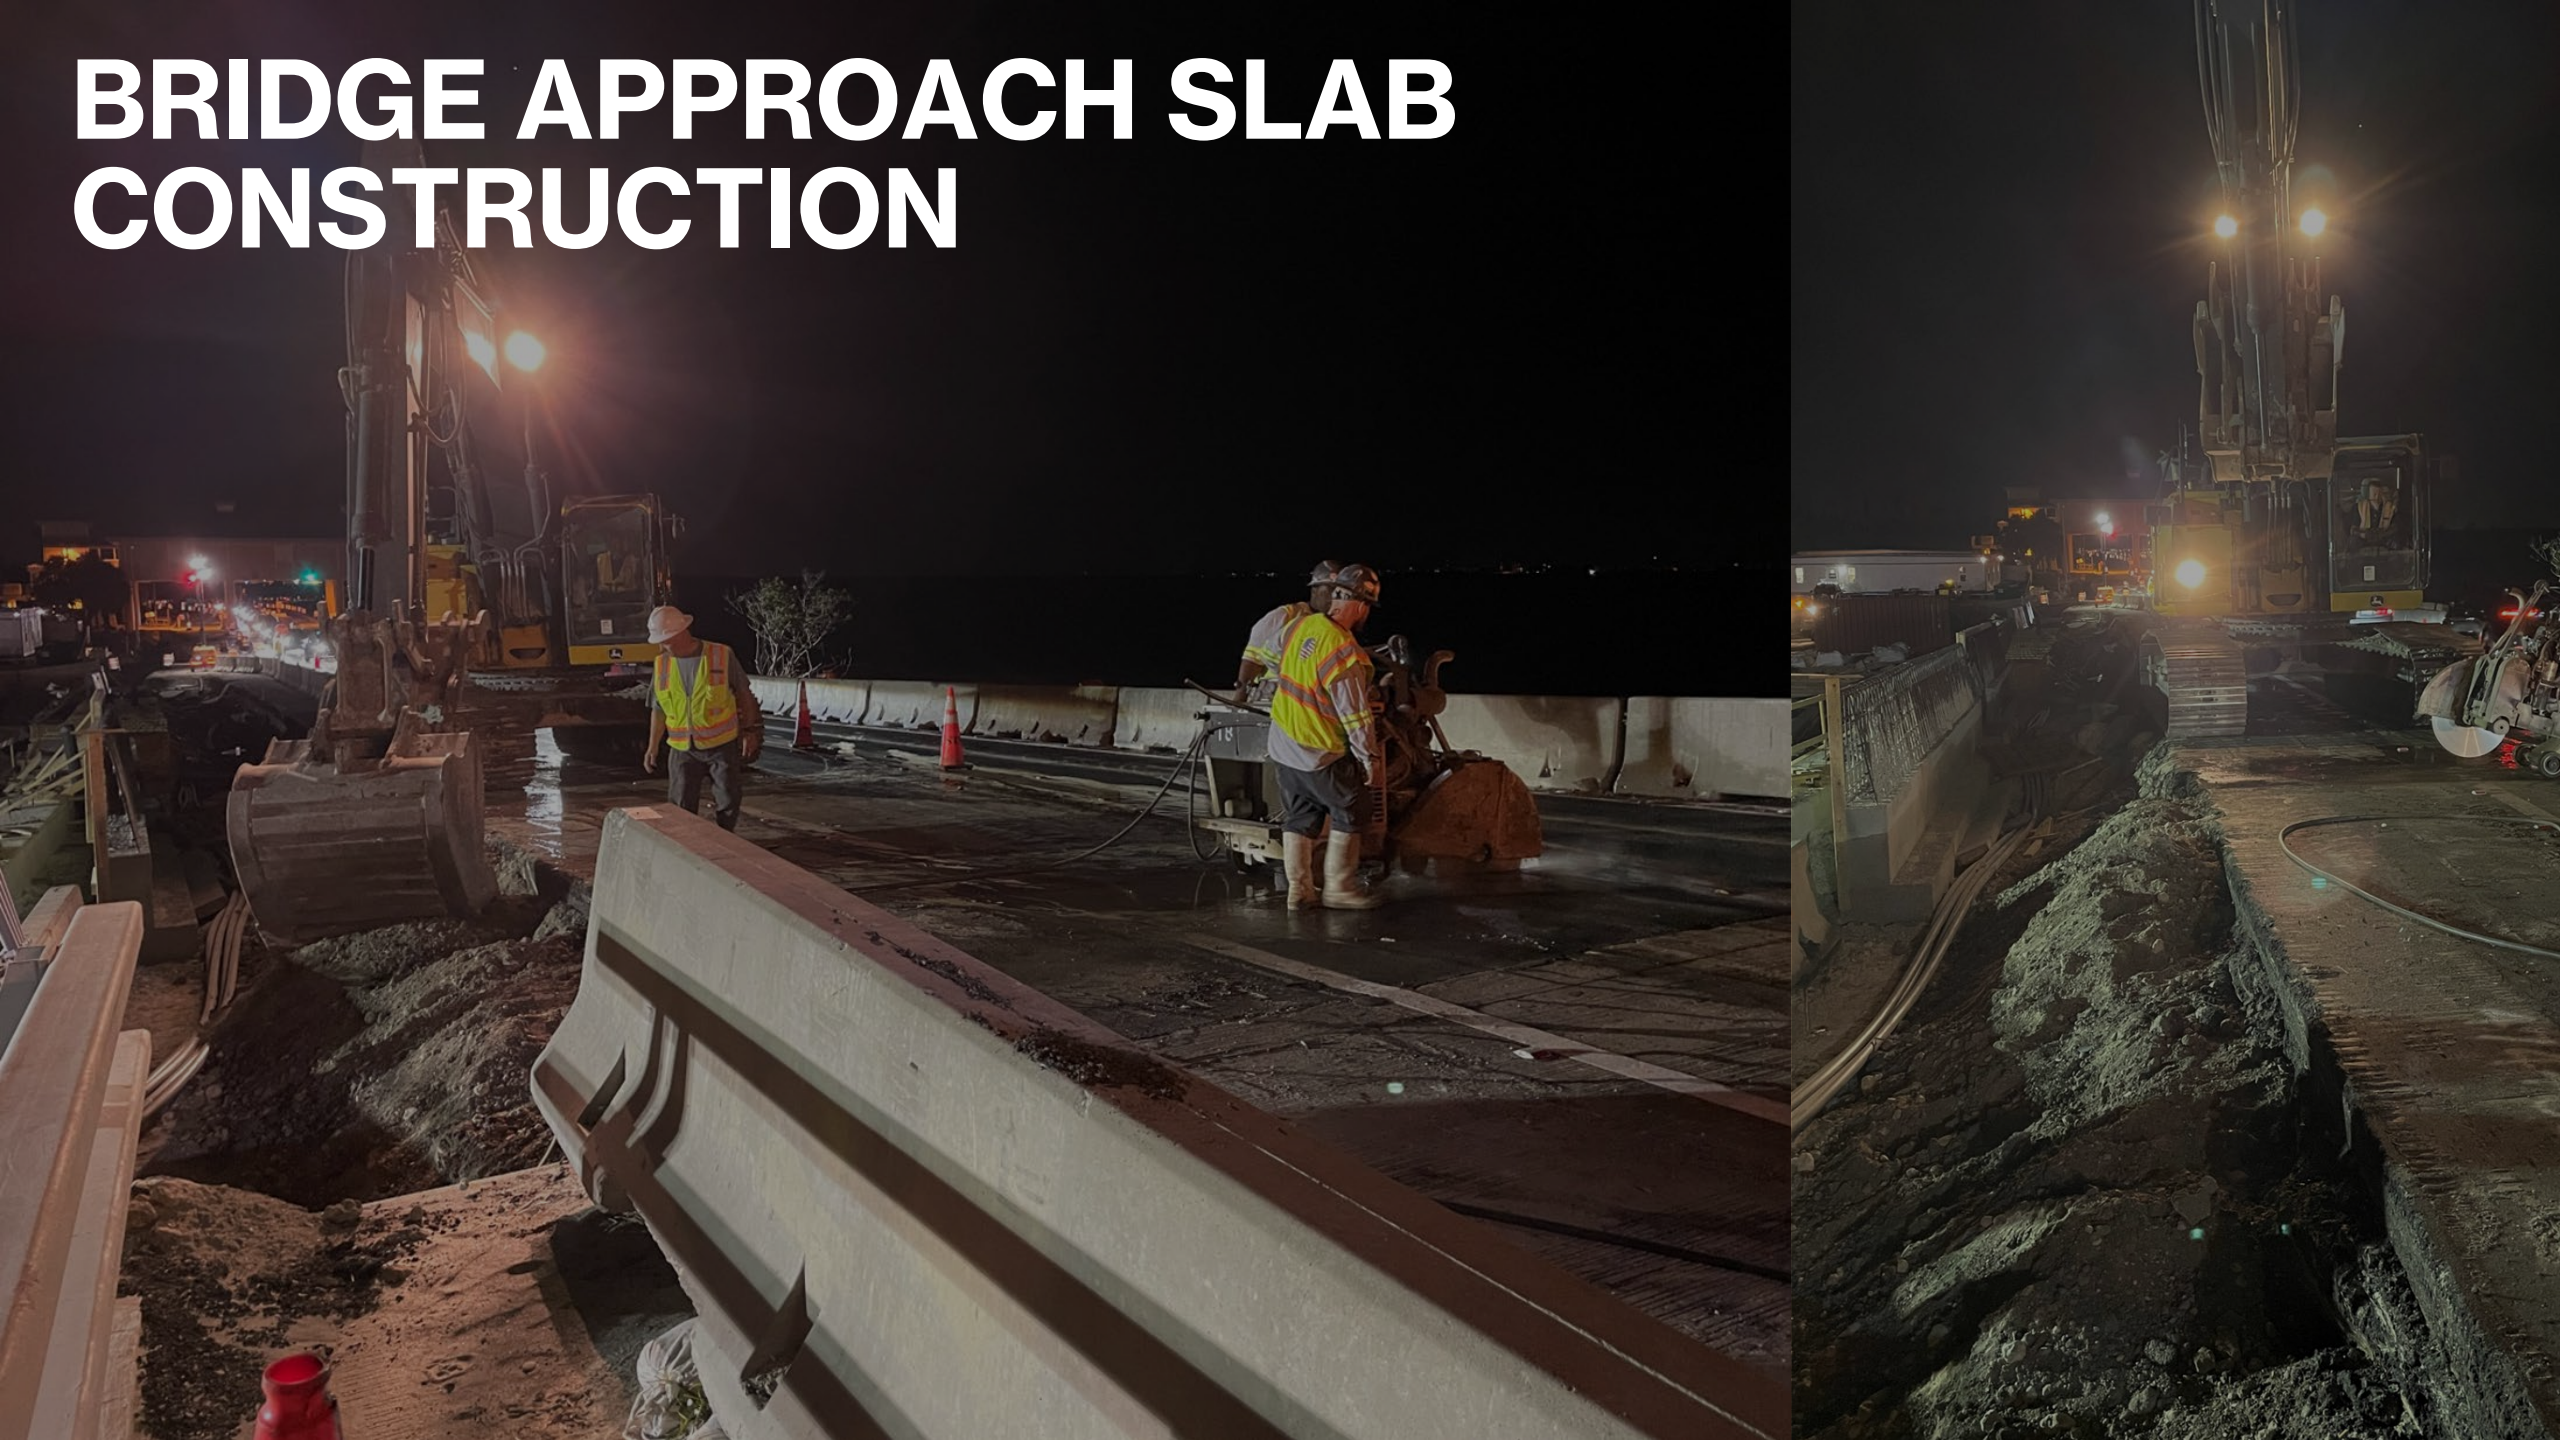
1 - EXCAVATE THE OLD

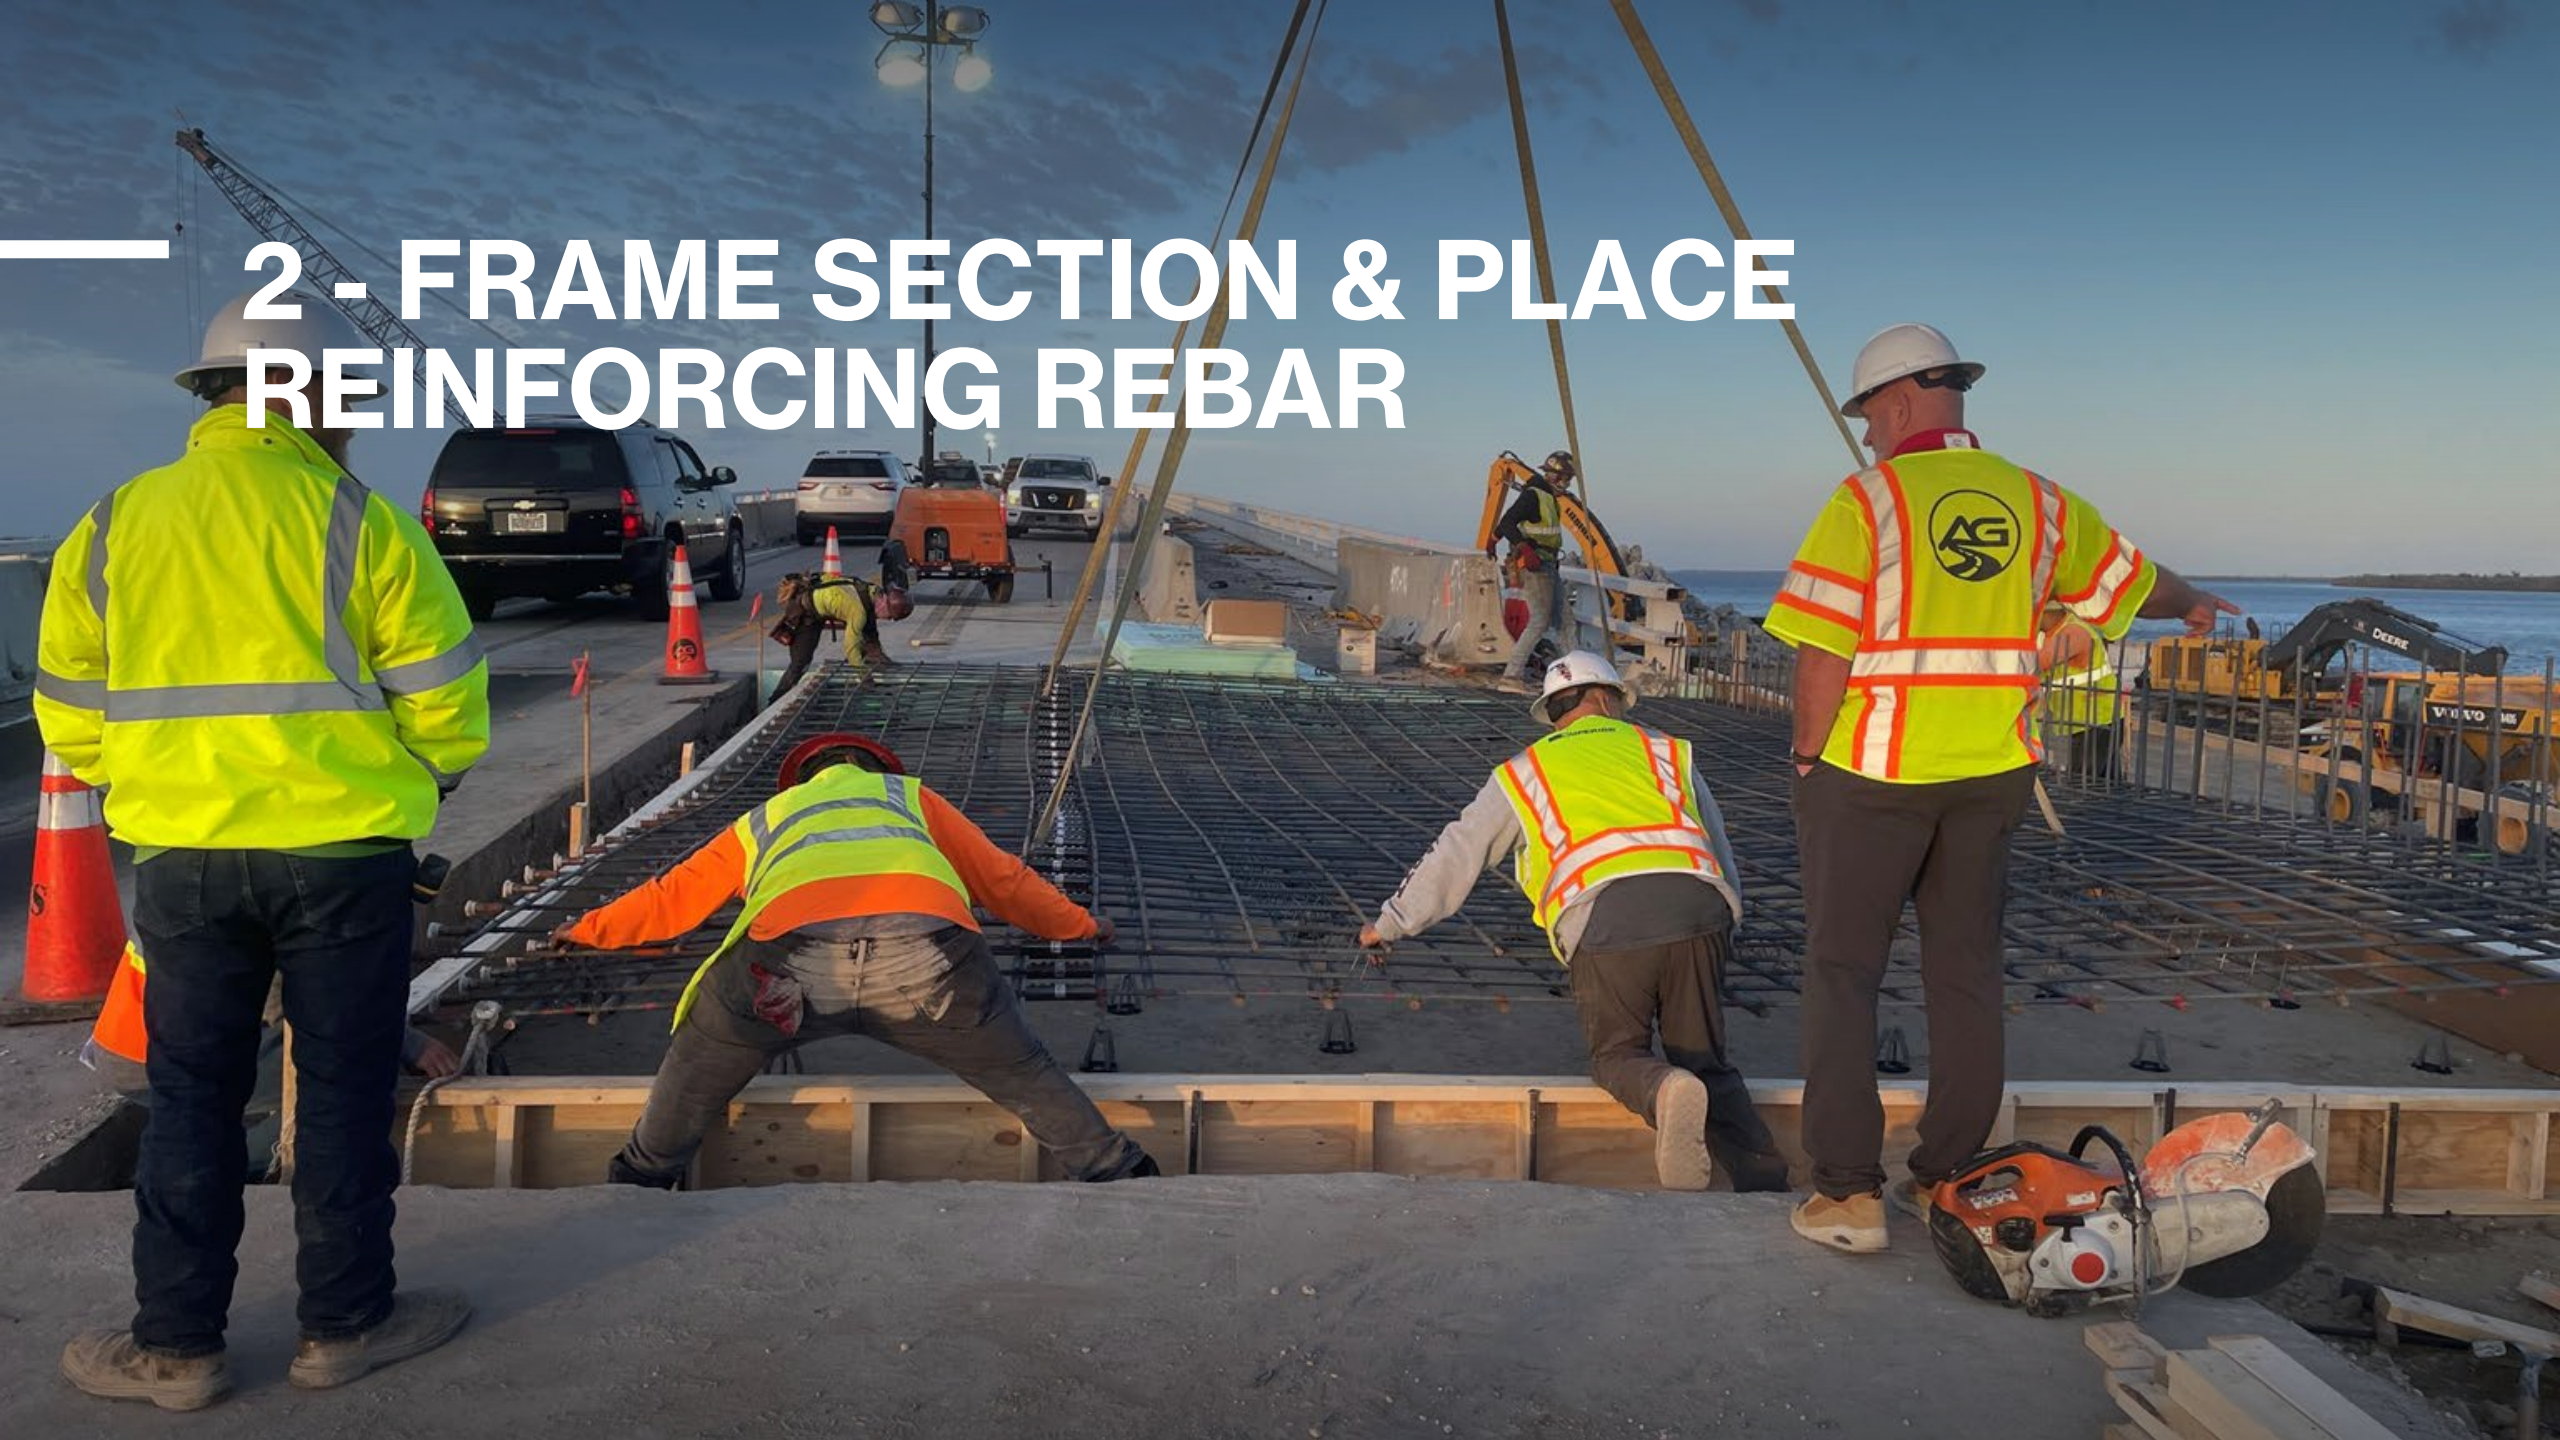
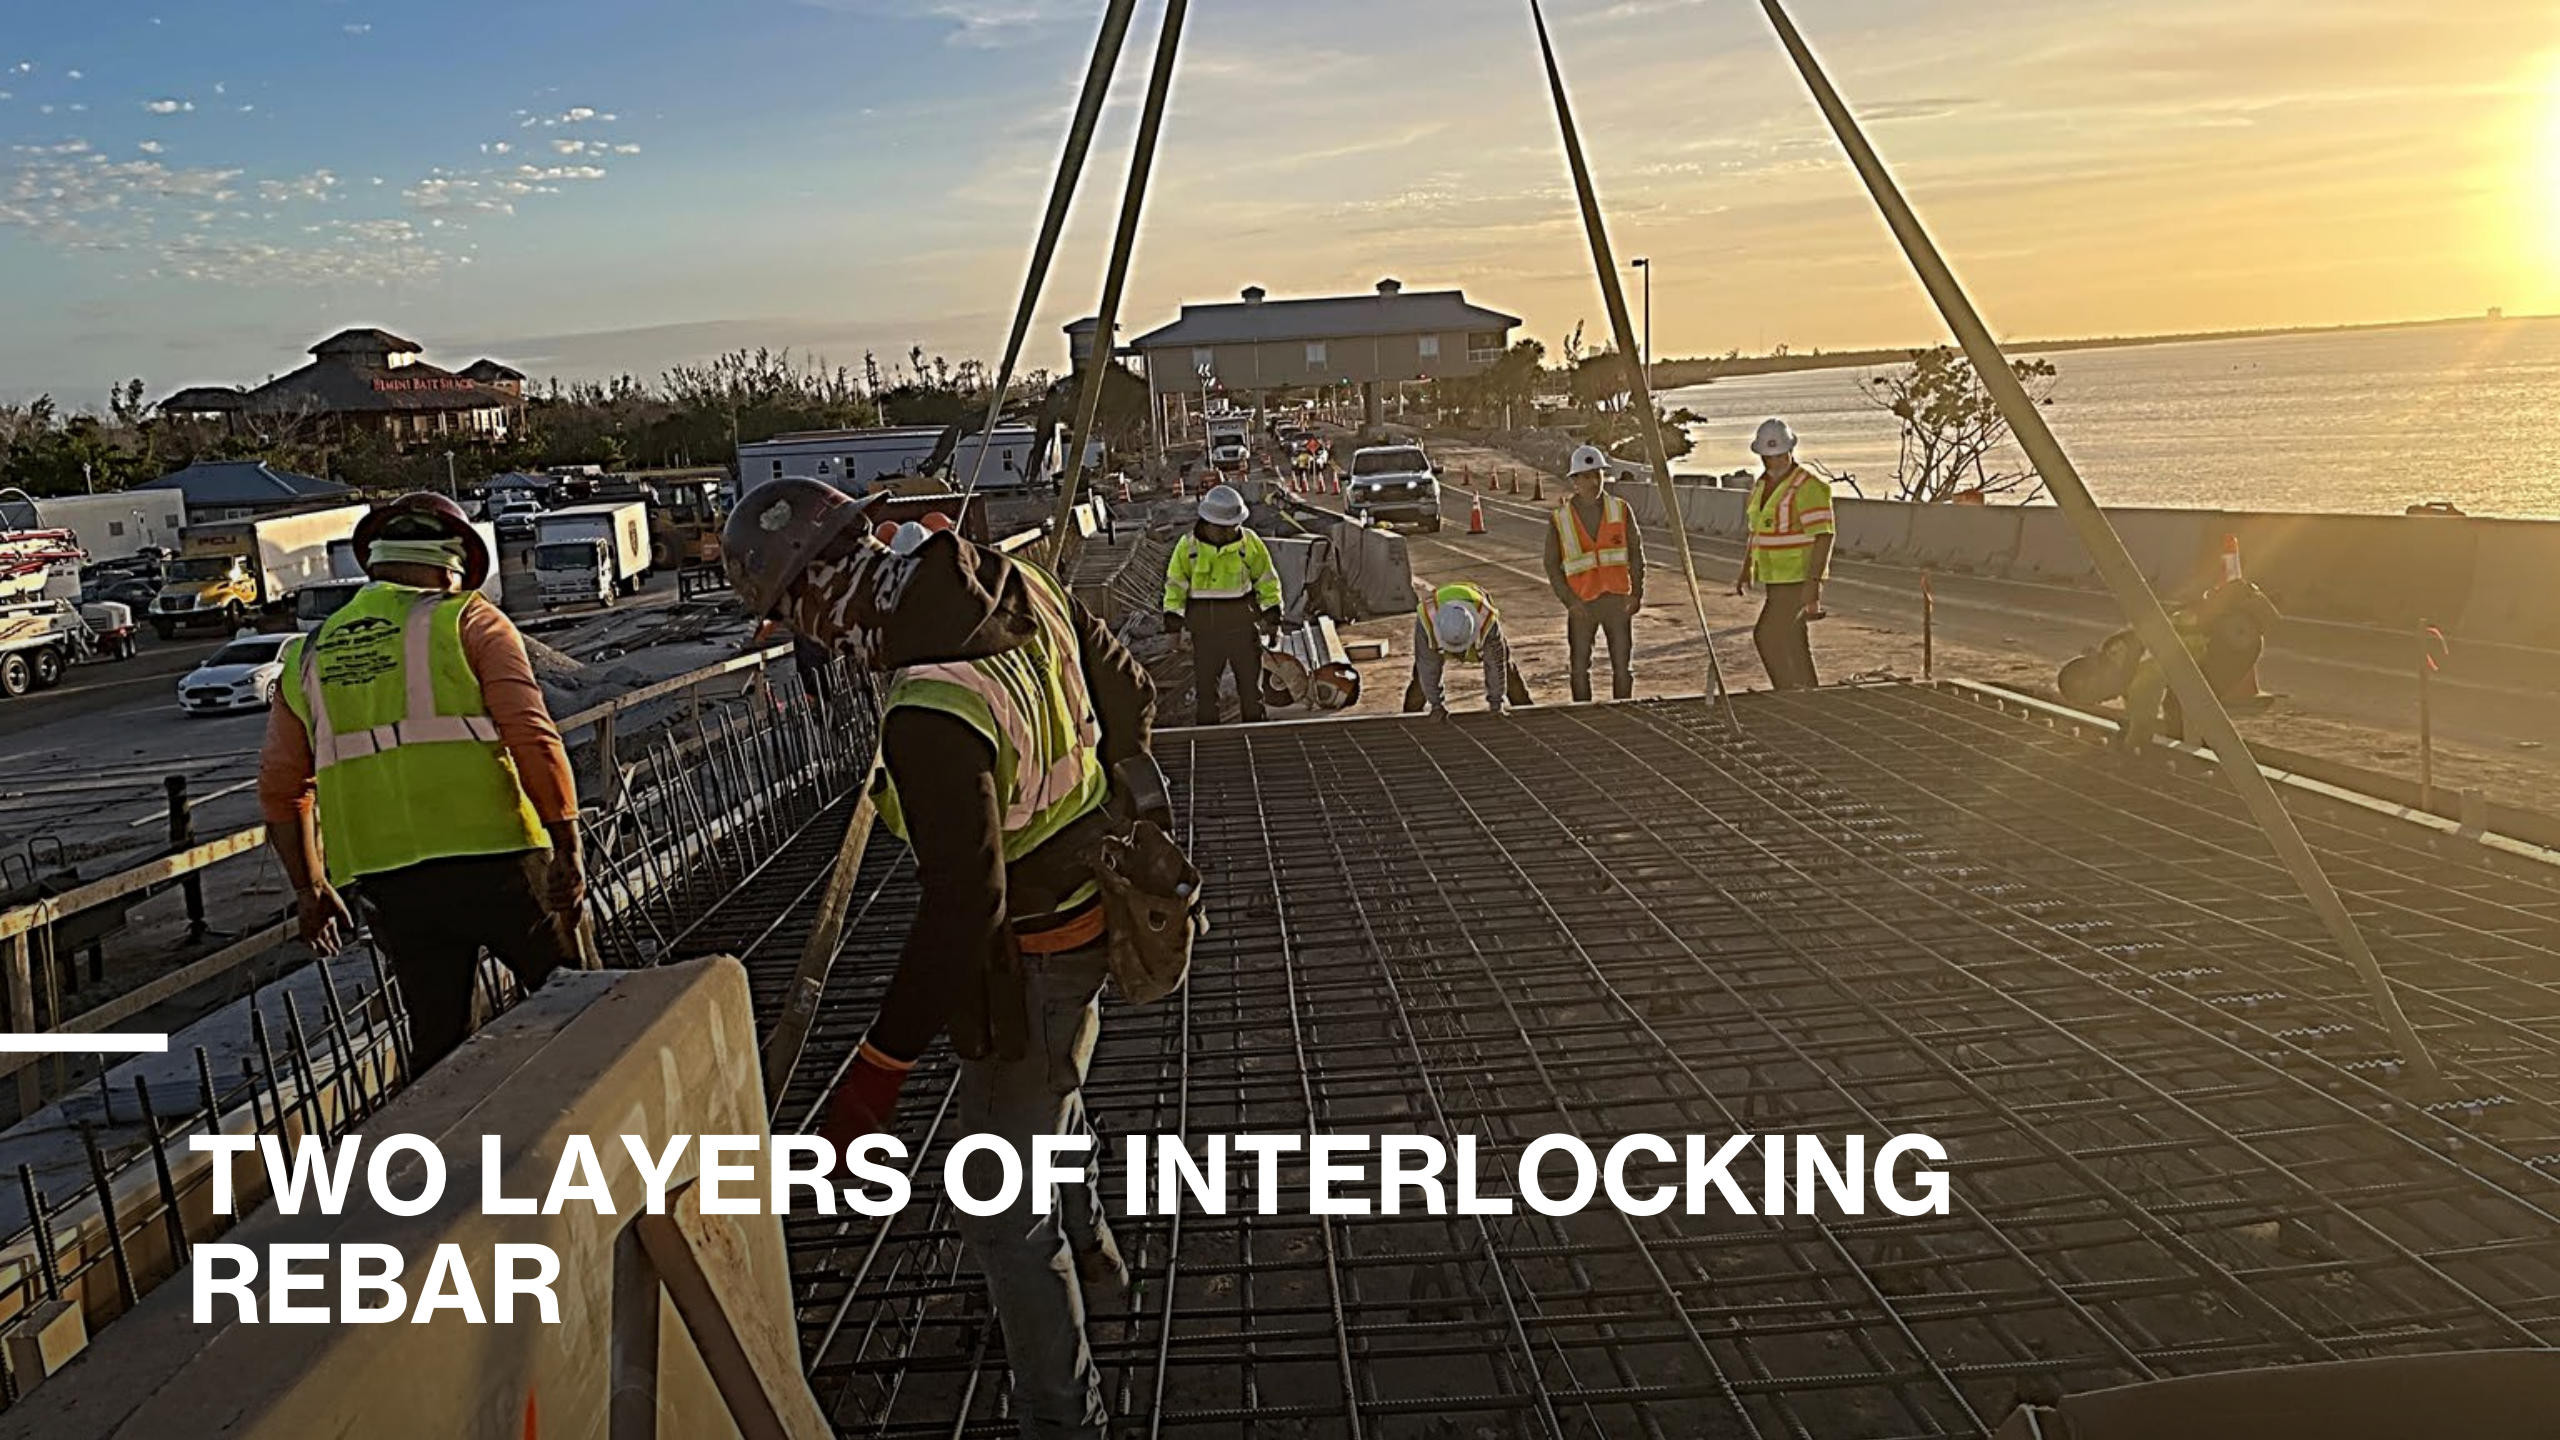
2 - FRAME SECTION & PLACE REINFORCING REBAR

**TWO LAYERS OF INTERLOCKING
REBAR**
