SANIBEL CAUSEWAY RESTORATION

Kiwanis Update | November 2023

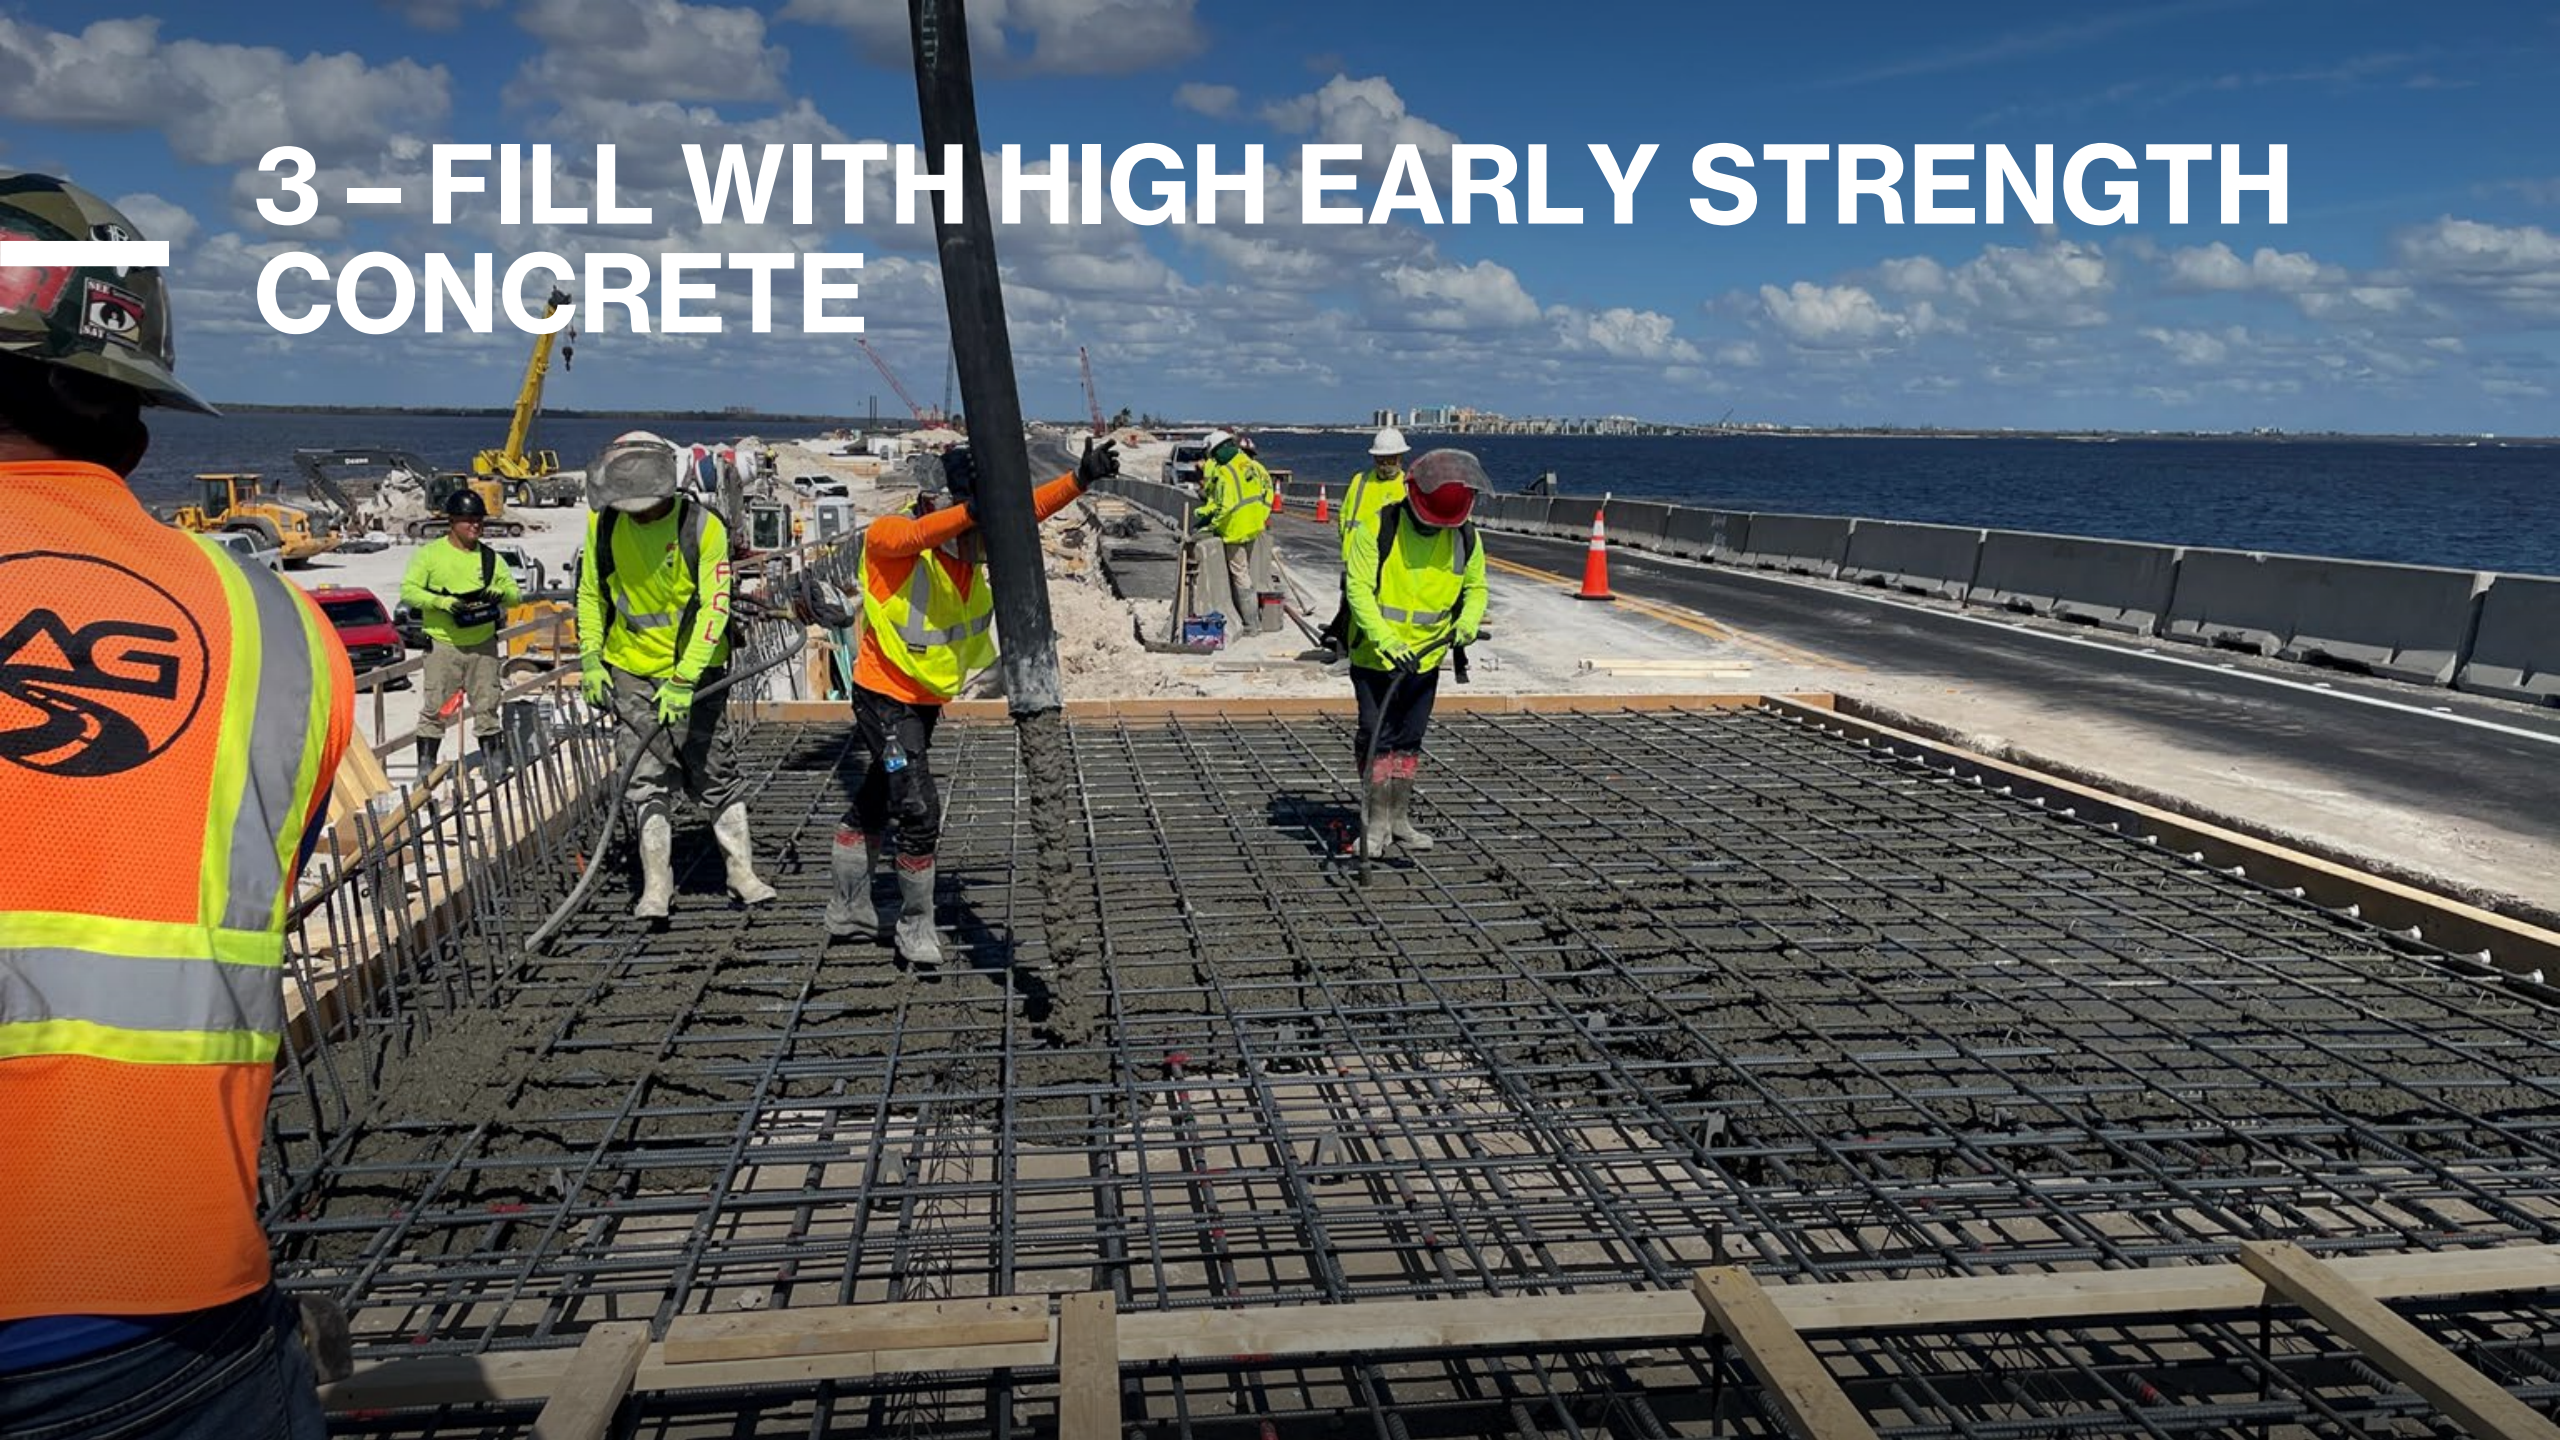
3 – FILL WITH HIGH EARLY STRENGTH CONCRETE

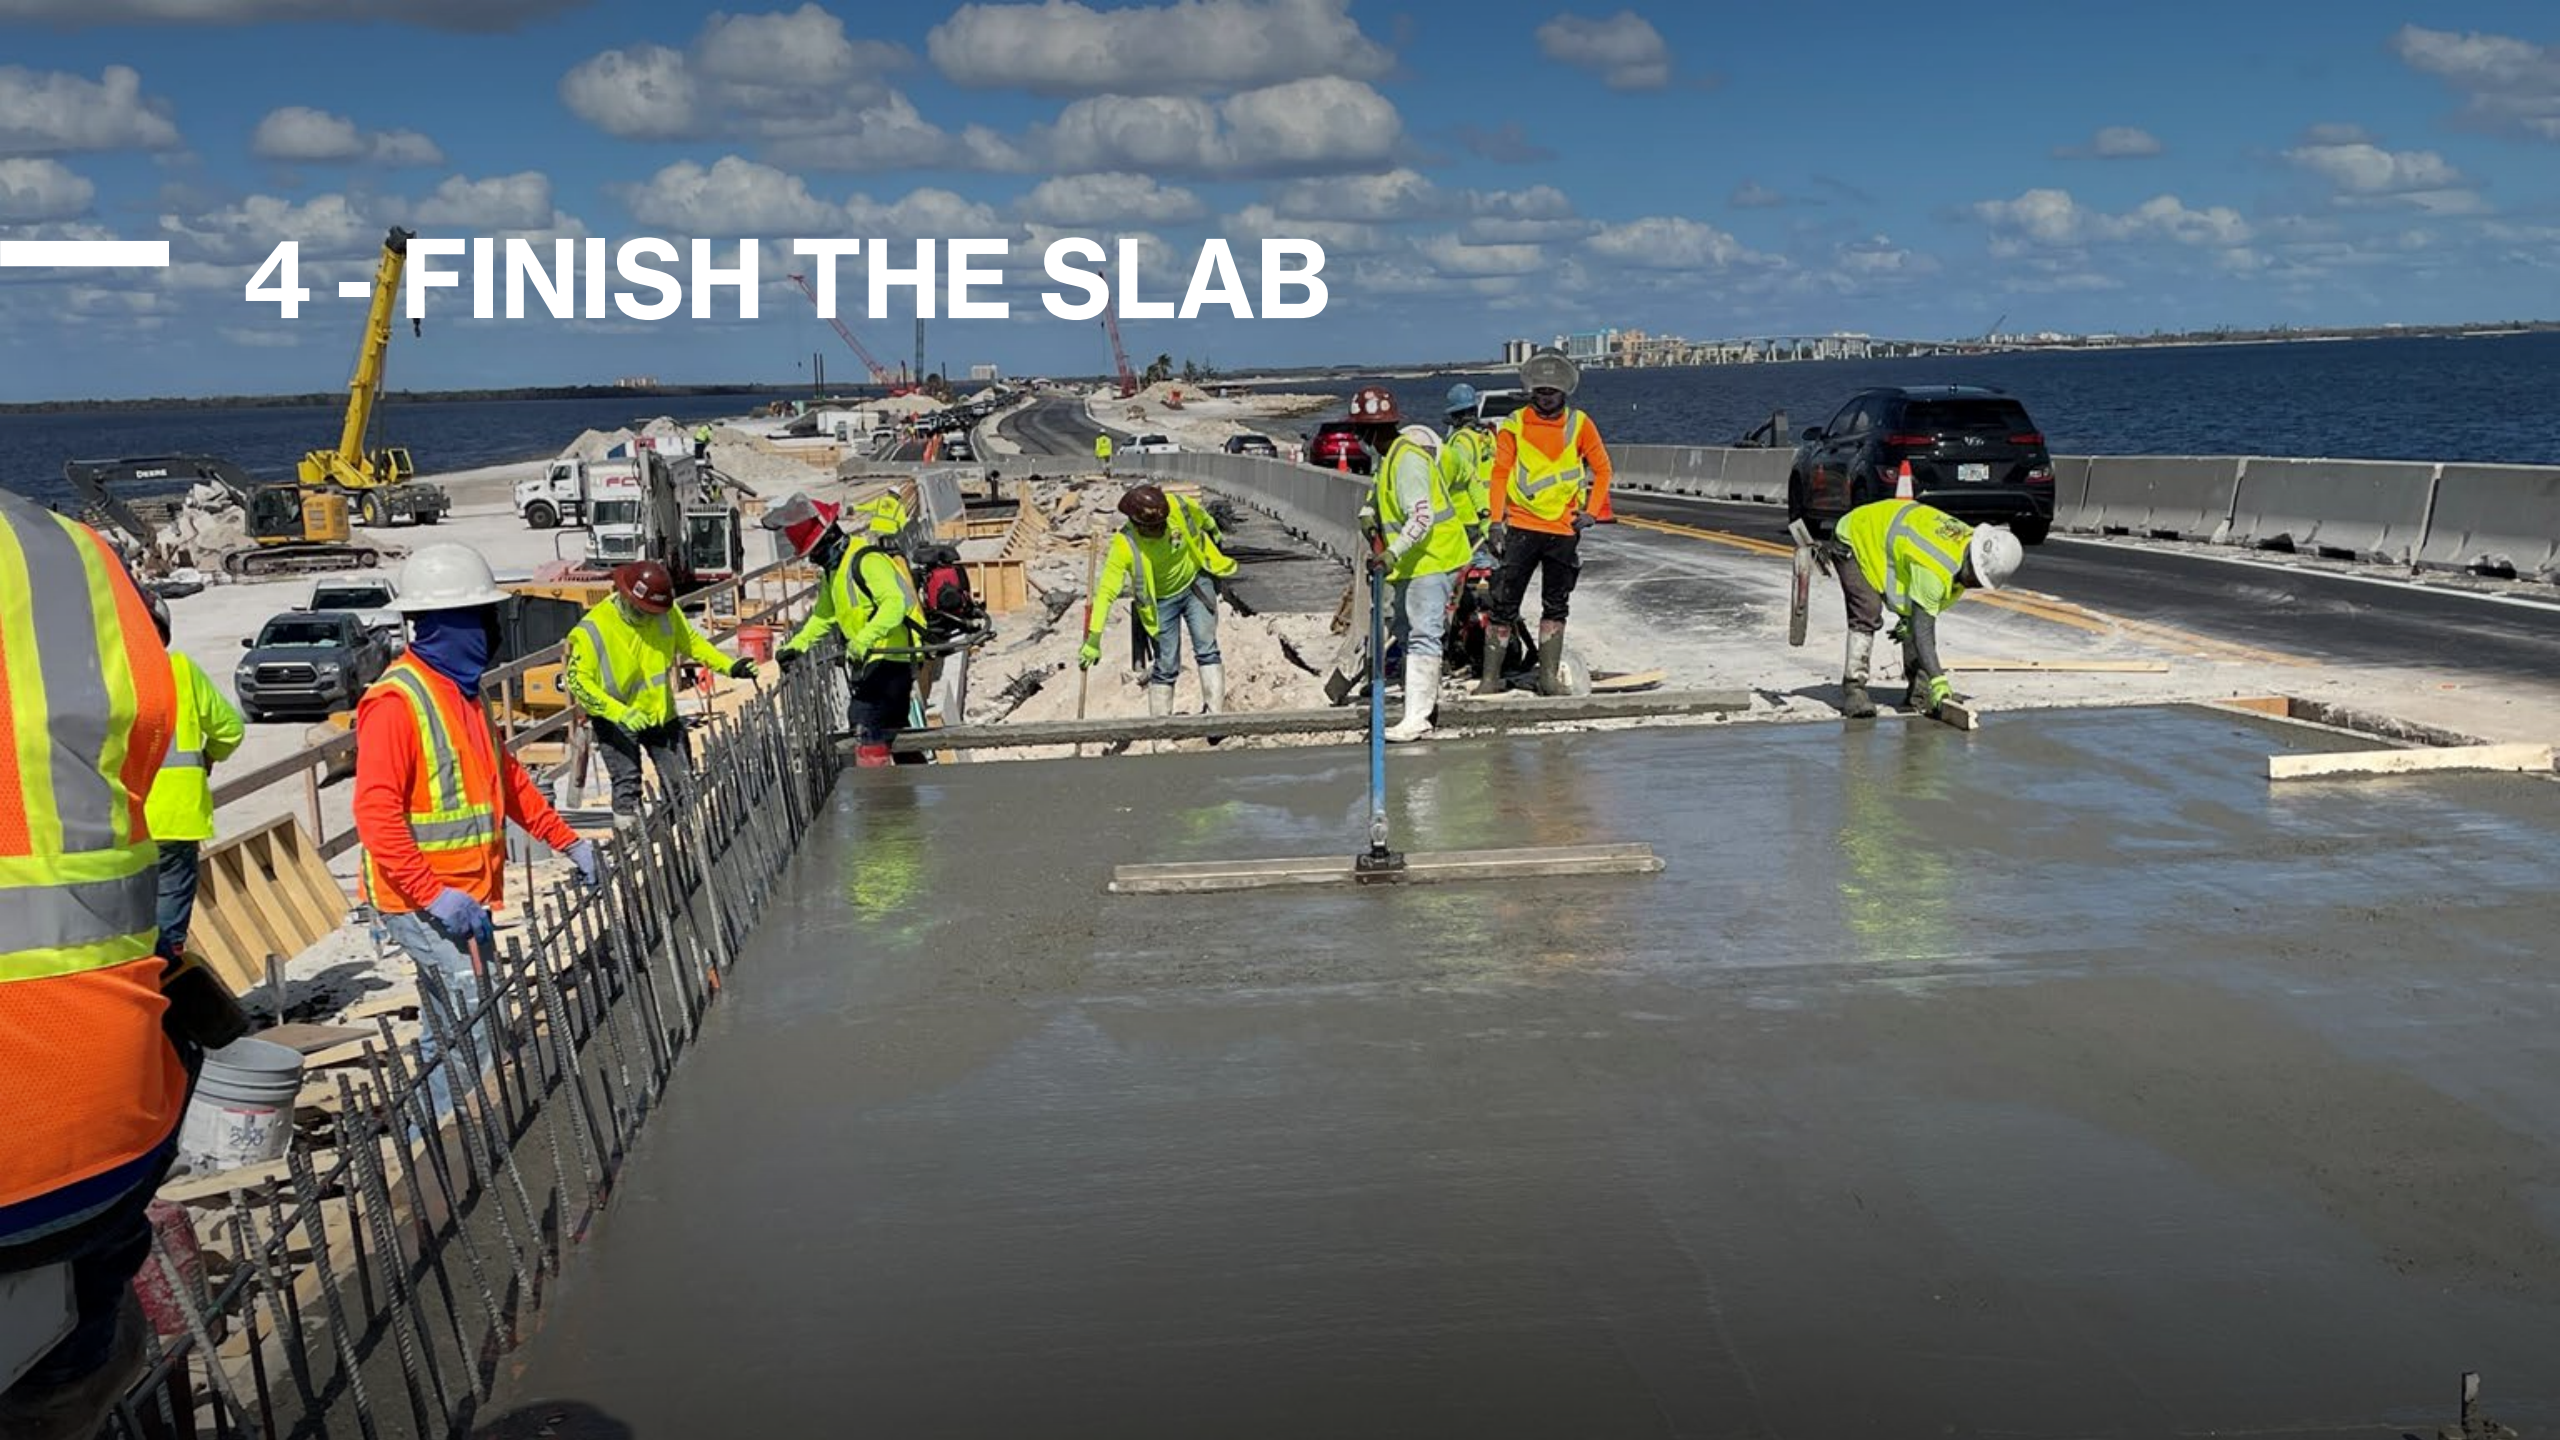
4 - FINISH THE SLAB

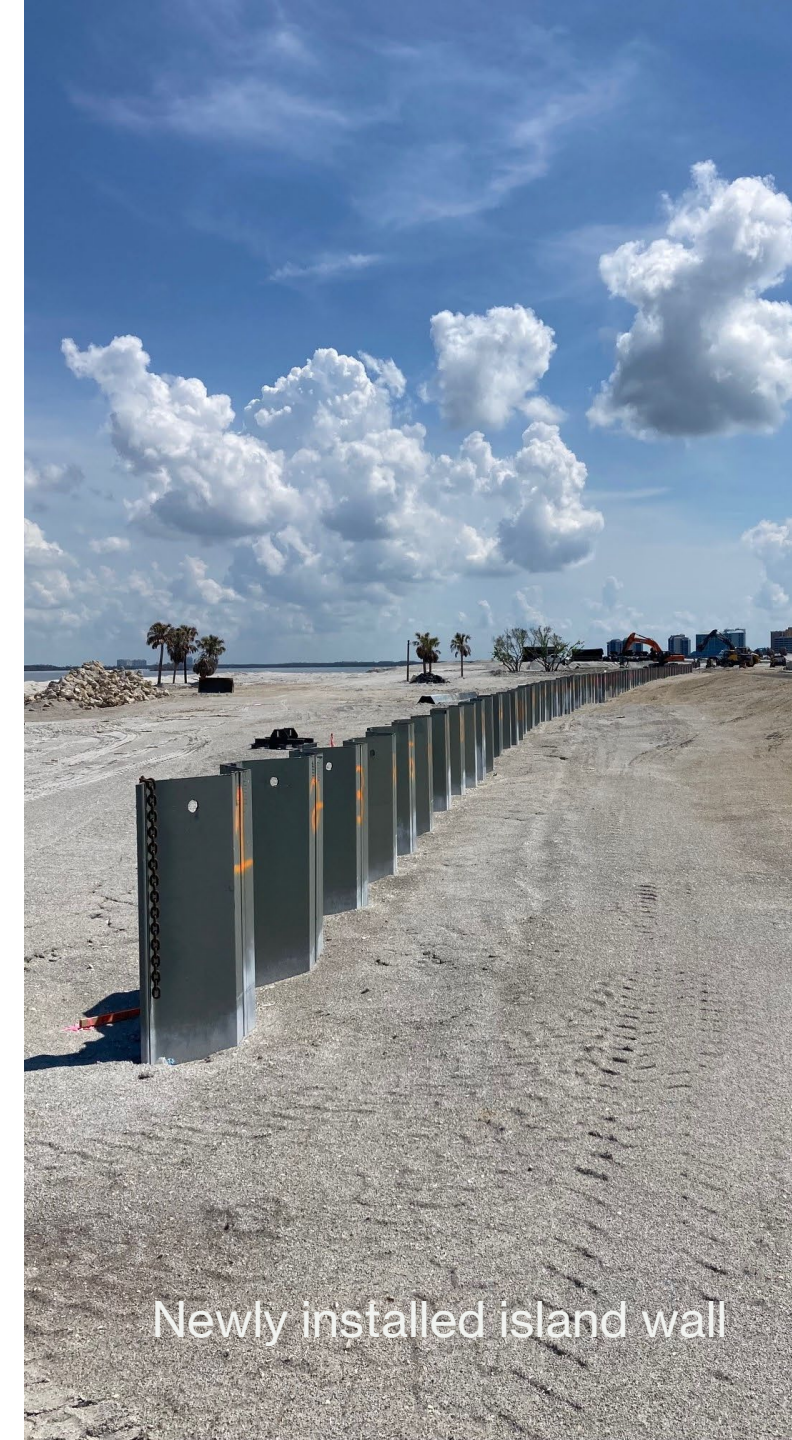
Newly installed island wall

- Several layers of protective sheet pile walls
 - **Island walls** to protect the causeway islands roadway
 - **Sea walls** to protect the bridge approaches
 - **Retaining walls** to protect the sides of the bridges
 - **King pile walls** to wrap around the bridge abutments

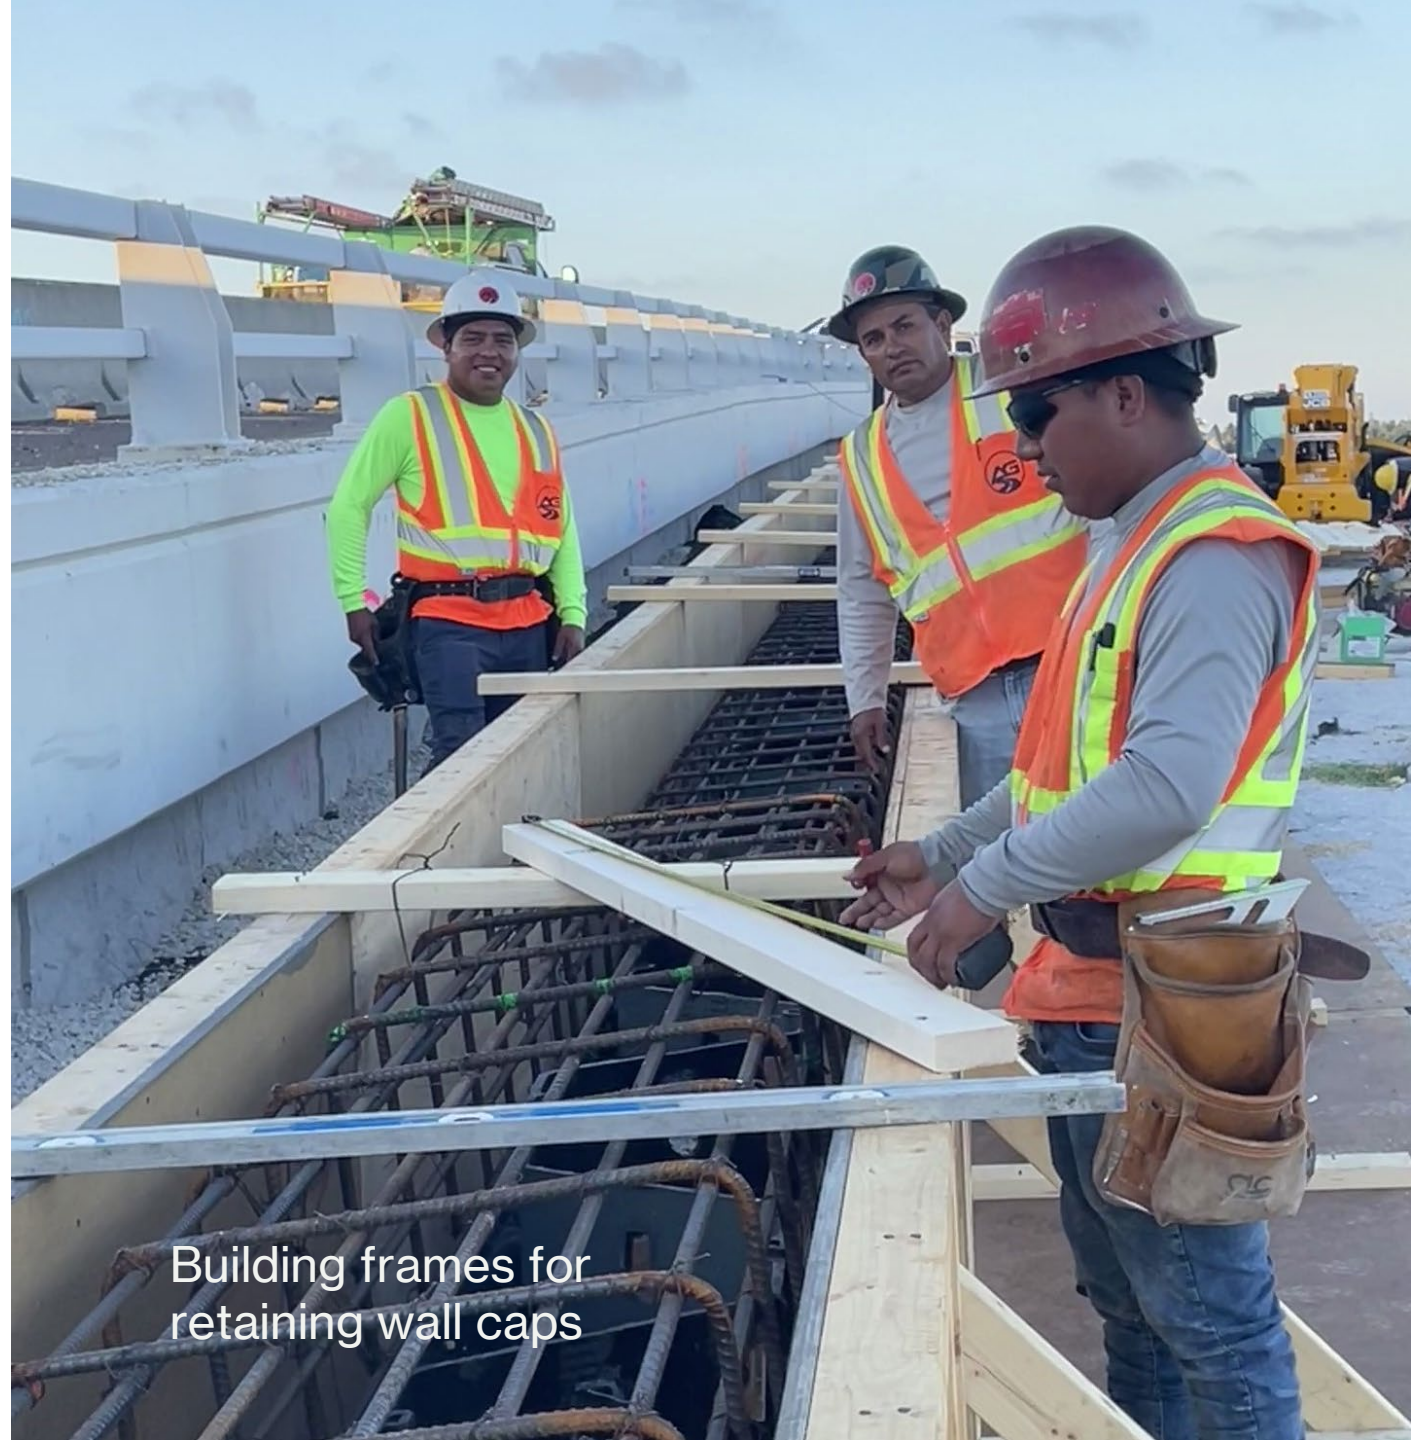
Building frames for retaining wall caps

A retaining wall will protect the sides of the bridges.

Each portion of the retaining wall also requires a concrete cap.

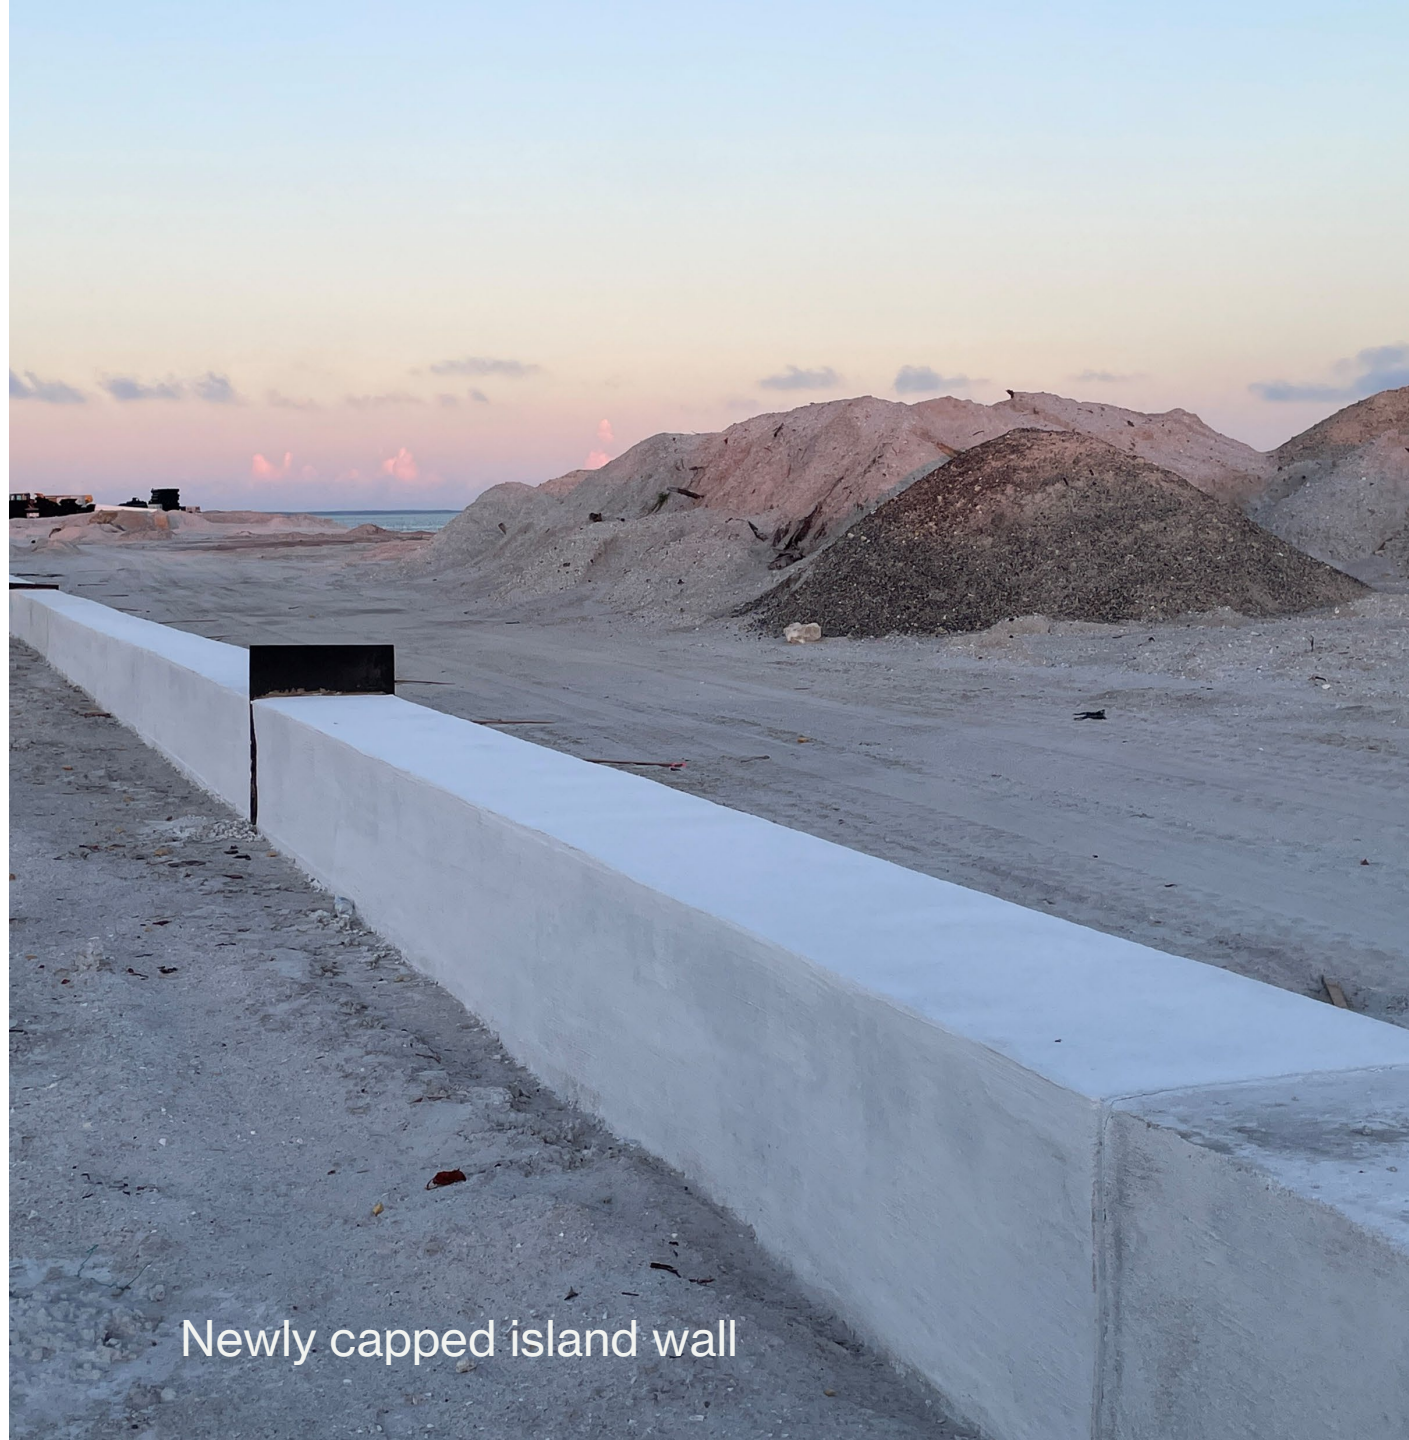
Newly capped island wall

Each wall has a protective concrete cap that is formed and then poured.

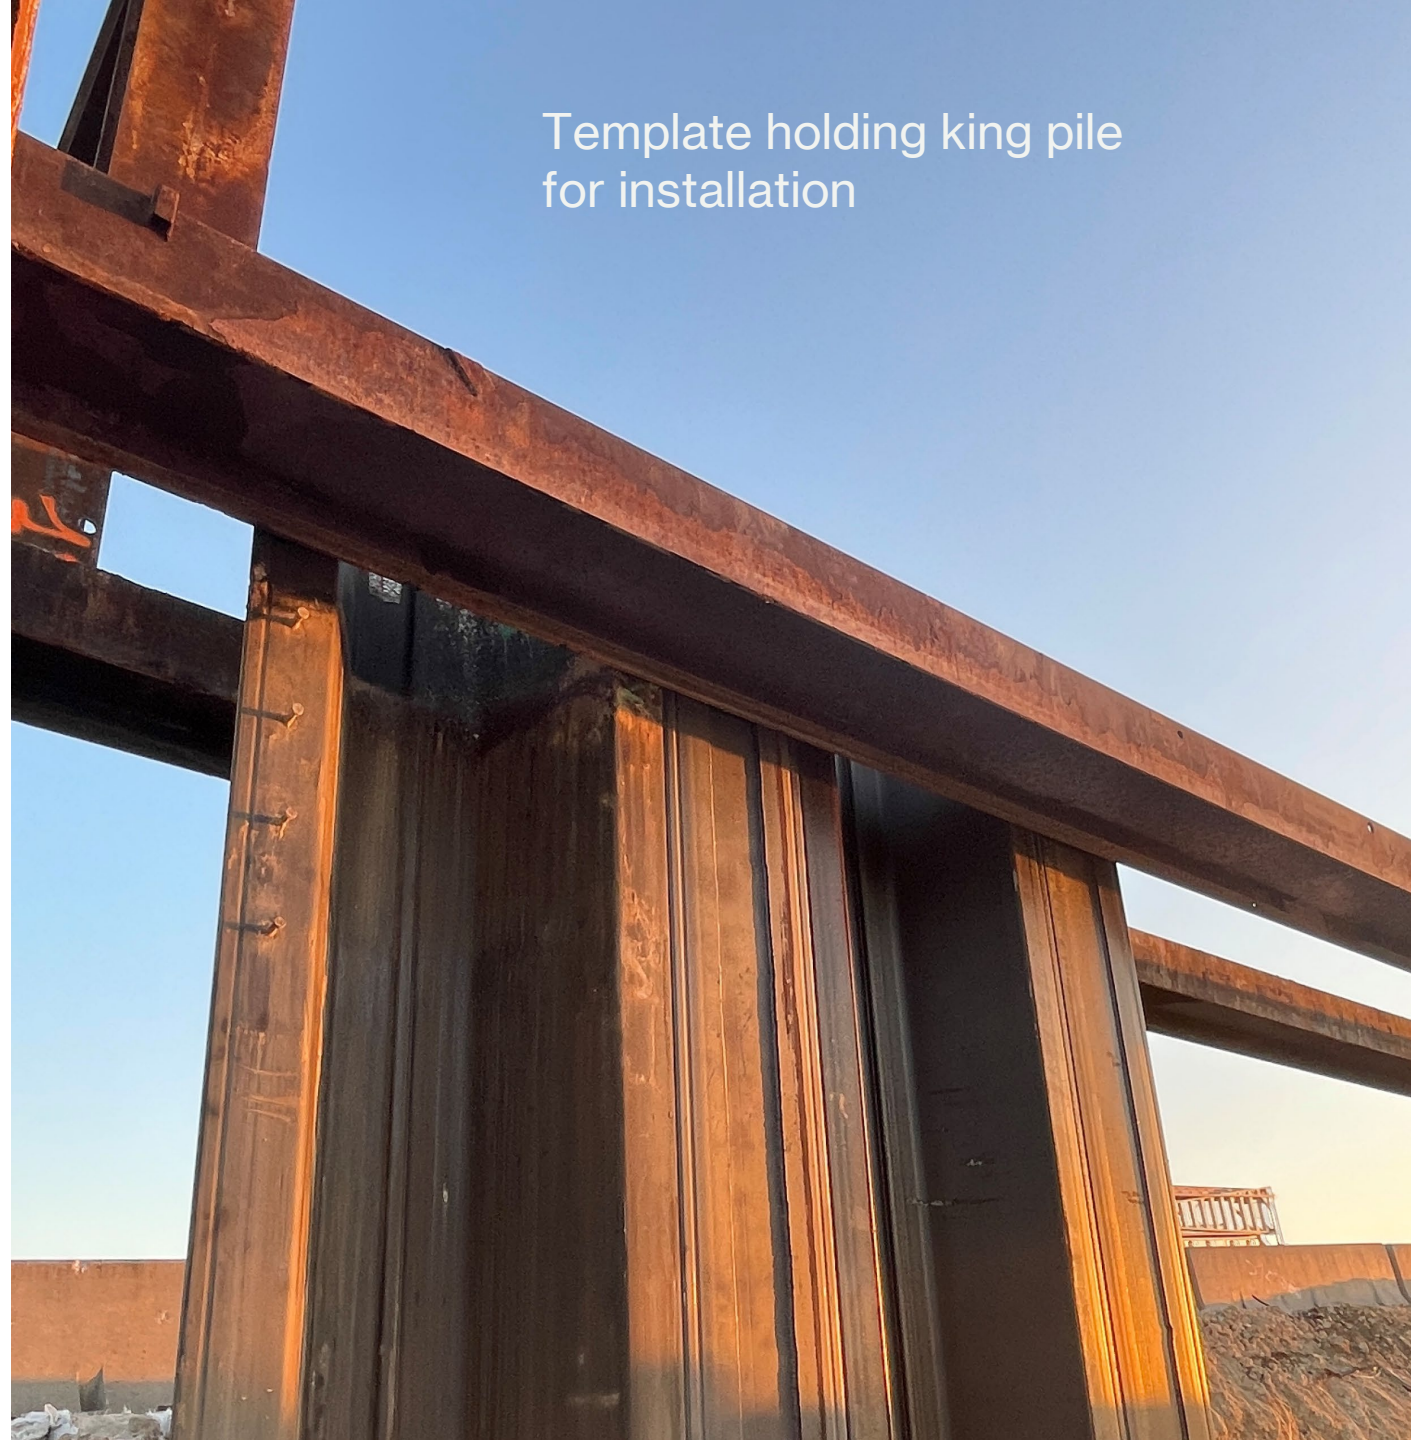
Template holding king pile
for installation

- Large “King” pile sheets are driven 50’ under the water’s surface to protect the bridge abutments
- Held in place by a template while driven into the ground
- King pile installation is complete

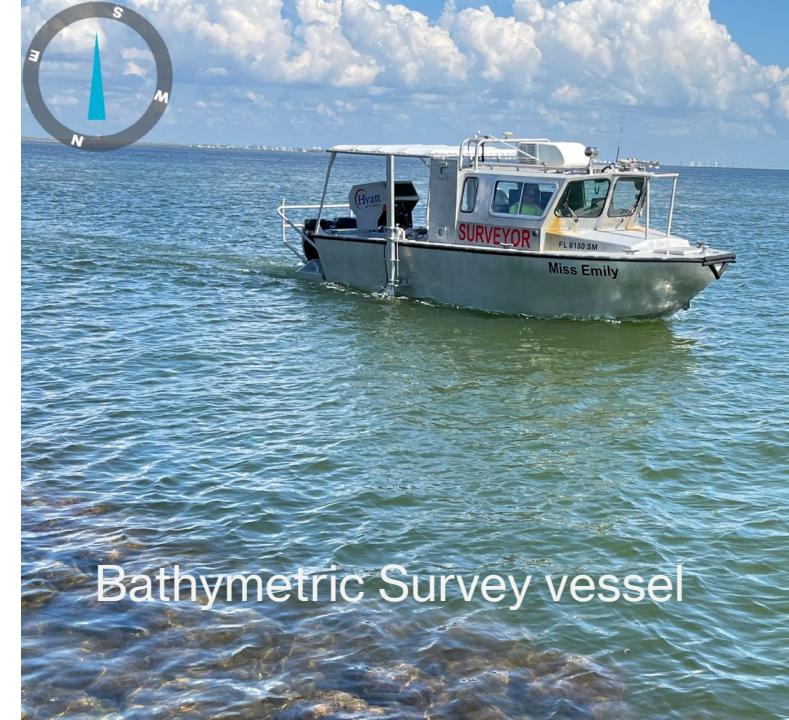
Bathymetric Survey vessel

- A bathymetric (water-based) survey was performed in September to determine placement of the armor stone.
- Granite “armor stone” from Georgia and Alabama will provide further protection of the bridge abutments.
- **Armor stone deliveries will continue for several months.**

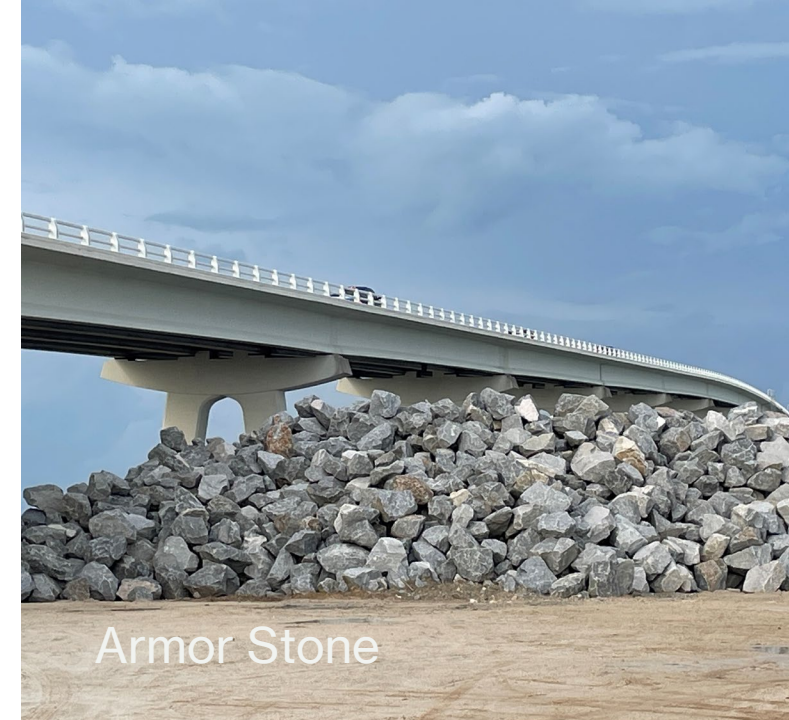
Armor Stone

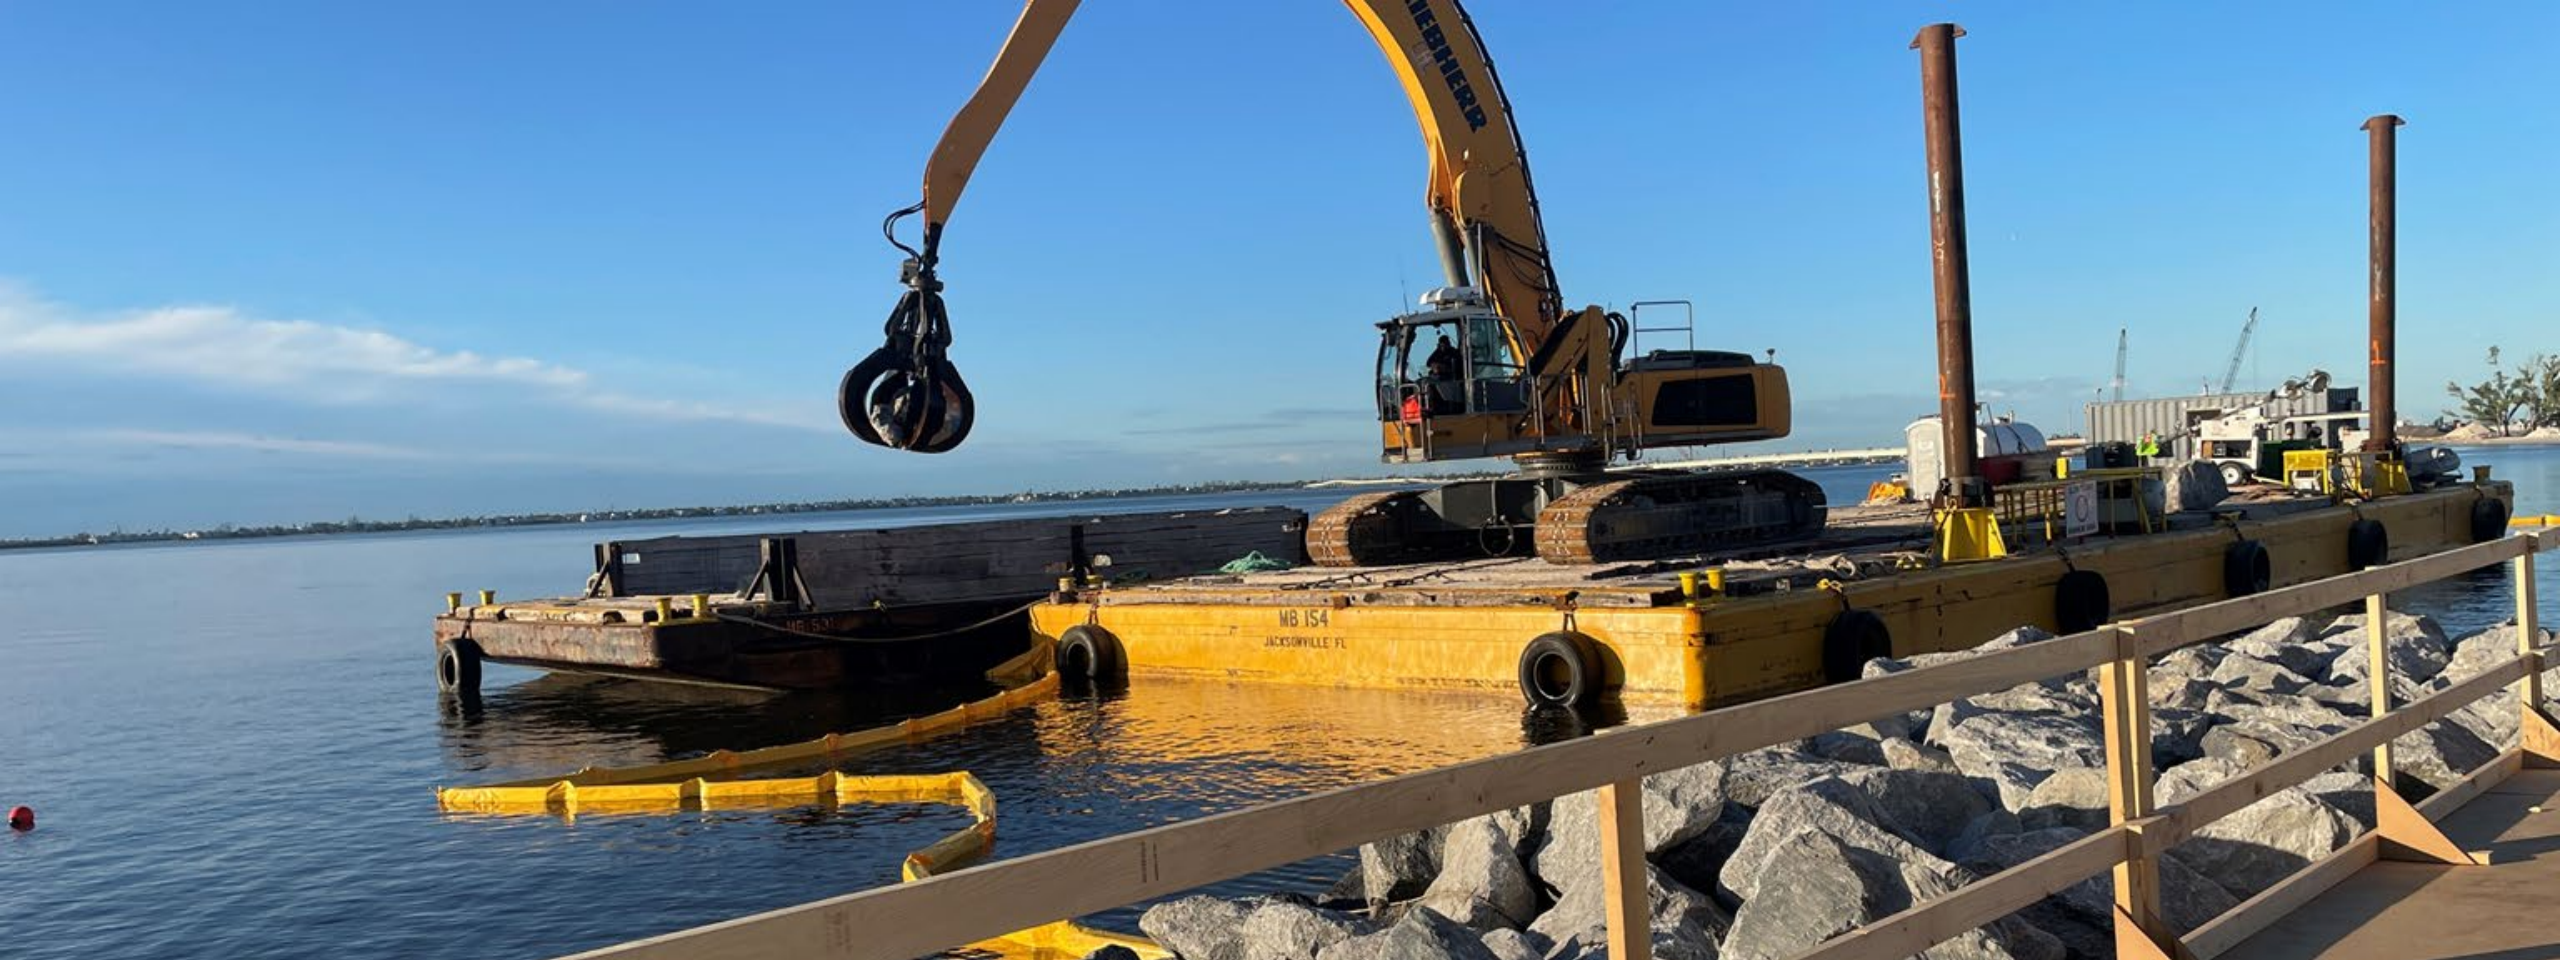
ARMOR STONE PLACEMENT

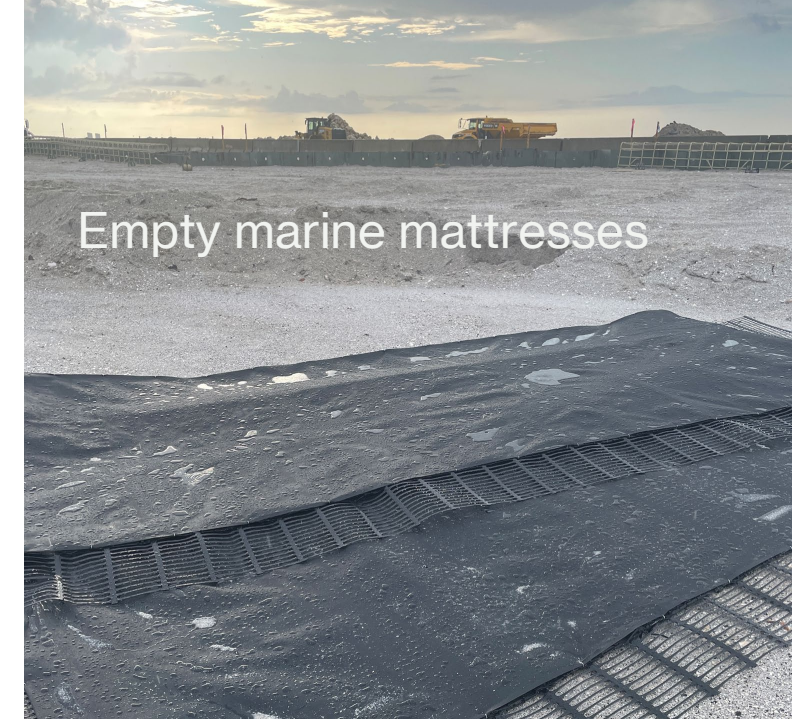
Empty marine mattresses

- Marine mattresses made of small rocks held within a framework will absorb wave energy to protect the bridge and shoreline
- As the mattresses fill with silt they support plant life and become habitat – providing further resilience
- **Crews are currently filling the marine mattress frames.** This will continue for several weeks

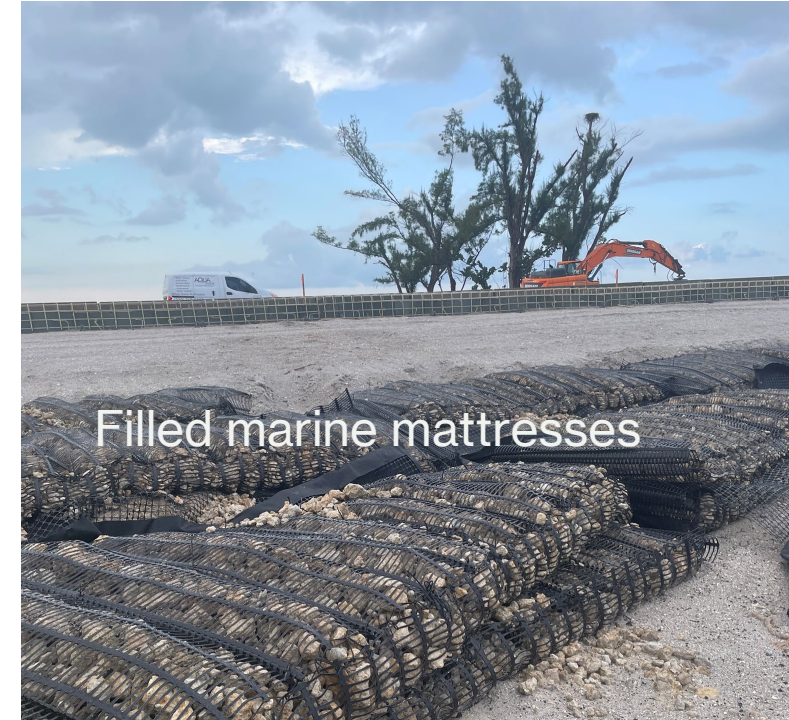
Filled marine mattresses

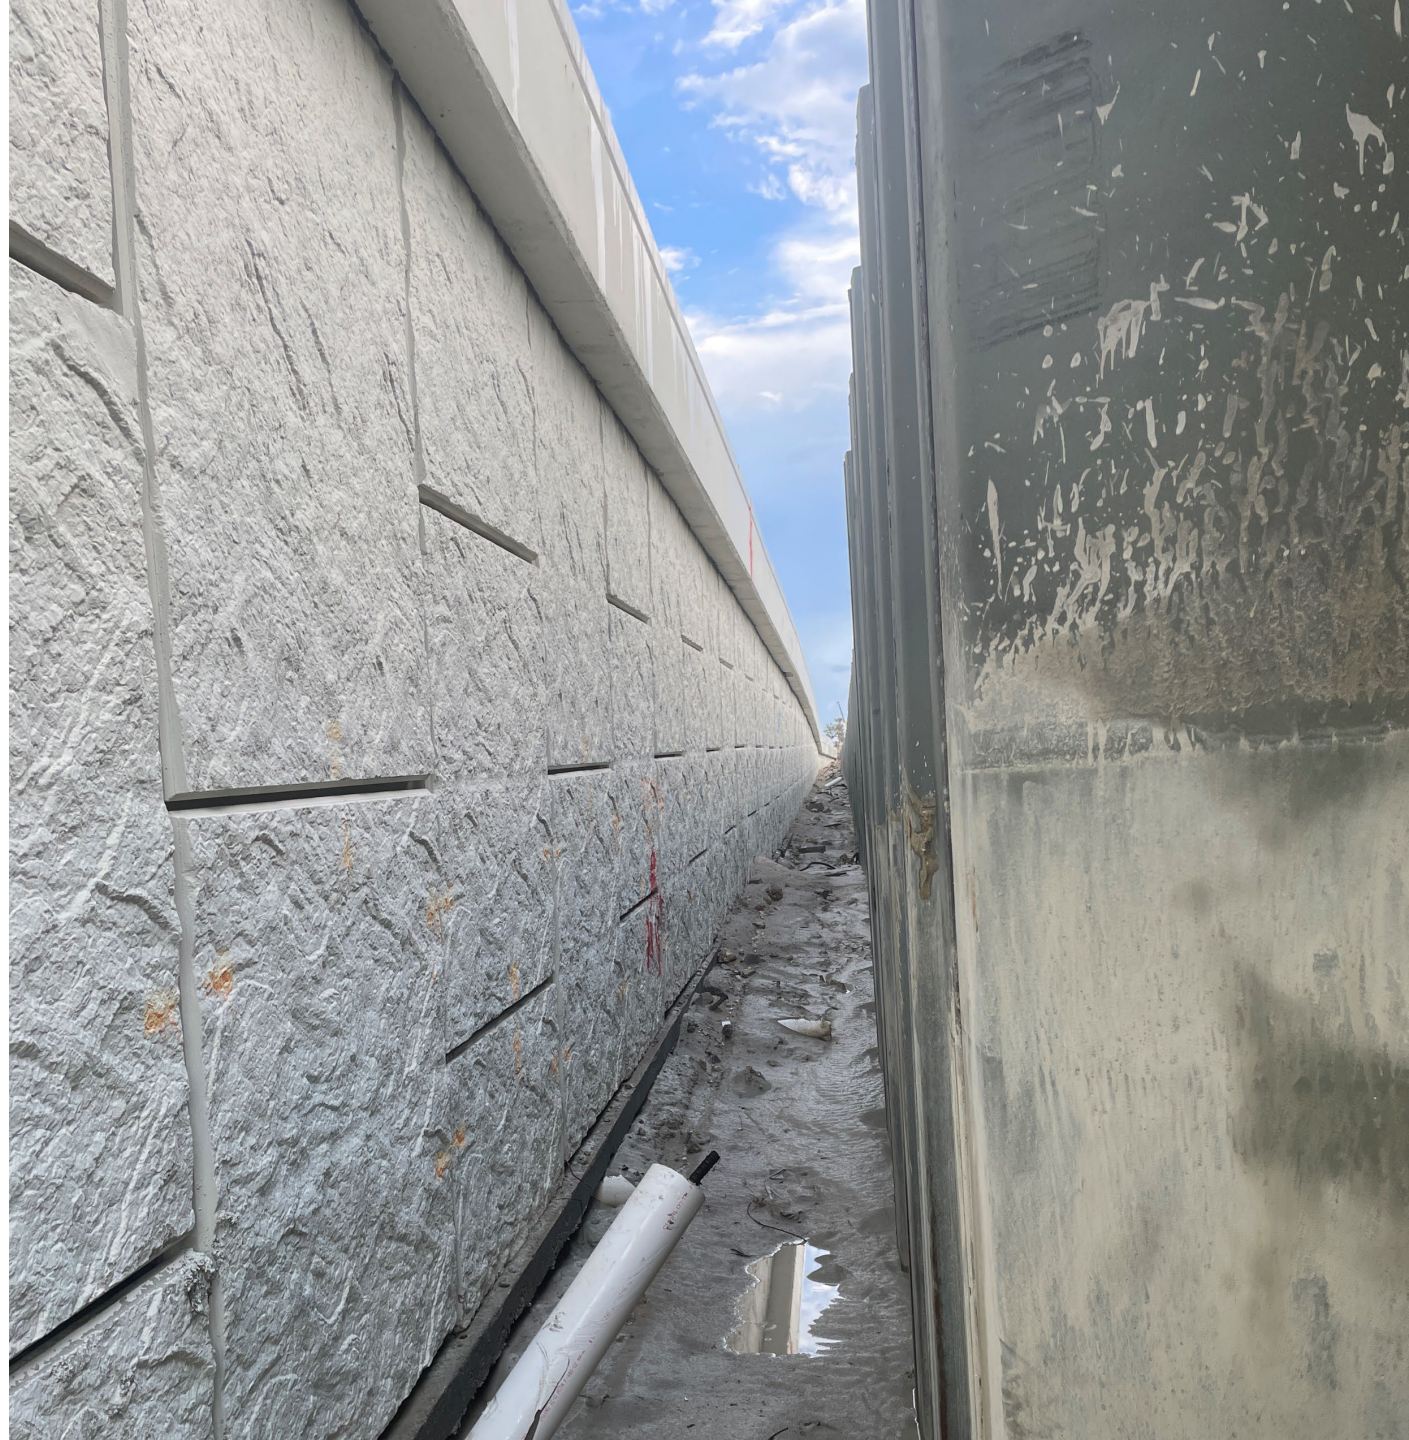
- A drainage structure between the bridge and the retaining wall will protect the roadway from high water.
- Sea water will drain off the road and be filtered here before returning to the Gulf.
