CULTURAL RESOURCE ASSESSMENT SURVEY ADDENDUM
PREFERRED POND SITES

State Road 70 PD&E Study

Limits of Project: C.R. 721 South to C.R. 559/128th Avenue

Highlands and Okeechobee Counties, Florida

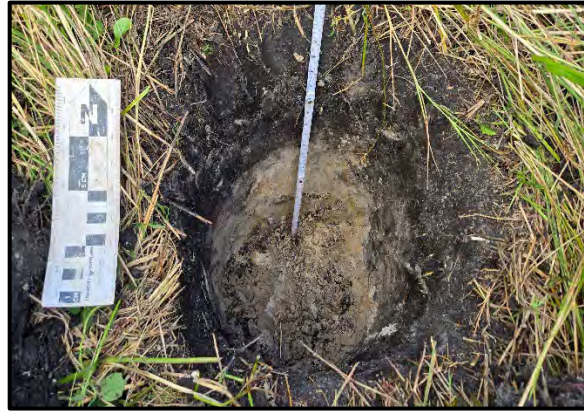
Photo 24. General stratigraphy example within the pasture environments, facing north.

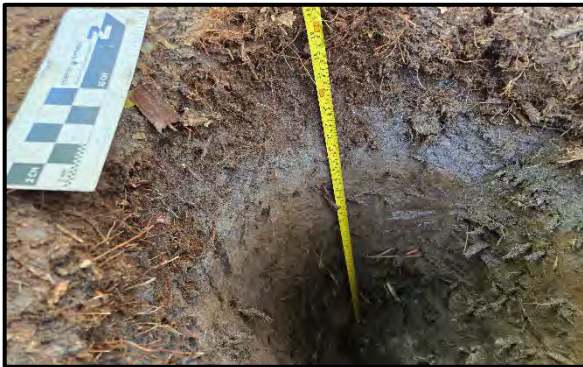
Photo 25. General stratigraphy example within seasonally wet pasture environments, facing north, terminated early due to compacted clay.

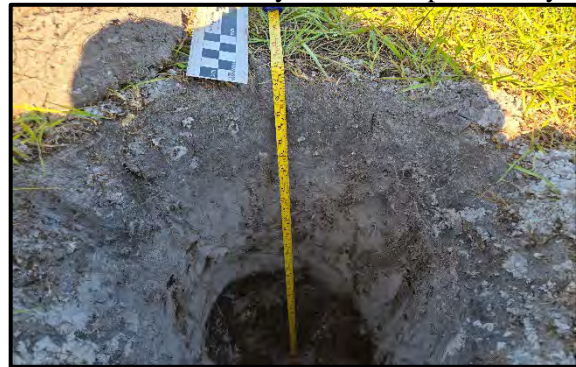
Photo 26. Stratigraphy within the tree island in the northeast portion of Pond 7A, facing north. Note similar stratigraphy is found in the scrub hammock environment of Pond 8A.

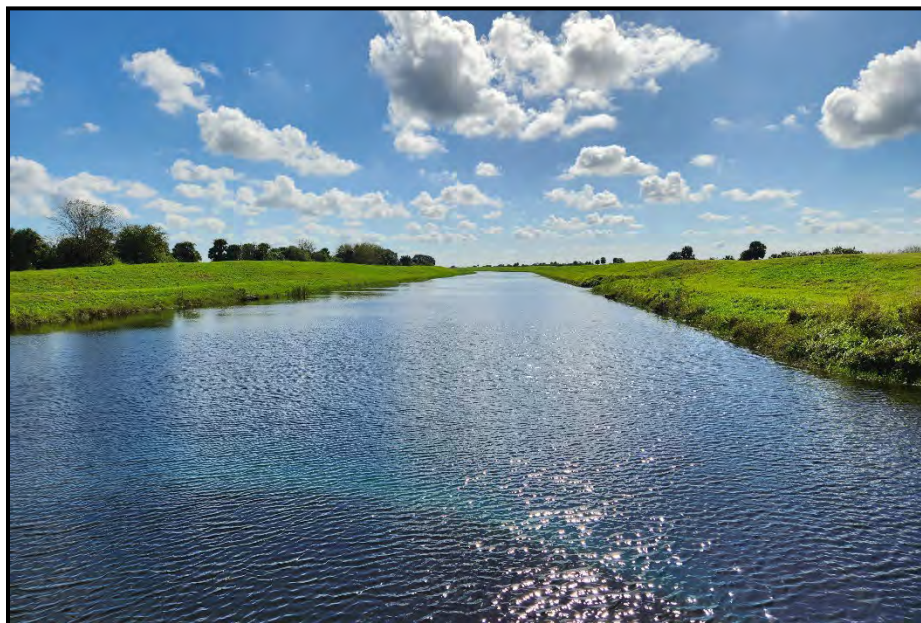
Photo 28. Slough Ditch Canal (C-41A) (8HG01127), looking southeast.

A portion of the segment within the Pond 3B APE was recorded during the mainline CRAS and was evaluated as eligible for listing in the NRHP under Criterion A in the areas of Community Planning and Development and Agriculture; however, there is insufficient information to evaluate NRHP eligibility for the linear resource as a whole. The SHPO concurred with the CRAS findings in September 2025 (Lotane 2025). The segment of the Slough Ditch Canal (C-41A) within the APE remains eligible for listing in the NRHP under Criterion A in the areas of Community Planning and Development and Agriculture; however, the segment within the APE does not appear eligible under Criterion C in the area of Engineering. The portion within the APE does not contain any water control structures and is only a fragment of the whole Slough Ditch Canal (C-41A) system that lacks unique design attributes or innovative engineering features. Most of the Slough Ditch Canal (C-41A) is located outside the APE, and a survey of the entire 20.1 miles is beyond the scope of this project.

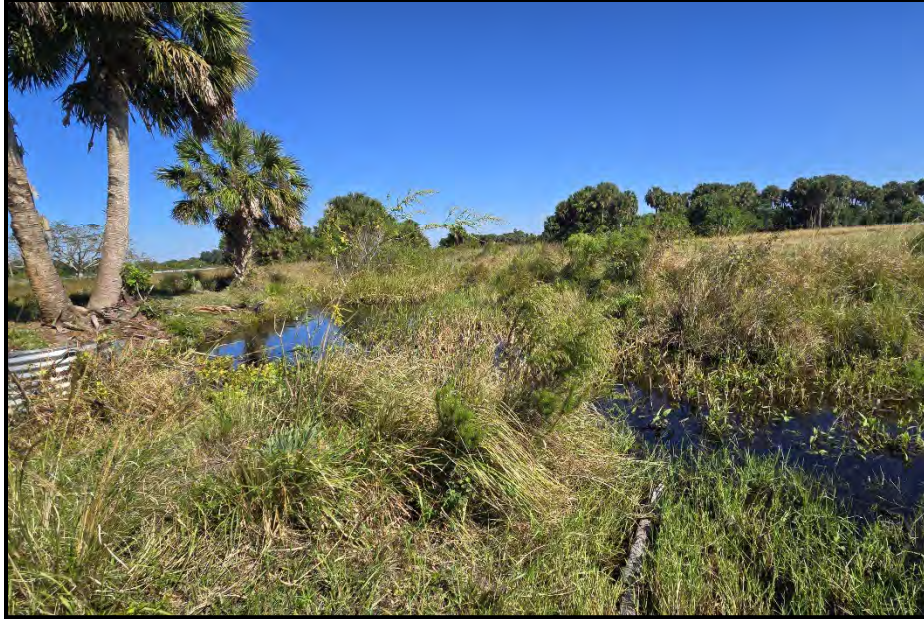
Photo 29. Lykes Drainage System (South) (8HG01725), looking southeast.

8HG01725: The segment of the ca. 1970 Lykes Drainage System (South) within the APE is located in Section 25 of Township 37 South, Range 32 East (USGS 1953a, FDOT 1970) (**Photo 29**). The segment is located within the Pond 3B APE, and it is approximately 0.3 mi long. Approximately 0.12 miles of this total length was also recorded within the APE of the mainline CRAS. The majority of the segment runs northwest-southeast; however, a portion also branches off to run southwest-northeast into the Slough Ditch Canal (C-41A) (8HG01127). In its entirety, the Lykes Drainage System (South) spans throughout Highlands County parcel No. C-25-37-32-A00-0020-0000 to the south of S.R. 70; however, the majority of the system is located outside of the APE. The drainage system does not appear to have an official name but was recorded during the mainline CRAS as the Lykes Drainage System (South) due to its location on land owned by Lykes Ranch to the south of S.R. 70 (McIntyre 2025). Lykes Ranch encompasses approximately 337,000 acres throughout Glades and Highlands County and is utilized for cattle, forestry, sugar cane, and landscape operations (Lykes Ranch 2024). The resource was first recorded during the mainline CRAS and the segment within the APE was evaluated as ineligible for listing in the NRHP with the overall resource having insufficient information for evaluating NRHP eligibility as the majority of the linear resource was located outside of the APE. The SHPO concurred with the findings in September 2025 (Lotane 2025). The linear resource is a common example of a drainage system found throughout South Florida and is not a significant embodiment of a type, period, or method of construction; and has no known significant historic associations. As a result, the segment of 8HG01725 within the APE does not appear eligible for listing in the NRHP, either individually or as part of a historic district; however, there is insufficient information to evaluate the resource as a whole.

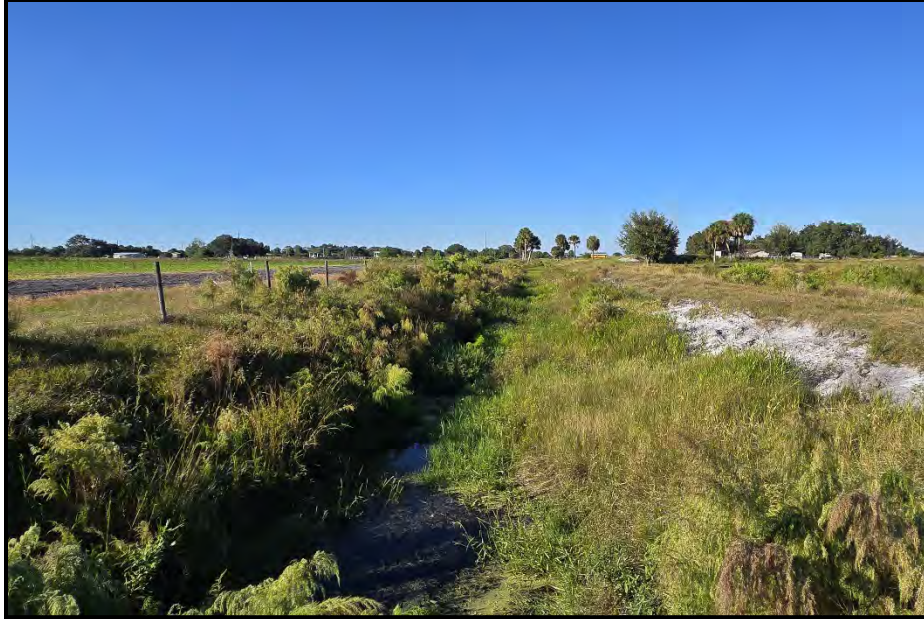
Photo 30. Arrow B Ranch Canal (8HG01728), looking north.

8HG01728: The segment of Arrow B Ranch Canal within the APE is located in Section 28 of Township 37 South, Range 33 East (USGS 1953a) (**Photo 30**). The segment of the canal located within the Pond 5C APE is approximately 0.2 miles long and the segment within the Pond 6C APE is approximately 0.28 miles long. The canal is approximately 10 ft wide with shallow earthen banks and was constructed ca. 1953 (USDA 1953). In its entirety, the Arrow B Ranch Canal spans from the Slough Ditch Canal (C-41A) Canal in the south to open pasture north of S.R. 70 in the north. At the time of construction, the Slough Ditch Canal (C-41A) had not yet been created and the canal ended in unaltered wetlands (USDA 1953). The canal is unnamed but was recorded as the Arrow B Ranch Canal due to its location on land historically owned by Arrow B Ranch (McIntyre 2025). The resource was first recorded during the mainline CRAS and the segment within the APE was evaluated as ineligible for listing in the NRHP with the overall resource having insufficient information for evaluating NRHP eligibility as the majority of the linear resource was located outside of the APE. The SHPO concurred with the findings in September 2025 (Lotane 2025). The linear resource is a common example of a drainage canal found throughout South Florida and is not a significant embodiment of a type, period, or method of construction; and has no known significant historic associations. As a result, the segment of 8HG01728 within the APE does not appear eligible for listing in the NRHP, either individually or as part of a historic district; however, there is insufficient information to evaluate the resource as a whole.

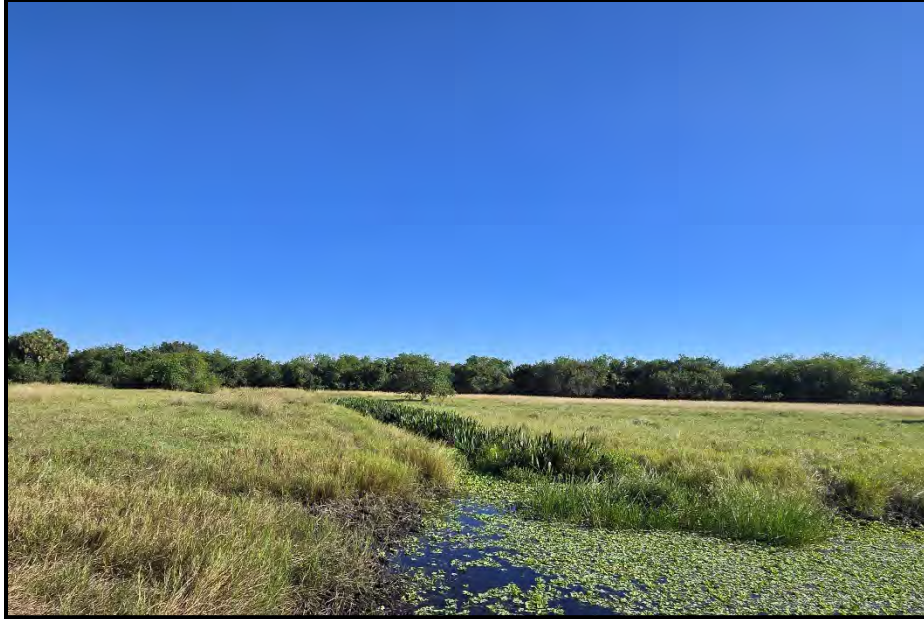
Photo 31. Lykes Drainage Canal (8HG01751), looking southeast.

8HG01751: The segment of the Lykes Drainage Canal within the APE is located adjacent to Pond 1A in Section 26 of Township 37 South, Range 32 East (USGS 1953a) (**Photo 31**). The segment is approximately 795 ft long and 8-10 ft wide with shallow earthen banks and travels mostly east-west before turning northwest. The canal first appears on historic aerial photographs ca. 1958 connecting a wetland and/or pond in the west to wetlands in the east which are no longer present due to subsequent drainage operations (USDA 1958). The canal was later widened and lengthened to the current configuration ca. 1974 (USDA 1974). In its entirety, the canal is approximately 0.57 miles long including segments located outside of the APE and reached the current full configuration during the 1990s (Google Earth 2025). The canal is located on land owned by Lykes Bros., Inc. The linear resource is a common example of a drainage canal found throughout South Florida and is not a significant embodiment of a type, period, or method of construction; and has no known significant historic associations. As a result, the segment of 8HG01751 within the APE does not appear eligible for listing in the NRHP, either individually or as part of a historic district; however, there is insufficient information to evaluate the resource as a whole.

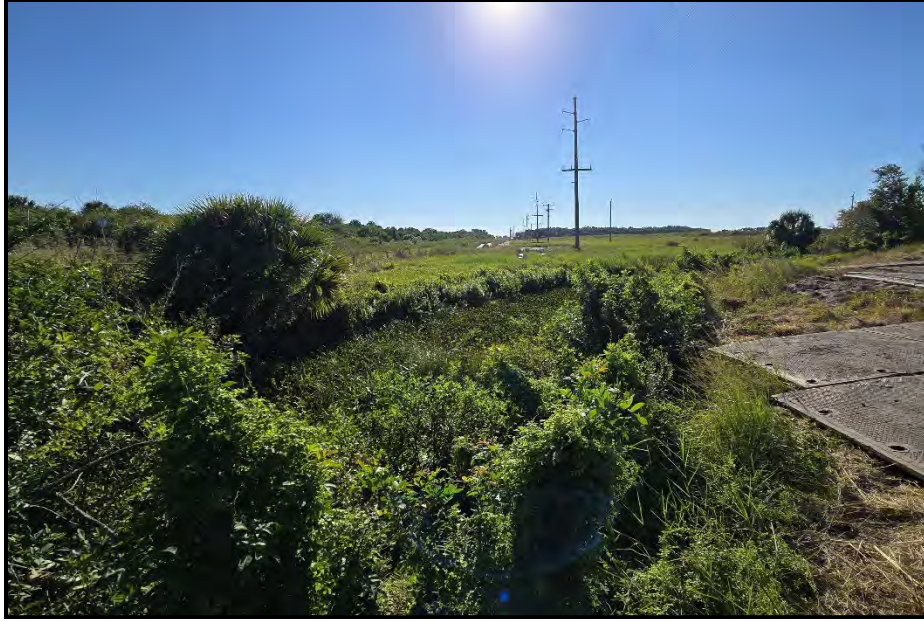
Photo 32. Unnamed Drainage Canal (8HG01752), looking west-southwest.

8HG01752: The segment of the Unnamed Drainage Canal within the APE is located adjacent to Pond 2C in Section 25 of Township 37 South, Range 32 East (USGS 1953a) (**Photo 32**). The segment is approximately 360 ft long and 15 ft wide with shallow earthen banks that are heavily overgrown. In its entirety, the canal spans approximately 900 ft northwest-southeast and was constructed ca. 1970 to connect wetlands in the west with the Slough Ditch Canal (C-41A) (8HG01127) in the east (FDOT 1970). The Unnamed Drainage Canal also merges with the S.R. 70 Drainage Canal - North (8HG01722) to the east of the APE before emptying into the Slough Ditch Canal (C-41A). The linear resource is a common example of a drainage canal found throughout South Florida and is not a significant embodiment of a type, period, or method of construction; and has no known significant historic associations. As a result, the segment of 8HG01752 within the APE does not appear eligible for listing in the NRHP, either individually or as part of a historic district; however, there is insufficient information to evaluate the resource as a whole.

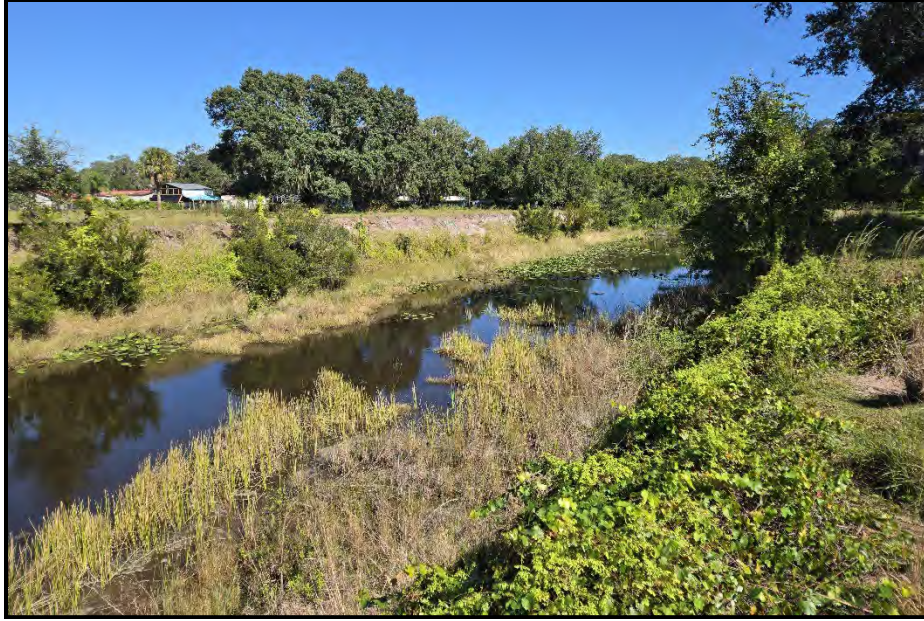
Photo 33. Kissimmee River Fishing Resort Canal (8HG01753), looking east.

8HG01753: The segment of the Kissimmee River Fishing Resort Canal within the APE is located to the north of Pond 7A in Section 26 of Township 37 South, Range 33 East (USGS 1953b) (**Photo 33**). The segment is approximately 0.23 miles long and 68 ft wide with steep earthen banks overgrown with vegetation and travels east-west parallel to and north of S.R. 70. The eastern end of the segment within the APE is located in the vicinity of NW Riverside Road. In its entirety, the canal spans a total of 1.1 miles from the Kissimmee River in the east to Jordan Terrace in the west. Based on a review of local drainage district maps and historic aerial photographs, the canal appears to be unnamed and associated with the development of the Kissimmee River Fishing Resort (8HG01729). The canal was likely constructed for boating and general river access for the resort ca. 1962 (USDA 1962). Overall, the linear resource is a common example of canals found throughout South Florida and is not a significant embodiment of a type, period, or method of construction; and has no known significant historic associations. As a result, the segment of 8HG01753 within the APE does not appear eligible for listing in the NRHP, either individually or as part of a historic district; however, there is insufficient information to evaluate the resource as a whole.

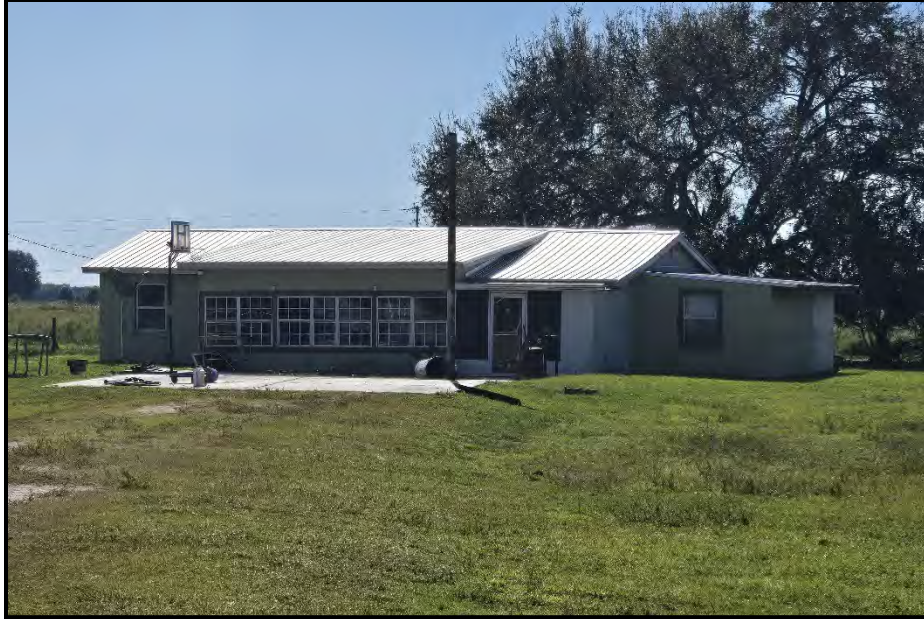
Photo 34. 150 Fulmar Terrace (8HG01754), looking south.

8HG01754: The Masonry Vernacular style building at 150 Fulmar Terrace was constructed ca. 1970 and is located adjacent to Pond 5C (FDOT 1970) (**Photo 34**). The one-story, irregular plan building rests on a concrete slab foundation and has a concrete block structural system covered with stucco. The side gable roofs and shed roofs are covered with ribbed sheet metal. The main entryway is on the north elevation, but it is obscured by the metal frame screened doorway to the porch. The open, partial width porch is located on the north elevation beneath a shed roof and is partially enclosed with stucco and screening. Visible windows include a mixture of individual and paired, one-over-one metal single-hung sash units, and individual, paired, and grouped (3), one-over-one and six-over-six vinyl single-hung sash units. Distinguishing architectural features include overhanging eaves with boxed rafter tails, concrete windowsills, stucco trim, and rectangular gable vents. Alterations include replacement roofing, siding, and windows, as well as the reconfiguration of the principal roof line. Additions include the shed roof, porch, and gable roof extensions on the west elevation. Multiple agricultural outbuildings are located on the property outside of the APE. Overall, the building has been altered, lacks sufficient architectural features, and is not a significant embodiment of a type, period, or method of construction. In addition, background research did not reveal any historic associations with significant persons and/or events. As a result, 8HG01754 does not appear eligible for listing in the NRHP, either individually or as part of a historic district.
