SR 70 from Lonesome Island to CR 721

Land Use Map

APPENDIX I
Audubon's Crested Caracara Survey Technical Report

**SR 70 FROM LONESOME ISLAND ROAD TO CR 721
SOUTH**

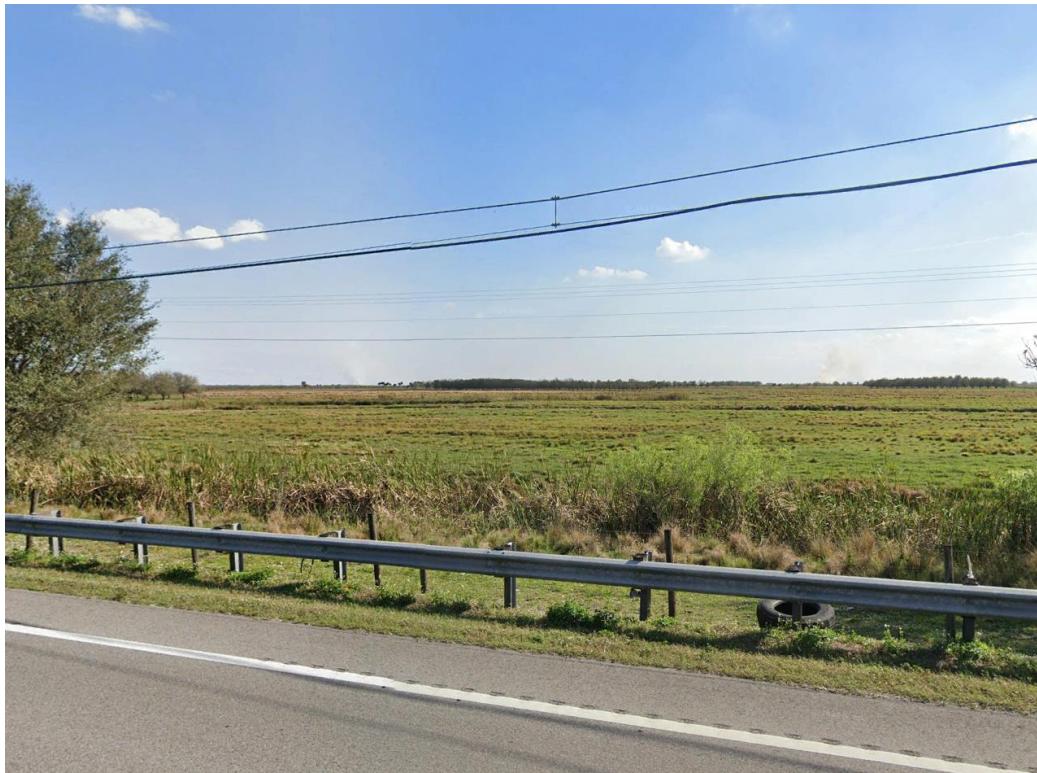
Photograph 1. Potential Florida grasshopper sparrow habitat. Improved pasture south of project study area. Unsuitable due to heavily grazed vegetation. Ditches present throughout causing periodic wet conditions. Saw palmetto not present.

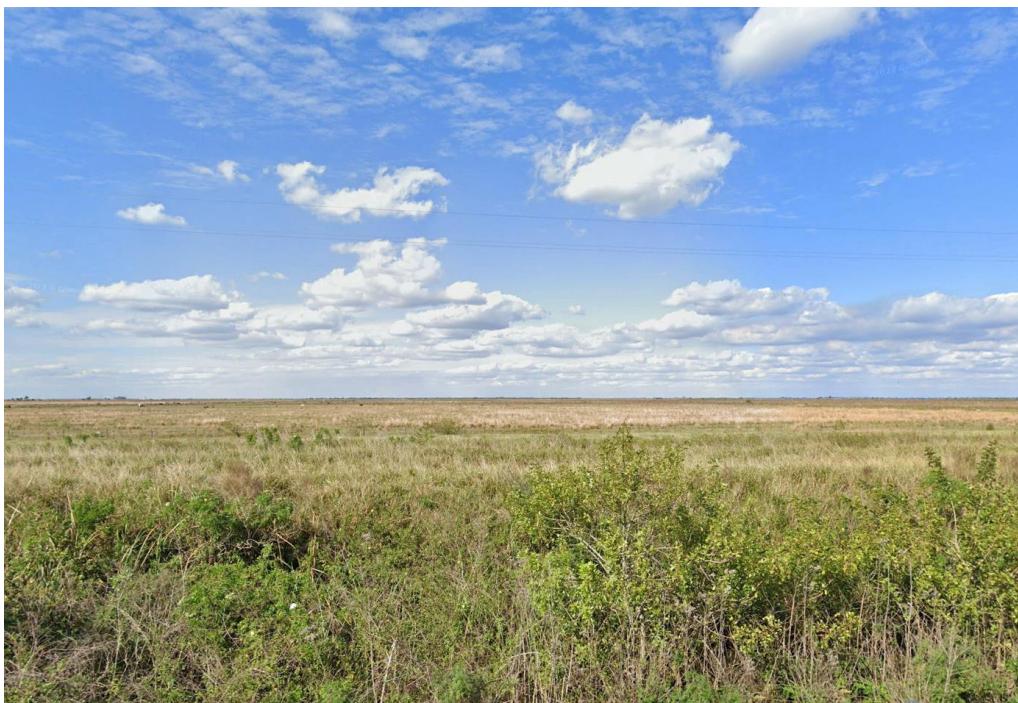
Photograph 2. Potential Florida grasshopper sparrow habitat. Unimproved pasture north of project study area. Unsuitable due to maintenance for grazing and periodic flooding. Minimal growth of native vegetation.

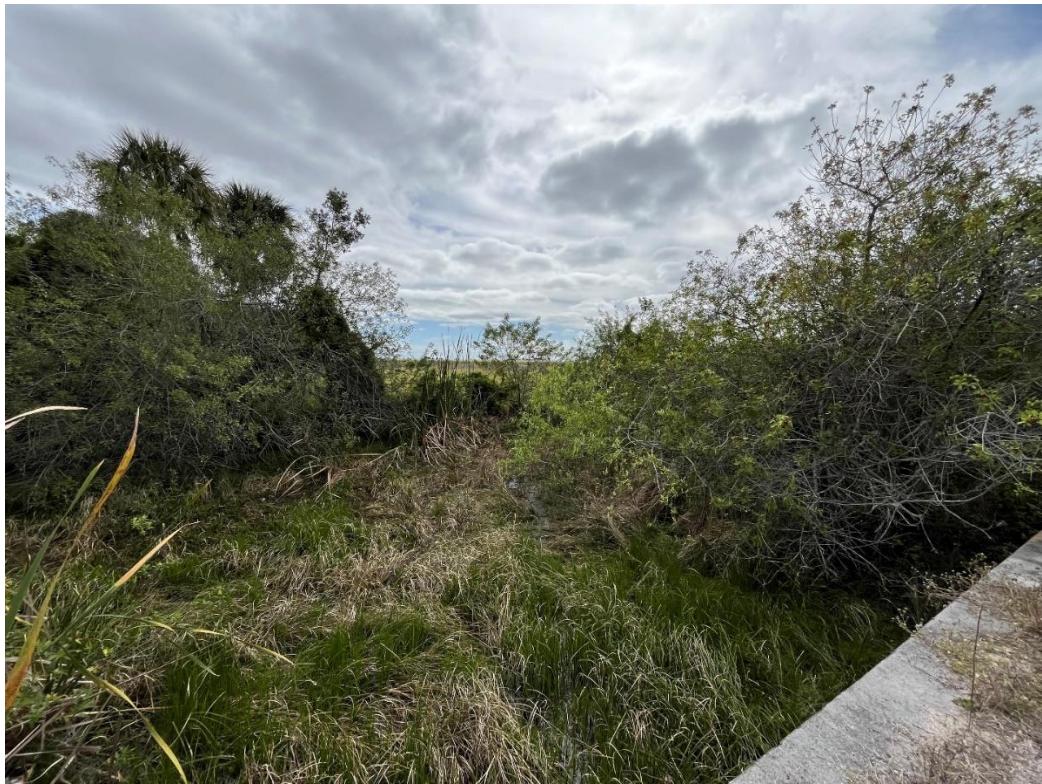
Photograph 3. Potential Everglade snail kite habitat. Unsuitable due to overgrown substrate, water depth below 0.2-1.3, and the substrate's proximity to the roadway.

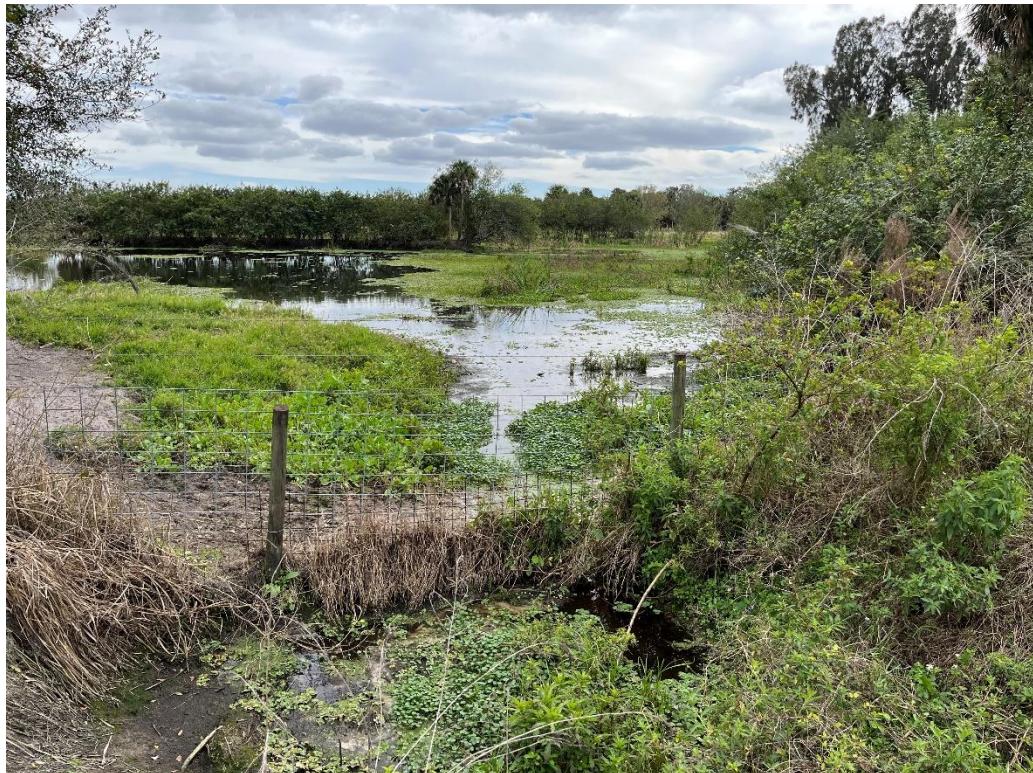
Photograph 4. Potential Everglade snail kite habitat. Unsuitable due to substrate's proximity to the roadway. Apple snails not present.

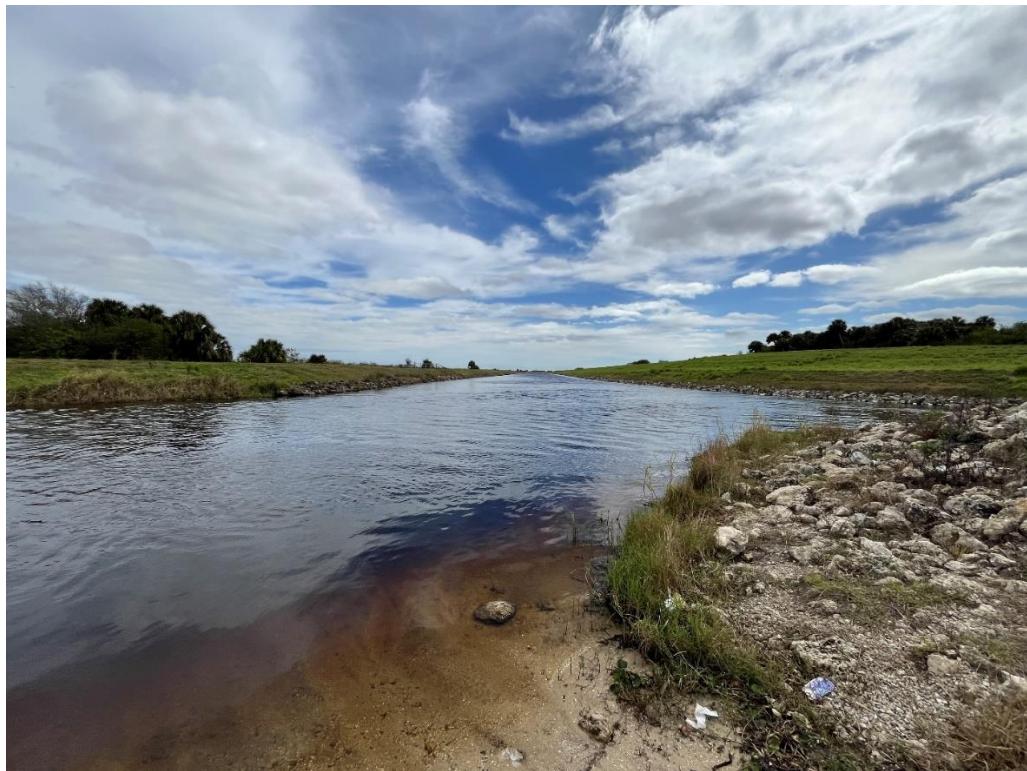
Photograph 5. Potential Everglade snail kite habitat. Unsuitable due to lack of substrate, steep side slopes, and exceeding water depth requirements.

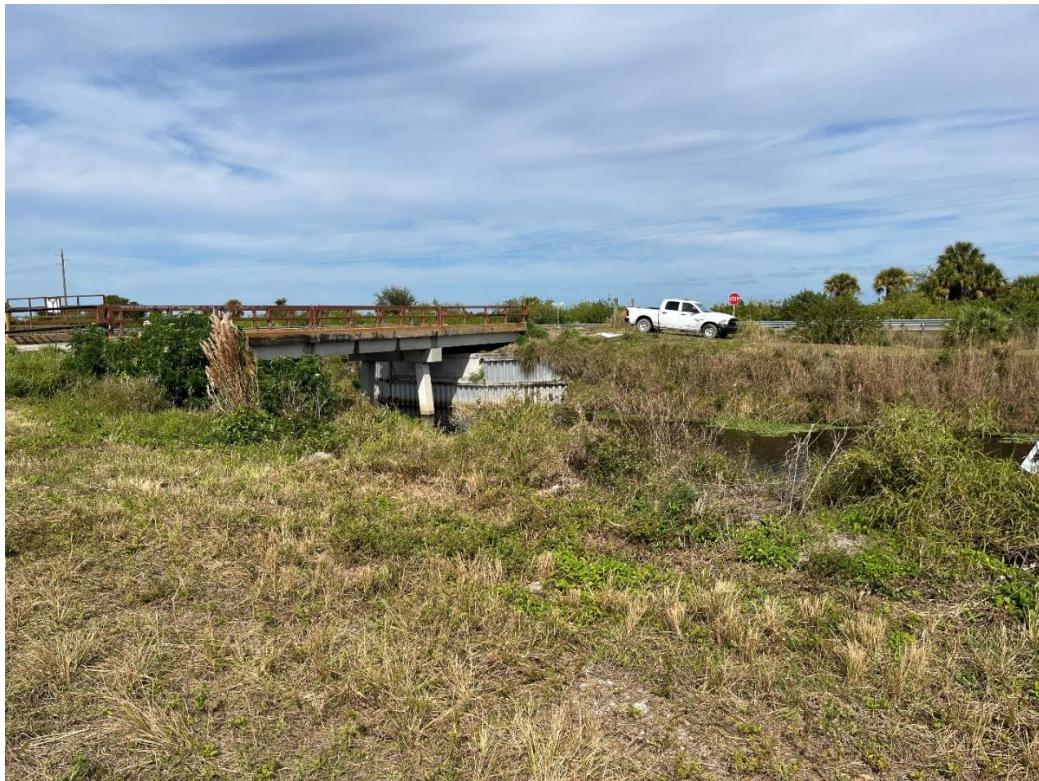
Photograph 6. Potential Everglade snail kite habitat. Unsuitable due to overgrown vegetation and substrate's proximity to the roadway.

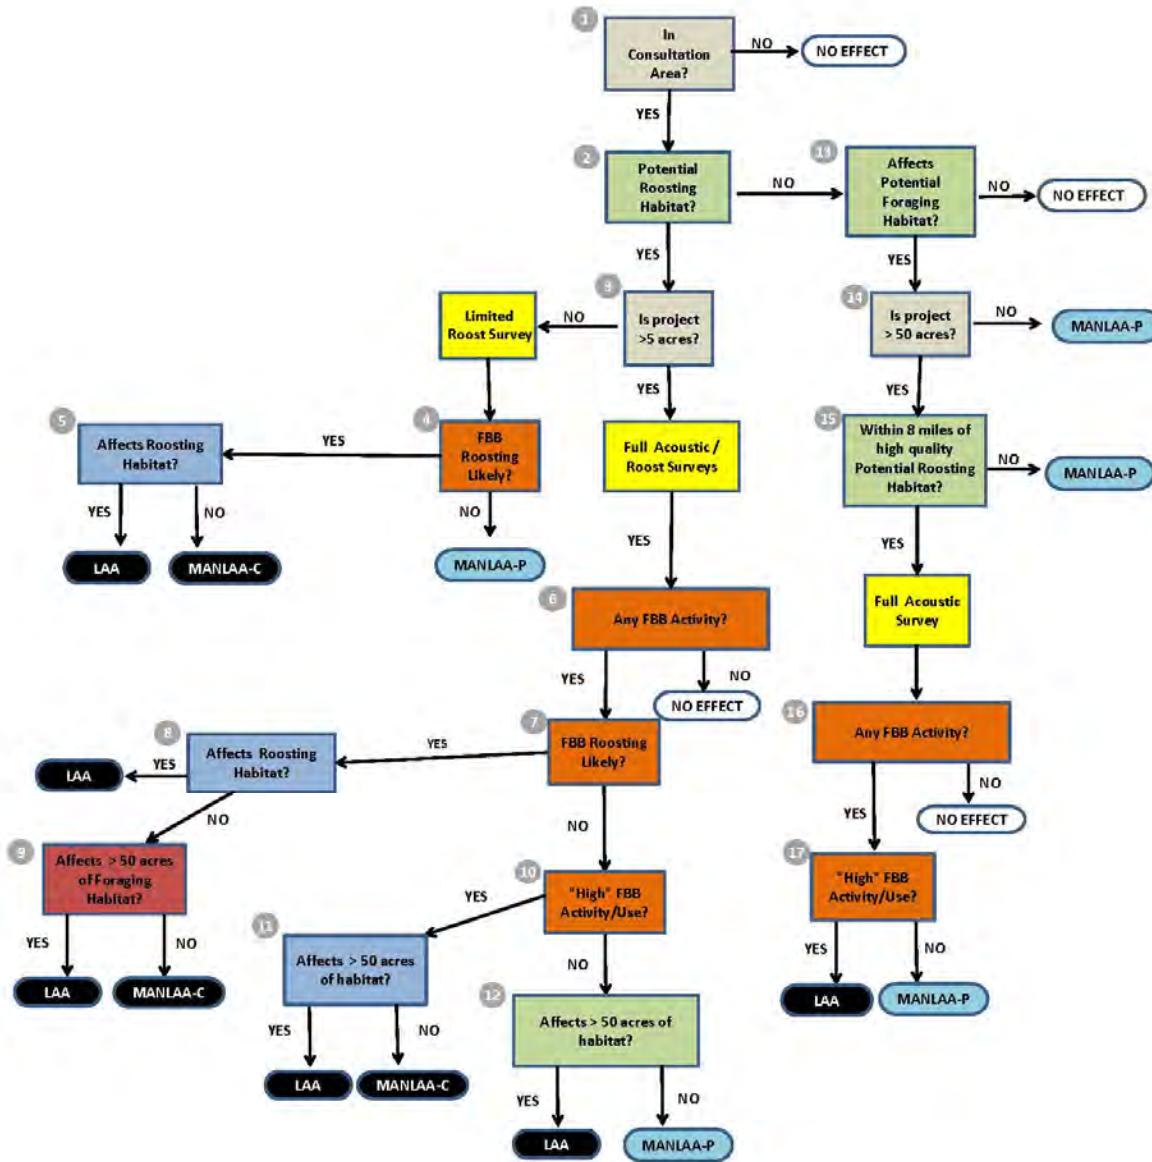
Figure 3. Florida bonneted bat Consultation Flowchart. “No effect” determinations do not need Service concurrence. “May affect, but not likely to adversely affect”, **MANLAA-P**, in blue have programmatic concurrence through the transmittal letter of these Guidelines, and therefore no further consultation with the Service is necessary unless assistance is needed in interpreting survey results. **MANLAA-C** determinations in black require further consultation with the Service. Applicants are expected to incorporate the appropriate **BMPs** to reach a **MANLAA** determination. “May affect, and is likely to adversely affect”, **LAA**, (also in black) determinations require consultation with the Service. Further consultation with the Service may identify project modifications that could change the **LAA** determinations in numbers 5, 8, 9, 11, 12, and 17 to **MANLAA** determinations. The Service requests Florida bonneted bat survey reports for all determinations.

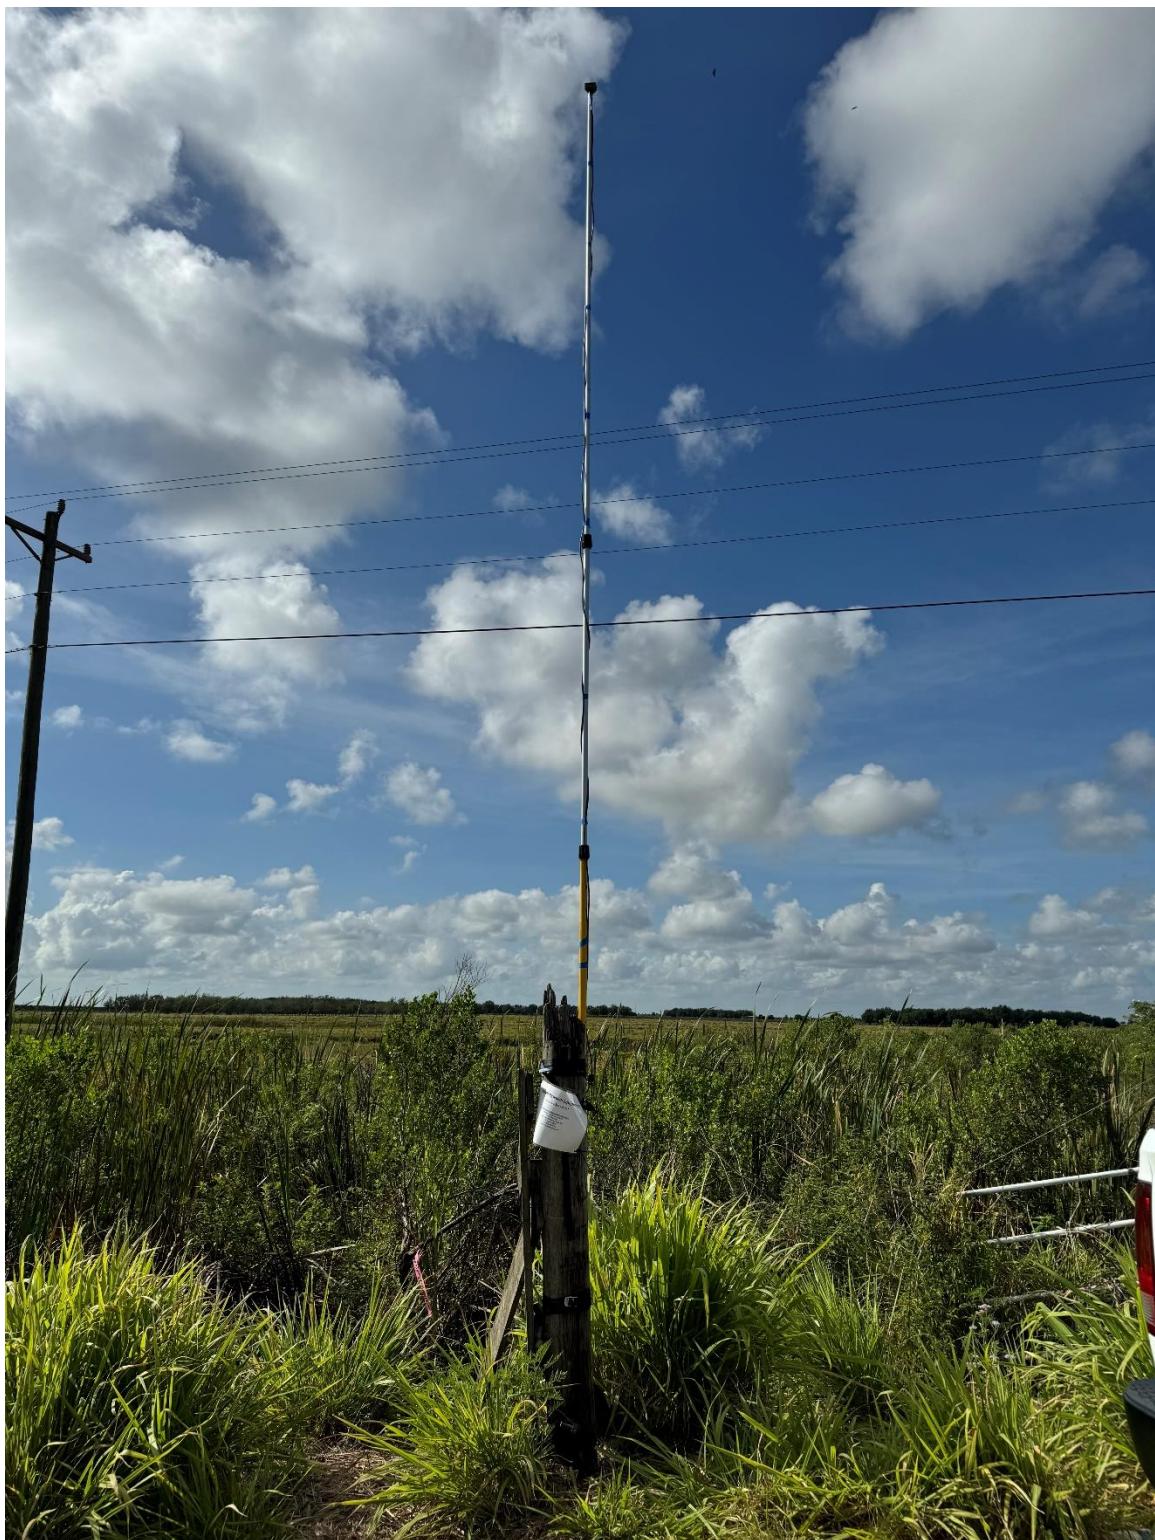
Photograph 1. Photograph looking south at Detector 1 with microphone deployment height of 5.94 meters – Wildlife Acoustics Song Meter SM4BAT FS Ultrasonic Recorder with SMM U2 Ultrasonic Mic.

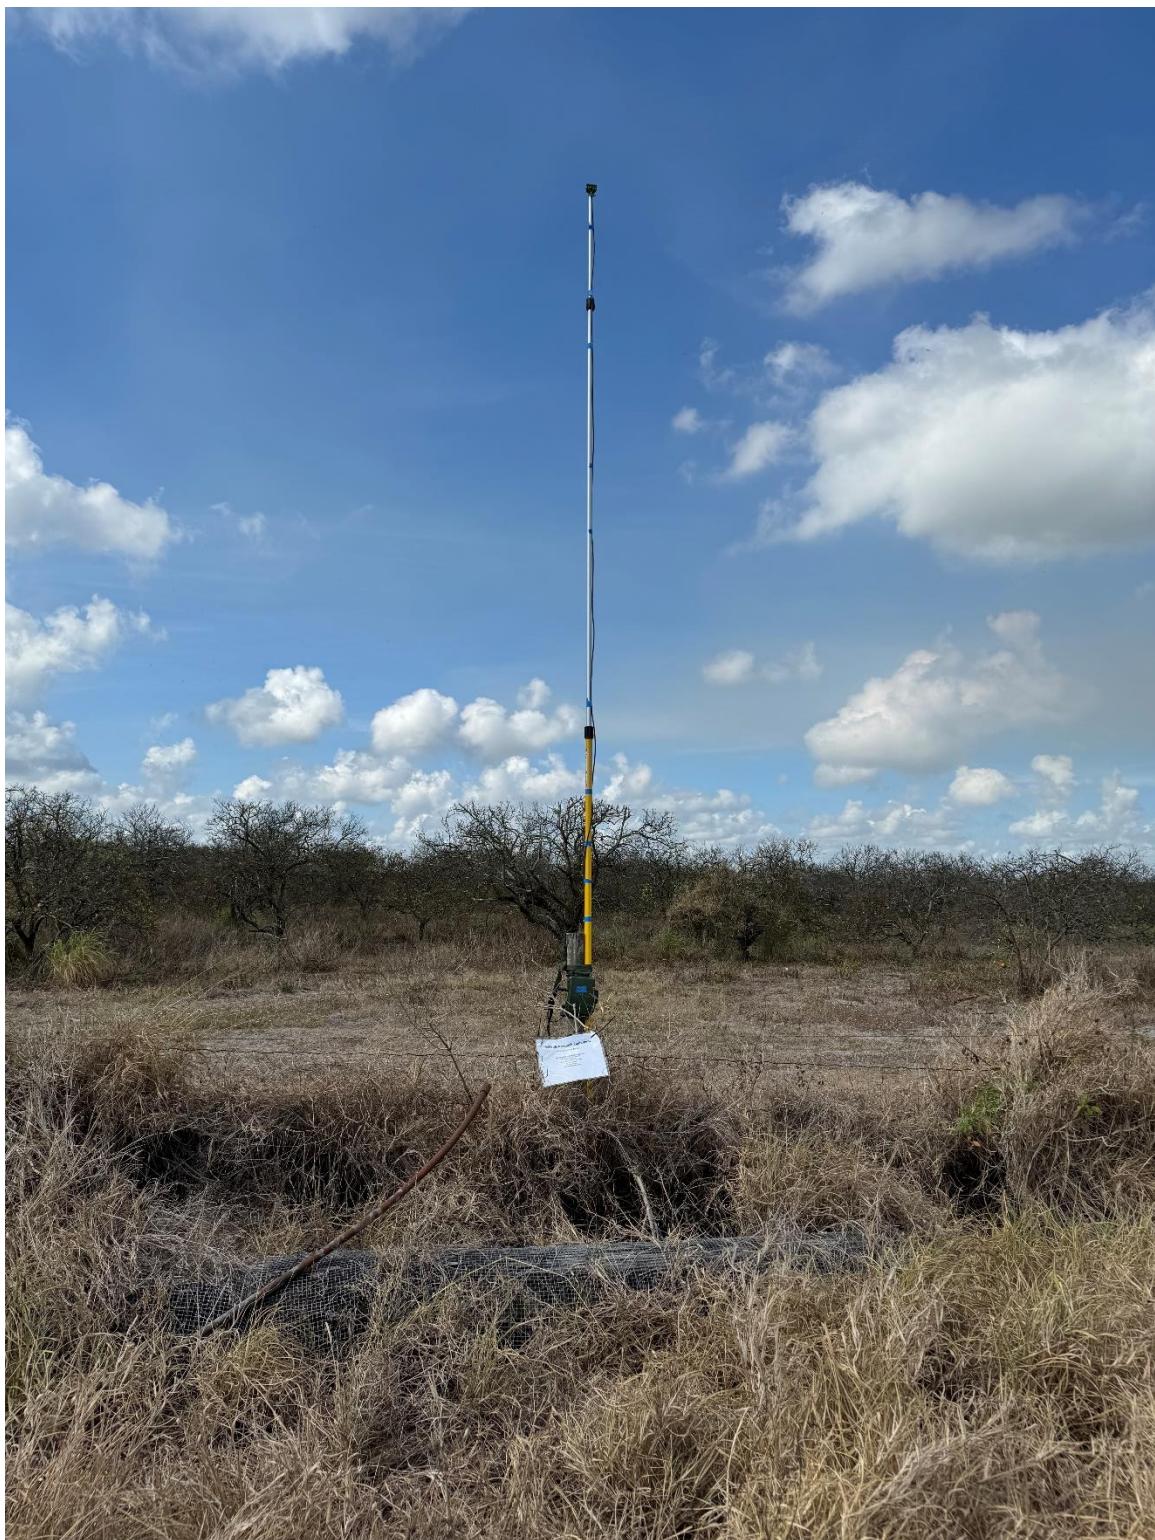
Photograph 2. Photograph looking south at Detector 2 with microphone deployment height of 5.33 meters – Wildlife Acoustics Song Meter SM4BAT FS Ultrasonic Recorder with SMM U2 Ultrasonic Mic.

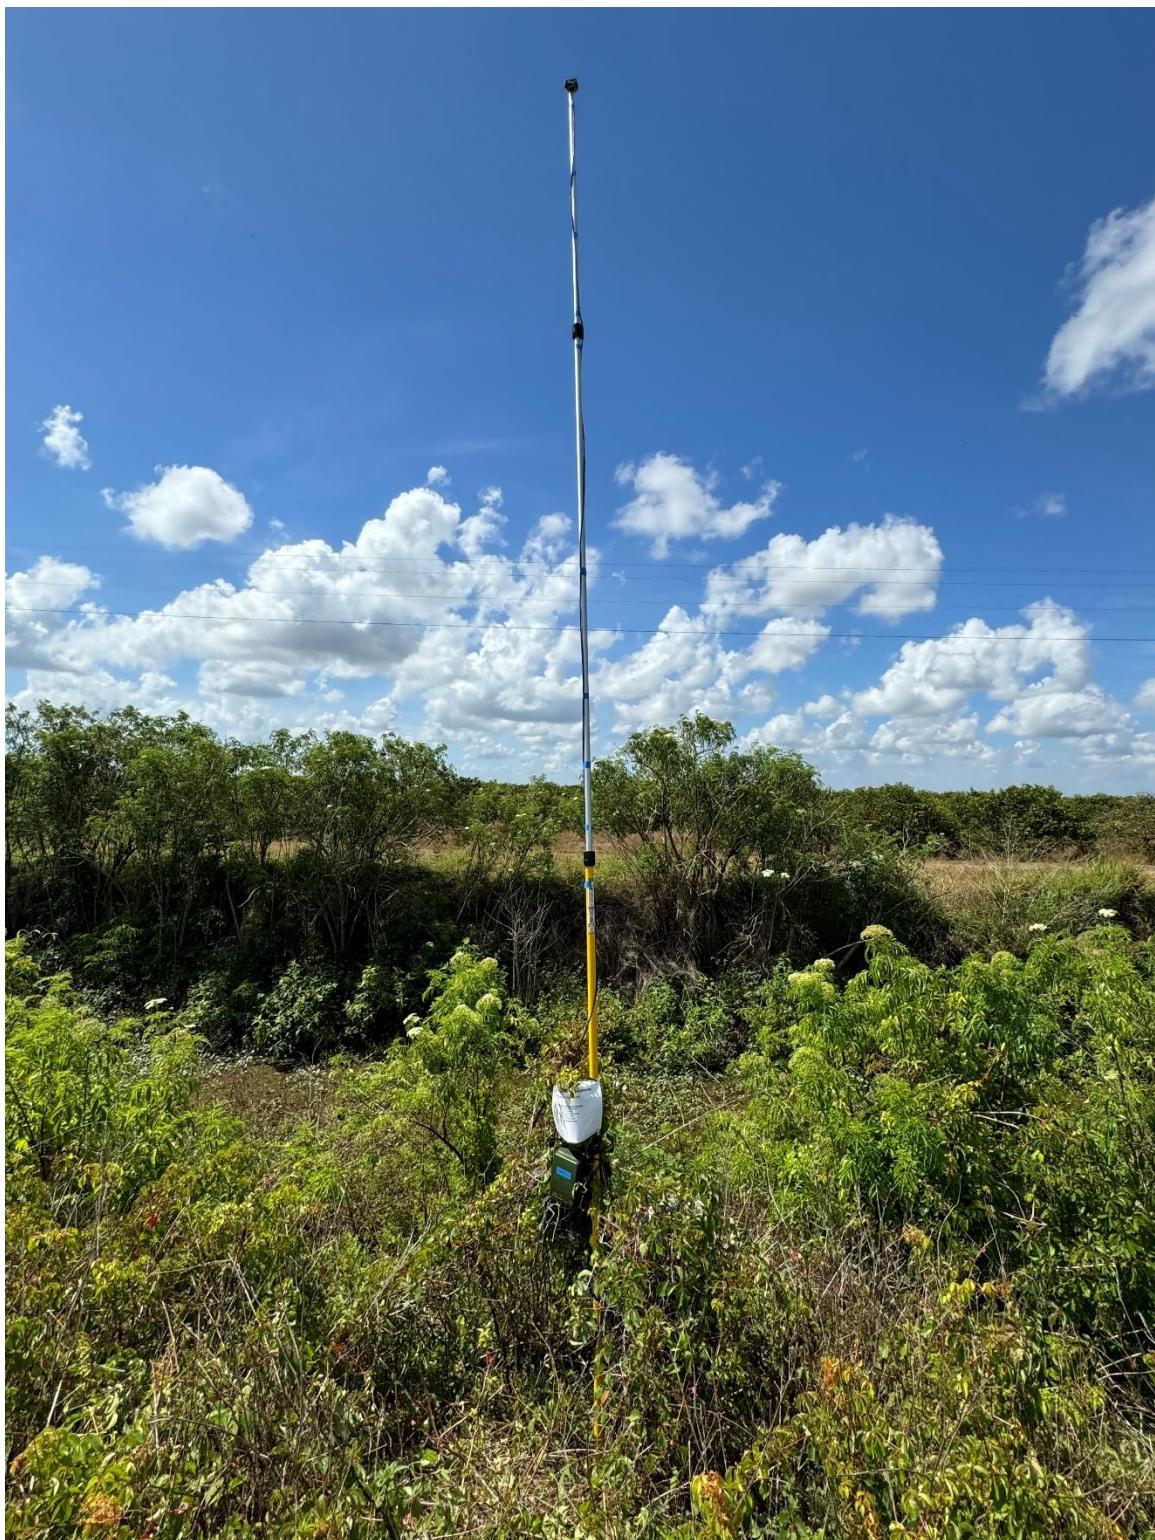
Photograph 3. Photograph looking south at Detector 3 with microphone deployment height of 5.94 meters – Wildlife Acoustics Song Meter SM4BAT FS Ultrasonic Recorder with SMM U2 Ultrasonic Mic.

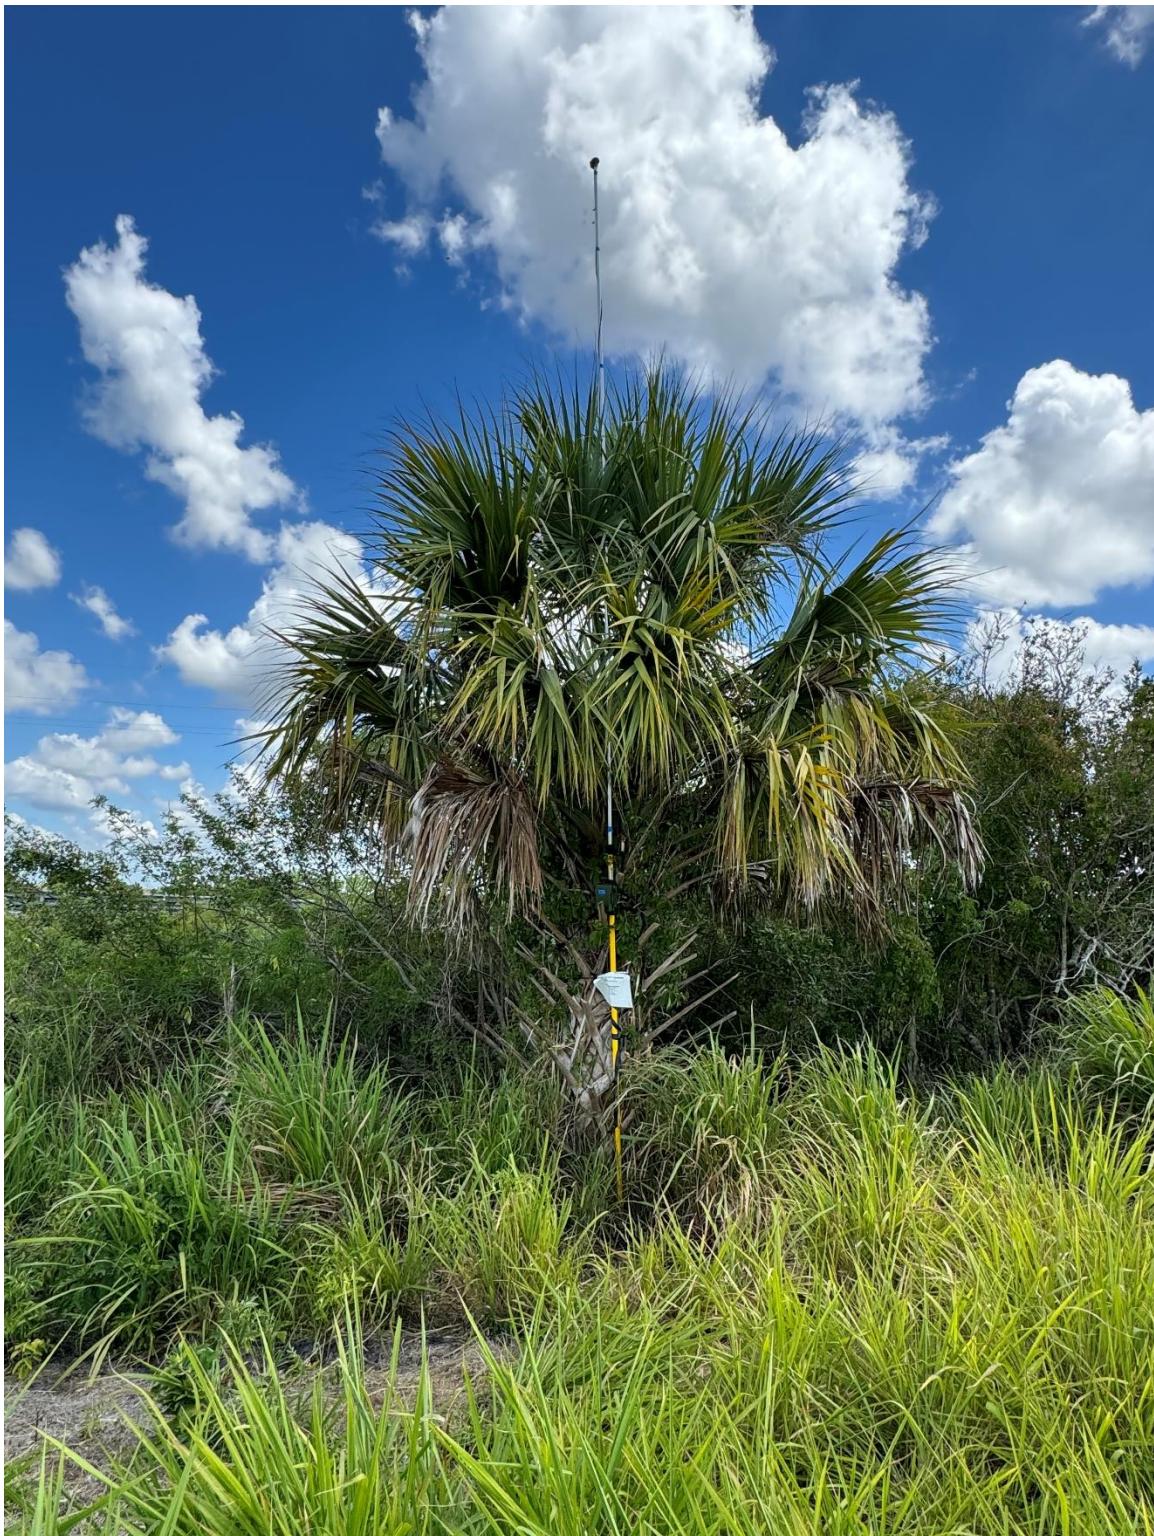
Photograph 4. Photograph looking south at Detector 4 with microphone deployment height of 6.86 meters – Wildlife Acoustics Song Meter SM4BAT FS Ultrasonic Recorder with SMM U2 Ultrasonic Mic.

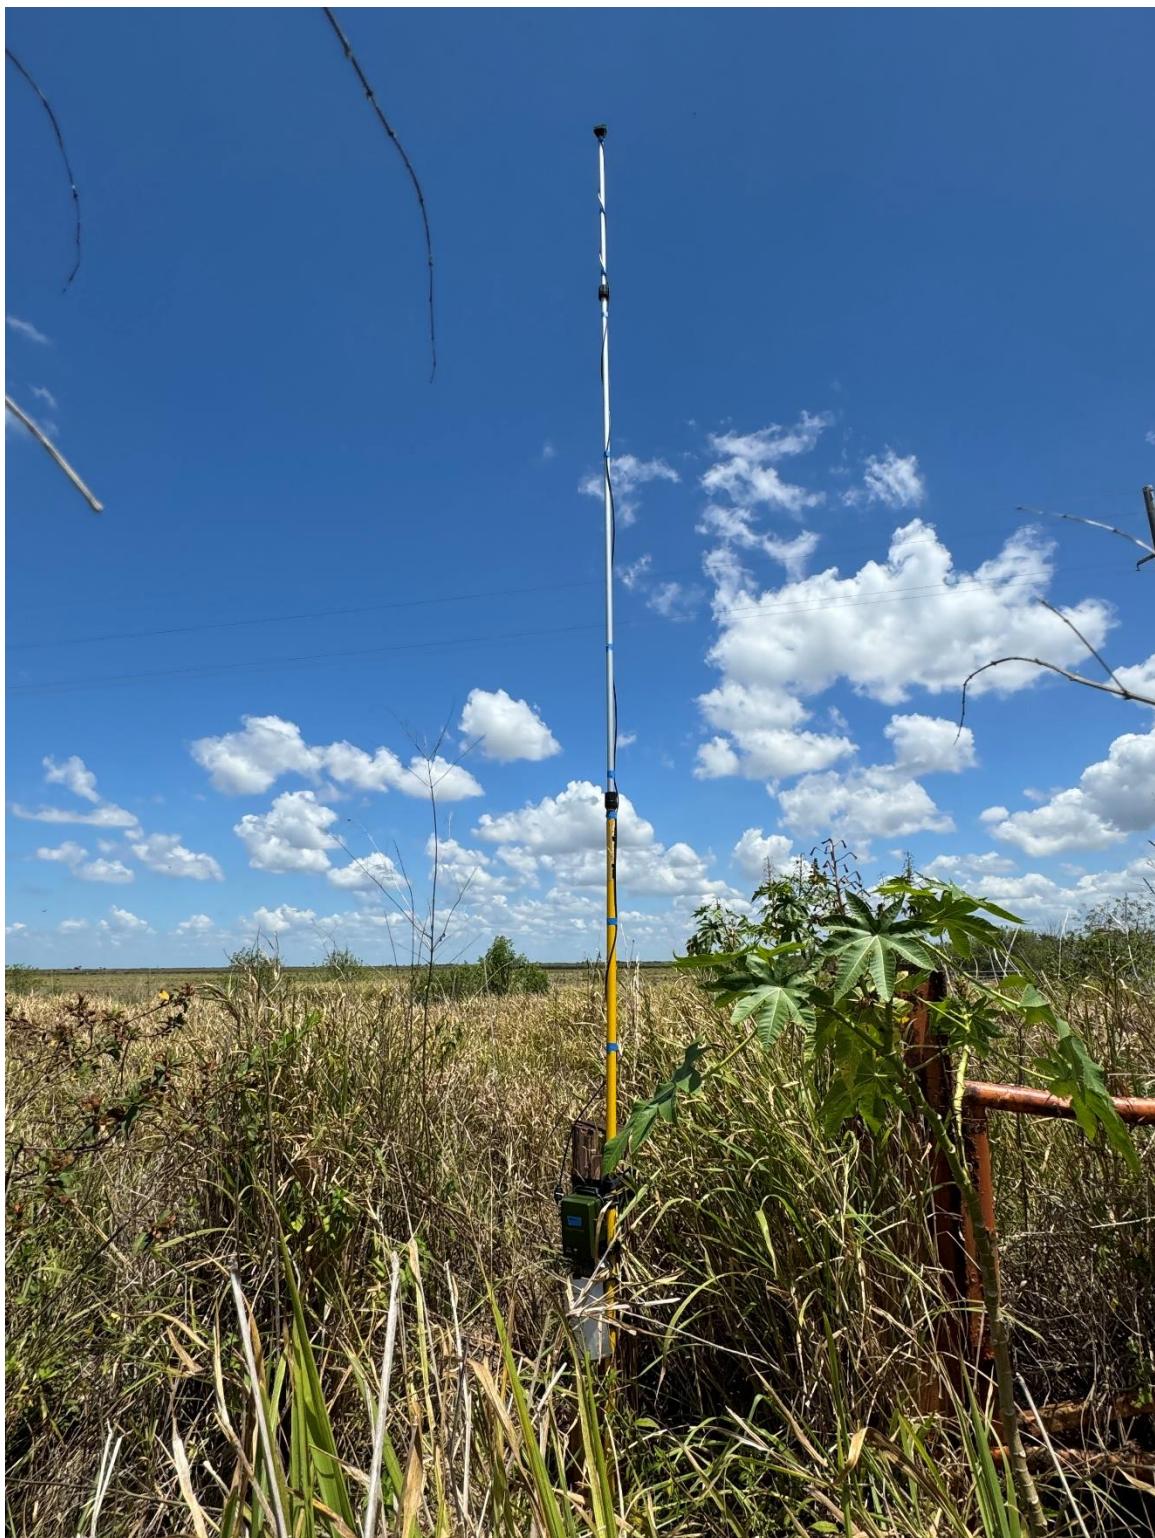
Photograph 5. Photograph looking south at Detector 5 with microphone deployment height of 5.67 meters – Wildlife Acoustics Song Meter SM4BAT FS Ultrasonic Recorder with SMM U2 Ultrasonic Mic.

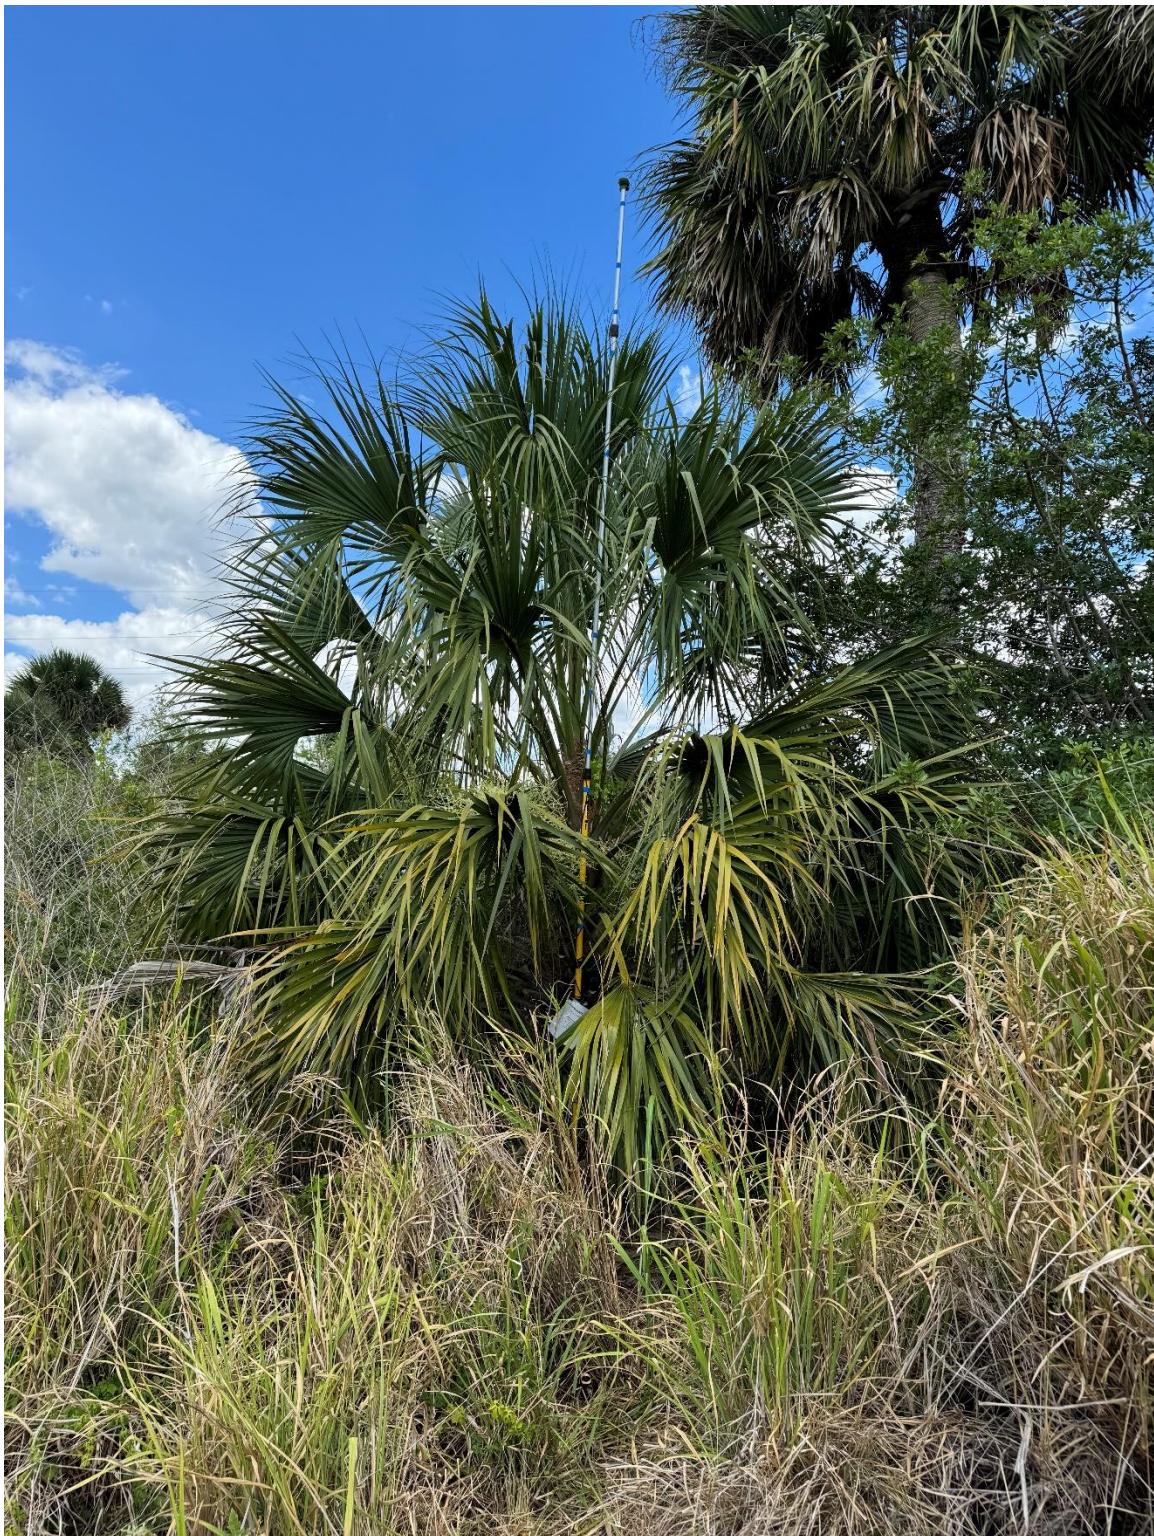
Photograph 6. Photograph looking south at Detector 6 with microphone deployment height of 5.49 meters – Wildlife Acoustics Song Meter SM4BAT FS Ultrasonic Recorder with SMM U2 Ultrasonic Mic.

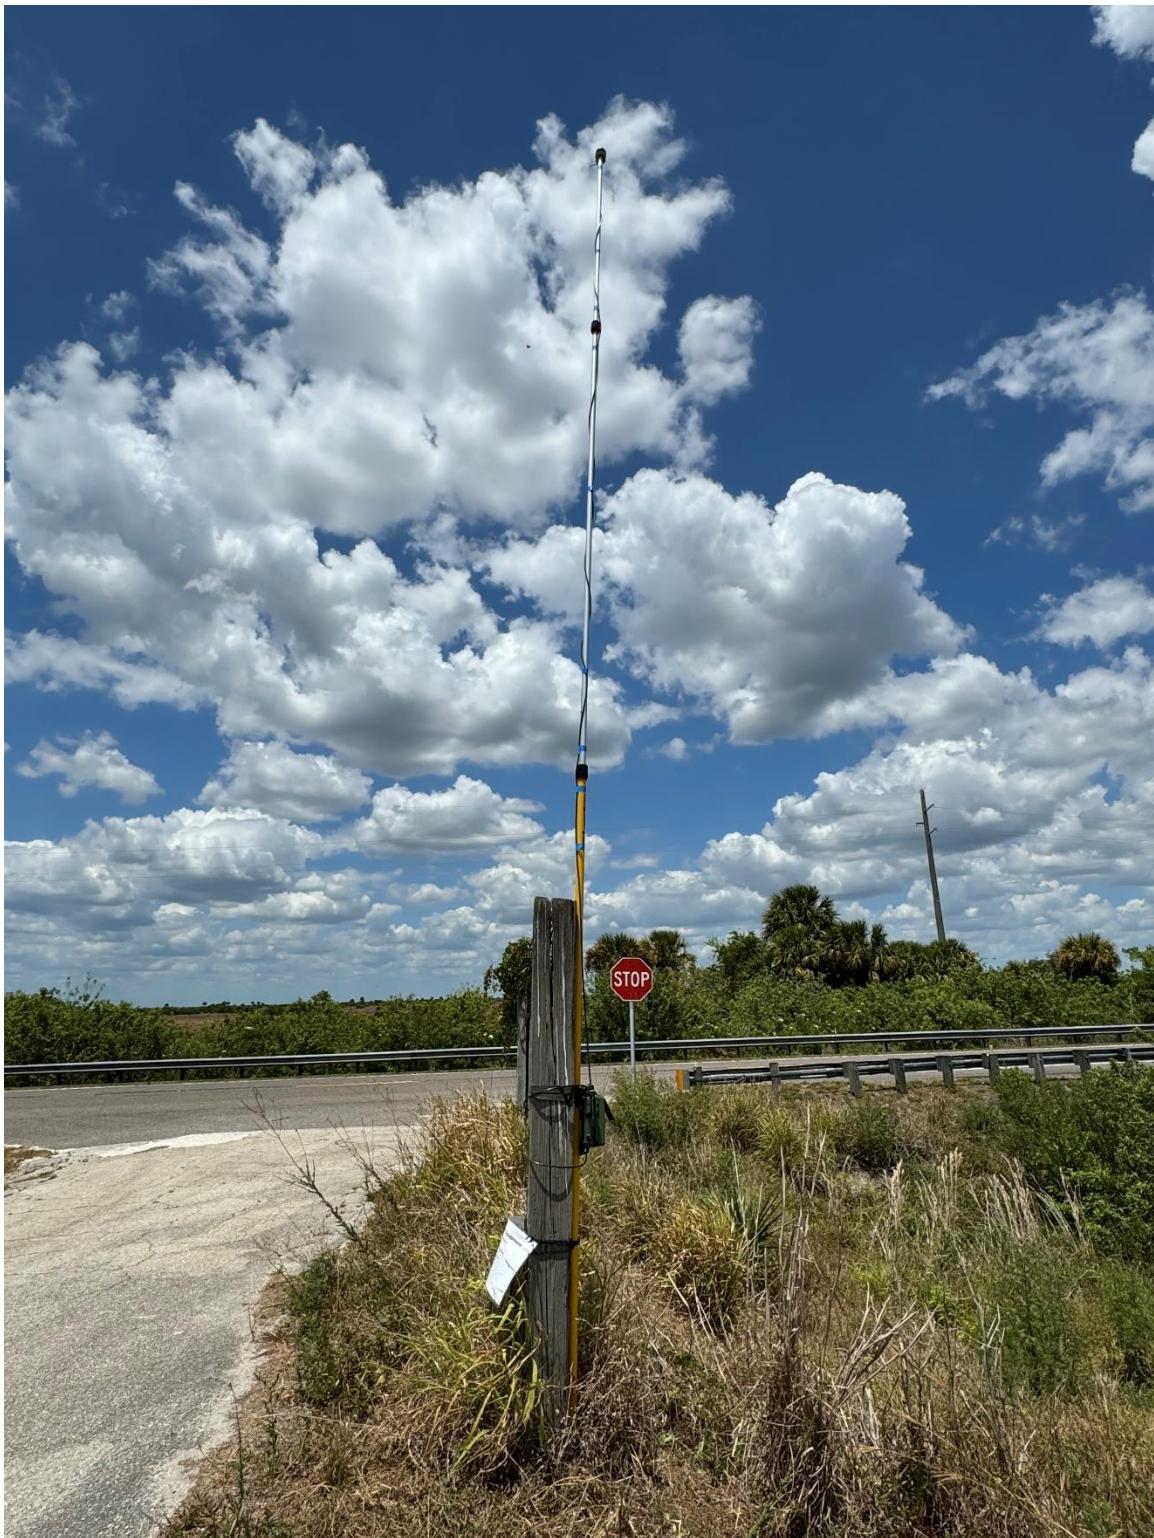
Photograph 7. Photograph looking south at Detector 7 with microphone deployment height of 5.94 meters – Wildlife Acoustics Song Meter SM4BAT FS Ultrasonic Recorder with SMM U2 Ultrasonic Mic.

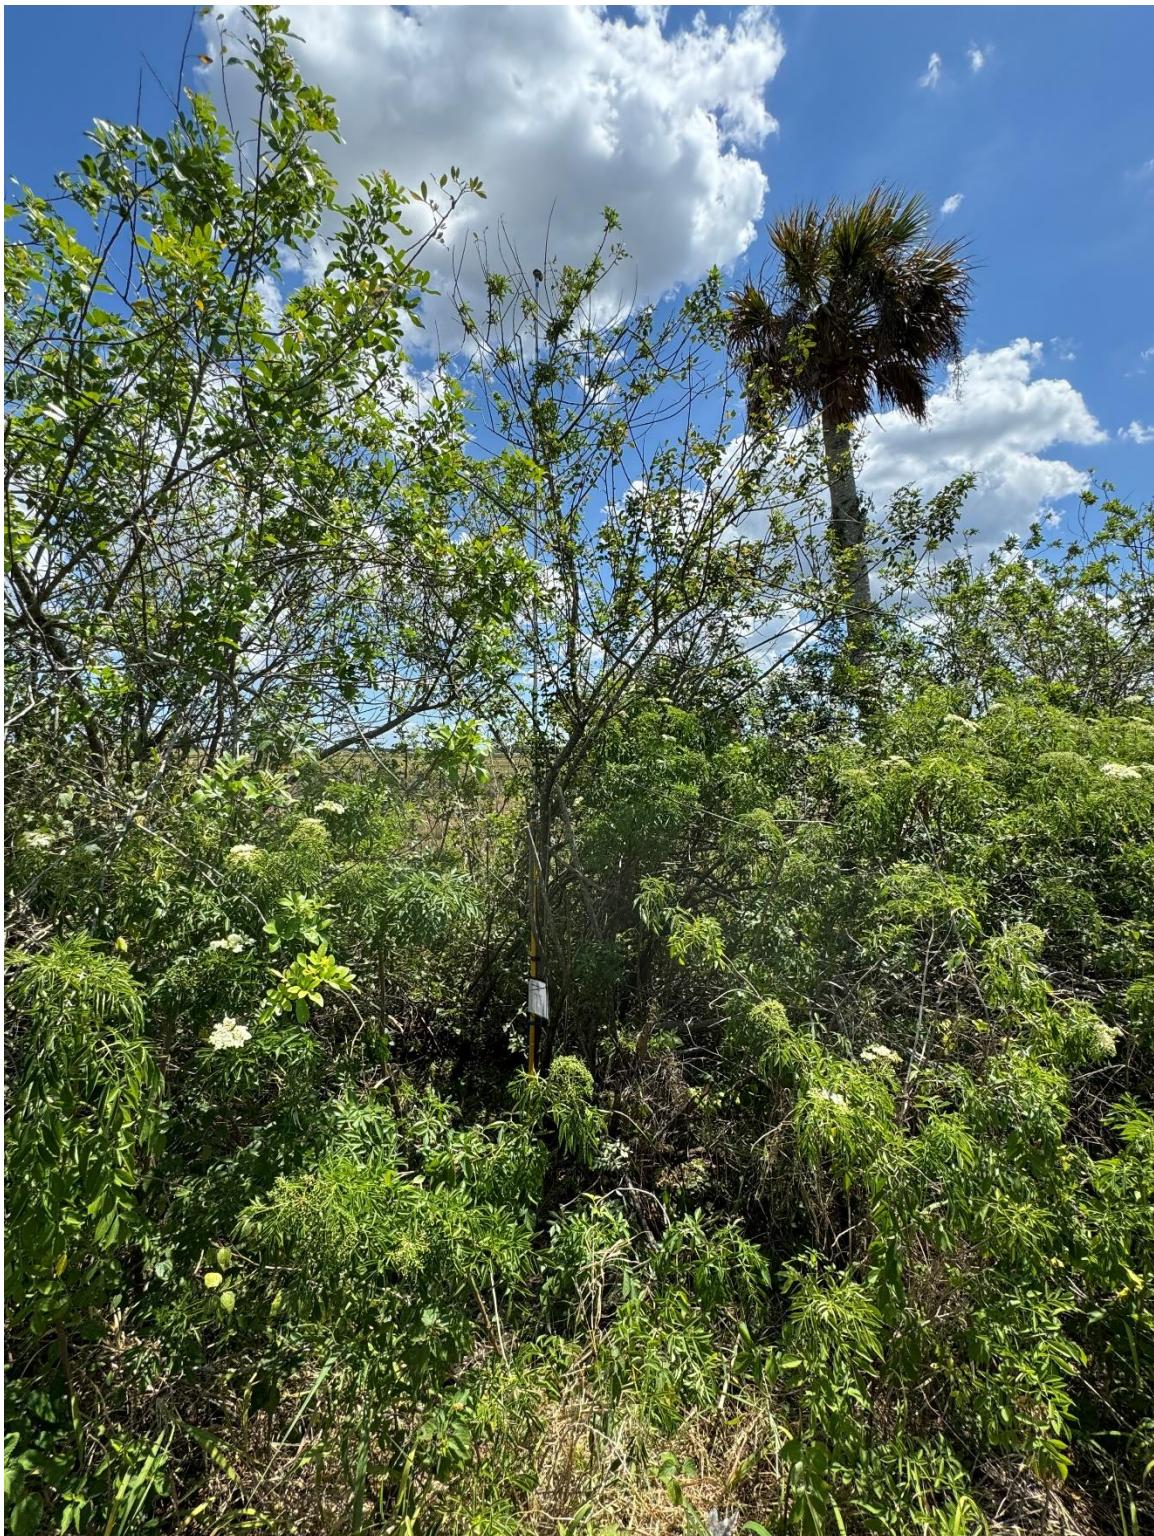
Photograph 8. Photograph looking south at Detector 8 with microphone deployment height of 5.94 meters – Wildlife Acoustics Song Meter SM4BAT FS Ultrasonic Recorder with SMM U2 Ultrasonic Mic.

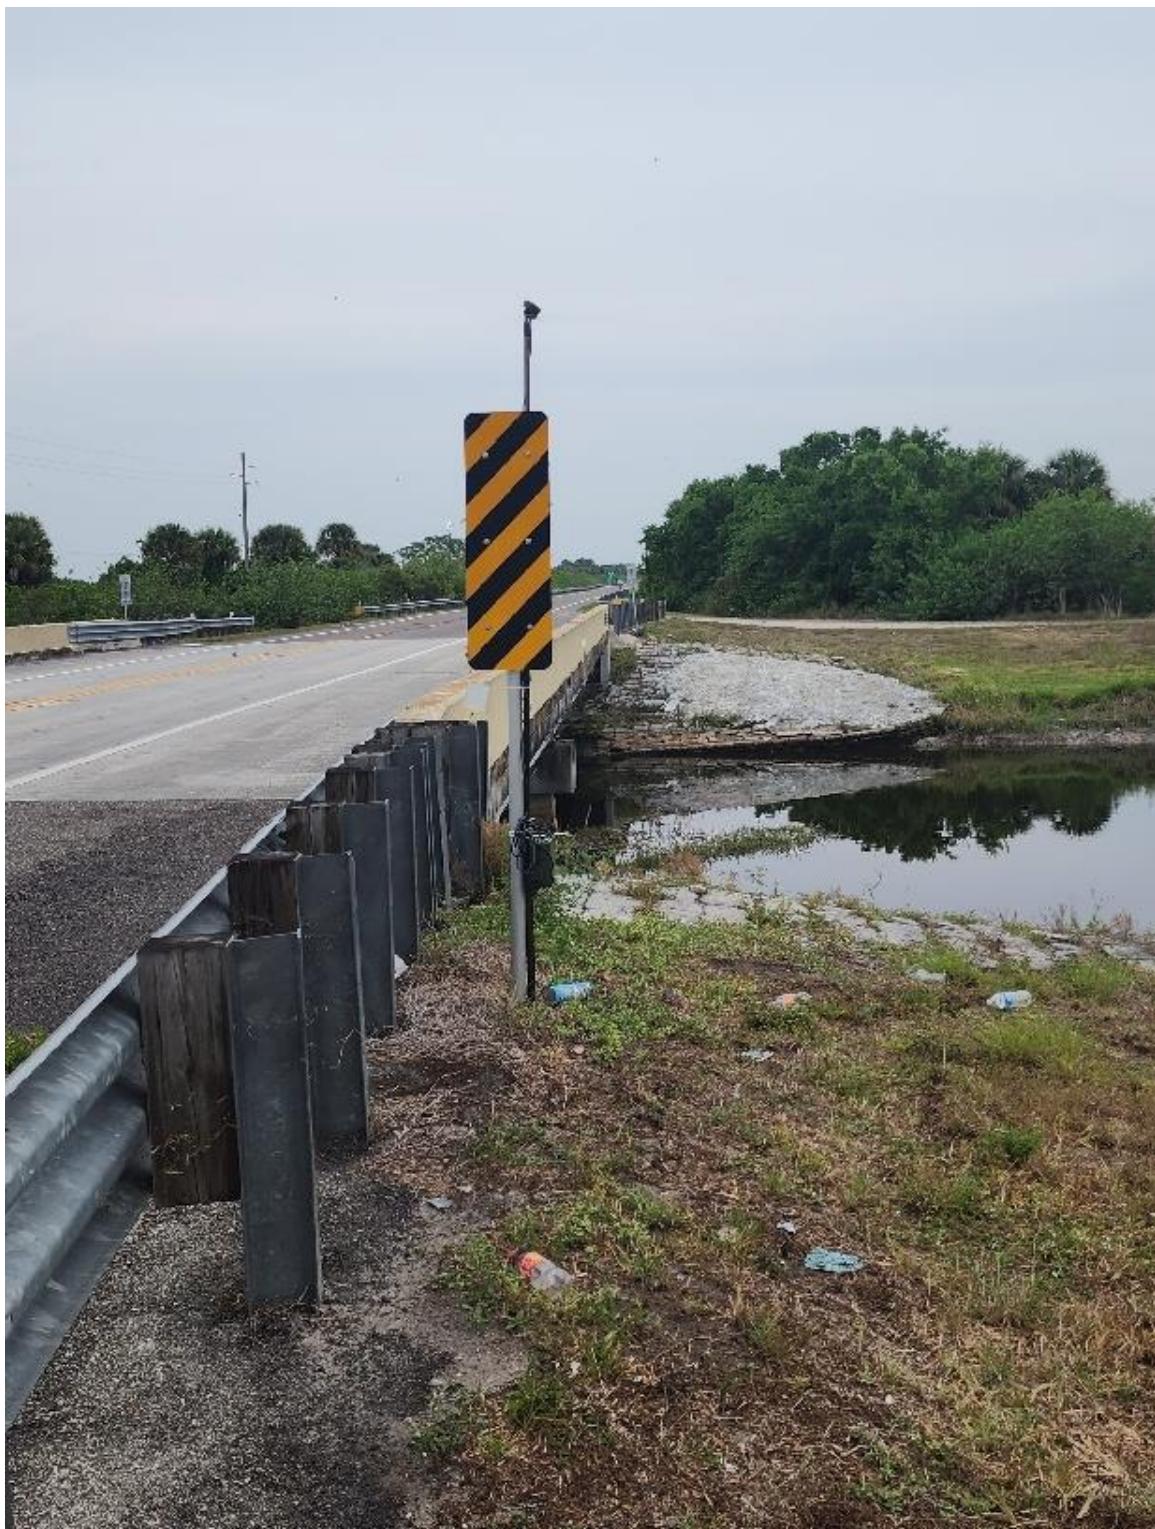
Photograph 9. Photograph looking east at Detector 9 with microphone deployment height of 3.04 meters – Wildlife Acoustics Song Meter SM4BAT FS Ultrasonic Recorder with SMM U2 Ultrasonic Mic.
