SR 70 from Lonesome Island to CR 721

Land Use Map

APPENDIX I
Audubon's Crested Caracara Survey Technical Report

**SR 70 FROM LONESOME ISLAND ROAD TO CR 721
SOUTH**

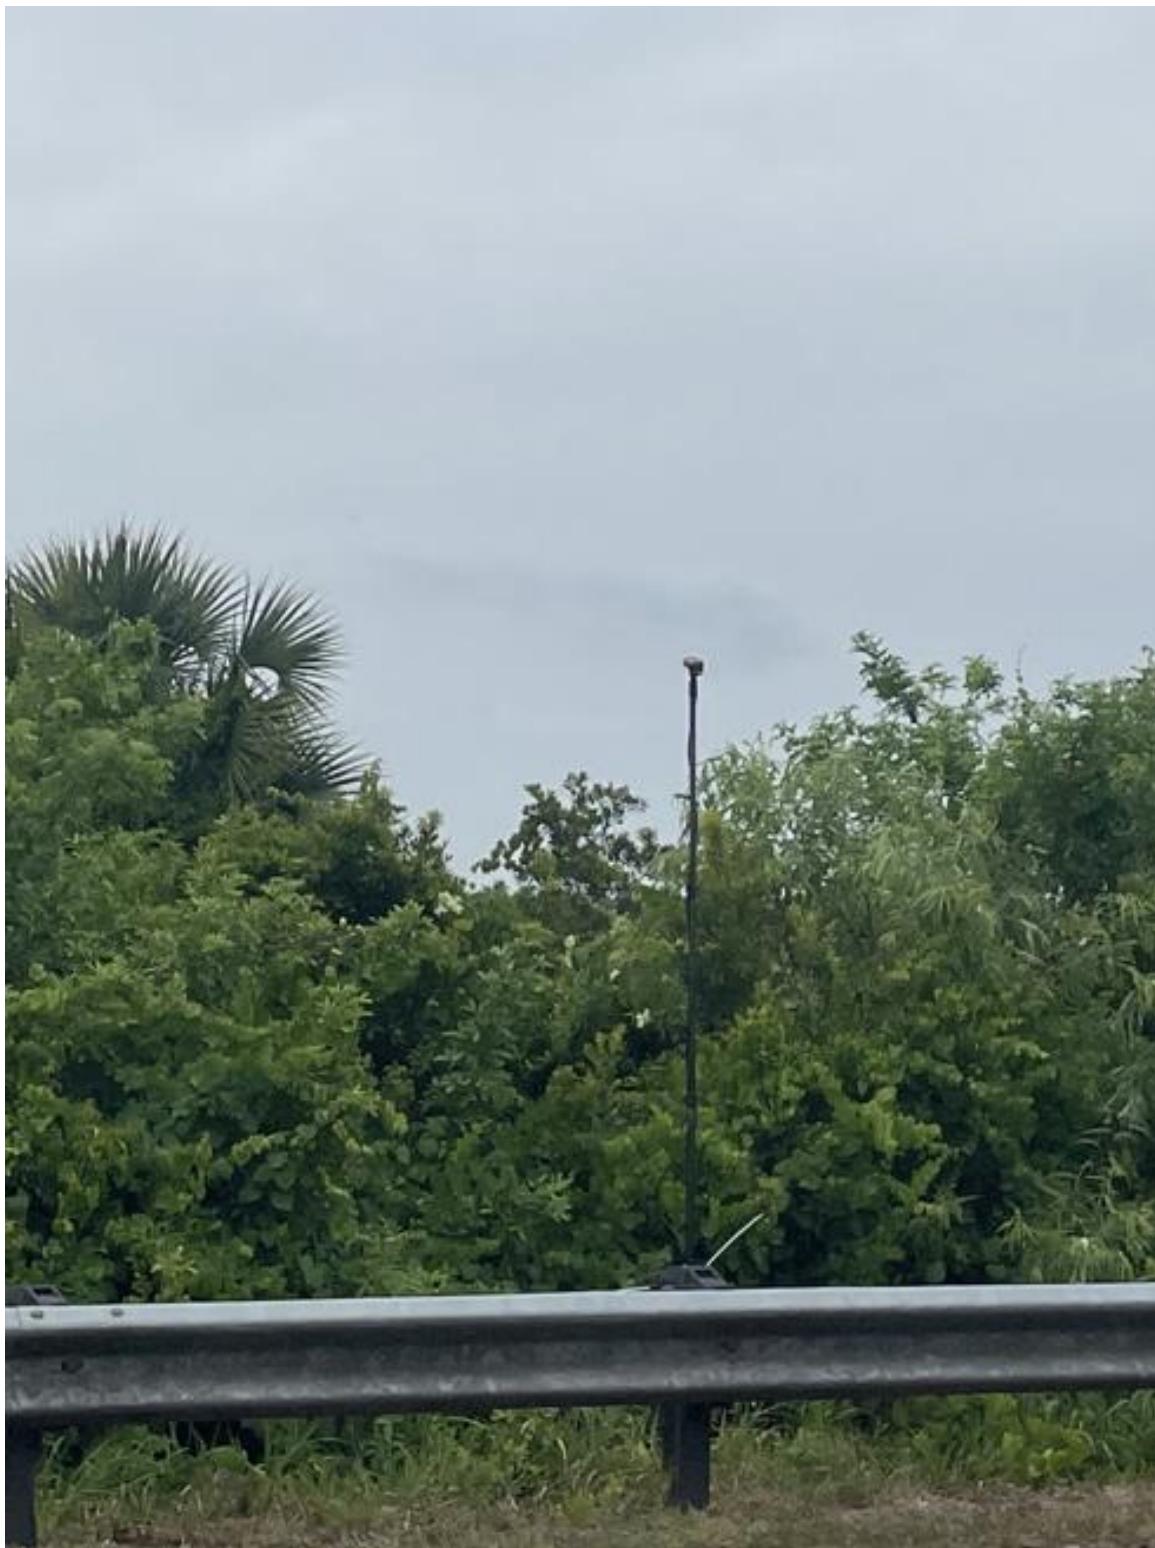
Photograph 10. Photograph looking south at Detector 10 with microphone deployment height of 3.04 meters – Wildlife Acoustics Song Meter SM4BAT FS Ultrasonic Recorder with SMM U2 Ultrasonic Mic.

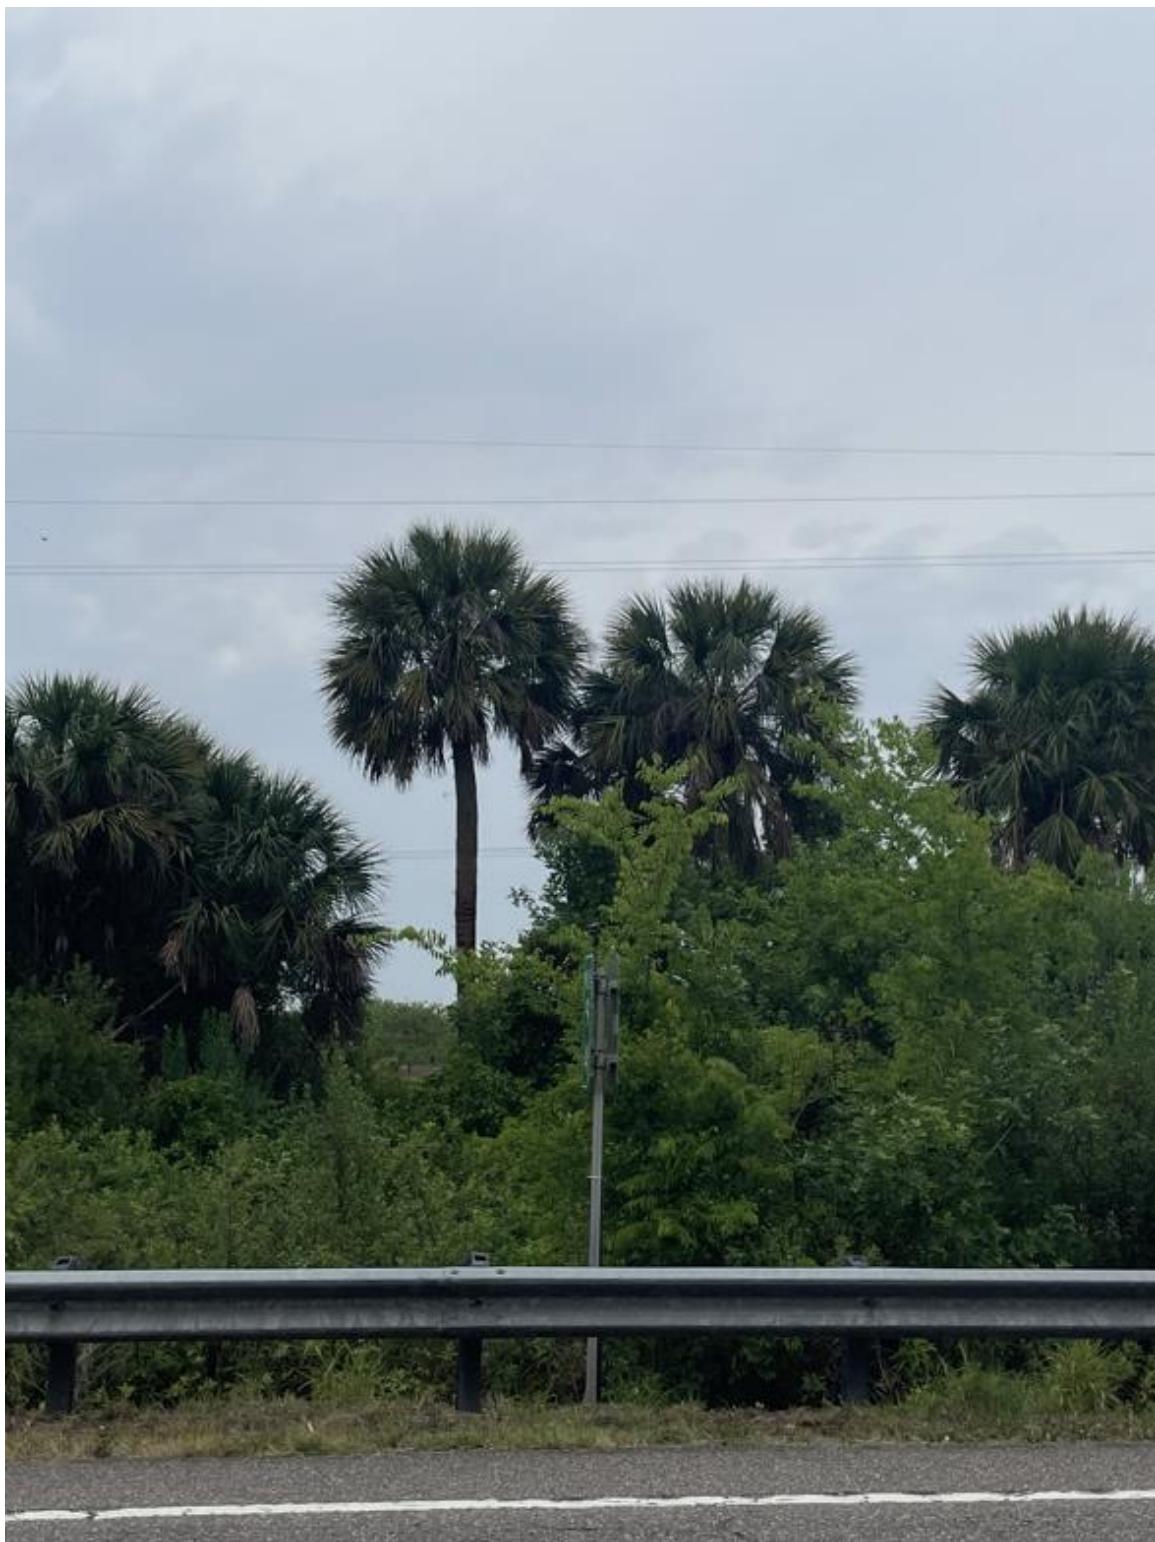
Photograph 11. Photograph looking north at Detector 11 with microphone deployment height of 3.04 meters – Wildlife Acoustics Song Meter SM4BAT FS Ultrasonic Recorder with SMM U2 Ultrasonic Mic.

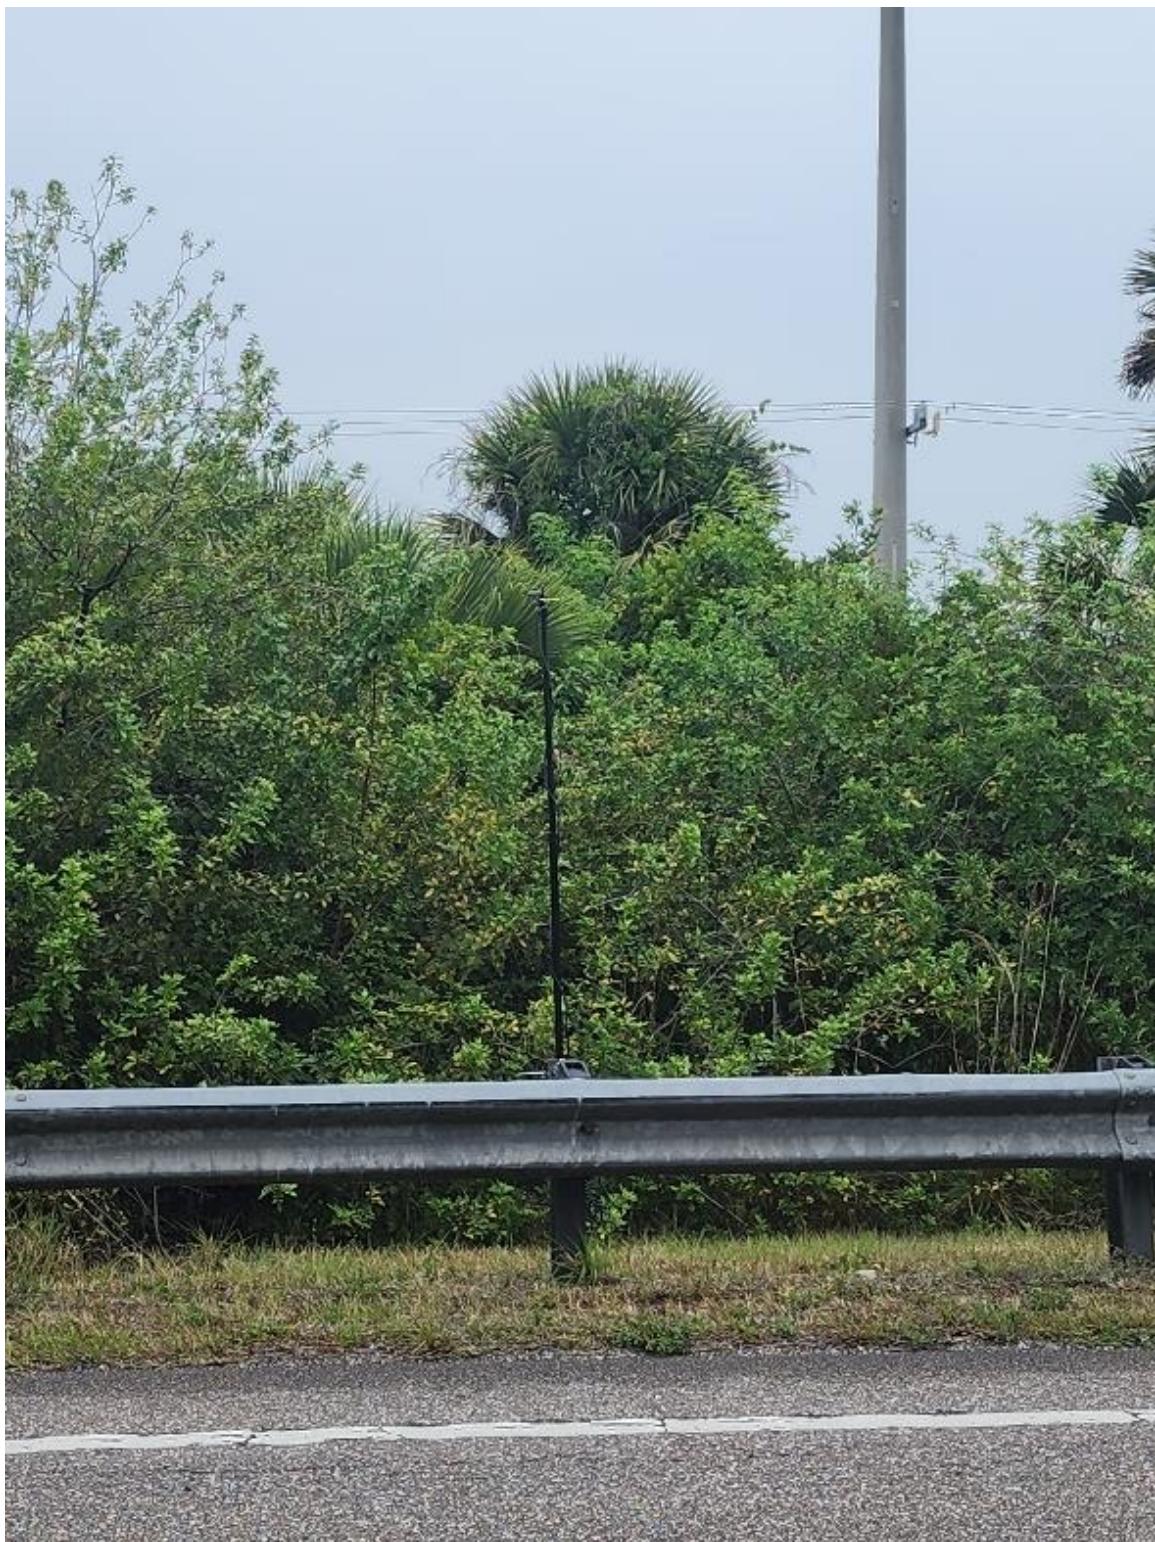
Photograph 12. Photograph looking north at Detector 12 with microphone deployment height of 3.04 meters – Wildlife Acoustics Song Meter SM4BAT FS Ultrasonic Recorder with SMM U2 Ultrasonic Mic.

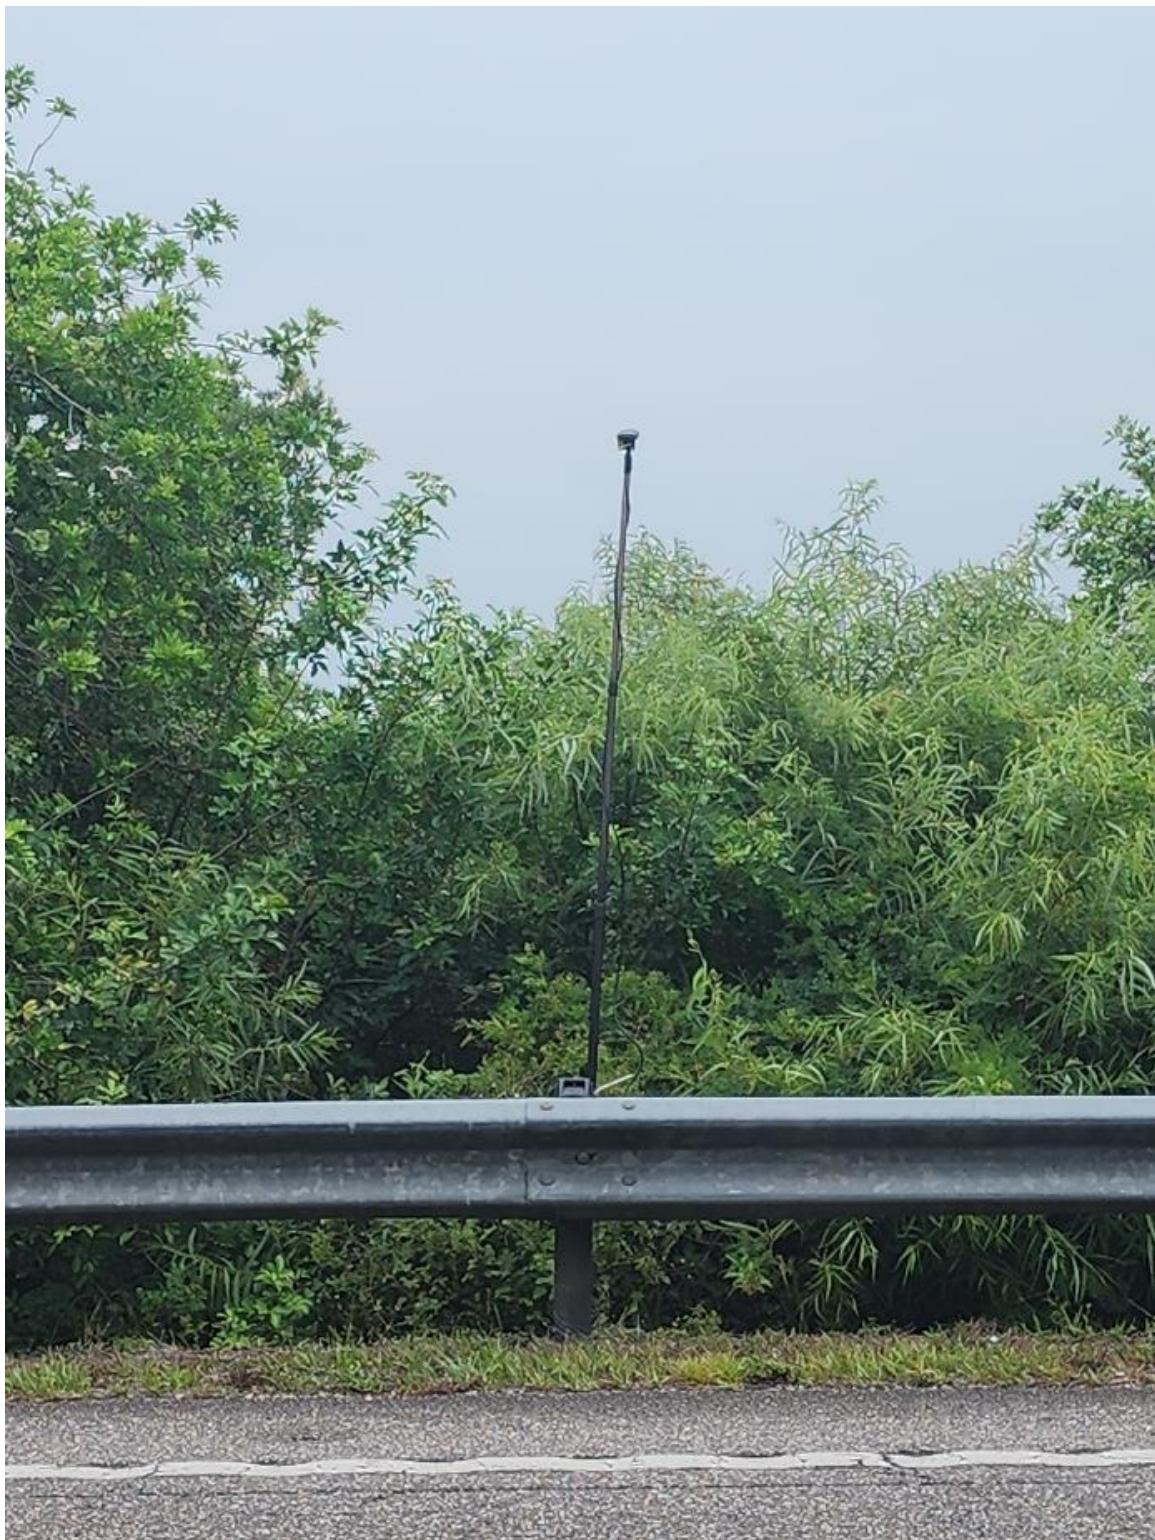
Photograph 13. Photograph looking southeast at Detector 13 with microphone deployment height of 3.04 meters – Wildlife Acoustics Song Meter SM4BAT FS Ultrasonic Recorder with SMM U2 Ultrasonic Mic.

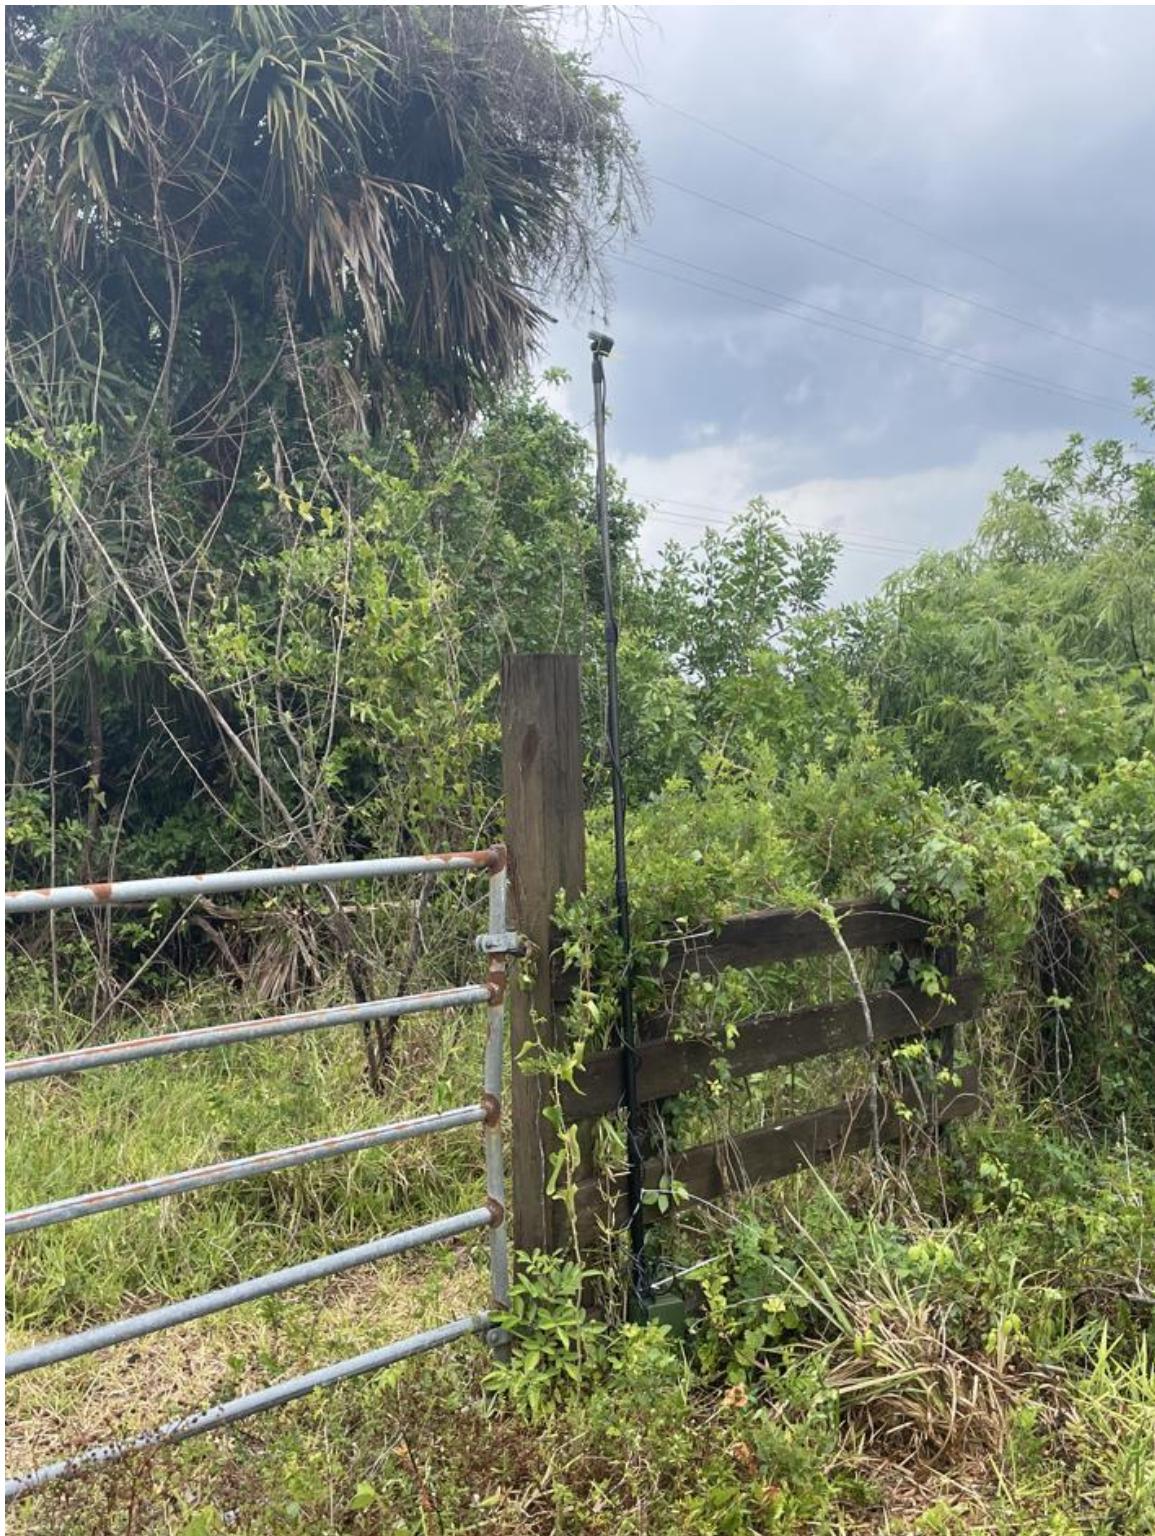
Photograph 14. Photograph looking northeast at Detector 14 with microphone deployment height of 3.04 meters – Wildlife Acoustics Song Meter SM4BAT FS Ultrasonic Recorder with SMM U2 Ultrasonic Mic.

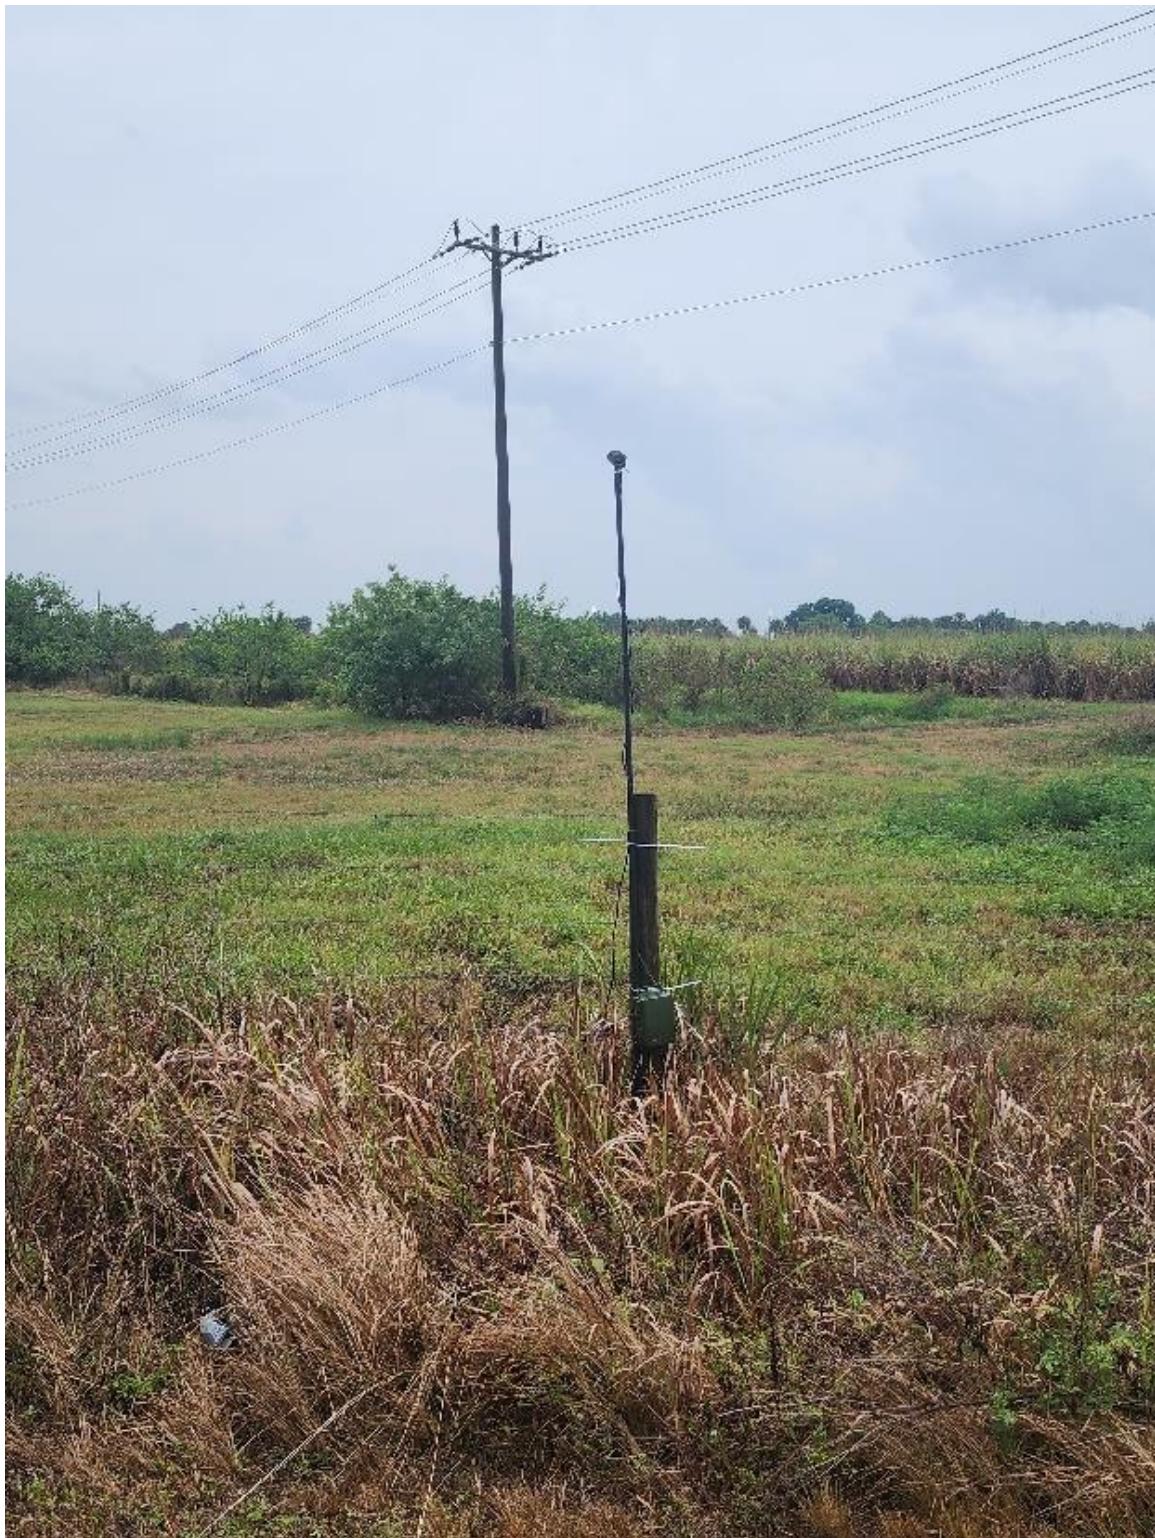
Photograph 15. Photograph looking southeast at Detector 15 with microphone deployment height of 3.04 meters – Wildlife Acoustics Song Meter SM4BAT FS Ultrasonic Recorder with SMM U2 Ultrasonic Mic.

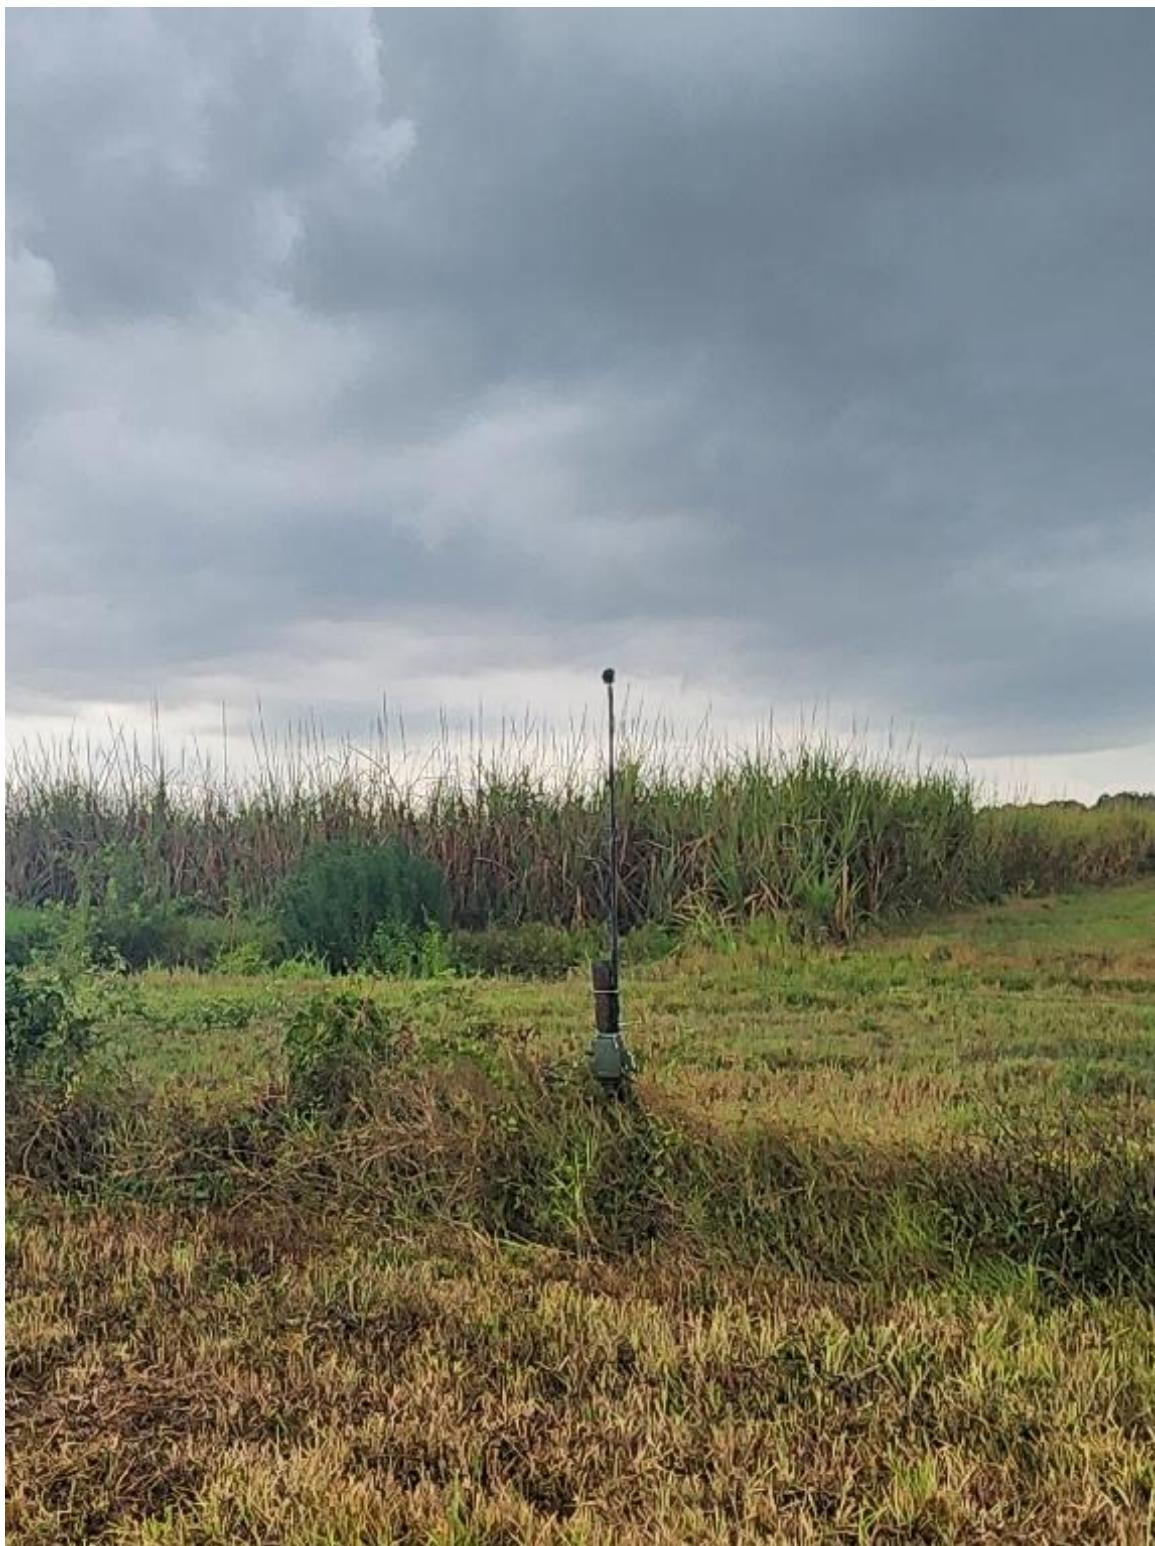
Photograph 16. Photograph looking west at Detector 16 with microphone deployment height of 3.04 meters – Wildlife Acoustics Song Meter SM4BAT FS Ultrasonic Recorder with SMM U2 Ultrasonic Mic.

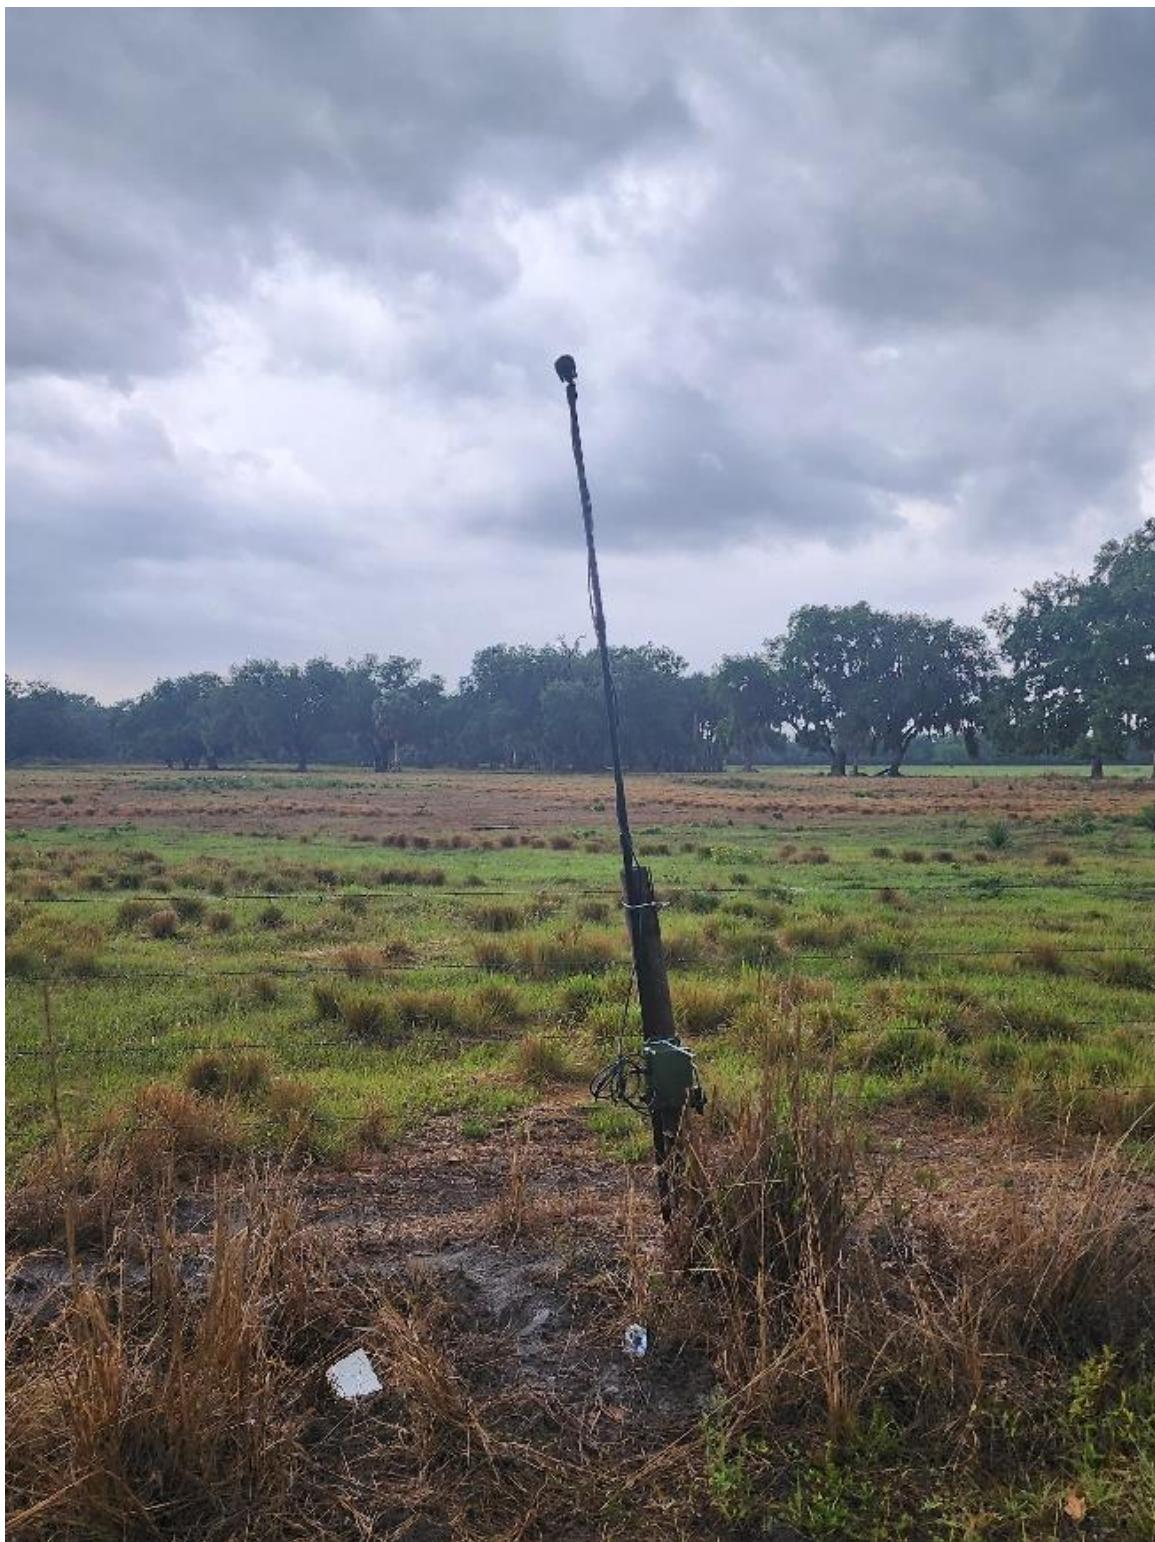
Photograph 17. Photograph looking southeast at Detector 17 with microphone deployment height of 3.04 meters – Wildlife Acoustics Song Meter SM4BAT FS Ultrasonic Recorder with SMM U2 Ultrasonic Mic.
