## **Appendix E – USGS Topographic Maps**

## **Appendix I – EDR Report Executive Summary**

# ***APPENDIX C***

Photolog

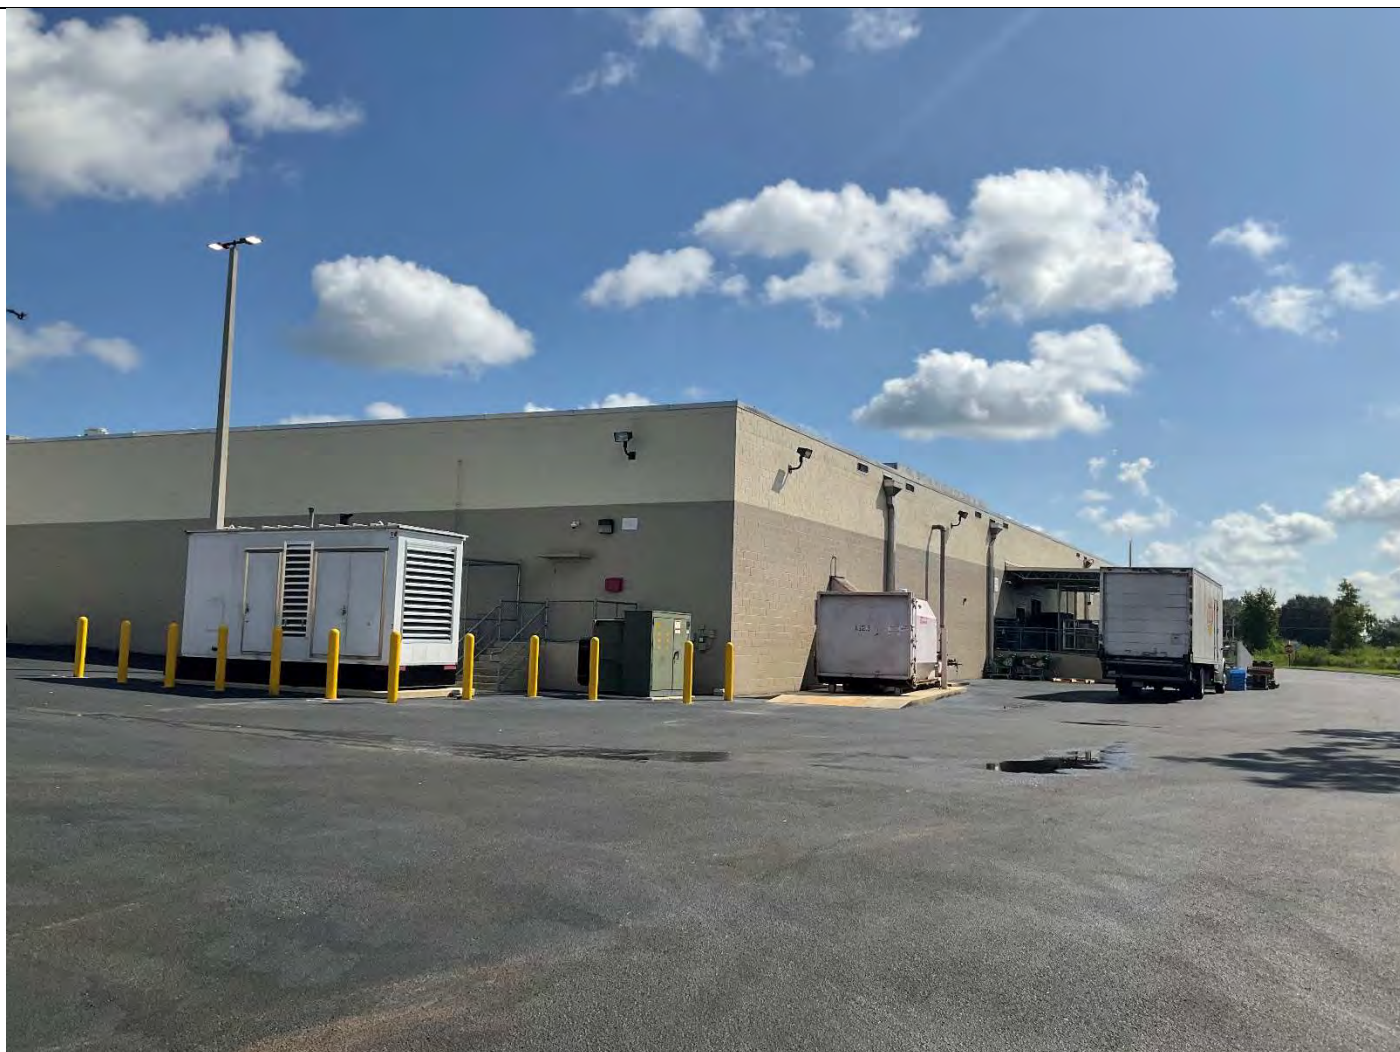
2024 Field Photo – Back of building/Facing Northeast

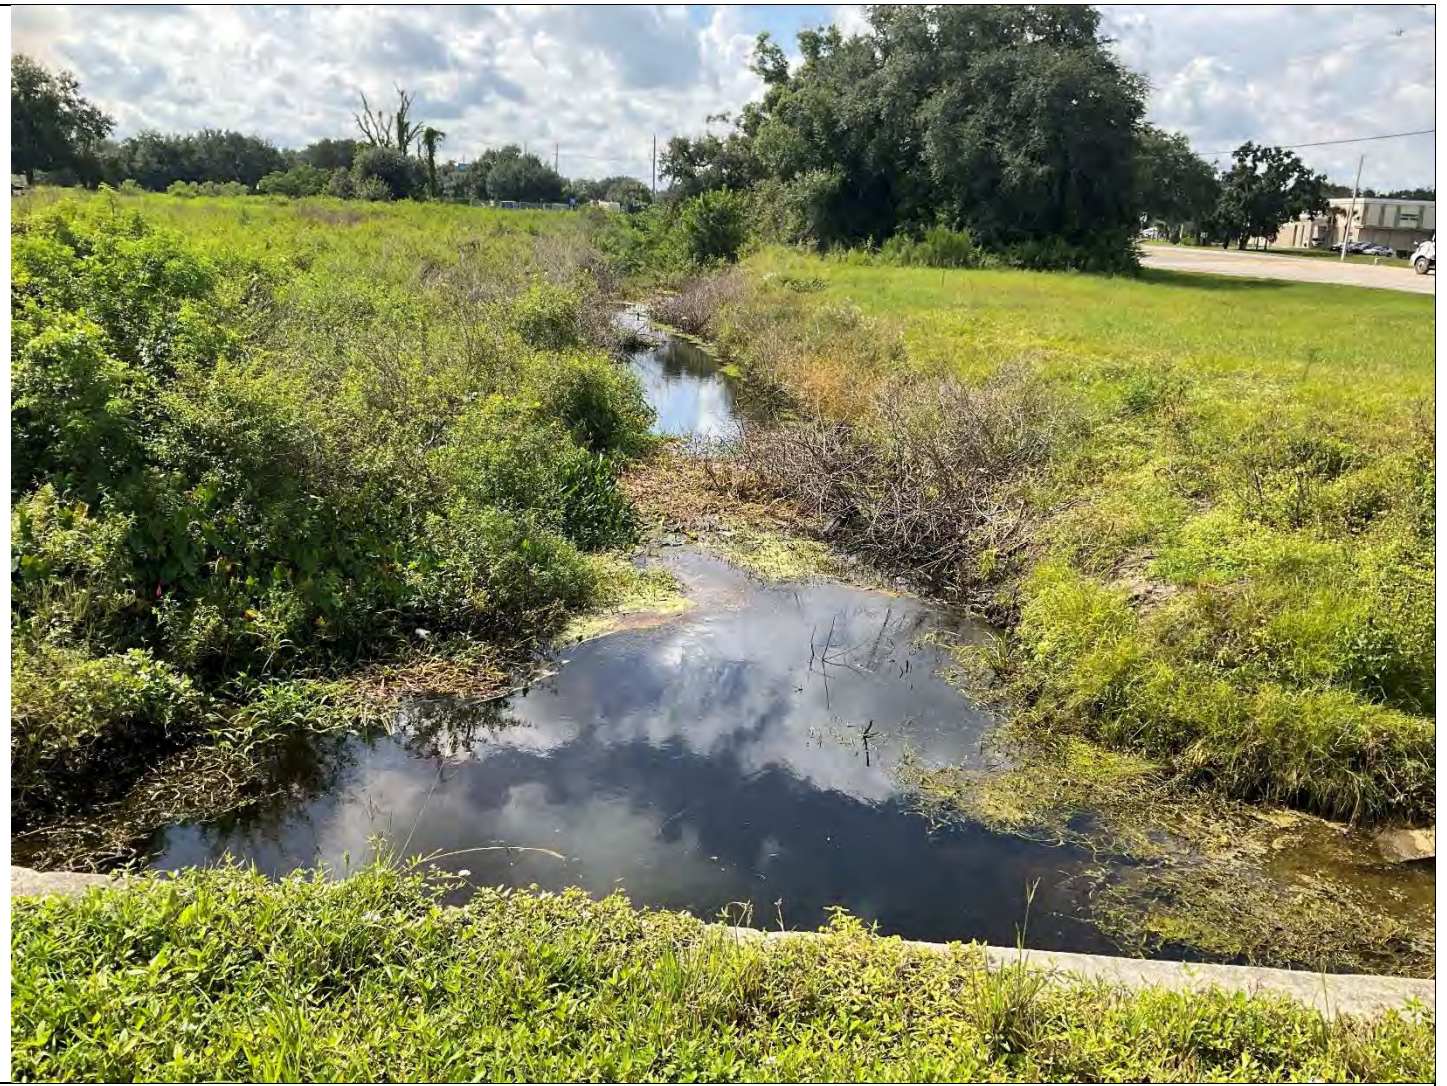
2024 Field Photo – Drainage area; facing south

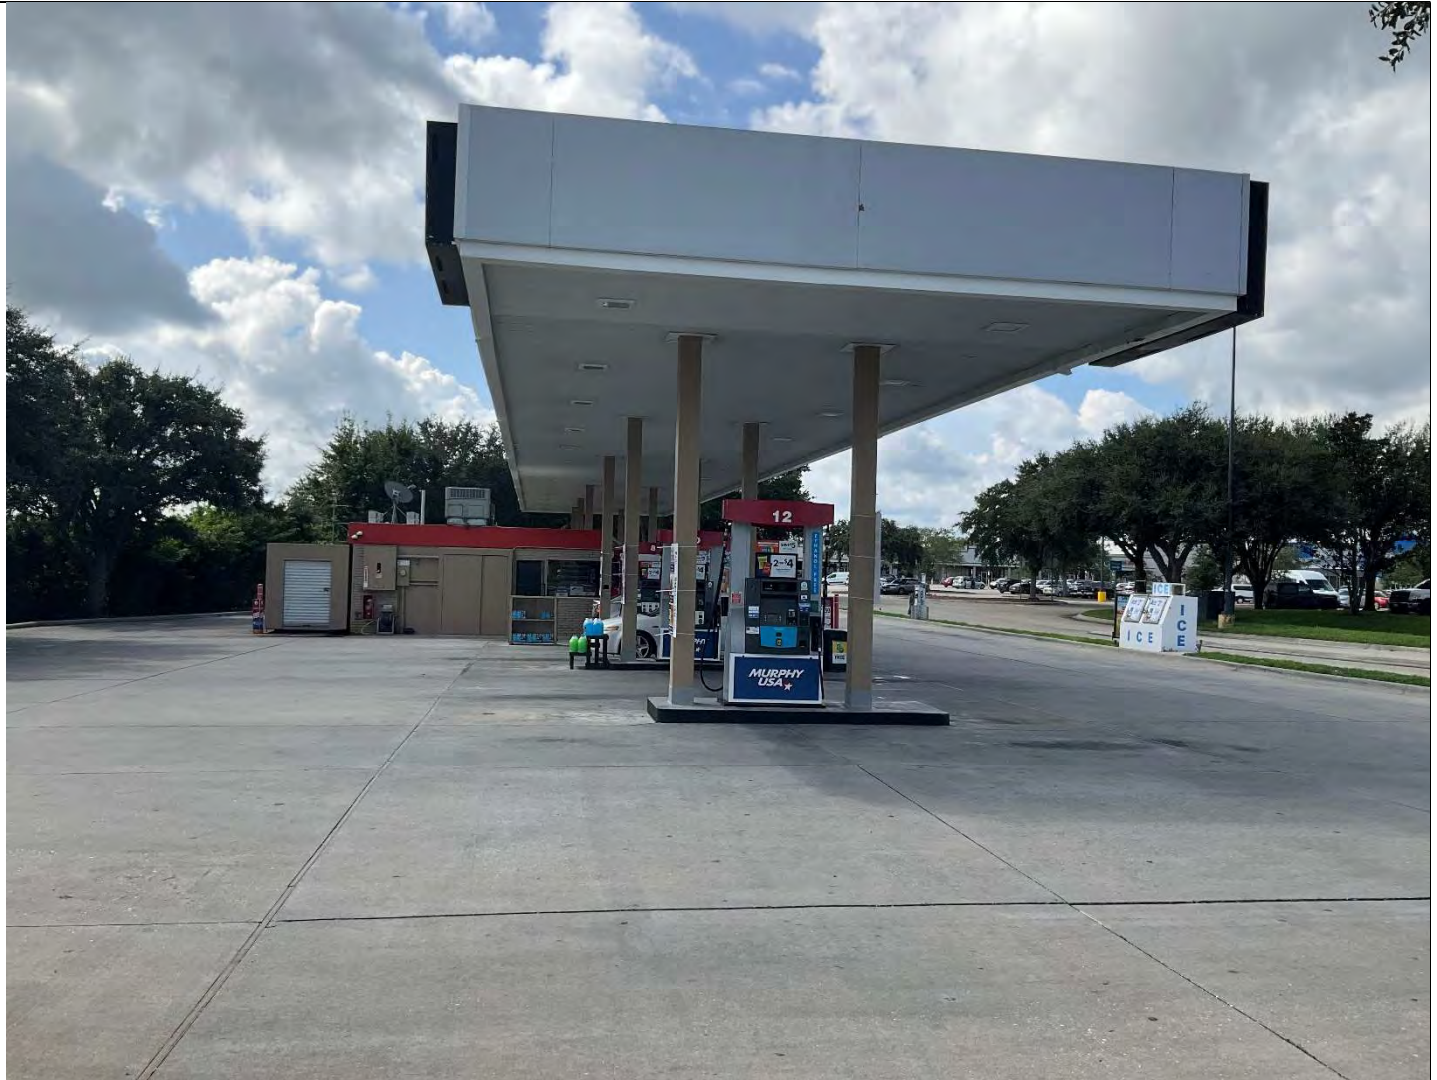
2024 Field Photo – Front of gas station; facing south

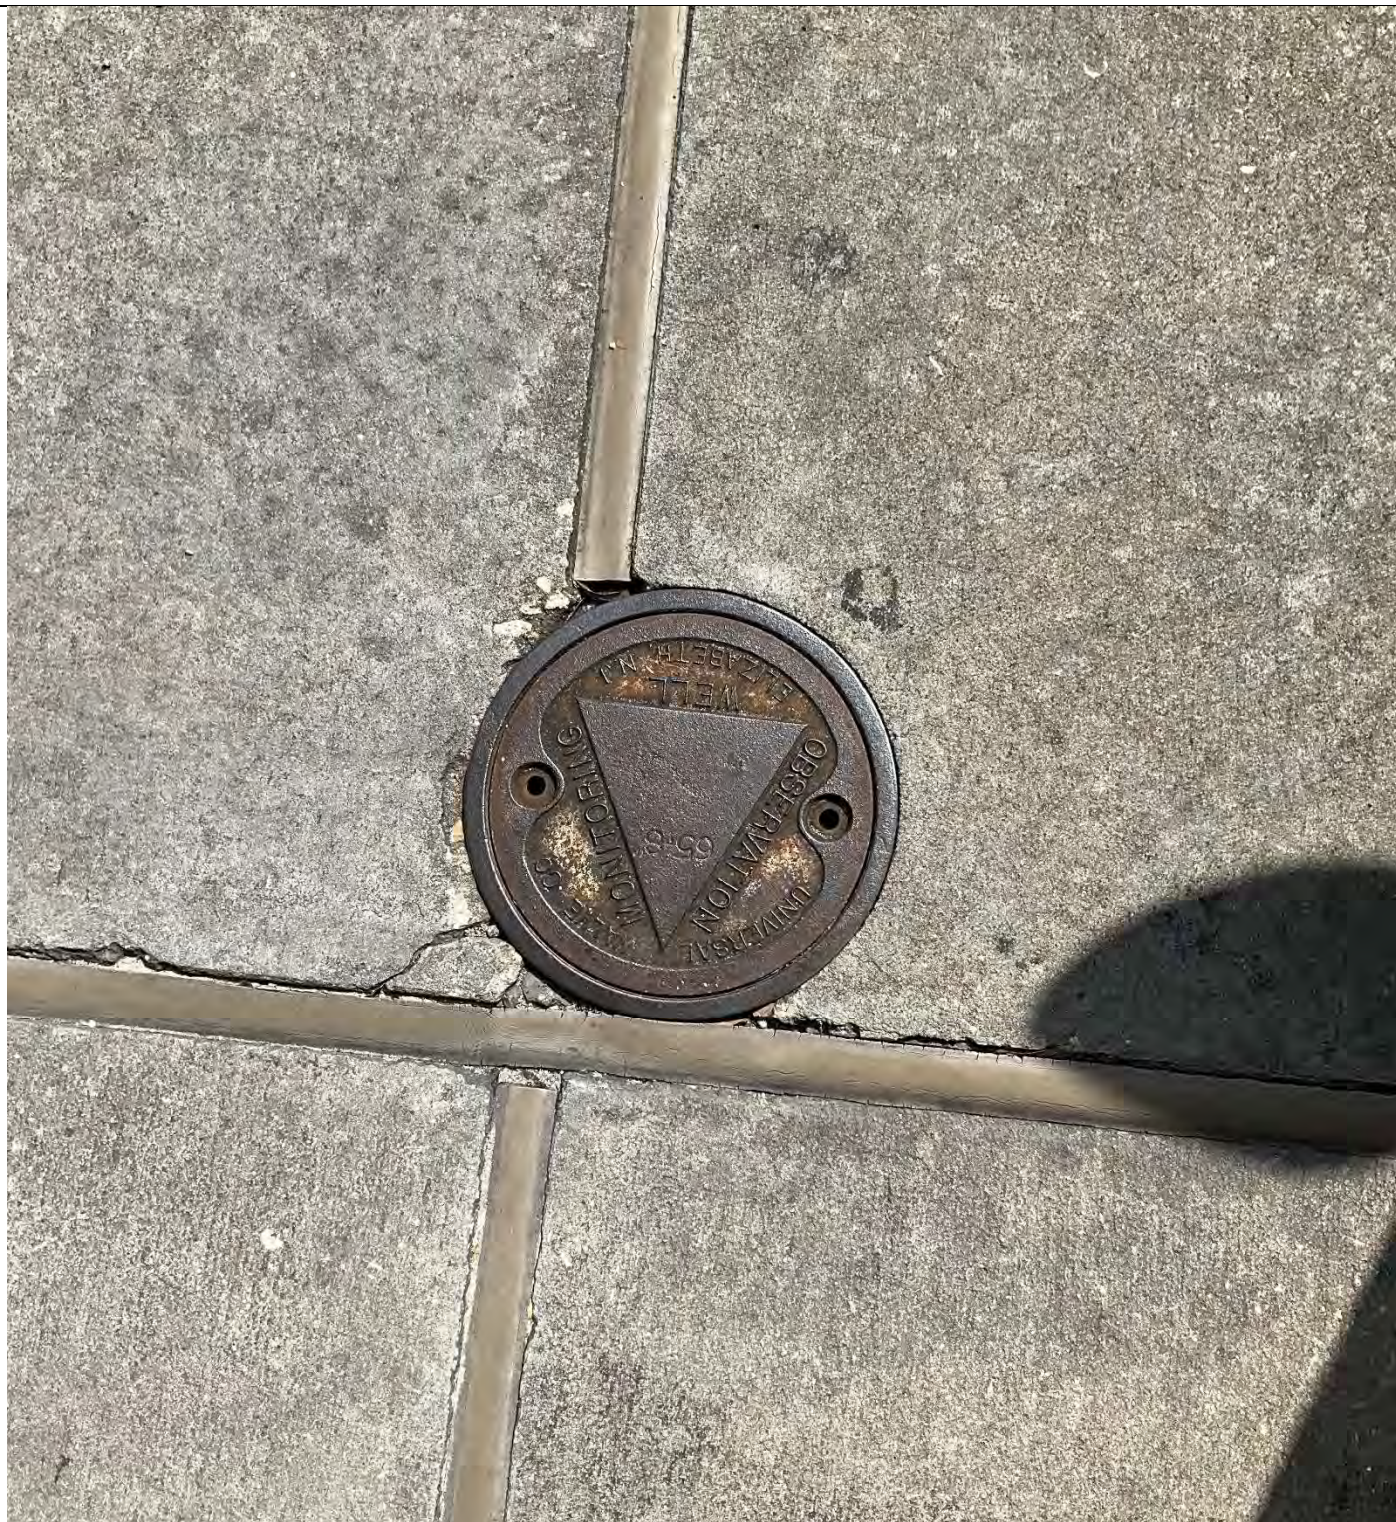
2024 Field Photo – Monitoring well next to fuel pumps

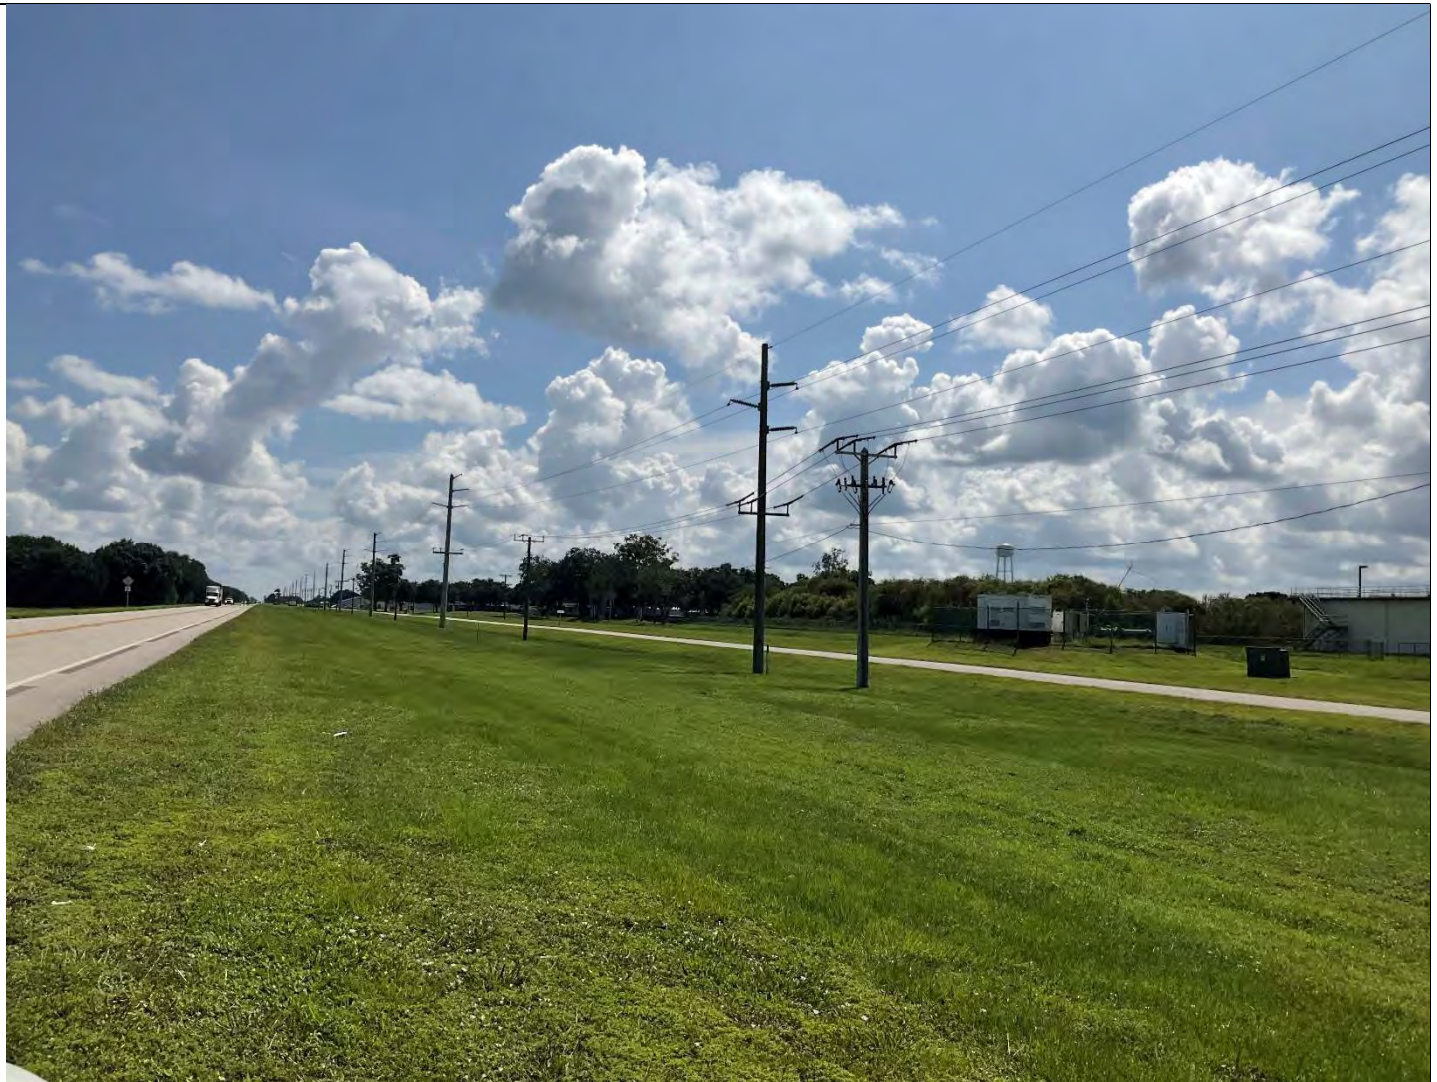
2024 Field Photo – Photo of lift station's proximity to SR 70; facing east

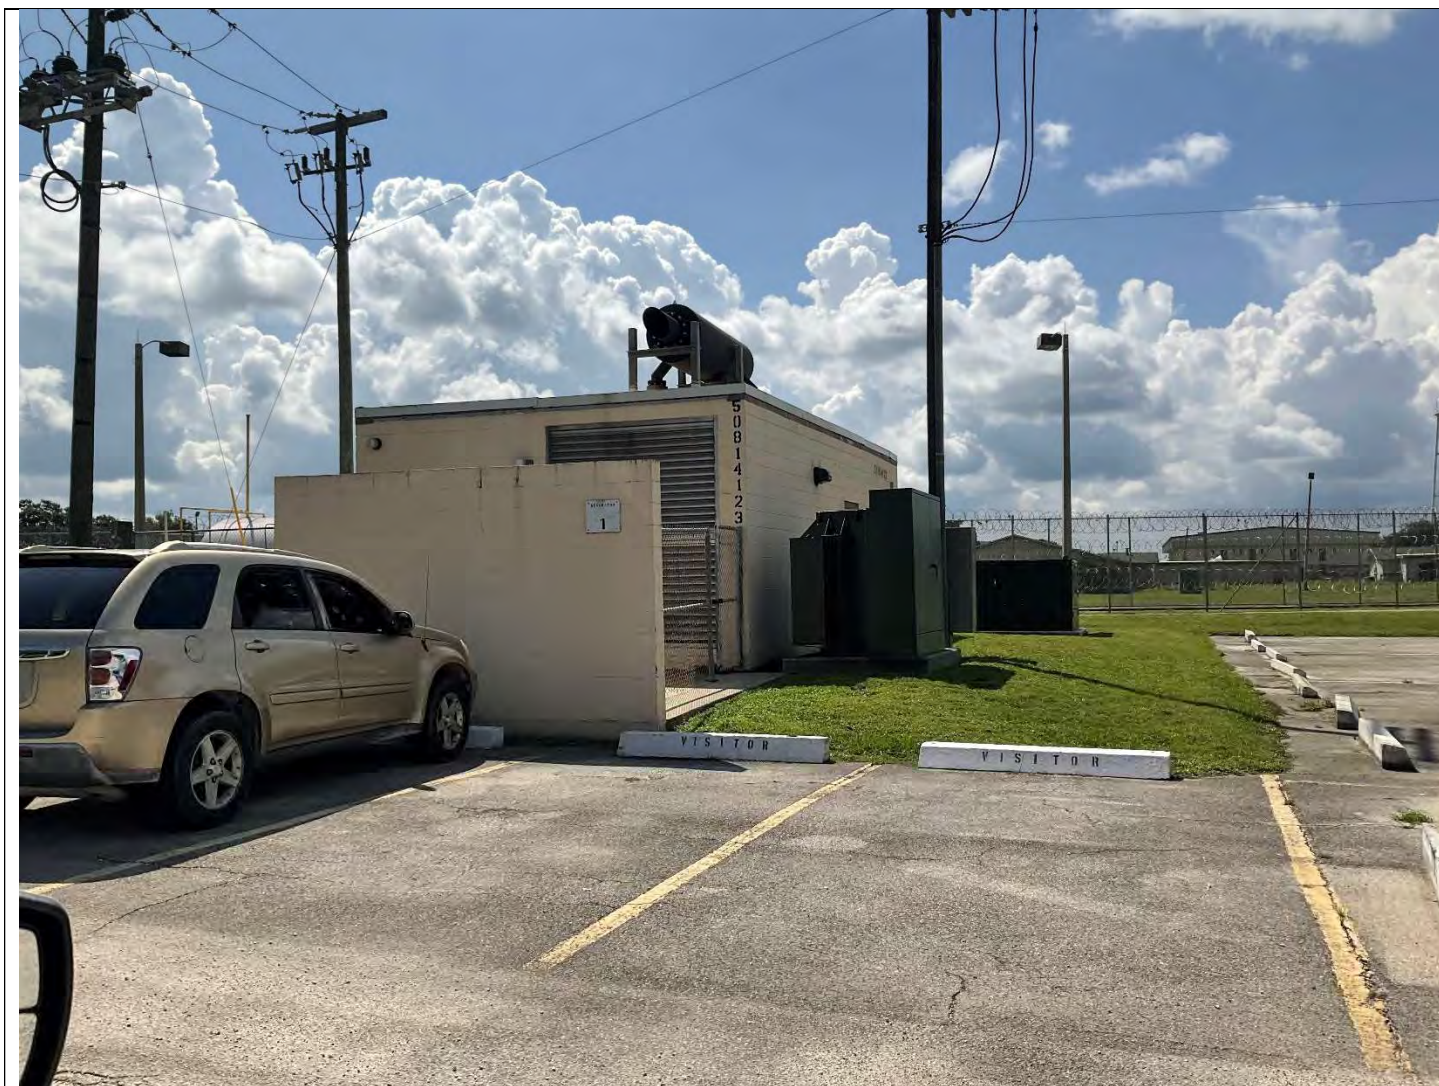
2024 Field Photo – Generator at entrance of DeSoto Corrections; facing southeast

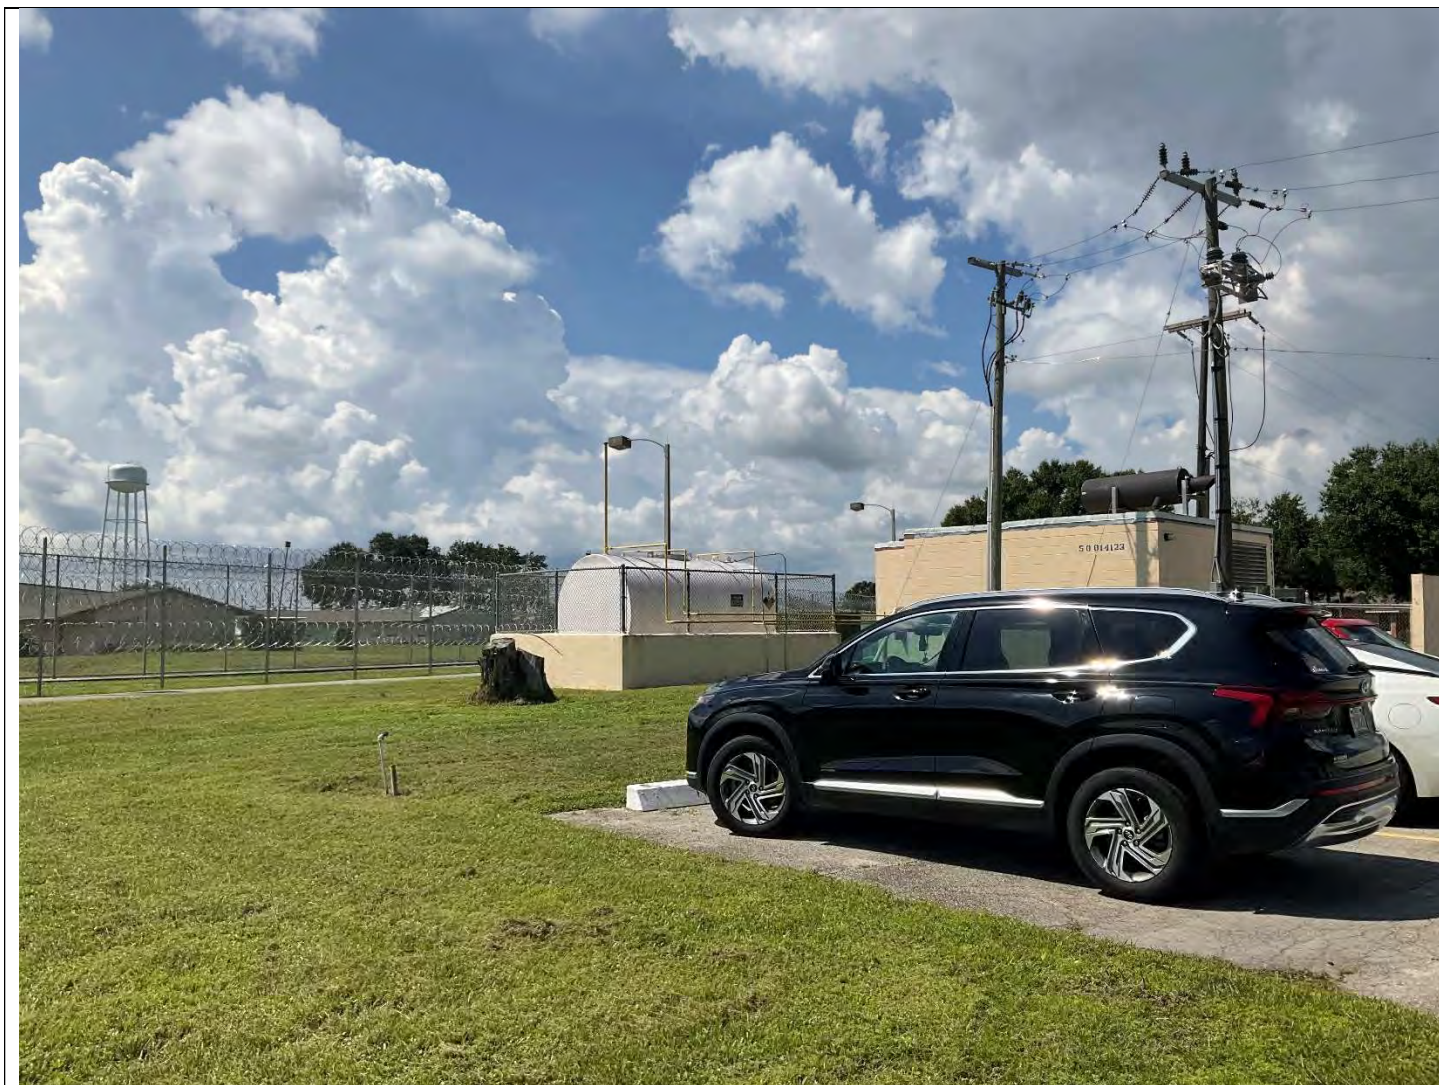
2024 Field Photo – Generator and tank next to facility entrance; facing southwest

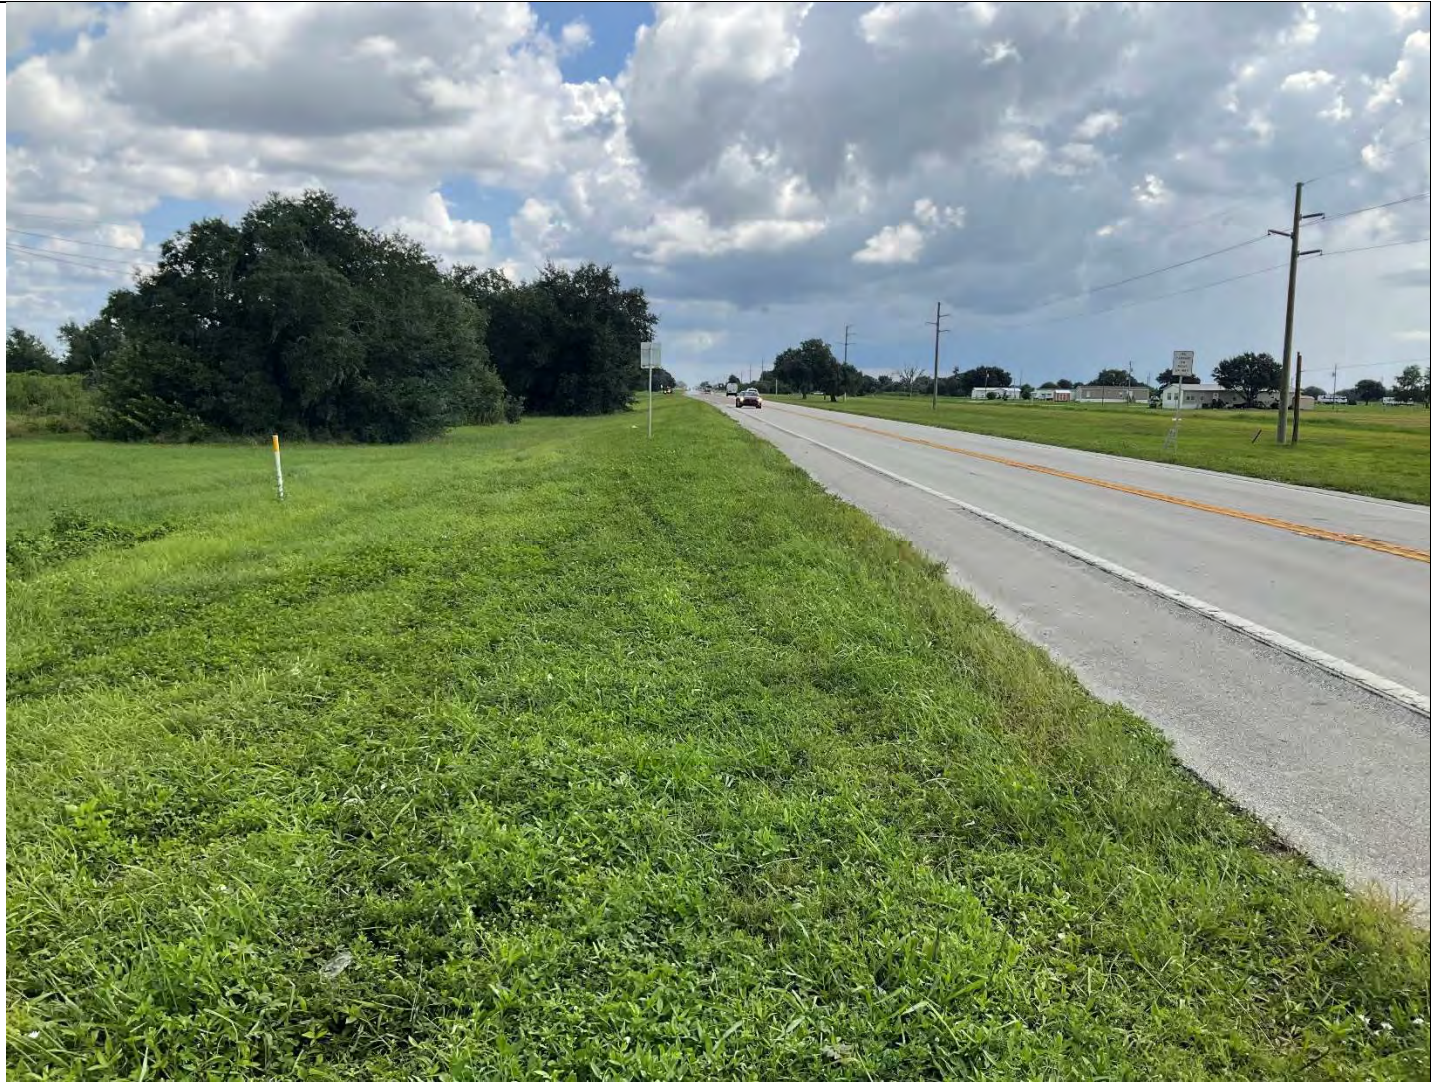
2024 Field Photo – Area of road marked as waste cleanup site; facing southeast

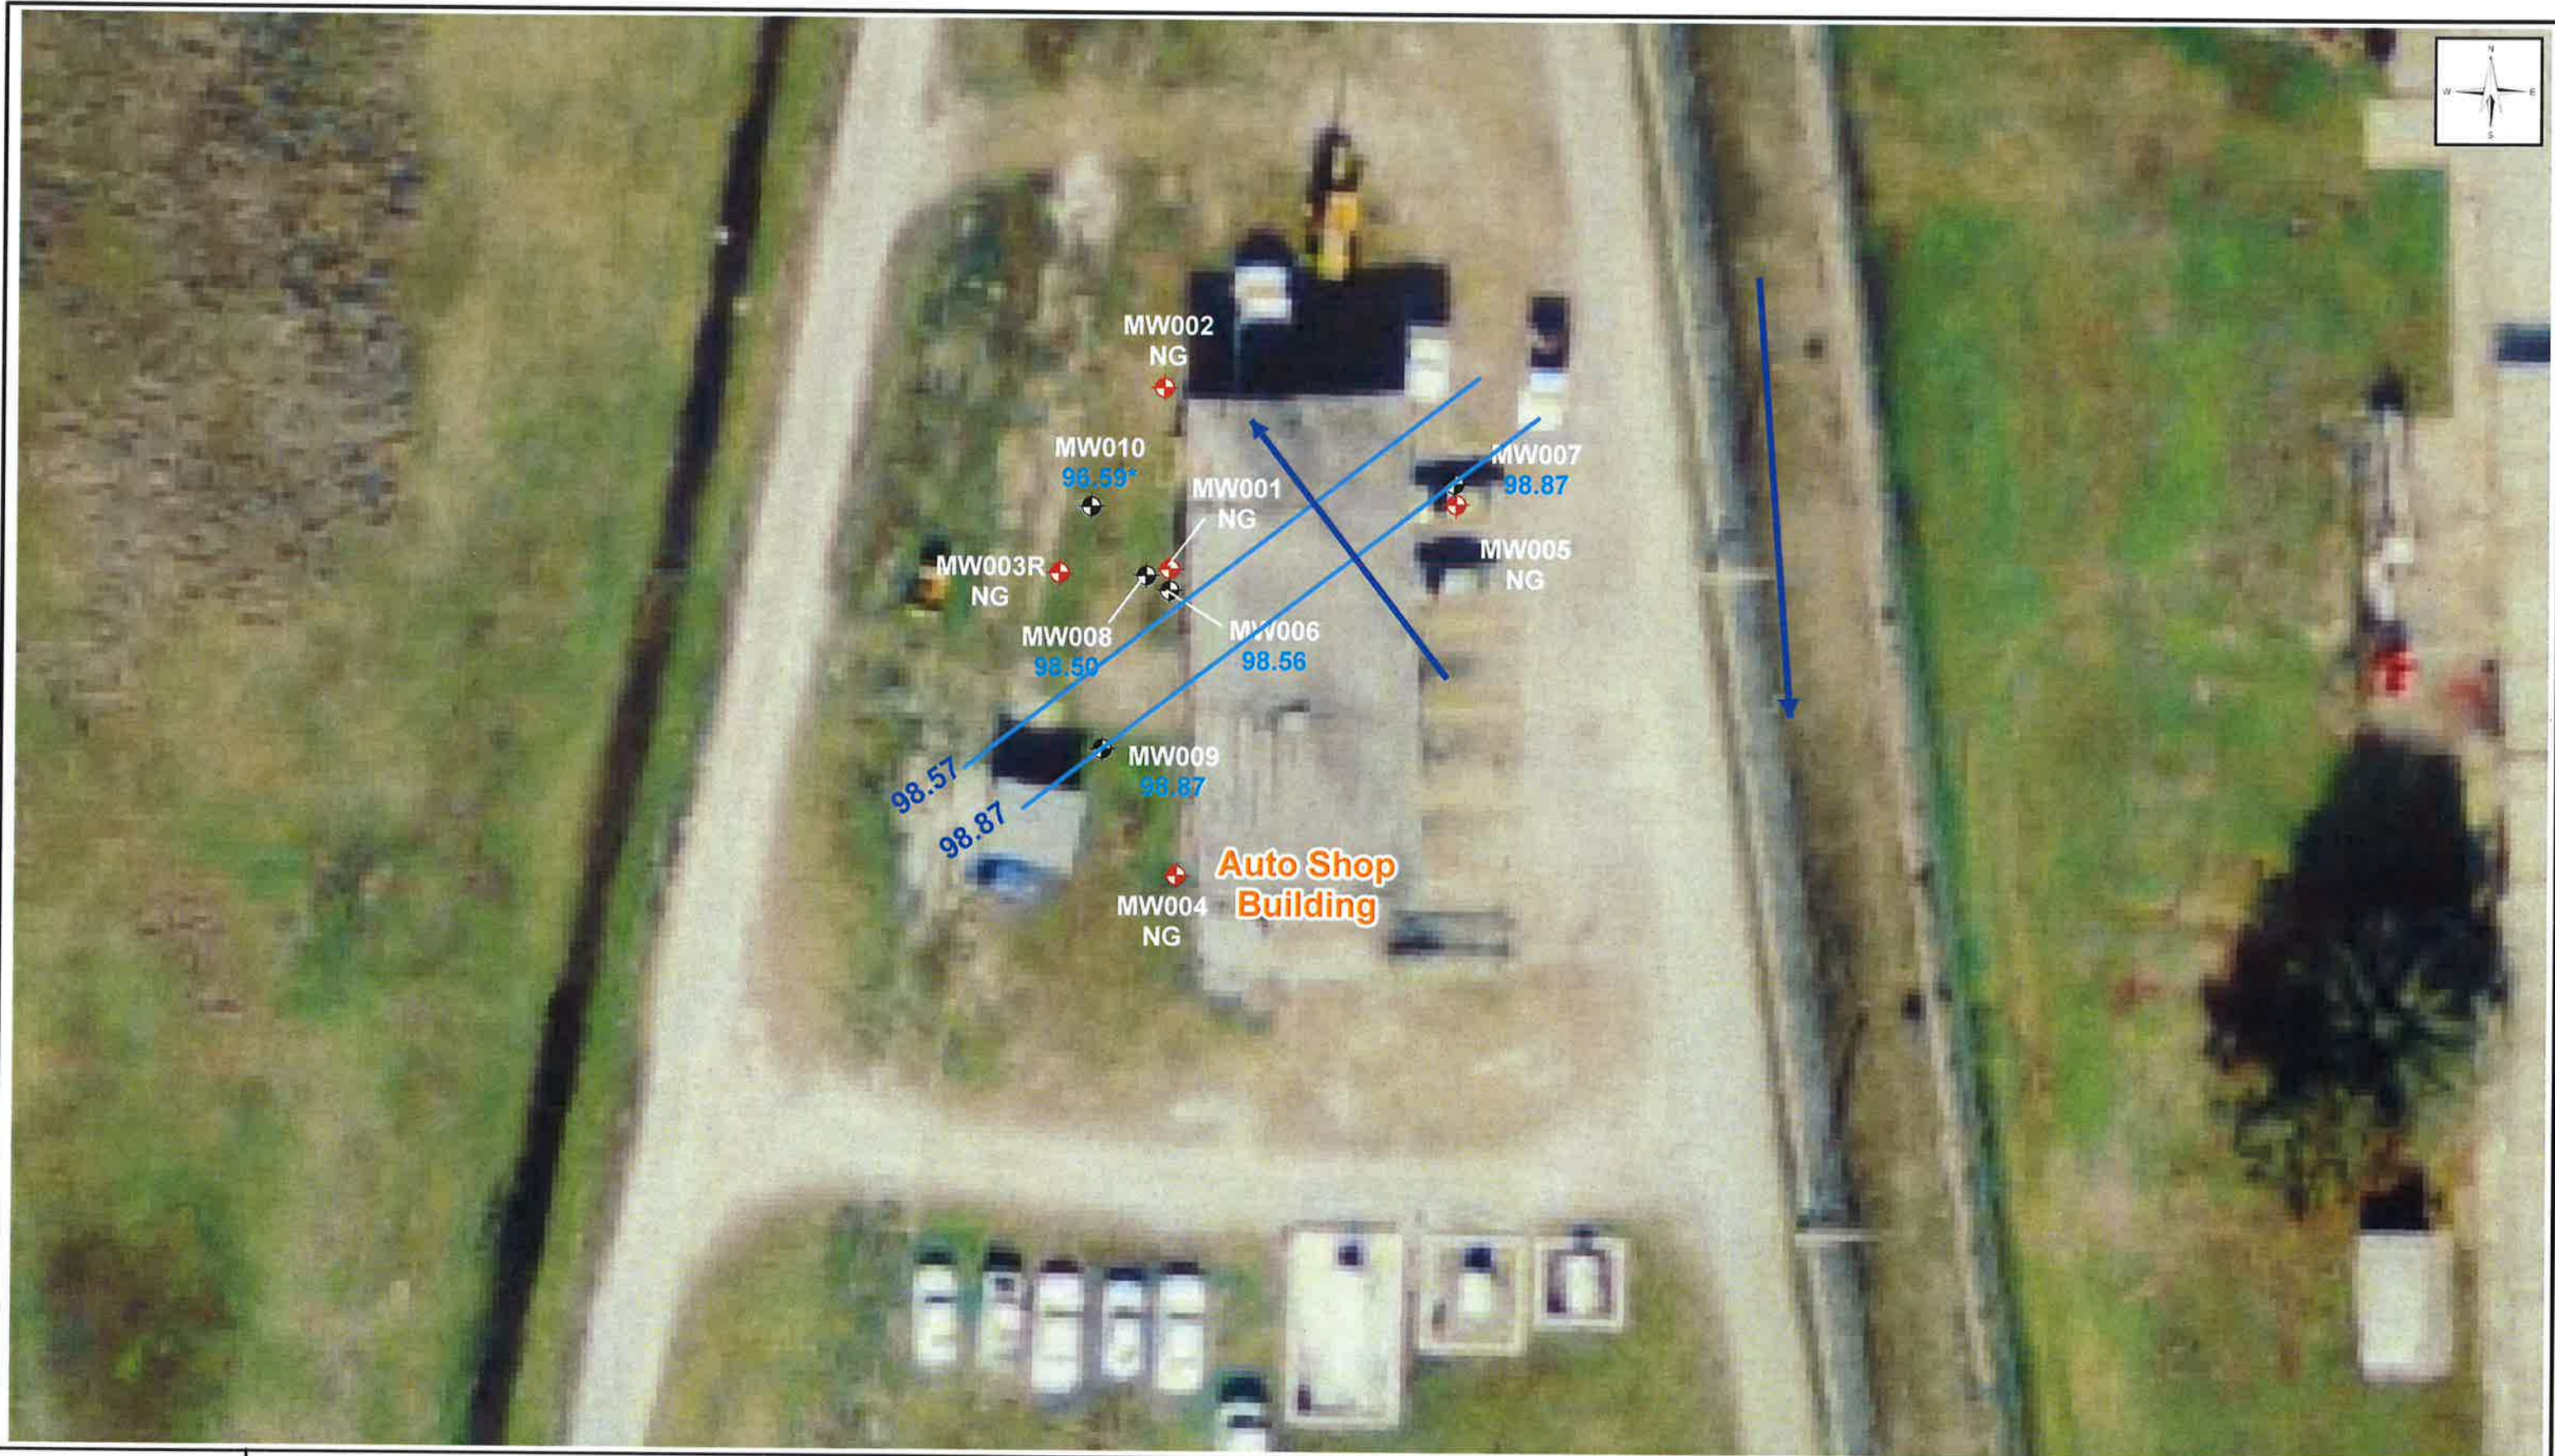
FIGURE 2

**LEGEND:**  
Survey Date: May 17, 2017  
Gauging Date: November 1, 2017  
All elevation measurements are accurate to  $\pm 0.01$  ft.  
94.68 - Relative groundwater elevation in feet.  
\* Anomalous Reading  
→ Groundwater elevation contour.  
→ Current apparent groundwater flow direction.

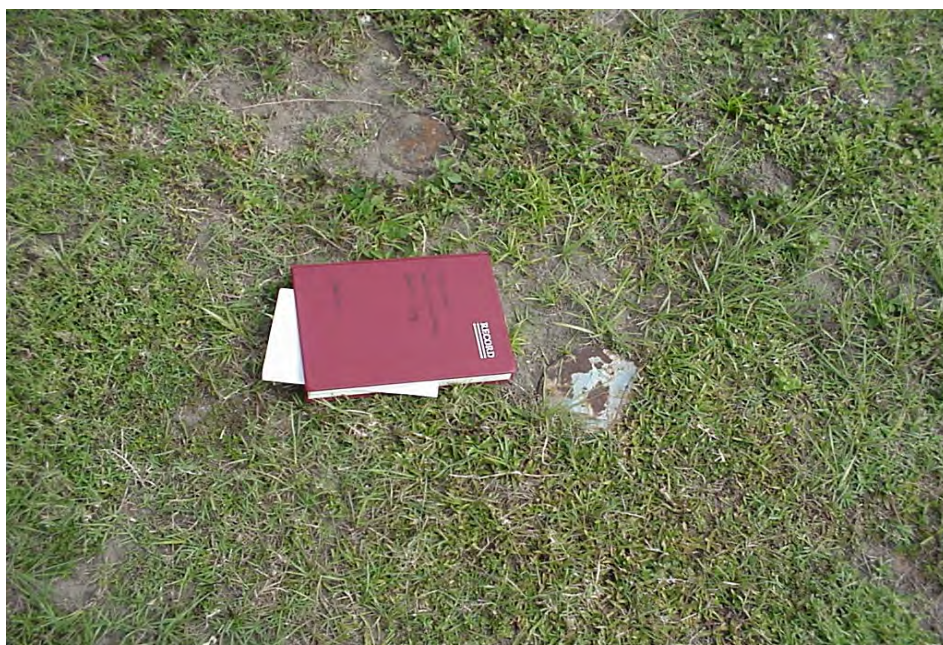
Approximately 15 feet south of the concrete slab at the southwest corner of the Maintenance Building, several paint can lids were observed exposed at the ground surface (Photo 1). Only minor stressed vegetation was noted around the paint can lids. Neither Mr. Vaughn nor Mr. Gallagher had any knowledge of dumping/burial of waste in this area.

**Photo 1. AOI 1: Paint can lids, stained soil and stressed vegetation**

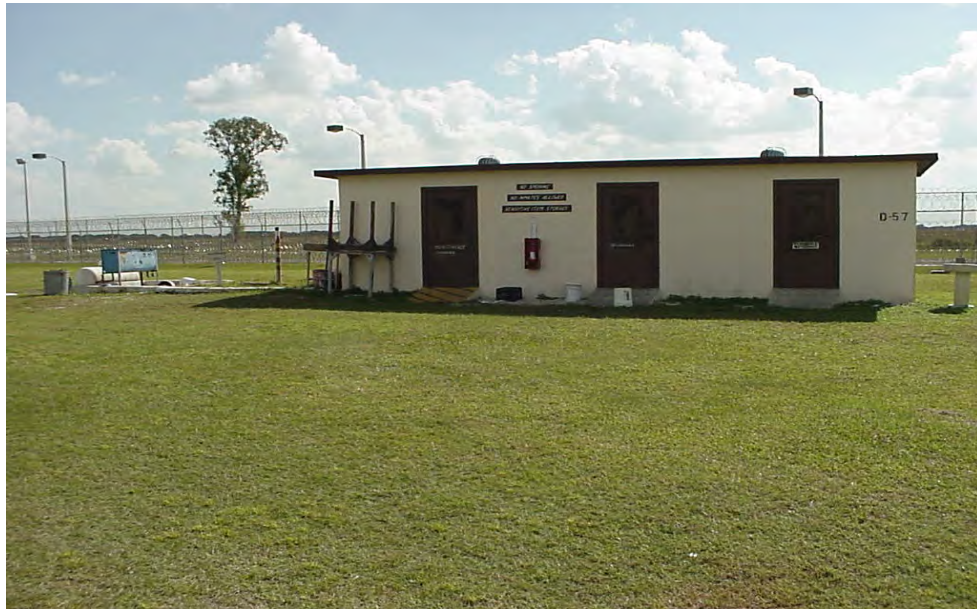
**Photo 2. AOI 2: Flammable storage building**

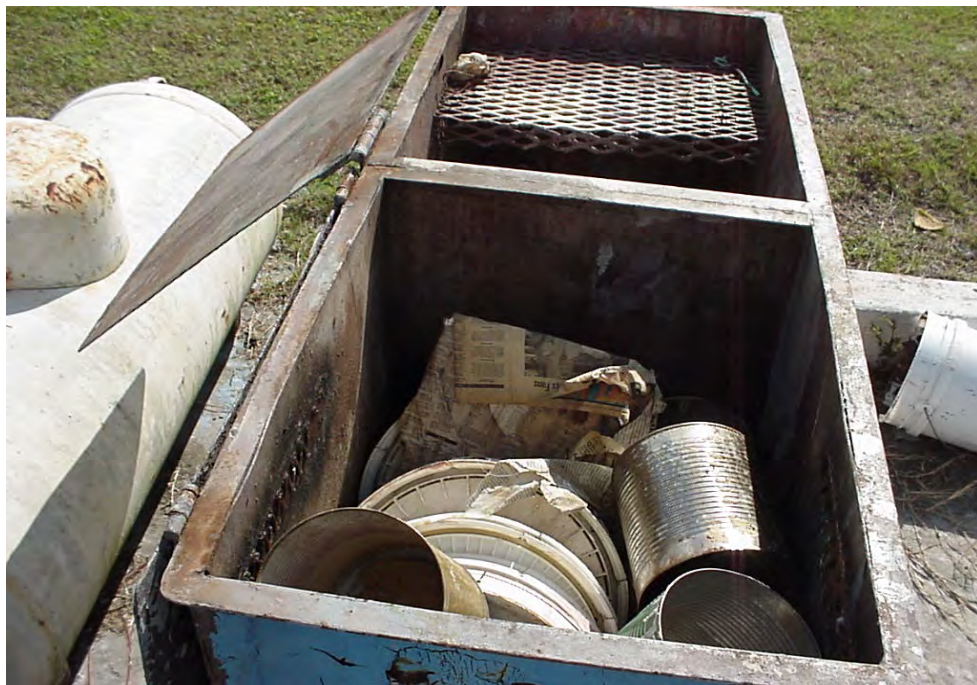
**Photo 3. AOI 2: Paint sink**

A sink is located on a concrete pad within a concrete berm on the east side of the building (Photo 3). Paint cans, paint waste, and newspaper were observed inside the sink. The sink is not plumbed to a drain. A white above ground propane tank is located a few feet east of the sink. Mr. Vaughn stated that paint waste is caught

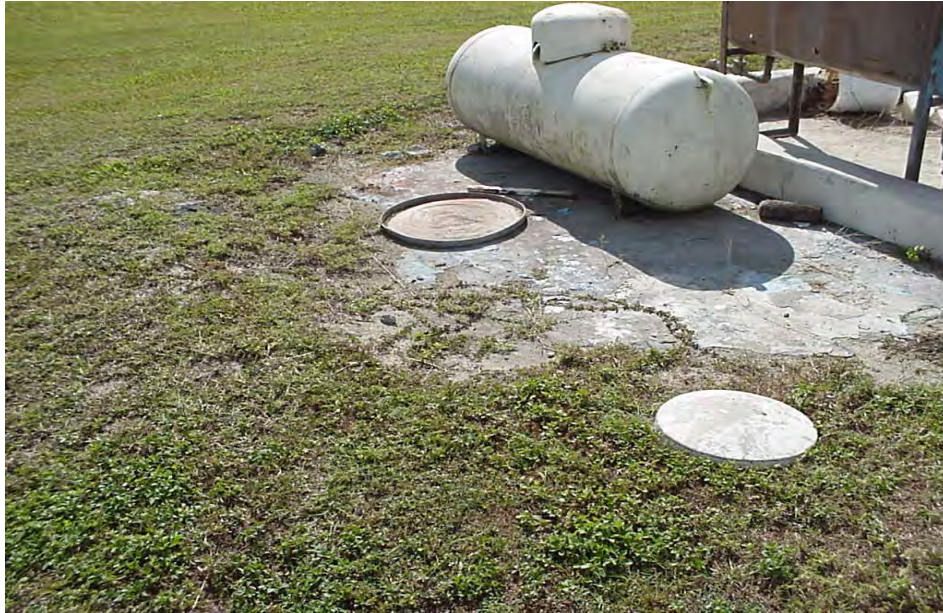
in a 5-gallon bucket and drummed. He said a vendor disposes of the drums of paint waste. Staining was observed on the cracked concrete slab east of the sink and in the containment area. Stressed vegetation and soil staining were observed around the edges of the concrete slab and around the containment pad (Photos 4 and 5).

**Photo 4. AOI 2: Stressed vegetation and soil staining**

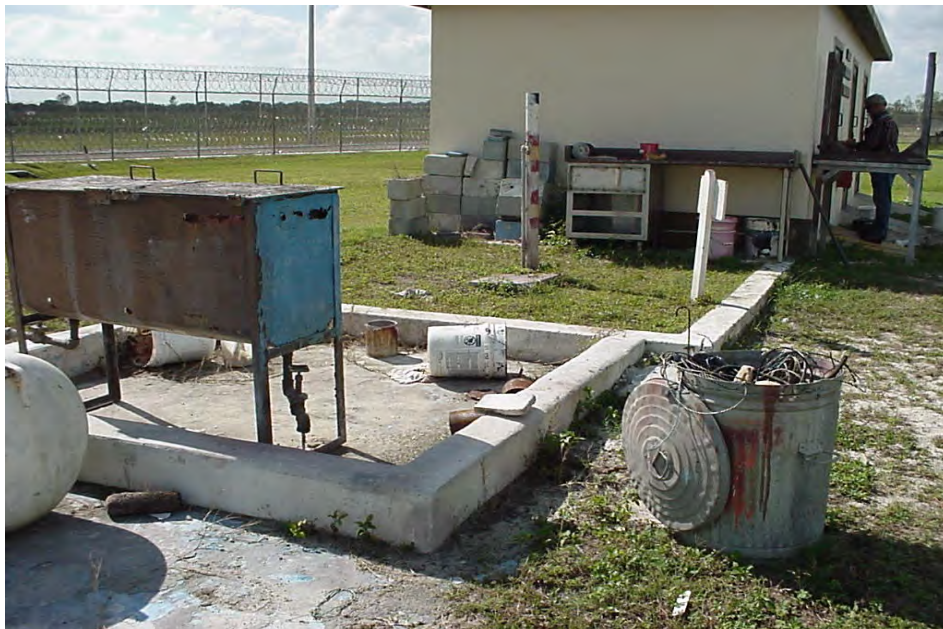
**Photo 5. AOI 2: Stressed vegetation and soil staining**

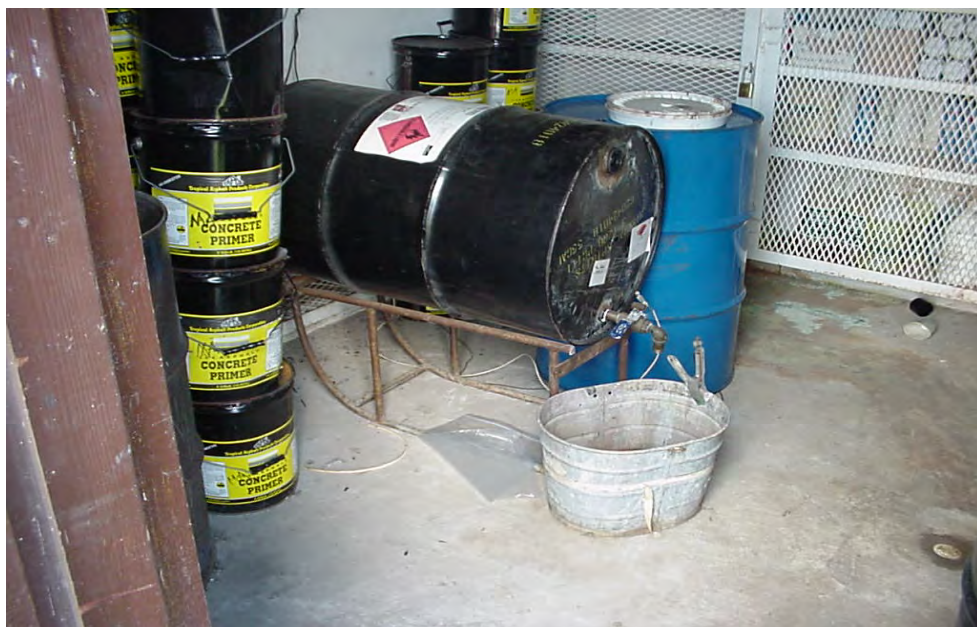
The east locker of the Flammable Storage Building is labeled as “Caustic / Flammable Storage.” Containers of grease, acrylic sealant, motor oil, pipe thread compound, PVC cement, WD-40, three drums marked “Mineral Spirits,” and refrigerants are stored in this locker. A floor drain was observed in the center of the locker. Staining was observed on the concrete floor leading to and around the floor drain. A spill of motor oil was observed under the shelves containing motor oil. (Photos 6, 7, 8, and 9).

**Photo 6. AOI 2: East Locker**

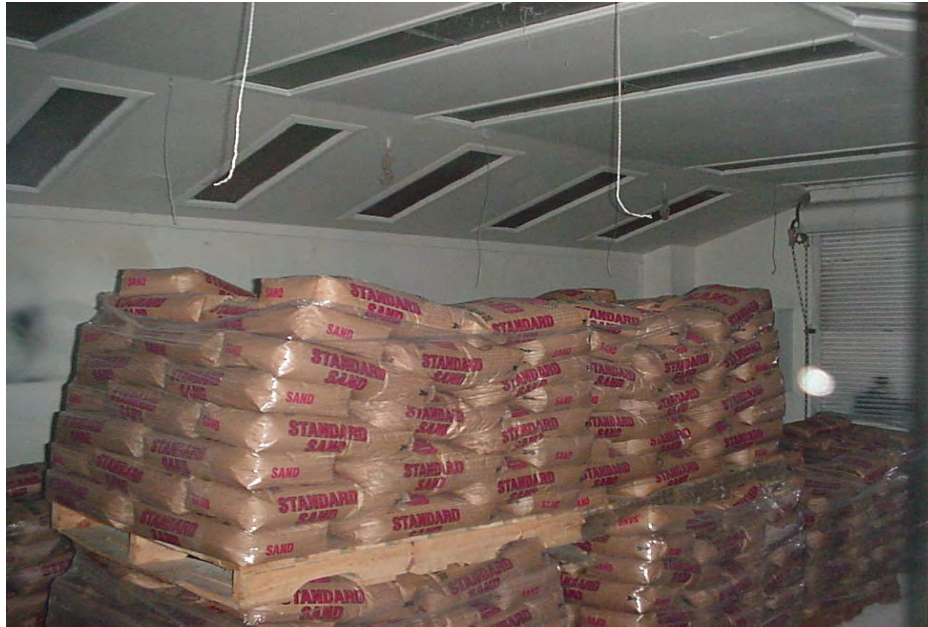
**Photo 14. AOI 4: Storage in paint booth**

was visible on the concrete under and around the compressors. The paint booth is no longer active and is used for storage (Photo 14).

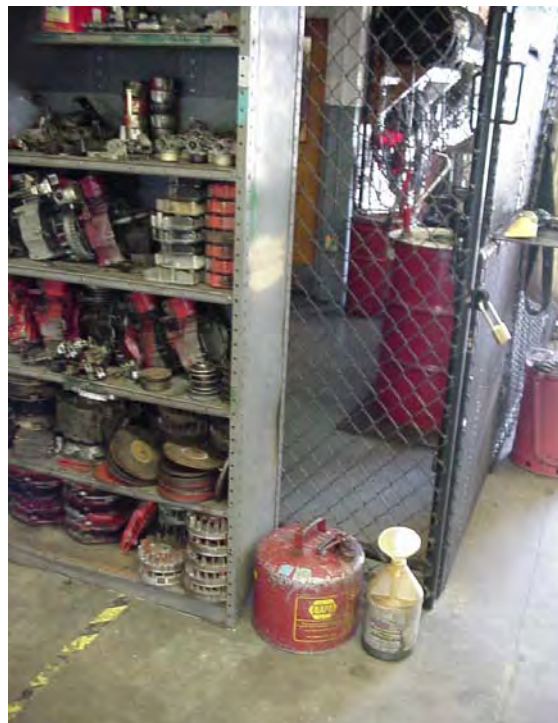
A Small Engine Repair Shop is located in the northwest corner of the building. This area maintains powered yard and maintenance equipment. Some maintenance activities were being conducted on the concrete slab west of the Shop door. Petroleum liquids (portable gasoline cans, motor oils, grease, used oil, etc.) are stored in a fenced locker along the south wall of this area (Photo 15). Two 55-gallon drums of 2-cycle oil and two 5-gallon buckets holding waste oil were observed. Personnel stated that the waste oil is taken to the waste oil tank at the Auto Shop. Parts, tools and equipment are located along the walls of the Shop. The shop had a neat and orderly appearance. Floor drains were observed in this area. No staining was observed on the floor or around the floor drains. Spill absorbent materials were observed to be on hand in the Shop.

**Photo 15 AOI 4: Petroleum storage, small engine repair**

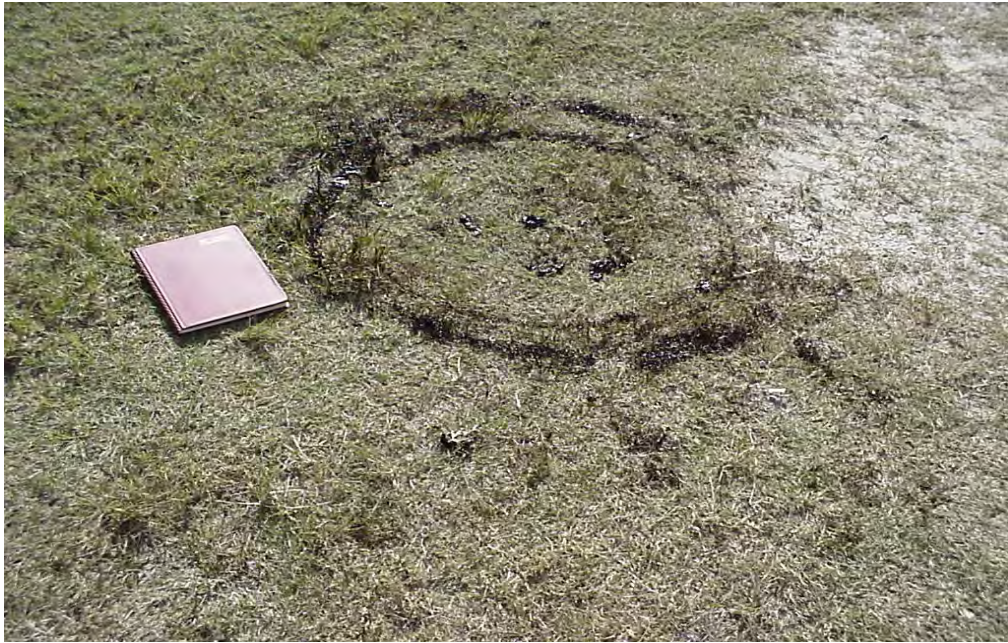
Grease stains, that appear to be consistent with a 55-gallon drum, were observed on soil and vegetation west of the ASTs and south of the building. Minor stressed vegetation was noted in this area. (Photo 16).

**Photo 16. AOI 10: Grease stains and stressed vegetation**
