## **Appendix E – USGS Topographic Maps**

## **Appendix I – EDR Report Executive Summary**

# ***APPENDIX C***

Photolog

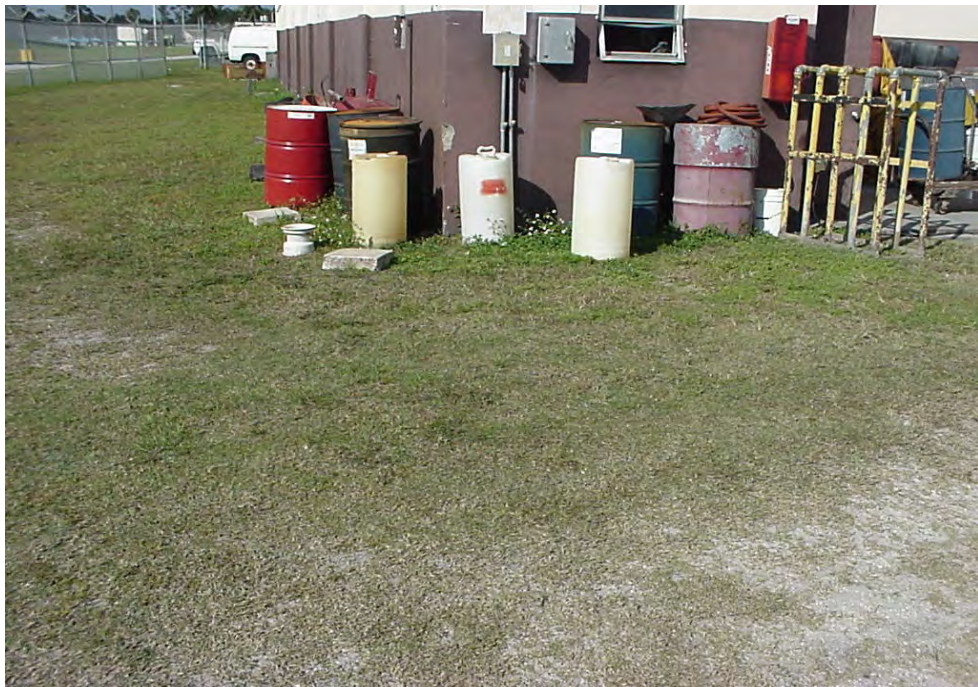
Drum storage was observed on the outside southwest corner of the building (Photo 17). No staining was observed on the ground around this area. Stressed vegetation was observed south and southwest of the drums.

**Photo 17. AOI 10: Drum storage and stressed vegetation**

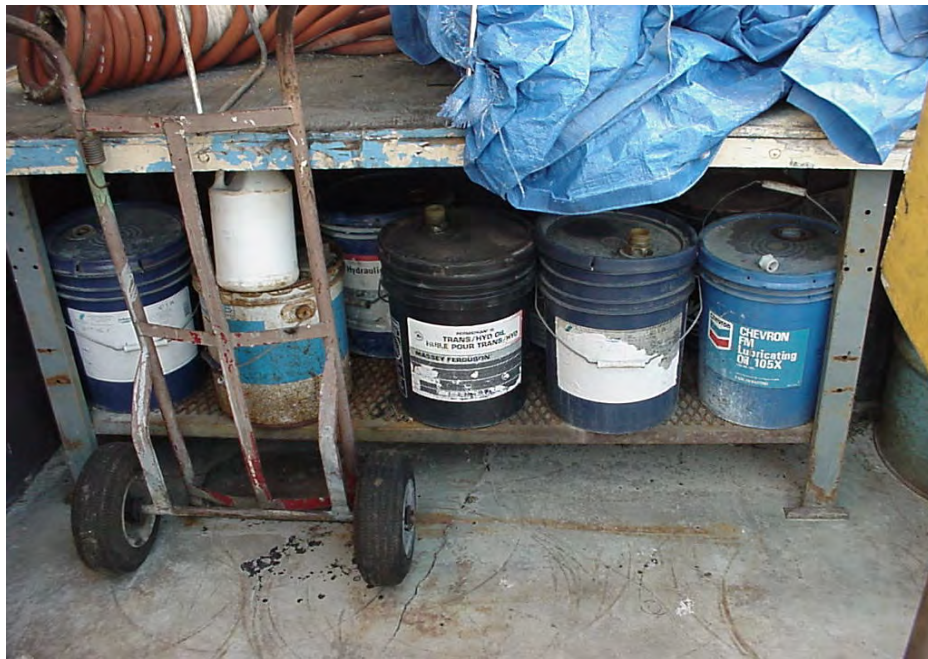
**Photo 18. AOI 10: Lubricant storage in auto shop**

A shelving unit storing various lubricants and motor oils was observed on a concrete slab at the southeast corner of the building (Photo 18). Adjacent to the shelving, on the east side, are three rusty 55-gallon drums of motor oil and one newer 55-gallon drum of antifreeze (Photo 19). Slight pitting and rust was noted at the base of one of the motor oil drums. Staining was noted on the concrete slab close to these drums.

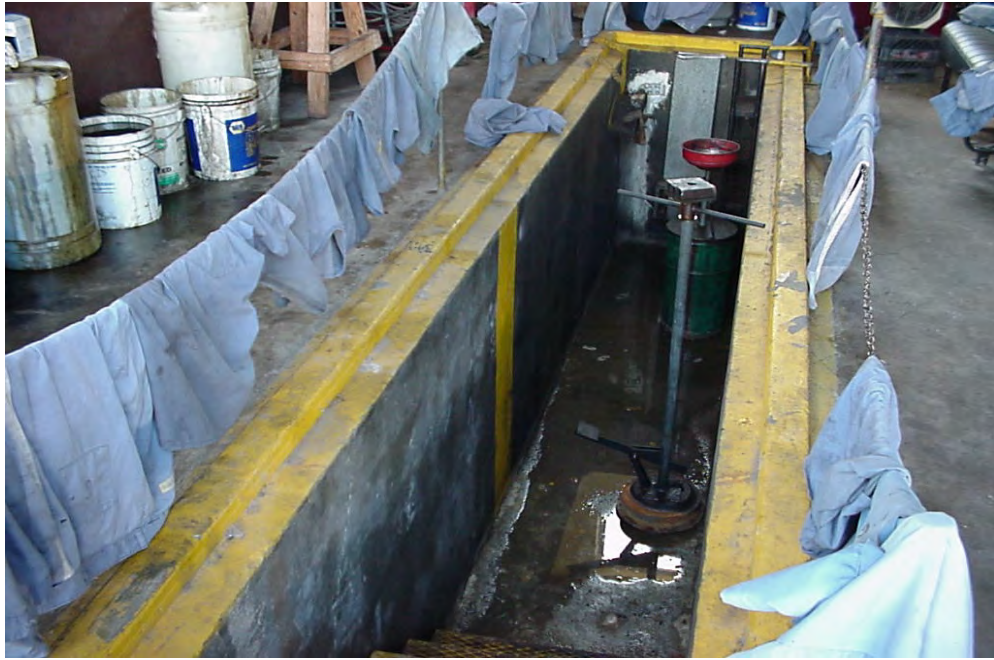
**Photo 20. AOI 10: Pit in auto shop**

The southern vehicle bay has a pit (Photo 20). A grouted floor drain was present in the pit. The bottom and sides of the pit are stained black. A drip stand attached to a 30-gallon drum was present in the pit. Liquid was observed to be puddled in the bottom of the pit. An inmate stated that the pit is routinely vacuumed out via a shop vac. When questioned about where water removed from the pit is placed, supervising correctional officer at the Auto Shop, Officer Hall, stated that water from the pit is not removed.

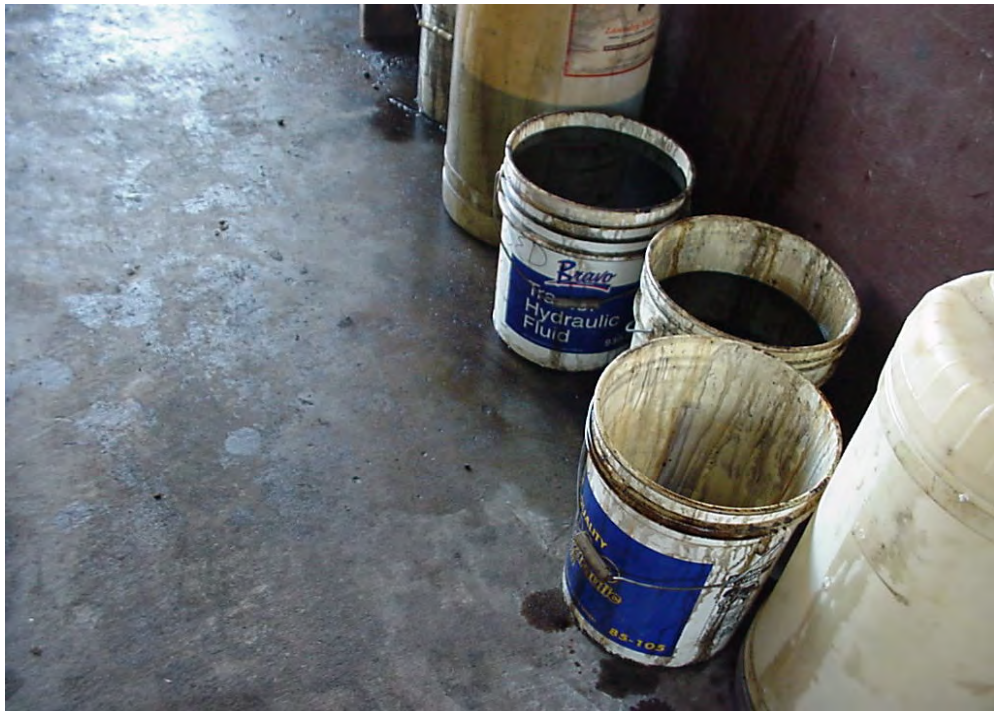
Petroleum liquids storage was observed along the southern wall of the southern vehicle bay (Photo 21). Several 5-gallon buckets and plastic 30-gallon drums were observed to contain what appeared to be waste oil. Staining and spilled petroleum liquids were observed on and around these containers. Excessive staining was noted on both the concrete wall adjacent to these and on the concrete floor between the pit and south wall.

**Photo 21. AOI 10: Buckets of used oil and concrete staining**

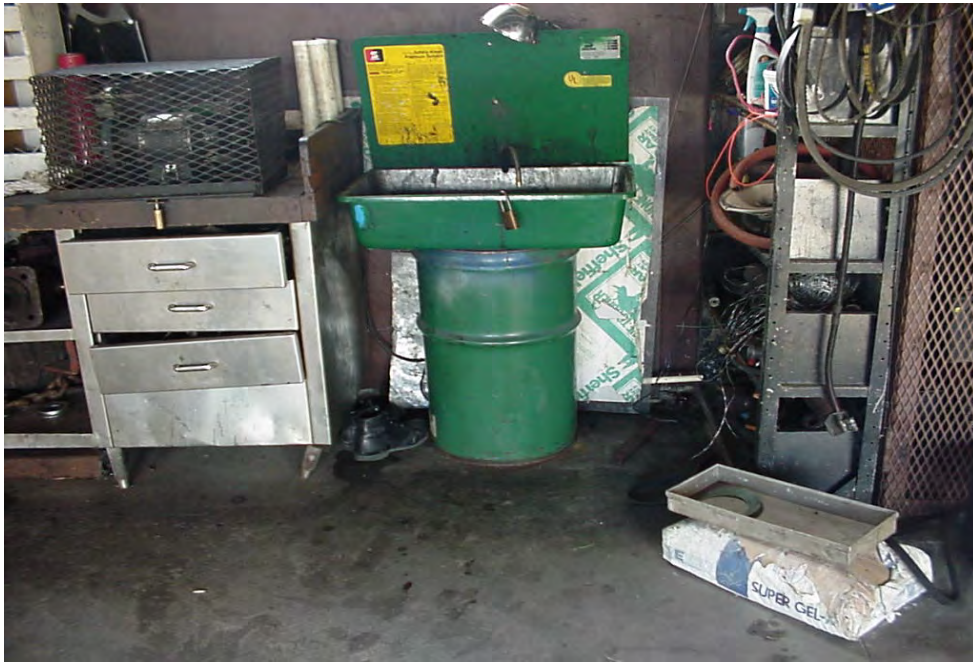
A parts cleaning sink is located along the west wall of the service bays. This sink is serviced by a vendor. Excessive amounts of staining and evidence of spills were noted on the floor at the base of the sink and in the general area (Photo 22).

**Photo 22. AOI 10: Parts cleaning sink and concrete staining**

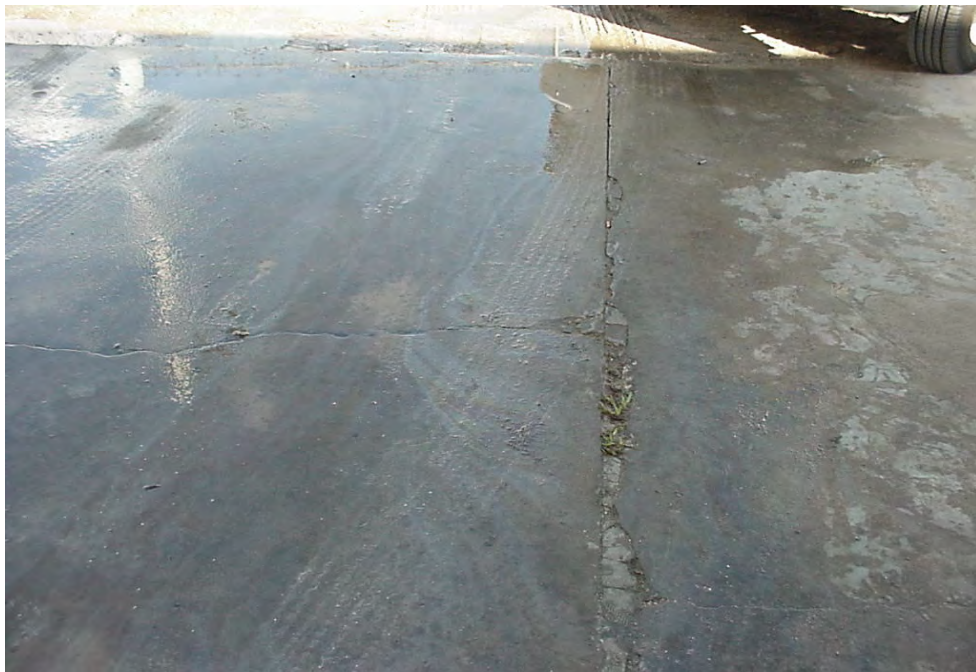
During the site visit, the garage floor was being hosed down with potable water. A sheen was observed on the runoff from this operation. Runoff from the shop floor was in a easterly direction to joints and cracks in the concrete and to the sand parking lot east of the vehicle bays (Photo 23). Due to staining and the flowpath of the runoff, the potential for soil and groundwater contamination from the migration of wash waters to pervious surfaces exists.

**Photo 23. AOI 10: Sheen on wash water**

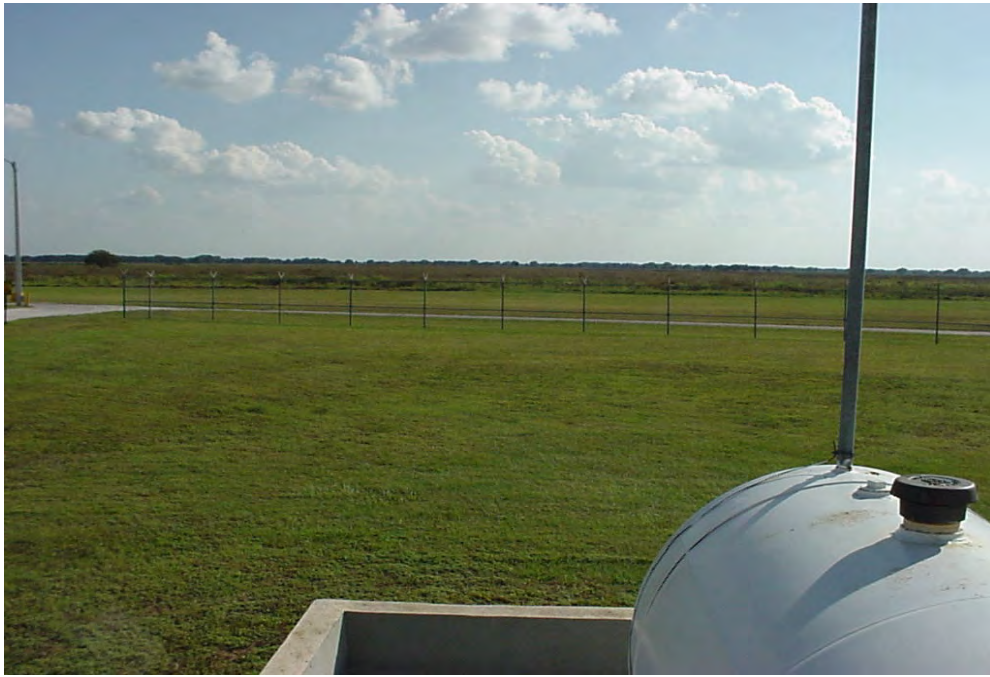
**Photo 24. AOI 11: 104 Acre Spray Field**

A 104-acre spray field is the WWTP effluent land application area (Photo 24). It is in a rectangular area south of the Firing Range, Auto Shop, west of DCI, and north of PRIDE pasture and agricultural fields (**Figure 2**). This is the area of concern for the Administrative Order regarding radionuclide contamination detailed in **Section 3.2**.

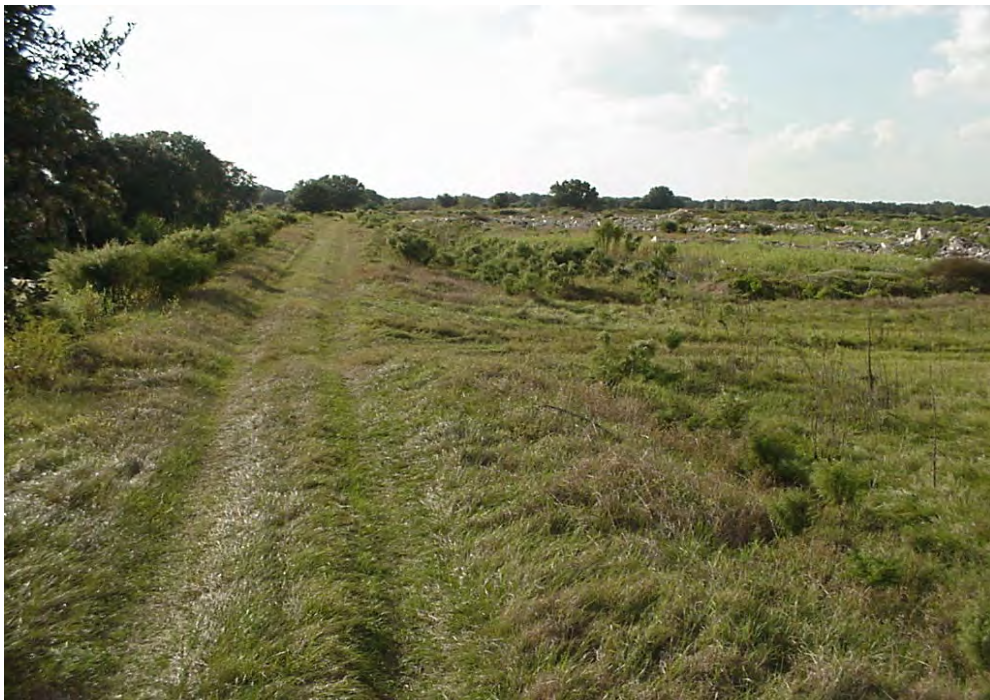
**Photo 25. AOI 13: Dumpsite**

A dump site is located in the southwest corner of the property. The perimeter road abuts the dumpsite to the south and west (Photo 25). The rim canal is located approximately 50 feet south and approximately 70 feet west of the

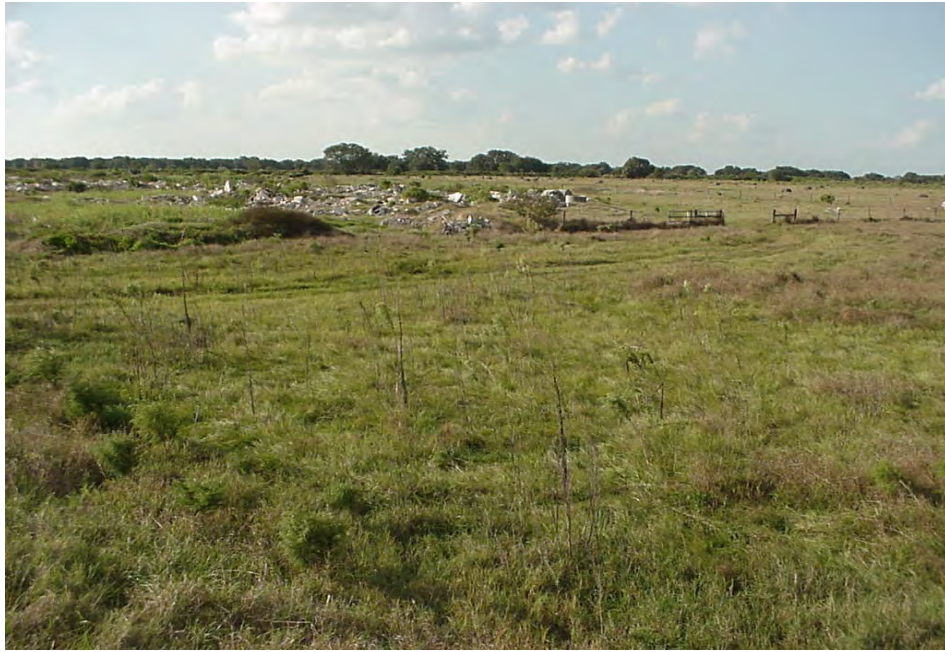
**Photo 26. AOI 13: Dumpsite**

Most of the dumpsite, visible through the vegetation, appeared to consist of building and demolition debris, construction materials, shingle, asphalt, concrete, soil piles, and scrap metal. Three blue, plastic 55-gallon drums were observed on their sides amongst the waste piles. It is not known if liquids, sludges and solid waste were disposed in this area. The dates of use for this facility are unknown. Mr. Montgomery stated that concrete debris was probably taken to this AOC as late as about four or five years ago. This site is the landfill indicated on the Site Screening Survey (**Section 3.2**) (Photos 26, 27, 28, and 29).

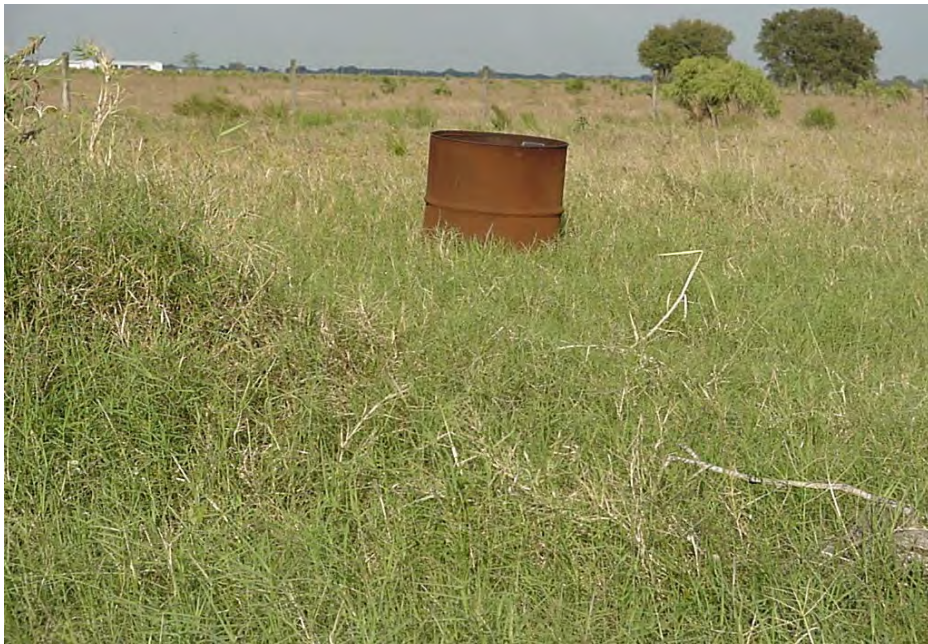
An empty rusty drum without a lid was observed on the northeast side of this. It is not known if the contents of the drum were deposited in the dumpsite.

**Photo 27. AOI 13: Rusty Drum**

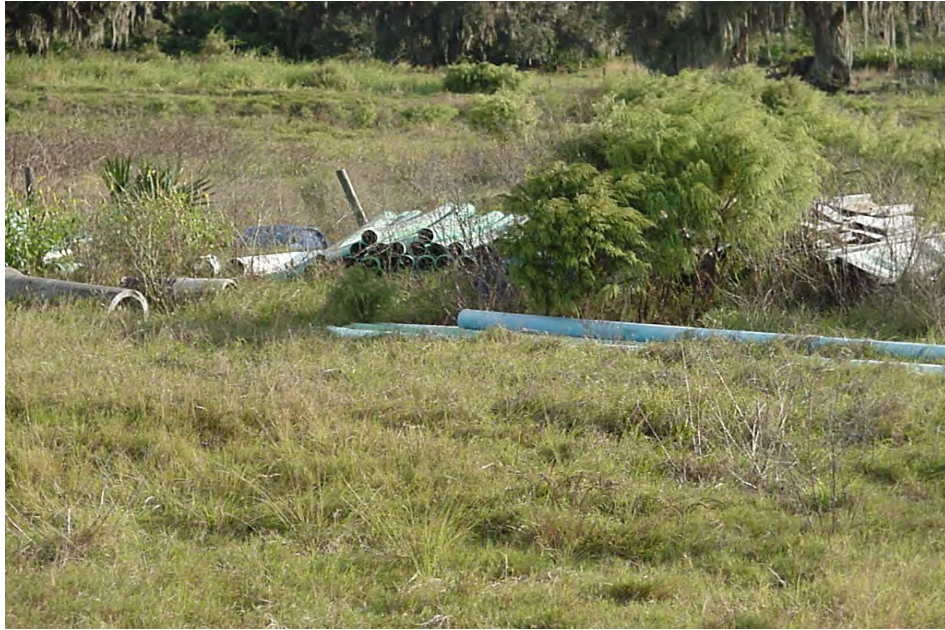
**Photo 28. AOI 13: Dumpsite; note drums on their sides.**

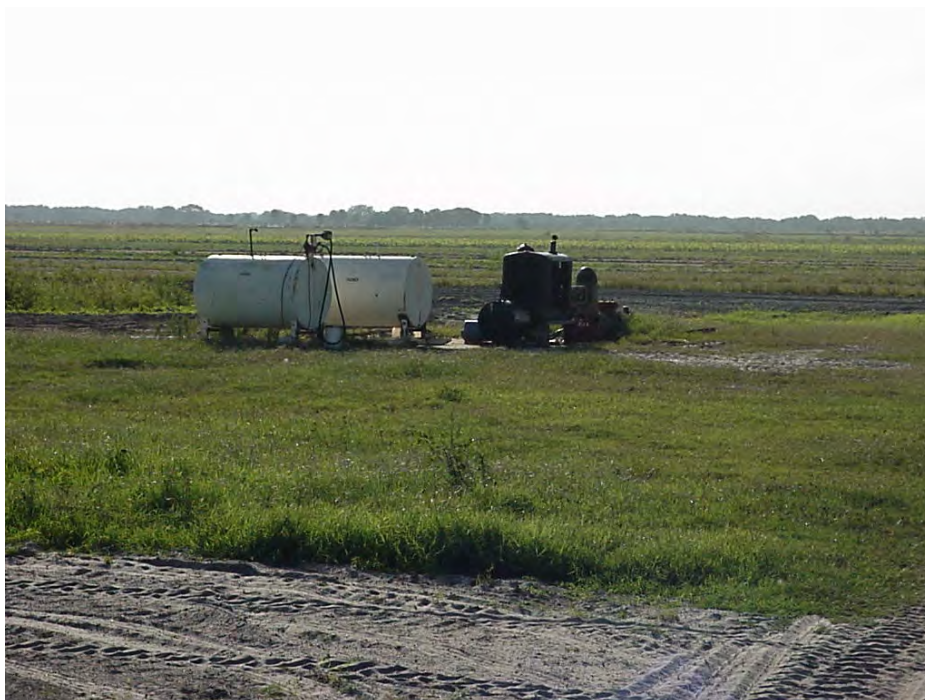
**Photo 30. AOI 14: (Typical) Irrigation Well and Diesel ASTs.**

DC maintains two irrigation wells onsite. The one observed was northeast of the Dump Site and directly south of the Farm Maintenance Area (AOI 15). The well is approximately 16-inches in diameter (Photo 30). A pump is connected to the well and the pump rate is not known. Two diesel ASTs and dispensers were located next to the well. No secondary containment is associated with these tanks. Soil staining was observed in this area.

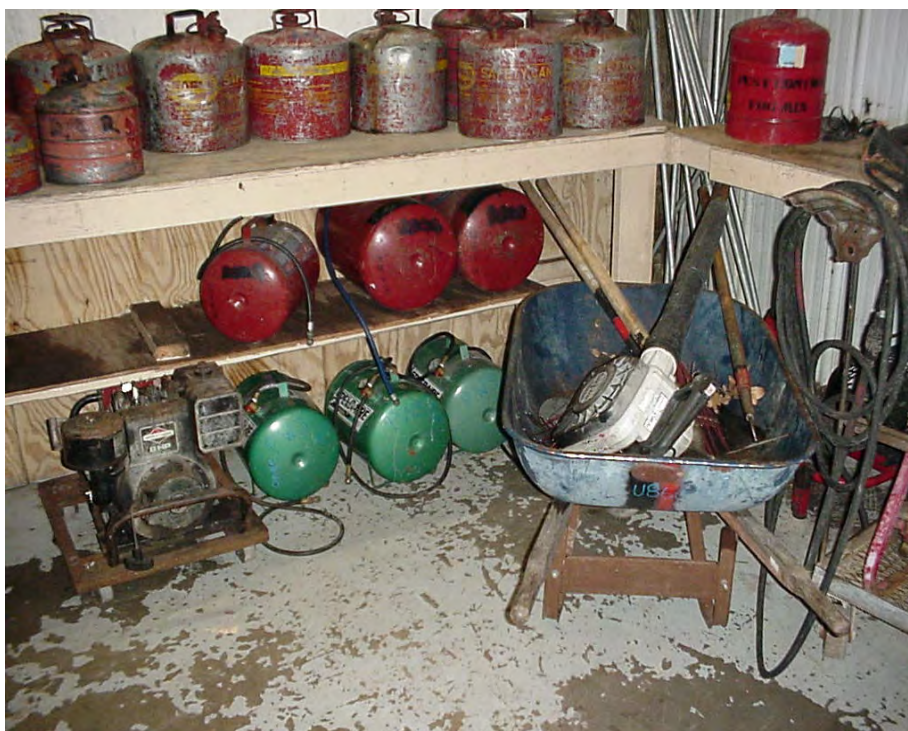
**Photo 31. AOI 15: Petroleum Storage in Farm Maintenance Building**

Petroleum storage (gasoline, motor oil, diesel, and hydraulic oil) is maintained at this facility on shelving in a locked room (Photo 31). The containers of petroleum ranged from empty to full. Petroleum staining was observed on some of the shelving. No staining was noted on the floor in the petroleum storage area. An empty pesticide fog can was located next to the gasoline cans.

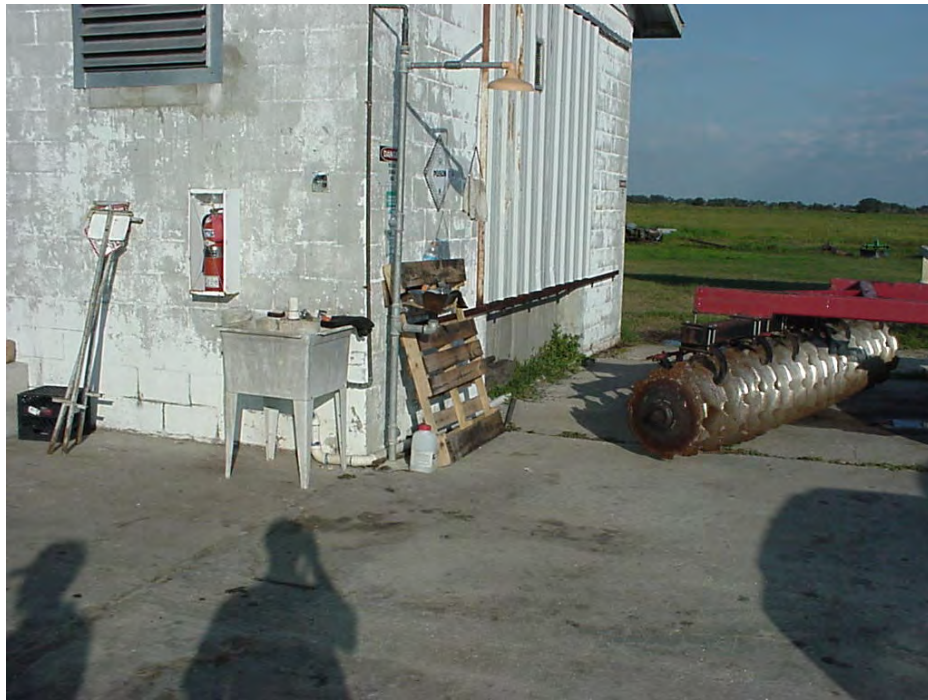
**Photo 32. AOI 16: Herbicide-Pesticide Mixing and Storage Area.**  
**Note: Sink, drain line, and puddle of liquid at east edge of concrete slab.**

The Pesticide and Herbicide Mixing/Storage Building is located on the southeast corner of the former livestock pens. It consists of cinderblock construction with a concrete floor. The building is placarded "Poison 6." A concrete slab extends approximately 20 feet south of the building. This slab is the chemical mixing area. Staining was observed on the concrete and around the joints and cracks in the slab (Photo 32).

A sink is mounted on the southwest corner of the Pesticide and Herbicide Mixing/Storage Building. The sink had a distinct chemical odor like that of pesticides. PVC pipe is plumbed from the sink's drain east along the south foundation of the building. The end of this pipe run is located at the eastern edge of the concrete slab. A pool of clear liquid with clouds of a milky white liquid was located under and east of the pipe end. This pool measured approximately 5 feet by 4 feet with a maximum depth of approximately ½-inch, and was located on the sandy soil. Stressed vegetation was noted around the puddle. Inmates were questioned about the sink's use. The inmates stated the sink is used to wash chemical scoops, measuring devices, personal protective equipment, hands and faces (Photo 32).

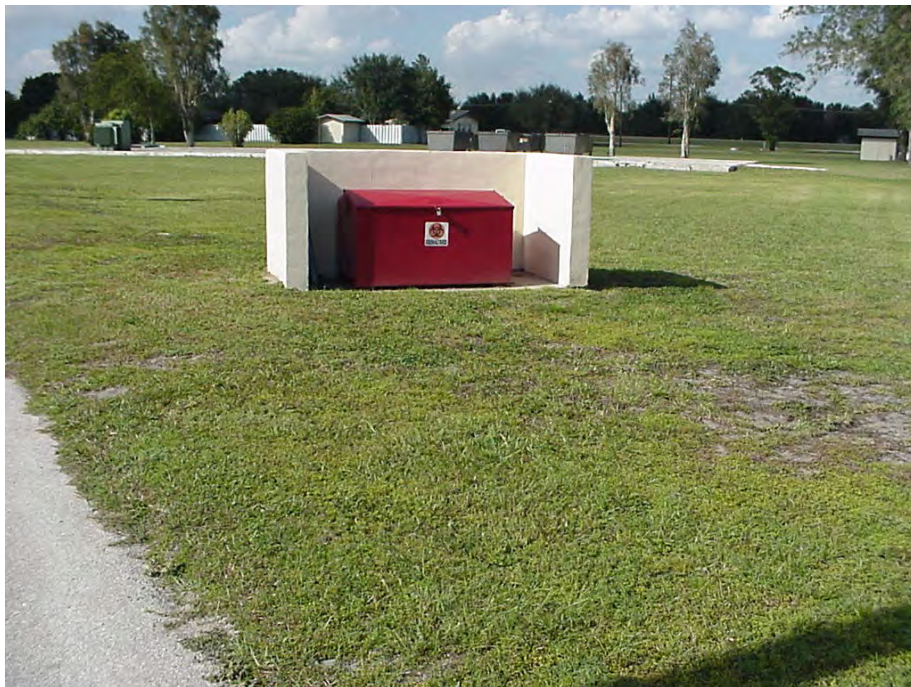
**Photo 33. AOI 17: Medical Waste Storage**

A dumpster for medical waste is located on a new concrete pad close to the DCI Main entrance (Photo 33). The dumpster is locked with a padlock. No staining was observed on, under or around the medical waste dumpster.
