CULTURAL RESOURCE ASSESSMENT SURVEY ADDENDUM DRAFT

State Road (S.R.) 70 Project Development and Environment (PD&E) Study

From West of S.R. 31 to SE Highlands County Line Road.

DeSoto County, Florida

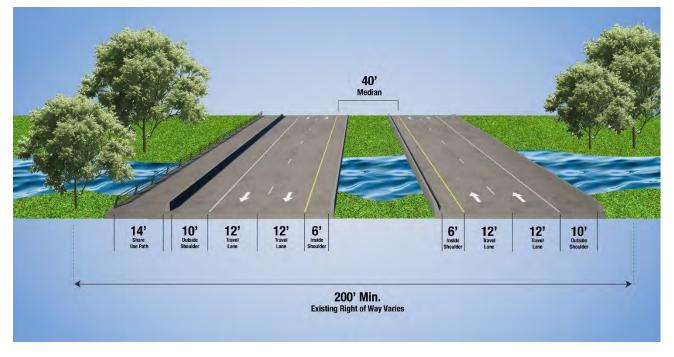
Figure 1-6. Preferred Alternative for S.R. 70 Bridges Over Whidden Creek and Joshua Creek.

The Preferred Alternative for the bridges over Whidden Creek and Joshua Creek (**Figure 1-6**) include four 12-ft travel lanes (two in each direction) with six-ft paved inside shoulders and 10-ft paved outside shoulders. Concrete barriers would be implemented on both shoulders. The westbound bridge will have a 14-ft shared use path with a concrete barrier separating pedestrian and bicycle users from the travel lane and a railing at the outside edge of the bridge. At Joshua Creek, the shared use path will switch from the north to the south side of S.R. 70 via a bicycle and pedestrian underpass under the reconstructed S.R. 70 bridges over Joshua Creek.

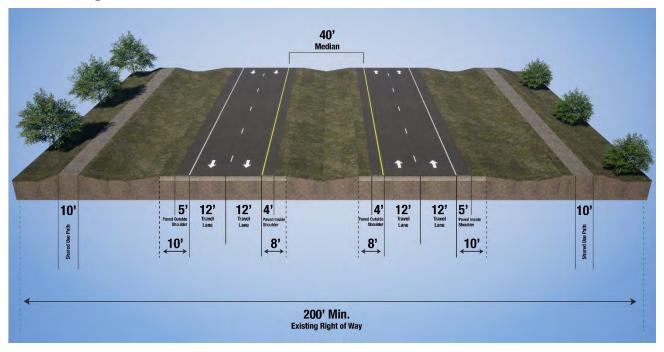
Figure 1-7. S.R. 70 Preferred Alternative from east of Joshua Creek to C.R. 760.

The Preferred Alternative east of Joshua Creek to C.R. 760 (**Figure 1-7**) features the construction of new westbound lanes to the north of the existing lanes, consisting of four 12-ft travel lanes (two in each direction) with an open median of 40 ft that includes 8-ft inside shoulders (4-ft paved), and 10-ft outside shoulders (5-ft paved). Between Joshua Creek and C.R. 760 two new 10-ft shared use paths will be constructed adjacent to both the northern and southern ROW lines. Along the north side of S.R. 70, the shared use path will end opposite the C.R. 760 intersection, while the shared use path adjacent to the southern ROW line will continue eastward.

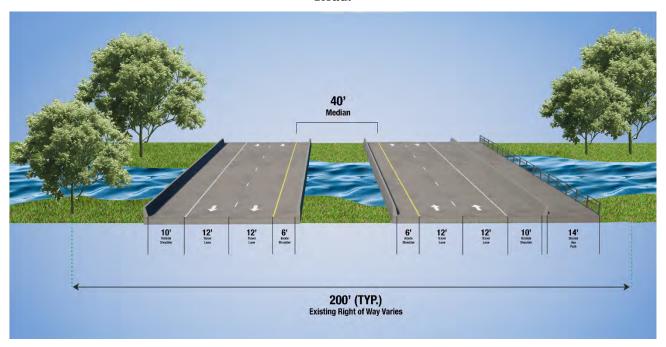
Figure 1-9. Preferred Alternative for S.R. 70 Bridges from C.R. 760 to SE Highlands County Line Road.

Between C.R. 760 and SE Highlands County Line Road, S.R. 70 has five additional bridge culvert crossings at Tiger Bay, Mossy Gully, DCI Canal, Long Point Marsh, and Parker Creek. The Preferred Alternative proposes new bridges (**Figure 1-9**) at each of these locations, including four 12-ft travel lanes (two in each direction) with 6-ft paved inside shoulders and 10-ft paved outside shoulders. Concrete barriers would be implemented on both shoulders. The eastbound bridge will have a 14-ft shared use path with a concrete barrier separating pedestrian and bicycle users from the travel lane and a railing at the outside edge of the bridge.

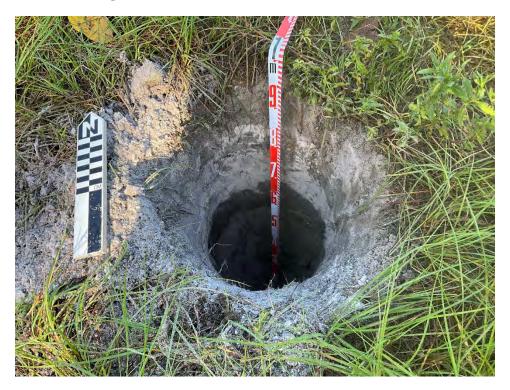
Figure 5-20. Profile from STP 5 in FPC 1001A.

The typical soil profile in the APE consisted of grey (10YR 5/1) sand to a depth of 40 cmbs (15.7 in), with grayish brown (10YR 5/2) sand to a depth of 100 cmbs (39.4 in). For an STP that terminated before 100 cmbs due to inundation a typical profile included grayish brown (10YR 5/2) sand to a depth of 40 cmbs, dark brown (10YR 3/3) sand to a depth of 60 cmbs, and yellowish brown (10YR 5/4) sand to 75 cmbs (**Figure 5-26** and **Figure 5-27**). The soils throughout the APE were poorly drained. Evidence of disturbance was noted in most of the pond sitings, mainly from drainage or irrigation activities, gravel roads, improvements for fields or crop cultivation, and active utilization for citrus groves or cattle pastures.

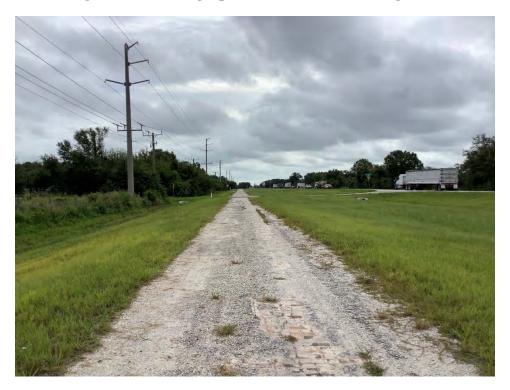
Figure 5-23. Photograph of 8DE00828 - 2, facing east.

Old SR 18 (8DE00828) is a 4.85-mi (7.81-km) previously recorded segment of a previously recorded resource group. The resource group is locally known as Mahon Avenue. Within the project area, the roadway is paved in areas and oriented east—west with a one-lane section that has low structural integrity on the western terminus of segment and throughout the eastern segment. The original brick paving can be seen in areas where the paving has worn away or is cracked. Portions of the roadway are overgrown by vegetation. A mix of residential and agricultural lots bound the roadway to the north (**Figure 5-25–Figure 5-28**).

The District previously recommended the resource eligible for listing in the NRHP, and the determination received concurrence from the DHR on October 16, 2025. 8DE00828 meets Criterion A in the areas of Transportation and Community Planning and Development and was constructed during the First World War era along with the construction of Dorr Airfield east of Arcadia. It was also part of the Coast to Coast Highway, connecting the west coast of Florida to the east coast of the state. Additionally, the brick construction conveys the development of roads throughout the state. It does not meet Criterion B, since there are no associations with significant persons. It is not eligible under Criterion C, as the existing historical materials are heavily damaged by traffic and lack of maintenance. 8DE00828 is not eligible under Criterion D, as it does not possess the potential to provide further information of historical importance.

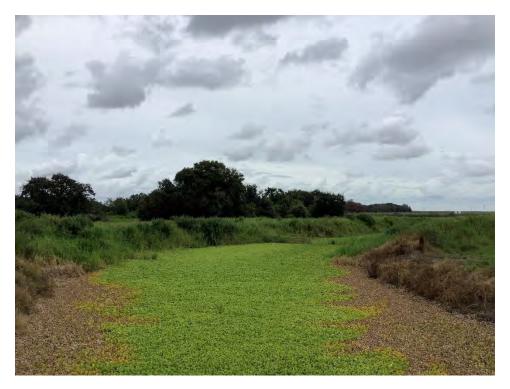
Figure 5-26. Photograph of 8DE00858 - 1, facing north.

DCI Canal (8DE00858) is a previously recorded 309.55-ft (94.35-m) segment of a linear resource that connects to Mossy Gully. Within the project area, 8DE00858 is a northwest–southeast oriented canal measuring 61 ft (19 m) in width. The canal is a deep earthen channel with grassy embankments that show evidence of being sprayed with herbicide (**Figure 5-29** and **Figure 5-30**). Within the project area, the canal runs beneath S.R. 70 (8DE01154), which is carried by FDOT Bridge No. 040033 (8DE00859). Proposed ponds SMF 1004A and FPC 1003A are to the east of this historic resource.

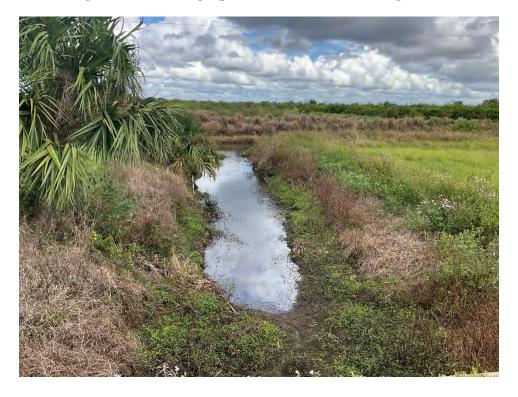
Figure 5-29. Photograph of 8DE01299 - 2, facing south.

The Long Point Marsh Canal (8DE01299) is a 646.44 ft (197.04 m) segment of a newly recorded linear resource that connects Long Point Marsh in the north with Cow Slough to the south. Within the project area, 8DE01299 is a northwest-southeast oriented canal ranging in in width from 20 ft (6.33 m) to 40 ft (12.19 m). The canal is constructed of excavated earth with uneven grassy embankments treated with herbicide (**Figure 5-31** and **Figure 5-32**). The canal runs beneath S.R. 70 (8DE01154), which is carried by FDOT Bridge No. 040037, within the project area. The proposed FPC 1009A will be adjacent to this resource.

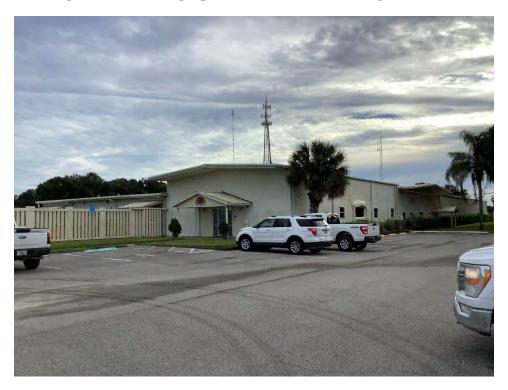
Figure 5-37. Photograph of 8DE01207 – 1, facing northeast.

12010 NE Highway 70 (8DE01207) is a previously recorded historical structure with Industrial Vernacular style. Built in 1970, 8DE01207 is a one-story, irregular-shaped plan office building set on a concrete slab foundation. The shallow intersecting-gable roof is topped with 5V crimp metal, and the walls are clad in corrugated metal. The main entry is centered on the west façade and consists of a glazed metal door with flanking sidelights. It is within a gable extension supported by metal posts. An additional entrance is centrally located on the south elevation. The south elevation also features a gable extension covering the entrance. Fenestration includes individual vinyl-framed single-hung-sash windows with one-over-one configuration and vinyl framed fixed windows with pointed arch headers. There are two additions on the north elevation. Both date to circa 1995. A paved parking lot abuts the building to the south (**Figure 5-40–Figure 5-44**). Proposed SMF 1005C-1L pond is adjacent to this resource.

The District recommends that **8DE01207** is ineligible for listing in the NRHP. It is not eligible under Criteria A or B, as no significant historical associations are known. The resource is not eligible under Criterion C due to its lack of architectural distinction. It is not eligible under Criterion D because it lacks the potential to yield further information of historical importance.
