PRELIMINARY ENGINEERING REPORT

Florida Department of Transportation
District One

**US 98 (Peace River – Ft Meade) at Bridge No 160064 (John
Singletary Bridge)
From west of Edgewood Drive to east of the
Fort Meade Recreation Area Entrance
Polk County, Florida**

ETDM No.: 14114
Financial Project ID: 434886-1-22-01
Federal Aid Project No.: 1801-006-P

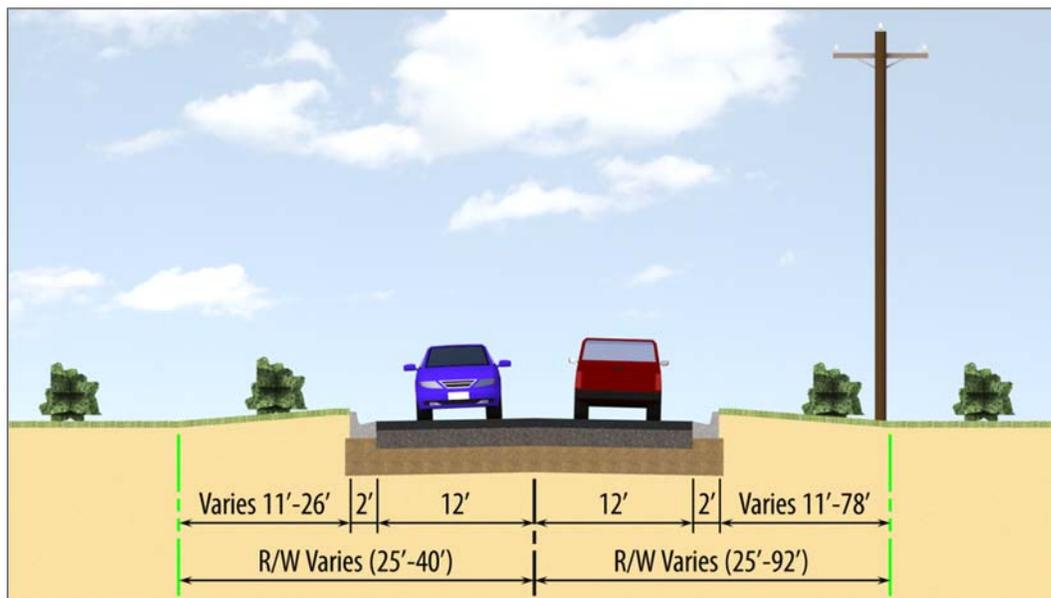
FIGURE 2-1: EXISTING ROADWAY TYPICAL SECTION

The existing roadway typical section is an urban, two-lane undivided roadway with 12-foot wide travel lanes and type F curb and gutter. There are no bicycle lanes or sidewalks. The posted speed limit is 40 mph from Washington Avenue to the west end of the bridge, 35 mph across the bridge, and 45 mph from the east end of the bridge to the Fort Meade Recreation Area entrance. The existing design speed is 35 mph from Washington Avenue to approximately 400 feet east of Edgewood Drive (Sta. 89+00). The design speed then changes to 45 mph to the end of the project. A typical section of the existing roadway is provided on **Figure 2-1**.

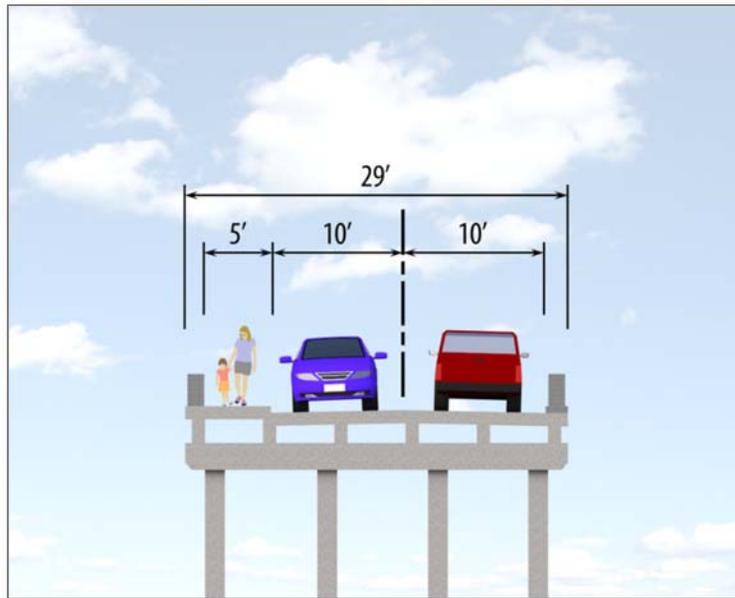
FIGURE 2-2: EXISTING BRIDGE TYPICAL SECTION

The existing bridge typical section includes two 10-foot wide travel lanes, an approximately five-foot wide raised sidewalk located on the north side, and a narrow seven-inch curb on the south side. The overall bridge width is 29 feet with no skew. There are no shoulders and the posted speed limit across the bridge is 35 mph. A typical section of the existing bridge is provided on **Figure 2-2**.

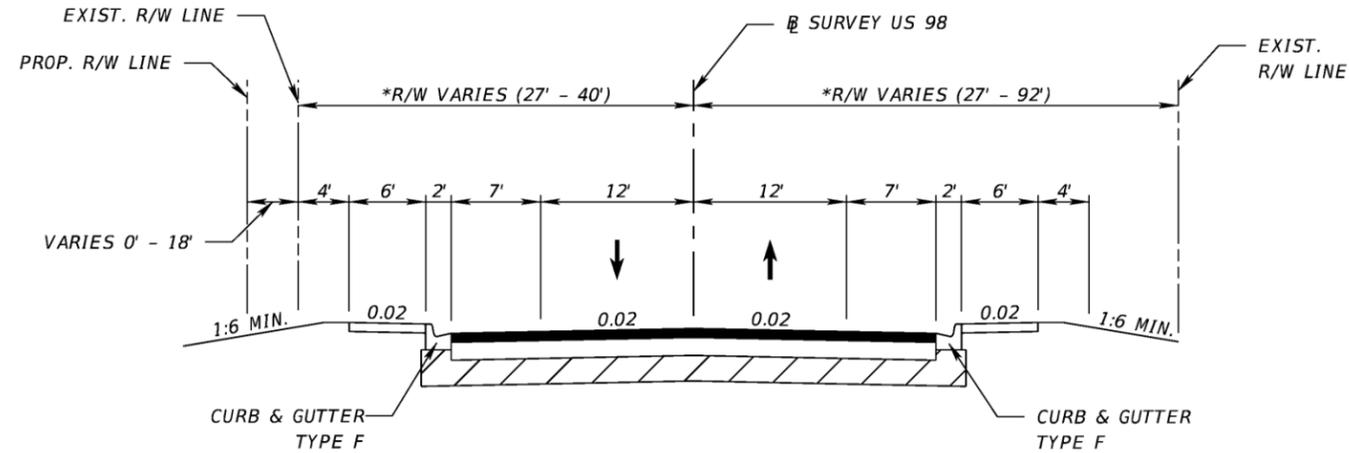
SECTION WITH 6' SIDEWALK ON BOTH SIDES OF THE ROADWAY

- Provides bicycle lanes and sidewalks on both sides of the roadway
- R/W impacts to adjacent properties on both sides of the roadway

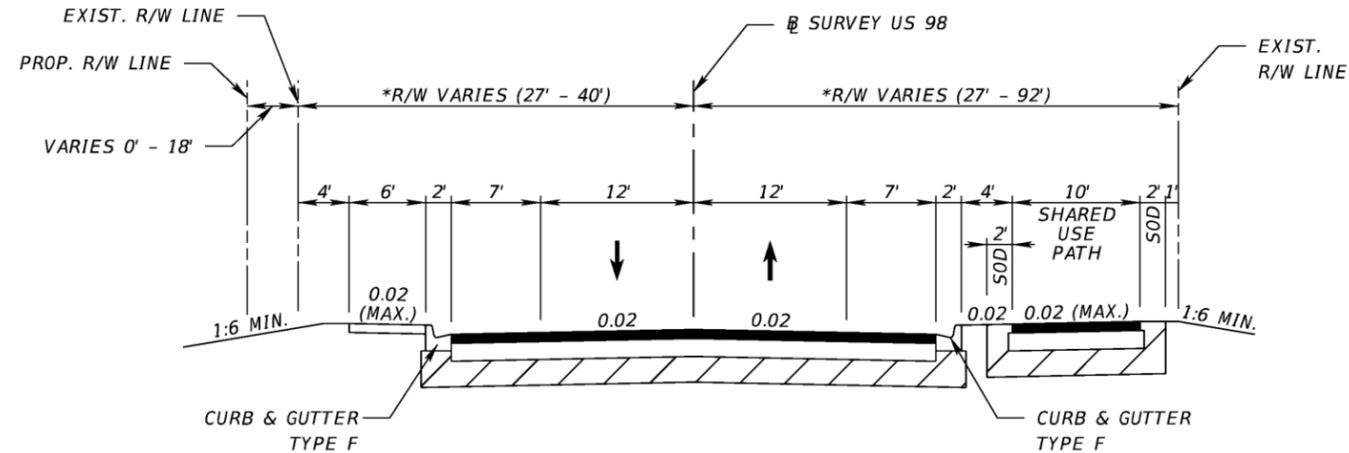
SECTION WITH SHARED USE PATH ON SOUTH SIDE OF THE ROADWAY

- Provides bicycle lanes and sidewalks on both sides of the roadway
- R/W impacts to adjacent properties
- More impervious area
- Provides shared use path that ties into the trail project
- More maintenance
- May facilitate the use of golf carts on the shared use path

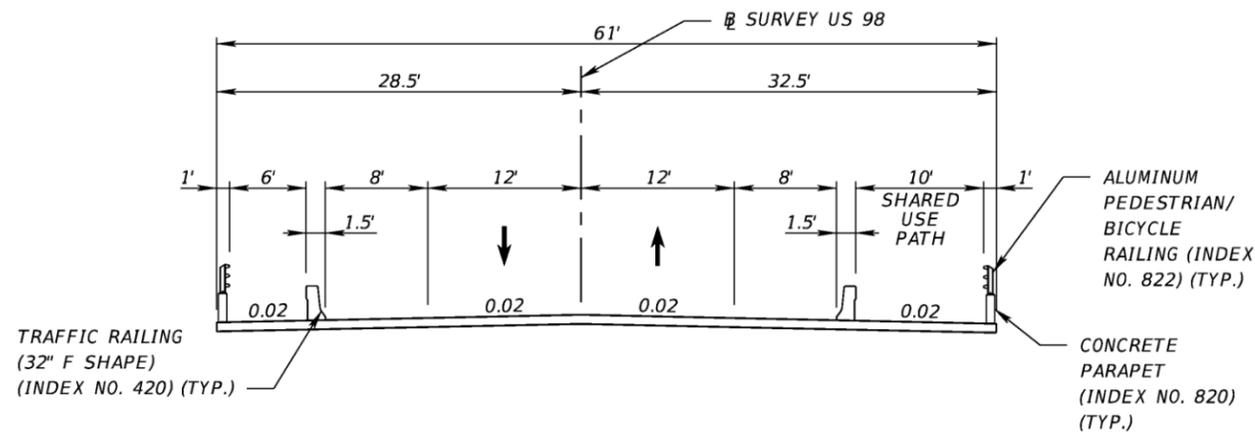
BRIDGE SECTION WITH TRAFFIC RAILING AND SIDEWALK ON NORTH SIDE AND WITH TRAFFIC RAILING AND 10' WIDE SHARED USE PATH ON SOUTH SIDE

- Provides bicycle lanes and sidewalks on both sides of the bridge
- Barrier wall provides a buffer between the bridge and sidewalk/shared use path
- Provides shared use path that ties into the trail project

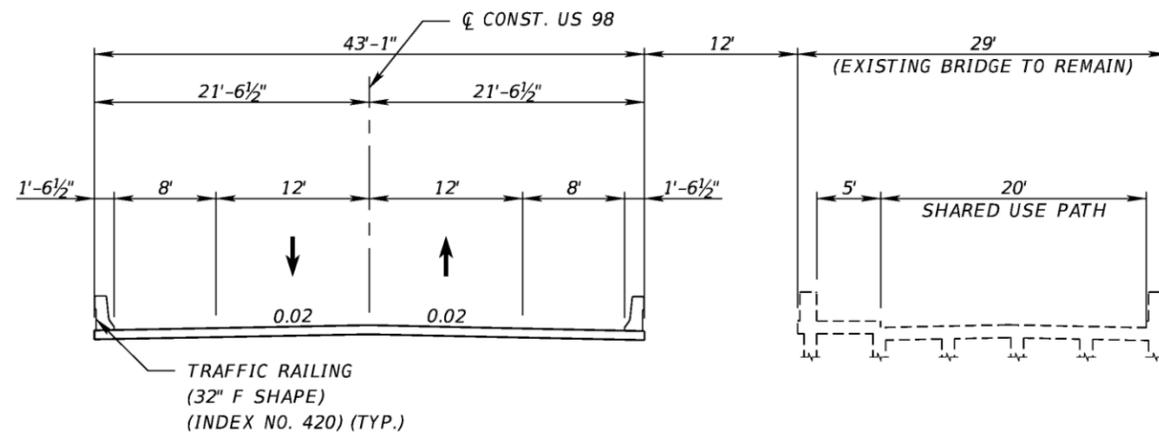
EXISTING BRIDGE TO REMAIN AS SHARED USE PATH, PROPOSED BRIDGE SECTION WITH BIKE LANES AND NO SIDEWALKS

- Provides bicycle lanes on both sides of the bridge
- Keeps the existing bridge as a shared use path that ties into the trail project

- R/W impacts to adjacent properties
- The existing bridge will need to be maintained
- No sidewalks will be present on the proposed bridge; no north side connection between sidewalks
- The proposed bridge will need to be widened in the future to accommodate sidewalks if the existing bridge can no longer be used

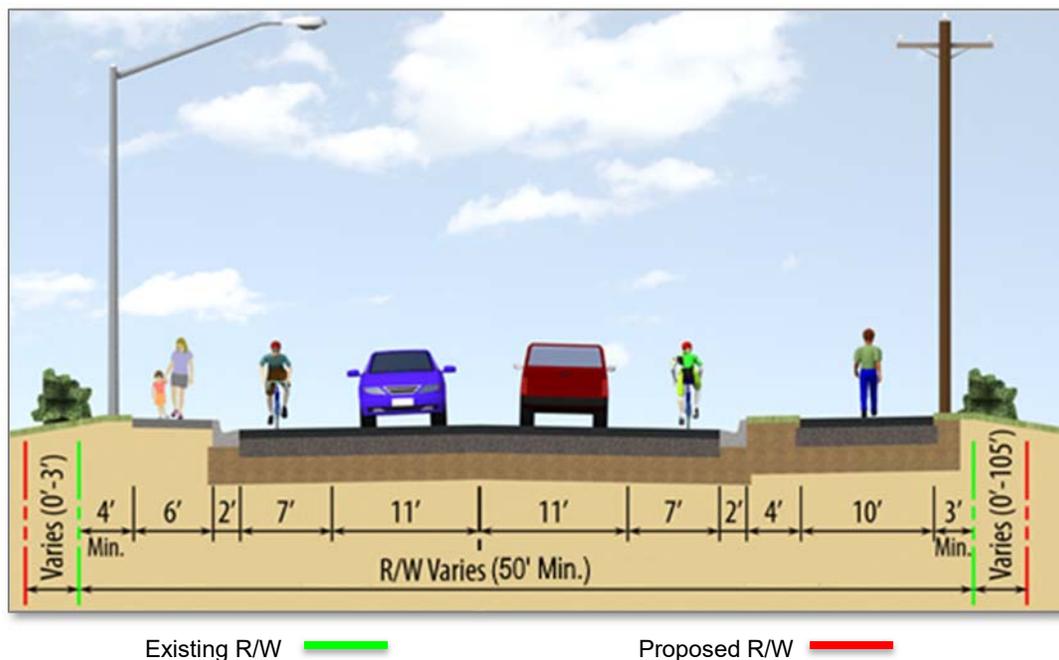
FIGURE 4-1: BUILD ALTERNATIVE 1 - ROADWAY TYPICAL SECTION

The roadway typical section for Build Alternative 1, from west of Edgewood Drive to east of the Fort Meade Recreation Area entrance, is an undivided urban section with two 11-foot wide travel lanes, seven foot wide buffered bicycle lanes, a six foot wide sidewalk on the north side of the road and a 10-foot wide shared use path on the south side of the road, as shown in **Figure 4-1**. The total R/W width needed for this roadway typical section varies with a 50-foot minimum width.

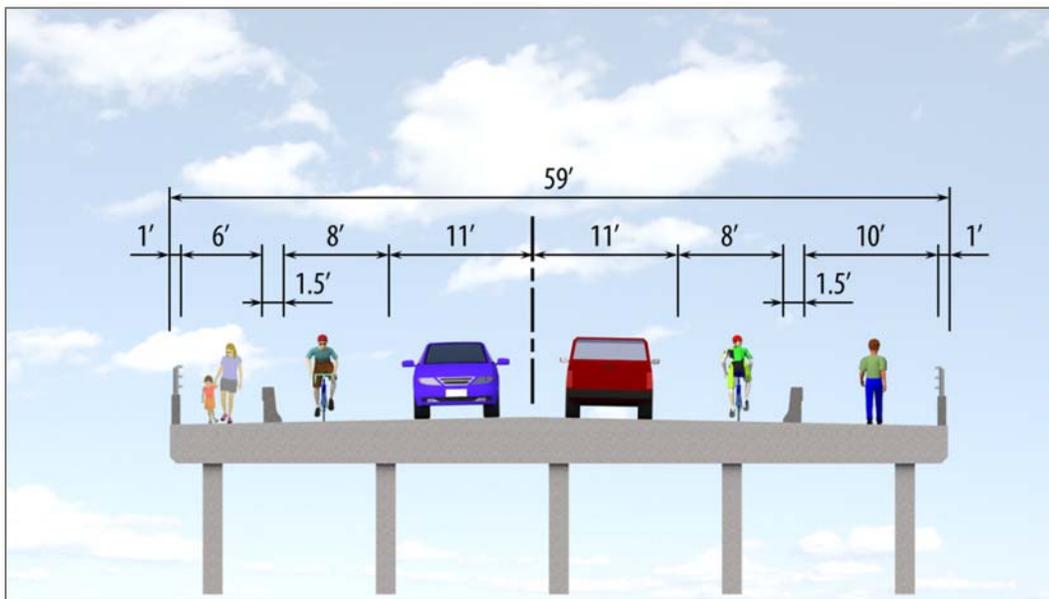
FIGURE 4-2: BUILD ALTERNATIVE 1 - BRIDGE TYPICAL SECTION

The bridge typical section for Build Alternative 1 is undivided with two 11-foot wide travel lanes, eight-foot wide shoulders/buffered bicycle lanes, a six-foot wide sidewalk on the north side of the bridge, and a 10-foot wide shared use path on the south side of the bridge, as shown in **Figure 4-2**. The proposed bridge is 600 feet long with a total bridge width of 59 feet. Traffic railings (FDOT Design Standards Index 420) will separate the sidewalk and shared use path areas from the traffic and bicycle lanes and concrete parapets (FDOT Design Standards Index 820) with aluminum pedestrian/bicycle railings (FDOT Design Standards Index 822) at each fascia. As an option to satisfy any aesthetic requirements of the local community, architecturally adorned pedestrian / bicycle railings designed with similar geometric characteristics of the existing railing can be at the fascia.

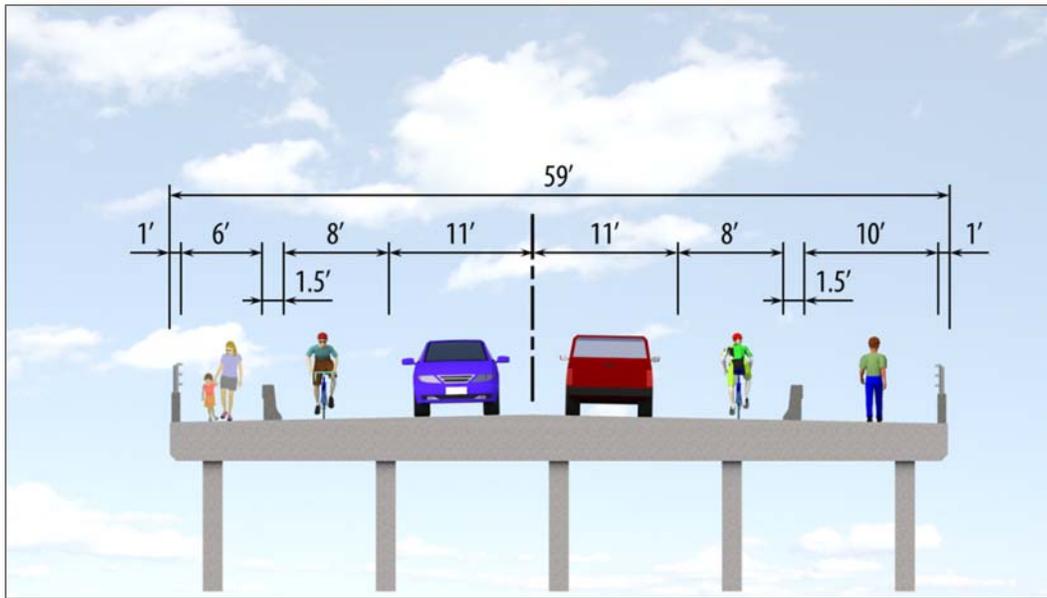
FIGURE 4-4: BUILD ALTERNATIVE 2 - BRIDGE TYPICAL SECTION

The bridge typical section for Build Alternative 2 is undivided with two 11-foot wide travel lanes, eight-foot wide shoulders/buffered bicycle lanes, a six-foot wide sidewalk on the north side of the bridge, and a 10-foot wide shared use path on the south side of the bridge, as shown in **Figure 4-4**. The proposed bridge is approximately 600 feet long with a total bridge width of 59 feet. Traffic railings (FDOT Design Standards Index 420) will separate the sidewalk and shared use path areas from the traffic and bicycle lanes and concrete parapets (FDOT Design Standards Index 820) with aluminum pedestrian/bicycle railings (FDOT Design Standards Index 822) at each fascia. As an option to satisfy any aesthetic requirements of the local community, architecturally adorned pedestrian/bicycle railings designed with similar geometric characteristics of the existing railing can be used at the fascia.

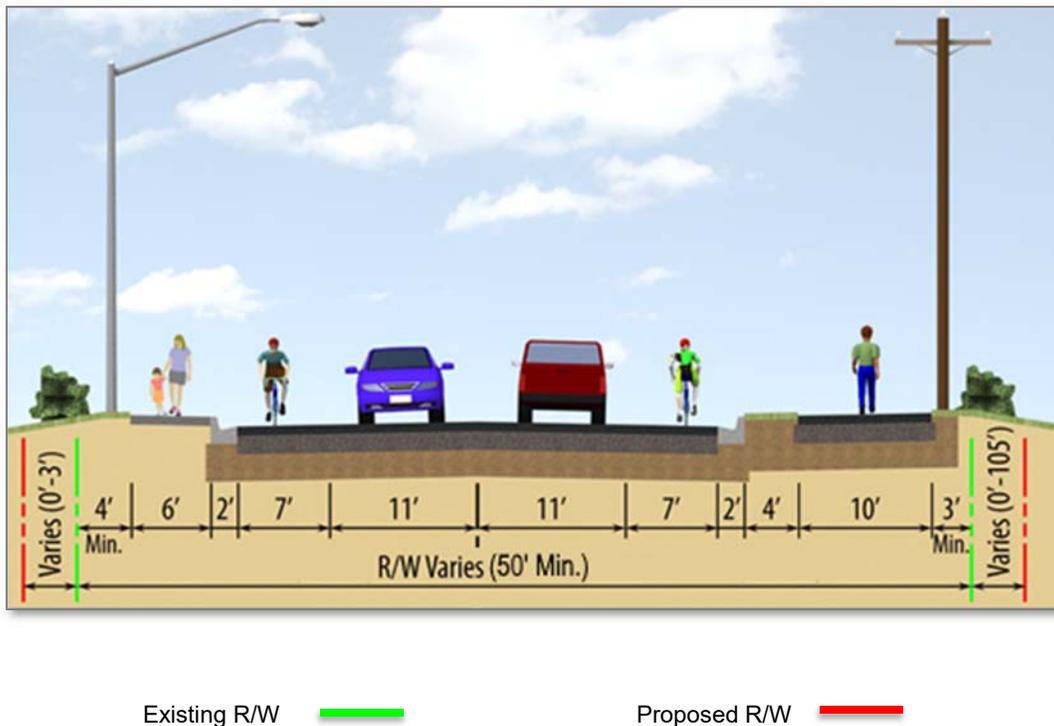
FIGURE 4-5: BUILD ALTERNATIVE 3 - ROADWAY TYPICAL SECTION

In addition to the proposed roadway improvements between Edgewood Drive and the Fort Meade Recreation Area entrance, a six-foot wide sidewalk will be added between Washington Avenue and Edgewood Drive to connect the proposed pedestrian improvements with the existing sidewalk that currently ends west of Washington Avenue.

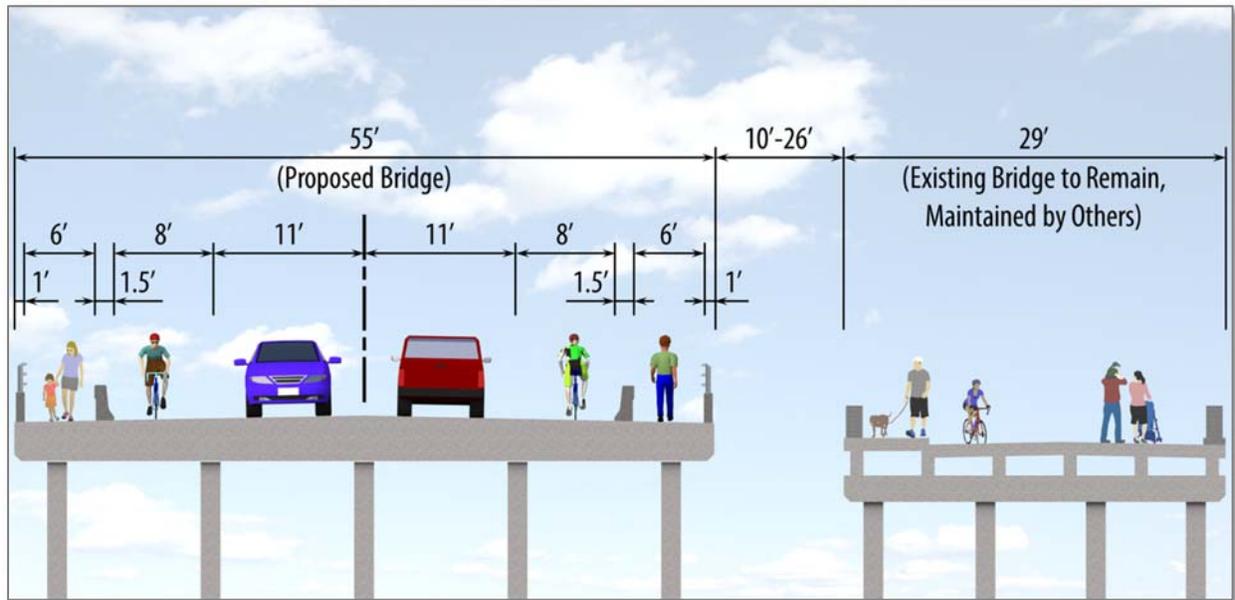
FIGURE 4-6: BUILD ALTERNATIVE 3 - BRIDGE TYPICAL SECTION

- Creates a safety concern for pedestrian connectivity between the City of Fort Meade and the Fort Meade Recreation Area. This would separate the southern community's access to use the existing bridge as a pedestrian facility and the need to cross the road at two different locations.

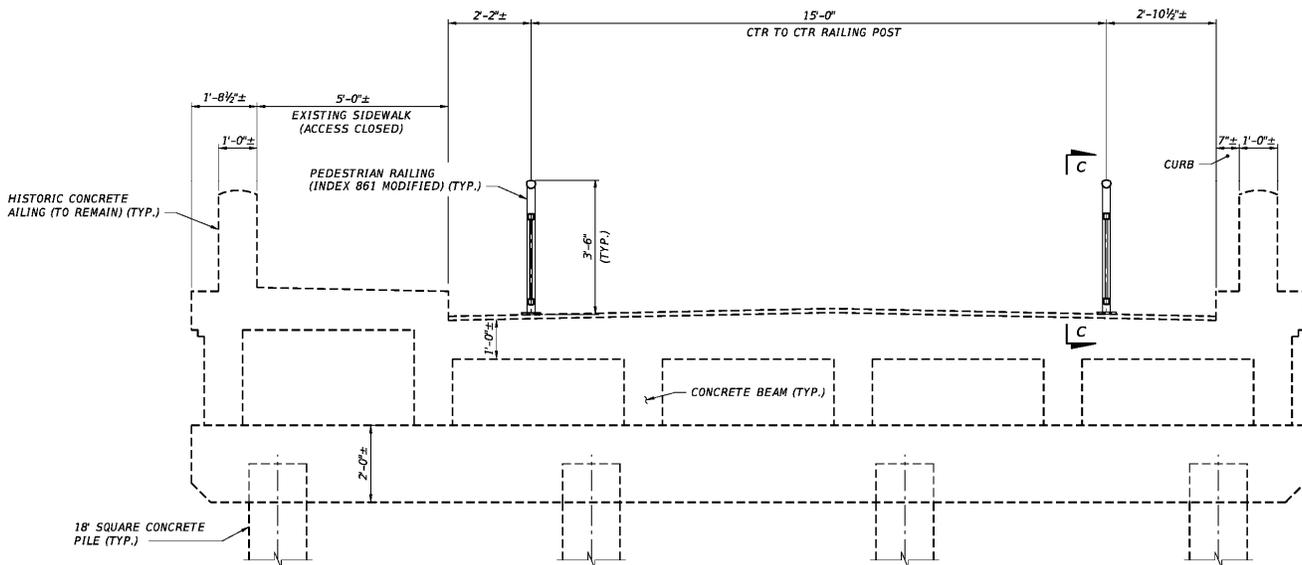
FIGURE 4-7: BUILD ALTERNATIVE 3 – EXISTING BRIDGE TO REMAIN

It is intended to rehabilitate the existing bridge and re-purpose it as a shared use path for pedestrian and bicycle use only. Bollards would be installed at the approaches to prevent vehicular access. Also access to existing sidewalk on the north side would be restricted. The proposed rehabilitation of the existing bridge will include:

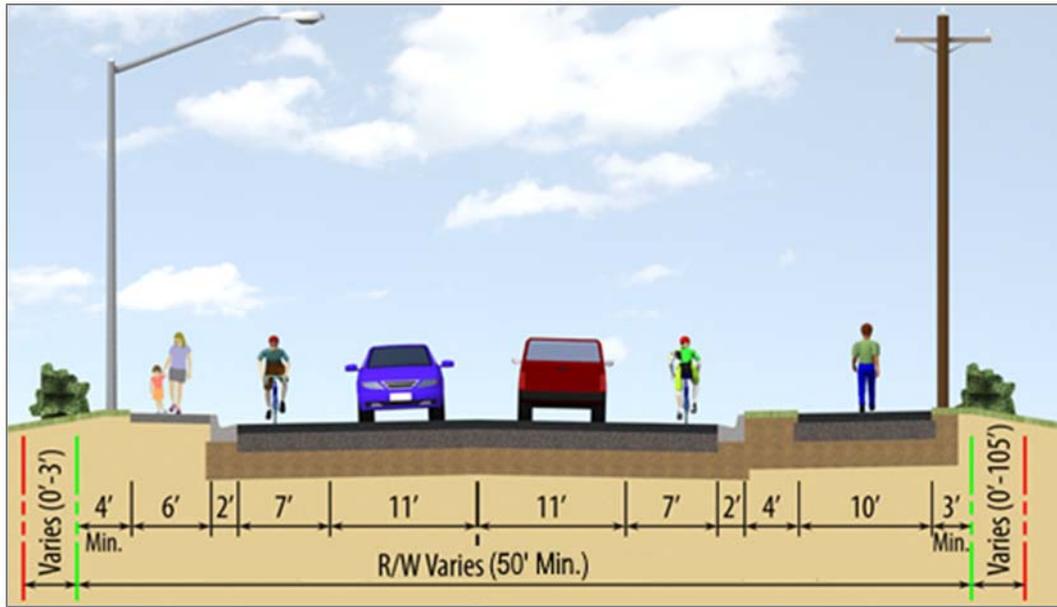
FIGURE 6-1: PREFERRED ALTERNATIVE ROADWAY TYPICAL SECTION

The proposed roadway typical section is an undivided urban typical section with two 11-foot wide travel lanes, seven-foot wide buffered bicycle lanes, a six-foot wide sidewalk on the north side of the road and a 10-foot wide shared use path on the south side of the road. This typical section has variable borders and a 45 mph design speed to be constructed within a minimum of 50 feet of R/W, as shown in **Figure 6-1**.

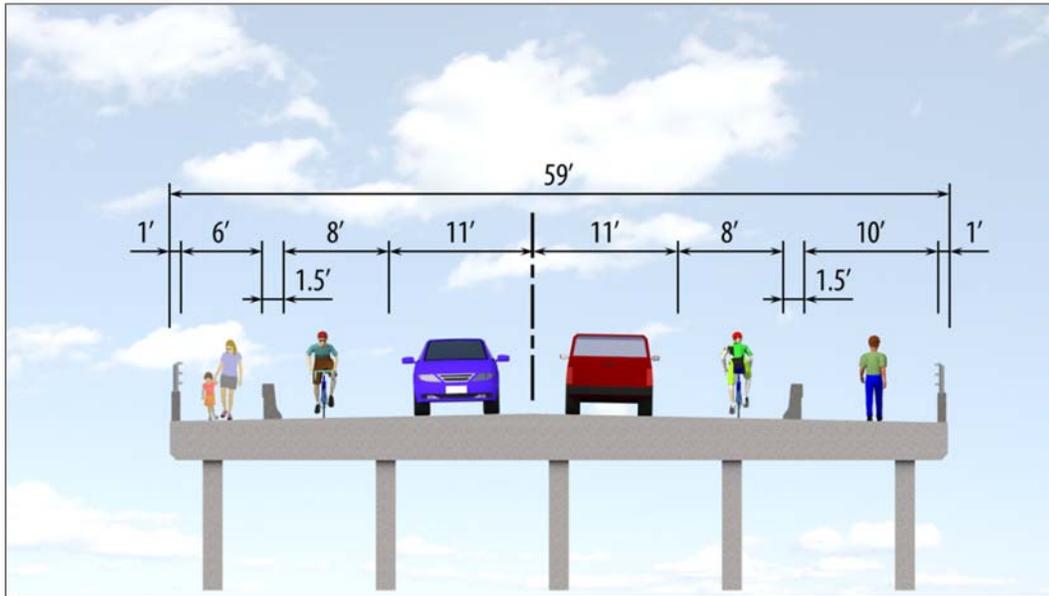
Figure 6-2: Preferred Alternative Bridge Typical Section

of the bridge. Traffic railings will separate the sidewalk and shared use path from the traffic and the paved should, as shown in **Figure 6-2**.

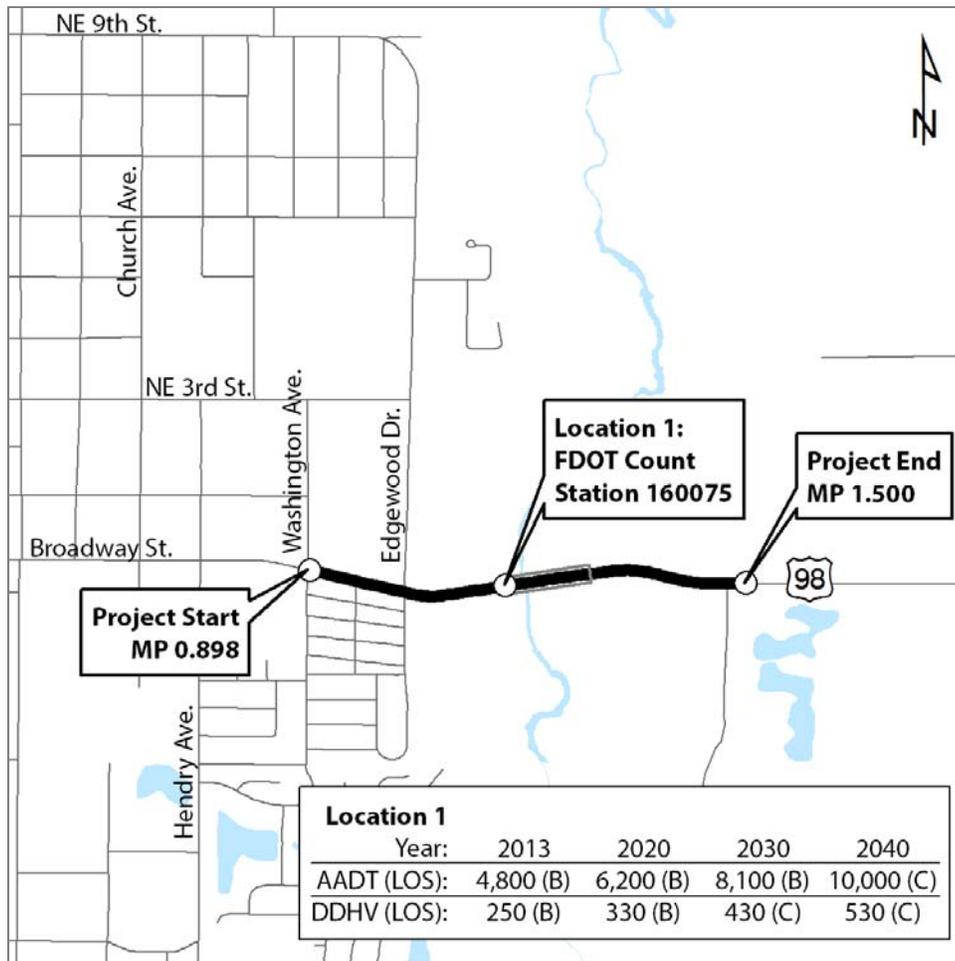
FIGURE 6-1: TRAFFIC PROJECTIONS AND LEVEL OF SERVICE

Figure 6-1, **Table 6-1**, and **Table 6-2** show the level of service analysis for US 98 during the daily and peak hour peak direction conditions. From the tables, US 98 is anticipated to operate at an acceptable level of service (LOS) through the design year (2040) under daily and peak hour peak direction conditions.

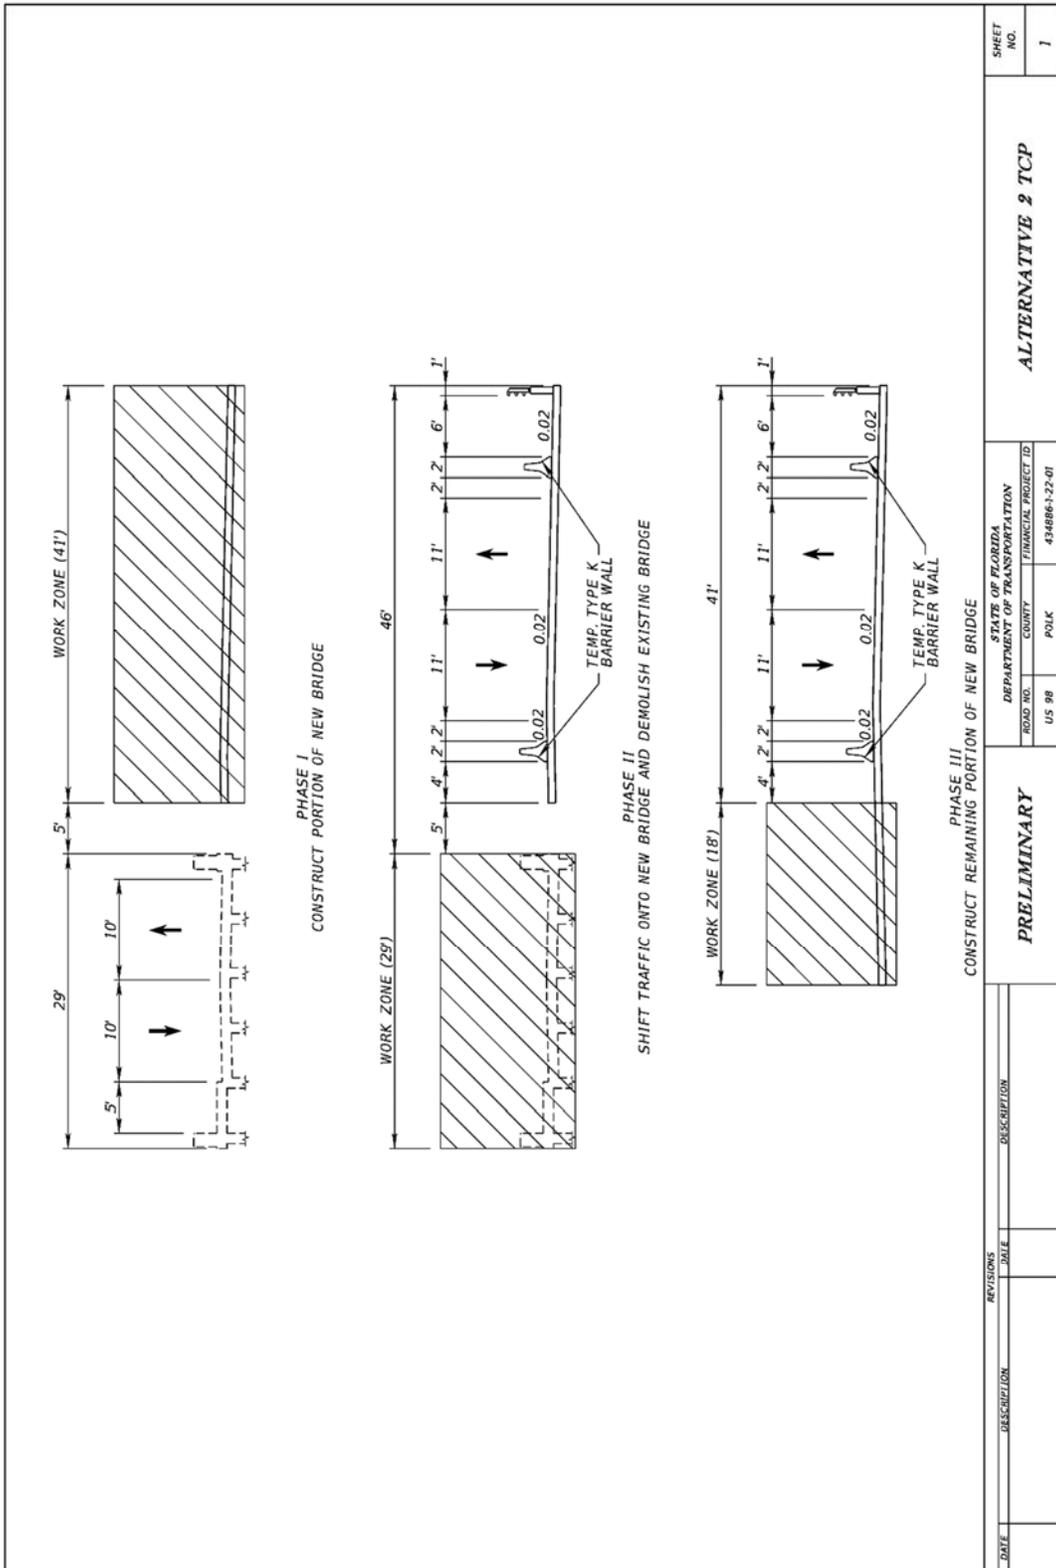
FIGURE 6-2: TEMPORARY TRAFFIC CONTROL PLAN FOR THE PREFERRED ALTERNATIVE

During Phase III construction, the remainder of the proposed bridge will be built, and the lanes configured for the final layout.

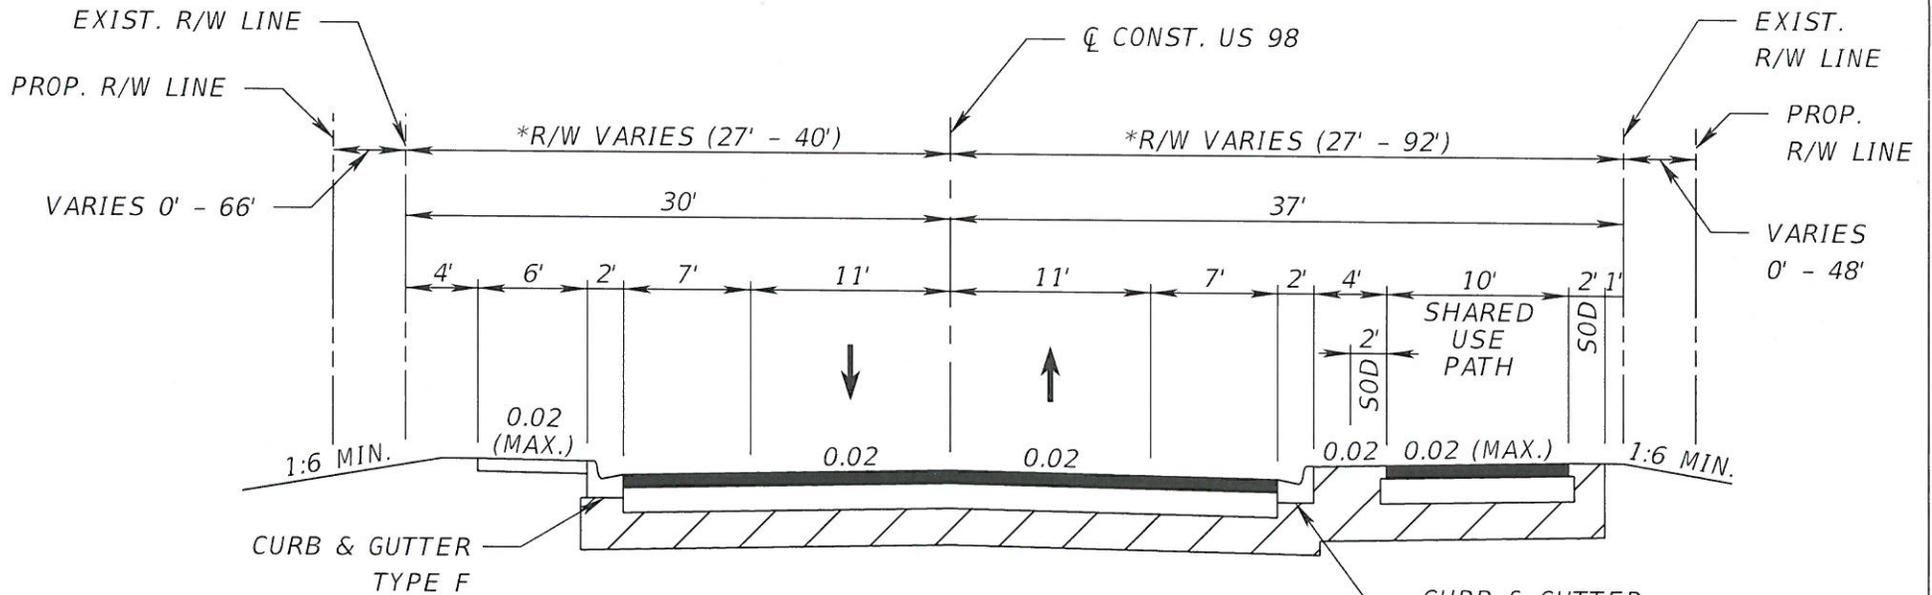
PROPOSED ROADWAY TYPICAL SECTION

*STATION RANGE	*TOTAL EXISTING R/W WIDTH
77+50.00 TO 84+70.13	50' EXIST. R/W
84+70.13 TO 87+14.99	100' TO 132' EXIST. R/W
87+14.99 TO 92+65.00	58' EXIST. MAINTAINED R/W
98+05.00 TO 109+87.00	54' EXIST. MAINTAINED R/W

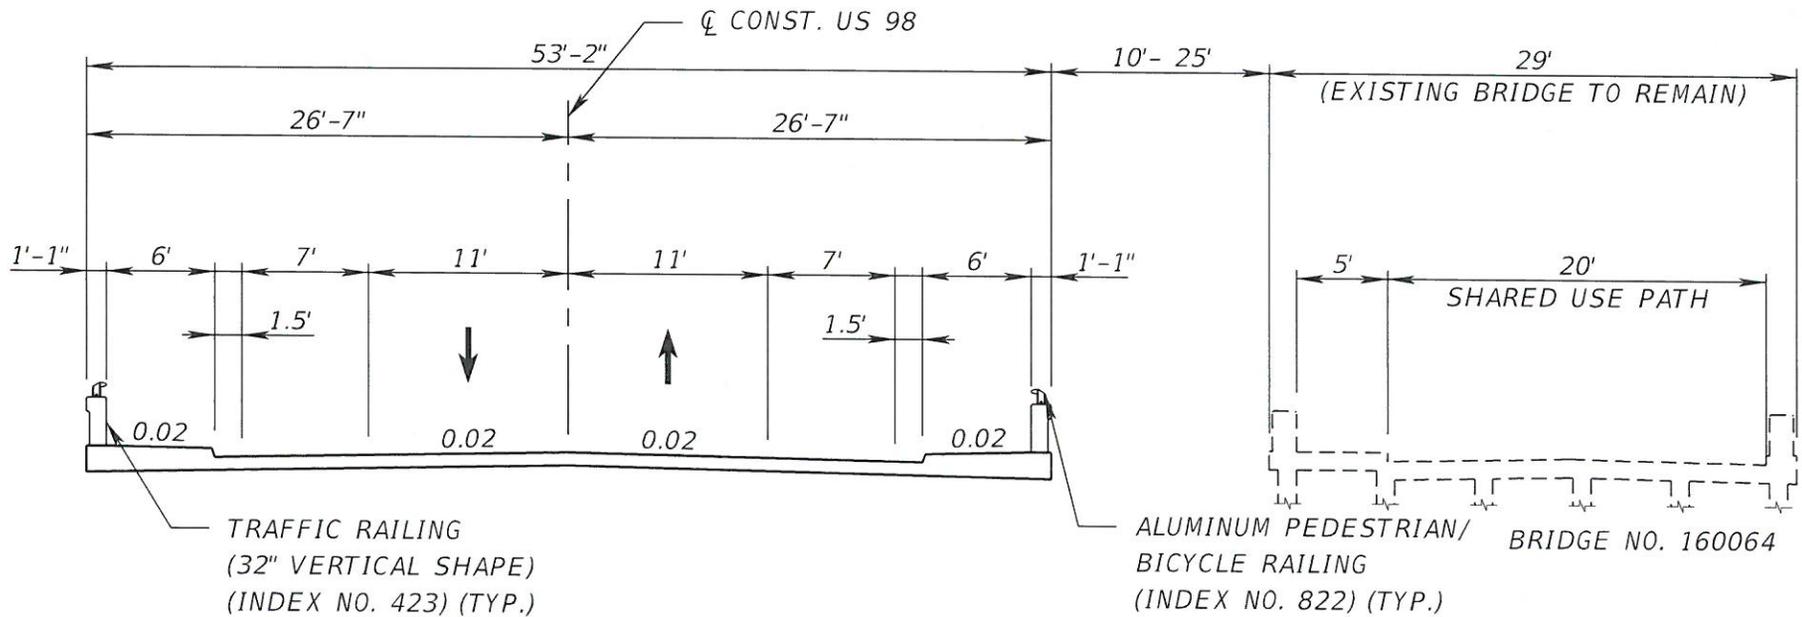
PROPOSED BRIDGE TYPICAL SECTION (EXISTING BRIDGE TO REMAIN OPTION)

STA. 92+60.00 TO STA. 98+07.00
 DESIGN SPEED = 45 MPH

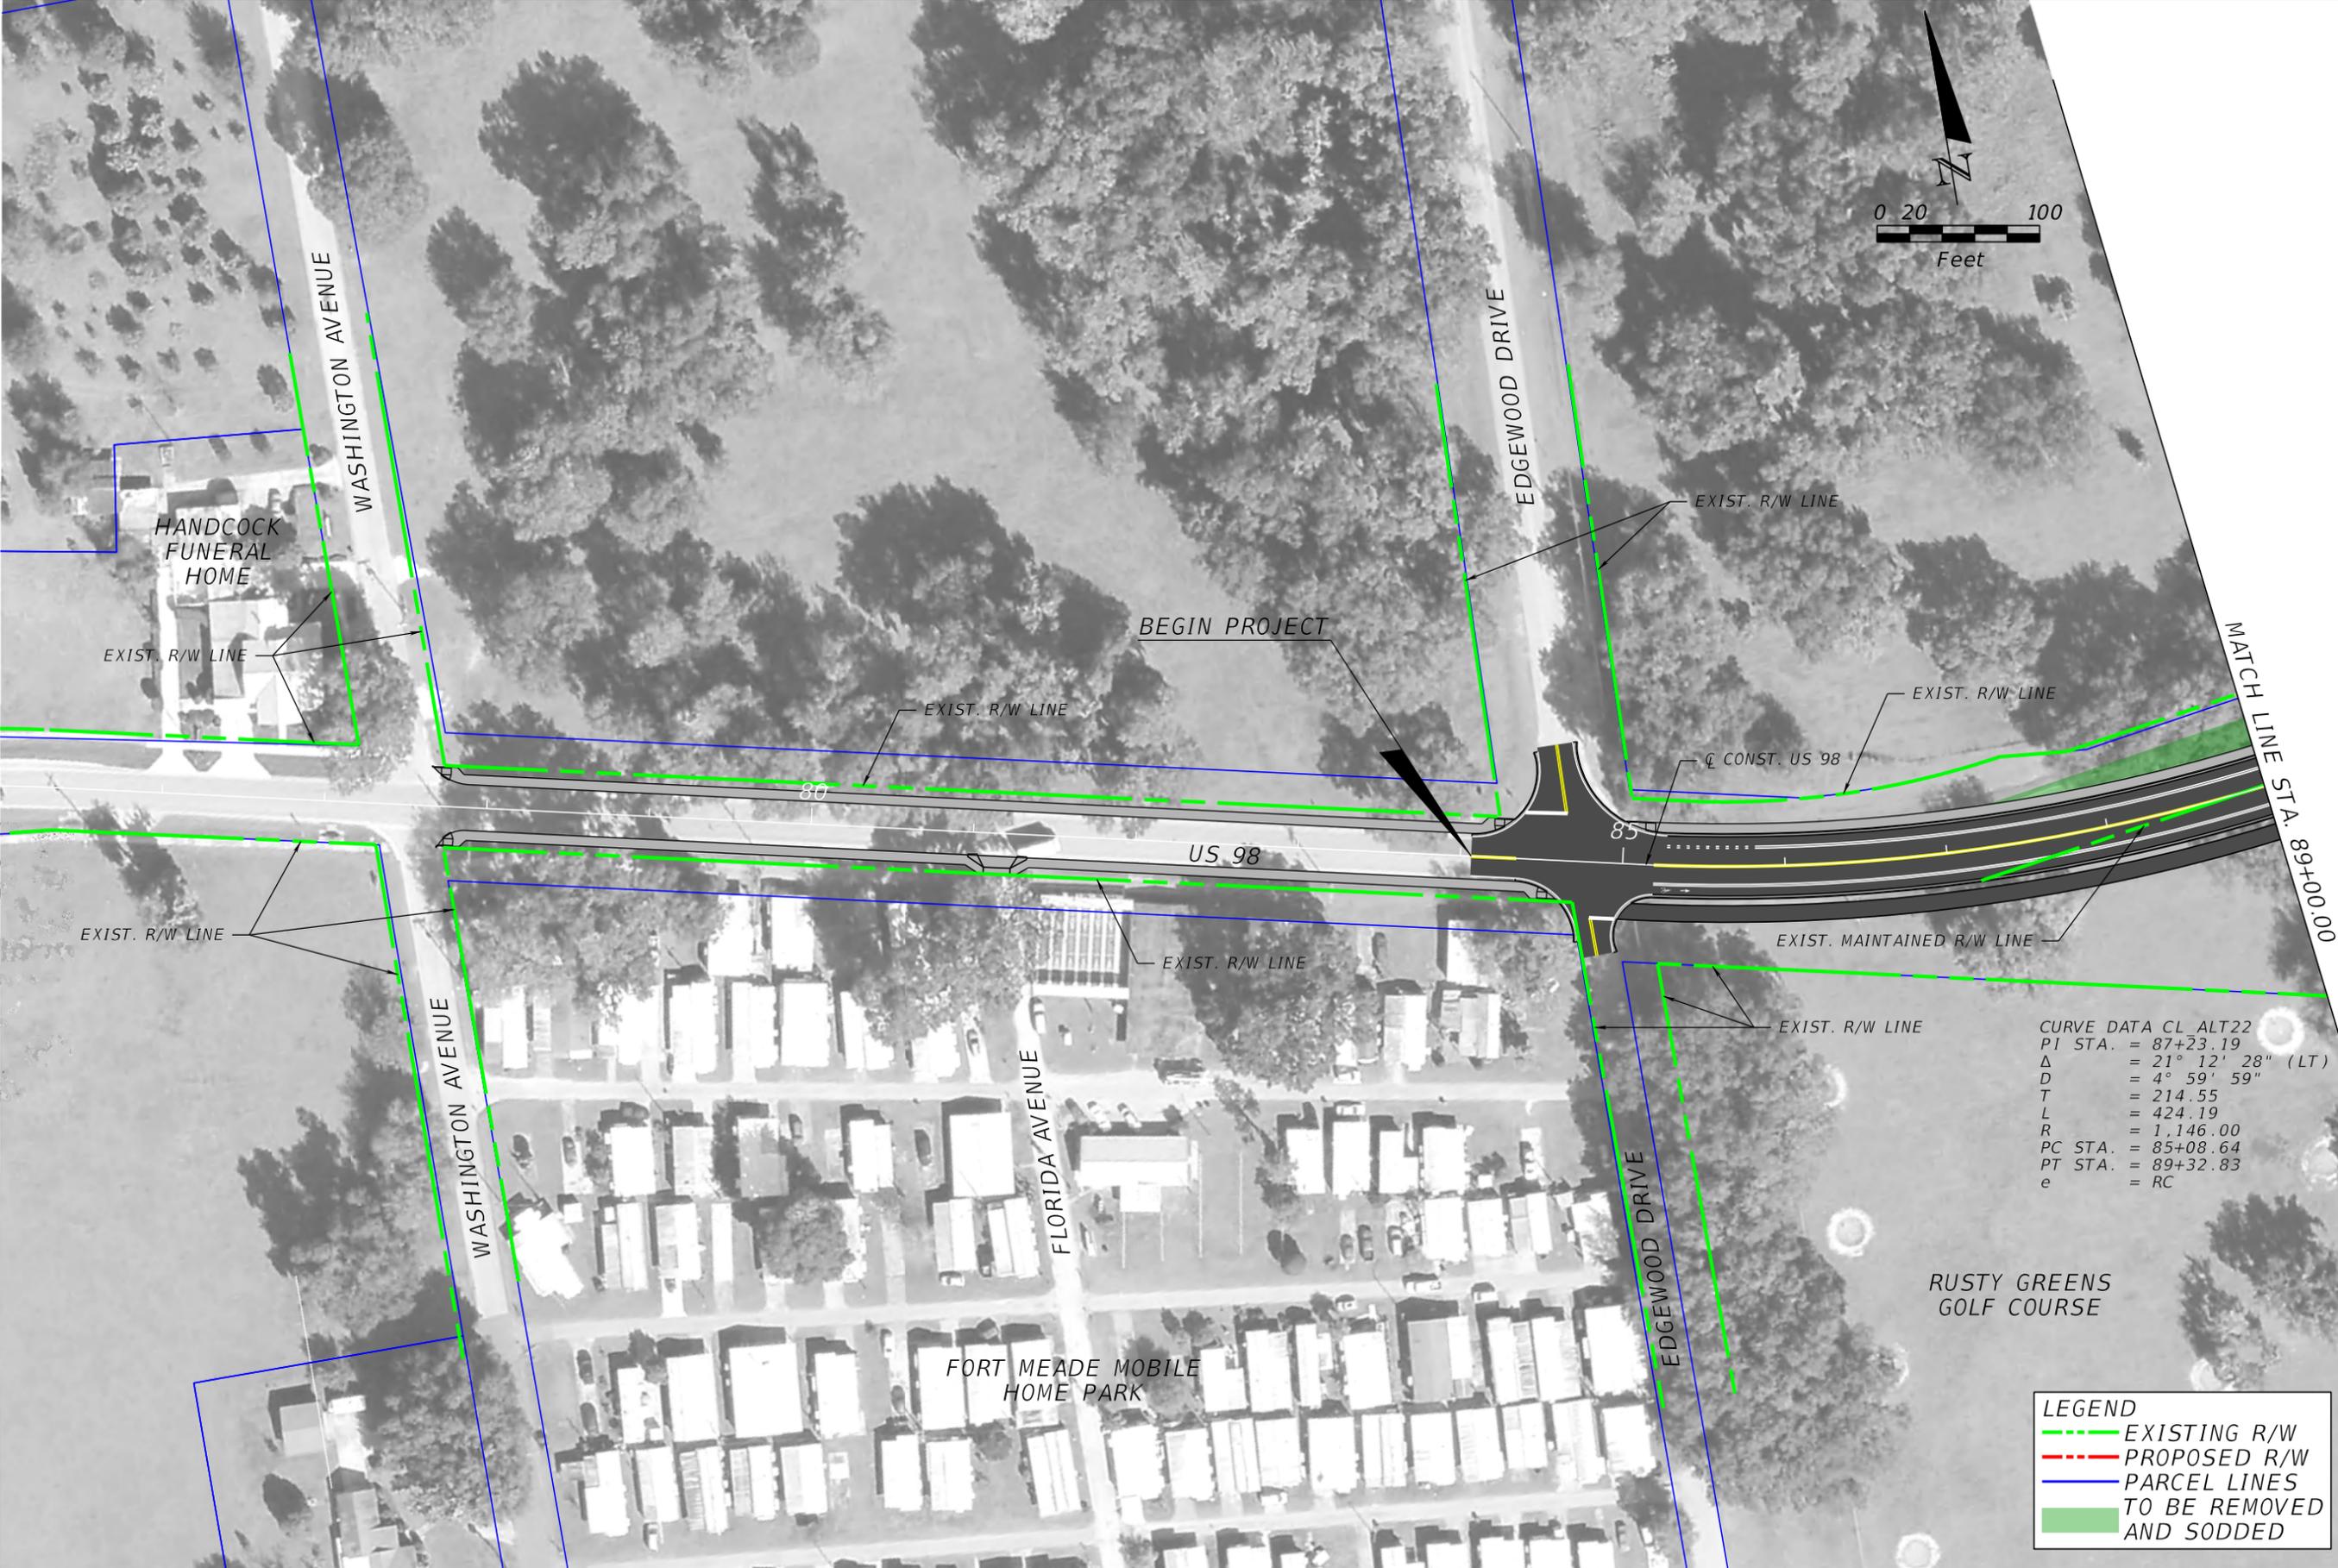
PREFERRED ALTERNATIVE CONCEPTUAL PLANS

CURVE DATA CL ALT22
 PI STA. = 87+23.19
 Δ = 21° 12' 28" (LT)
 D = 4° 59' 59"
 T = 214.55
 L = 424.19
 R = 1,146.00
 PC STA. = 85+08.64
 PT STA. = 89+32.83
 e = RC

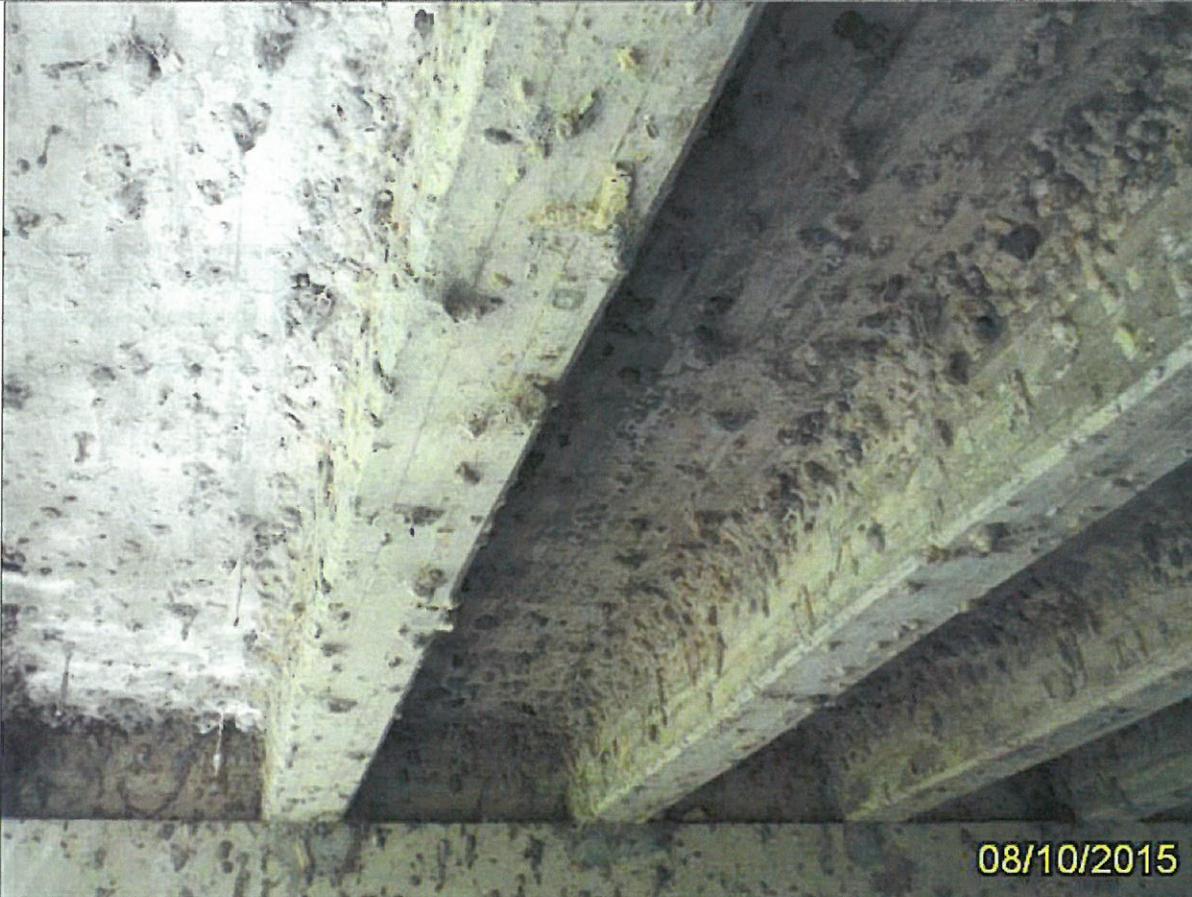
Photo 1 - Elements 13 Unp Conc Deck/AC Ovl & 110 R/Conc Open Girder

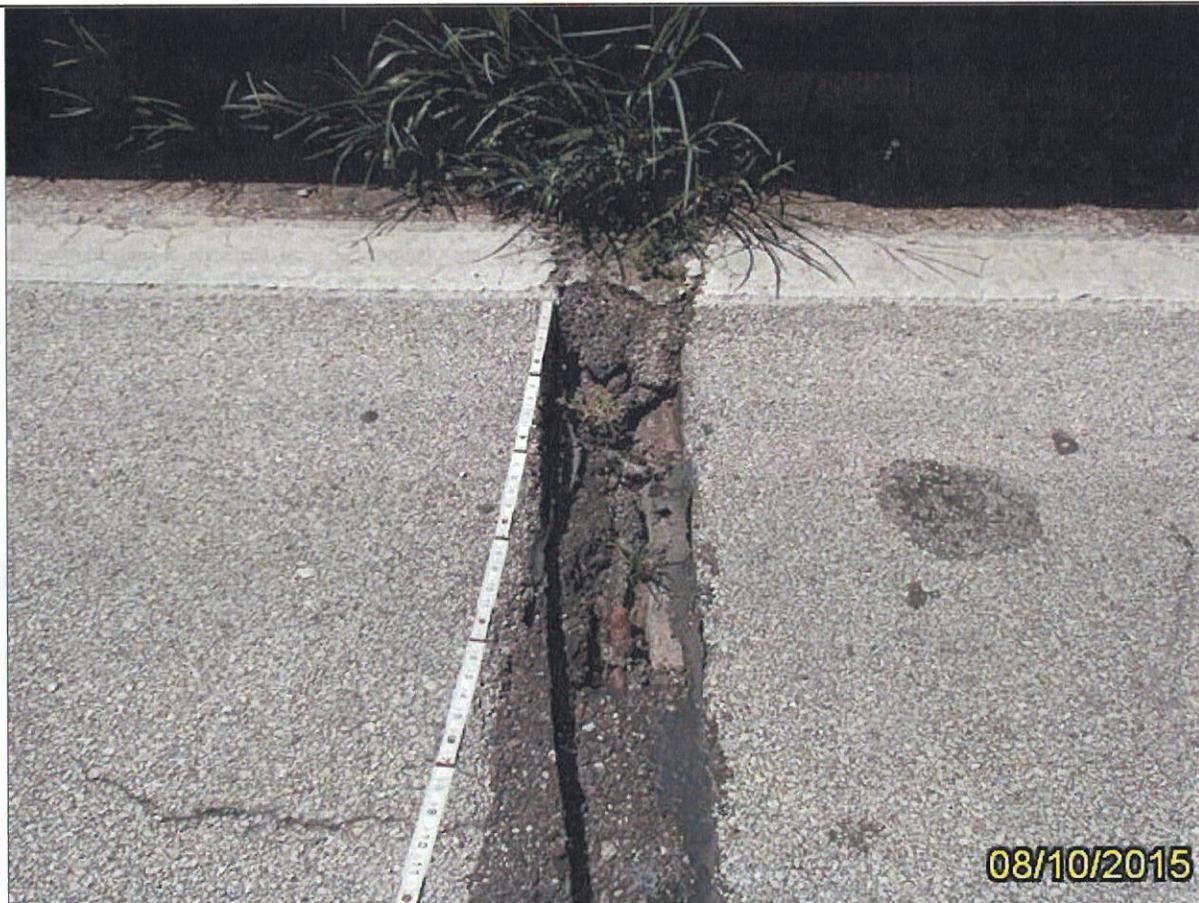
Photo 2 - Element 301 Pourable Joint Seal

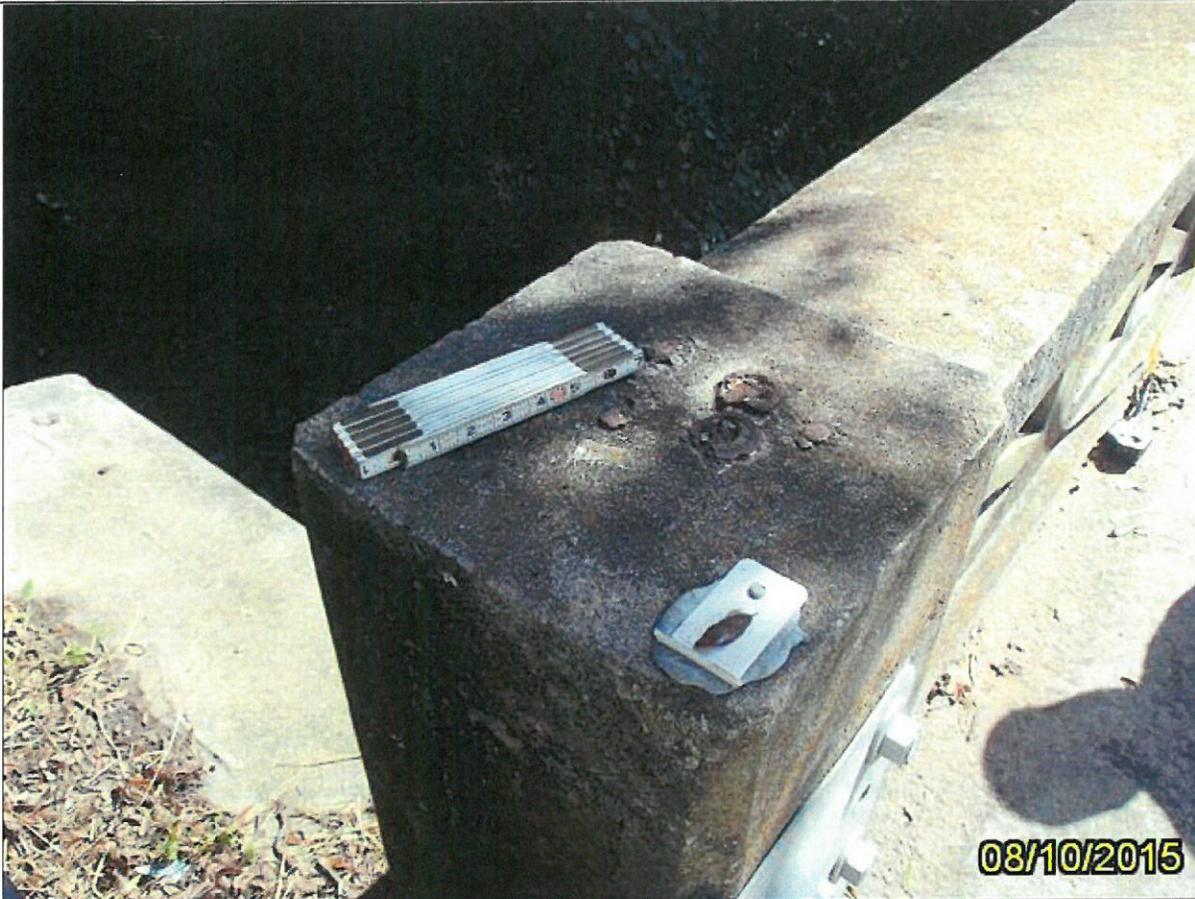
Photo 3 - Element 331 Conc Bridge Railing
