PRELIMINARY ENGINEERING REPORT

Florida Department of Transportation
District One

**US 98 (Peace River – Ft Meade) at Bridge No 160064 (John
Singletary Bridge)
From west of Edgewood Drive to east of the
Fort Meade Recreation Area Entrance
Polk County, Florida**

ETDM No.: 14114
Financial Project ID: 434886-1-22-01
Federal Aid Project No.: 1801-006-P

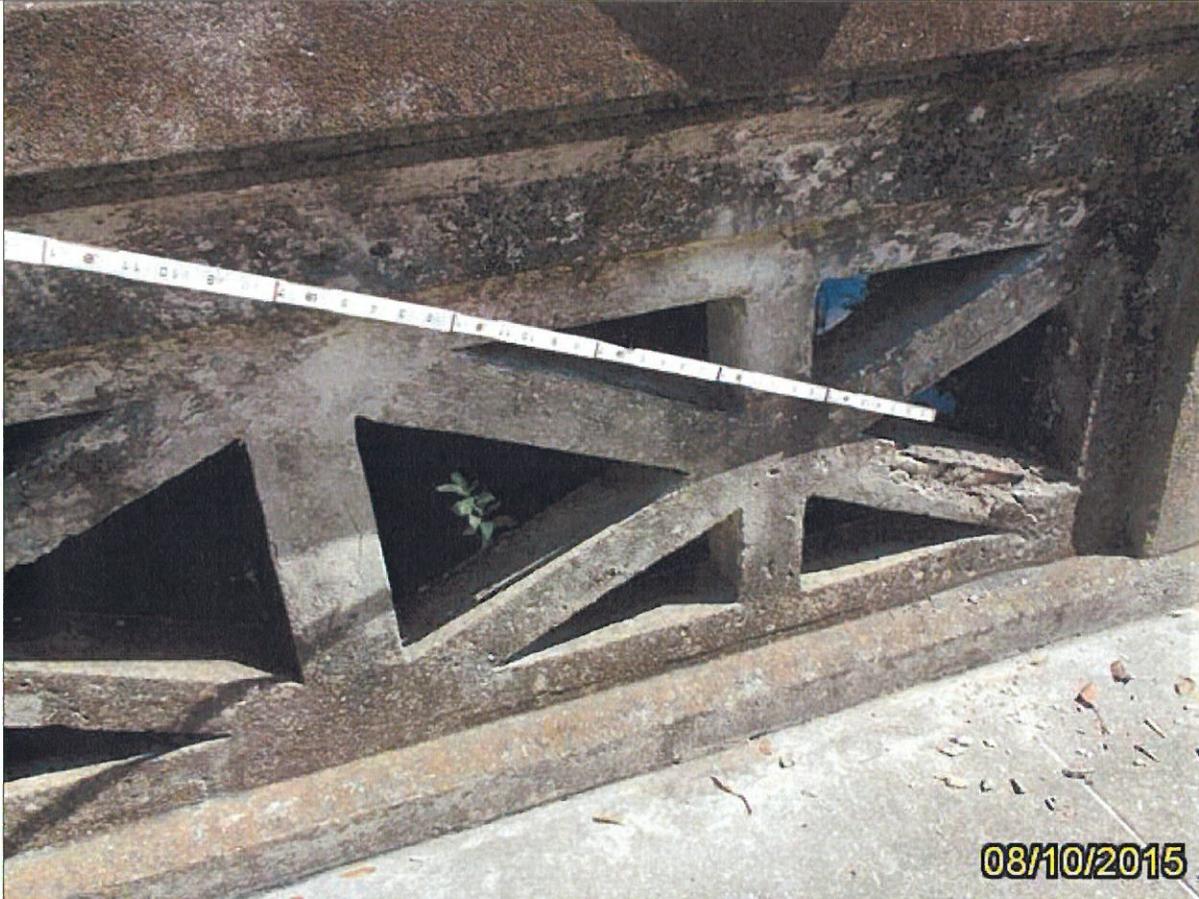
Photo 4 - Element 331 Conc Bridge Railing

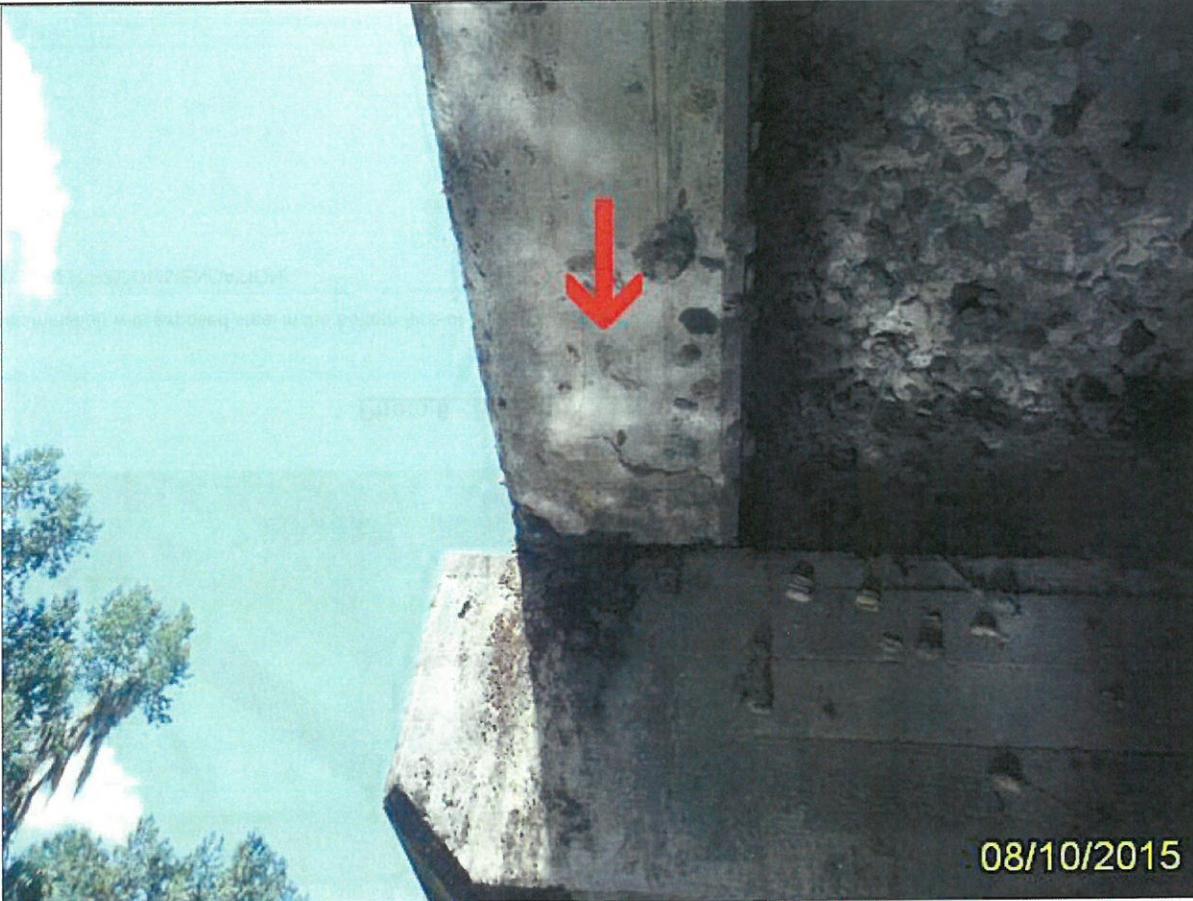
Photo 5 - Element 110 R/Conc Open Girder

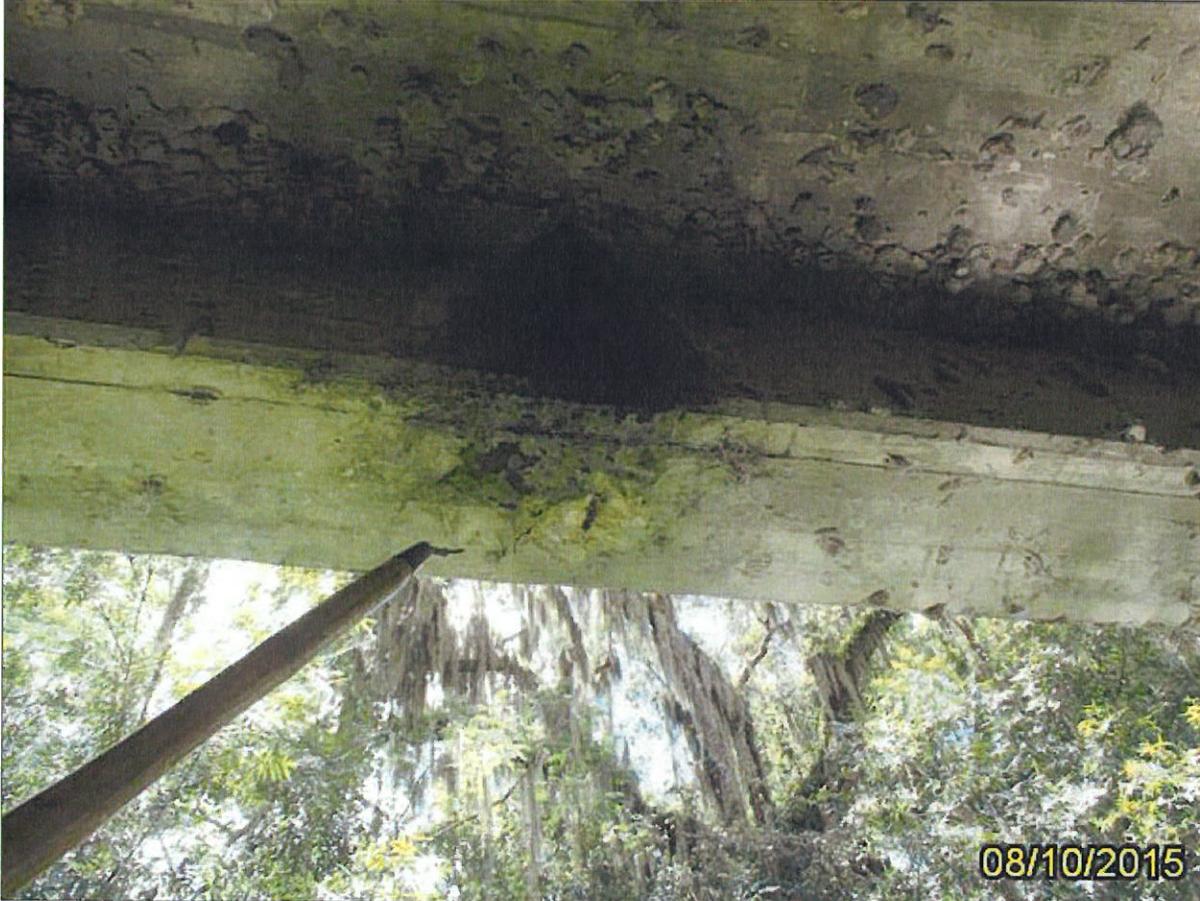
Photo 6 - Element 110 R/Conc Open Girder

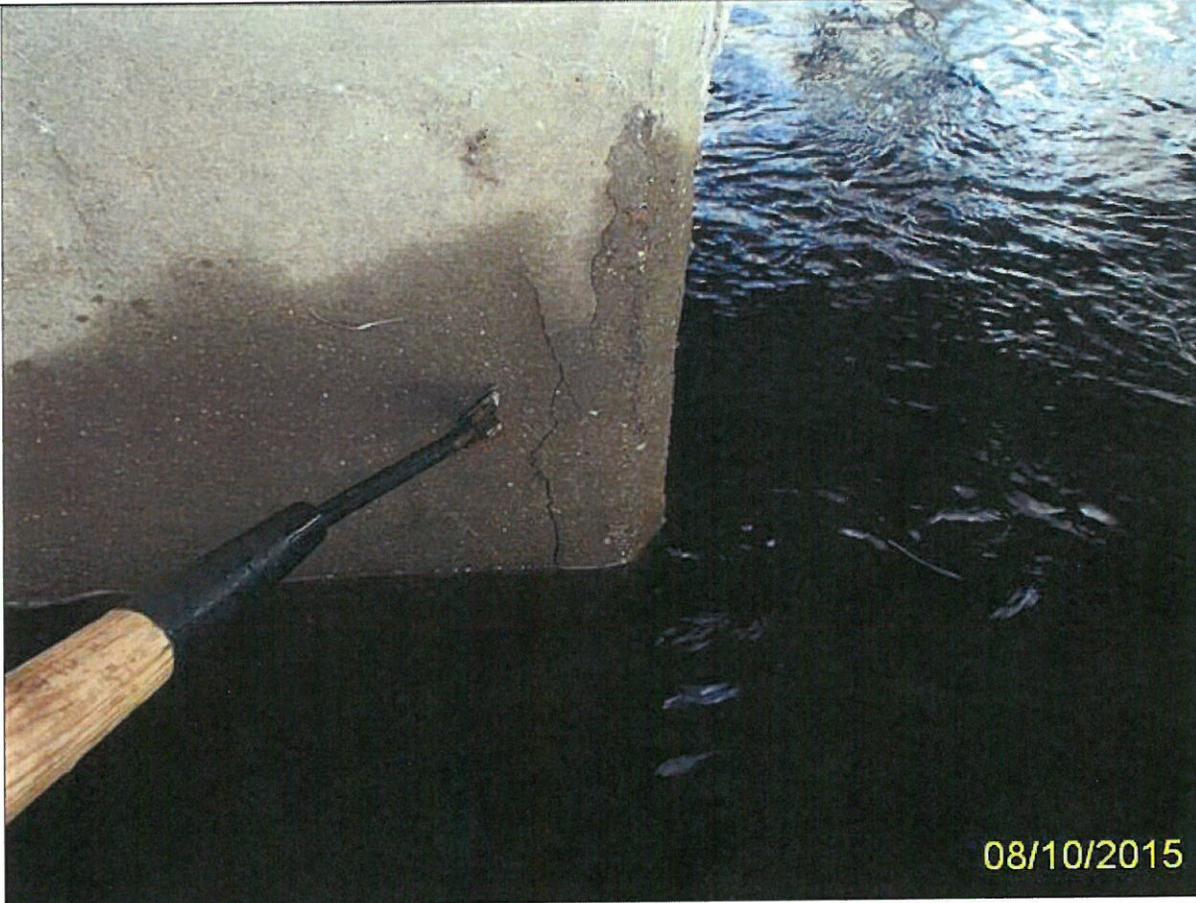
Photo 7 - Element 205 R/Conc Column

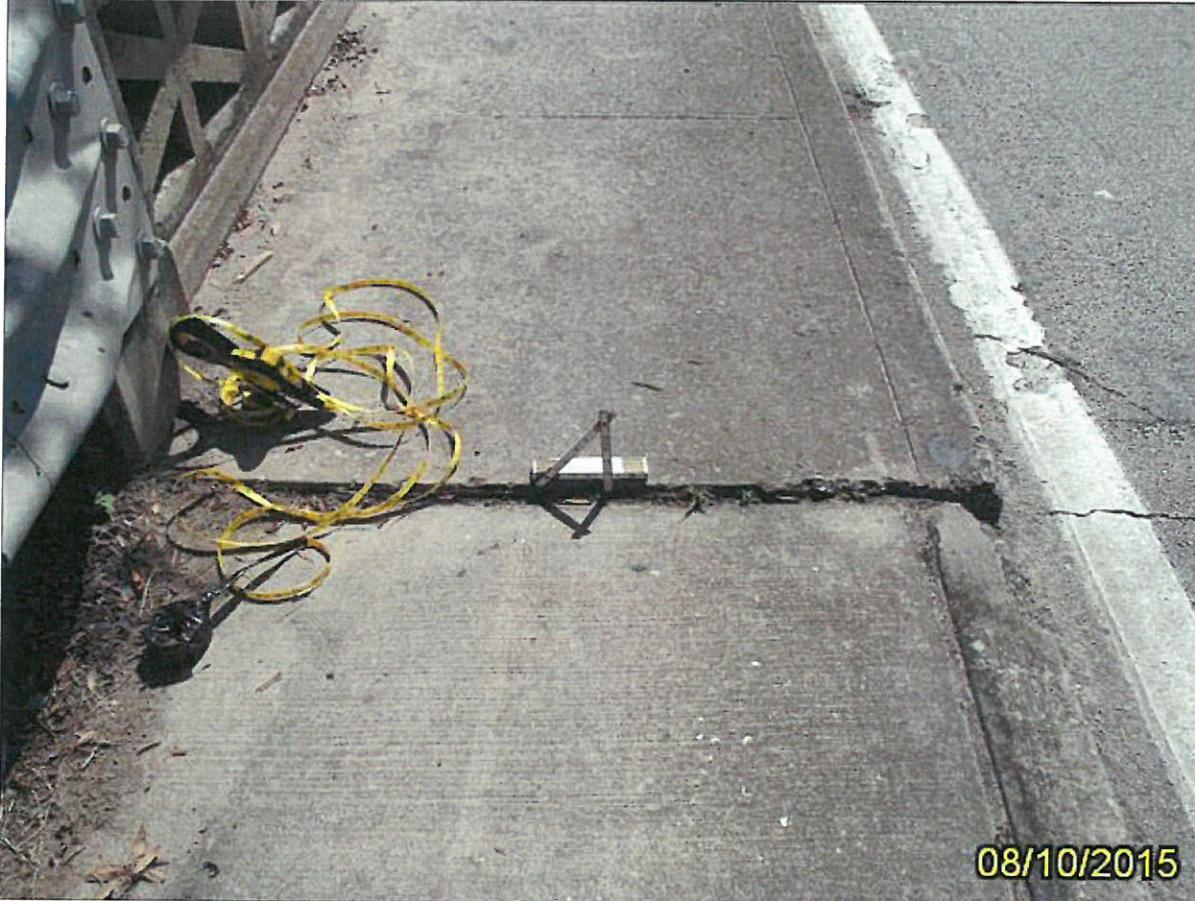
Photo 9 - Inspection Notes

Elevation difference at the northwest approach sidewalk/bridge sidewalk transition

There is a 3/4in. elevation difference at the northwest approach sidewalk/bridge sidewalk transition. Refer to photo 9.

There is a 3/4in. elevation difference at the northwest approach sidewalk / bridge sidewalk transition - NEW. Refer to Photo 9.

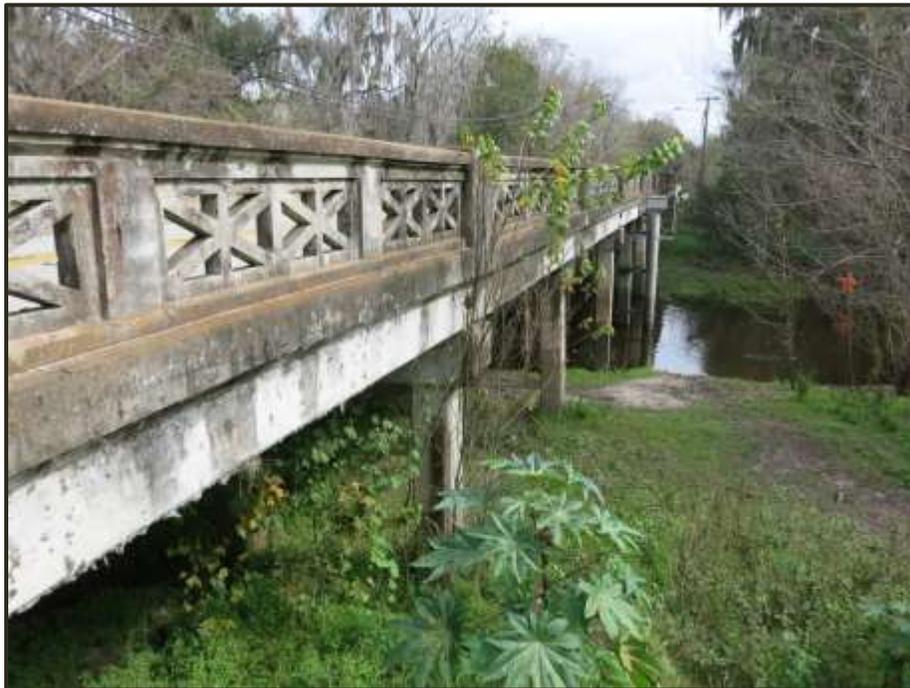
PHOTO 3.2: JOHN SINGLETARY BRIDGE OVER THE PEACE RIVER (8PO05440), LOOKING EAST (2014).

As a result of the PD&E Study CRAS, one NRHP-eligible significant historic resource was identified within the APE, the John Singletary Bridge (8PO05440). The aforementioned CRAS was reviewed and accepted by the FHWA on January 20, 2015 and the SHPO concurred on February 18, 2015. A copy of the concurrence letter is included in **Appendix A**, and a copy of the Florida Master Site File (FMSF) form created for the John Singletary Bridge is included in **Appendix B**. The bridge was built in 1931 to provide a crossing over the Peace River and is a well-preserved example of a concrete T-Beam bridge with cast-concrete railings featuring geometric designs (FMSF 2016). The bridge has 22 spans for a total length of 550 feet. It was determined eligible for listing in the NRHP by the SHPO as part of the recent update to *The Historic Highway Bridges of Florida* (ACI 2012) and confirmed again as a result of the PD&E Study CRAS conducted in 2014 (ACI 2015). It is considered NRHP-eligible under National Register Criterion C for its engineering and architecture because it is an “early example of its type, and distinguished by its decorative geometric-design railings” in a neoclassical pattern (ACI 2012). The NRHP boundary is limited to the bridge structure and does not include the approaches on either side. The bridge was named by the Polk County Commission after John O. Singletary, who served as Commissioner of the Second District between 1927 and 1931. A plaque honoring Mr. Singletary abuts the western limit of the bridge on the south side of US 98 (**Photo 3.1**). The bridge has not been altered since the submittal of the PD&E Study CRAS in 2015 and thus retains the historic significance, physical integrity, and qualities for which it was found eligible for listing in the NRHP by the Florida SHPO (**Photo 3.2**).

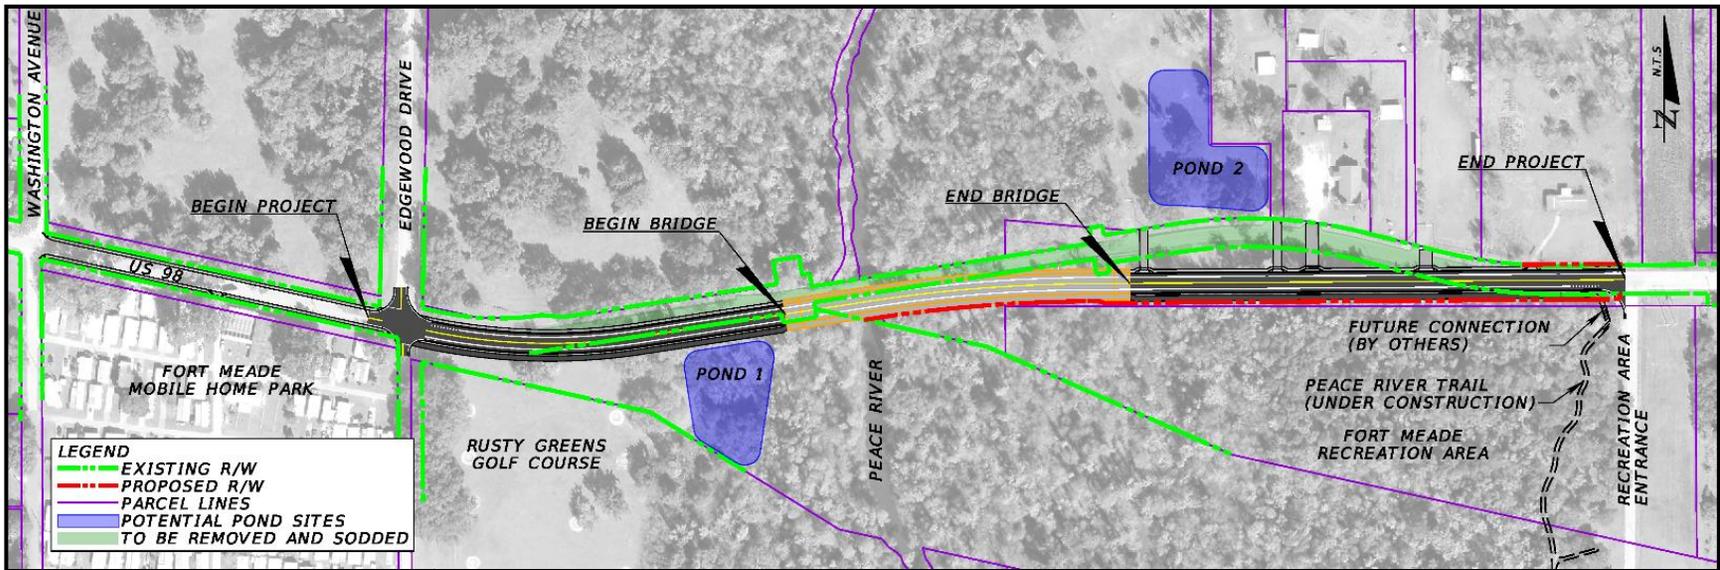
Concept Plan, Build Alternative 2: Existing Bridge Removed, New Bridge Shifted South

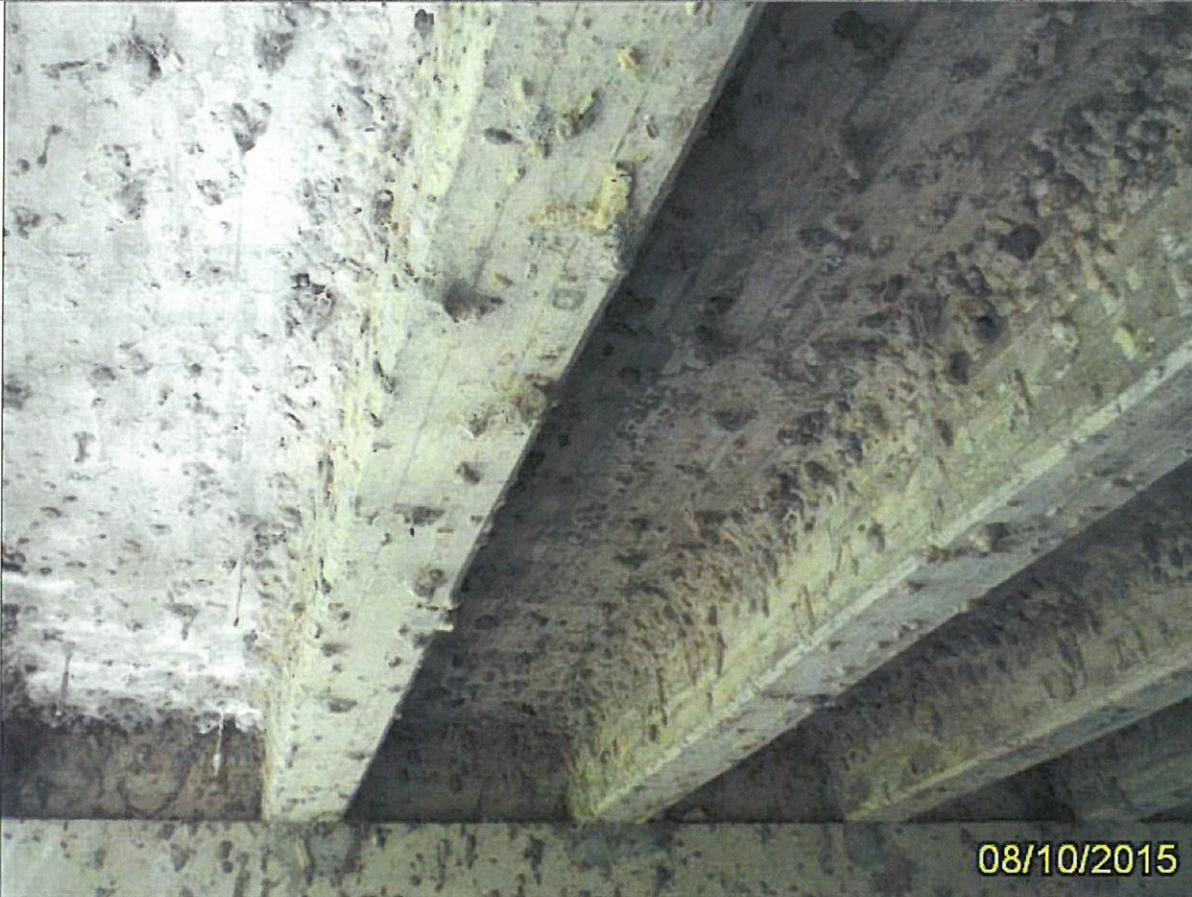
Photo 1 - Elements 13 Unp Conc Deck/AC Ovl & 110 R/Conc Open Girder

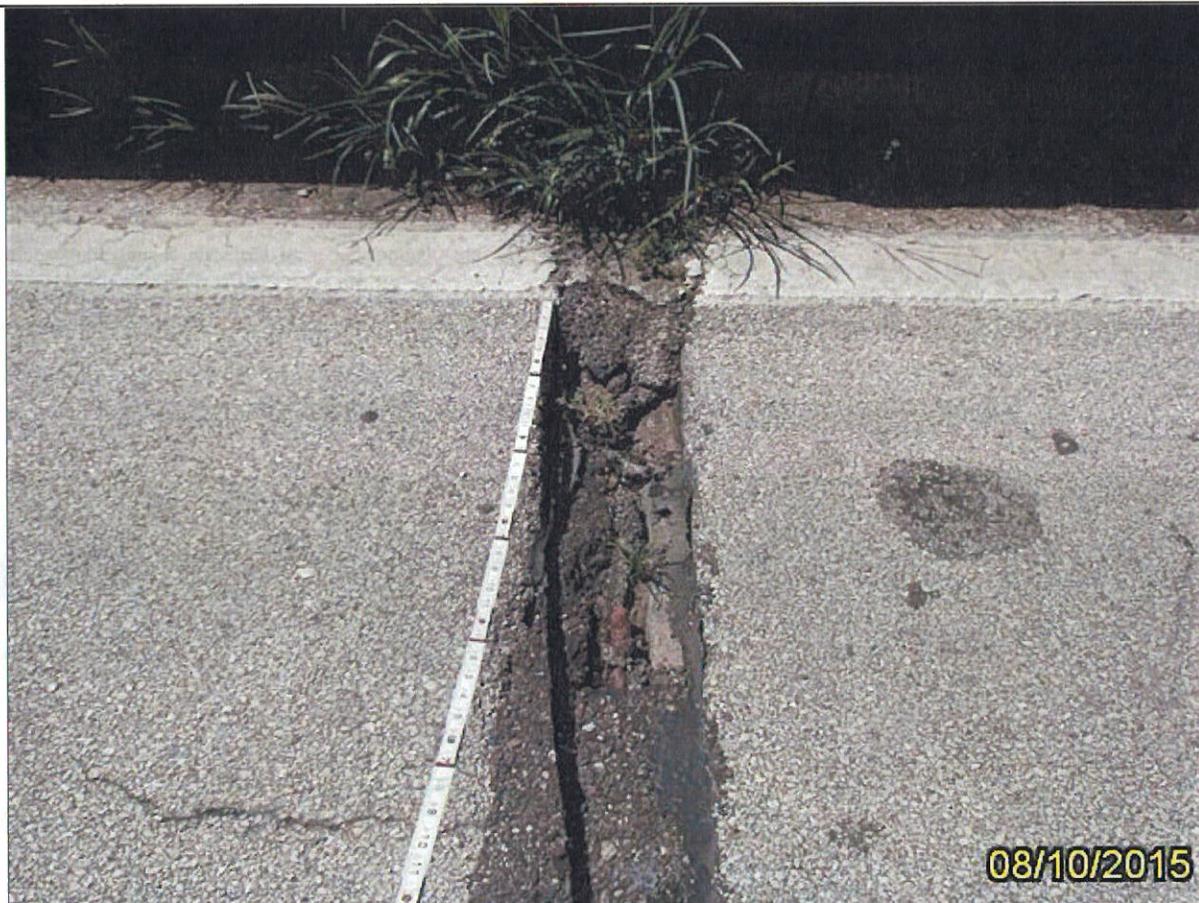
Photo 2 - Element 301 Pourable Joint Seal

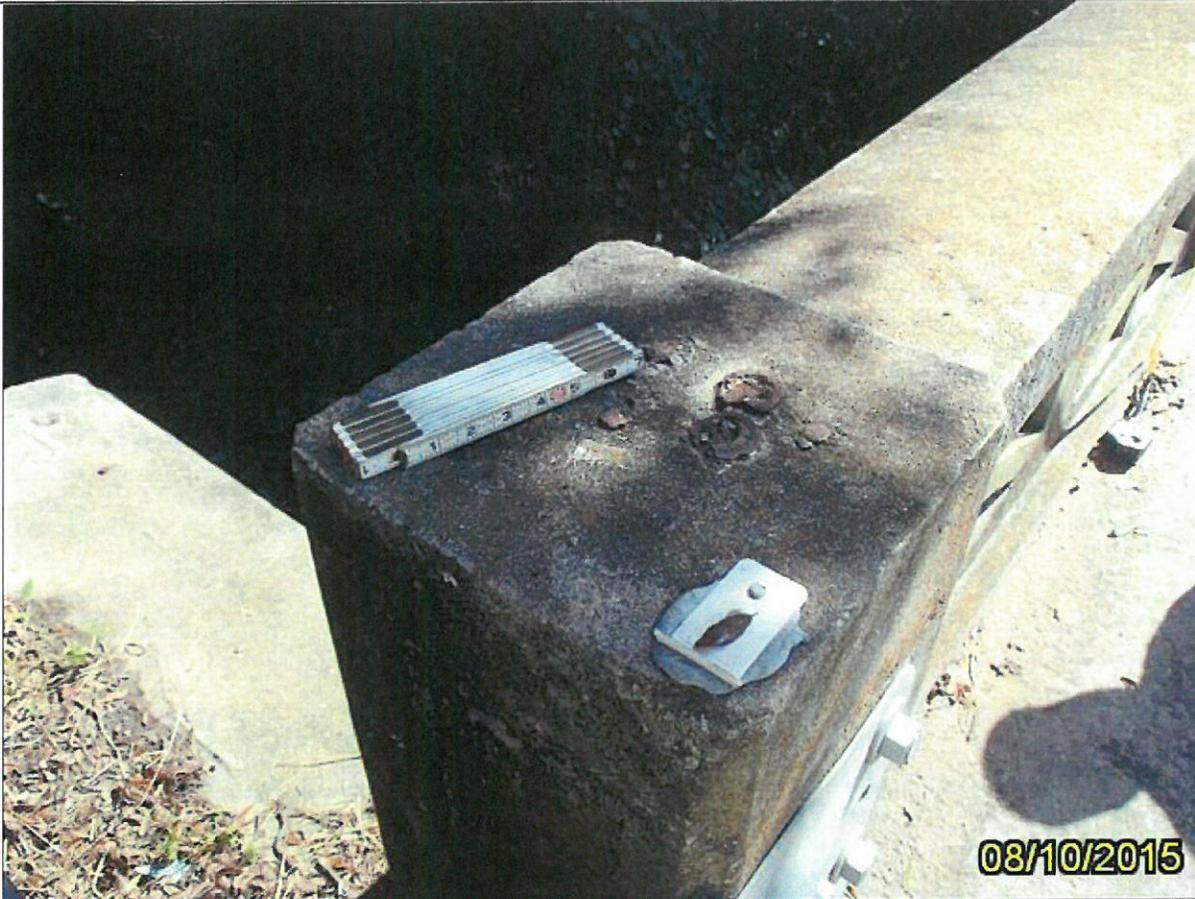
Photo 3 - Element 331 Conc Bridge Railing

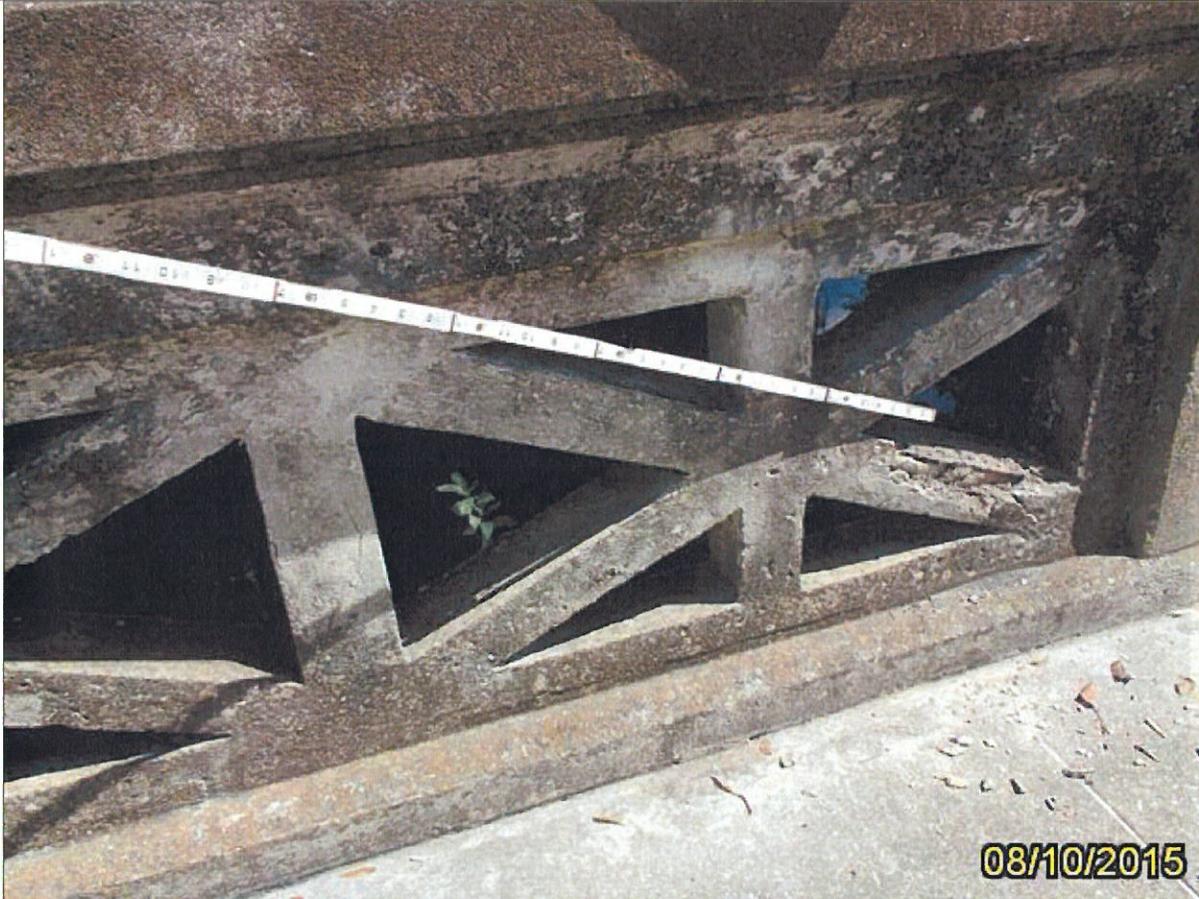
Photo 4 - Element 331 Conc Bridge Railing

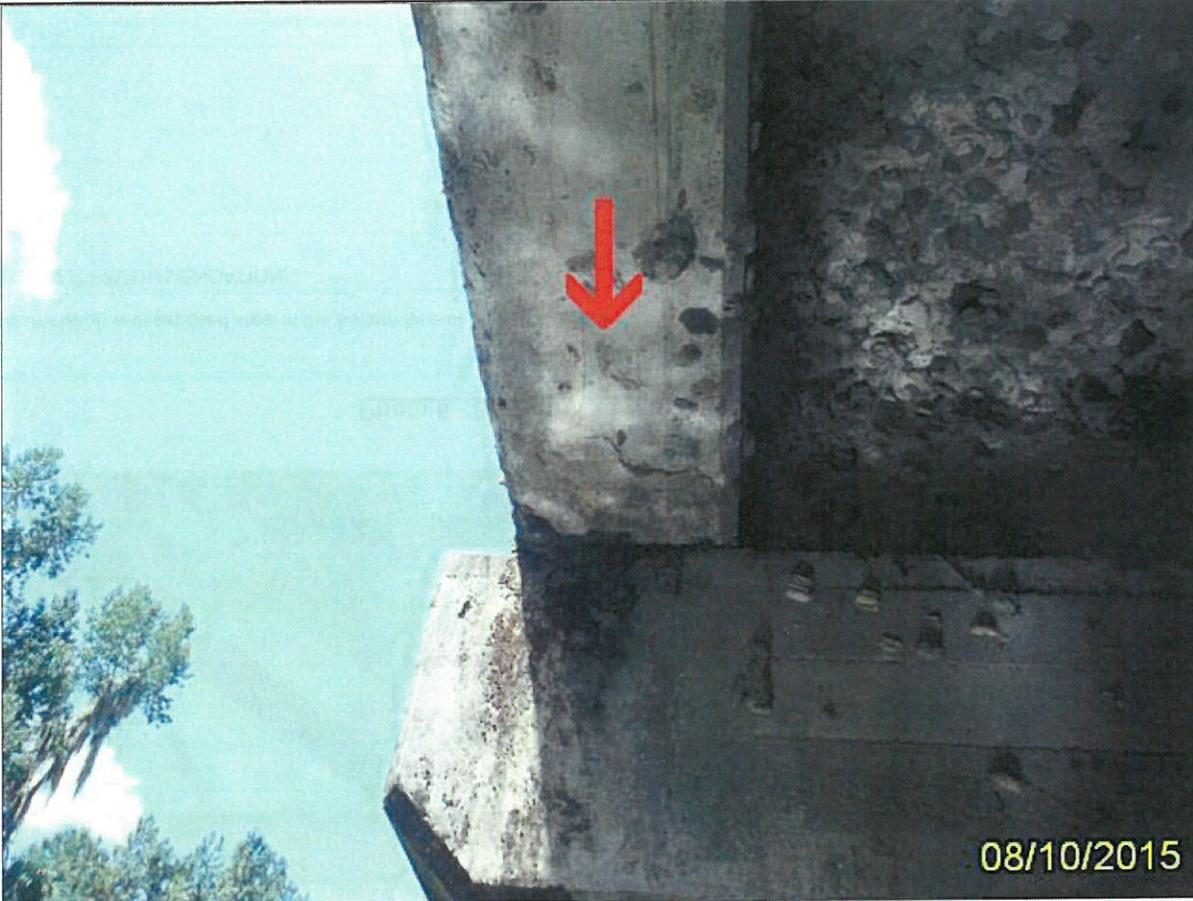
Photo 5 - Element 110 R/Conc Open Girder

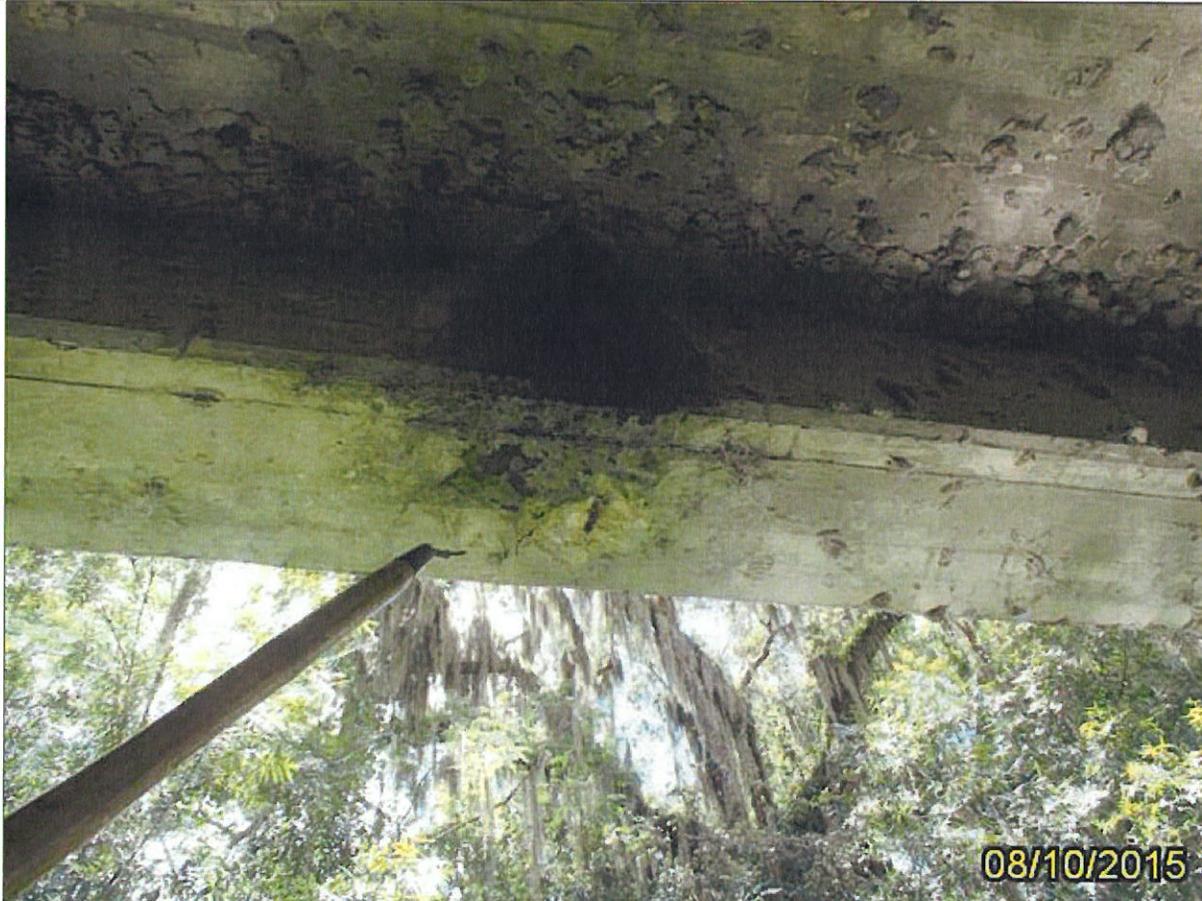
Photo 6 - Element 110 R/Conc Open Girder

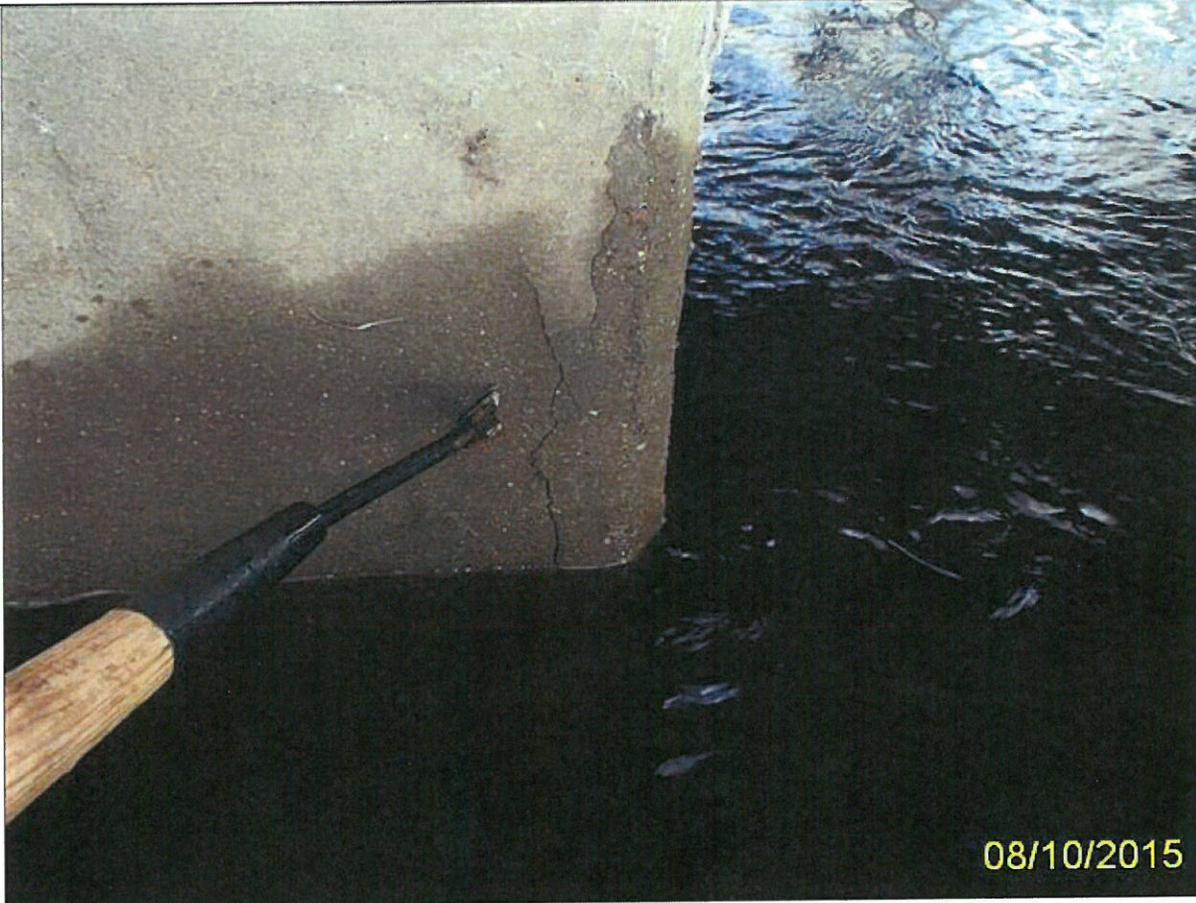
Photo 7 - Element 205 R/Conc Column

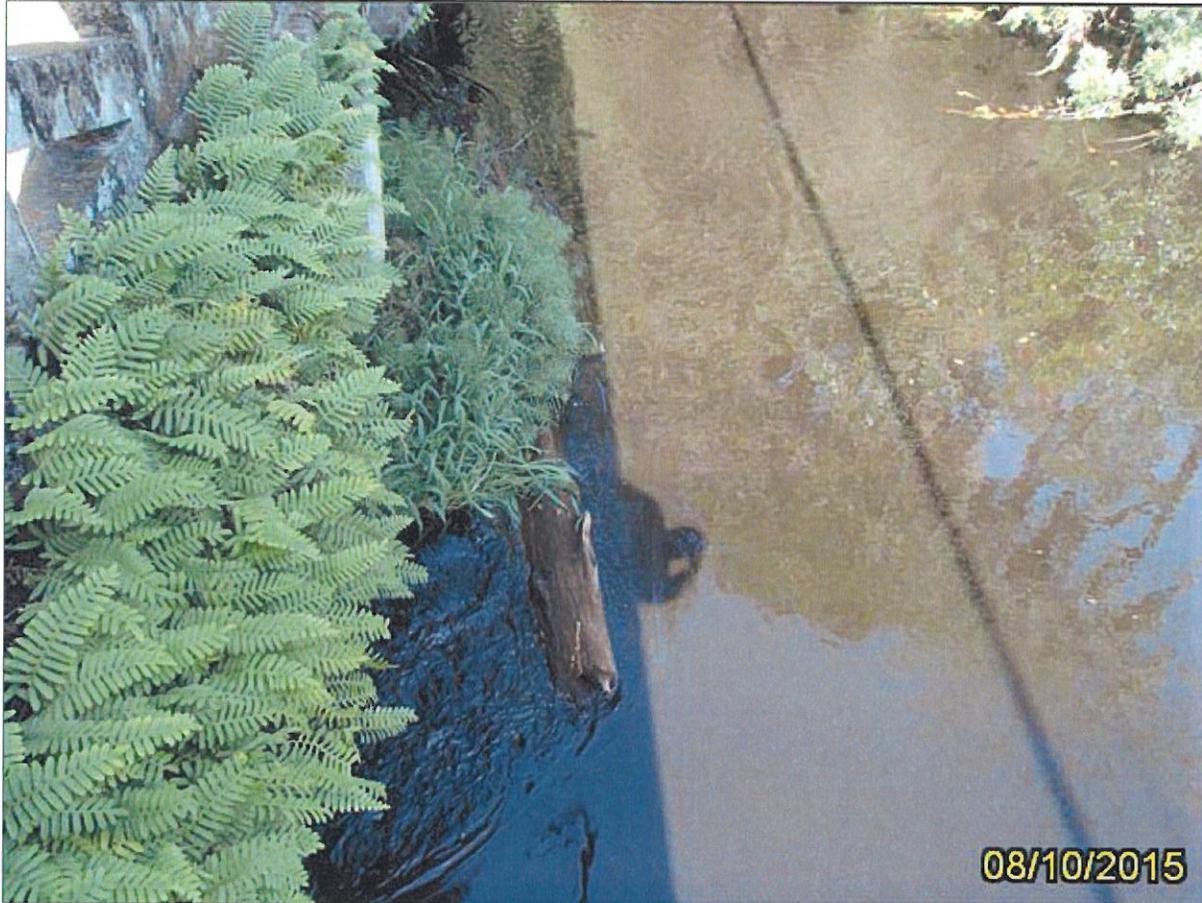
Photo 8 - Element 290 Channel

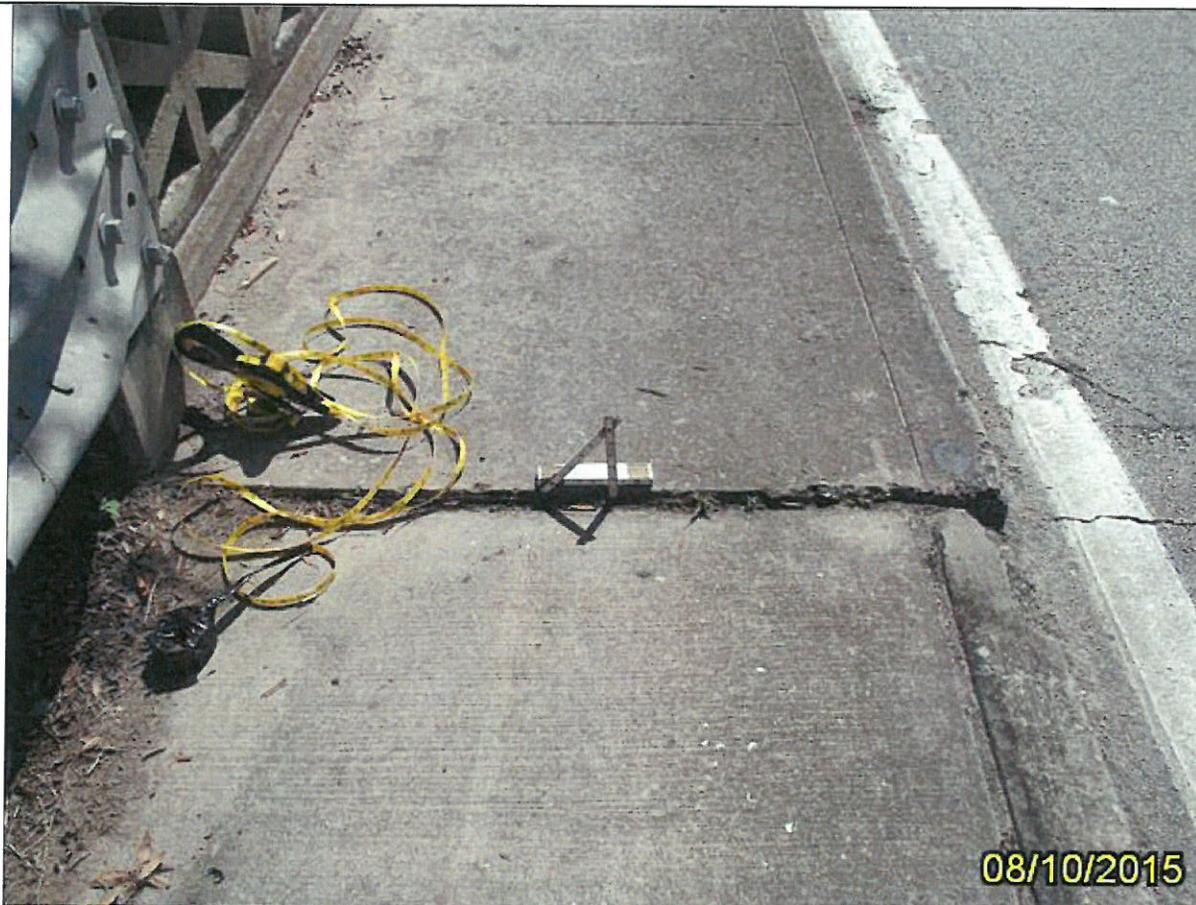
Photo 9 - Inspection Notes

Elevation difference at the northwest approach sidewalk/bridge sidewalk transition

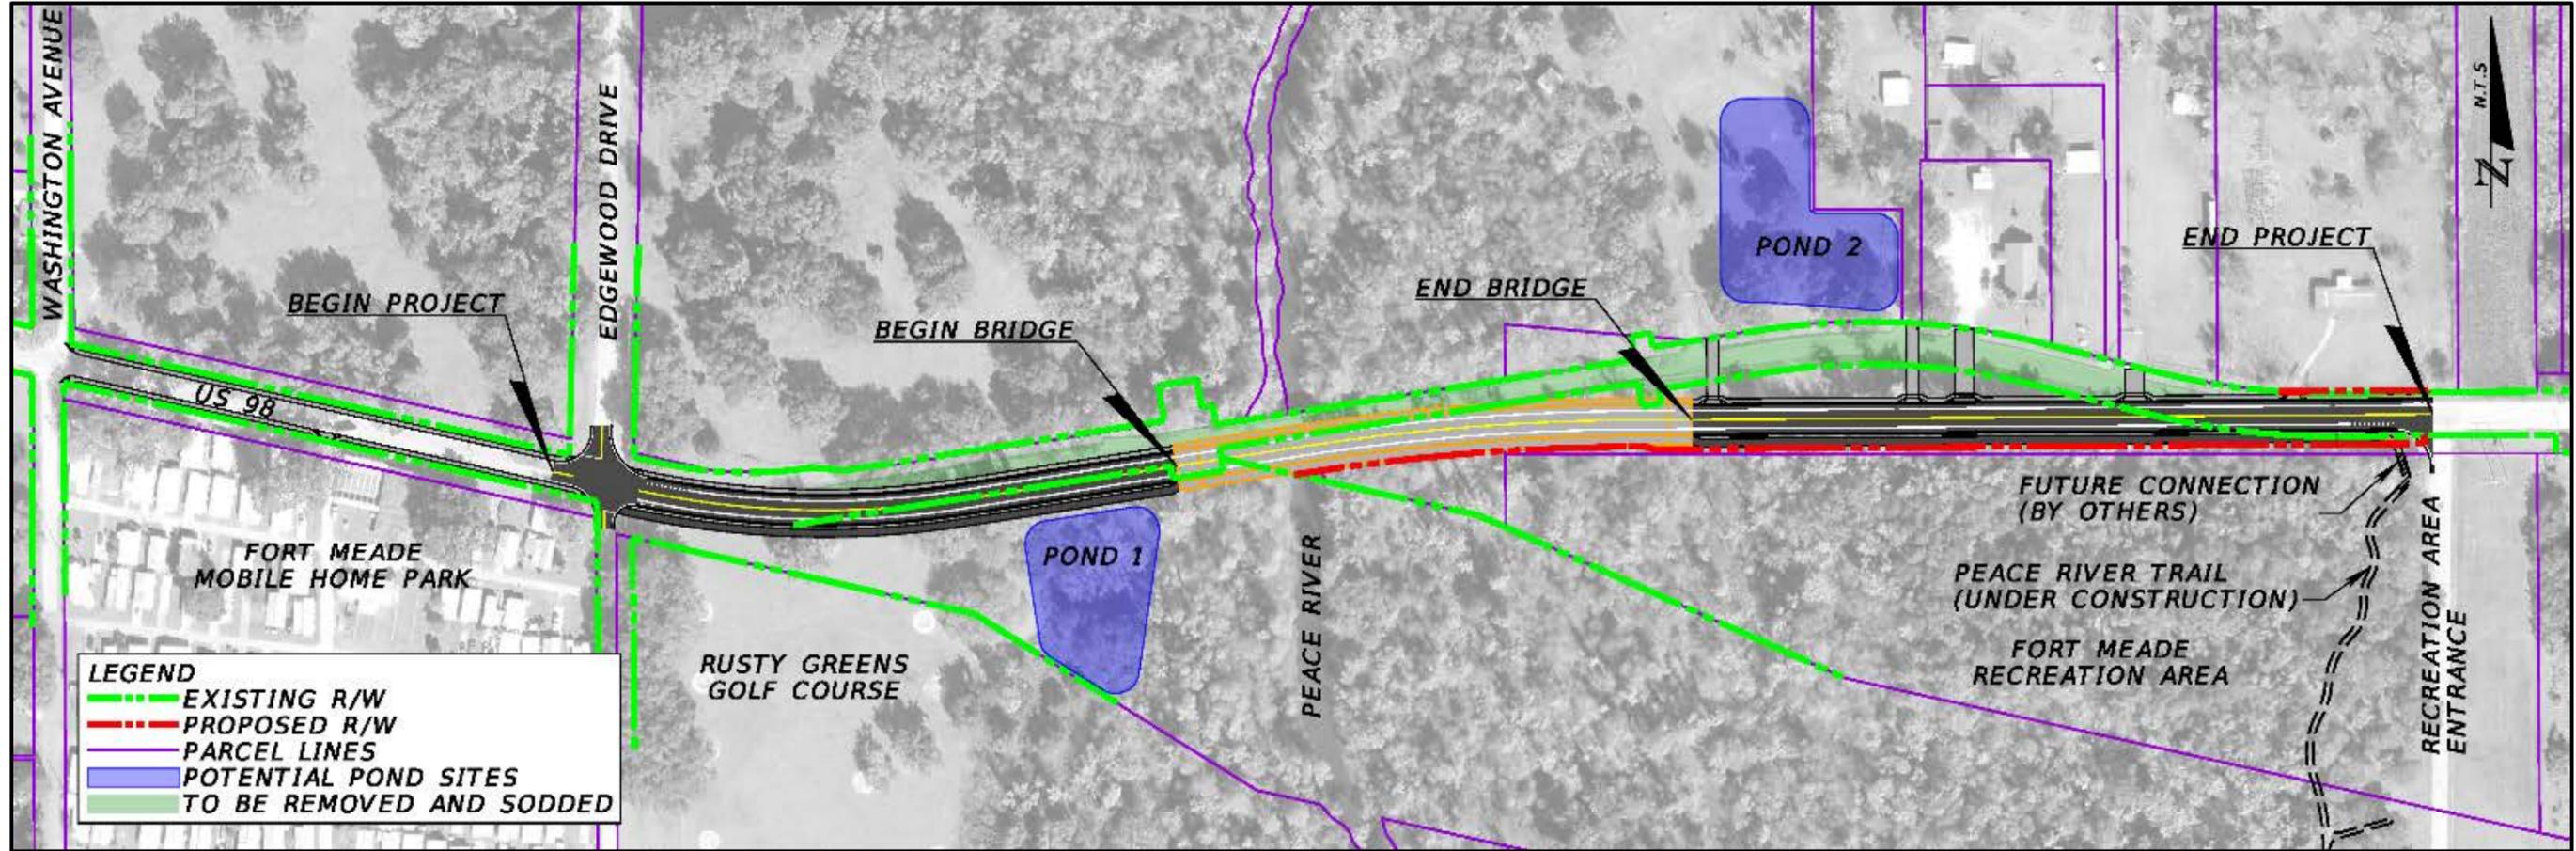
EXHIBIT B: PREFERRED ALTERNATIVE (BUILD ALTERNATIVE 2)
