CULTURAL RESOURCE ASSESSMENT SURVEY

S.R. 789 (Longboat Key) PD&E Study

Limits of Project: From North Shore Road to Coquina Park Entrance

Date: April 2025

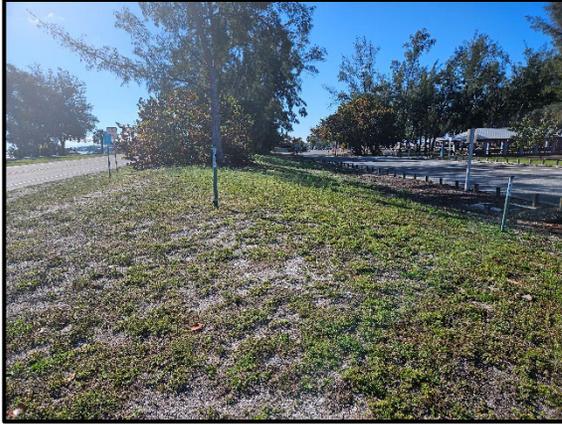
Photo 2.3. Sewer pipeline utilities running perpendicular to S.R. 789, facing south-southwest.

S.R. 789 past the north and south ends of the bridge have considerable disturbance due to utilities, both above ground and subsurface (sewer, gas, cable, streetlamp/electric, etc.), and infrastructure such as sidewalks and roadway pavement. Shell and fill are also visible along the surface of the ROW. The north end of the bridge is on top of a slope with guardrails that extend to the south end of the bridge (**Photos 2.1-2.15**).

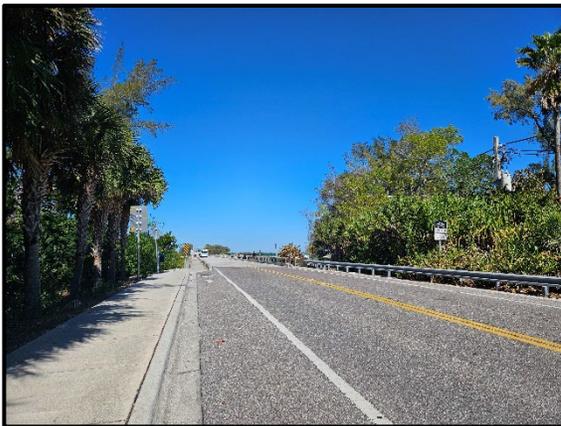
Photo 2.11. View of Longboat Key Bridge south entrance, facing north

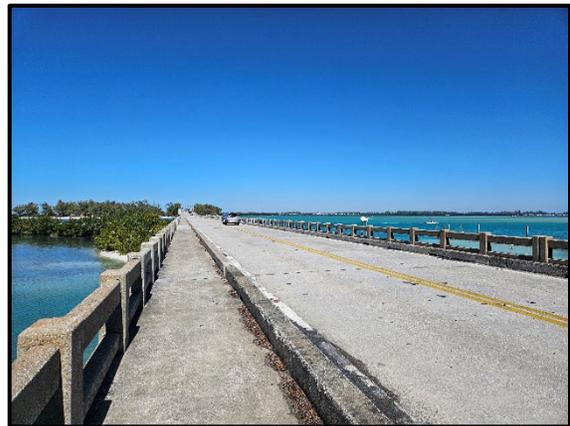
Photo 2.12. View of length of Longboat Key Bridge, facing north.

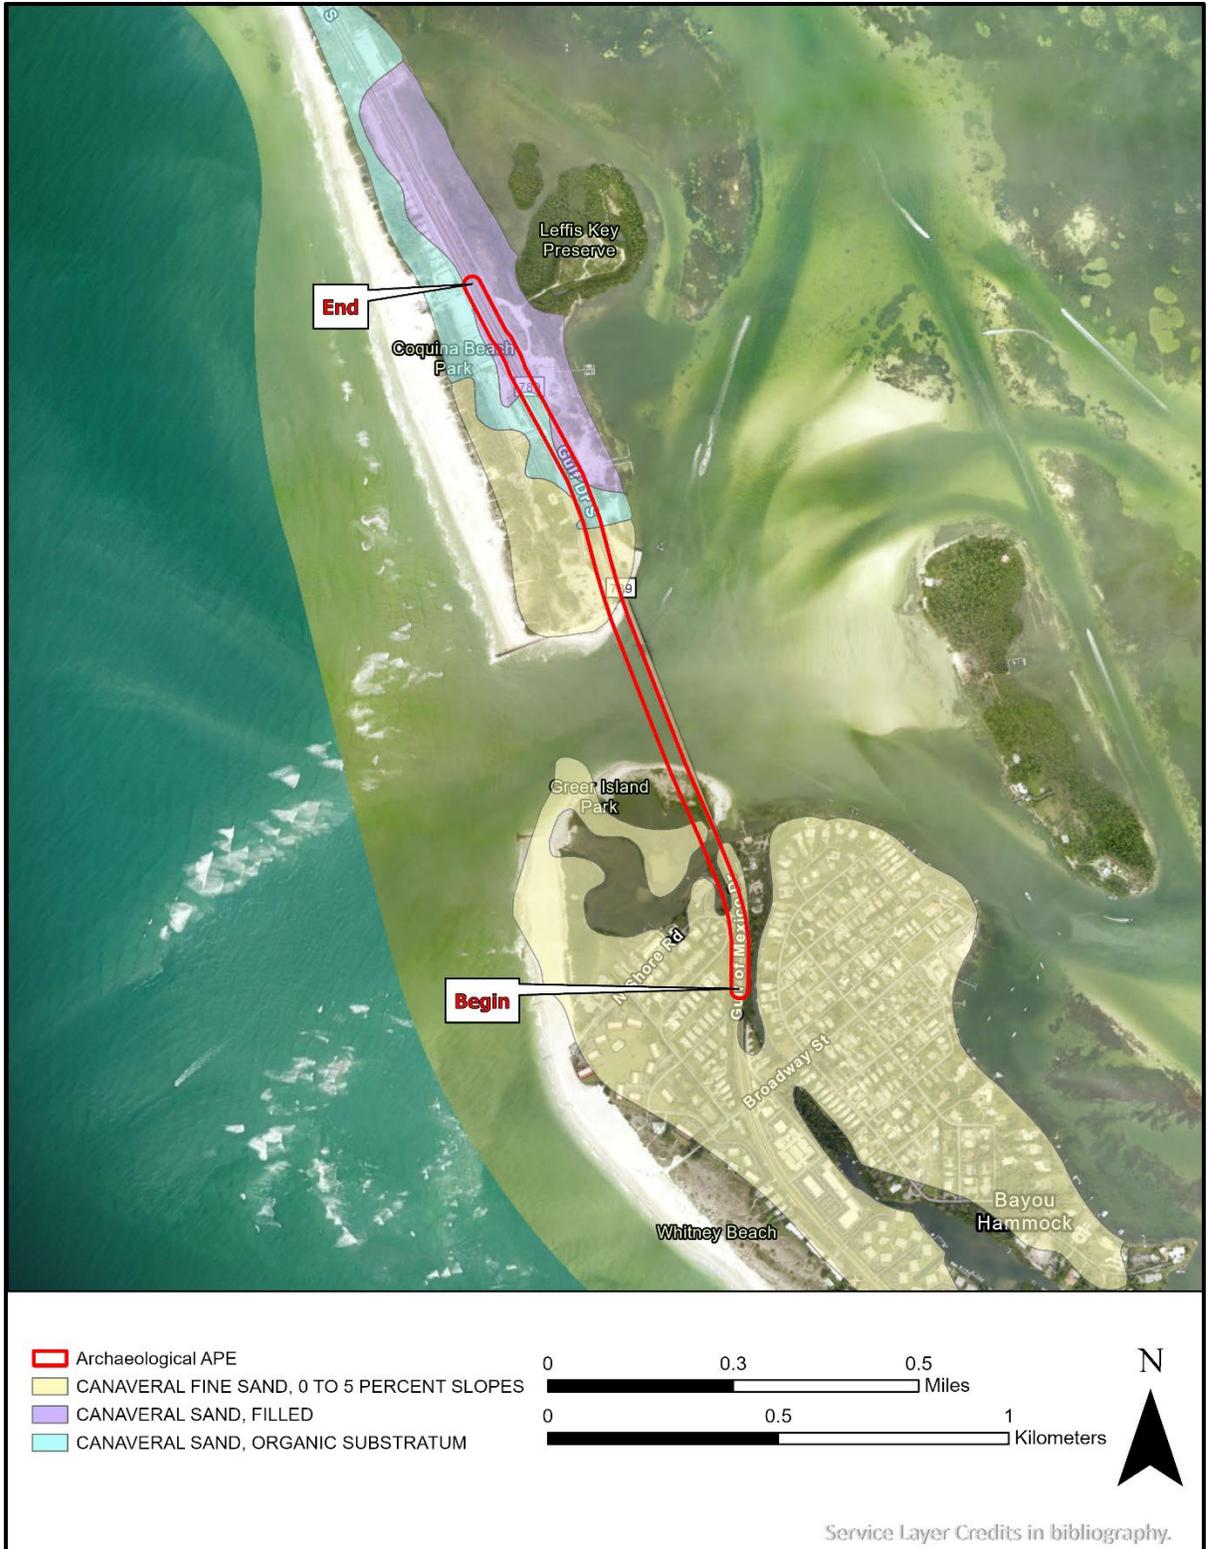
Figure 2.2. Soil types in the S.R. 789 APE.

According to the United States Department of Agriculture (USDA 1991), the APE is located within two soil associations. The first one is the Smyrna-Basinger-St. Johns soil association, which is characterized by nearly level, poorly drained and very poorly drained soils that are sandy throughout. Some have an organic-stained subsoil at a depth of less than 30 inches. In areas of Smyrna and St. Johns soils, the natural vegetation is both longleaf and slash pines with an understory that includes waxmyrtle, saw palmetto, pineland threeawn, bluestem, inkberry, and running oak. In areas of Basinger soils, the natural vegetation consists of mixed stands of pondcypress, sweetgum, scattered pond pine, and black tupelo. The understory consists of blue maidencane, chalky bluestem, and other water-tolerant grasses and sedges. The second soil association is the Urban land-Smyrna-Pomello which is characterized by nearly level to gently sloping, poorly drained and moderately well drained soils that are sandy throughout. Some areas have an organic-stained subsoil at a depth of less than 30 inches, while others have an organic-stained subsoil at a depth of 30 to 50 inches. Most areas have been modified for urban use. The existing natural vegetation consists of longleaf and slash pines with an understory of saw palmetto, lopsided Indiangrass, creeping bluestem, pineland threeawn, inkberry, and running oak. The specific soil types within the project are shown in **Figure 2.2** and noted in **Table 2.1**.

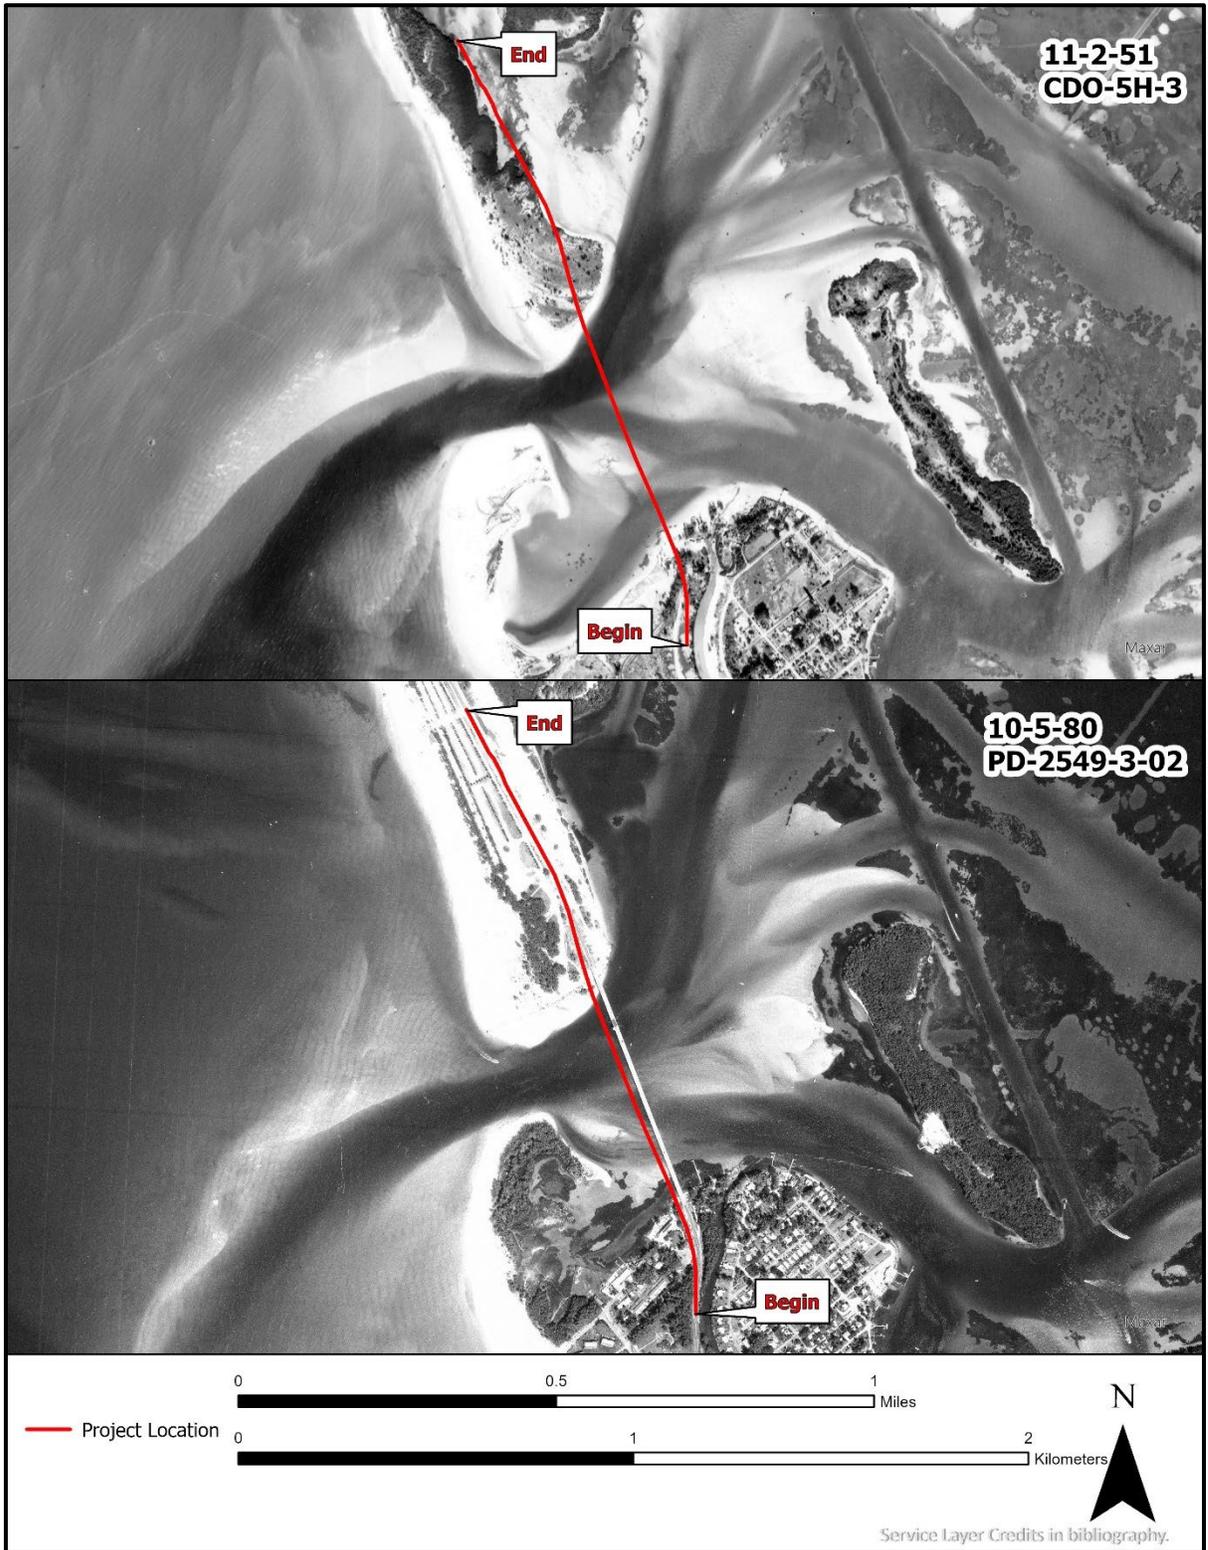
Figure 3.3. 1951 and 1980 historic aerial photographs of the S.R. 789 project (USDA 1951; FDOT 1980).

A review of historic aerial photographs revealed that a bridge was not present at Longboat Pass in 1940 (USDA 1940). The southern end of Anna Maria Island was undeveloped, and the northern end of Longboat Key was minimally developed. S.R. 789 had not yet been constructed, but a tree-lined road spanned north-south along Longboat Key following what is now Firehouse Road and Firehouse Court. A small residence was located on the northern shore of Longboat Key. The APE remained largely unchanged into the early 1950s but by ca. 1957, the Longboat Key Bridge had been constructed between Anna Maria Island and Longboat Key crossing Longboat Pass (USDA 1951, 1957) (**Figure 3.3**). The southern end of Anna Maria Island appears to have been utilized as a public beach by this time with a jetty extending into the Gulf of Mexico outside of the APE. Residential development had increased but remained minimal on Longboat Key within the APE at this time and a segment of what is now S.R. 789 had been constructed from the bridge south to Broadway Street outside of the APE. The area within the APE largely reached the current configuration during the 1960s and 1970s with additional residential construction along North Shore Road and northeast of S.R. 789 (FDOT 1973, 1977, 1980) (**Figure 3.3**). The remainder of the residences within the APE were constructed during the 1990s and 2000s (Google Earth 2024).

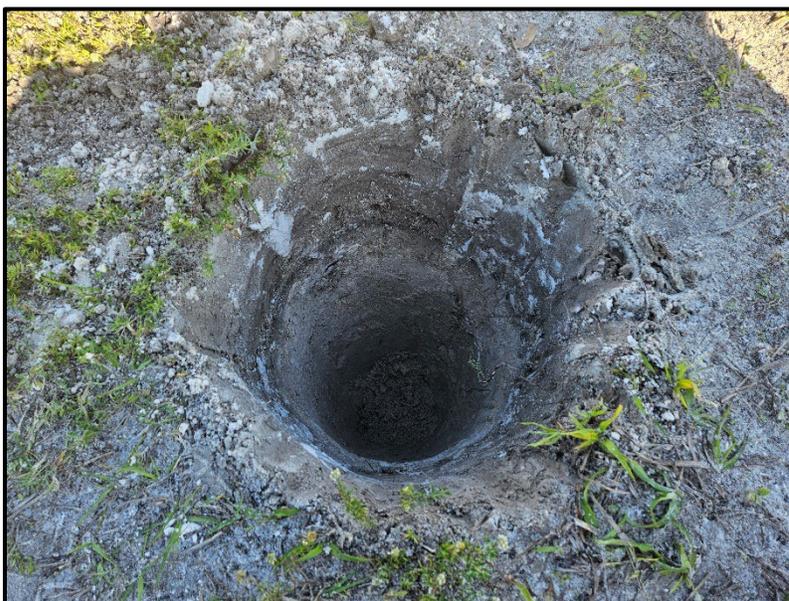
Photo 5.1. Stratigraphy on north side of the S.R. 789/ Longboat Key Bridge, facing north.

- **North of Longboat Key Bridge:** 0-25 centimeters below surface (cmbs) gray mottled light and dark gray sand, 25-100 cmbs light gray sand (**Photo 5.1**).
- **Coquina Beach:** 0-35 cmbs pale gray/white beach sand, 36-50 cmbs light gray mottled speckled dark gray sand, 50-100 light gray-gray wet sand (**Photo 5.2**).
- **South of Longboat Key Bridge, South LBK Bridge and North Shore Road:** 0-30 cm light gray shell and rocky fill with roots (**Photo 5.3**). Compactness of the fill prevented further digging

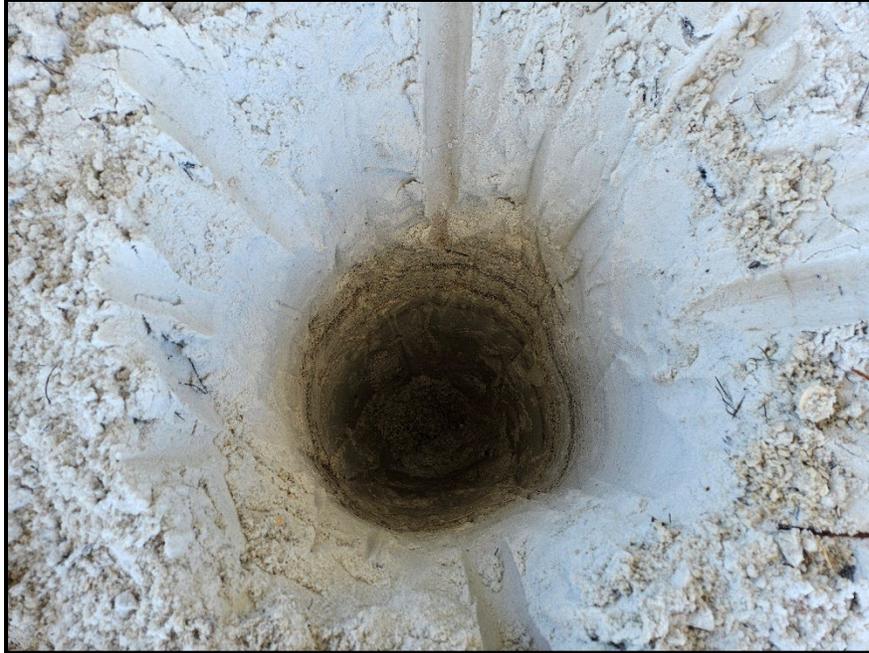
Photo 5.2. Stratigraphy on Coquina Beach under the S.R. 789/Longboat Key Bridge, facing north.

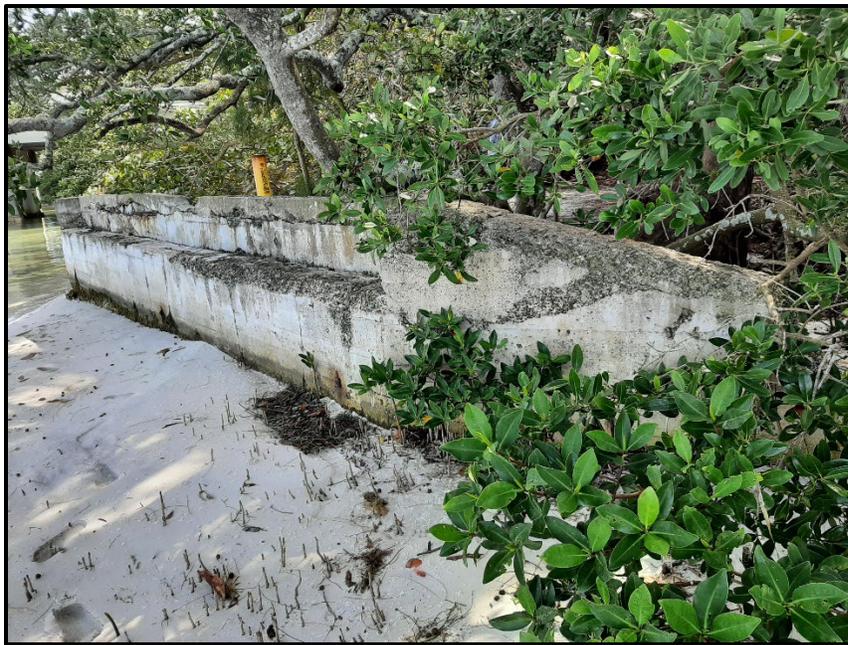
Photo 5.4. Site 8MA02599 south bridge abutment remains, facing southeast.

Site **8MA02599**, the Old Longboat Pass Bridge Site, is located in the southeast quarter of Section 15, Township 35 South, Range 16 East, west of the southern entrance of Longboat Pass Bridge (**Figure 5.1**). The Old Longboat Pass Bridge, which consists of the remains of the south bridge abutment, was identified during historic background research (**Photo 5.4**). A historic marker contributed by the Town of Longboat Key and the Longboat Key Historical Society explains that the Old Longboat Pass Bridge was built in 1923 and washed away by high tide in 1932 (**Photo 5.5**). During ACI's most recent survey, the south abutment of the Old Longboat Pass Bridge site was located and documented. An attempt was made to locate the north abutment of the Old Longboat Pass Bridge Site, but this portion of the site is inaccessible due to being located within the Longboat Pass waterway, according to the historic marker. No shovel tests were able to be placed around the south abutment. The site area is surrounded by beach type vegetation with residences located just southwest of the abutment. 8MA02599, the Old Longboat Pass Bridge Site, includes the remains of the south bridge abutment; the north abutment could not be located. Therefore, this site has insufficient information to make a determination of eligibility for listing in the NRHP.

No Pre-contact period archaeological sites were discovered, but one historic archaeological site was found. This site consists of the remains of the southern abutment that were part of the historic 1926 bridge connecting Longboat Key to Anna Maria Island, to the west of the current Longboat Pass bridge. Photos and a description of this historic bridge abutment are included below. A reasonable and good faith effort was made per the regulations laid out in 36 CFR § 800.4(b)(1) (Advisory Council on Historic Preservation n.d.) to test all areas of the project APE.

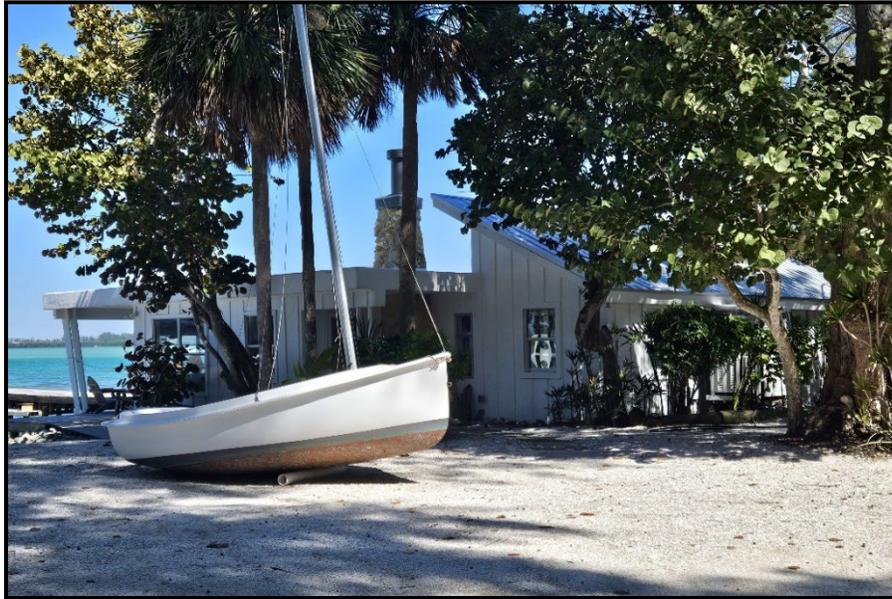
Photo 5.6. 7300 Gulf of Mexico Drive/Mayers House (8MA01155), looking northeast.

8MA01155: The Mayers House at 7300 Gulf of Mexico Drive is a Frame Vernacular style building that was constructed in ca. 1936 (**Photo 5.6**). The residence was constructed on land formerly owned by John Savarese, a prominent fisherman and businessman of Tampa, until the 1930s when the property was purchased by Savarese's great-niece, Frances Fitzgerald Mayers and husband Frank Mayers (Hartig 1999). The original Savarese house on the property was destroyed during a hurricane in 1921 and the property was vacant at the time of the Mayers' purchase. In ca. 1936, the Mayers constructed a simple rectangular cottage with a gable roof on the property for use as a pioneering vacation home outside of Tampa (Mayers 2009). The cottage remained with the Mayers family over the years and in ca. 1960 the property — known locally as Land's End — was turned into the Land's End Marina by Frank Mayers. Mayer's established Land's End Marina following the construction of the adjacent Longboat Key bridge to serve the local fishing industry and tourism brought in by the new transportation route (Mayers 2009). Prior to the construction of the bridge, Longboat Key was largely undeveloped and considered a rather remote location only accessible from Sarasota. Land's End Marina was run by the Mayer's family from ca. 1960 to 1968 and included a dock, boat rentals, and small restaurant which served hamburgers, hot dogs, and candy. The flat roof was also utilized for dances and music performances. In addition to the Mayers House/Land's End Marina, one Frame Vernacular style building is located on the property to the south (8MA02598) of the building, as well as two Masonry Vernacular style buildings (8MA02596 and 8MA02597). The buildings were incorporated into the property over the years and a dock remains along the waterfront. The property remains in the ownership of the Mayers family, including Tom Mayers and his sisters, Michael Saunders and Joan Bergstrom — regionally known real estate agents. The Mayers House was recorded during the *Historic Properties Survey of Longboat Key, Florida* conducted in 1999 and has not been evaluated by the SHPO (Hartig 1999).

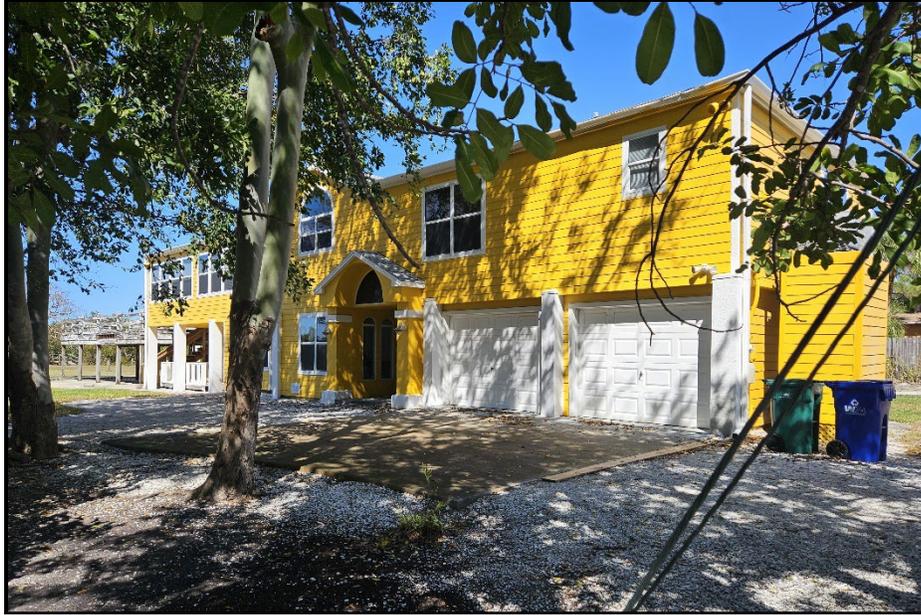
Photo 5.7. 300 North Shore Road (8MA02590), looking northeast.

8MA02590: The Frame Vernacular style building at 300 North Shore Road was constructed in ca. 1977 (**Photo 5.7**). The two-story, irregular plan building rests on a concrete pier foundation and has a wood frame structural system clad in composition board and stucco. The side gable roof with a front gable roof projection is covered with composition shingles, as is the half-hip roof. The main entryway is on the west elevation through an obscured entryway that is recessed beneath the second story. Visible windows include a mixture of individual, paired, and grouped (4, 5), one-over-one vinyl single-hung sash units; individual and paired single pane vinyl awning units; individual vinyl fixed units with one pane and one pane with a half round top. Distinguishing architectural features include overhanging eaves with boxed rafter tails, corner boards, and support posts covered with stucco siding. Alterations include replacement roofing, siding, and windows, as well as the partial enclosure of the ground level to create additional living space and two garages. An addition was constructed on the north elevation. Overall, the building has been altered, lacks sufficient architectural features, and is not a significant embodiment of a type, period, or method of construction. In addition, background research did not reveal any historic associations with significant persons and/or events. As a result, 8MA02590 does not appear eligible for listing in the NRHP, either individually or as part of a historic district.

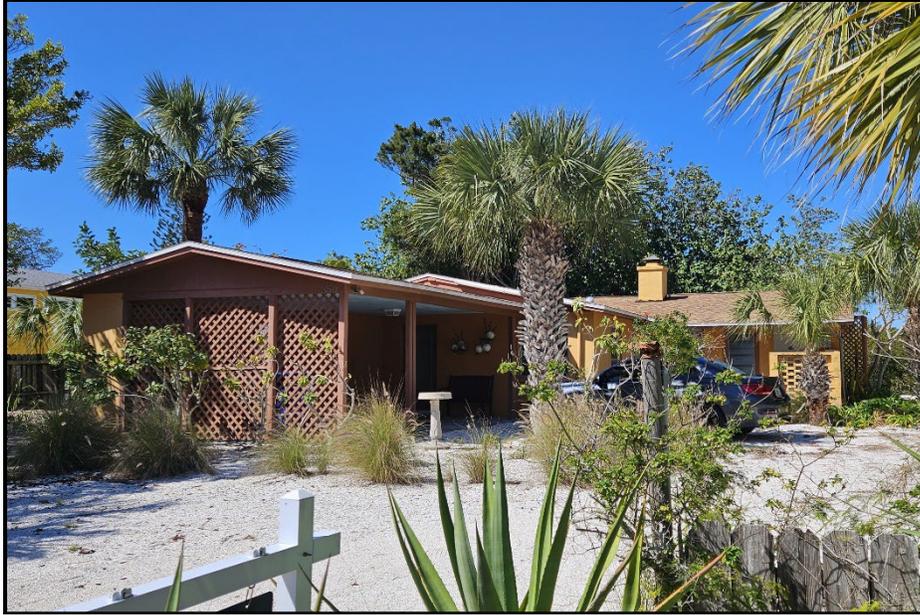
Photo 5.8. 350 North Shore Road (8MA02591), looking northwest.

8MA02591: The Masonry Vernacular style building at 350 North Shore Road was constructed in ca. 1966 (**Photo 5.8**). The one-story, irregular plan building rests on a concrete slab foundation and has concrete block structural system clad in stucco. The principal intersecting gable roof and gable roof over the carport are covered with composition shingles, while the shed roof is covered with composition roll. A masonry chimney covered with stucco is located within the slope of the roof on the south elevation. The main entryway is on the south elevation through a single door with an inset jalousie unit. Visible windows include a mixture of individual, one-over-one metal single-hung sash units, and individual three-stacked metal awning units. Distinguishing architectural features include overhanging eaves with boxed rafter tails, concrete windowsills, and a brick screen wall. Alterations include replacement roofing. Additions include a large gable roof carport on the south elevation and a shed roof on the north elevation. Overall, the building has been altered, lacks sufficient architectural features, and is not a significant embodiment of a type, period, or method of construction. In addition, background research did not reveal any historic associations with significant persons and/or events. As a result, 8MA02591 does not appear eligible for listing in the NRHP, either individually or as part of a historic district.

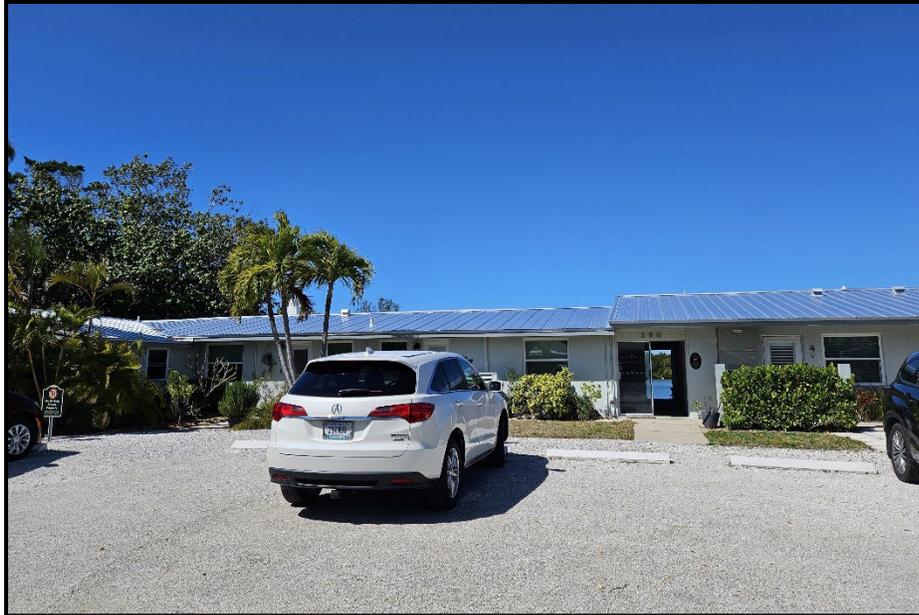
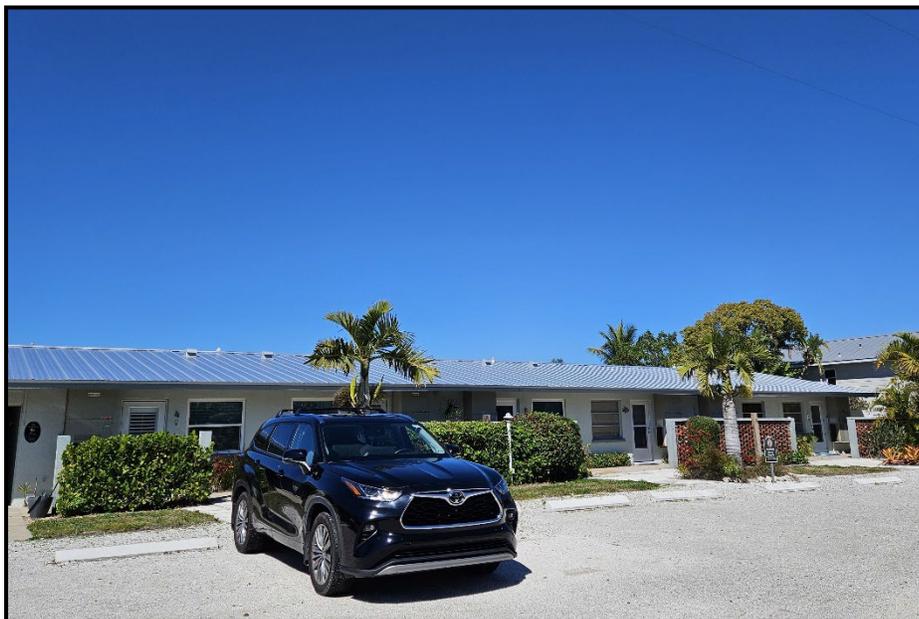
Photo 5.9. 380 North Shore Road (8MA02592), looking northwest.

Photo 5.10. 380 North Shore Road (8MA02592), looking northeast.

8MA02592: The Masonry Vernacular style condo building at 380 North Shore Road was constructed in ca. 1969 and contains nine units (**Photos 5.9 and 5.10**). The one-story, irregular plan building rests on a concrete slab foundation and has a concrete block structural system clad in stucco. The intersecting gable roof and shed roof are covered with ribbed sheet metal. A masonry chimney is located within the slope of the roof on the north elevation. The main entryways are on the south elevation through a single door per condo unit. The doors are of varying styles, but several include a full-length inset light. Visible windows include a mixture of individual, one-over-one vinyl single-hung sash units, and individual three-stacked metal awning units. Distinguishing architectural features include overhanging eaves with boxed rafter tails, concrete windowsills, and a central breezeway. The breezeway provides access between the parking lot to the south and the waterfront to the north and is

accessed through a sliding glass door. Alterations include replacement roofing and windows. A boat dock is located to the north of the building and brick screen walls are located along the south of the building between the entrances and the parking lot. Overall, the building has been altered, lacks sufficient architectural features, and is not a significant embodiment of a type, period, or method of construction. In addition, background research did not reveal any historic associations with significant persons and/or events. As a result, 8MA02592 does not appear eligible for listing in the NRHP, either individually or as part of a historic district.

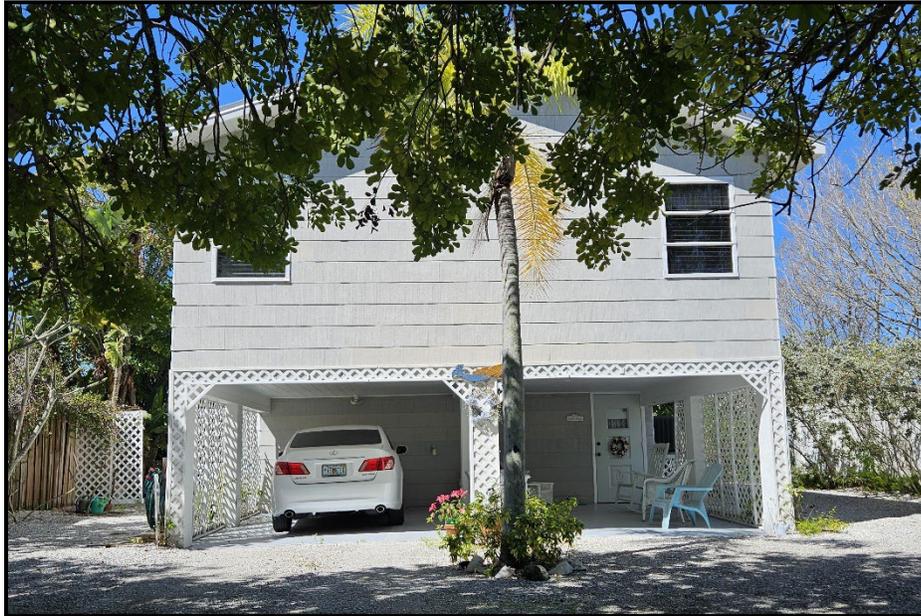
Photo 5.11. 400 North Shore Road (8MA02593), looking northwest.

8MA02593: The Frame Vernacular style building at 400 North Shore Road was constructed in ca. 1960 (**Photo 5.11**). The two-story, rectangular plan building rests on a concrete pier foundation and has a wood frame structural system clad in asbestos siding. The front gable roof is covered with composition shingles standing seam sheet metal. The main entryway is on the south elevation through a single door with square paneling and inset light beneath the second story. Visible windows include a mixture of individual one-, two-, and three-stacked metal awning units. Distinguishing architectural features include overhanging eaves with boxed rafter tails, concrete support piers, and wood lattice. Alterations include replacement roofing. An addition is located on the north elevation but is not visible from the public ROW. Two carports are located on the ground level beneath the residence. Overall, the building has been altered, lacks sufficient architectural features, and is not a significant embodiment of a type, period, or method of construction. In addition, background research did not reveal any historic associations with significant persons and/or events. As a result, 8MA02593 does not appear eligible for listing in the NRHP, either individually or as part of a historic district.

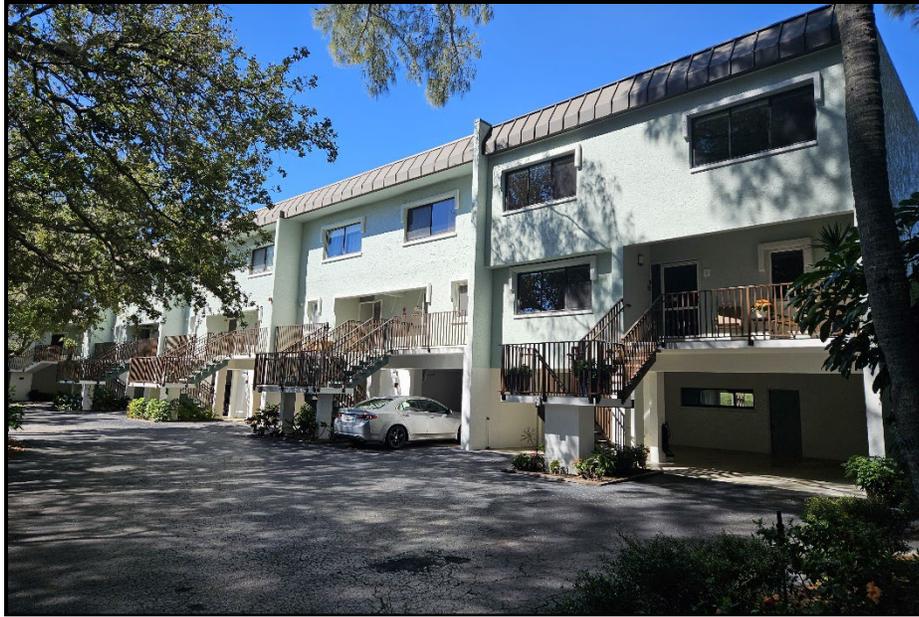
Photo 5.12. Northgate of Longboat Key (8MA02594), looking northwest.

8MA02594: The Masonry Vernacular style condo building at 490 North Shore Road was constructed in ca. 1978 (**Photo 5.12**). The building is known as Northgate of Longboat Key and contains nine units. The three-story, irregular plan building rests on a concrete slab foundation and has a concrete block structural system clad in stucco. The flat roof is covered with built-up roofing membrane. The main entryways are on the second story of the south elevation through a single door per unit, recessed beneath the third story. Visible windows include a mixture of individual one-by-one metal sliding units; individual metal picture units comprised of two fixed lights with one sliding light; individual single pane metal fixed units. Distinguishing architectural features include a non-structural faux-mansard style metal parapet, concrete wing walls, concrete windowsills, and bracket shaped lintels over the windows and doors. Alterations include replacement roofing. A flat roof addition is located on the west elevation. Each unit has a ground level carport recessed beneath the second story and a floating exterior staircase leading to the main entryway on the second story. A boat dock and swimming pool are located to the north of the building and a tennis court is located to the south. Overall, the building lacks sufficient architectural features, and is not a significant embodiment of a type, period, or method of construction. In addition, background research did not reveal any historic associations with significant persons and/or events. As a result, 8MA02594 does not appear eligible for listing in the NRHP, either individually or as part of a historic district.

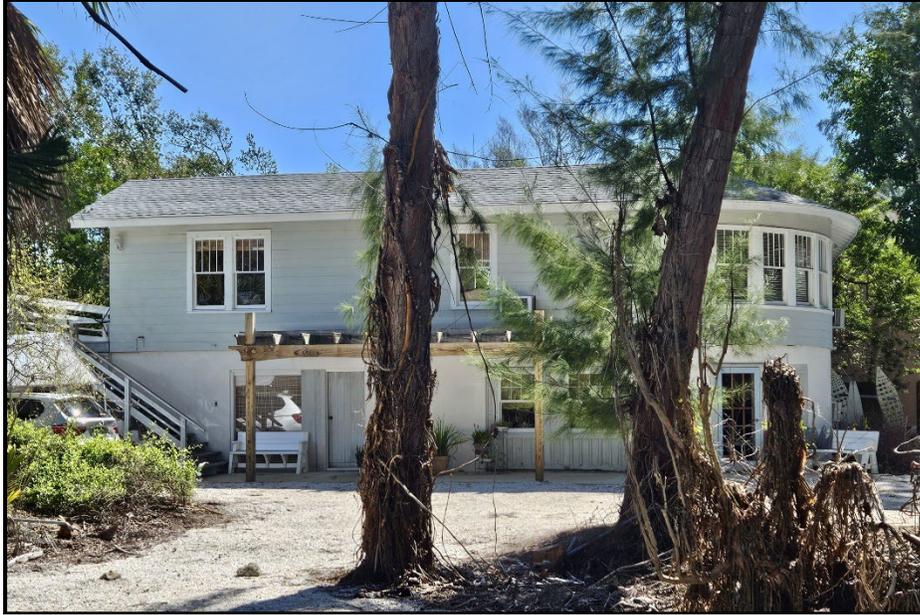
Photo 5.13. 7200 Gulf of Mexico Drive (8MA02595), looking southeast.

8MA02595: The Frame Vernacular style building at 7200 Gulf of Mexico Drive was constructed in ca. 1970 according to the property appraiser; however, the residence may predate this based on the construction and features such as the windows and partially exposed rafter tails (**Photo 5.13**). The lot on which the residence was constructed has historically been overgrown with little detail visible in historic aerial photographs. The first aerial photograph in which the building is clearly visible dates to ca. 1991 (FDOT 1991). The two-story, L-shaped building rests on a concrete slab foundation and has a concrete block structural system covered with stucco on the first story and a wood frame structural system clad in wood siding on the second story. It is unclear whether the house was originally open along the first story such as a stilt house. The L-shaped gable roof is covered with composition shingles. The main entryway is on the north elevation through a single door with a 15-pane inset light. Visible windows include a mixture of individual, paired, and grouped (7), four-over-one wood single-hung sash units; individual, eight-over-one vinyl single-hung sash units; paired four-pane metal casement units.; individual single pane metal fixed units. Distinguishing architectural features include overhanging eaves with partially exposed rafter tails, wood window and door surrounds, and a curved elevation at the bend in the L-shaped plan. Alterations include replacement roofing, windows, and siding where a portion of the first story appears to have been enclosed. It is unclear if any additions have been constructed due to the overgrown nature of the lot. Overall, the building has been altered, lacks sufficient architectural features, and is not a significant embodiment of a type, period, or method of construction. In addition, background research did not reveal any historic associations with significant persons and/or events. As a result, 8MA02595 does not appear eligible for listing in the NRHP, either individually or as part of a historic district.

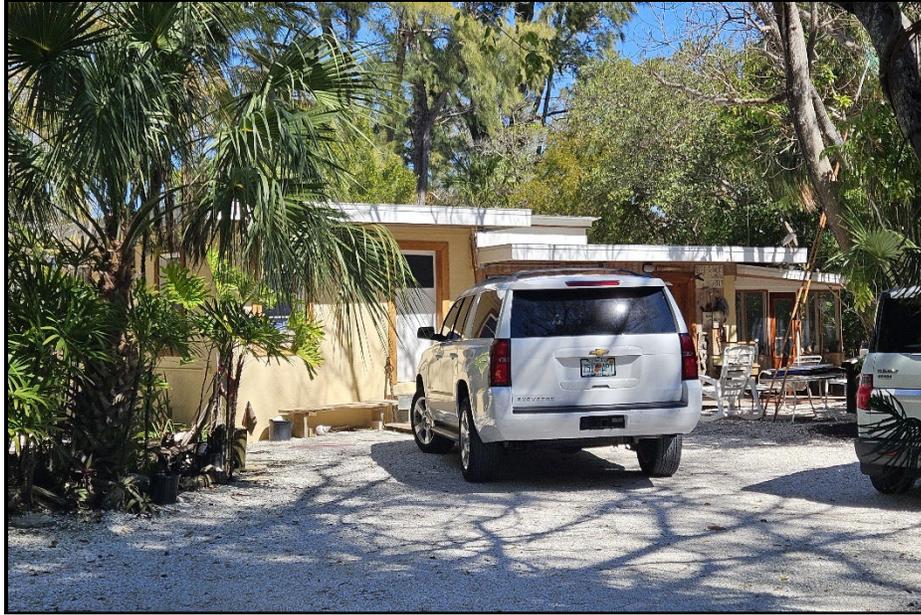
Photo 5.14. 7250 Gulf of Mexico Drive (Building 1) (8MA02596), looking northeast.

8MA02596: The Masonry Vernacular style building at 7250 Gulf of Mexico Drive was constructed in ca. 1950 (**Photo 5.14**). The one-story, irregular plan building rests on a continuous concrete block foundation and has a concrete block structural system clad in stucco and wood siding. The flat roofs are covered with built-up roofing membrane and the shed roofs are covered with 5V crimp sheet metal. The main entryway is on the north elevation through a single door accessed by concrete steps. Visible windows include a mixture of individual two-over-two wood single-hung sash units and paired single pane wood fixed units. Distinguishing architectural features include overhanging eaves with boxed rafter tails and wood surrounds on the windows and doors. Alterations include replacement roofing, siding, and windows. A large addition is located on the north elevation. The building is heavily obscured from the public ROW by surrounding vegetation. The property on which the building is located is referred to as “Land’s End” and was described during the *Historic Properties Survey of Longboat Key, Florida* conducted in 1999 (Hartig 1999). The resource was not recorded during this survey due to its age; however, it was described as having been originally constructed as a garage and workshop. Two Frame Vernacular style buildings are located on the property to the west (8MA02598) and north (8MA01155) of the building, as well as a Masonry Vernacular style building to the north (8MA02597) of the building. Overall, the building has been altered, lacks sufficient architectural features, and is not a significant embodiment of a type, period, or method of construction. In addition, background research did not reveal any historic associations with significant persons and/or events. As a result, 8MA02596 does not appear eligible for listing in the NRHP, either individually or as part of a historic district.

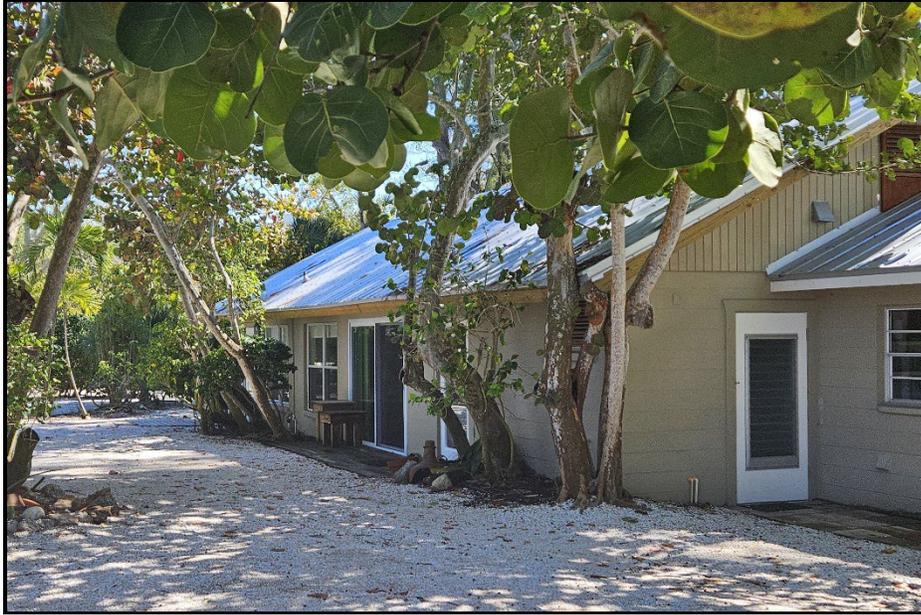
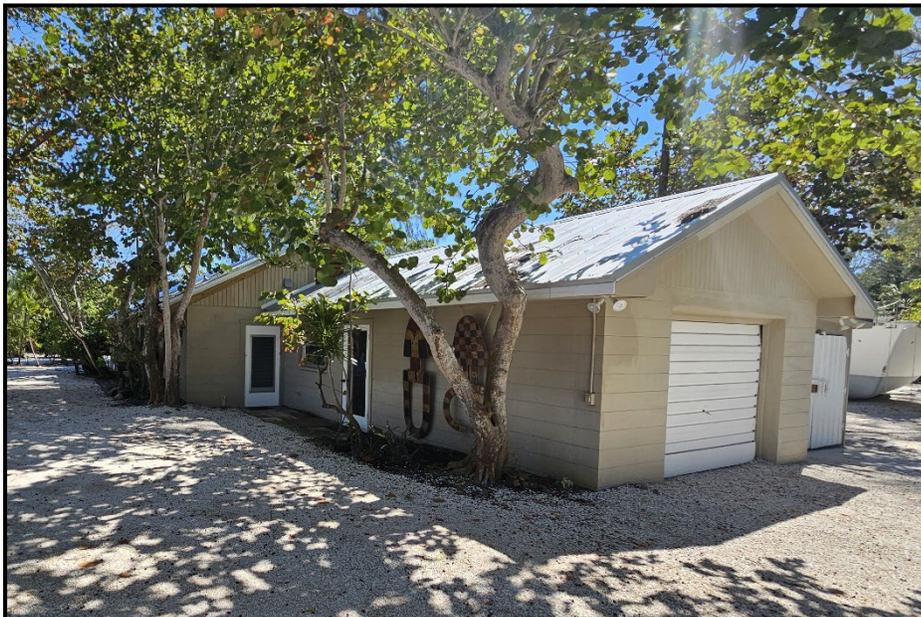
Photo 5.15. 7270 Gulf of Mexico Drive (8MA02597), looking southeast.

Photo 5.16. 7270 Gulf of Mexico Drive (8MA02597), looking southeast.

8MA02597: The Masonry Vernacular style building at 7270 Gulf of Mexico Drive was constructed in ca. 1970 (**Photos 5.15 and 5.16**). The one-story, irregular plan building rests on a concrete slab foundation and has a concrete block structural system clad in stucco and wood siding in the gable ends. The side gable roof and shed roof are covered with ribbed sheet metal. The main entryway is on the north elevation through a single door with a full-length inset light. Visible windows include a mixture of individual and paired, one-over-one and two-over-two metal single-hung sash units. Distinguishing architectural features include overhanging eaves with boxed rafter tails, concrete windowsills, rectangular gable vents, and stucco siding scored with horizontal lines. Alterations include replacement roofing and windows. A one-car garage is located on the west elevation and a shed roof addition with a secondary one-car garage is located on the south elevation of the primary garage. The

property on which the building is located is referred to as “Land’s End” and was described during the *Historic Properties Survey of Longboat Key, Florida* conducted in 1999 (Hartig 1999). The resource was not recorded during this survey due to its age. Two Frame Vernacular style buildings are located on the property to the south (8MA02598) and north (8MA01155) of the building, as well as a Masonry Vernacular style building to the south (8MA02596) of the building. Overall, the building lacks sufficient architectural features, and is not a significant embodiment of a type, period, or method of construction. In addition, background research did not reveal any historic associations with significant persons and/or events. As a result, 8MA02597 does not appear eligible for listing in the NRHP, either individually or as part of a historic district.

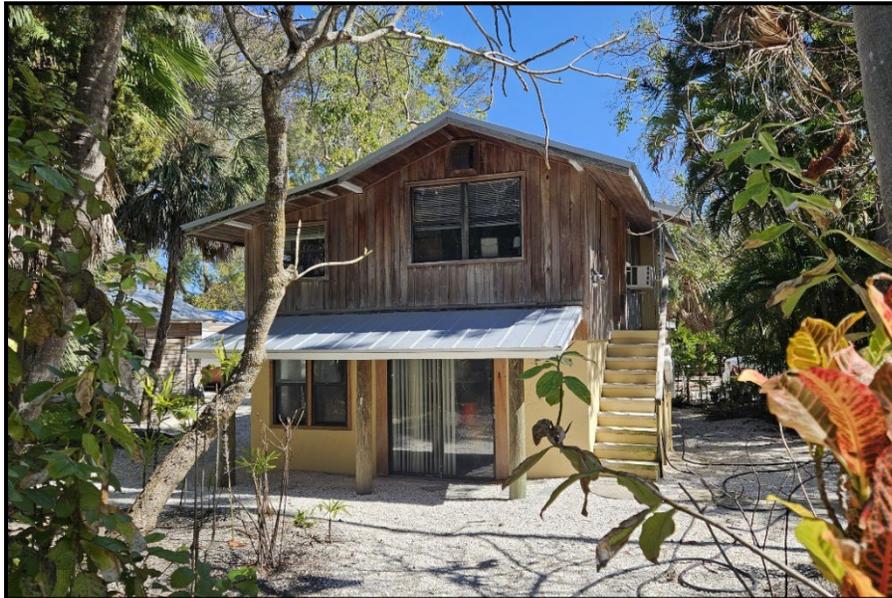
Photo 5.17. 7250 Gulf of Mexico Drive (Building 2) (8MA02598), looking east-northeast.

8MA02598: The Frame Vernacular style apartment building at 7250 Gulf of Mexico Drive was constructed in ca. 1942 (**Photo 5.17**). The two-story, irregular plan building rests on a concrete slab foundation and has a wood frame structural system clad in stucco on the first story and wood siding on the second story. The front gable roof and shed roofs are covered with 5V crimp sheet metal. The main entryway to the first story unit is on the west elevation through double metal frame sliding doors within a full width open porch beneath a shed roof with wood pile supports. The main entryway to the second story unit is on the south elevation through a single wooden door with inset four pane light over three panels beneath a shed roof extension with metal scroll supports. It is accessed by a flight of concrete steps with a wood railing. Visible windows include a mixture of individual and paired, one-over-one metal single-hung sash units. Distinguishing architectural features include overhanging eaves with boxed rafter tails, wood surrounds on the windows and doors, and a rectangular gable vent. Alterations include replacement roofing and windows. The shed roof porch on the west elevation is an addition. The property on which the building is located is referred to as “Land’s End” and was described during the *Historic Properties Survey of Longboat Key, Florida* conducted in 1999 (Hartig 1999). The resource was not recorded during this survey. One Frame Vernacular style building is located on the property to the north (8MA01155) of the building, as well as two Masonry Vernacular style buildings to the east (8MA02596) and north (8MA02597) of the building. Overall, the building lacks sufficient architectural features, and is not a significant embodiment of a type, period, or method of construction. In addition, background research did not reveal any historic associations with significant persons and/or events. As a result, 8MA02598 does not appear eligible for listing in the NRHP, either individually or as part of a historic district.

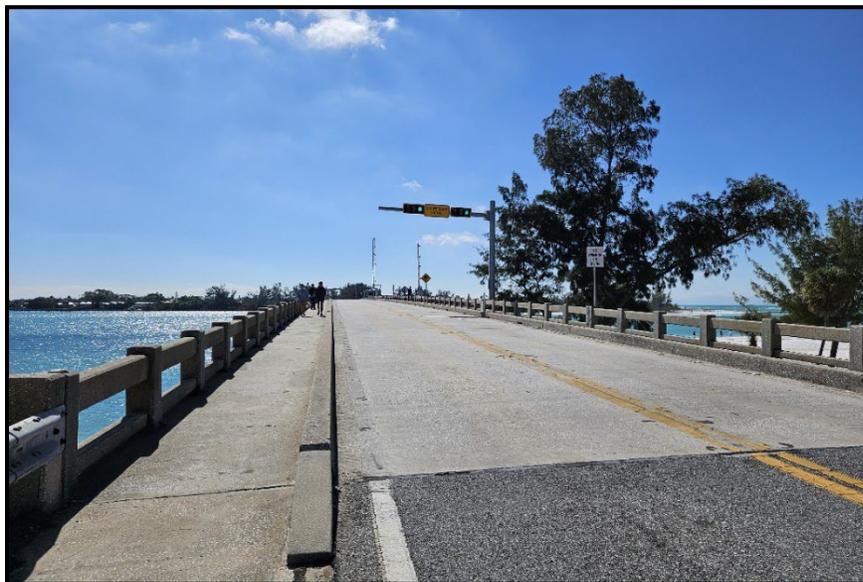
Photo 5.19. Longboat Key Bridge (FDOT 130057) (8MA01807), looking south.

8MA01807: The Longboat Key Bridge (FDOT 130057) is a 44 span movable bascule style bridge that was constructed in 1957 to carry S.R. 789 over Longboat Pass and provide northern access to Longboat Key from Anna Maria Island (**Photos 5.18 and 5.19**). A former bridge was located at this point from ca. 1926 until 1932 when it was washed away by a high tide. Between ca. 1932 and 1957, the only access to Longboat Key was from the south end of the island in Sarasota. The overall dimension of the bridge measures approximately 2,128-ft long and 37-ft wide with a roadway width of approximately 24-ft. The main span is a steel single leaf movable bascule that is approximately 64-ft long. The remainder of the bridge is comprised of 43 concrete stringer multi-beam approach spans. The substructure has sloped concrete bag abutments while the superstructure is supported by concrete bents, each comprised of four squared piers with a concrete header. The bridge deck along the approach spans is concrete paved with asphalt, while the movable bascule is steel grid. Decorative details include a
