**CULTURAL RESOURCE ASSESSMENT SURVEY  
PROJECT DEVELOPMENT AND ENVIRONMENT STUDY  
STATE ROAD (SR) 659 (COMBEE ROAD)  
FROM US 98 TO NORTH CRYSTAL LAKE DRIVE**

**POLK COUNTY, FLORIDA**

**Financial Project ID.: 440274-1-22-01  
Federal Aid Project No.: D117-089-B  
Work Program Item Segment No.: 440274-1-22-01  
ETDM No: 14326**

**March 2021**

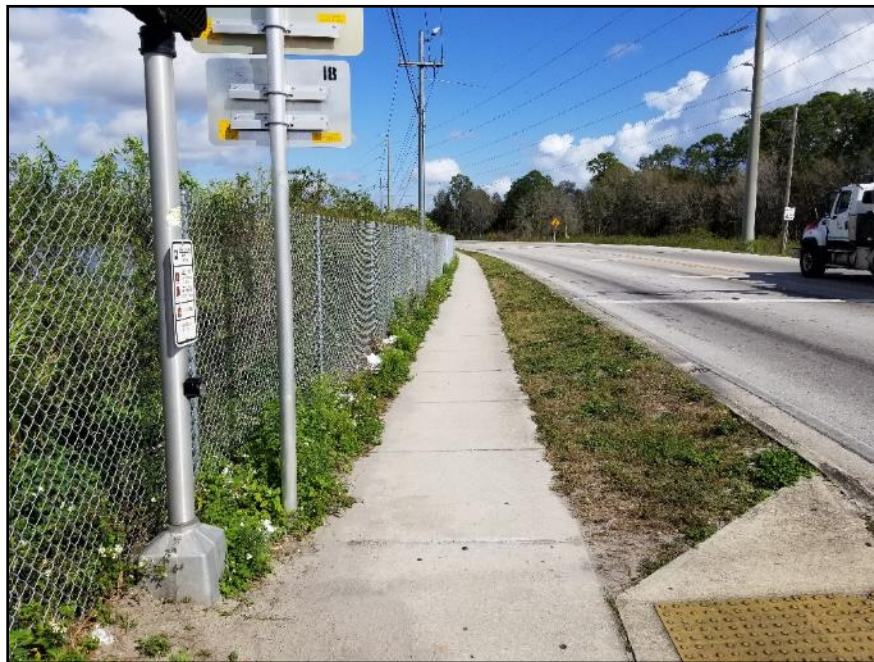
**Photo 2.1** Looking north at typical conditions found along the northwest portion of the APE. Crystal Lake is to the west (left in photo). Note modern disturbance within APE.

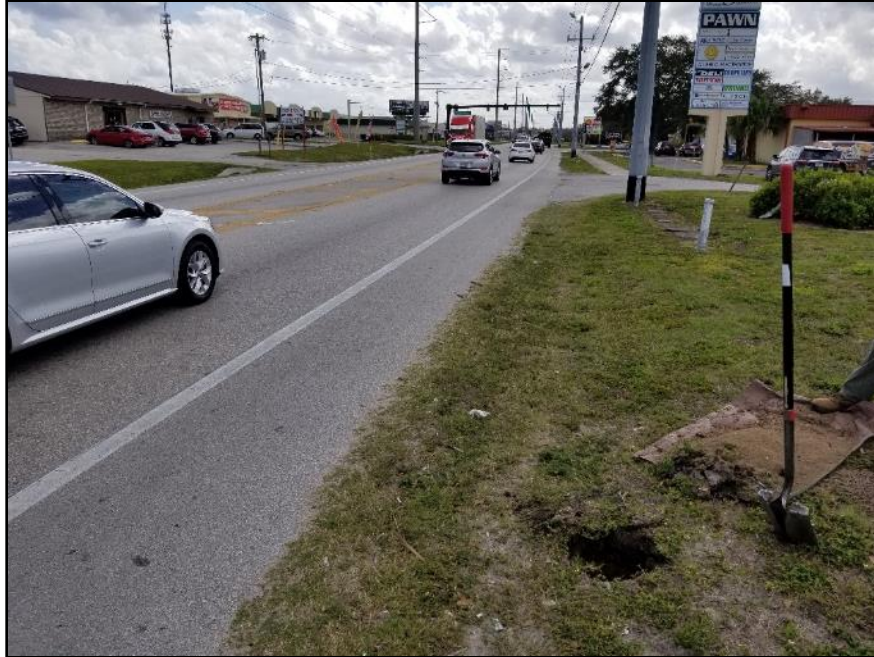
**Photo 2.2.** Looking south at typical conditions found along the middle portion of the west side of the APE. Note modern disturbance within APE.

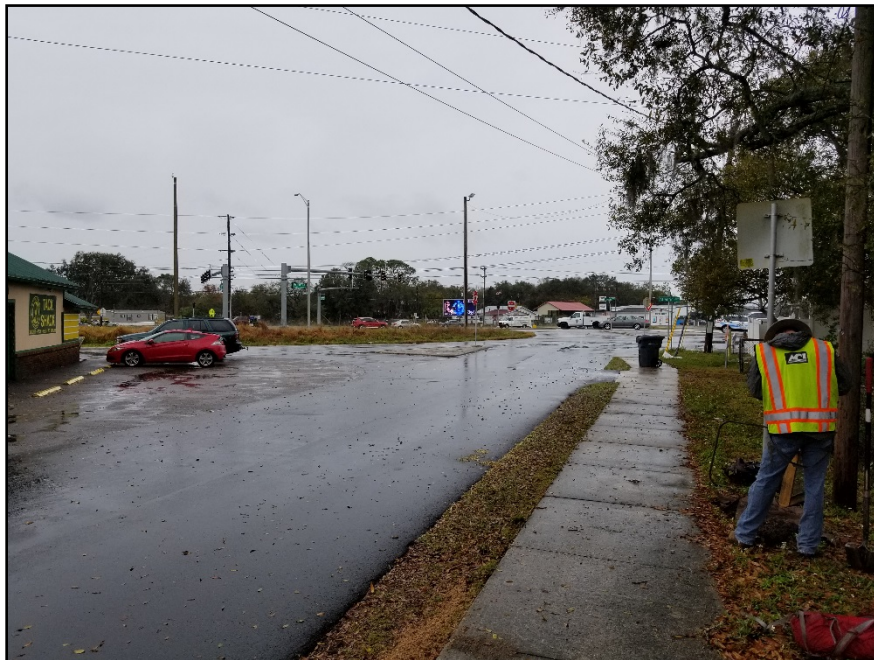
**Photo 2.3.** Looking west at conditions found along the south western portion of the APE. The testing is being conducted along Eaton Avenue, east of Combee Road. Note modern disturbance within APE.

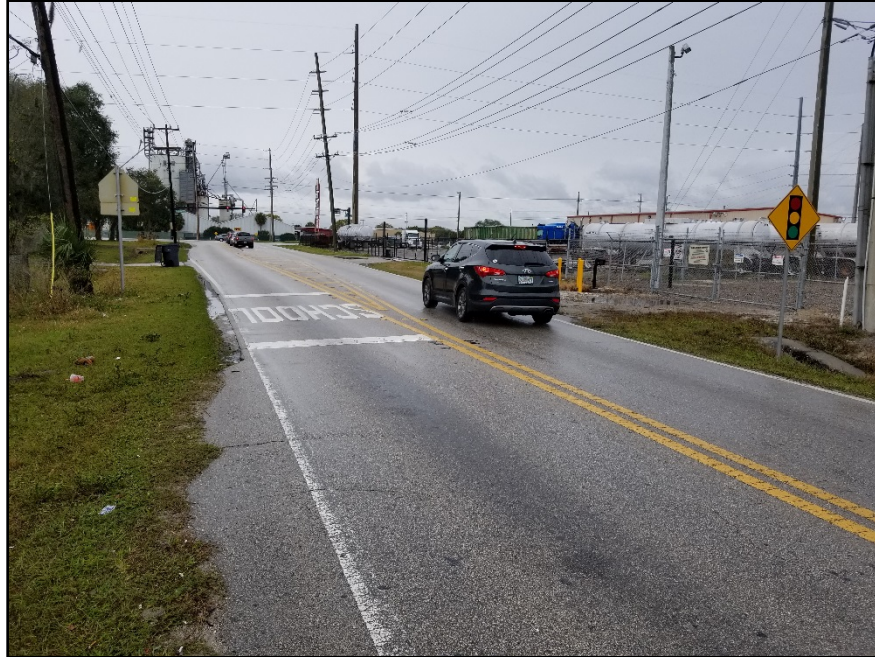
**Photo 2.4.** Looking west northwest at conditions from Maine Avenue toward Combee Avenue. Note modern disturbance such as drainage, light poles, signage, and driveways within APE.

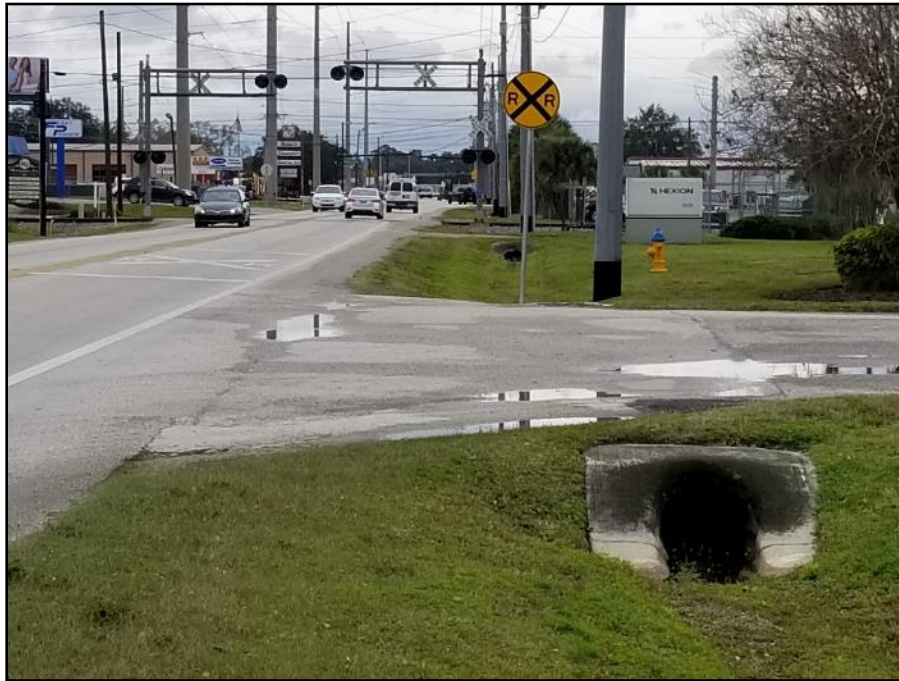
**Photo 5.1.** Looking south at west side of APE, south of Crystal Wood Drive. Note the numerous examples of modern disturbance within the archaeological APE.

The archaeological investigations consisted of surface reconnaissance combined with systematic and judgmental subsurface testing. A total of 49 shovel tests was excavated within the APE (Figures 5.1 & 5.2). Of these, 26 were placed in the area of moderate probability around Crystal Lake and Exchange Avenue (prior to land-altering activities) at 50 m intervals, and 23 were placed judgmentally. The judgmental tests were placed at various intervals depending on availability of non-disturbed soil and safety. A reasonable and good faith effort was made per the regulations laid out in 36 CFR § 800.4(b) (1) (Advisory Council on Historic Preservation n.d.) to test all areas of the project APE; however, some areas were not tested due to the presence of sidewalks, ditches, underground and above ground utilities, concrete paving, signage, and other significant disturbance (Photos 5.1-5.4; Photos 2.1-2.4; Appendix B).

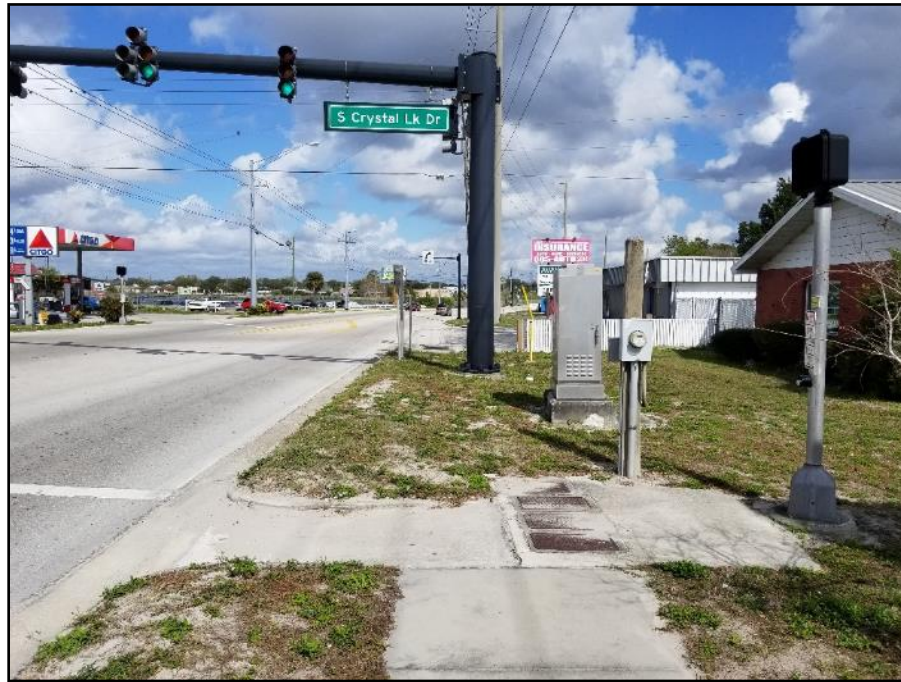
**Photo 5.2.** Looking north at numerous examples of disturbance with the archaeological APE. Crystal Lake is to the west (left on photograph).

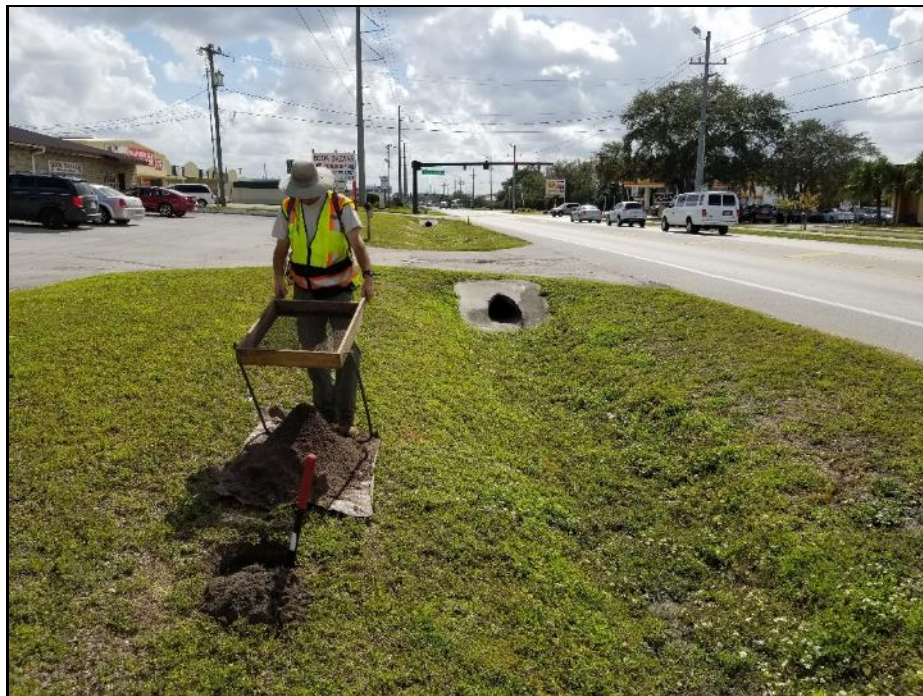
**Photo 5.3.** Looking south at examples of disturbance within archaeological APE. Commerce Point Drive is in the background. Note the limited and disturbed area available for testing.

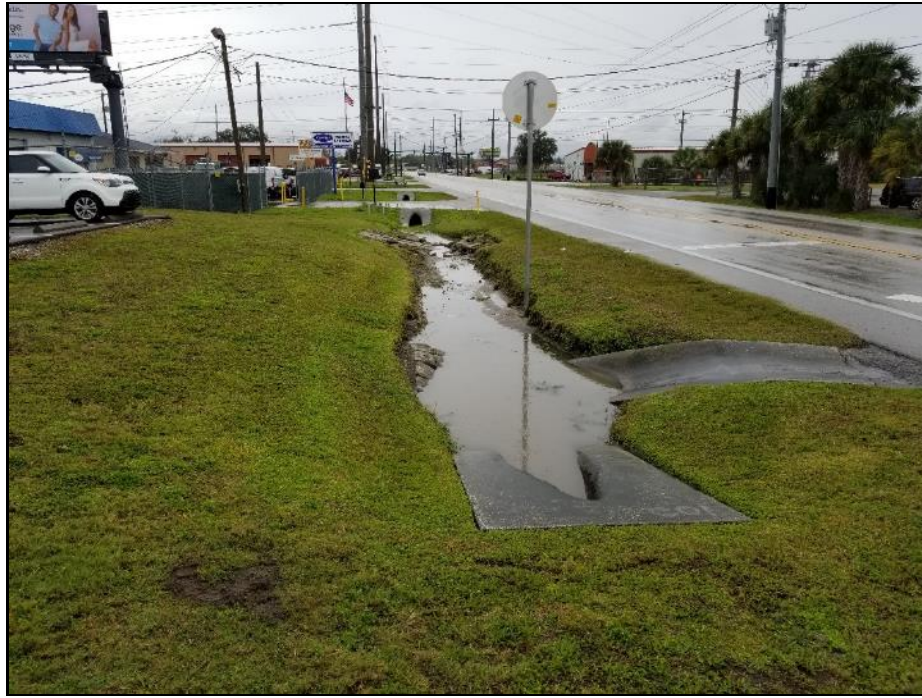
**Photo 5.4.** Looking south at examples of soil disturbance within APE. Area is between McJunkin Road and Crystal Wood Drive. Note various utility lines and retention/drainage ditch.

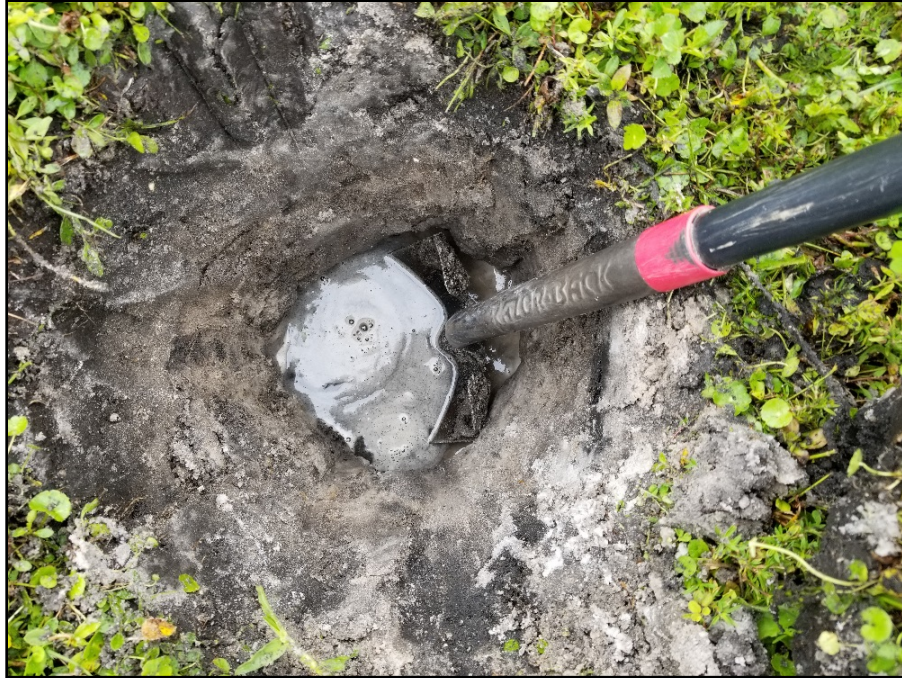
**Photo 5.5.** Example of shovel test with early water intrusion.  
Area is within APE, south of McJunkin Road.

The stratigraphy found in the shovel tests varied slightly depending on location. In the moderate probability area in the northern portion of the APE (around Crystal Lake) the stratigraphy consisted of 0 to 50 centimeters below surface (cmbs) of dark gray-brown gravelly sand, 50 to 80 cmbs of brown mottled gravelly sand, followed by 80 to 100 cmbs of very light gray sand. Water usually entered the shovel tests at 90 cmbs. In the moderate probability area in the middle portion of the APE (near Exchange Avenue), the stratigraphy was 0 to 20 cmbs of dark gray-brown gravelly sand, 20 to 80 cmbs of gray-brown gravelly sand, followed by 80 to 100 cmbs of dark gray brown sand. The remainder of the tests had similar stratigraphy to that noted above. Some tests were terminated prior to reaching 100 cmbs due to the presence of utilities, water, or excessive fill material (**Photos 5.5-5.6**).

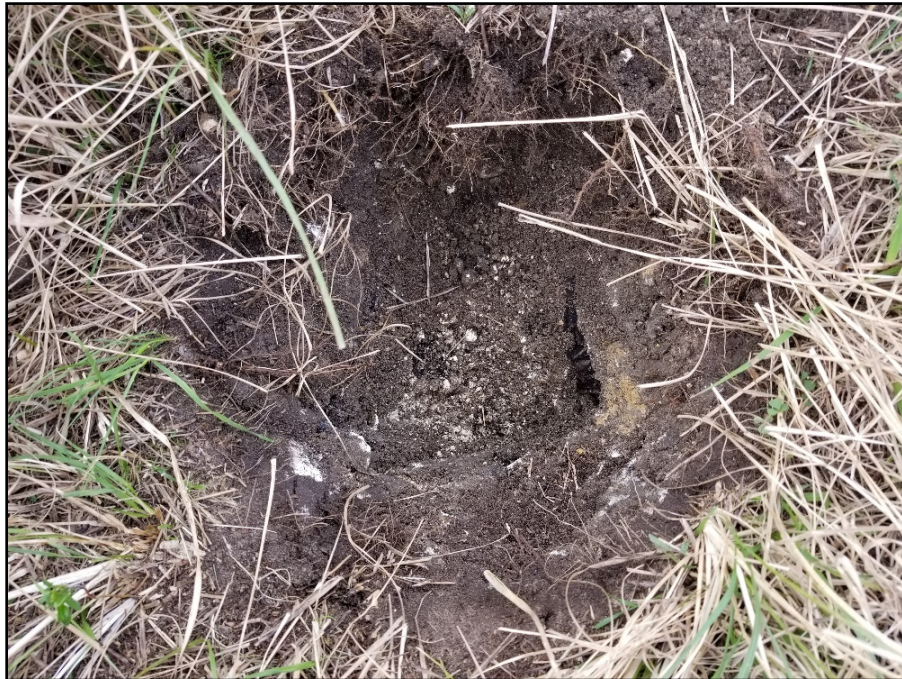
**Photo 5.6.** Example of shovel test with dense gravel fill.

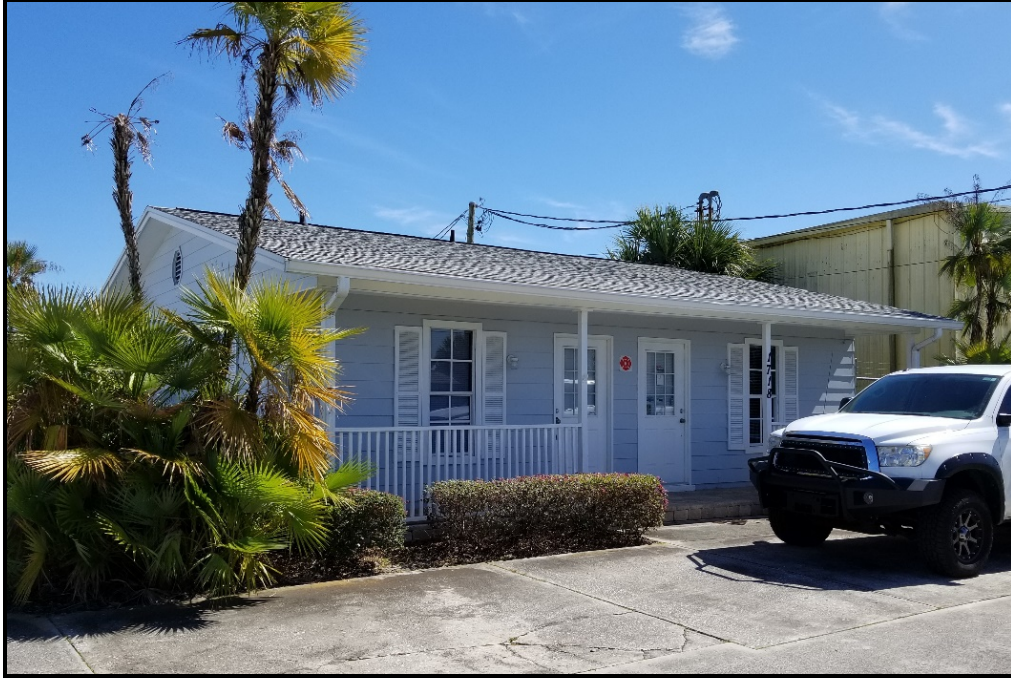
**Photo 5.7.** The Frame Vernacular style office building at 1718 Combee Road S (8PO08185), facing southeast.

**Frame Vernacular:** Four historic resources within the historic APE are of the Frame Vernacular style (**Photo 5.7**) and were constructed between ca. 1920 and 1969 (**Table 5.1; Figure 5.1**). This building serves as the front office, while the masonry additions is for loading and receiving of shipments. Frame Vernacular buildings reflect the local customs, environment, and building materials, and do not rely on academic architectural vocabulary for their design and ornament. They are often built by developers, contractors, master carpenters, or the building's occupants. These buildings are decidedly practical structures. Within the APE, this building type generally has a concrete slab or concrete block pier foundation with a variety of siding including drop siding, plywood, brick, or horizontal plank. Roof types consist of gable or cross gabled, most of which are clad with composition shingles. Windows are typically single-hung sash. Exterior ornamentation consists mostly of concrete trim around windows and doors, awnings, and shutters. Most display replacement windows and roofs.

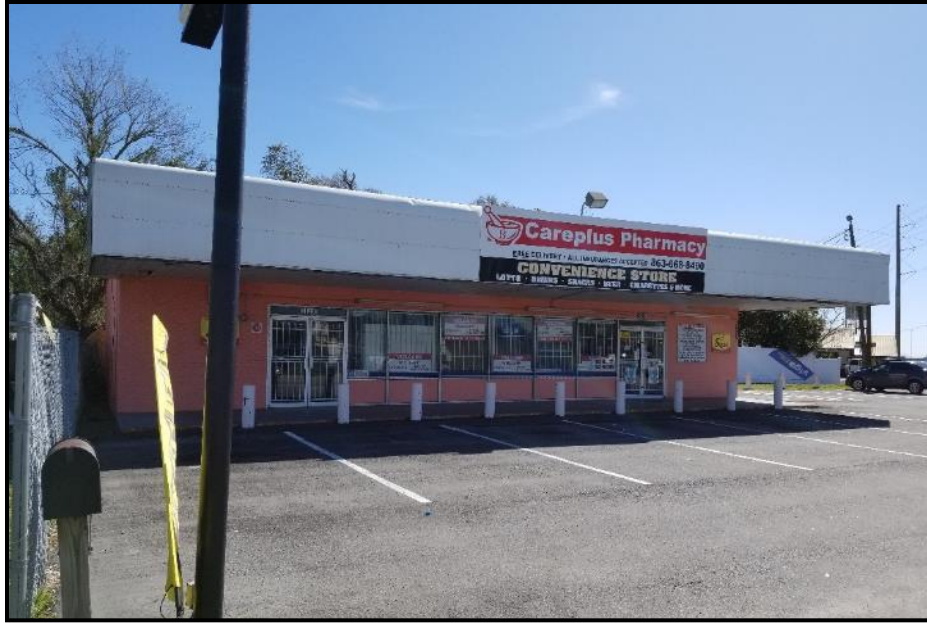
**Photo 5.8.** The Masonry Vernacular style store at 3020 Combee Road S (8PO08162), facing southeast.

**Masonry Vernacular:** A total of 15 historic resources within the historic APE are of the Masonry Vernacular style (**Photos 5.8 through 5.10**). The majority of these resources are store or office buildings with construction dates that range from the late-1950s through the 1960s (see **Table 5.1**). Like Frame Vernacular style buildings, Masonry Vernacular style buildings are simply built with available local materials and boasting little ornamentation. Within the APE, this building type generally has concrete slab foundations and concrete block walls. Roof types consist of gable or flat, most of which are clad with composition shingles. The exterior cladding often consists of stucco. Windows typically are awning or single-hung sash. Exterior ornamentation consists mostly of concrete window sills, security grills, and shutters. Most display replacement windows and roofs, and wood-frame additions are common as seen in **Photo 5.10**.

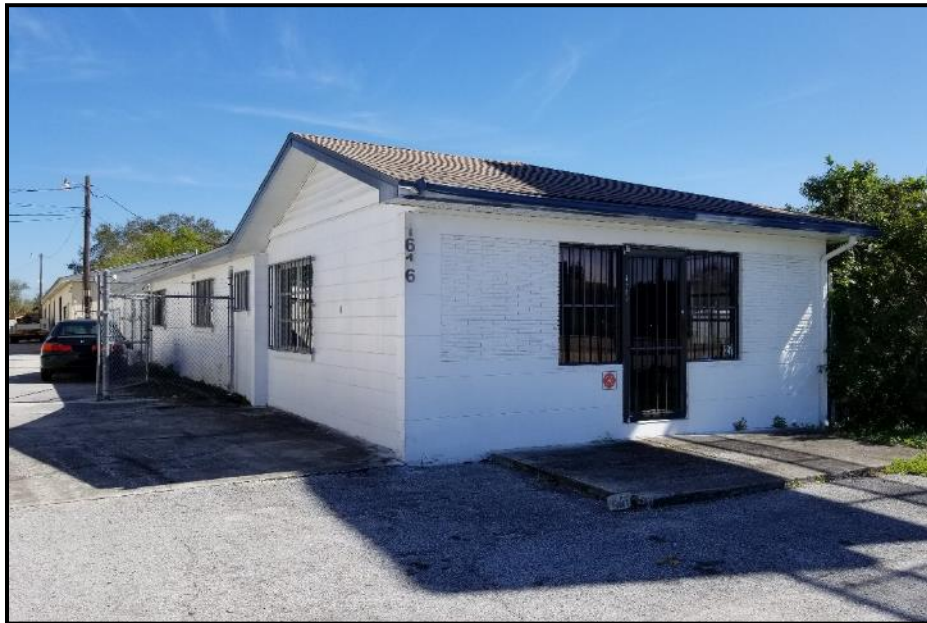
**Photo 5.9.** The Masonry Vernacular style office at 1616 Combee Road S (8PO08191), facing southeast.

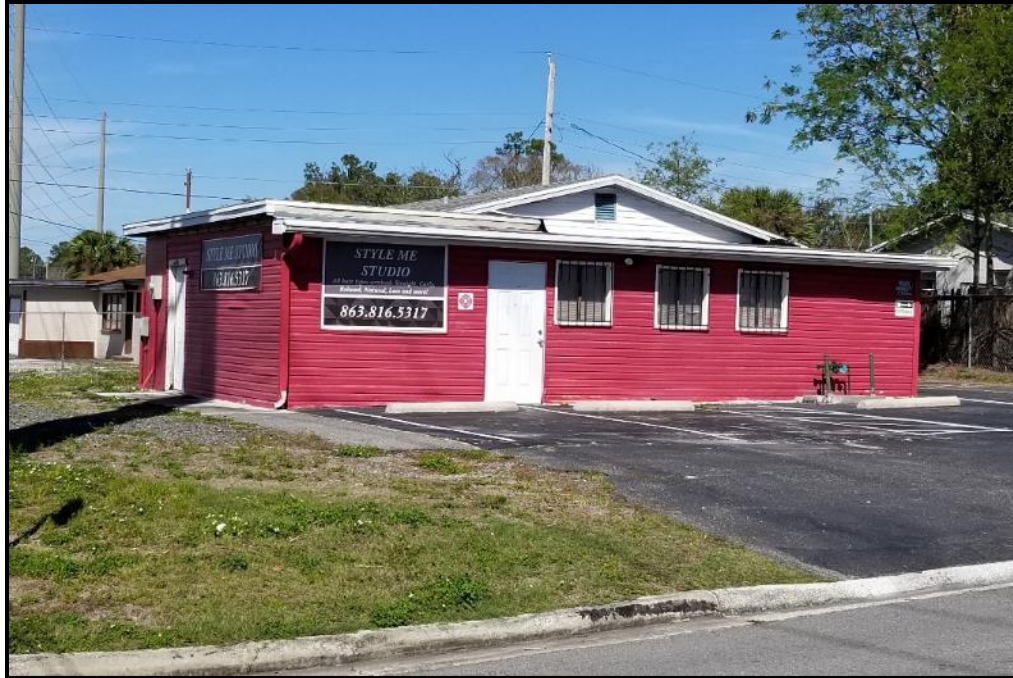
**Photo 5.10.** The Masonry Vernacular style store at 1440 Combee Road S (8PO08195), facing northeast.

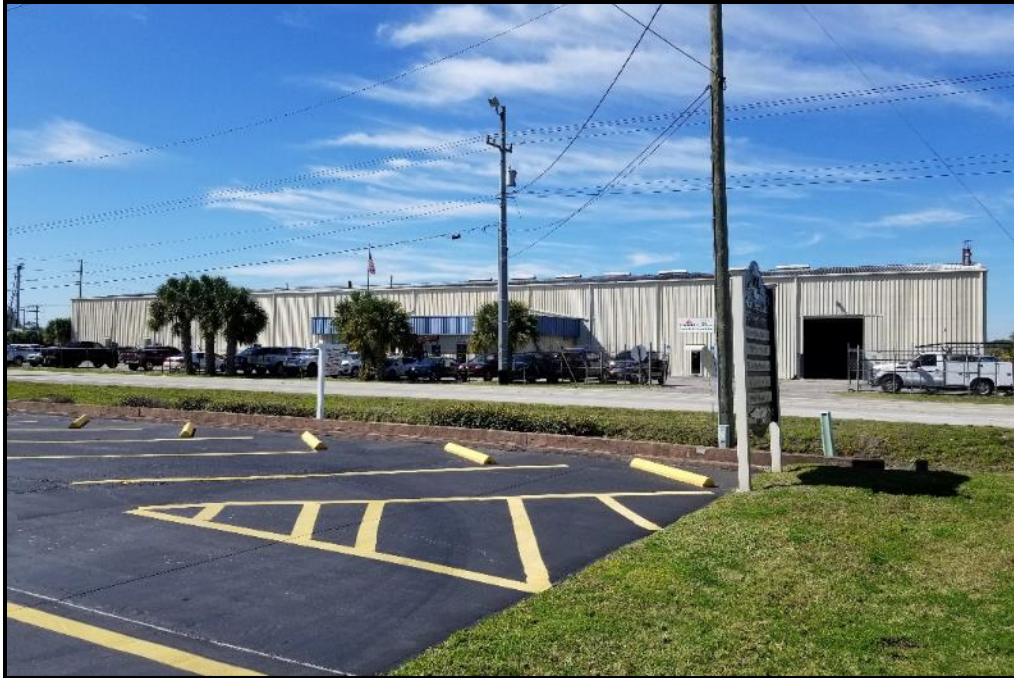
**Photo 5.11.** The Industrial Vernacular style building at 2701 Combee Road S (8PO08165), facing southwest.

Vernacular style buildings, Industrial Vernacular style structures are simply built with available local materials and display little ornamentation. Within the APE, this building type usually has slab foundations, and gable is the most represented roof type. Most of the building exteriors, as well as the roofs, are clad with metal. Most of the warehouse facilities have an office attached to the front that are typically partially clad in brick veneer (**Photo 5.12**). Awning metal windows are most common, and exterior ornamentation is minimal. The majority display alterations or additions.

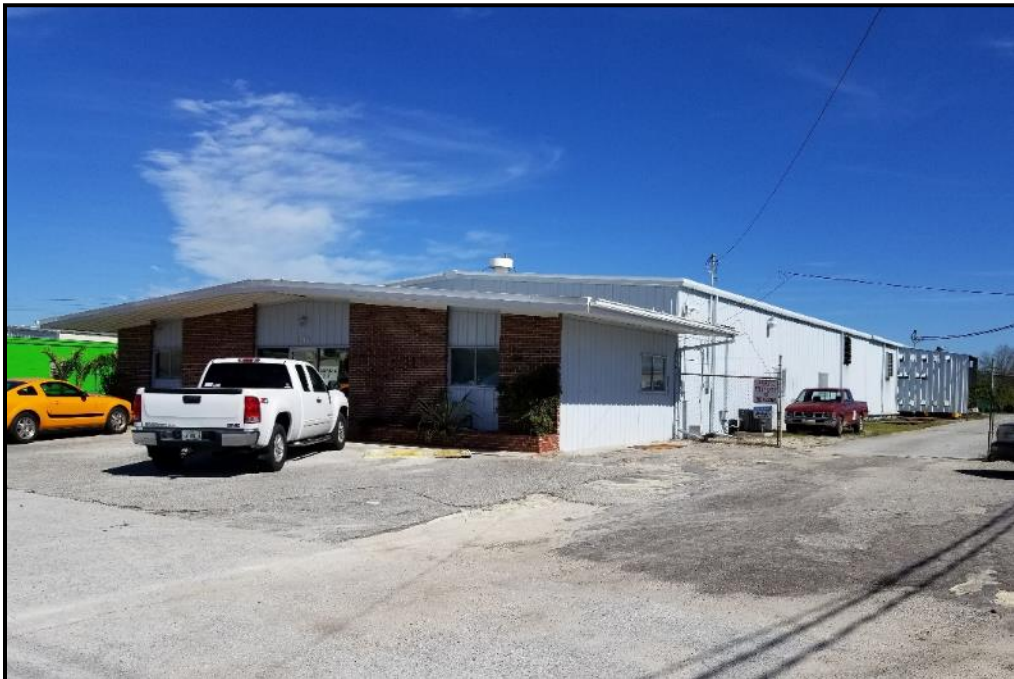
**Photo 5.12.** The Industrial Vernacular style building at 1716 Combee Road S (8PO08186), facing northeast.

**Industrial Vernacular:** Seven historic resources within the historic APE are of the Industrial Vernacular style (**Photos 5.11 & 5.12**) and have construction dates that range from 1965 to 1969 (see **Table 5.1**). The majority are industrial or storage buildings. Similar to Masonry Vernacular and Frame

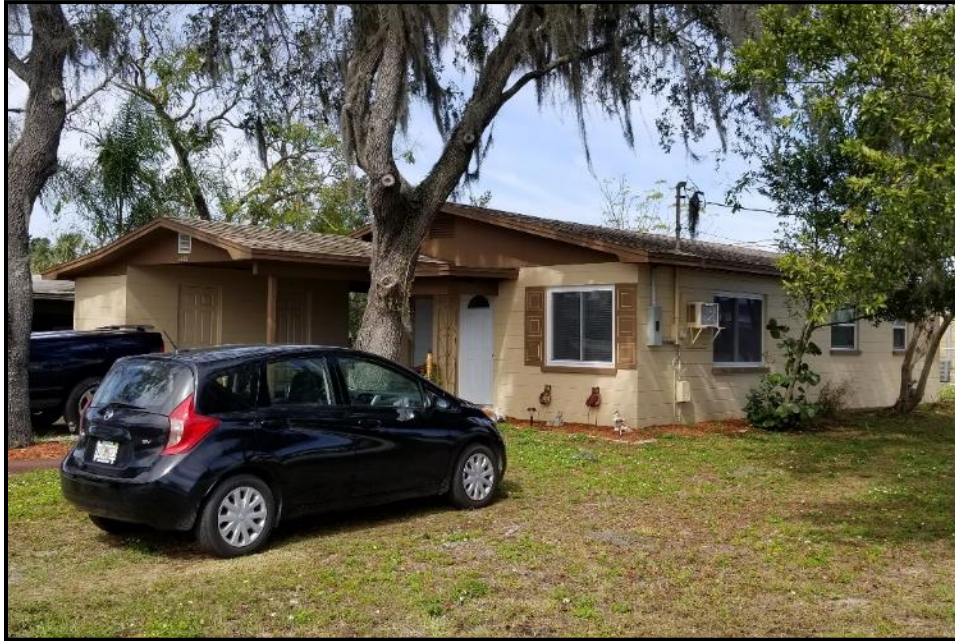
**Photo 5.13.** The Minimal Ranch style residence at 2626 Civitan Avenue (8PO08171), facing northwest.

**Minimal Ranch:** Thirteen historic resources within the historic APE are of the Minimal Ranch style (**Photos 5.13-5.15**) and have construction dates from 1959 to 1960 (see **Table 5.1**). These historic resources are part of the Royal Oak Manor subdivision and are all residential buildings. The style, which gained popularity after World War II, features low-slung buildings and a low-pitched roof with large windows (McAlester 2015). Within the APE, this building type has a concrete slab foundation with a concrete block structural system. The majority of these buildings are partially clad in brick veneer and have an attached carport. Roof types consist of side or front gable roofs clad with composition shingles. Fenestration typically includes picture, awning, and single-hung sash windows. Exterior ornamentation is minimal, and typically consists of gable vents with different siding on the gable end and brick veneer. Most display alterations or additions, such as replacement roofs and windows, living-space additions and carports converted into a living-space.

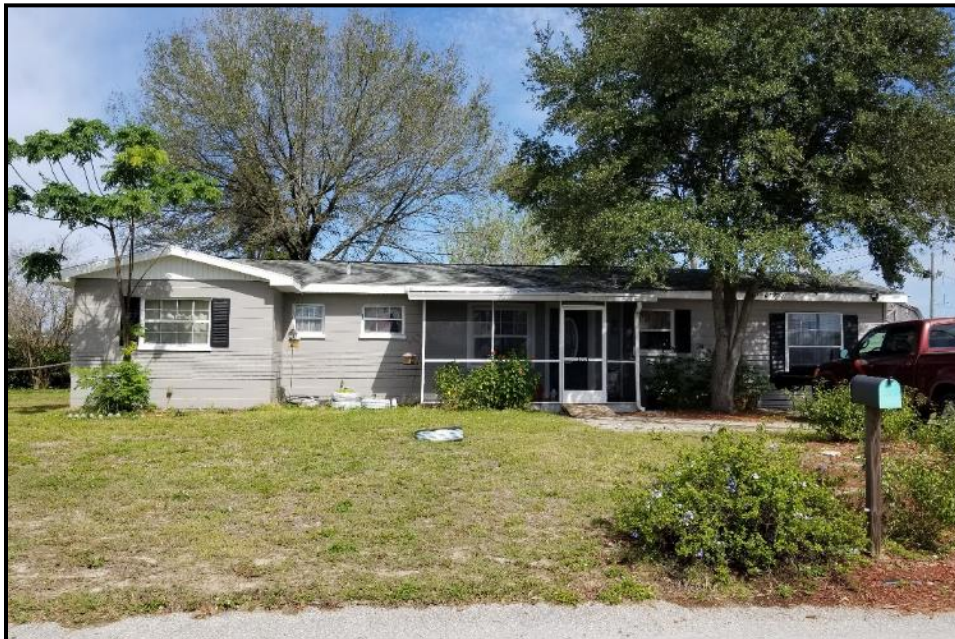
**Photo 5.14.** The Minimal Ranch style residence at 2624 Exchange Avenue (8PO08173), facing north.

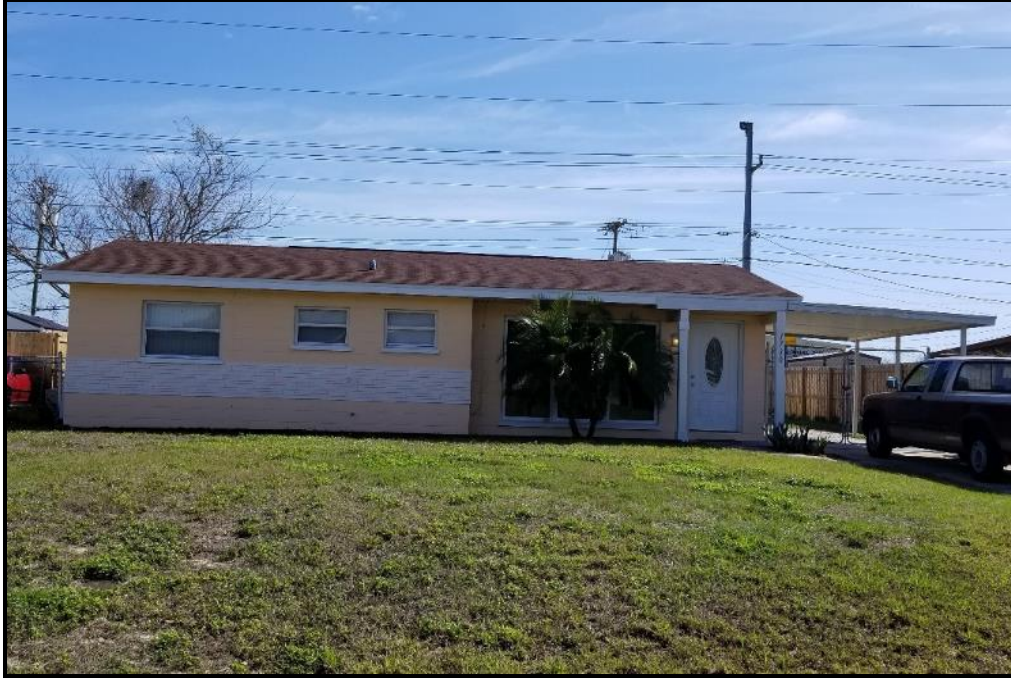
**Photo 5.15.** The Minimal Ranch style residence at 1730 Rotary Drive (8PO08180), facing east.

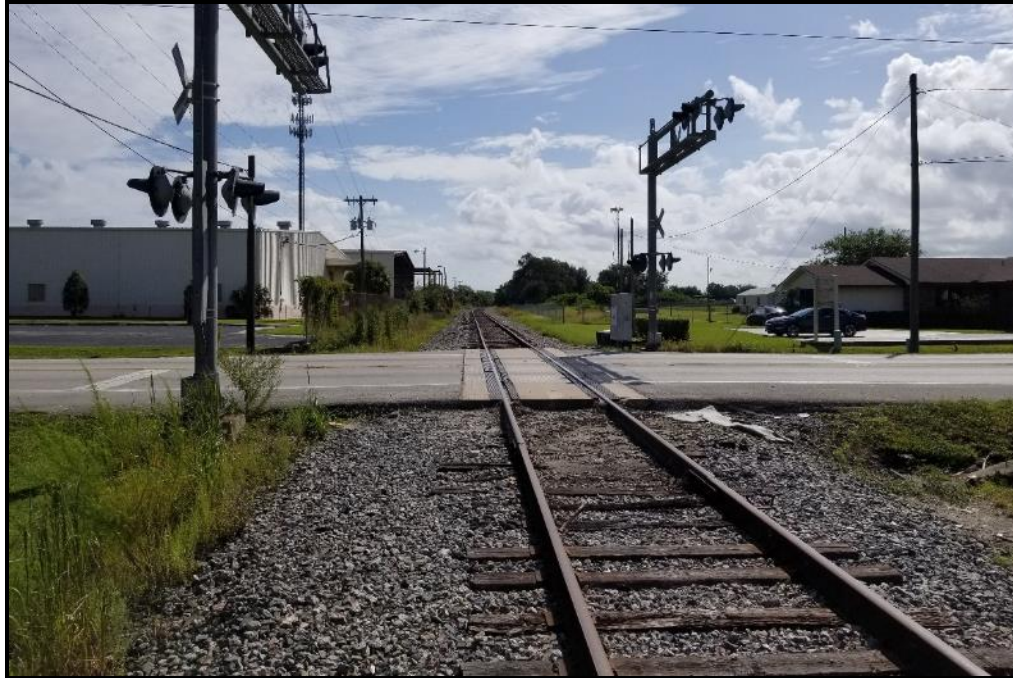
**Photo 5.16.** Atlantic Coast Line – Eaton Park Spur (8PO08480), facing east.

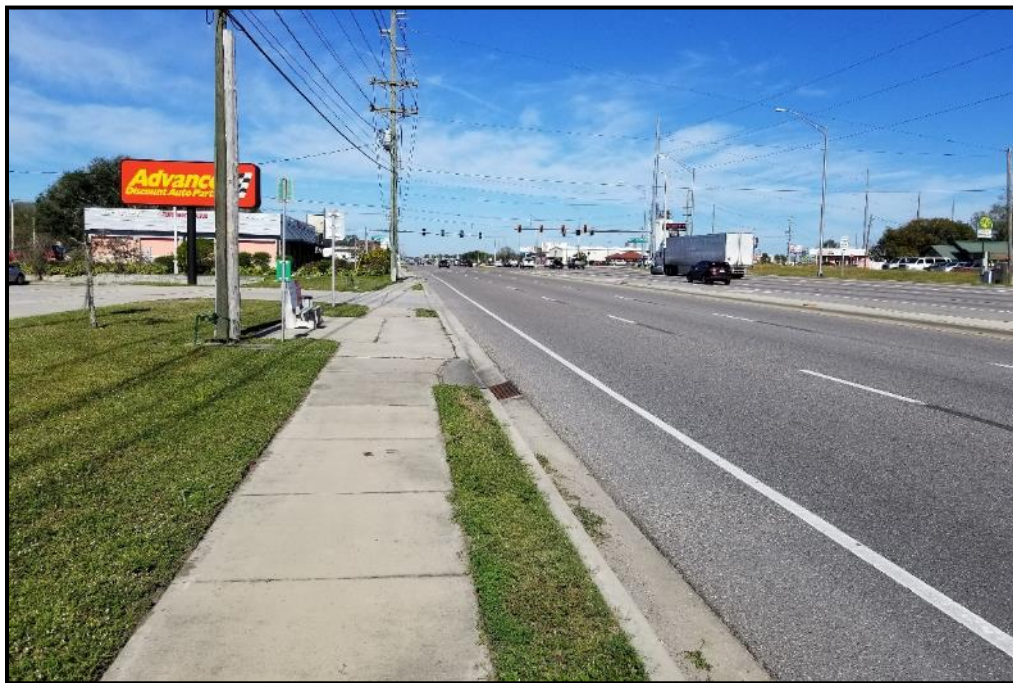
**Photo 5.17.** US 98 (8PO08009), facing northwest.

**Linear Resources:** Three historic resources within the historic APE are linear resources (**Photos 5.16 & 5.17**) and have construction dates from c. 1885 to c. 1963 (see **Table 5.1**). These include the South Florida Railroad (CSX Railroad) (8PO07219), US 98 (8PO08009), a six-lane divided highway, constructed in c. 1940, and a segment of the Atlantic Coast Line – Eaton Park Spur (8PO08480) constructed in c. 1963. The South Florida Railroad (CSX Railroad) (8PO07219) and US

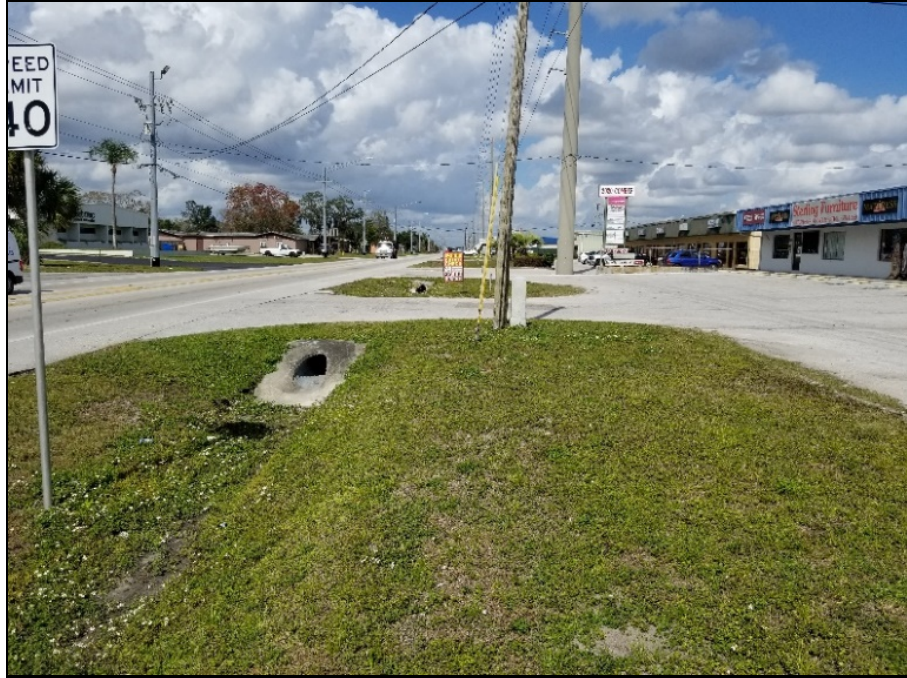
Looking north at ditch, pavement, and utilities within a moderate probability area of APE.

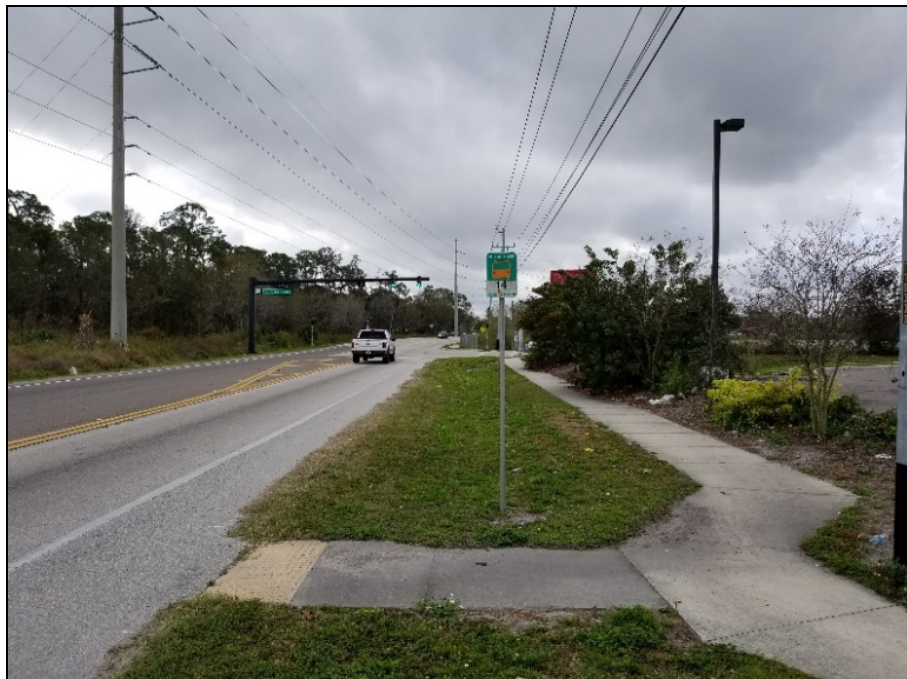
Looking south at disturbance within area of moderate probability near the north end of APE.

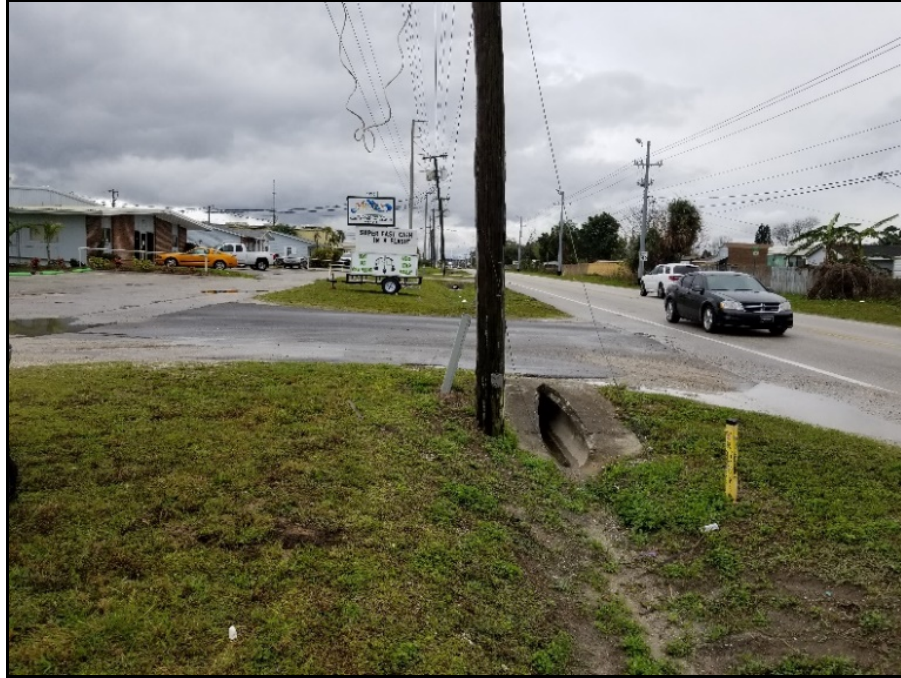
Looking south at gas line, utilities, pavement, and ditch in area east of Kiwanis Avenue within the APE.

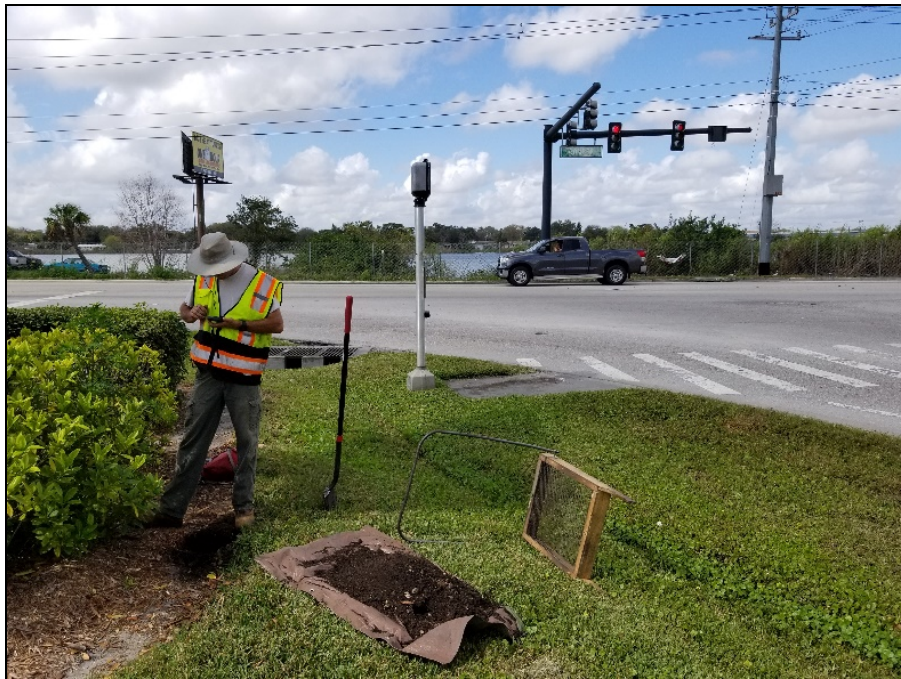
Looking west at intersection of Combee Road and Skyview Drive at the northern end of the APE.  
Note examples of disturbance.

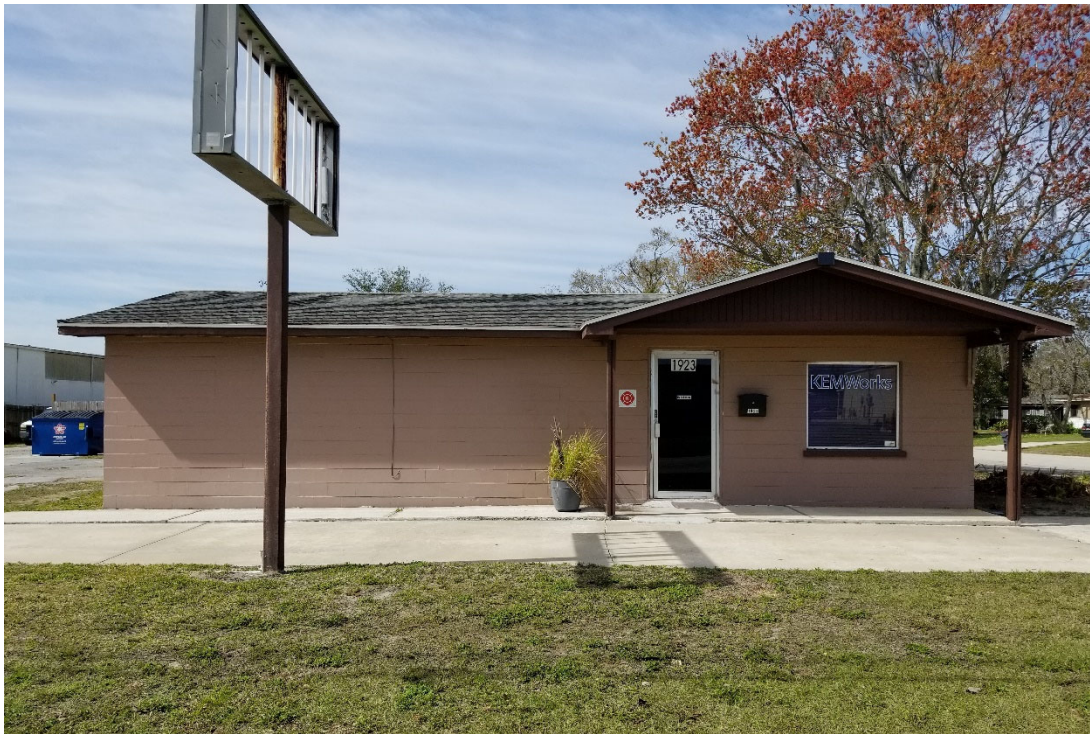
**PHOTOGRAPH**

Facing west

Chimney: No. \_\_\_\_ Chimney Material(s): 1. \_\_\_\_ 2. \_\_\_\_  
 Structural System(s): 1. Concrete block 2. \_\_\_\_ 3. \_\_\_\_  
 Foundation Type(s): 1. Slab 2. \_\_\_\_  
 Foundation Material(s): 1. Concrete, Generic 2. \_\_\_\_  
 Main Entrance (stylistic details) S elev: through single panel door with fanlight beneath a flat roof with metal supports  
 Porch Descriptions (types, locations, roof types, etc.) S/ENTRANCE: open, partial-width, within the carport beneath a gable roof

Condition (overall resource condition): ☐ excellent ☒ good ☐ fair ☐ deteriorated ☐ ruinous

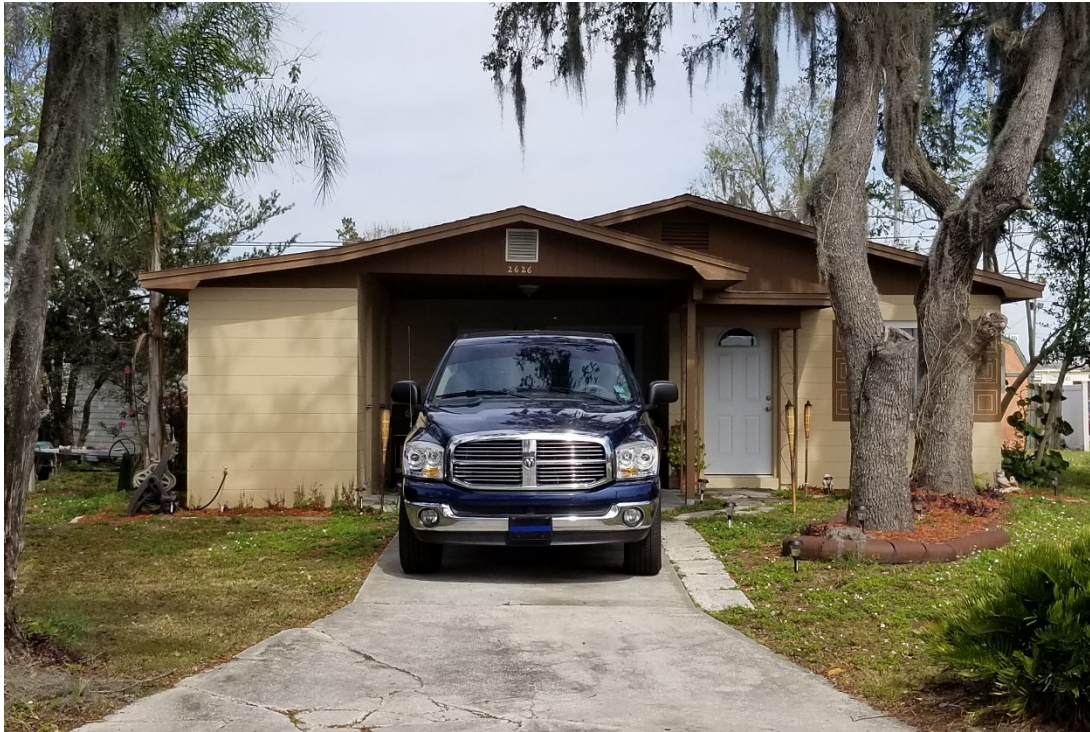
**PHOTOGRAPH**

Facing north

Chimney: No. \_\_\_\_ Chimney Material(s): 1. \_\_\_\_ 2. \_\_\_\_  
 Structural System(s): 1. Concrete block 2. \_\_\_\_ 3. \_\_\_\_  
 Foundation Type(s): 1. Slab 2. \_\_\_\_  
 Foundation Material(s): 1. Concrete, Generic 2. \_\_\_\_  
 Main Entrance (stylistic details) N elev: through single panel door with fanlight beneath a flat roof with metal supports  
 Porch Descriptions (types, locations, roof types, etc.) N/ENTRANCE: open, partial-width, beneath a flat roof with metal supports

Condition (overall resource condition): ☐ excellent ☒ good ☐ fair ☐ deteriorated ☐ ruinous

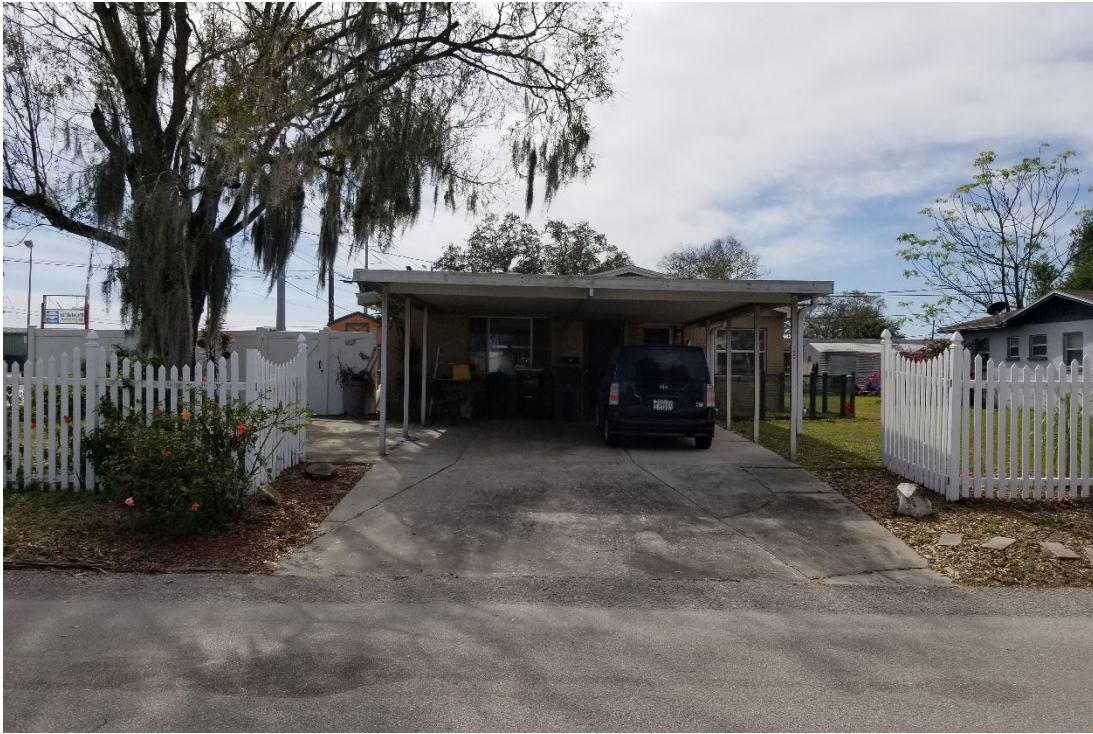
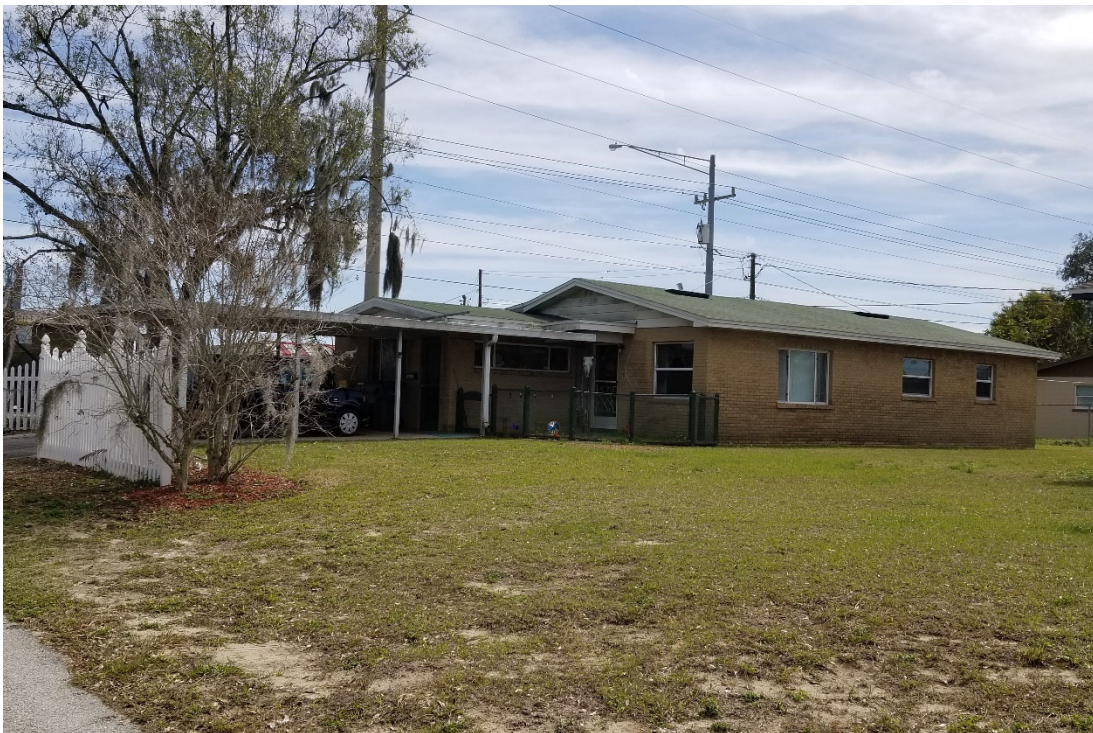
**PHOTOGRAPH**

Facing south

Facing southeast

Chimney: No. \_\_\_\_ Chimney Material(s): 1. \_\_\_\_ 2. \_\_\_\_  
 Structural System(s): 1. Concrete block 2. \_\_\_\_ 3. \_\_\_\_  
 Foundation Type(s): 1. Slab 2. \_\_\_\_  
 Foundation Material(s): 1. Concrete, Generic 2. \_\_\_\_

Condition (overall resource condition): ☐excellent ☒good ☐fair ☐deteriorated ☐ruinous

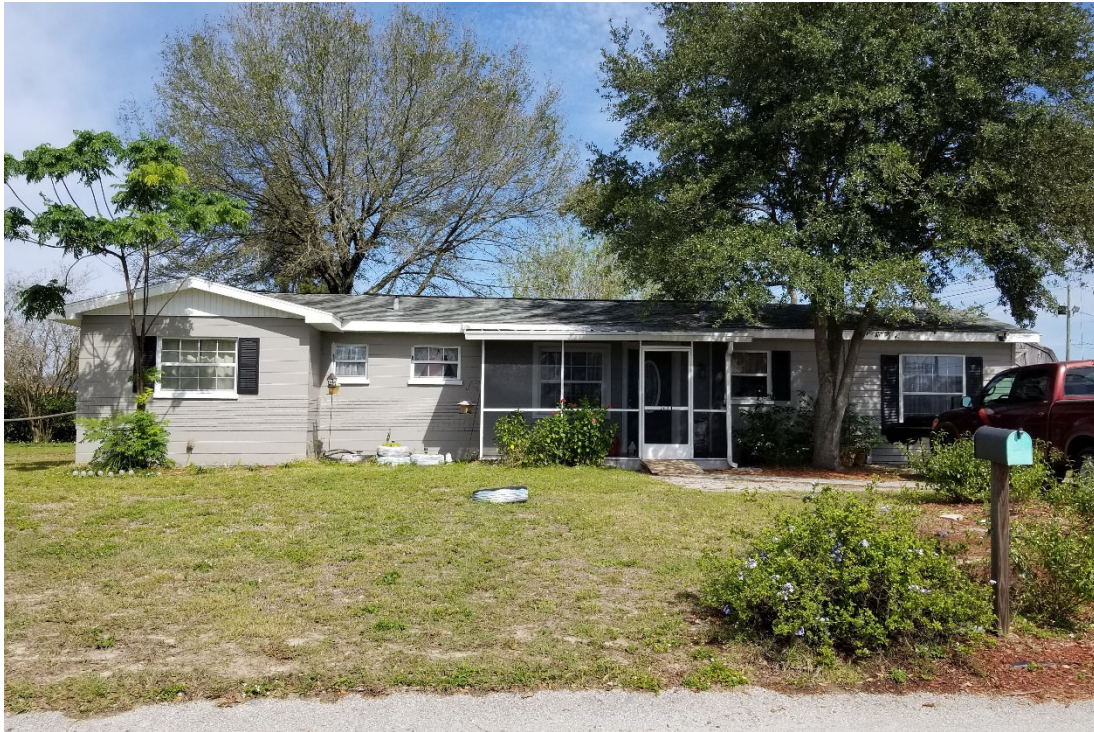
**PHOTOGRAPH**

Facing north

Chimney: No. \_\_\_\_ Chimney Material(s): 1. \_\_\_\_ 2. \_\_\_\_  
 Structural System(s): 1. Concrete block 2. \_\_\_\_ 3. \_\_\_\_  
 Foundation Type(s): 1. Slab 2. \_\_\_\_  
 Foundation Material(s): 1. Concrete, Generic 2. \_\_\_\_  
 Main Entrance (stylistic details) W elev: through single panel door recessed beneath the principal gable roof

Condition (overall resource condition): ☐excellent ☒good ☐fair ☐deteriorated ☐ruinous
