**CULTURAL RESOURCE ASSESSMENT SURVEY  
PROJECT DEVELOPMENT AND ENVIRONMENT STUDY  
STATE ROAD (SR) 659 (COMBEE ROAD)  
FROM US 98 TO NORTH CRYSTAL LAKE DRIVE**

**POLK COUNTY, FLORIDA**

**Financial Project ID.: 440274-1-22-01  
Federal Aid Project No.: D117-089-B  
Work Program Item Segment No.: 440274-1-22-01  
ETDM No: 14326**

**March 2021**

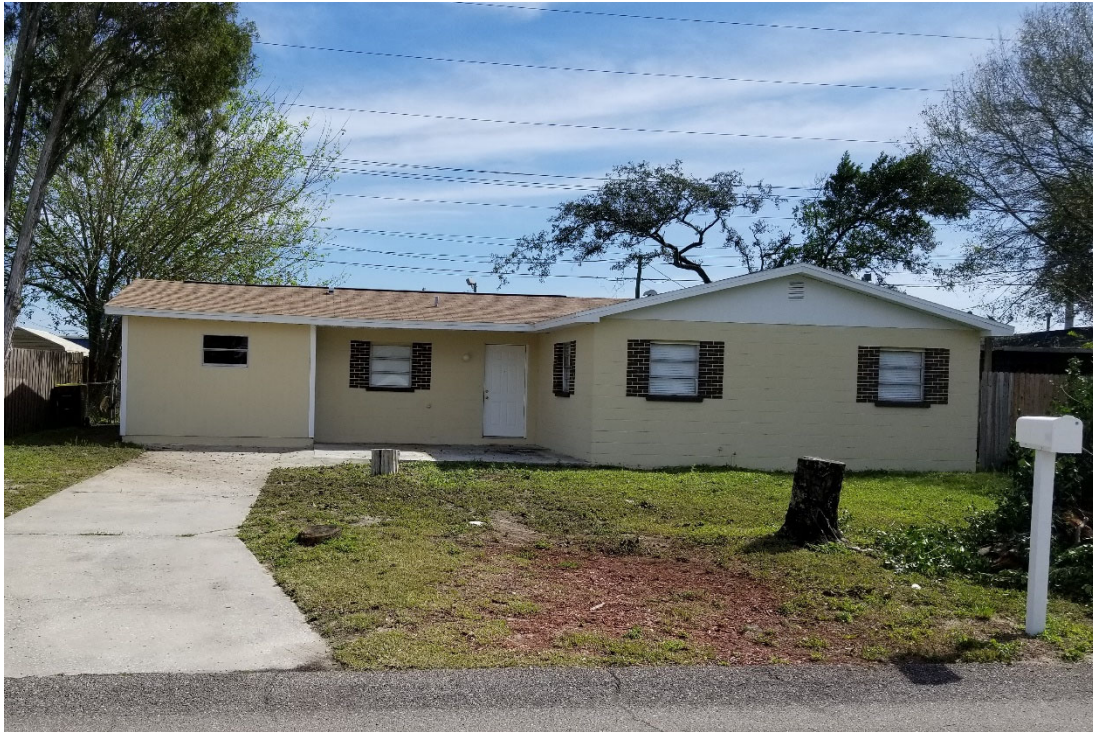
**PHOTOGRAPH**

Facing east

Chimney: No. \_\_\_\_ Chimney Material(s): 1. \_\_\_\_ 2. \_\_\_\_  
 Structural System(s): 1. Concrete block 2. \_\_\_\_ 3. \_\_\_\_  
 Foundation Type(s): 1. Slab 2. \_\_\_\_  
 Foundation Material(s): 1. Concrete, Generic 2. \_\_\_\_  
 Main Entrance (stylistic details) W elev: through single panel door beneath a flat roof

Condition (overall resource condition): ☐excellent ☒good ☐fair ☐deteriorated ☐ruinous

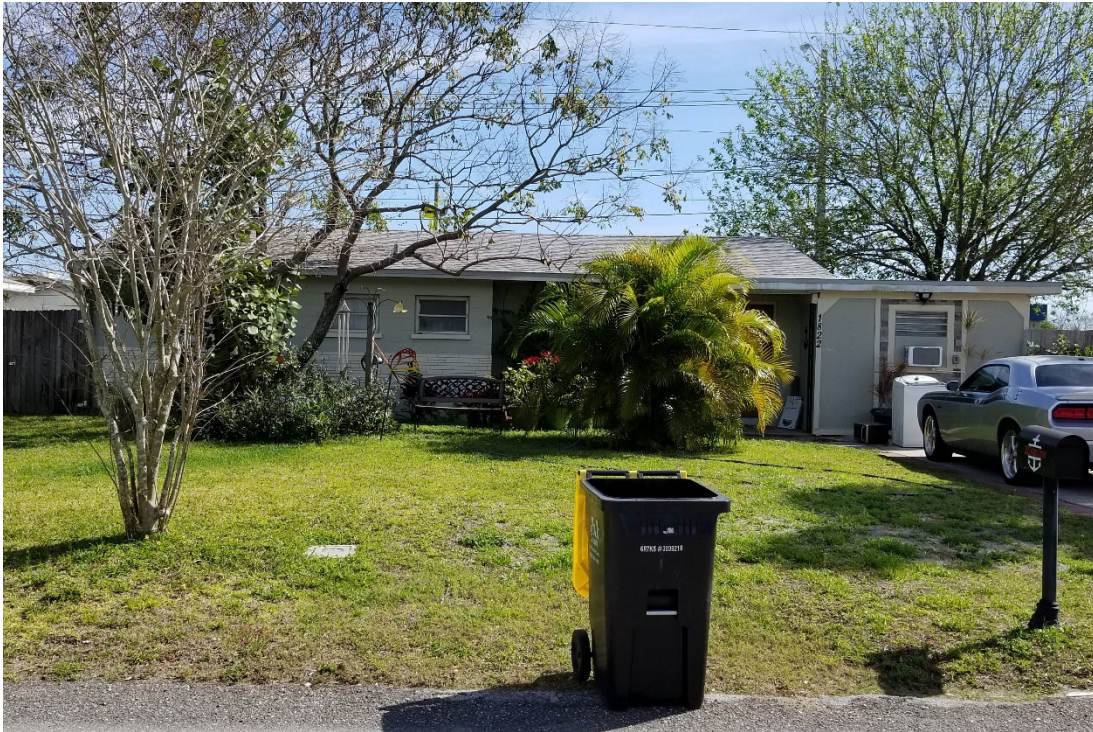
**PHOTOGRAPH**

Facing east

Chimney: No. \_\_\_\_ Chimney Material(s): 1. \_\_\_\_ 2. \_\_\_\_  
 Structural System(s): 1. Concrete block 2. \_\_\_\_ 3. \_\_\_\_  
 Foundation Type(s): 1. Slab 2. \_\_\_\_  
 Foundation Material(s): 1. Concrete, Generic 2. \_\_\_\_  
 Main Entrance (stylistic details) W elev: through single panel door with an oval window beneath a pent shed roof

Condition (overall resource condition): ☐excellent ☒good ☐fair ☐deteriorated ☐ruinous

Narrative Description of Resource The building has a side gable roof with an attached carport beneath a gable roof. The building is a typical example of a Minimal Ranch style residence with alterations and additions found throughout Polk County.

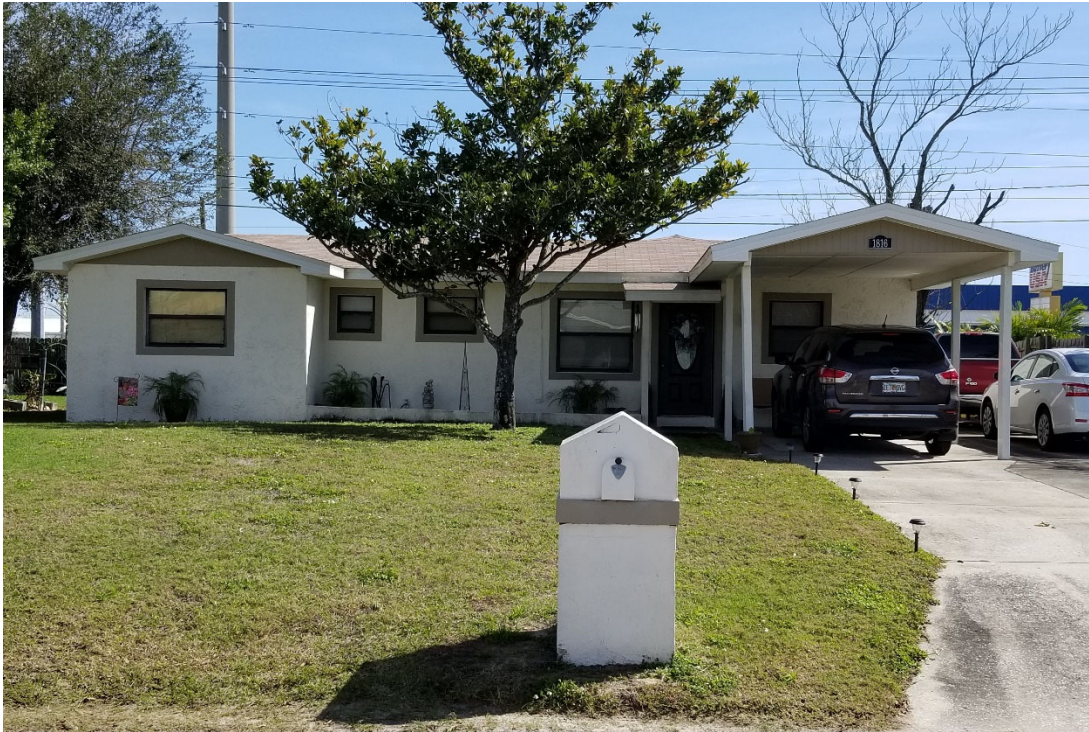
**PHOTOGRAPH**

Facing east

Chimney: No. \_\_\_\_ Chimney Material(s): 1. \_\_\_\_ 2. \_\_\_\_  
 Structural System(s): 1. Wood frame 2. \_\_\_\_ 3. \_\_\_\_  
 Foundation Type(s): 1. Slab 2. \_\_\_\_  
 Foundation Material(s): 1. Concrete, Generic 2. \_\_\_\_  
 Main Entrance (stylistic details) W elev: through single screen door beneath a pent gable roof

Condition (overall resource condition): ☐ excellent ☒ good ☐ fair ☐ deteriorated ☐ ruinous

Narrative Description of Resource The building has a cross-gable roof with an attached carport beneath a flat roof. The building is a typical example of a Minimal Ranch style residence with alterations and additions found throughout Polk County.

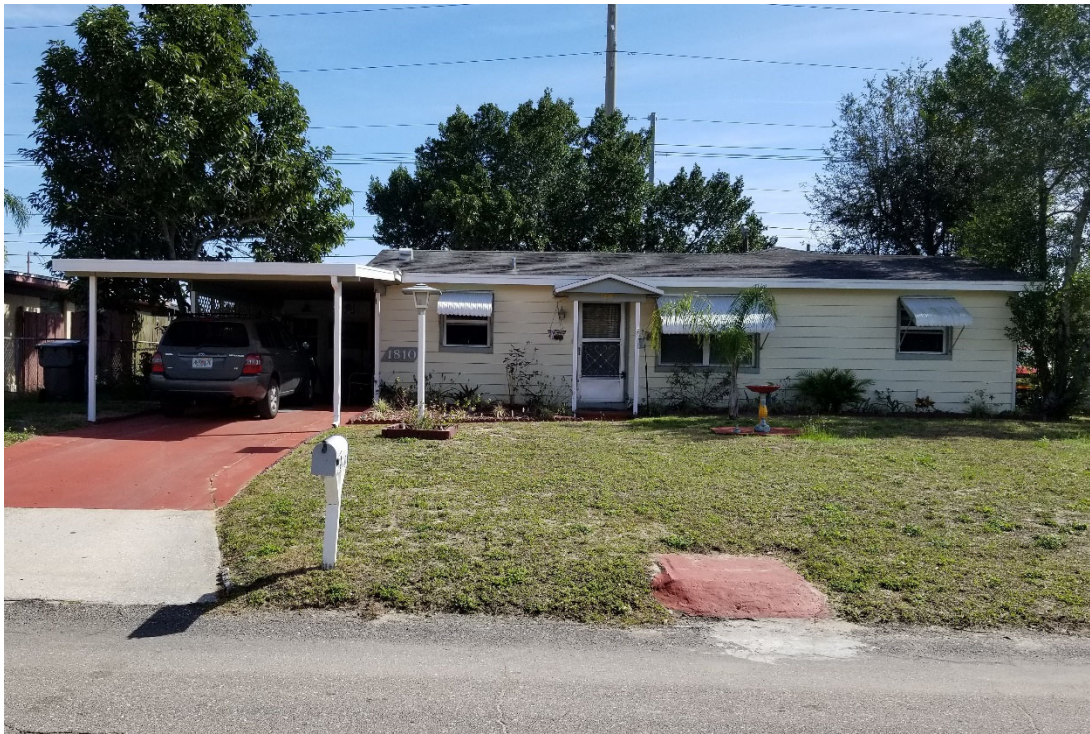
**PHOTOGRAPH**

Facing east

Chimney: No. 1 Chimney Material(s): 1. Concrete block 2. \_\_\_\_\_  
 Structural System(s): 1. Concrete block 2. \_\_\_\_\_ 3. \_\_\_\_\_  
 Foundation Type(s): 1. Slab 2. \_\_\_\_\_  
 Foundation Material(s): 1. Concrete, Generic 2. \_\_\_\_\_  
 Main Entrance (stylistic details) W elev: through single panel door with an oval window recessed beneath the principal hip roof  
 Porch Descriptions (types, locations, roof types, etc.) E elev: open, partial-width beneath a flat roof

Condition (overall resource condition): ☐ excellent ☒ good ☐ fair ☐ deteriorated ☐ ruinous

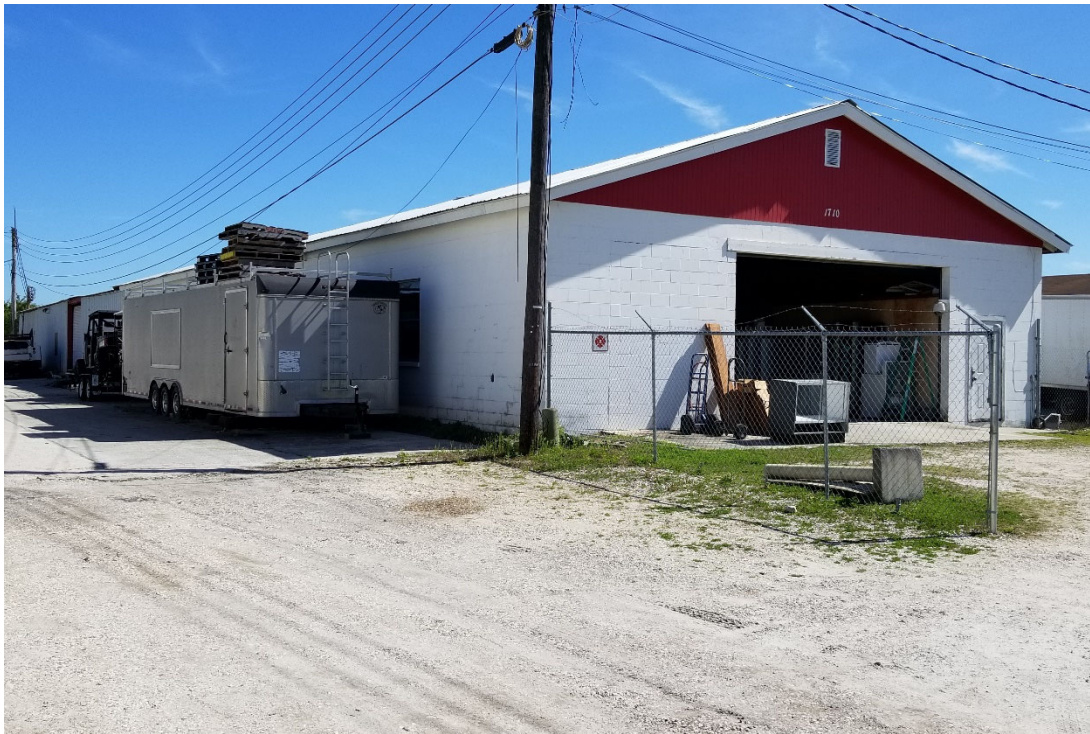
**PHOTOGRAPH**

Facing southeast

Condition (overall resource condition): ☐ excellent ☒ good ☐ fair ☐ deteriorated ☐ ruinous

Narrative Description of Resource The building has mixed concrete block and brick veneer facade. The building is a typical example of a Masonry Vernacular style office building found in the area and Polk County.

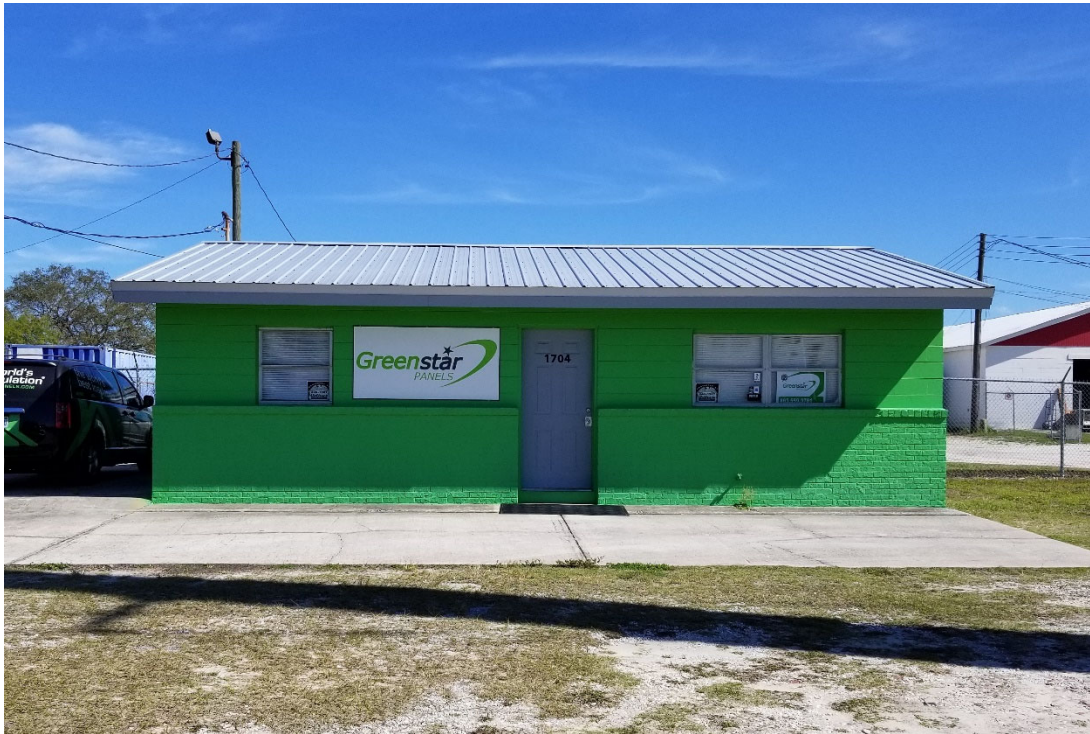
**PHOTOGRAPH**

Facing east

Condition (overall resource condition): ☐ excellent ☒ good ☐ fair ☐ deteriorated ☐ ruinous

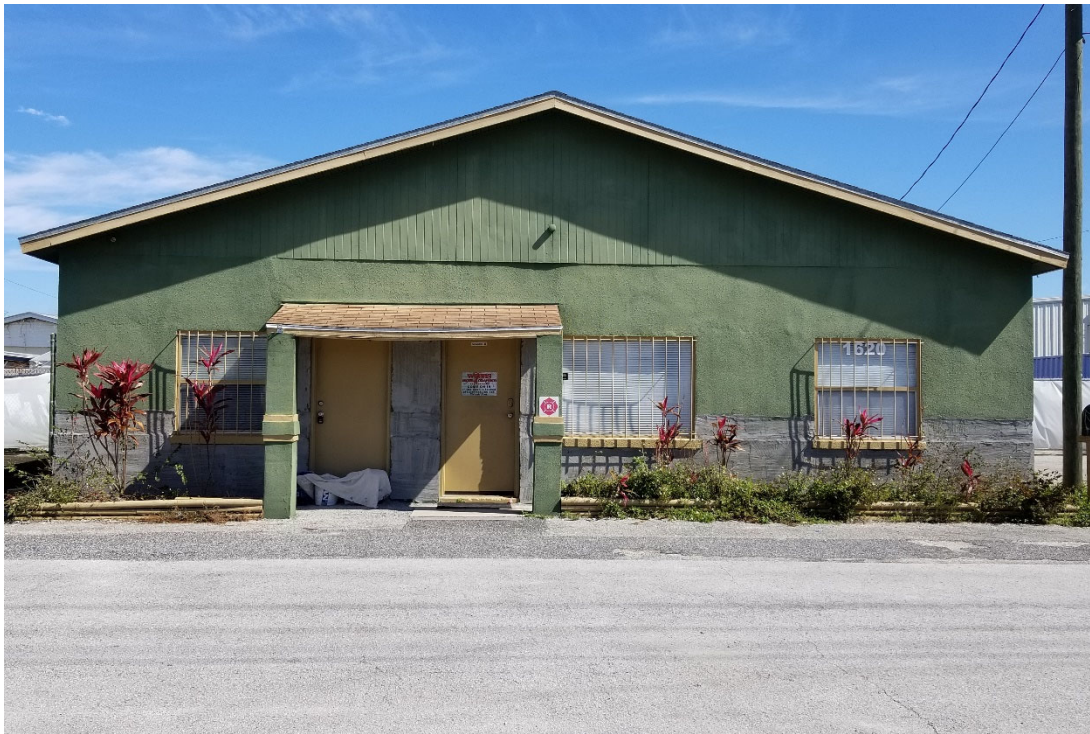
**PHOTOGRAPH**

Facing east

Condition (overall resource condition): ☐ excellent ☒ good ☐ fair ☐ deteriorated ☐ ruinous

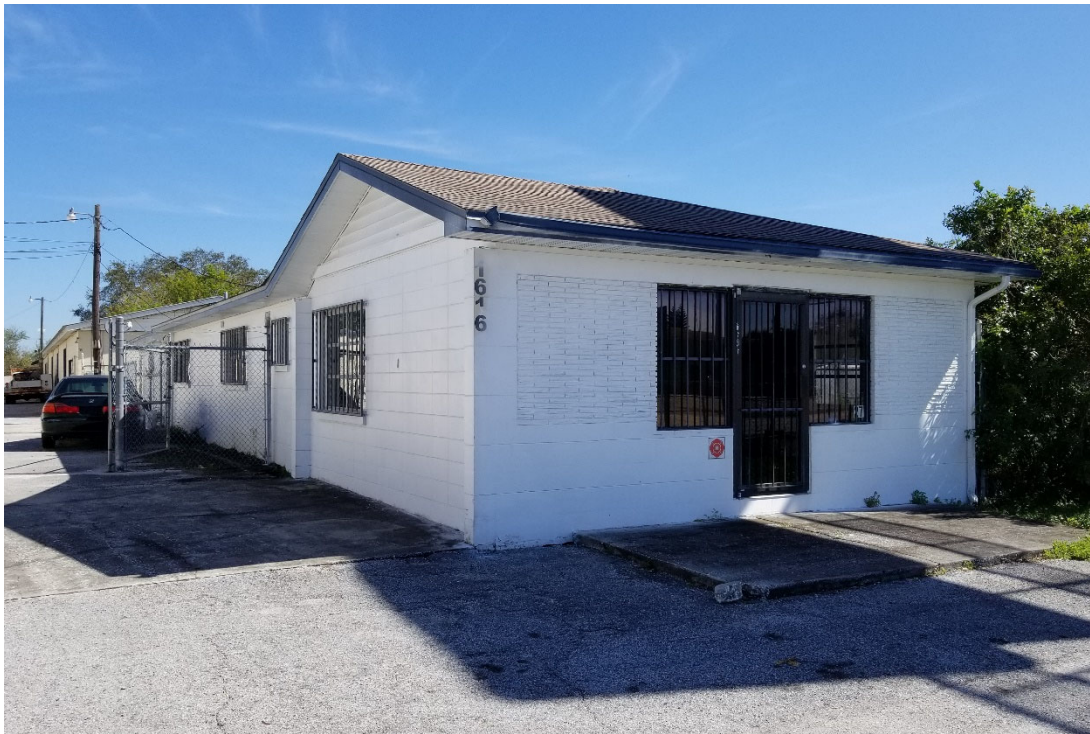
**PHOTOGRAPH**

Facing southeast

Condition (overall resource condition): ☐ excellent ☒ good ☐ fair ☐ deteriorated ☐ ruinous

Narrative Description of Resource The building has a 1980s steel frame warehouse addition located on the east elevation. The building is a typical example of an altered Masonry Vernacular style office building found in the area and Polk County.
