CONTAMINATION TECHNICAL MEMORANDUM FOR MAINLINE AND DRAINAGE SITES

Florida Department of Transportation

Harborview Road PD&E Re-evaluation

Limits of Project: From Melbourne Street to I-75

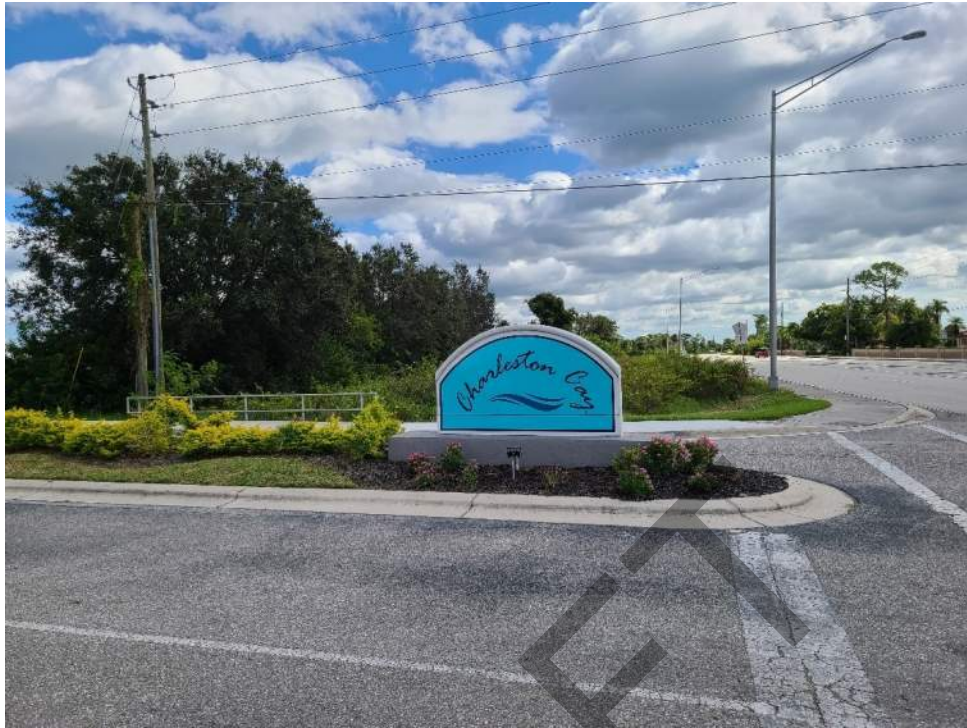
Site 3 – Charleston Cay Apartments  
Harborview Road looking east

3	<b>Charleston Cay Apartments</b> NE of intersection of Melbourne Street and Harborview Road	No	No	The PD&E CSER notes that no releases have been reported at this site. No new discharges have been reported since 2018. No updated regulatory information was identified. During the site reconnaissance, the site was observed as an apartment complex. No change is recommended to the risk rating. Therefore, the risk rating remains No.
4	<b>Bethanie 7<sup>th</sup> Day Adventist Church</b> 24300 Harborview Road	No	No	The PD&E CSER notes that no releases have been reported at this site. No new discharges have been reported since 2018. No updated regulatory information was identified. During the site reconnaissance, the site was observed as Bethanie 7 <sup>th</sup> Day Adventist Church. No change is recommended to the risk rating. Therefore, the risk rating remains No.
5	<b>Charlotte County Pest Management</b> 25550 Harborview Road, Suite 2	No	No	The PD&E CSER notes that no releases have been reported at this site. No new discharges have been reported since 2018. The FDEP's Storage Tanks & Contamination Monitoring database lists one 10,000-gallon pesticide underground storage tank (UST) and one 750-gallon diesel aboveground storage tank (AST) in use at this facility. The 10,000-gallon pesticide UST is listed as Non-regulated/ <i>de minimis</i> . The 750-gallon diesel AST has an active status and is listed for emergency generator use. Files in the FDEP OCULUS database ( <b>Appendix B</b> ) include a Routine Storage Tank Inspection Form dated September 12, 2022 that found the site "In Compliance" with no discharges reported. During the site reconnaissance, the site was observed as Charlotte County Pest Management/Utilities Department. The facility was vacant due to exterior damage caused by Hurricane Ian. Inspection of the site was not possible due to a security gate. Given a lack of a reported discharge and recent documentation finding the facility "In Compliance," no change is recommended to the risk rating and therefore it remains No.

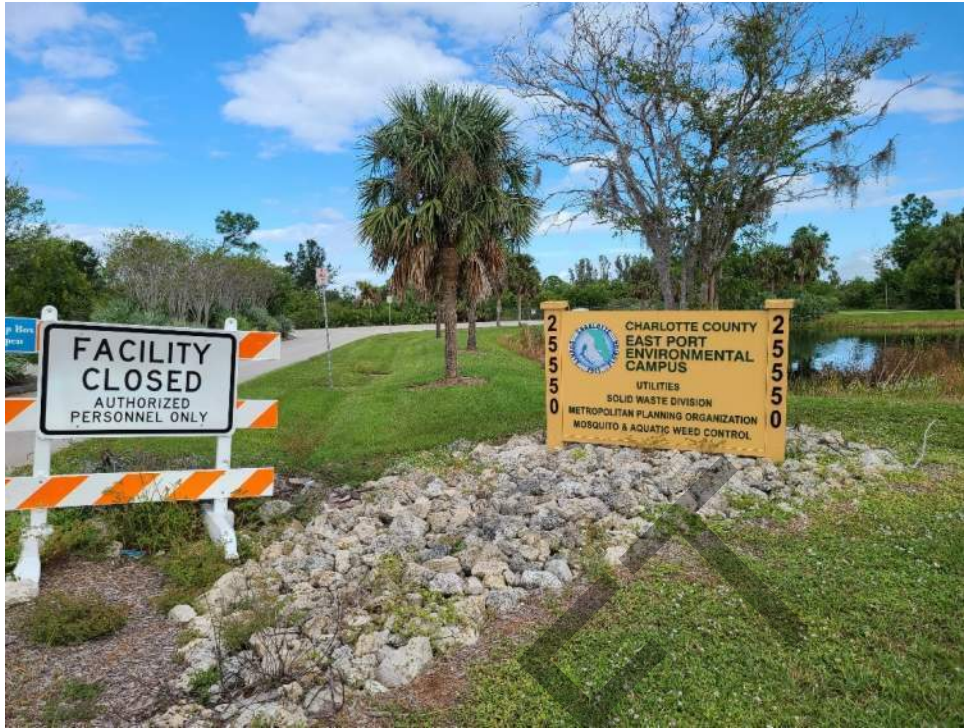
Site 5 – Charlotte County East Port Environmental Campus/Charlotte County Pest Management Harborview road looking northwest

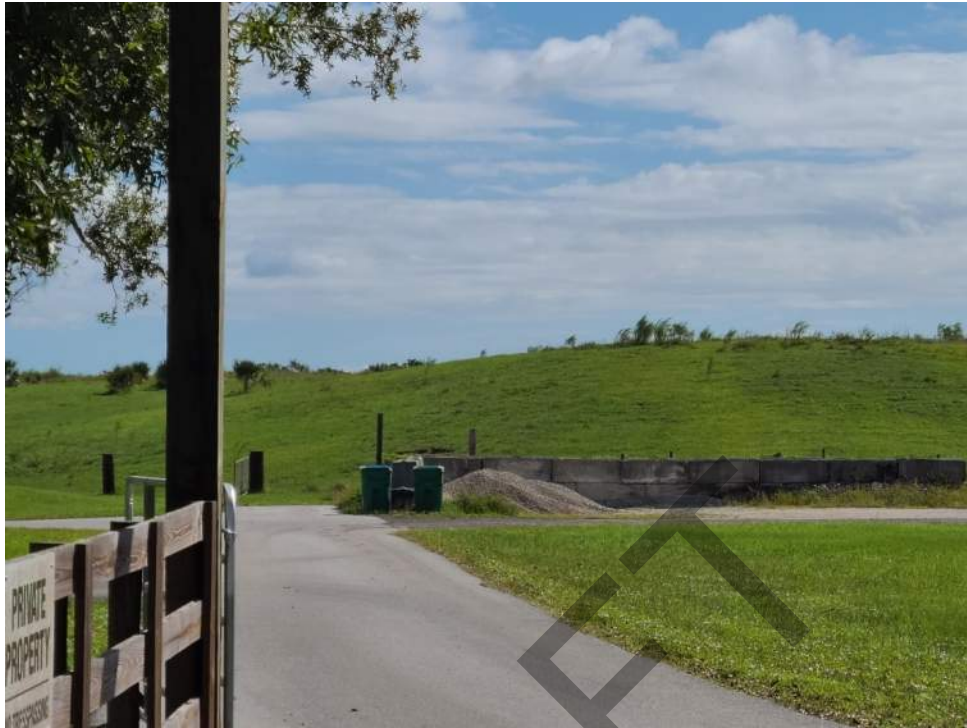
6	<b>Former Raulerson Yard Trash Compost Site</b> Rowland Drive Punta Gorda, FL Facility ID: 72563, 72909	2023 Re-Evaluation MapDirect Aerial photographs Site reconnaissance	570 feet north of Harborview Road ROW	Petroleum Hazardous waste	Low	This site was first identified in the April 2023 Re-evaluation and was assigned a risk rating of Low due to a lack of reported soil or groundwater contamination. This site is located 570 feet north of the Harborview Road ROW and had a petroleum ASTs removed in 1993. During the April 2023 and October 2023 site reconnaissance, this site was observed as a residential home with a few smaller structures used for storage. The area of the former Yard Trash Compost site is a series of medium sized mounds covered with grass and light vegetation approximately 570 feet north of the Harborview Road ROW. No contamination concerns were observed on-site. No subsequent regulatory files were identified since the April 2023 Re-evaluation.  <b>Risk Rating:</b> Given a separation distance of 570 feet north, and no reports of hazardous waste or petroleum-related contamination at this facility, this site retains a risk rating of Low.

Site 6 – Former Raulerson Yard Trash Compost Site Rowland Drive looking east

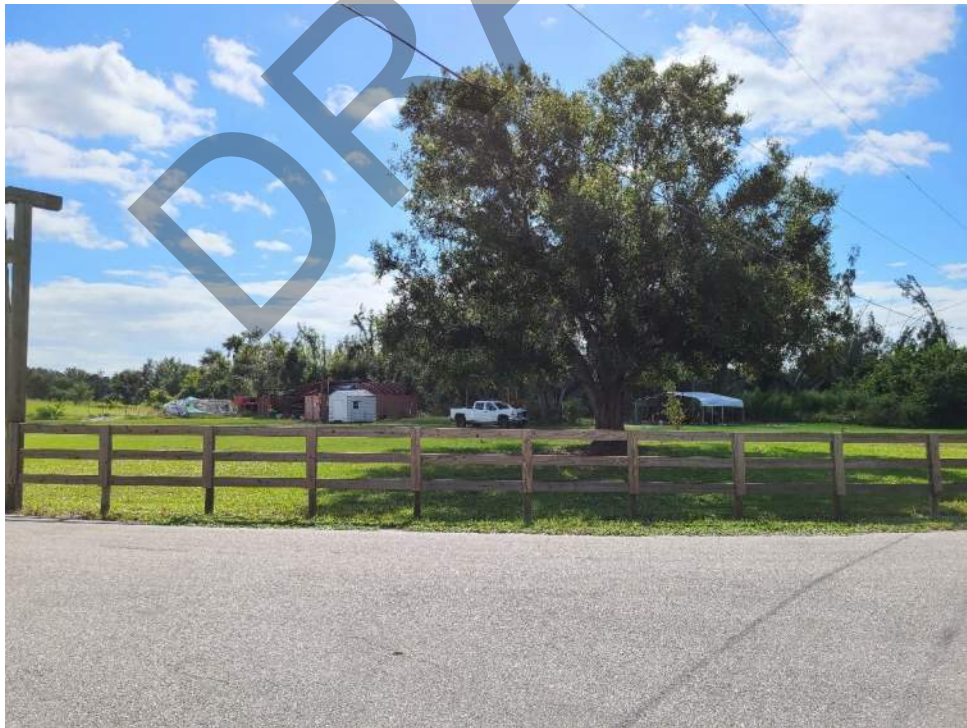
Site 6 – Former Raulerson Yard Trash Compost Site  
Area of former AST looking southeast

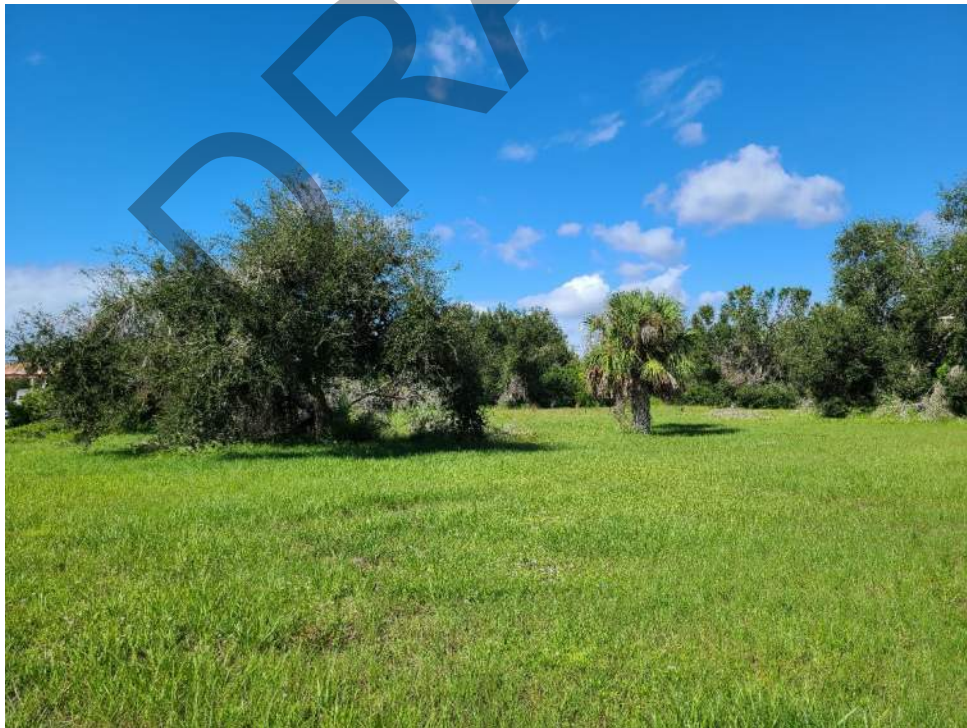
SMF 3	Herbicides Pesticides Petroleum Solid Waste	Medium	<p>This drainage site was first identified in the September 2021 CSER (Drainage) as Pond 3C and was assigned a risk rating of <b>Medium</b> due to the former groves located within this drainage site from 1975 to 2005. Aerial photographs (<b>Appendix B</b>) depict this site as an open field from 2022 to 2023. No likely sources of concentrated contamination concerns such as pole barns, irrigation pumps, or machinery were observed during aerial photograph review. During the September 2021 and October 2023 site reconnaissance, this drainage site was observed as an open field. No regulatory information was identified.</p> <p>One contamination site identified as <b>MAP ID 7 – Former Groves</b> is located within SMF 3. Contamination impacts regarding <b>Map ID 7</b> are anticipated.</p> <p>The nearest offsite contamination concern is <b>Map ID 6 - Former Raulerson Yard Trash Compost Site</b>, Rowland Drive Punta Gorda (Facility ID: 72563, 72909), located 450 feet north of SMF 3. This site was first identified in the September 2021 CSER (Drainage), and the April 2023 Re-evaluation. No subsequent regulatory files were found after the April 2023 Re-evaluation. Contamination impacts are not anticipated.</p> <p><b>Risk Rating:</b> Given the historic land use of groves within SMF 3, this site retains a risk rating of <b>Medium</b>.</p>

SMF 3  
Looking west

- One drainage site identified as SMF 3 is assigned a risk rating of Medium. Level II testing is recommended given the potential for contamination impacts related to the use of pesticides and herbicides. The Former Groves appear to be within and adjoining the SMF 3 drainage site footprint and therefore Level II testing is warranted. Laboratory analysis of soil samples may include one or more of the following: arsenic by EPA Method 6010, Organochlorine Pesticides by EPA Method 8081, Organophosphorus Pesticides by EPA Method 8141, and Chlorinated Herbicides by EPA Method 8151. If impacts from this site are identified during Level II testing, Level III support activities such as source removal and/or dewatering may be required during construction. Level II testing costs are estimated at \$2,000 to \$10,000 per site.

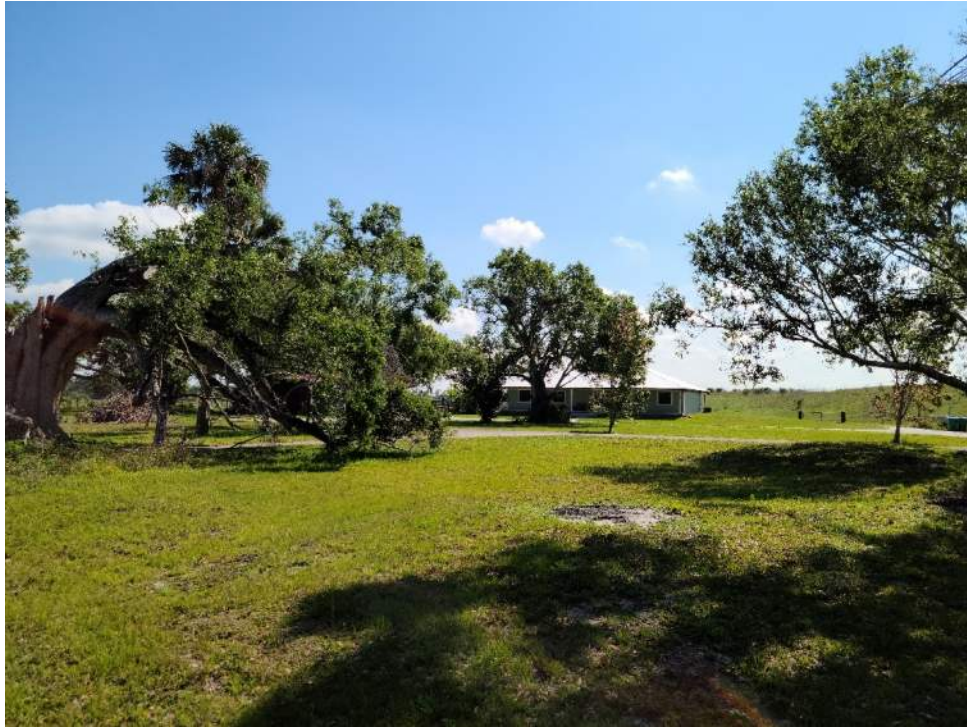
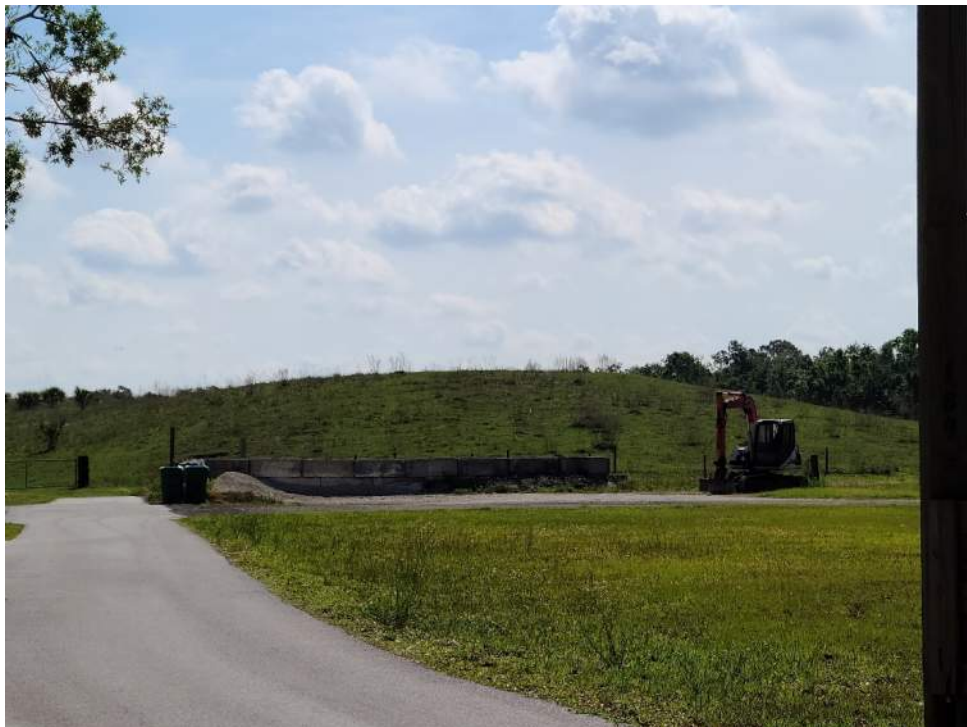
Site 6 – Former Raulerson Yard Trash Compost Site  
Rowland Dr, near central portion of the project looking west

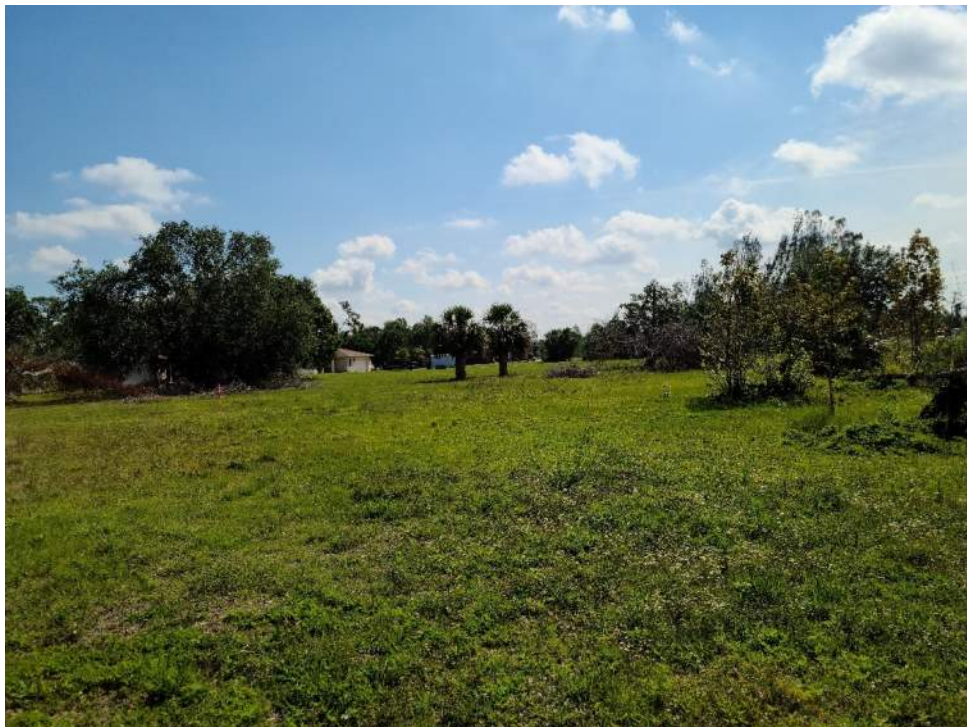
Site 7 – Former groves  
Near central portion of project looking northwest

Site 7 – Former groves  
Near central portion of project looking east

Site 7 – Former groves  
Near central portion of project looking southeast

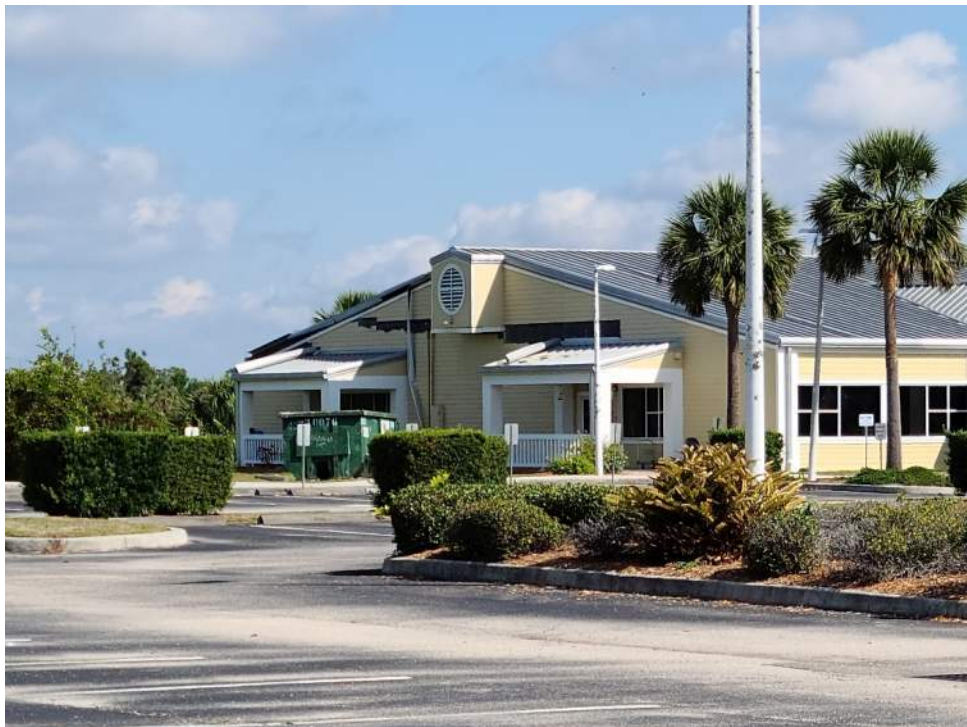
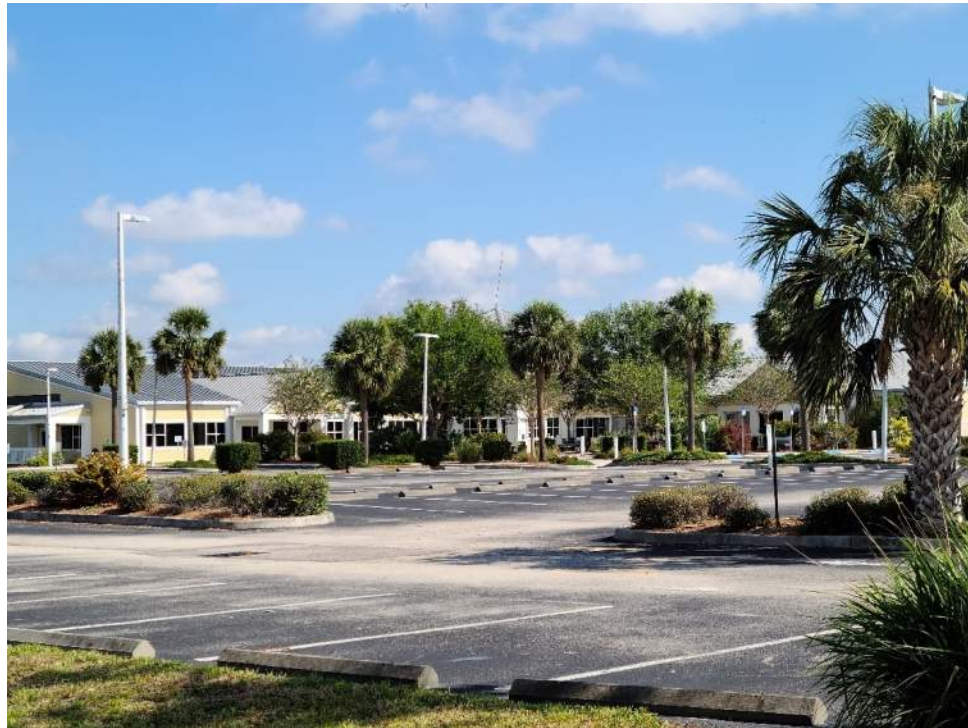
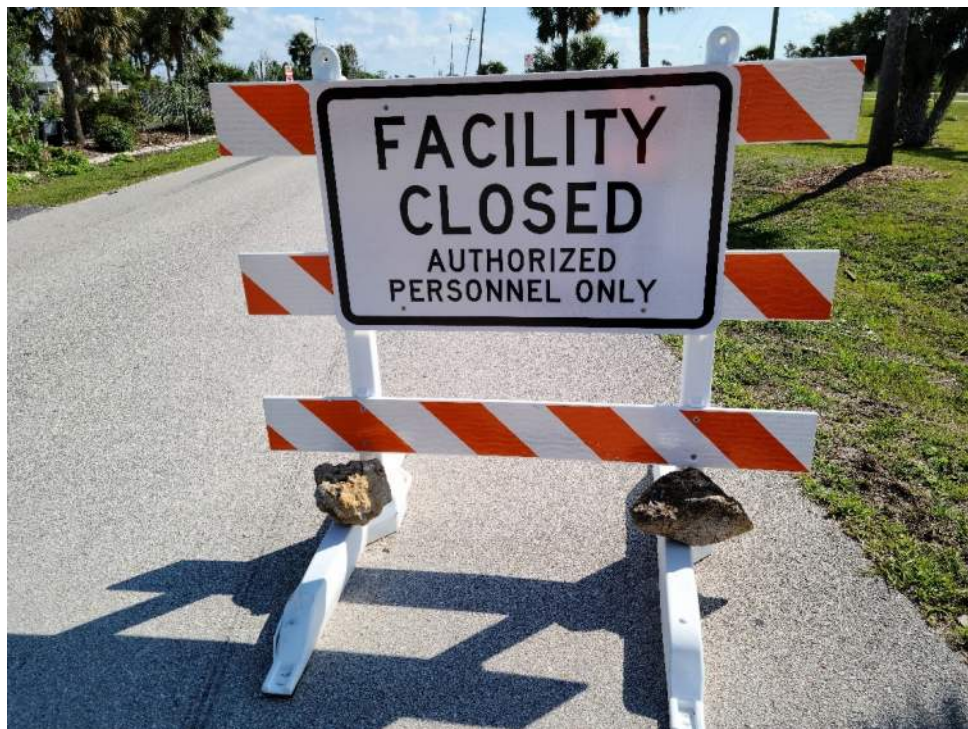
Site 5 – Charlotte County Pest-Management  
Harborview road near eastern project boundary, looking northeast
