PRELIMINARY ENGINEERING REPORT

Florida Department of Transportation

DeSoto Bridge Replacement SR 55 US 301/US 41

Financial Management Number: 442630-1

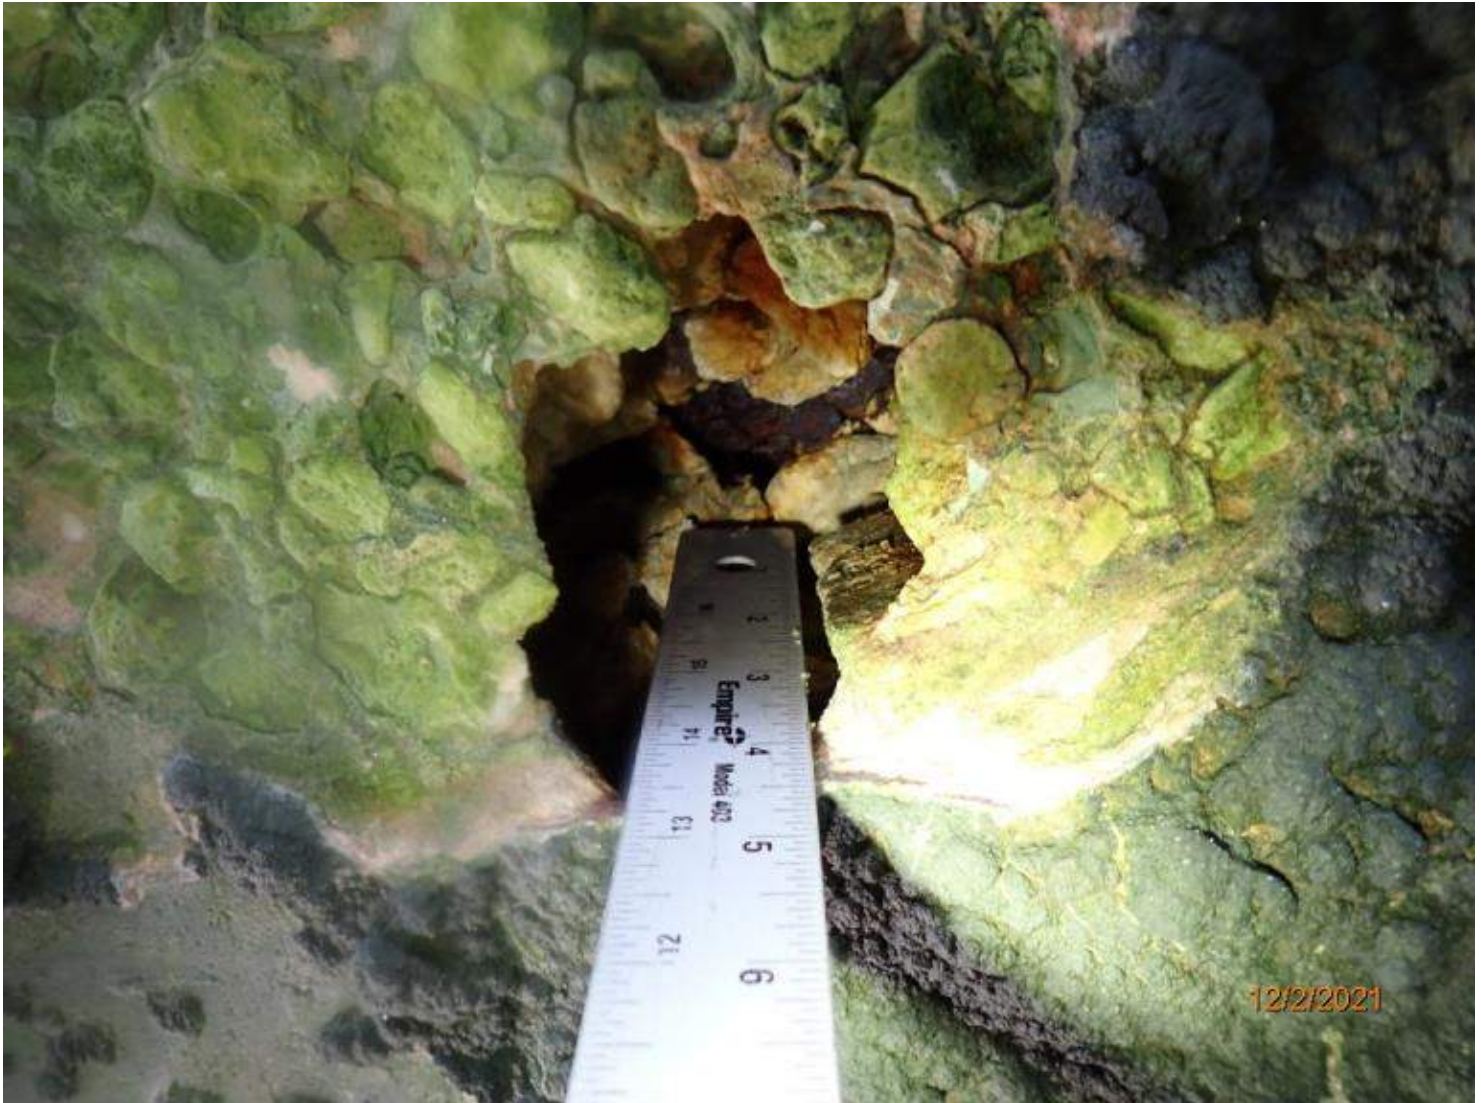
Photo 7 - Element 220 Re Conc Pile Cap/Ftg

CS3 1090 = Footing 13-3: NE corner of Pile 15, bottom of footing, honeycomb/void, 12in. x 8in. x 5in., with exposed rebar with delaminative corrosion and section loss. Refer to photo 7. (1FT)

Footing 13-3 northeast corner of Pile 15 void with exposed steel

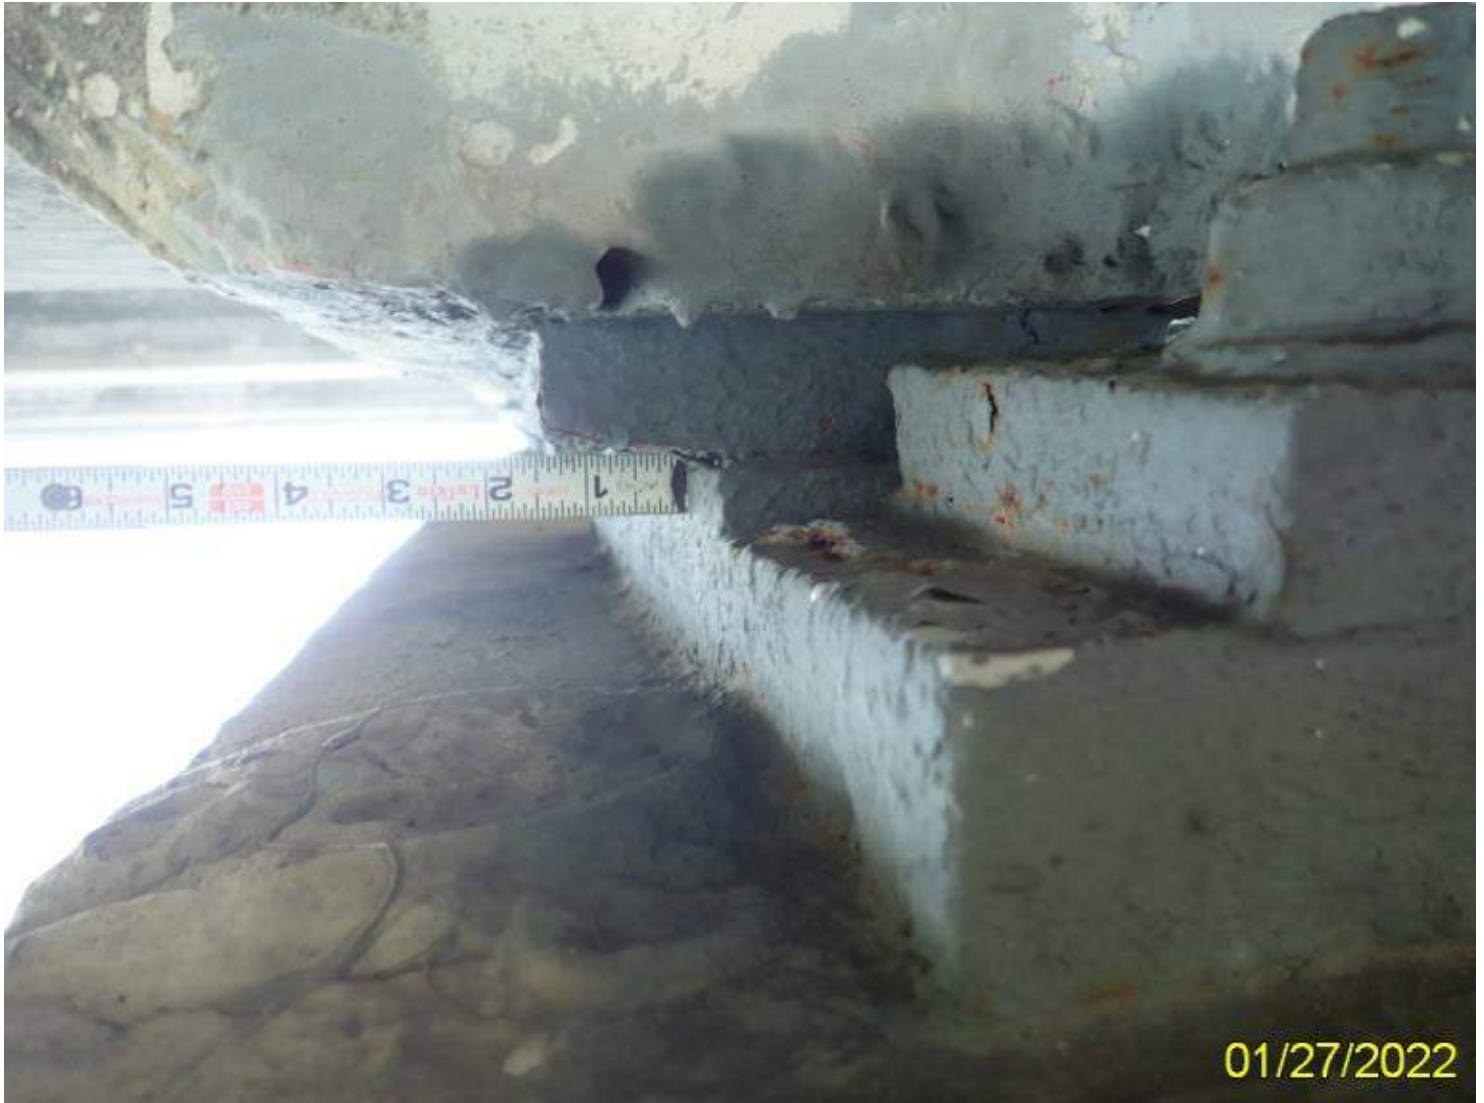
Photo 14 - Element 311 Moveable Bearing

- 311/4 CS3 2210 = The steel bearing assemblies have restricted movement due to painted-over corrosion. Refer to photo 13. (300EA)
- The bearings at Beams 9-1 through 9-7 at Pier 9 are misaligned up to 2in. north; however, limits are tolerable and there is no visible distress to the assemblies. Refer to photo 14.

Bearing 9-5 over Pier 9 misaligned to the north

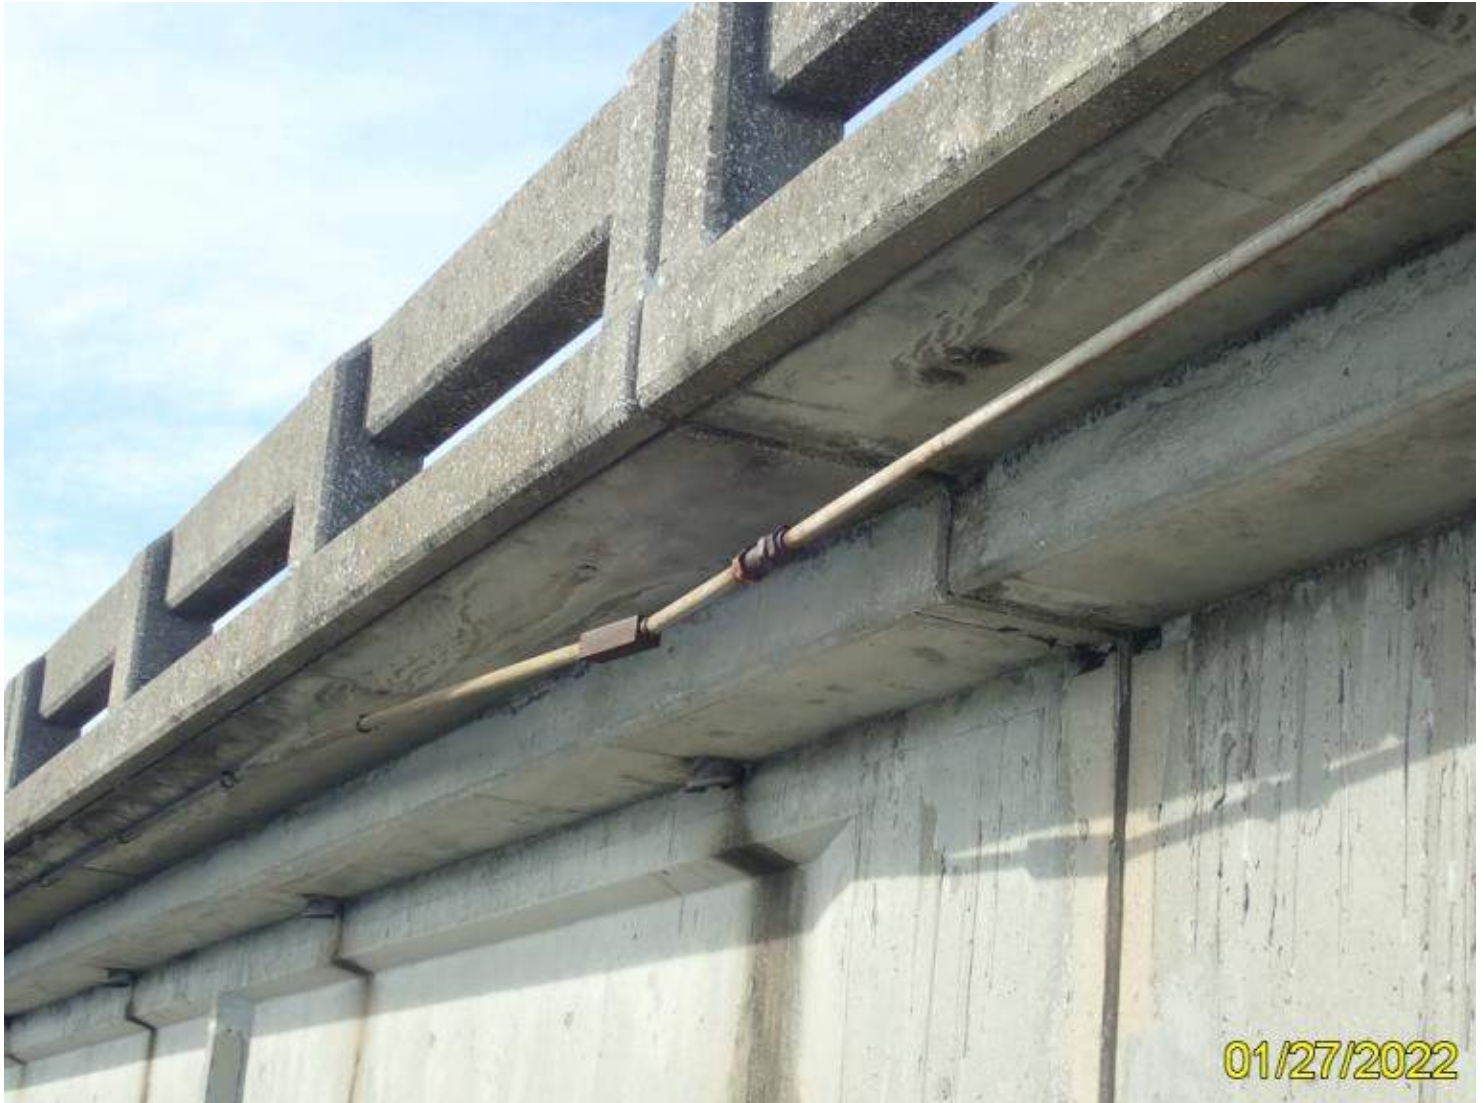
Photo 23 - Inspection Notes

Utility conduits on the right overhang are sagging at Piers 5 and 11. Refer to photo 23. REPAIR

Pier 5 right sagging utilities

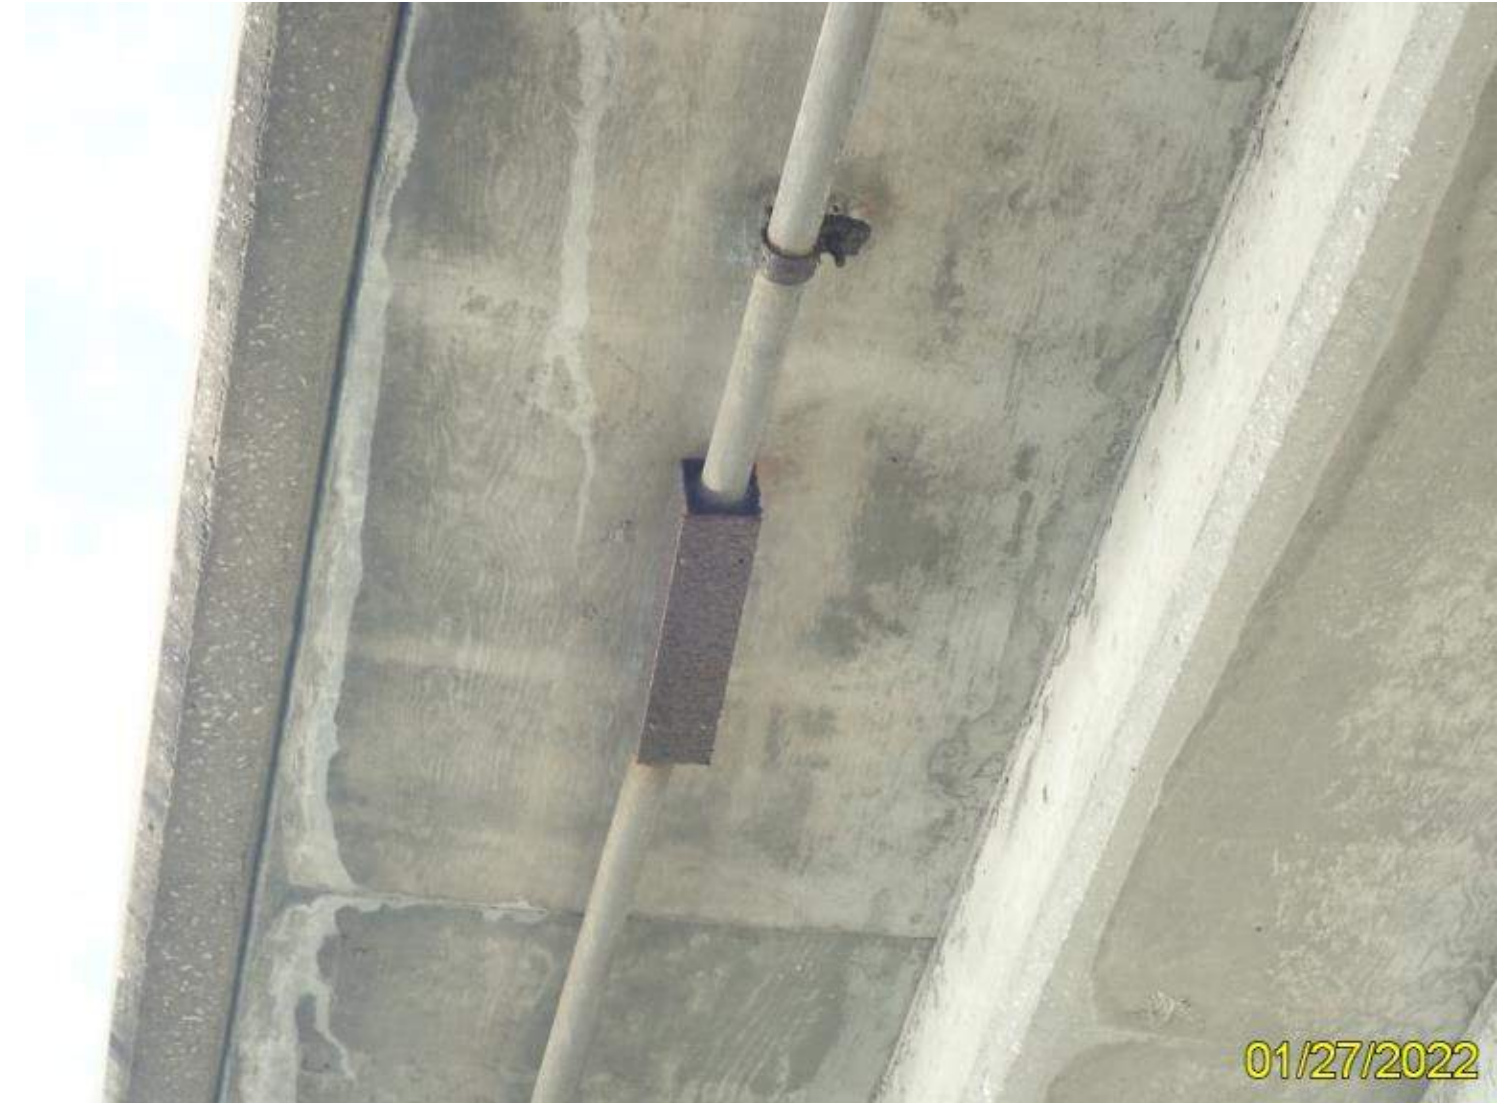
Photo 24 - Inspection Notes

The utility conduit at the right overhang in Span 13 is separated from the pull elbow. Refer to photo 24. REPAIR

Span 13 separated utilities right side

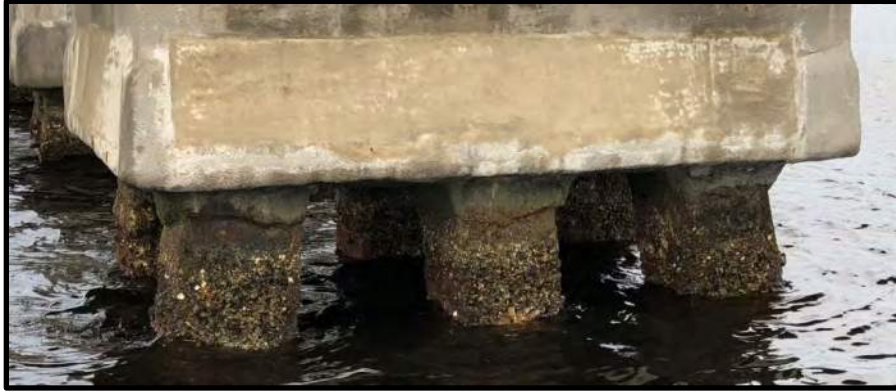
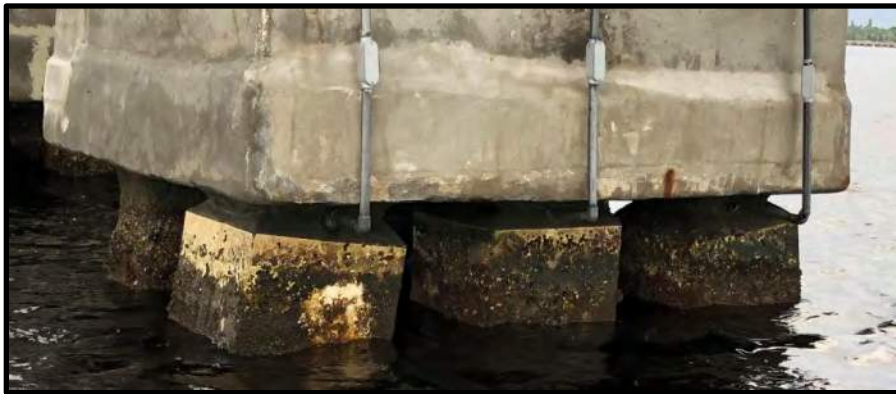
Figure 8. Typical exposed portions of piles at low tide.

There are six concrete piles under each of the waterline footings at Piers 5 to 16 and 19 to 33 (total of 486 piles) and the top portion of the piles is in the tidal zone. At low tide, only a small length of each pile is exposed. Most of the exposed areas are covered with marine growth, cathodic protection jackets, and/or gunite overspray from footing repairs (see Figure 8) which significantly impedes access to the pile surfaces for inspection. Consequently, no attempt was made to determine a condition rating for each pile. Instead, the piles were briefly inspected visually and random sounding surveys were conducted in areas where pile surfaces were accessible. Cracks were found on six of the piles and the concrete on one of those piles was also delaminated. Figure 9 shows the cracks found on one of the piles. No concrete repairs were observed on any of the piles.

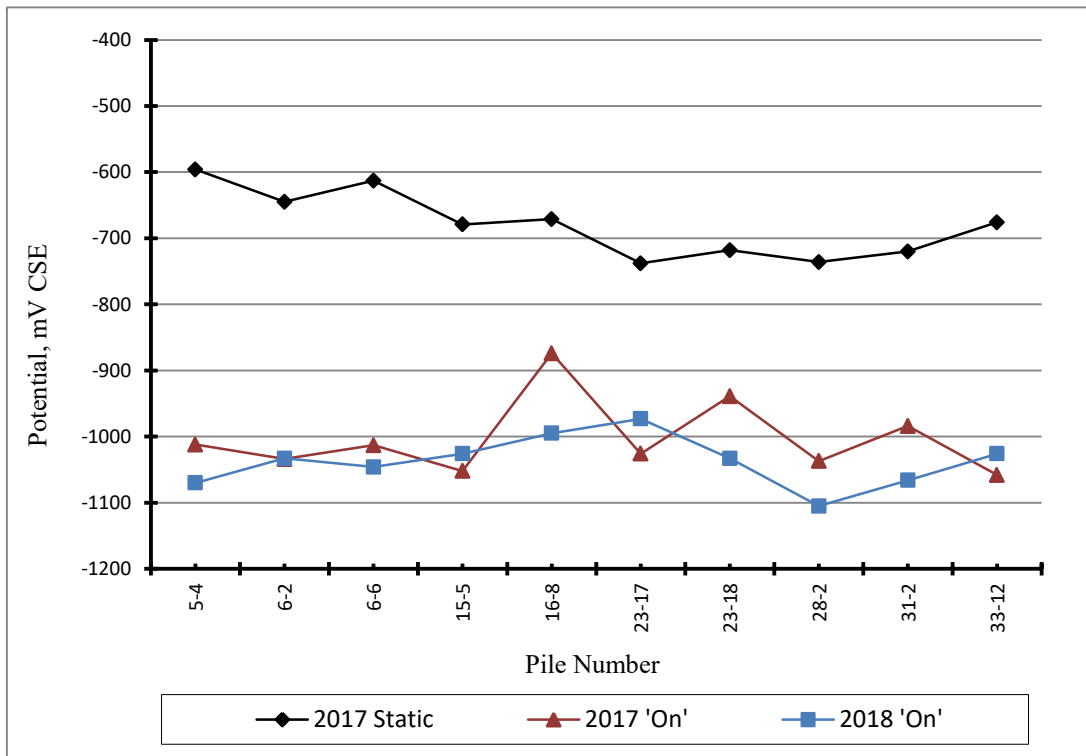
Figure 16. Satic and 'on' potentials for the CP pile jackets that were installed in 2017.

CP system performance testing was also conducted on all 75 of the piles in September 2018. 'On' potentials obtained with a copper-copper sulfate reference electrode (CSE) in the water adjacent to each pile are shown in Figures 15 (CP systems installed in 2012) and 16 (CP systems installed in 2017). Figures 15 and 16 also include static potentials and historical 'on' potentials. The 'on' potential for Pile 9-1 (the CP system on this pile was installed prior to 2016) was -1091 mV CSE in September 2018. The static potential for this pile is unknown and the 'on' potential that was measured in 2016 was -978 mV CSE. The 'on' potentials for all 75 piles indicate that the CP systems are functioning satisfactorily. Also, according to the January 25, 2018 routine bridge inspection report, the bulk zinc anodes have approximately 80% or more of their section remaining.

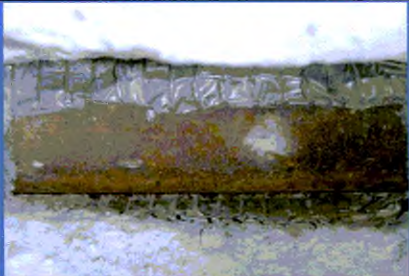
Uniform minor surface corrosion, no pitting.

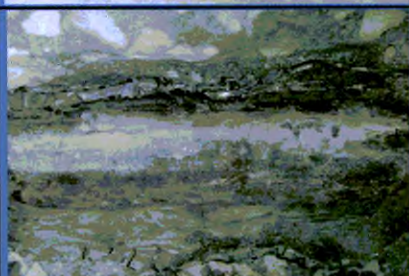
Spotty minor surface corrosion, no pitting.

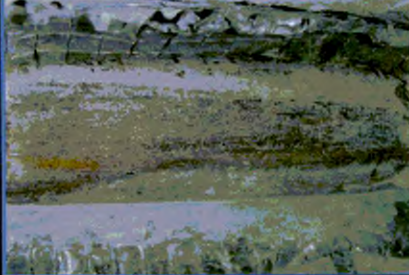
Spotty minor surface corrosion, no pitting.

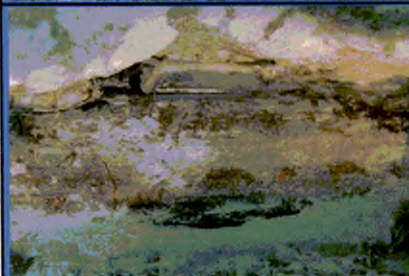
Spotty minor surface corrosion, no pitting.

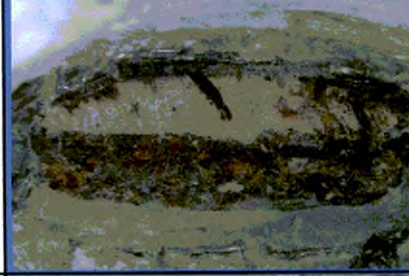
Spotty minor surface corrosion, no pitting.

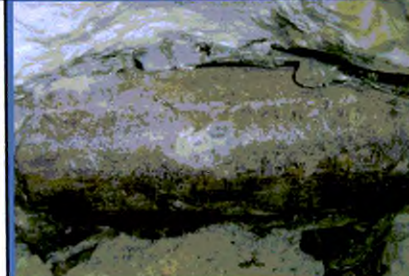
Spotty minor surface corrosion, no pitting.
