PRELIMINARY ENGINEERING REPORT

DESOTO BRIDGE FROM STATE ROAD (SR) 64 (MANATEE AVENUE EAST) TO HABEN
BOULEVARD-BRIDGE #130053

Date 08/05/2025

APPENDIX D – DeSoto Bridge Inspection Report

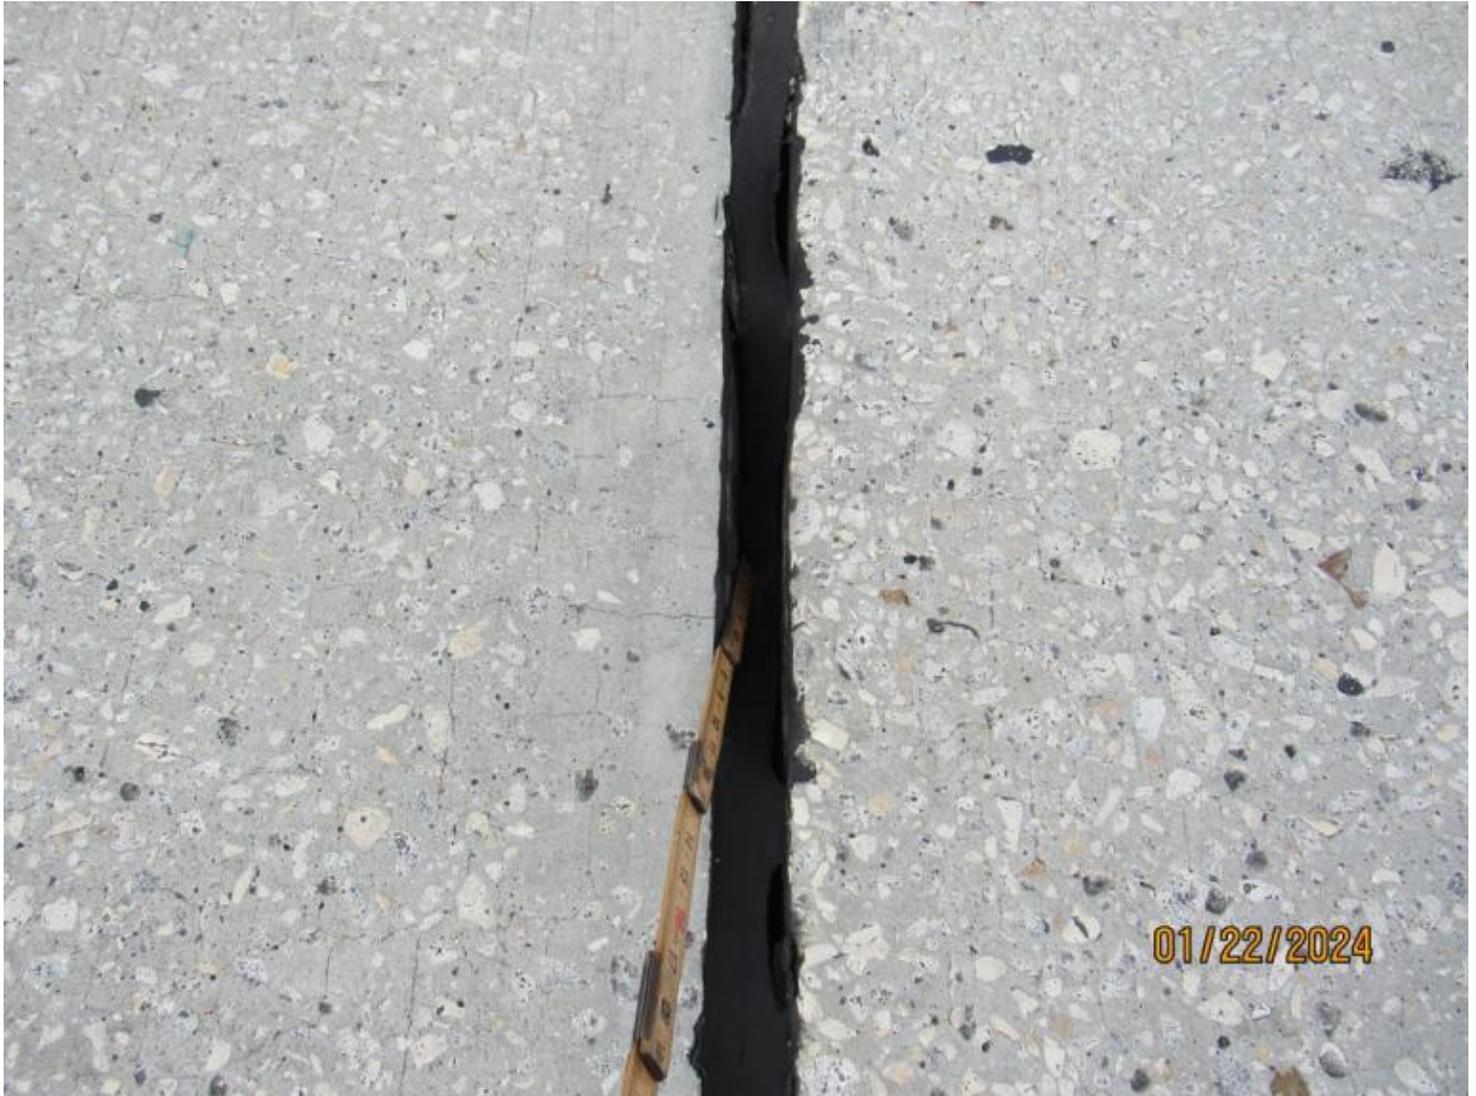
Photo 7: Element 301 Pourable Joint Seal

CS4 2320: The joints have areas of adhesion failure up to 4ft. long at the following locations:

Pier 5, Lane 1
 Pier 7, Lane 1
 Pier 12, Lane 1
 Pier 14, Lanes 1, 3 and 4
 Pier 15, Lanes 1 and 4
 Pier 19, Lane 3
 Pier 22, Lanes 3 and 4
 Pier 24, Lane 3
 Pier 26, Lanes 3 and 4
 Pier 30, Lanes 3 and 4
 - NEW. Refer to Photo 7. P3WO (48FT)

Typical area of adhesion loss Lane 3 over Pier 22 shown.

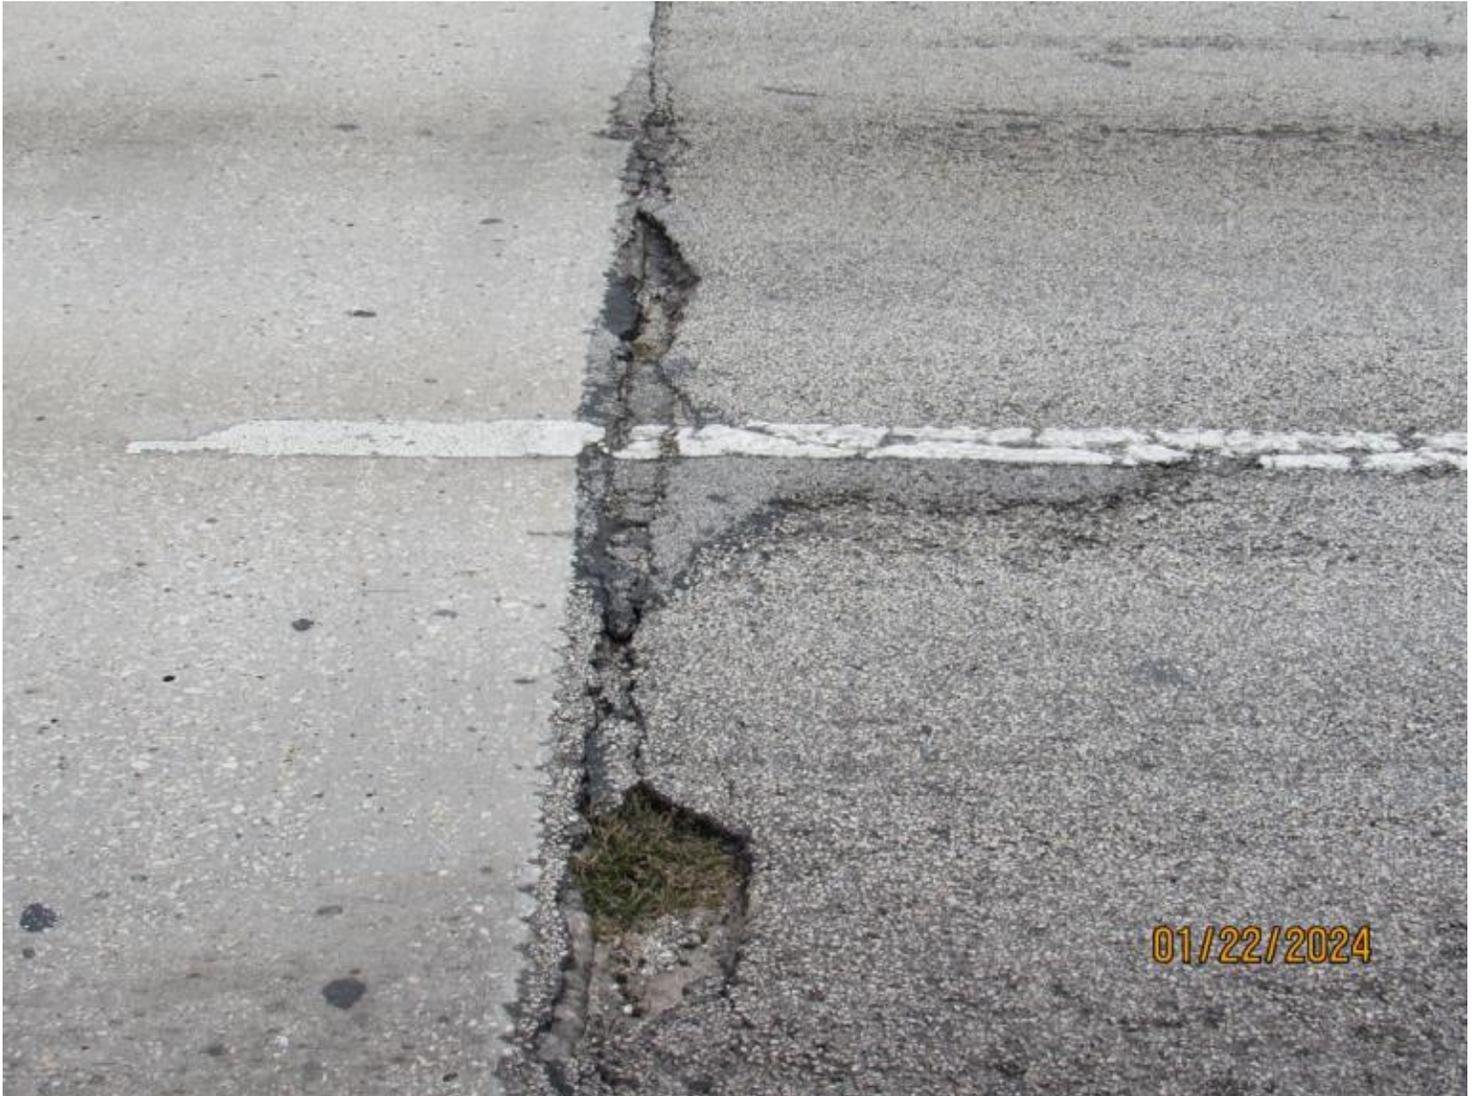
Photo 11: Element 321 Re Conc Approach Slab

CS3 3230: The south and north approach slab asphalt overlay along the abutment joints are deteriorated in the southbound lanes with upheaving up to 3/4in. in the shoulder areas with impending potholes and potholes up to 3ft. x 10in. x 2in. along Abutment Joints 1 and 34 in the travel lanes - INCREASE. Refer to Photo 11. P3WO (104SF)

Typical pothole/impending pothole in the north approach slab asphalt.

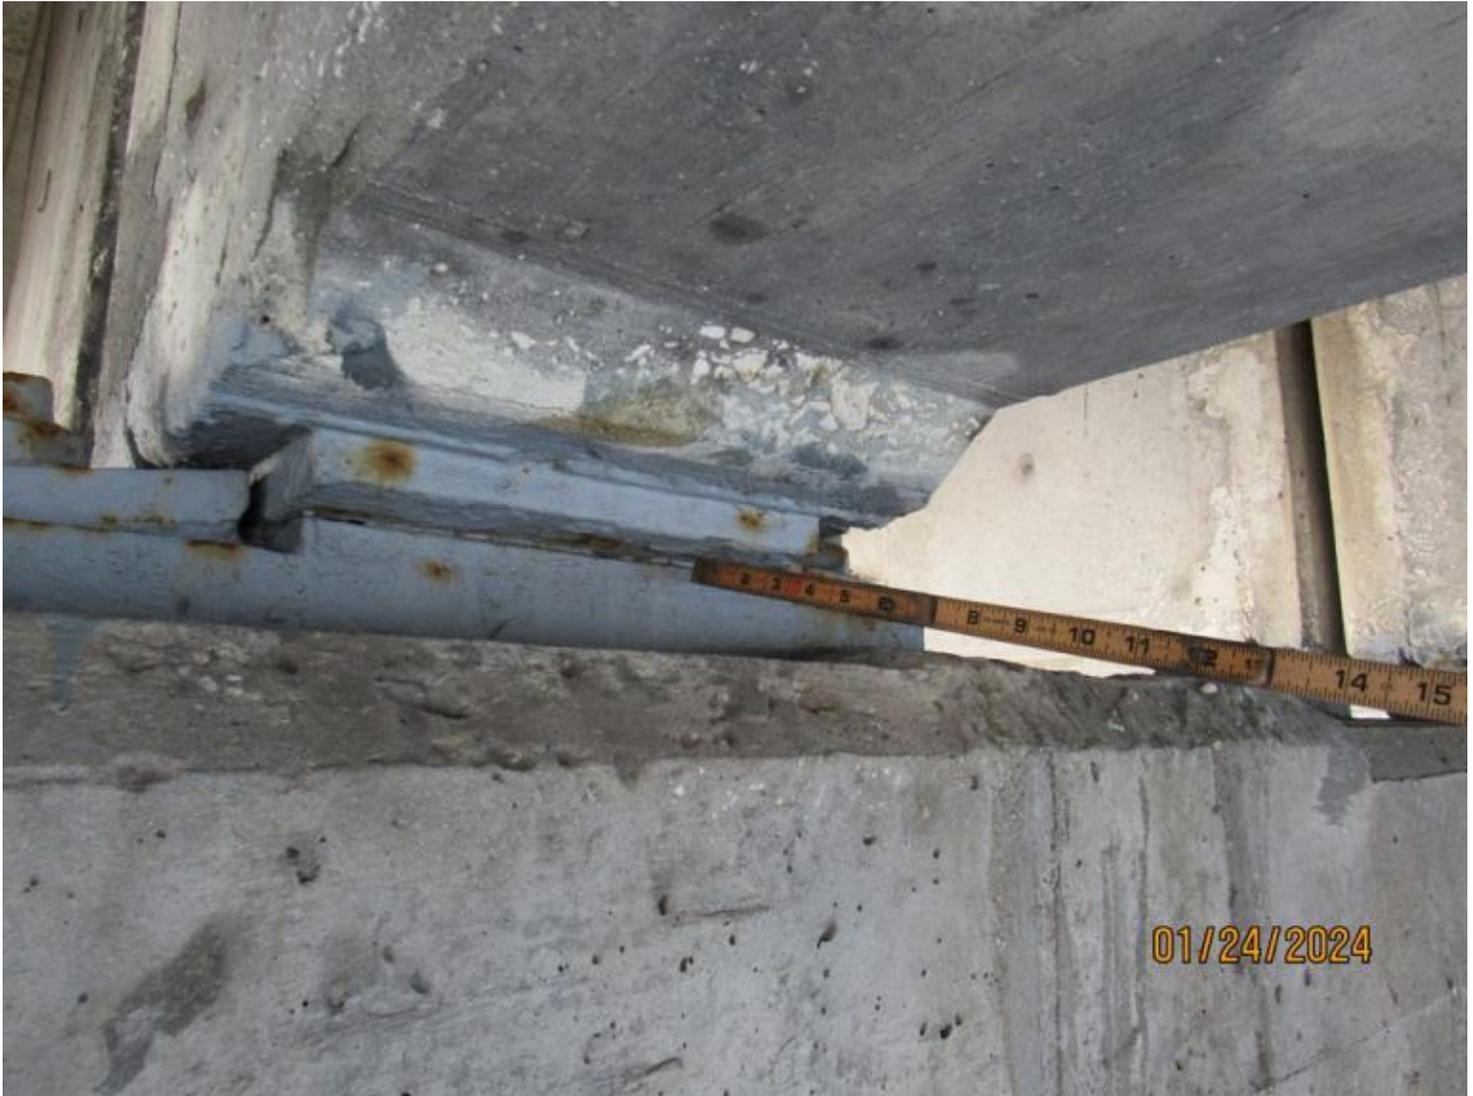
Photo 24: Element 311 Moveable Bearing

There are several bearings misaligned up to 2in.; however, limits are tolerable and there is no visible distress to the assemblies INCREASE. Refer to Photo 24.

Bearing 9-5 over Pier 9 misaligned to the north. Typical.

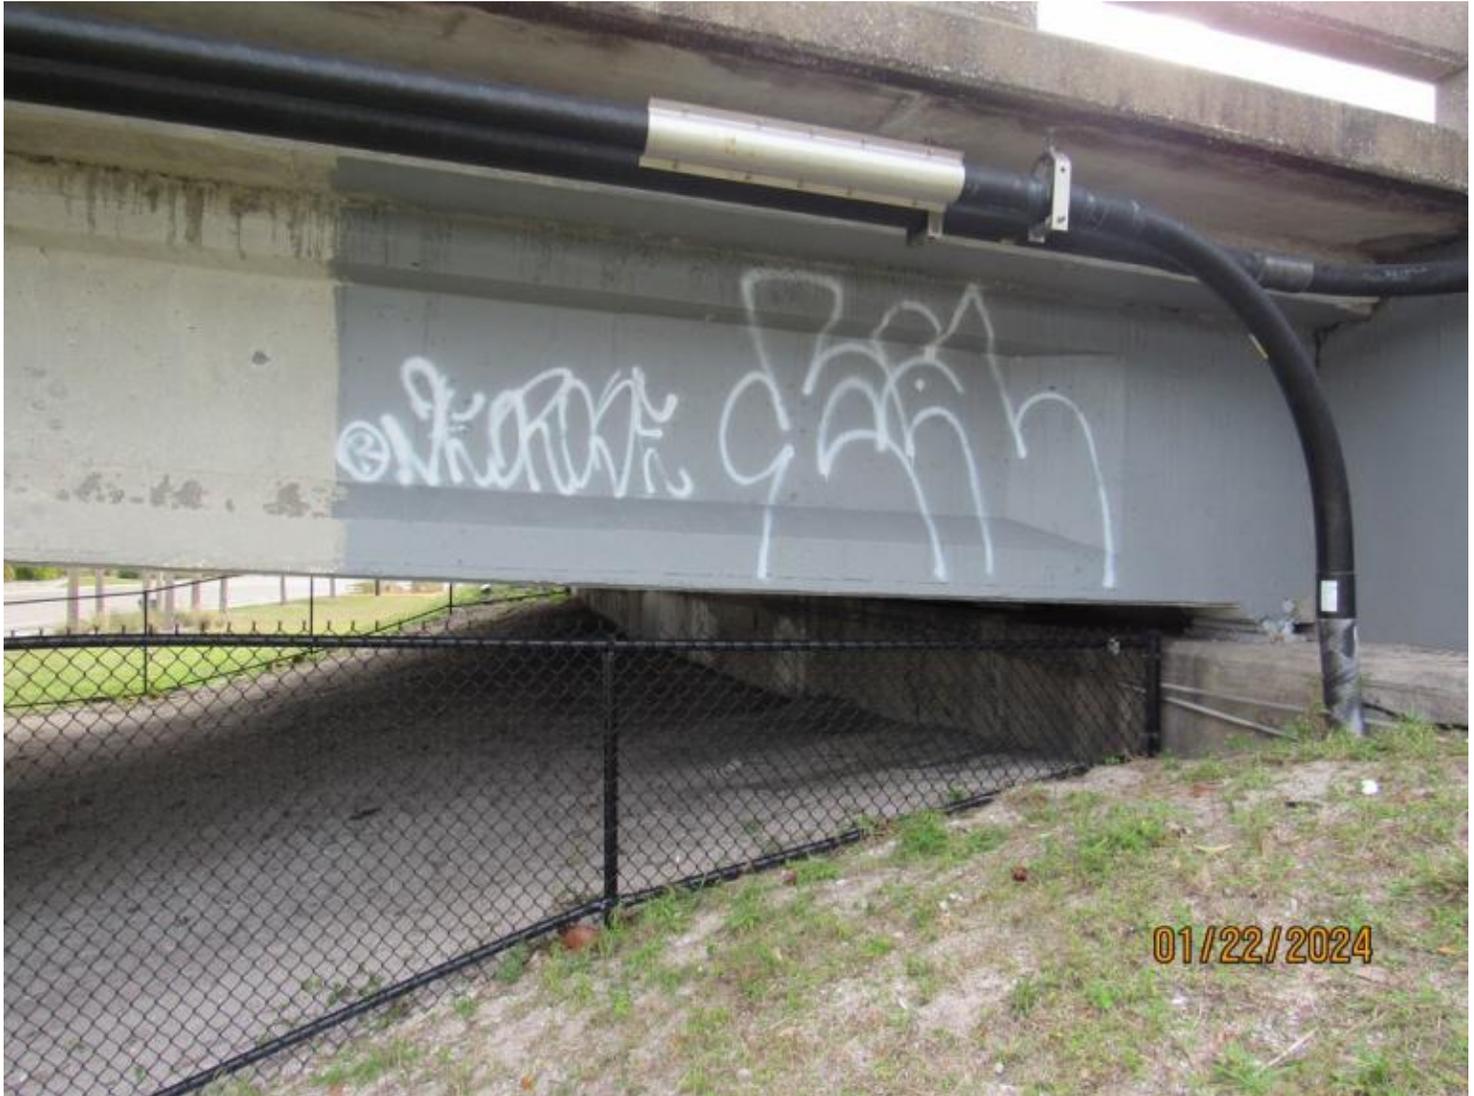
Photo 32: Element 109 Pre Opn Conc Girder/Beam

The beams in Spans 1 and 33 have graffiti - NEW. Refer to Photo 32. P3W0

Typical graffiti in Span 1 beams.

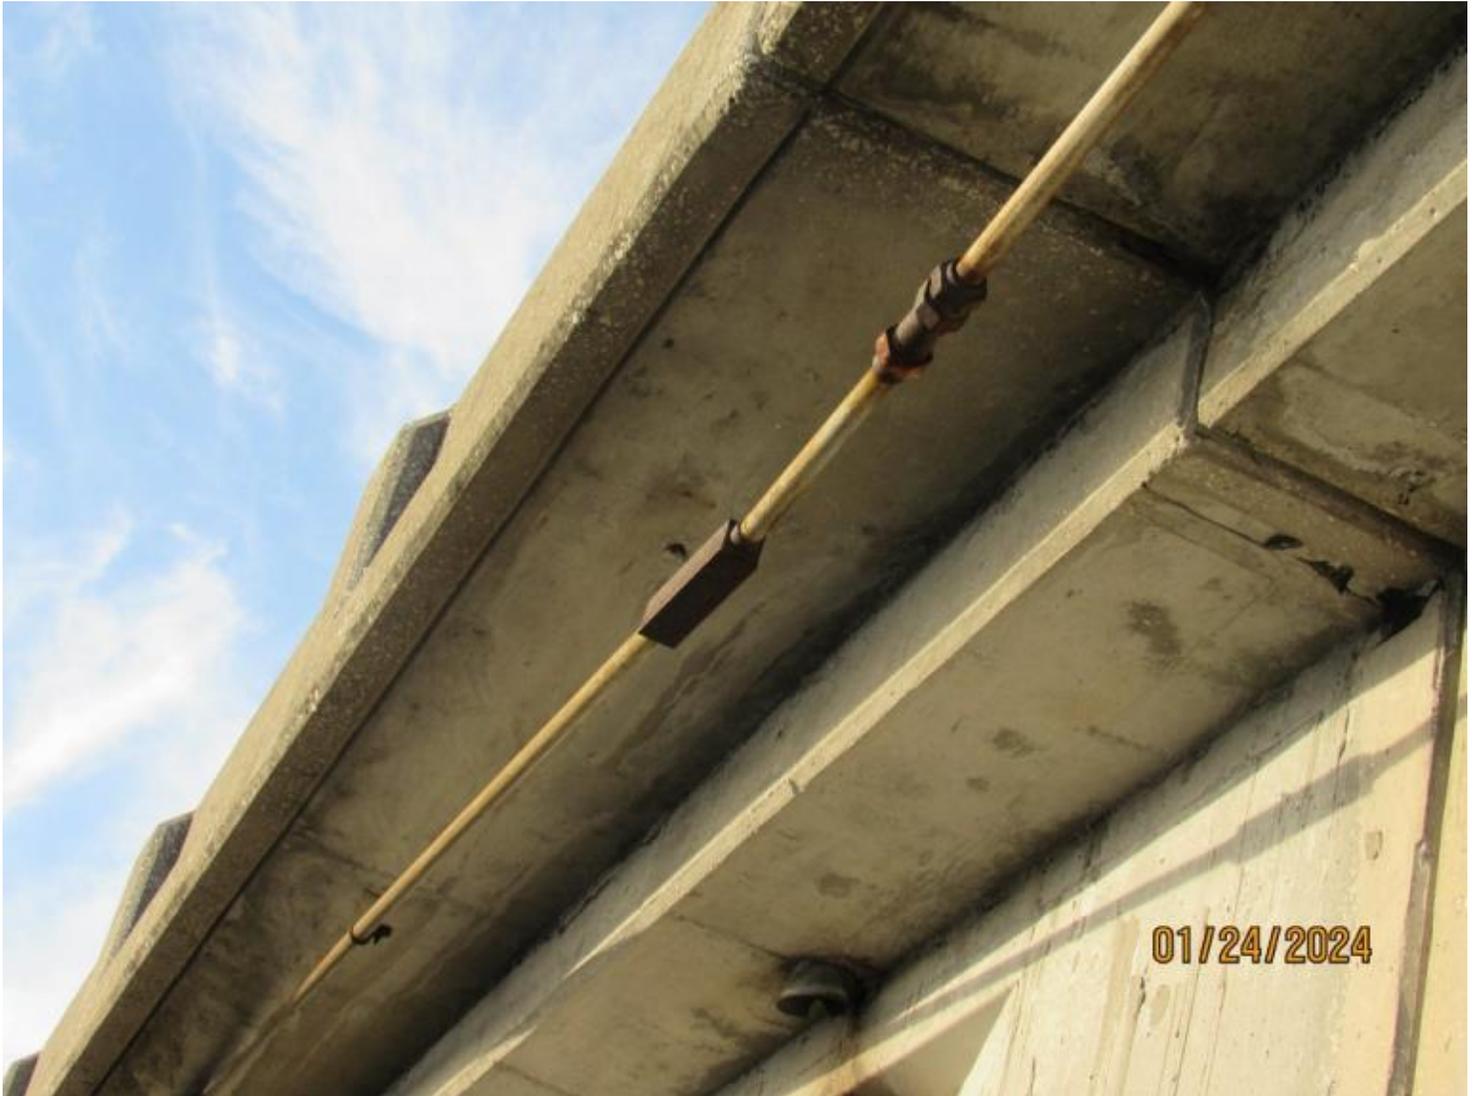
Photo 35: Inspection Notes

Utility conduits on the right overhang are sagging at Piers 5 and 11. Refer to Photo 35. REPAIR

Pier 5 right sagging utilities. Typical.

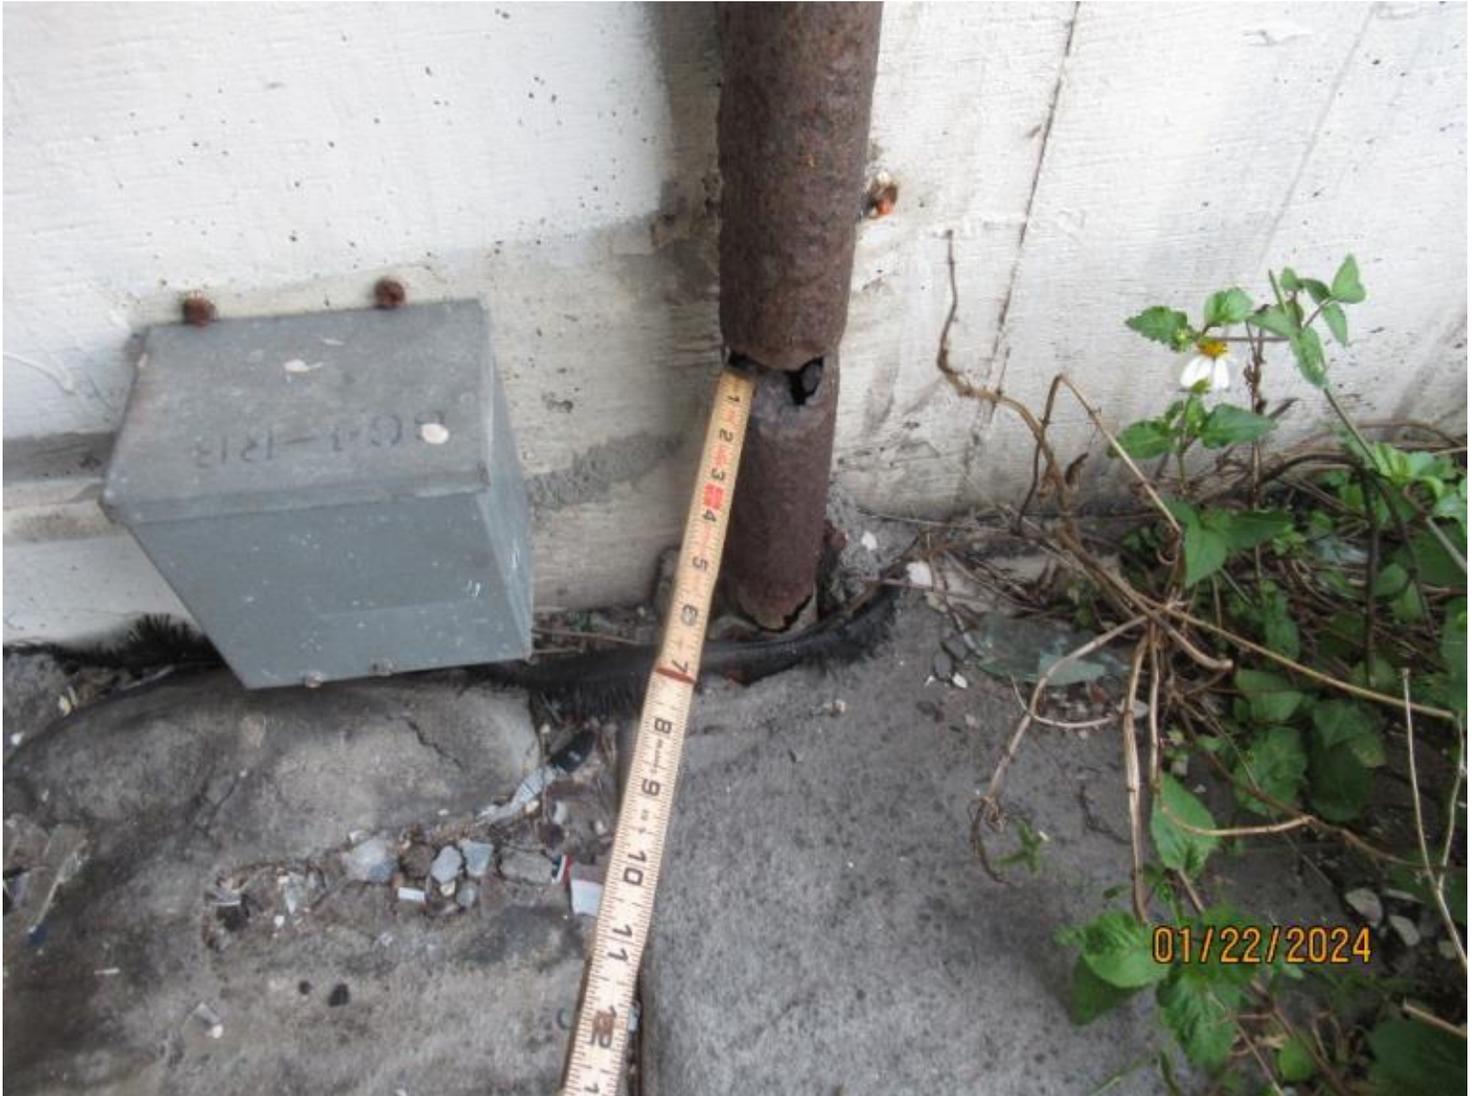
Photo 37: Inspection Notes

The utility conduit at Abutment 34 has a corrosion hole. Refer to Photo 37. REPAIR

Corrosion hole in Abutment 34 utility conduit.

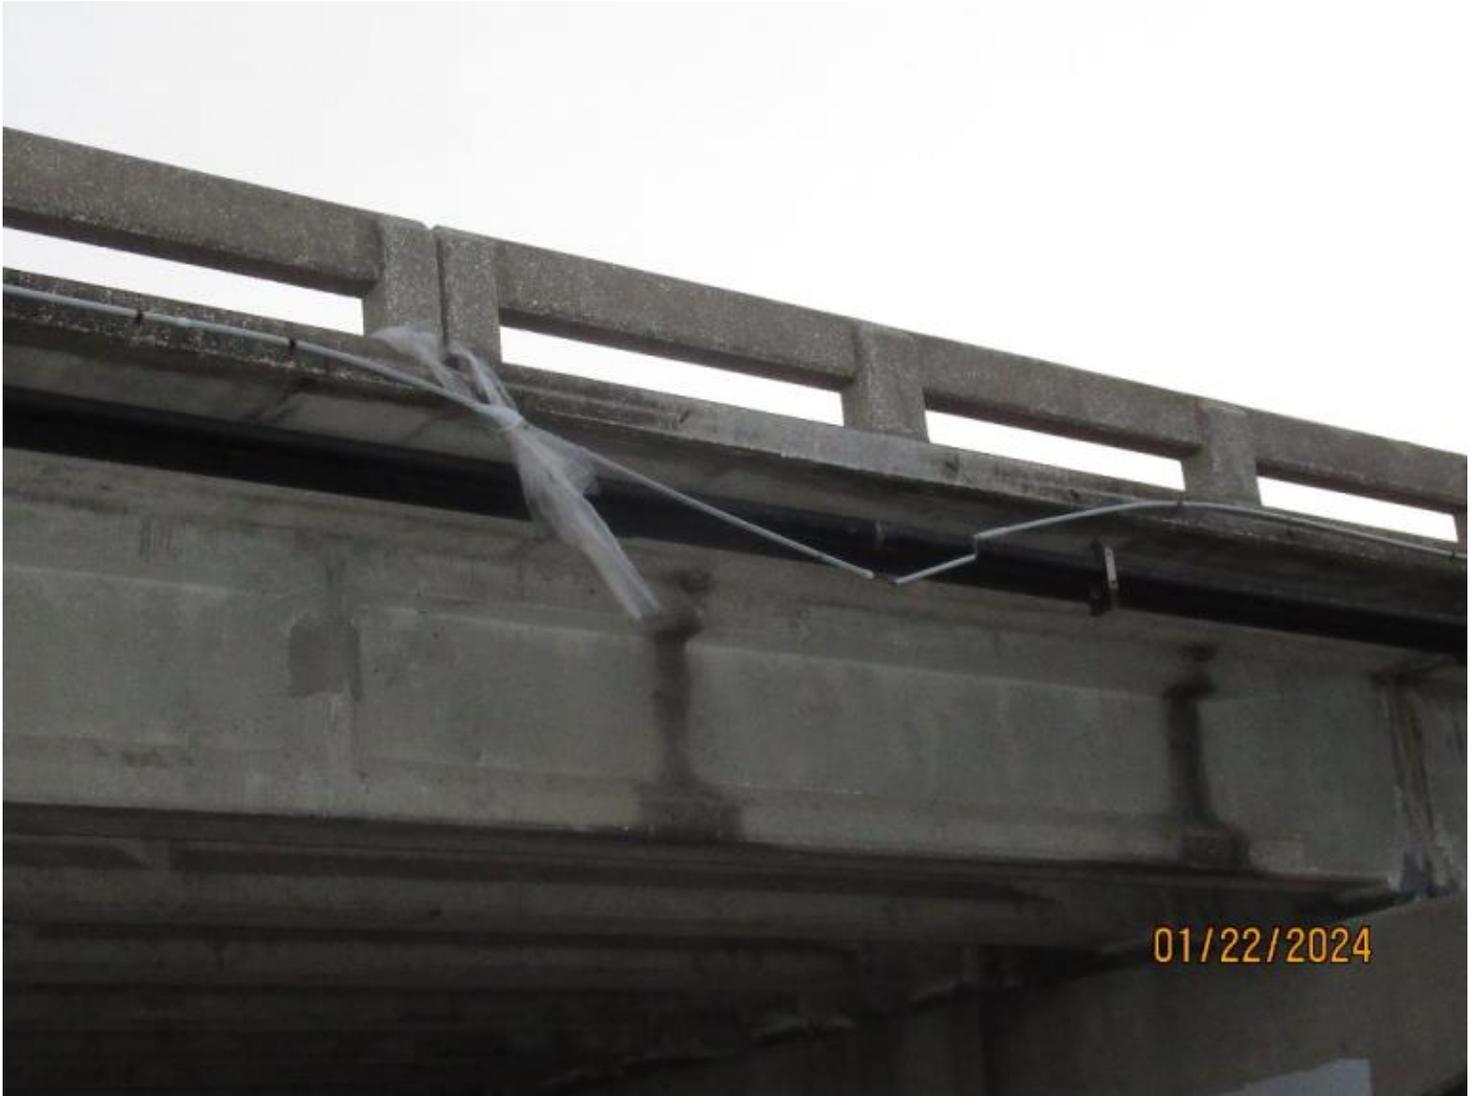
Photo 38: Inspection Notes

The conduit attached to the left side of Span 33 is separated and hanging with exposed internal wires - NEW. Refer to Photo 38. REPAIR

Conduit attached to the left side of Span 33 separated and hanging.

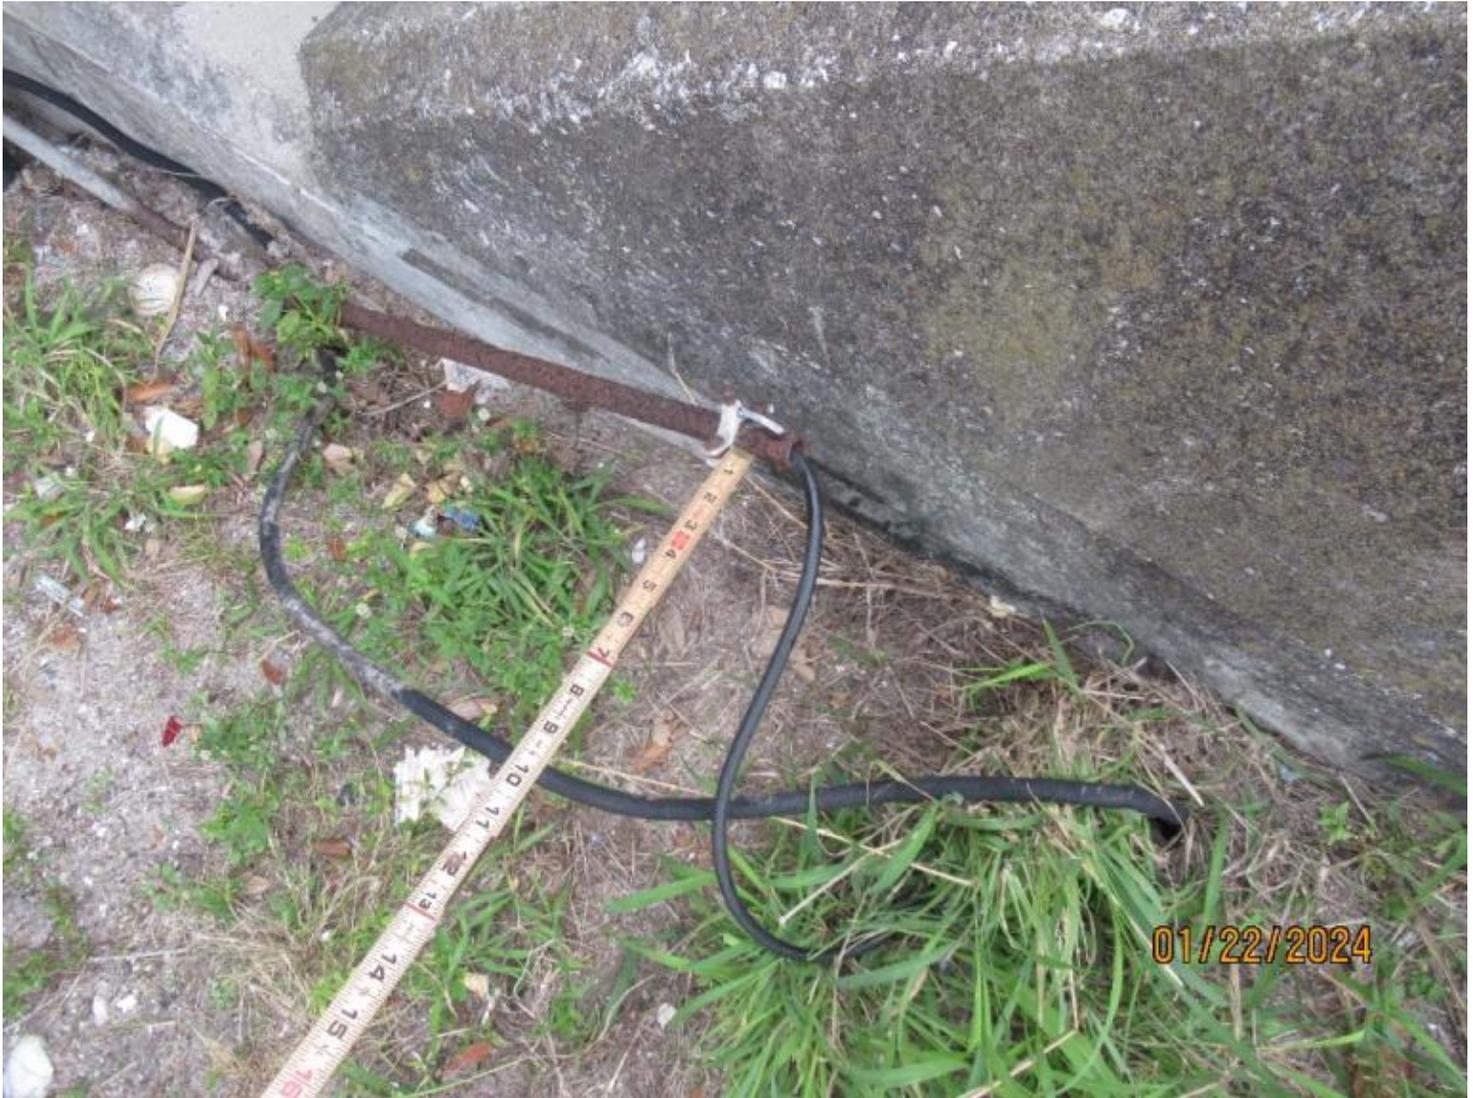
Photo 39: Inspection Notes

There are exposed wires at the west side of Abutment 1 - NEW. Refer to Photo 39. REPAIR

Exposed wires at the west side of Abutment 1.

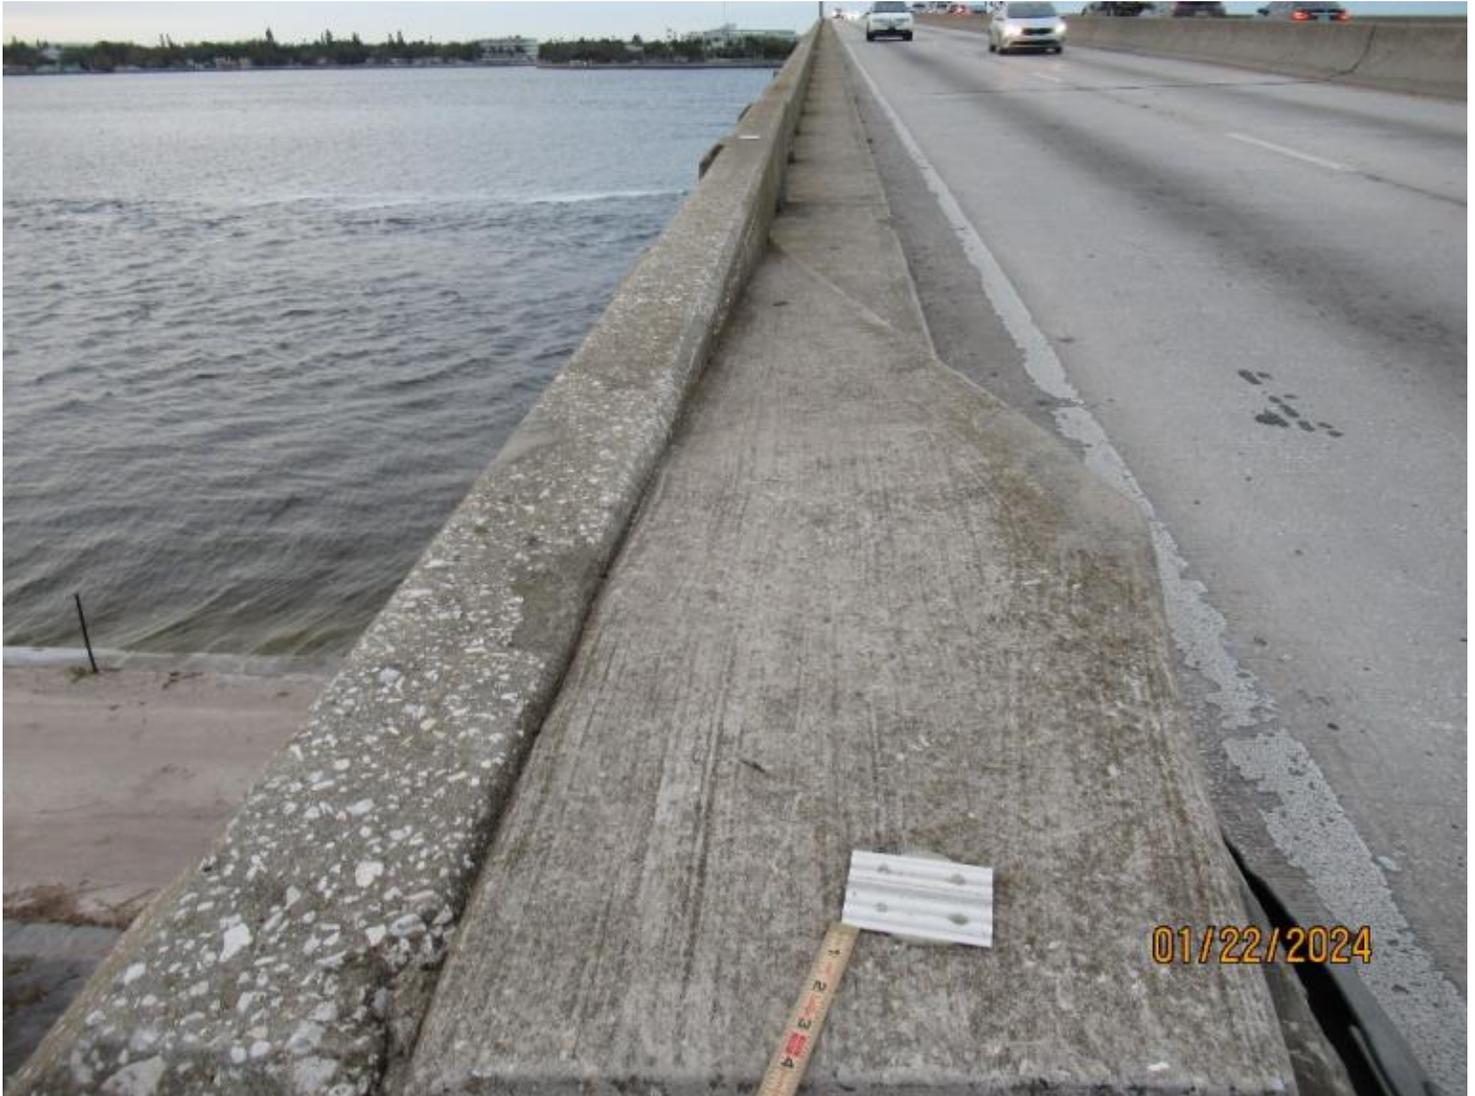
Photo 40: Inspection Notes

The bridge rails, median barriers and approach guardrails are missing reflectors randomly throughout - NEW. Refer to Photo 40. REPAIR

Typical missing reflector for the bridge rails.

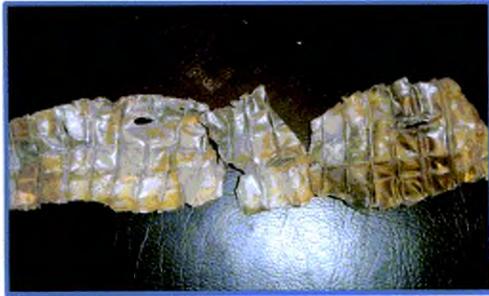
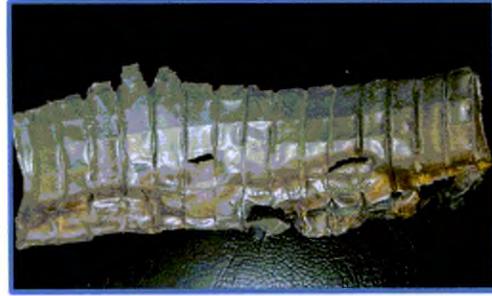
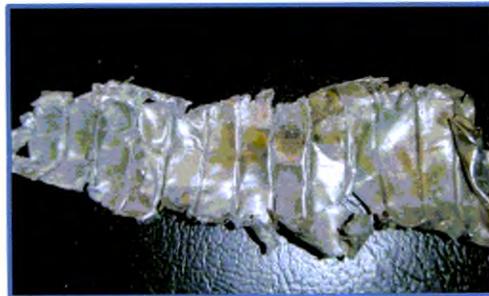
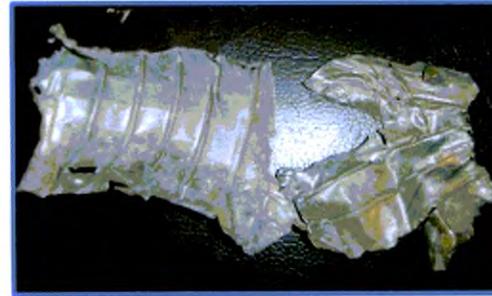
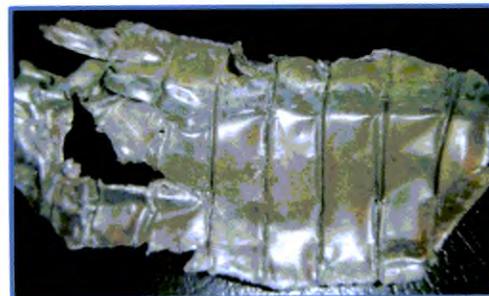
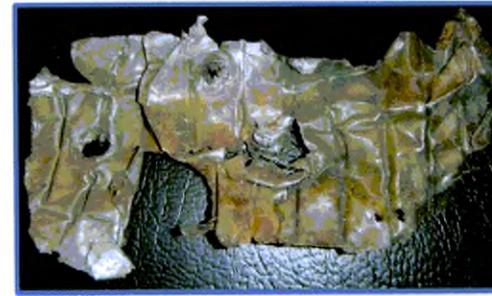
Figure 2. Condition on the inside surface of the ducts.

Table 2 shows the condition of the duct (exterior surface) and tendon at each excavation. No corrosion was found on the exterior surface of the ducts. All of the tendons exhibited varying amounts of minor surface corrosion with no discernable pitting. The inside surface of the ducts had varying amounts of minor corrosion (see Figure 2).
