**NESHAP ASBESTOS SURVEY REPORT AND
SCREENING FOR METALS-BASED COATINGS**

State Road 710 from US 441 to the L-63 Canal

**RE: NESHAP Asbestos Survey Report and Screening for Metals-Based Coatings
SR 710 over Interceptor Canal L-63N (Bridge No. 910065)**

SR 710 from US 441 to the L-63 Canal
Okeechobee County, Florida
FPID: 419344-3-32-01
Tierra Project No.: 6511-12-054A

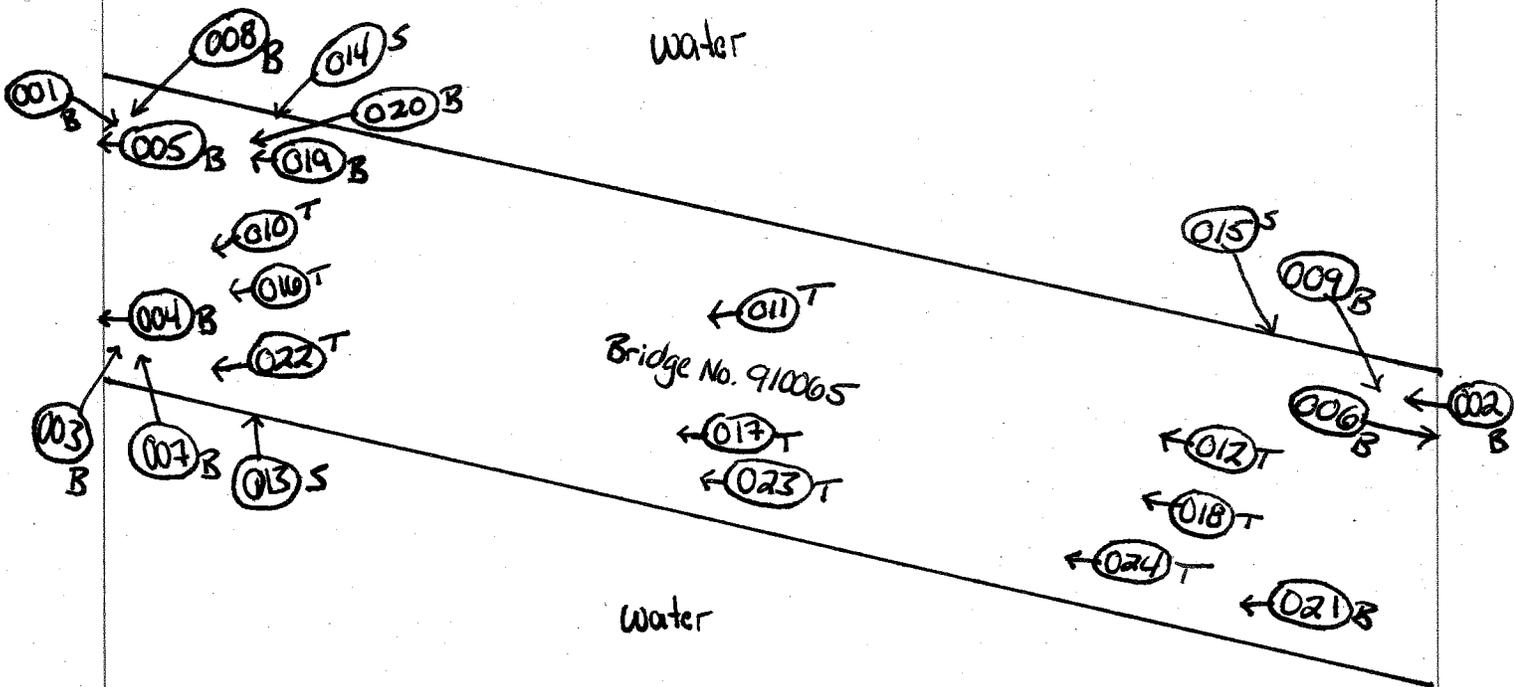
Sample Location Sketch

HA #: 1	Sample #: 001	Friable: Y / (N)	Condition: Good
Material Description: Black Bearing Pad		Location(s): NW CORNER - Between Girder + End Bent	
HA #: 1	Sample #: 002	Friable: Y / (N)	Condition: Good
Material Description: "		Location(s): NE CORNER - Between Girder + End Bent	
HA #: 1	Sample #: 003	Friable: Y / (N)	Condition: Good
Material Description: "		Location(s): SW CORNER, Between Girder + End Bent	
HA #: 2	Sample #: 004	Friable: Y / (N)	Condition: Good
Material Description: Gr. End Bent Concrete		Location(s): SW CORNER, End Bent	
HA #: 2	Sample #: 005	Friable: Y / (N)	Condition: Good
Material Description: "		Location(s): NW CORNER, End Bent	
HA #: 2	Sample #: 006	Friable: Y / (N)	Condition: Good
Material Description: "		Location(s): NE CORNER, End Bent	
HA #: 3	Sample #: 007	Friable: Y / (N)	Condition: Good
Material Description: Gr. Girder Concrete		Location(s): SW CORNER, Girder	
HA #: 3	Sample #: 008	Friable: Y / (N)	Condition: Good

Material Description: "		Location(s): NW CORNER, Girder	
HA #: 3	Sample #: 009	Friable: Y / (N)	Condition: Good
Material Description: "		Location(s): NE CORNER, Girder

HA #: <i>4</i>	Sample #: <i>010</i>	Friable: <i>Y / (N)</i>	Condition: <i>Good</i>
Material Description: <i>Gr. Deck Concrete</i>		Location(s): <i>W. Area, Deck</i>	
Approx. Amount:			
HA #: <i>4</i>	Sample #: <i>011</i>	Friable: <i>Y / (N)</i>	Condition: <i>Good</i>
Material Description: "		Location(s): <i>C. Area, Deck</i>	
Approx. Amount:			
HA #: <i>4</i>	Sample #: <i>012</i>	Friable: <i>Y / (N)</i>	Condition: <i>Good</i>
Material Description: "		Location(s): <i>E. Area, Deck</i>	
Approx. Amount:			
HA #: <i>5</i>	Sample #: <i>013</i>	Friable: <i>Y / (N)</i>	Condition: <i>Good</i>
Material Description: <i>Gr. Barrier Wall Concrete</i>		Location(s): <i>SW Corner, Barrier Wall</i>	
Approx. Amount:			
HA #: <i>5</i>	Sample #: <i>014</i>	Friable: <i>Y / (N)</i>	Condition: <i>Good</i>
Material Description: "		Location(s): <i>NW Corner, Barrier Wall</i>	
Approx. Amount:			
HA #: <i>5</i>	Sample #: <i>015</i>	Friable: <i>Y / (N)</i>	Condition: <i>Good</i>

Material Description: "		Location(s): <i>NE Corner, Barrier Wall</i>	
Approx. Amount:			
HA #: <i>6</i>	Sample #: <i>016</i>	Friable: <i>Y / (N)</i>	Condition: <i>Good</i>
Material Description: <i>Black Reflector Mastic</i>		Location(s): <i>W. Area, Deck</i>	
Approx. Amount:			
HA #: <i>6</i>	Sample #: <i>017</i>	Friable: <i>Y / (N)</i>	Condition: <i>Good</i>
Material Description: "		Location(s): <i>C. Area, Deck</i>	
Approx. Amount:			
HA #: <i>6</i>	Sample #: <i>018</i>	Friable: <i>Y / (N)</i>	Condition: <i>Good</i>
Material Description: "		Location(s): <i>E. Area, Deck</i>	
Approx. Amount:

HA #: 7	Sample #: 019	Friable: Y / (N)	Condition: Good
Material Description: Gr. Pile Concrete		Location(s): W. Best. N. Pile	
		Approx. Amount:	
HA #: 7	Sample #: 020	Friable: Y / (N)	Condition: Good
Material Description: "		Location(s): "	
		Approx. Amount:	
HA #: 7	Sample #: 021	Friable: Y / (N)	Condition: Good
Material Description: "		Location(s): E. Best S. Pile	
		Approx. Amount:	
HA #: 8	Sample #: 022	Friable: Y / (N)	Condition: Good
Material Description: Gr. Expansion Fill		Location(s): W. Area, Deck	
		Approx. Amount:	
HA #: 8	Sample #: 023	Friable: Y / (N)	Condition: Good
Material Description: "		Location(s): C. Area, Deck	
		Approx. Amount:	
HA #: 8	Sample #: 024	Friable: Y / (N)	Condition: Good
Material Description: "		Location(s): E. Area, Deck	
		Approx. Amount:	
HA #:	Sample #:	Friable: Y / N	Condition:
Material Description:		Location(s):	
		Approx. Amount:	
HA #:	Sample #:	Friable: Y / N	Condition:
