# CONTAMINATION SCREENING EVALUATION REPORT

## (MAINLINE AND DRAINAGE SITES)

CR 887 (Old US 41) Project Development and Environment Study

From US 41 to Lee County Line and from Collier County Line to Bonita Beach Rd

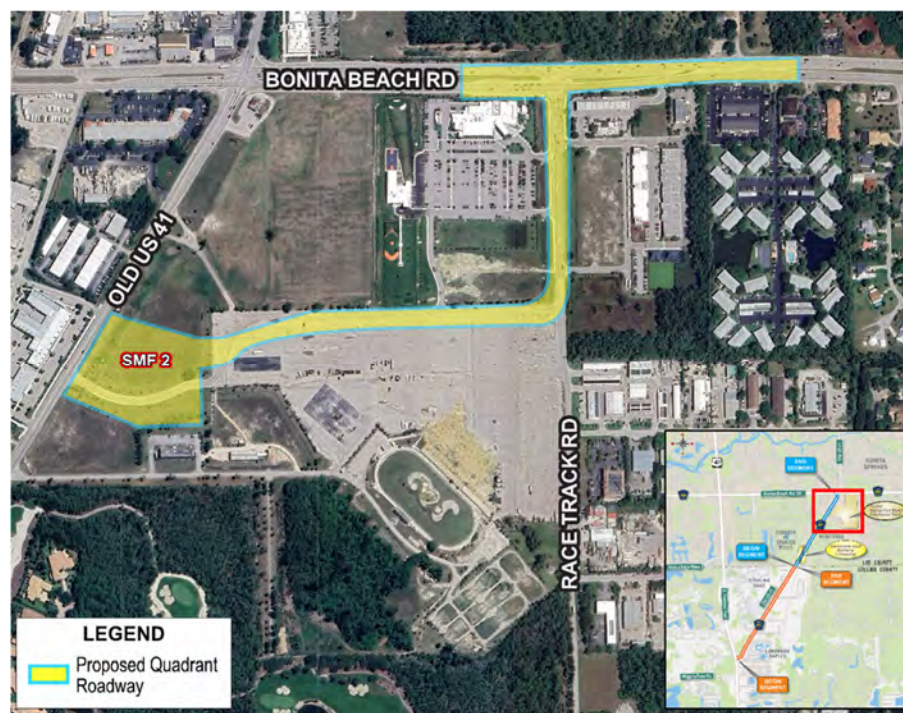
**Figure 2-1: Proposed Quadrant Roadway Location Map**

The proposed improvement will expand the roadway to a four-lane divided roadway with 11-foot travel lanes. The Preferred Alternative would require the purchase of additional ROW includes a shared use path and bicycle lanes in both directions. There are no improvements planned for Old 41 north of the proposed new Quadrant Roadway, including the Old 41 and Bonita Beach Road intersection. The proposed new Quadrant Roadway connects Old 41 with Race Track Road (**Figure 2-1**) which then continues onto Bonita Beach Road for the rest of the project segment. The new Quadrant Roadway will be a 2-lane undivided road with 11-ft travel lanes, a 12-ft shared use path, an 8-ft sidewalk within a total of 70-ft ROW.
