CONTAMINATION TECHNICAL MEMORANDUM FOR MAINLINE AND DRAINAGE SITES

Florida Department of Transportation

Harborview Road PD&E Re-evaluation

Limits of Project: From Melbourne Street to I-75

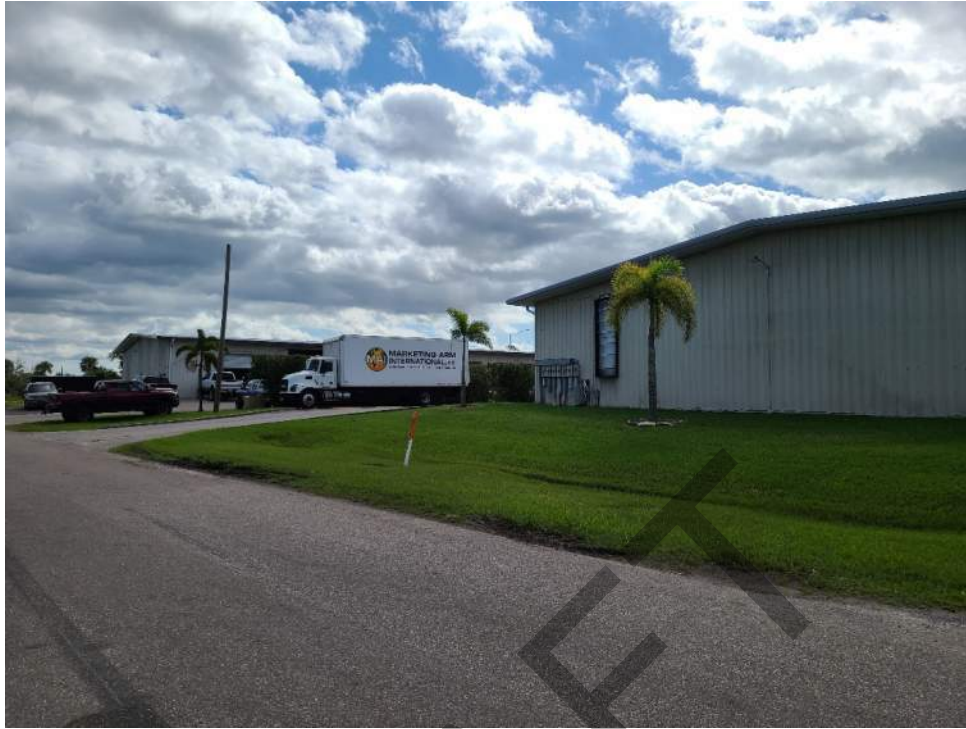
Site 1 – Marketing Arm International  
Janice Avenue looking southeast

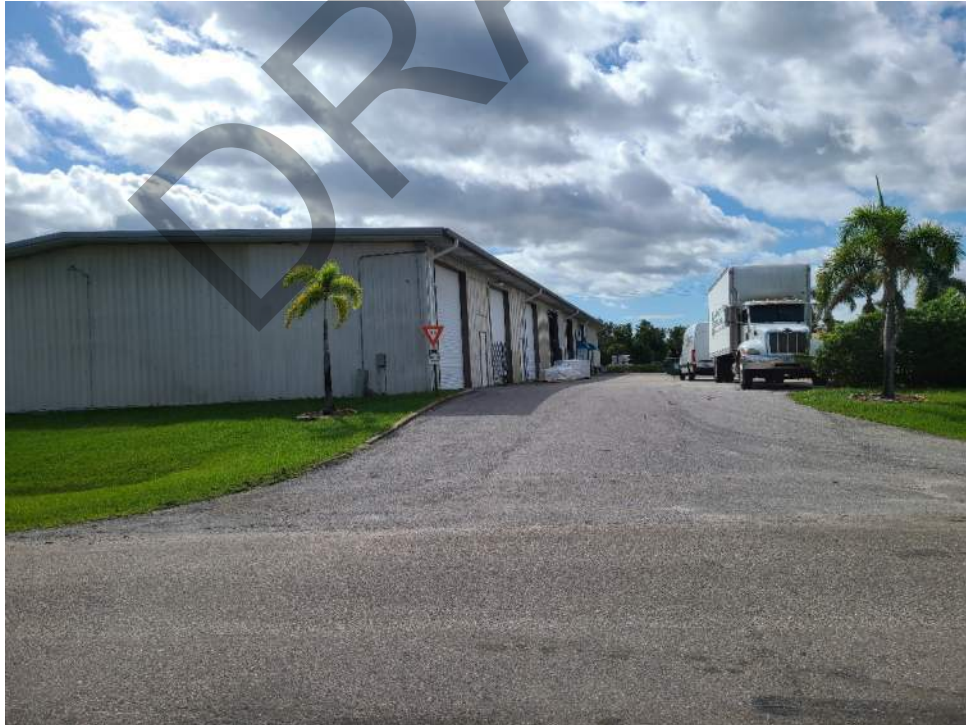
Site 1 – Marketing Arm International  
Janice Avenue looking south

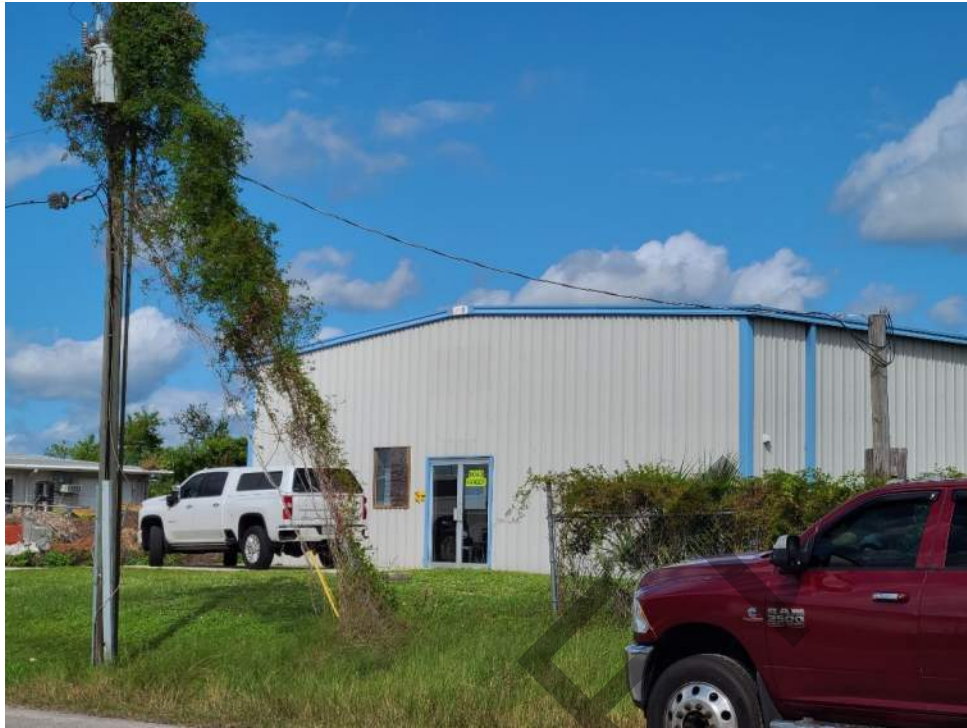
Site 2 – Former Bailey’s Towing  
Janice Avenue looking northwest

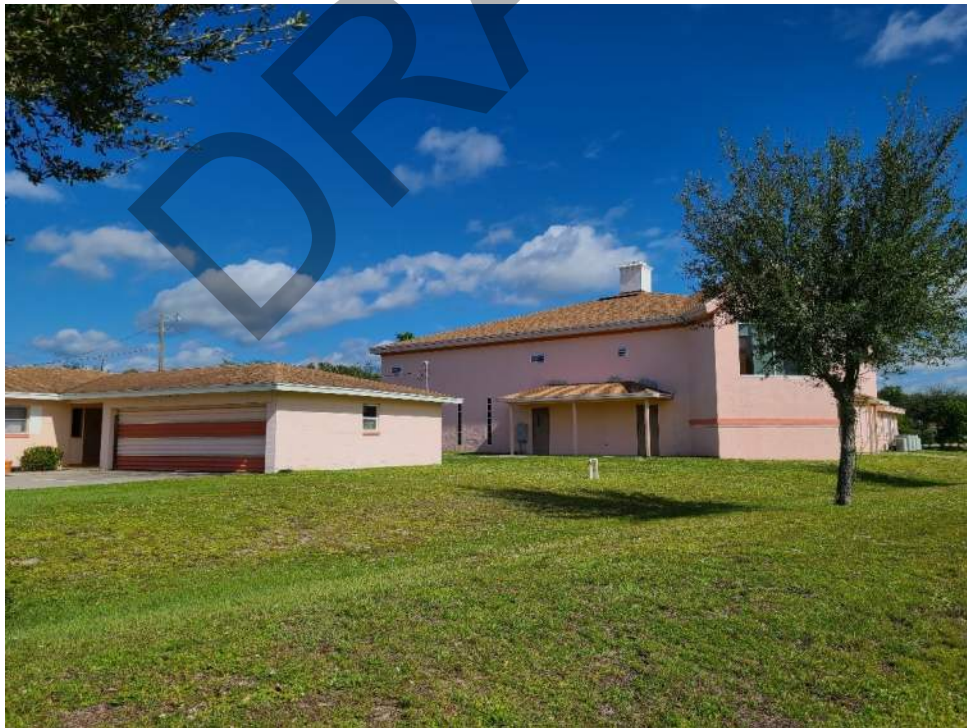
Site 4 – Bethanie 7<sup>th</sup> Day Adventist Church  
Harborview Road looking northeast

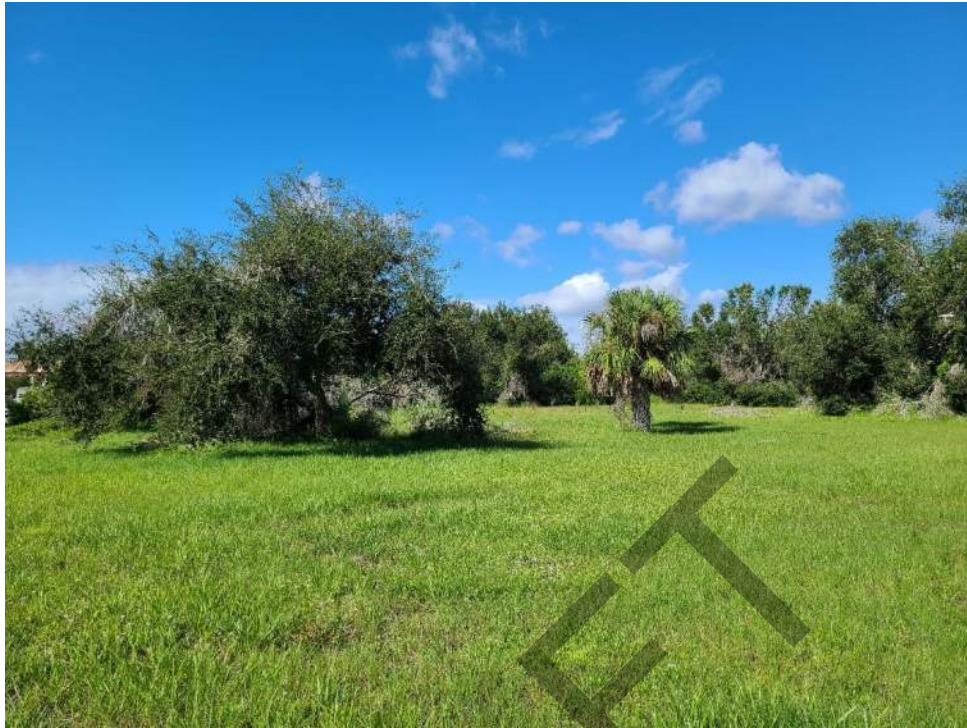
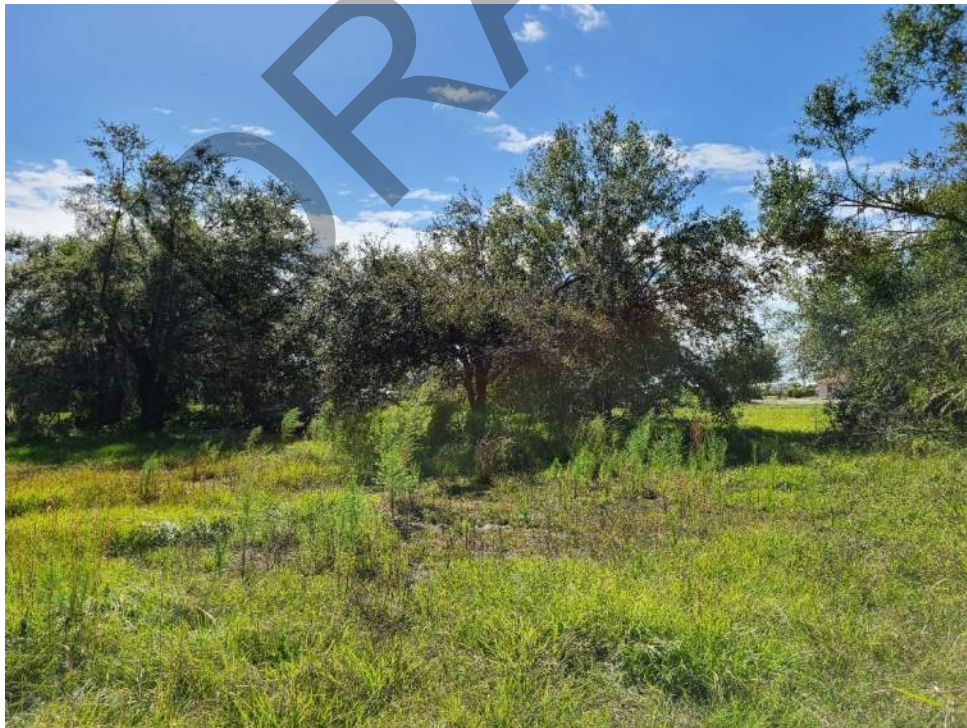
Site 7 – Former Groves  
Harborview Road looking west

- One site (Map ID 7 – Former Groves) is assigned a risk rating of Medium. Level II testing is recommended given the potential for contamination impacts related to the use of pesticides and herbicides. The Former Groves appear to be adjoining north of the Harborview Road mainline and therefore Level II testing is warranted. Laboratory analysis of soil samples may include one or more of the following: arsenic by EPA Method 6010, Organochlorine Pesticides by EPA Method 8081, Organophosphorus Pesticides by EPA Method 8141, and Chlorinated Herbicides by EPA Method 8151. If impacts from this site are identified during Level II testing, Level III support activities such as source removal

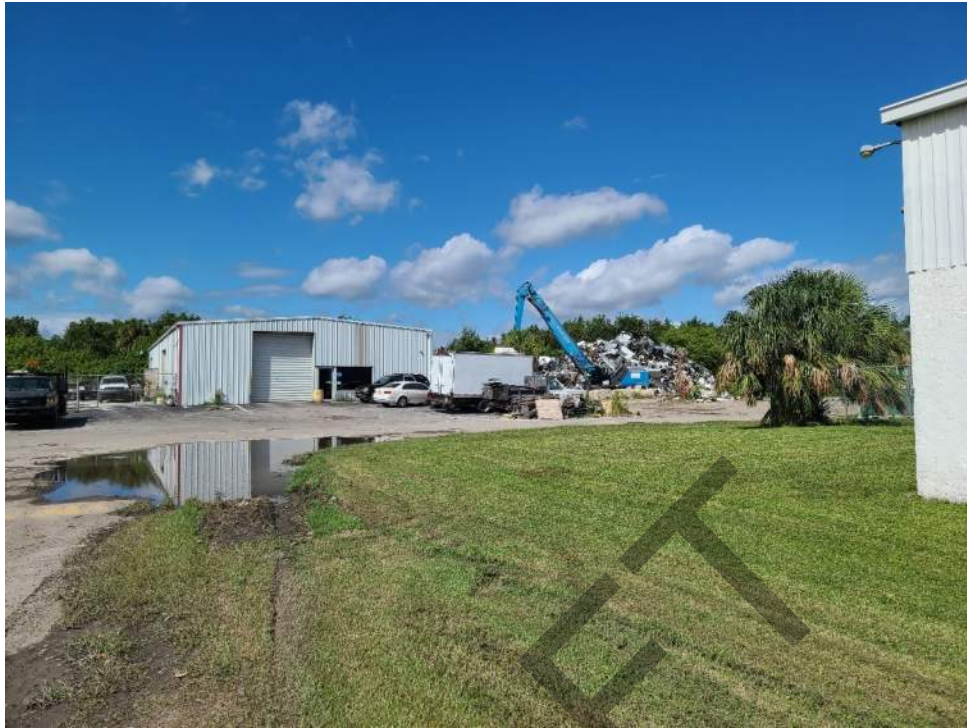
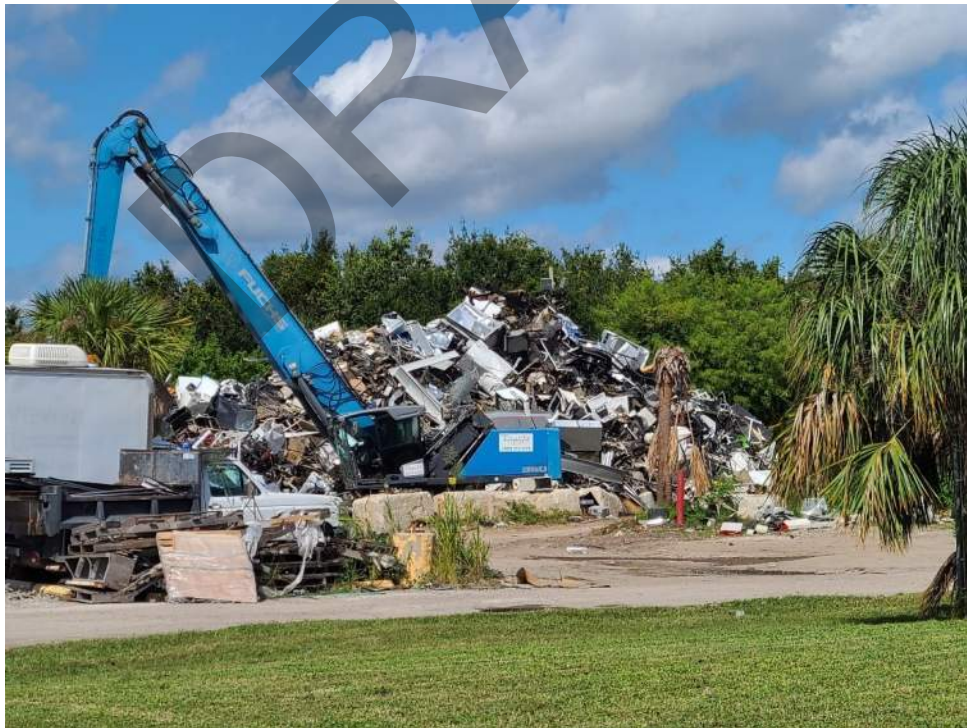
Site 9 – Allied Recycling Port Charlotte  
James Street looking west

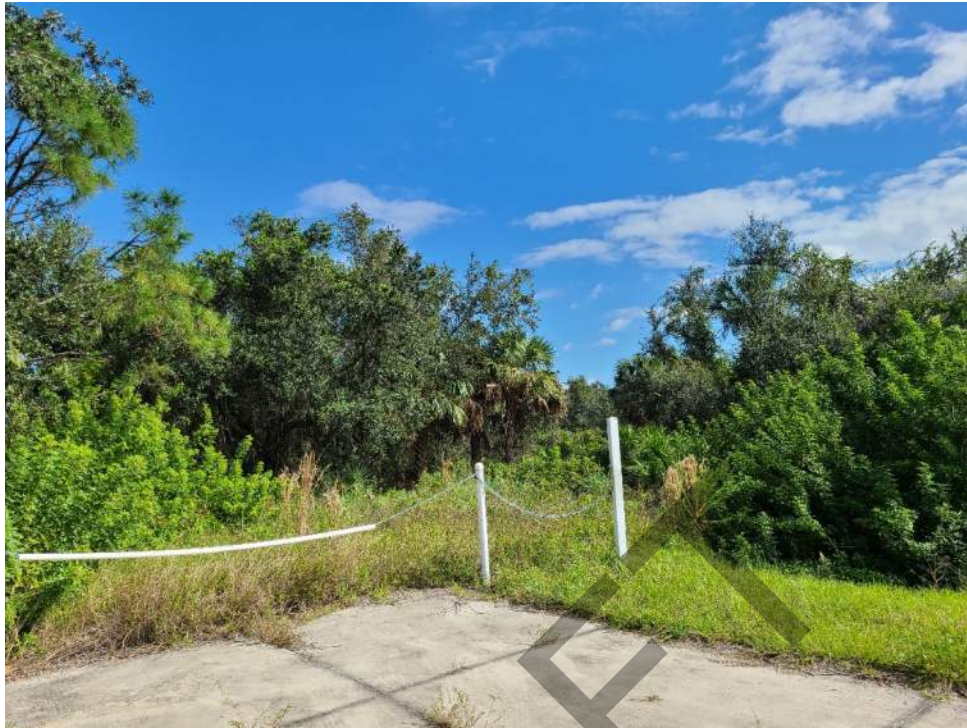
SMF 4	N/A	No	<p>This drainage site was first identified in the September 2021 CSER (Drainage) as Pond 4B and was assigned a risk rating of No. A risk rating of No was assigned due to the lack of reported contamination concerns, and the undeveloped status of Pond 4B. Aerial photographs (<b>Appendix B</b>) depict woods from 2022 to 2023. During the September 2021 and October 2023 site reconnaissance, Pond 4B was observed as woods. No contamination concerns were observed. No regulatory information was identified for SMF 4.</p> <p><b>Risk Rating:</b> Given the lack of reported contamination concerns, this site retains a risk rating of No.</p>
SMF 5-6	N/A	No	<p>This drainage site was first identified in the February 2018 Contamination Technical Memorandum as Pond 5, and the September 2021 CSER (Ponds) as Pond 5C. Both previous drainage reports assigned a risk rating of No. A risk rating of No was assigned due to the lack of reported contamination concerns, and the undeveloped status of Pond 5/Pond 5C. Aerial photographs (<b>Appendix B</b>) depict woods and a trail from 2022 to 2023. During the September 2021 and October 2023 site reconnaissance, Pond 5C was observed as woods. Inspection of the drainage site in October 2023 was not possible due to a security gate. No regulatory files were found, and no contamination concerns were observed.</p> <p><b>Risk Rating:</b> Given the lack of reported contamination concerns, this site retains a risk rating of No.</p>

SMF 4  
Looking northeast

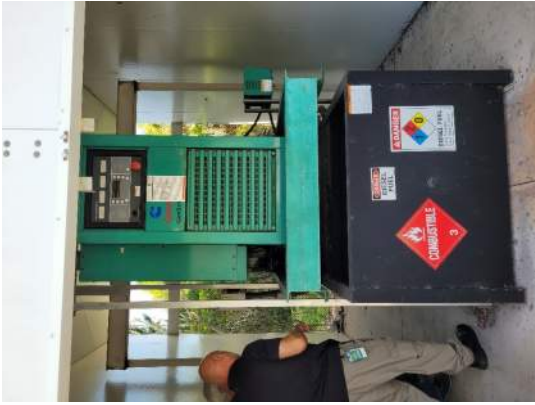
Site Overview

**TANKS:** Consists of one (1) 750-gallon diesel, steel, double-walled, sub-base generator tank EQ - 66. Tank coating appears to be in satisfactory condition. No dripping/leaking issues were observed during the inspection. Tank interstitial is, visually and electronically monitored. No active alarm noted during the inspection.

**SPILL CONTAINMENT:** - OPW Pomeco : EQ-226 Single-walled (SW) spill bucket mounted on top of the tank, with a drain valve that goes directly into the tank. No evidence of cracking or product/liquid observed during the inspection. The system is properly labeled.

**OVERFILL PROTECTION:** – Equipped with an Krueger leal guage EQ - 730. The vents are present and observed to be in satisfactory condition.

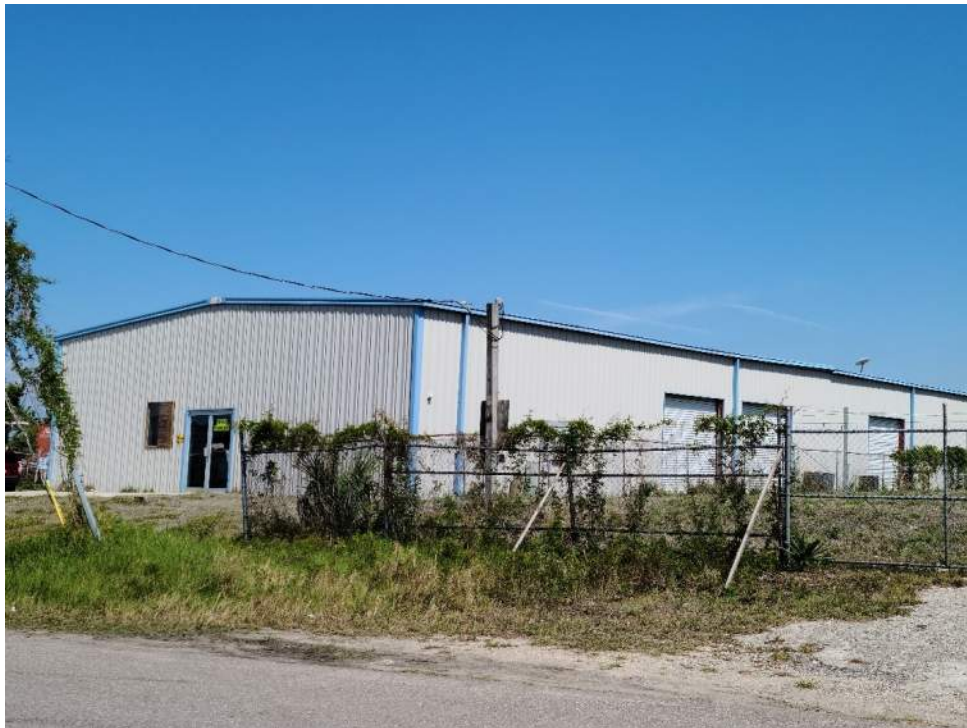
Site 2 – Former Bailey's Towing  
Janice Avenue looking northwest

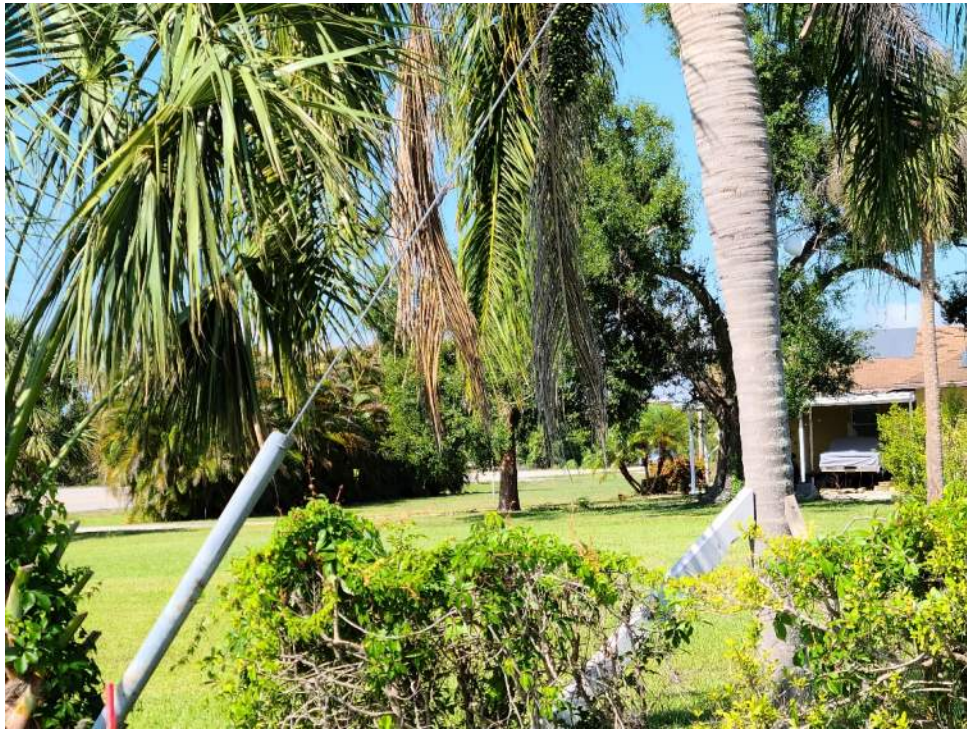
*	<b>SMF 1-2</b>	N/A	No	SMF 1-2 was not previously identified in the PD&E CSER dated October 2018. No regulatory information was identified for SMF 1-2. During the site reconnaissance, SMF 1-2 was observed as three residential homes. No contamination concerns were observed. Given a lack of contamination concerns associated with SMF 1-2, it was assigned a risk rating of No.

Eastern portion Pond SMF 1-2  
Lavern Street, looking southwest

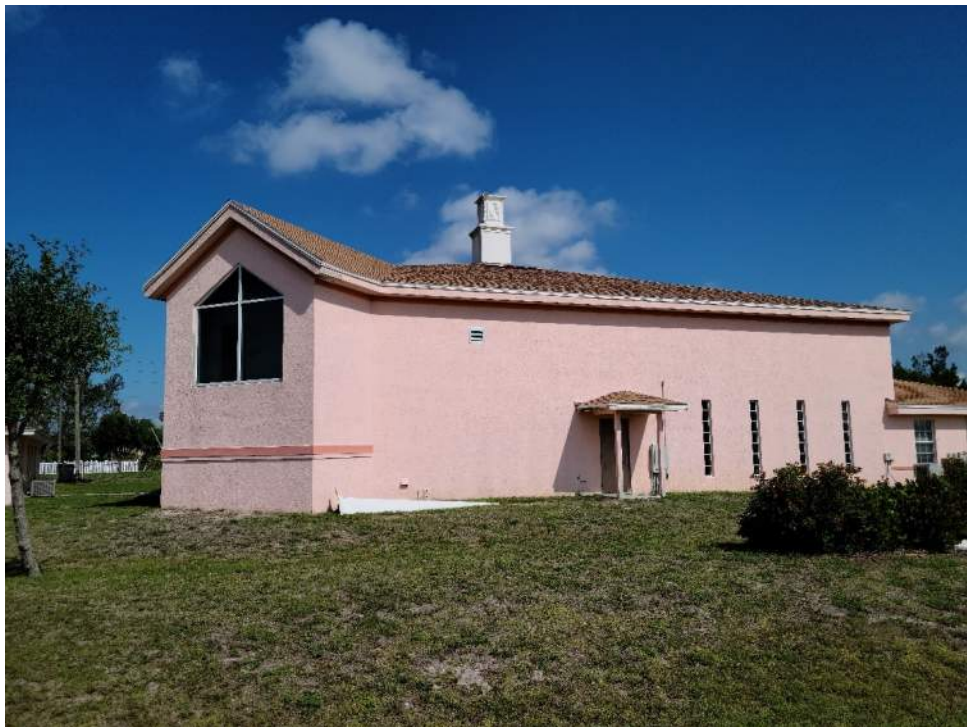
Site 4 – Bethanie 7<sup>th</sup> Day Adventist Church  
Harborview Road looking northwest

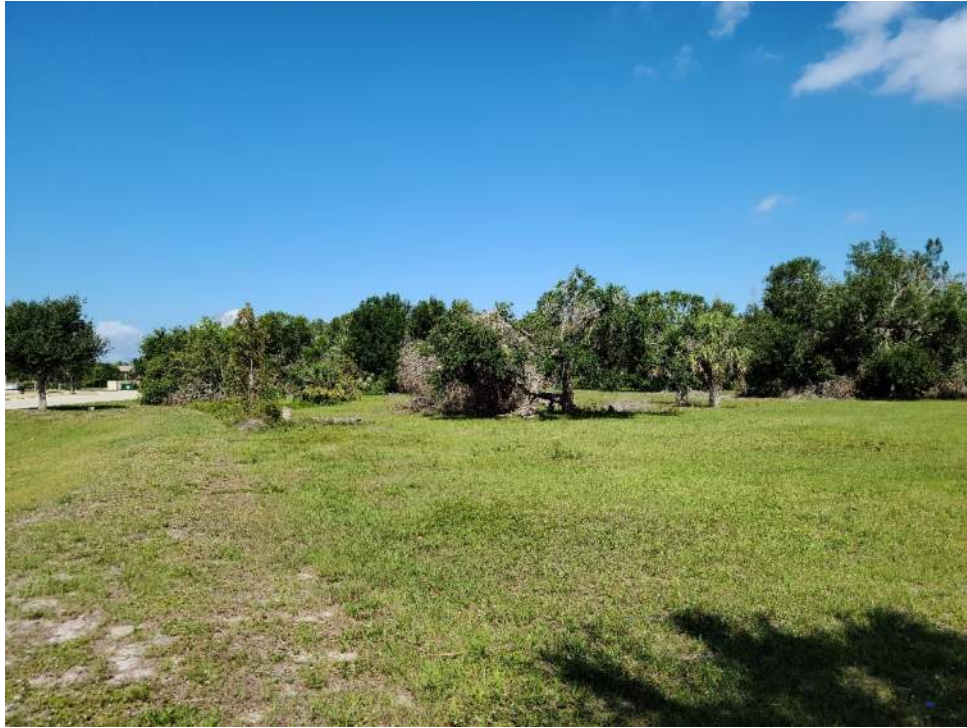
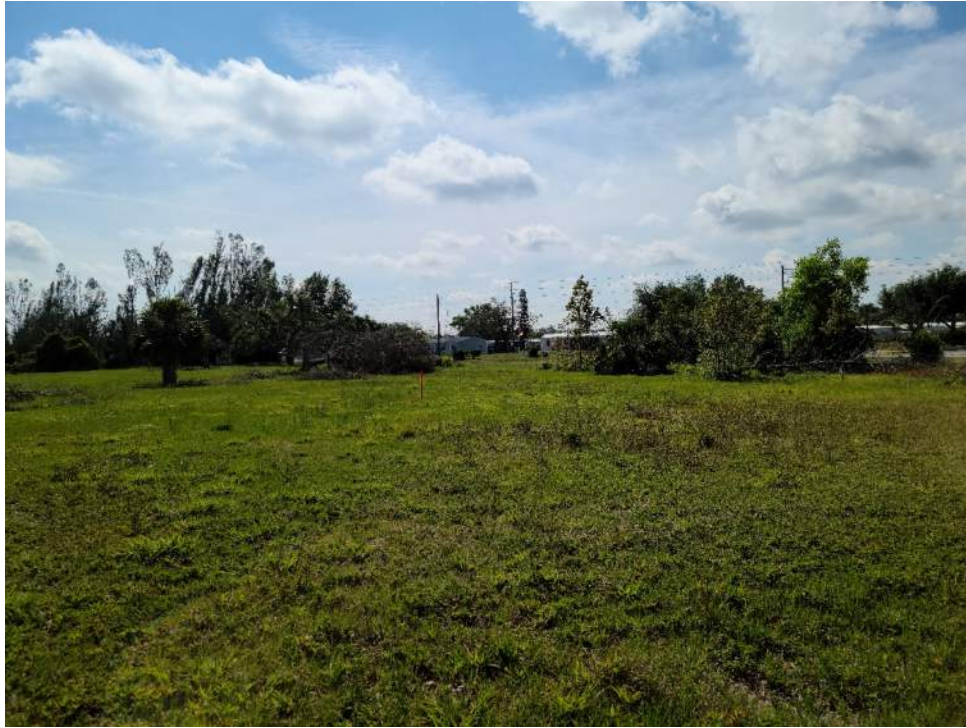
Site 7 – Former groves  
Near central portion of project looking northwest

Site 7 – Former groves  
Near central portion of project looking east

Site 7 – Former groves  
Near central portion of project looking southeast
